PRELIMINARY AIRCRAFT ACCIDENT REPORT

A02/19

**ACCIDENT INVOLVING BD100 CHALLENGER REGISTRATION 9M-TST
AT SULTAN ABDUL AZIZ SHAH AIRPORT, SUBANG, SELANGOR**

18 MARCH 2019

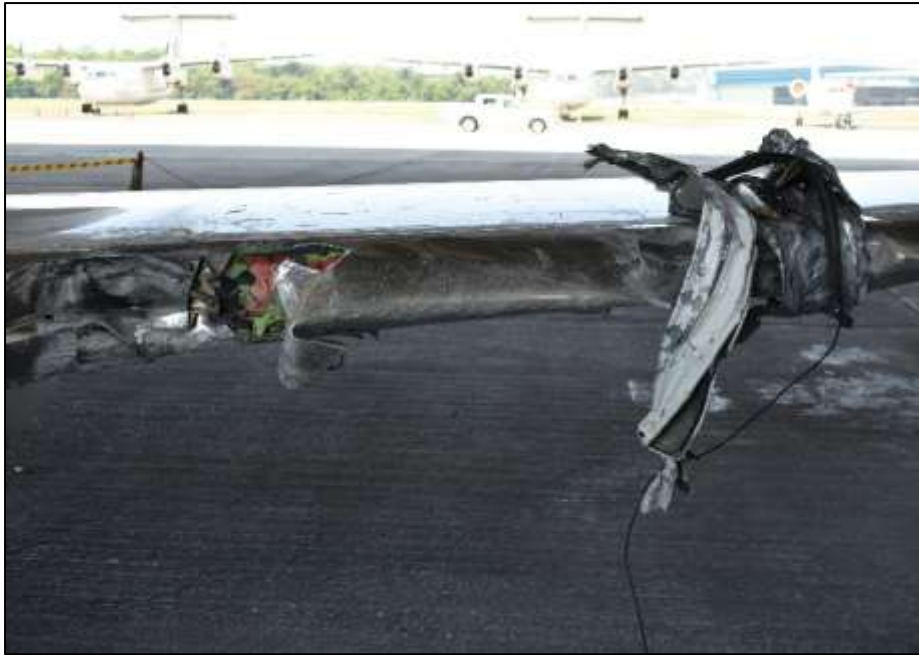
Severe damage to LH mid wing leading edge and front Spar.

Picture 1 – Mid wing leading edge’s damages with parts of the vehicle Perodua Kembara’s roof stuck to it.

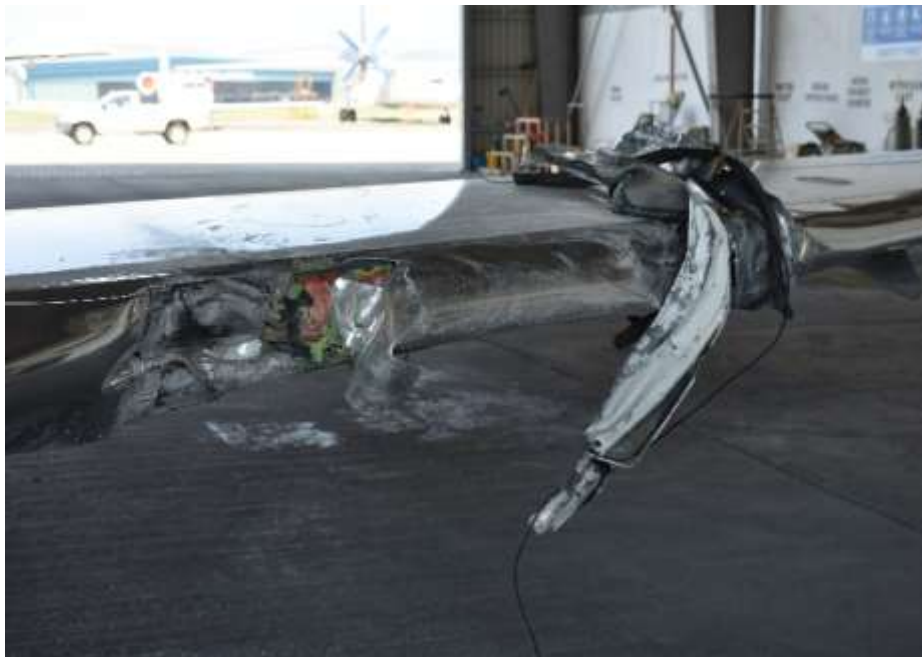
Severe damage to LH mid wing leading edge

Picture 2 – LH mid wing leading edge

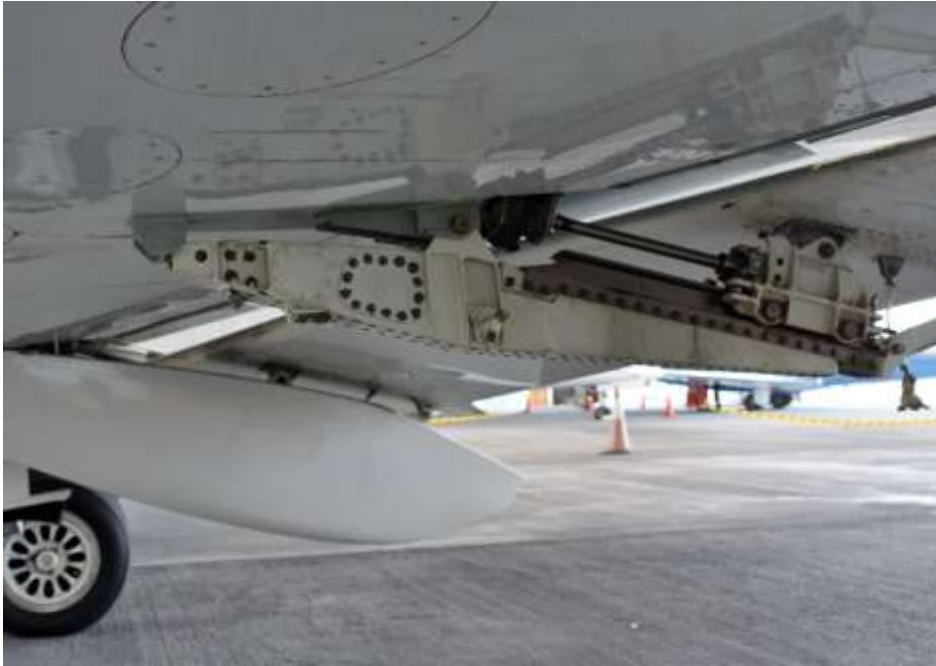
Lower wing surface and fuel panel dented and numerous gauges and scratches on upper and lower areas of the wing surface.

Picture 3 – Damages to the lower wing surface.

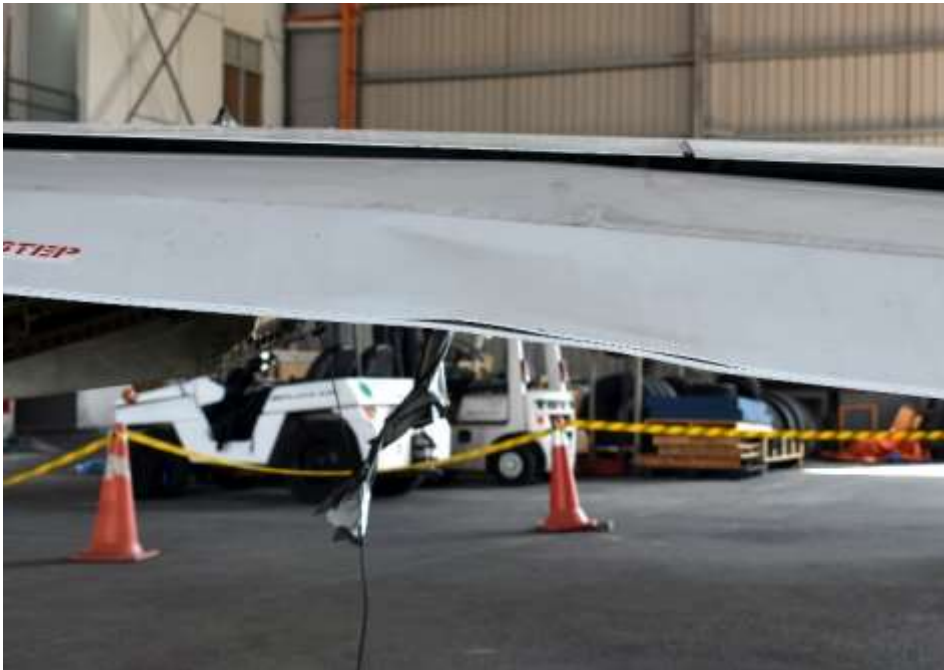
Damages to the trailing edge flaps and flaps carriage.

Picture 4 – Trailing edge flaps and flaps carrier

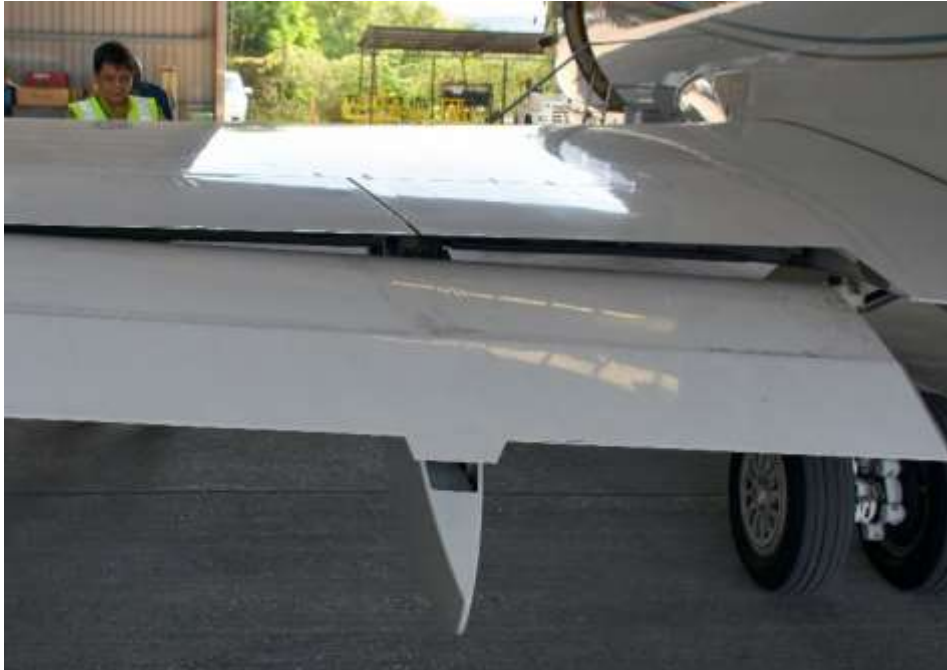
Damages to the trailing edge flaps and flaps carriage.

Picture 5 - Trailing edge flaps and flaps carrier

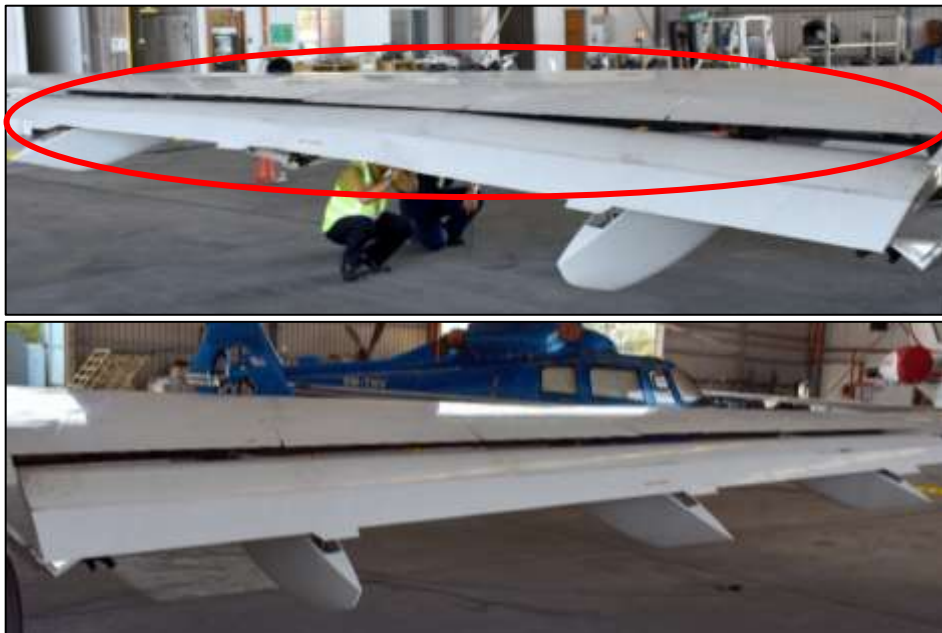
Comparison between left wing (top) and right wing (bottom) of the aircraft

Picture 6 - The flap of the Left Wing was badly damaged as compared to the Right Wing Flap

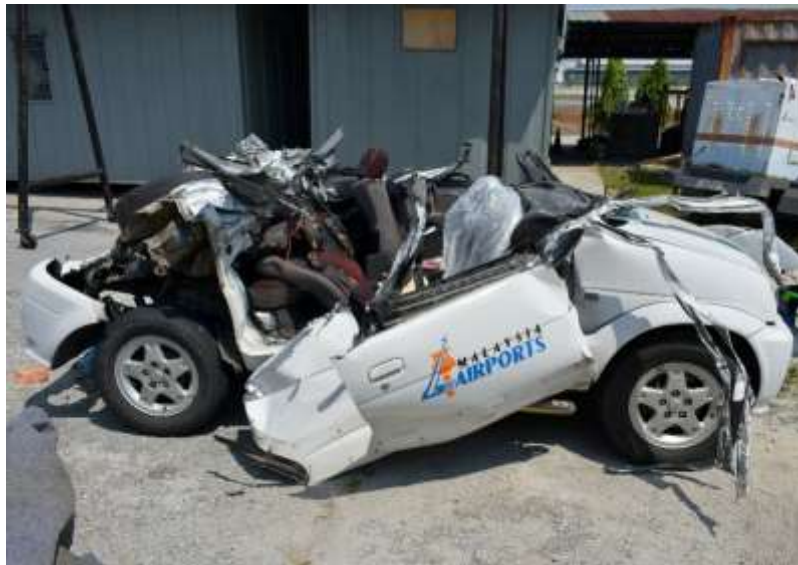
The vehicle was hit by the aircraft from the rear. The top parts were ripped off totally with some parts stuck to the left wing of the aircraft.

Picture 7 - Perodua Kembara belonged to MAHB AFRS had to cut off and removed the driver's side door in order to remove the victim from the vehicle

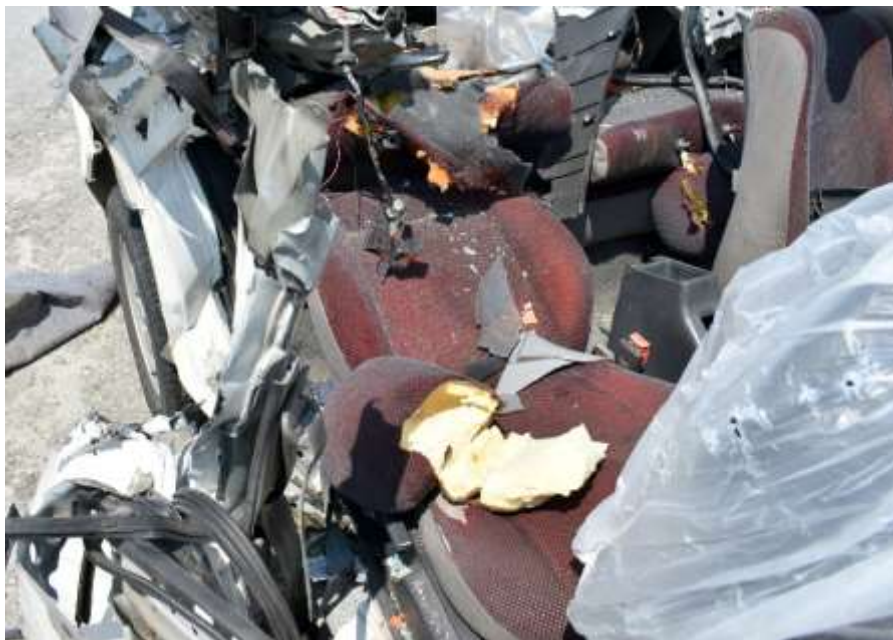
Picture 8 – The driver's seat was in reclining position

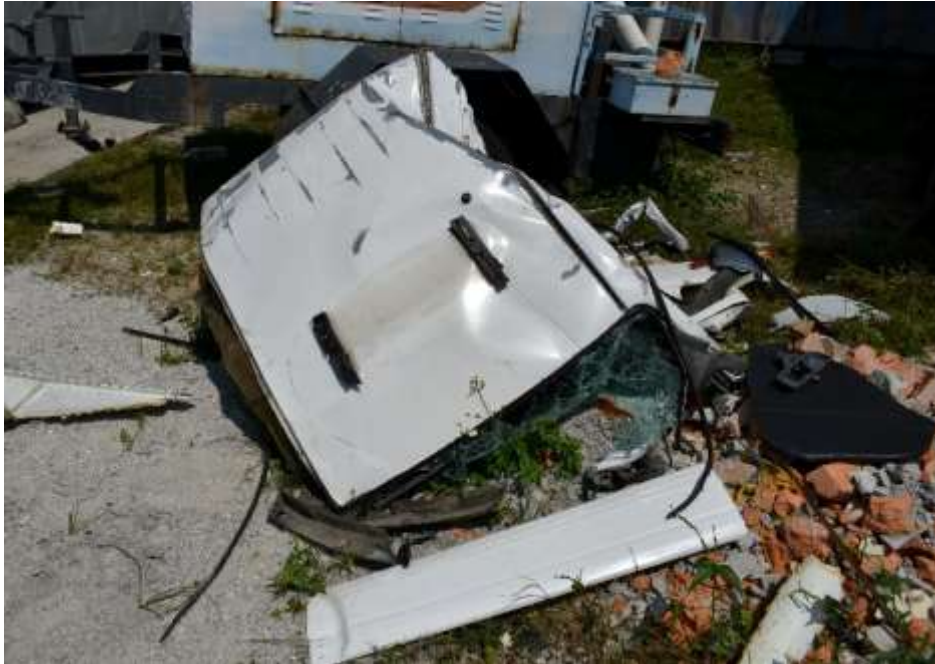
The top part of the vehicle

Picture 9 – The roof was totally ripped off from the vehicle

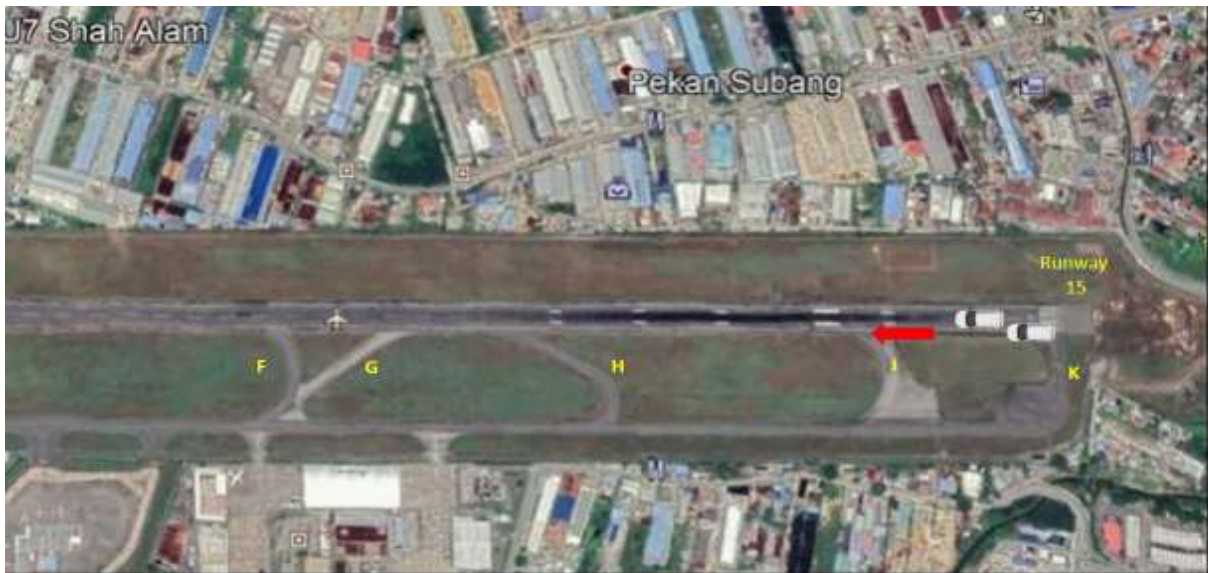
1	Initial Position and movement of vehicles from Threshold Runway 15 (Not to Scale)
---	---

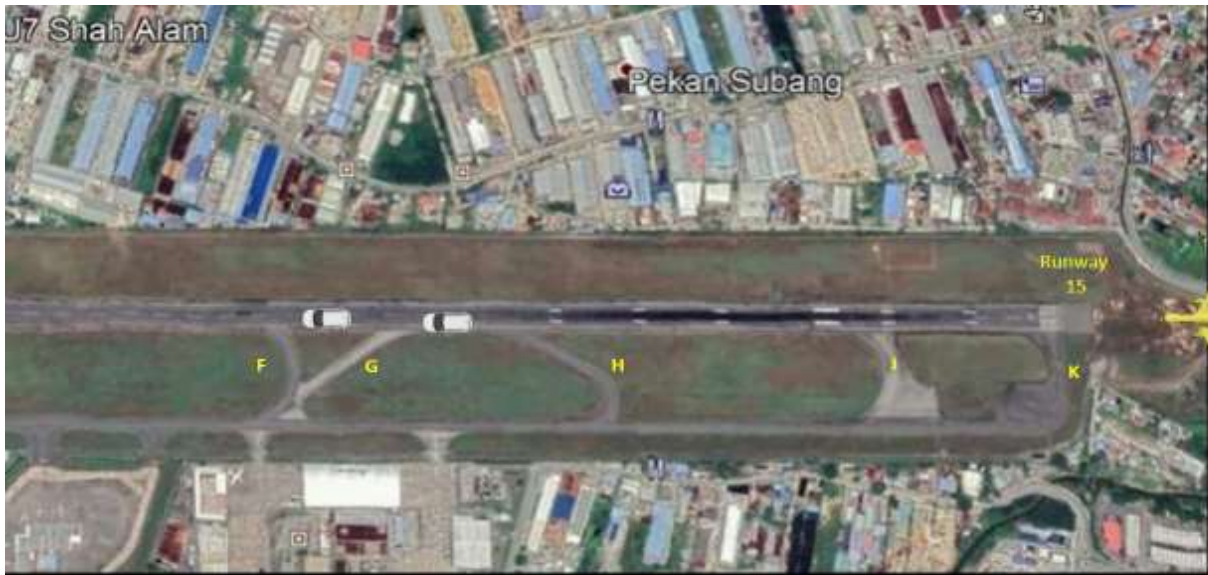
2	Vehicles position when aircraft on short final (Not to scale)
---	---

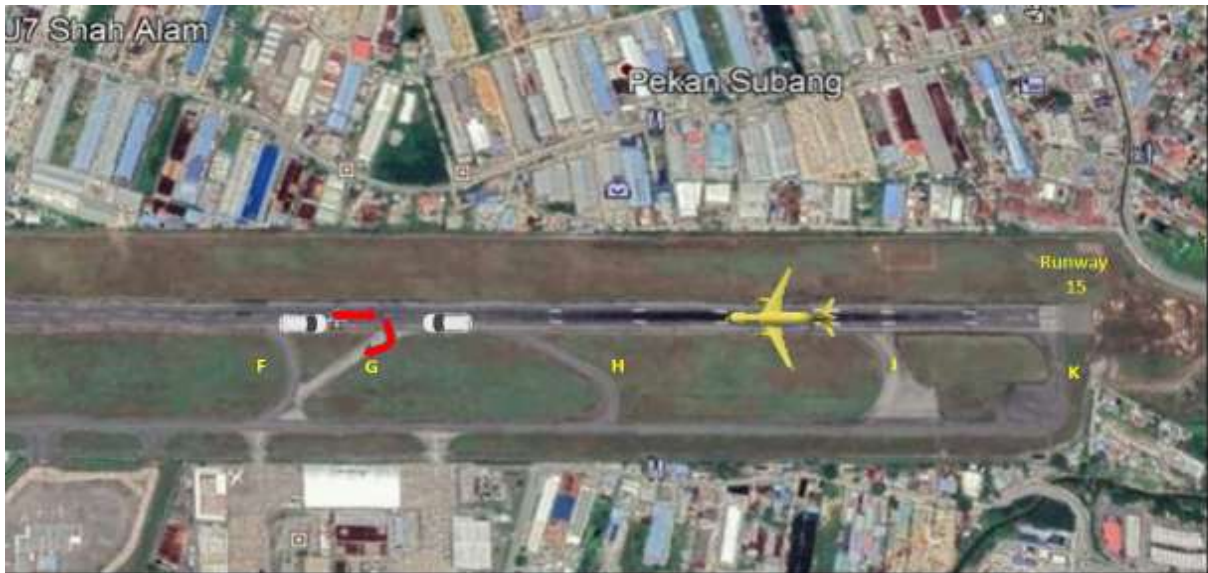
3	Contractor's vehicle making a turn and vacated the runway (Not to Scale)
---	--

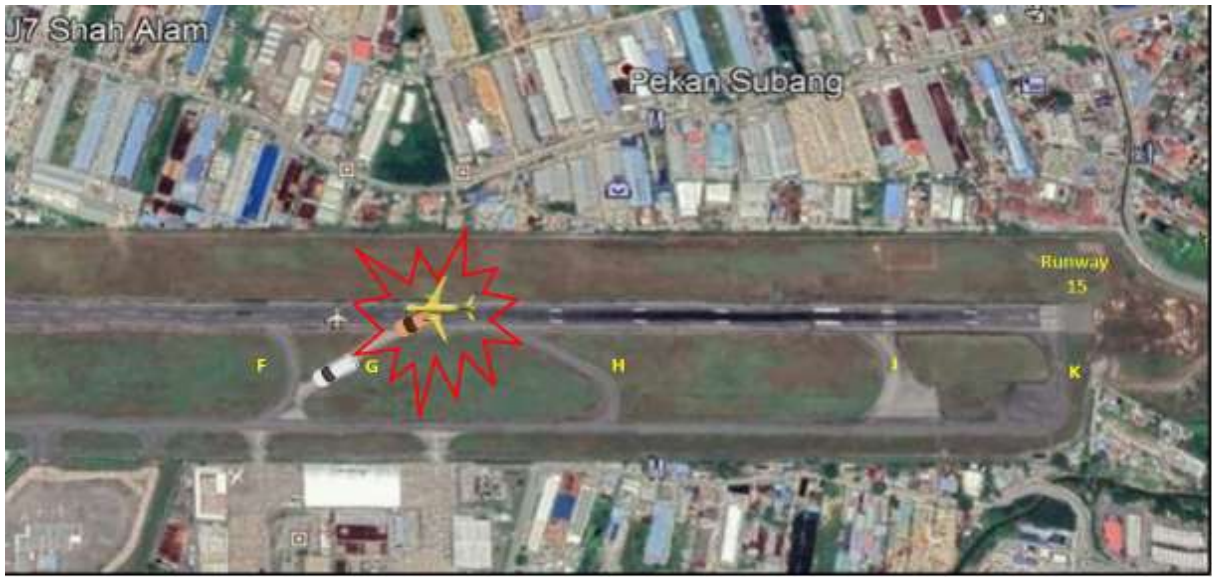
4	The escort vehicle hit by the aircraft (Not to Scale)
---	---
