Hard landing involving an Airbus A330-323, 9M-MTA

Melbourne Airport, Victoria | 14 March 2015

ATSB Transport Safety Report
Aviation Occurrence Investigation
AO-2015-032
Final – 5 April 2017

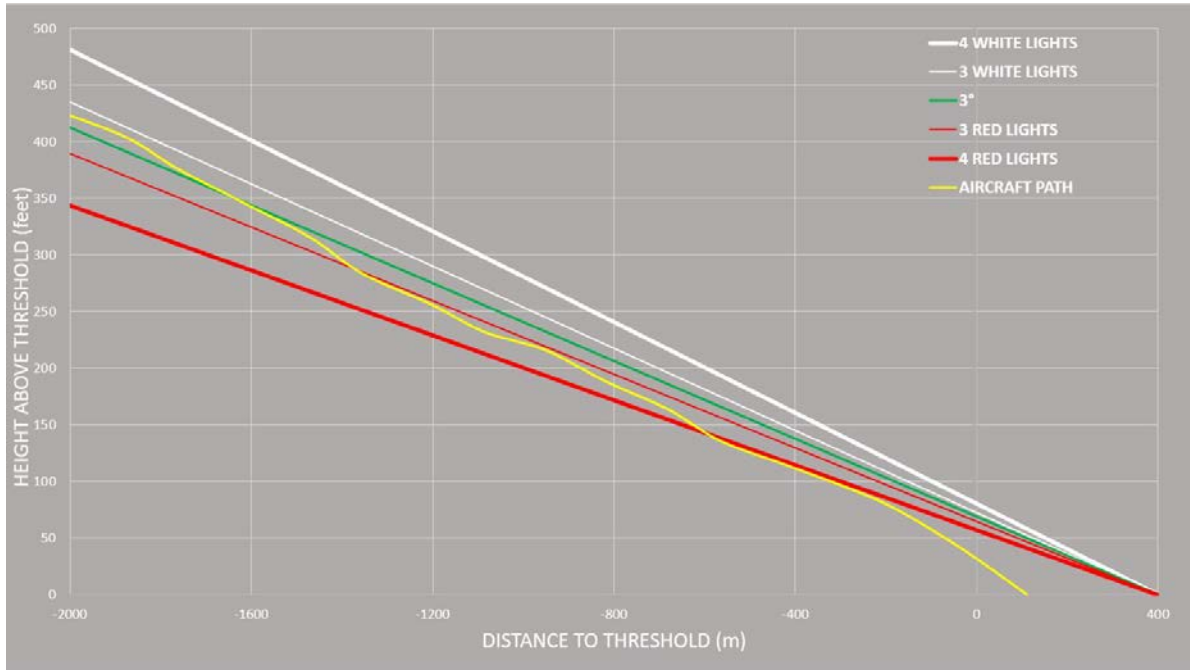
Figure 2: Aircraft path relative to the PAPI indications the pilots would have observed during the approach

As the aircraft passed 300 feet above ground level (AGL) a rate of descent of 960 feet per minute was recorded. This neared the operator's maximum stabilised approach limit of 1000 feet per minute when below 500 feet AGL. As well as a high rate of descent, actual exceedances of the operator's stabilisation criteria included:

- large changes to pitch inputted by the pilot flying, including negative pitch values,
- fluctuations in the rate of descent over a large range that were abnormal for the phase of flight,
- incorrect glide path. From approximately 250 feet AGL, the aircraft was trending low and continuing below the glide path. At this point the pilots would have been able to observe 3 red lights and one white light on the PAPI. This trend was allowed to continue until the aircraft was well below the desired glide path to the extent that the PAPI would have indicated 4 red lights from approximately 125 feet AGL (Figure 2). From this point the PF made numerous pitch commands which were mostly nose down. These included a full range nose down deflection at 24 feet AGL.

Figure 2 displays in green the ideal glide path during an approach and the PAPI thresholds in red (low) and white (high). The yellow is the actual path of the aircraft derived from the flight data. Just below 150 feet 4 red light would have been indicated to the crew.

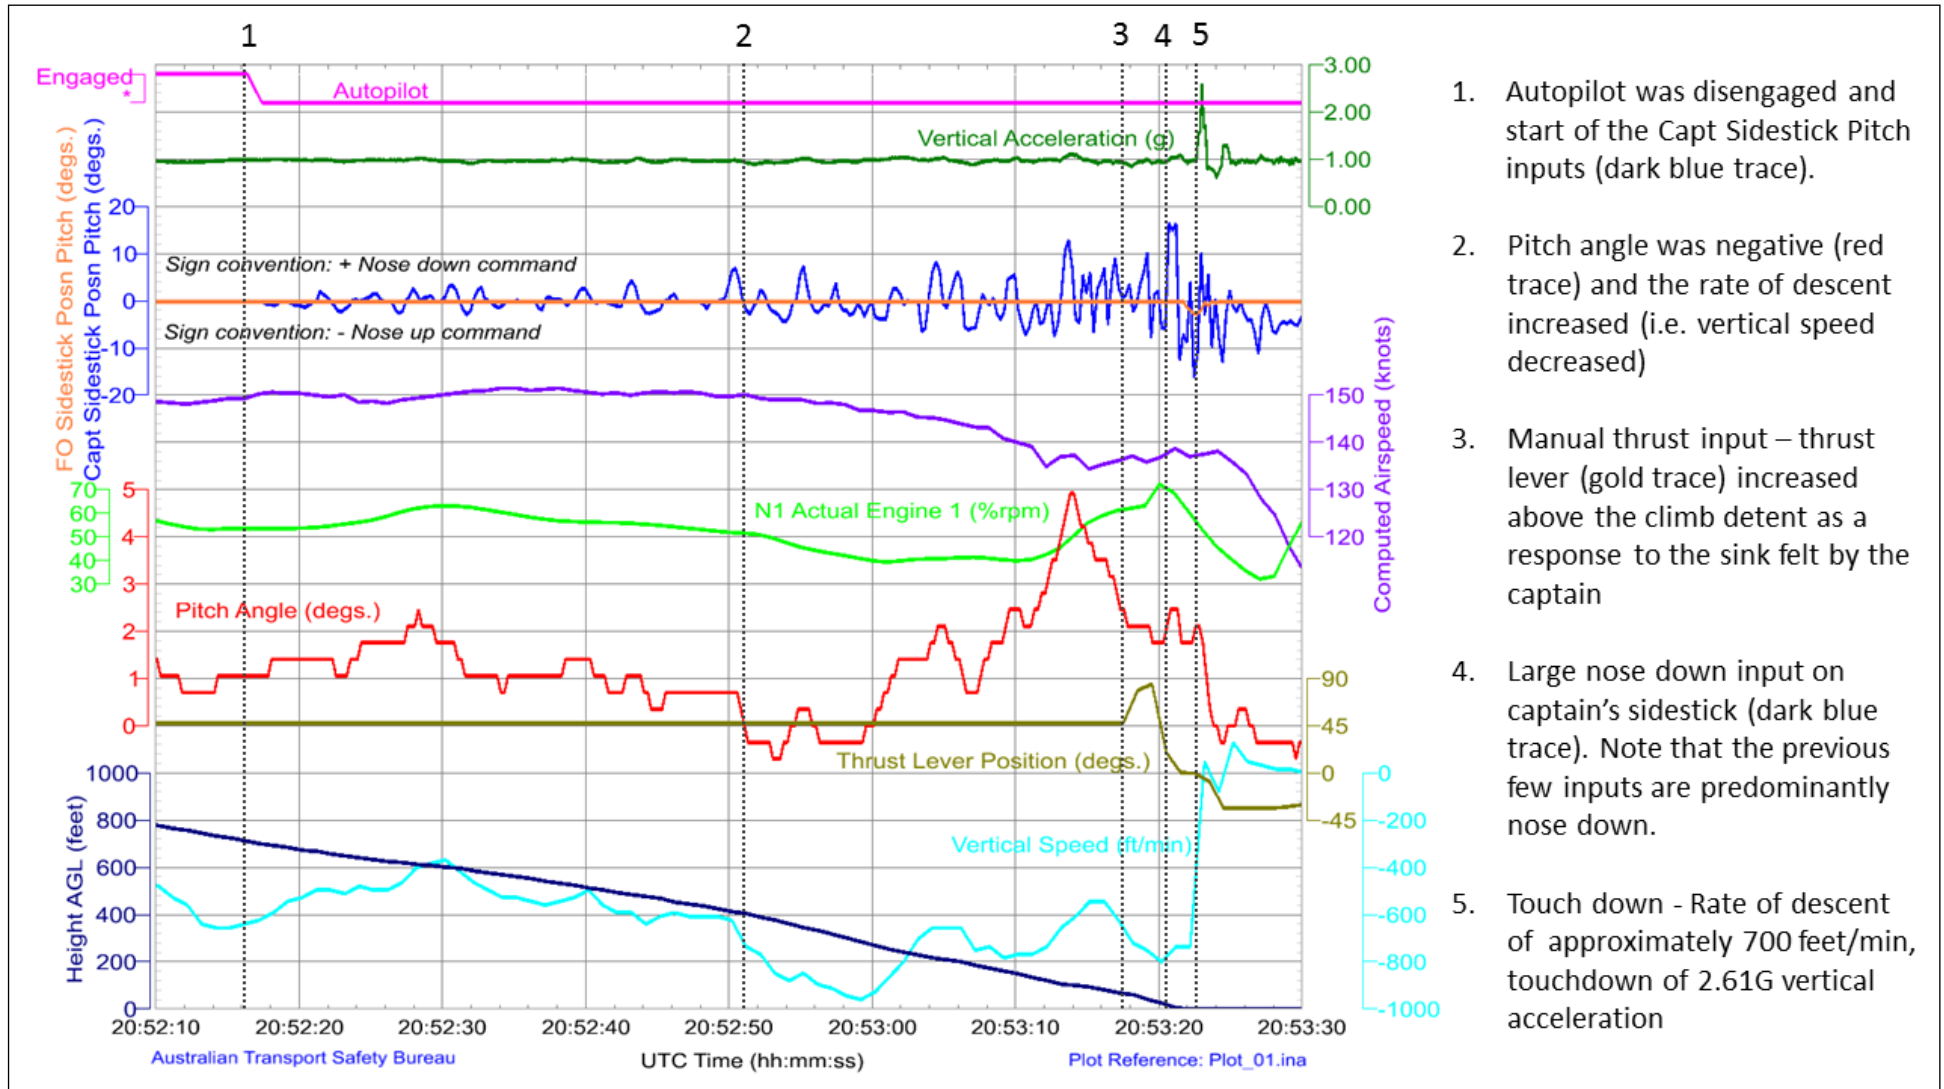
Figure 4: Graphical representation of the flight data from the incident approach

Flight data showed that the PF disengaged the autopilot at approximately 700 feet above ground level (AGL) and from that point until touchdown there was an increase in the frequency and magnitude of sidestick pitch control inputs by the PF (Figure 4).

Shortly after this action, the aircraft touched down at a vertical speed of approximately 700 feet per minute and a vertical acceleration of 2.61 G was recorded. The aircraft also touched down at approximately 170m (560 feet) from the landing threshold, short of the normal touchdown zone of between 304m (1000 feet) and 609m (2000 feet).

1. Autopilot was disengaged and start of the Capt Sidestick Pitch inputs (dark blue trace).
2. Pitch angle was negative (red trace) and the rate of descent increased (i.e. vertical speed decreased)
3. Manual thrust input – thrust lever (gold trace) increased above the climb detent as a response to the sink felt by the captain
4. Large nose down input on captain’s sidestick (dark blue trace). Note that the previous few inputs are predominantly nose down.
5. Touch down - Rate of descent of approximately 700 feet/min, touchdown of 2.61G vertical acceleration
