**SERIOUS INCIDENT REPORT NUMBER SI 01/2017
(FINAL REPORT)**

**SERIOUS INCIDENT INVOLVING MALAYSIA AIRLINES MH2718
BOEING B737-800 REGISTRATION 9M-MXX
AT SIBU AIRPORT, SARAWAK
8 APRIL 2017**

SERIOUS INCIDENT REPORT NO.: SI 01/2017

OPERATOR : MALAYSIA AIRLINES BERHAD (MAB)
AIRCRAFT TYPE : BOEING B737-800
NATIONALITY : MALAYSIA
REGISTRATION : 9M-MXX
PLACE OF INCIDENT : SIBU AIRPORT, SARAWAK
DATE AND TIME : 08 APRIL 2017 AT 2217 HOURS (LT)

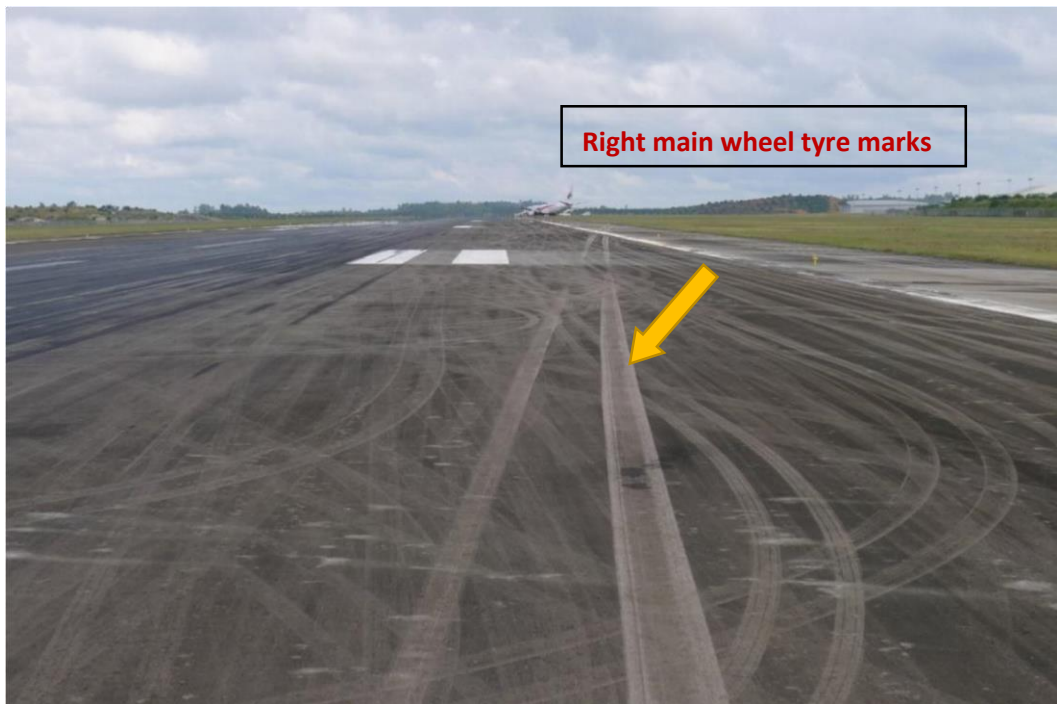
Figure 4: Right Wheel tyre marking on runway
(Shown as “Image 2 in the airport layout in Figure 3)

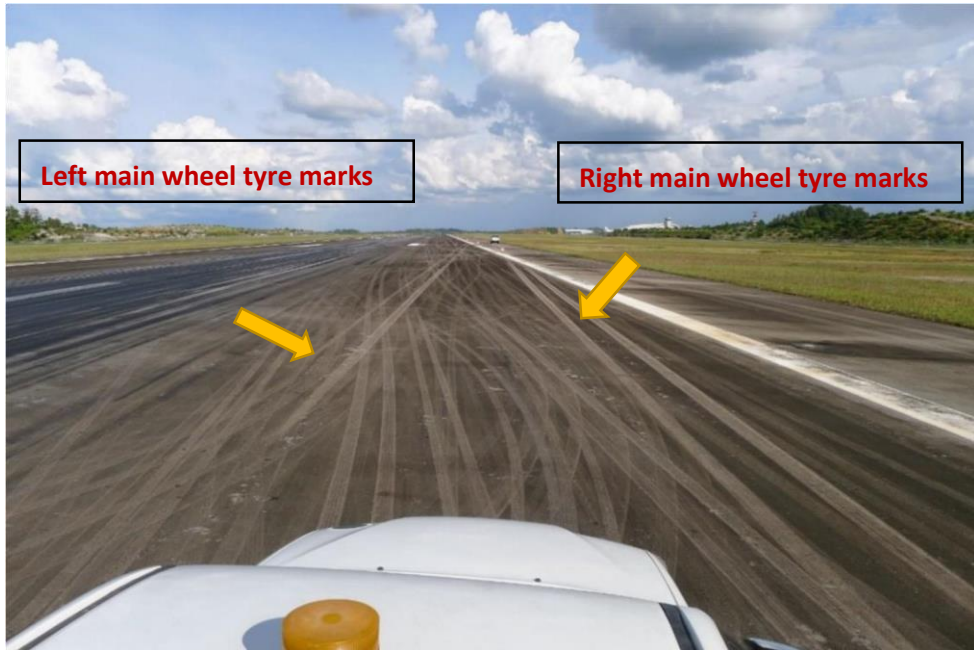
Figure 5: Both main wheel marks show aircraft veering to the right. Left main wheel contacted runway at 620 m from Threshold Runway 13 (shown as “Image 3” in the airport layout in Figure 3)

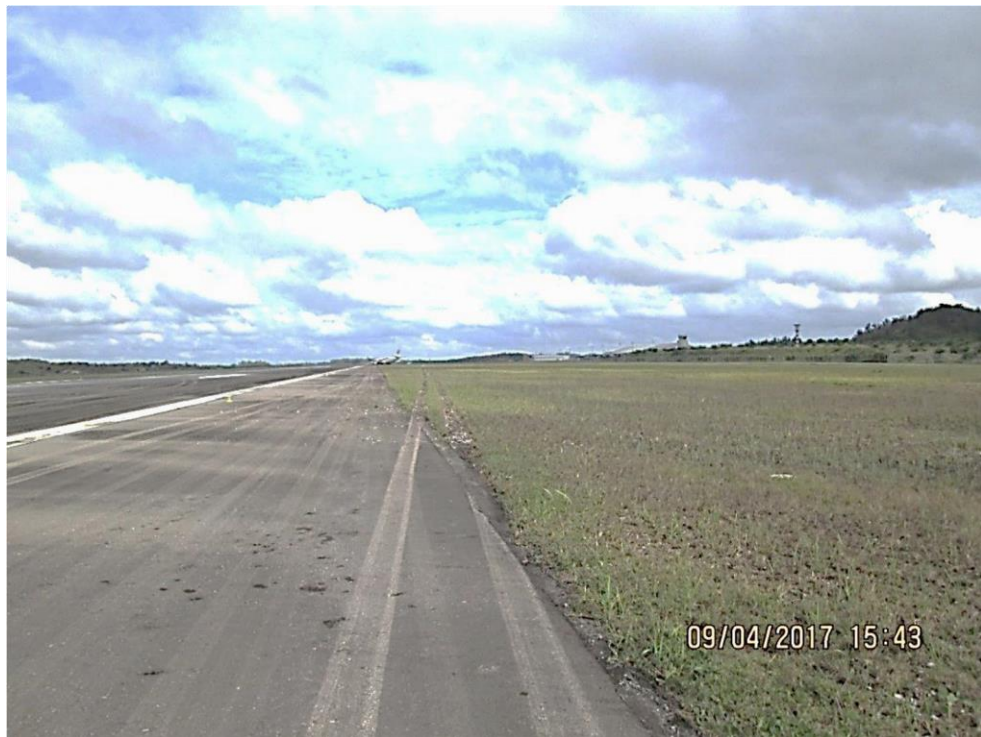
1.4 Other Damages. One of the runway edge light cover on the right-hand side of the runway located approximately 720 m from Threshold Runway 13 was damaged by the aircraft. There were minor damages to the runway surface around the areas where the aircraft came to a stop.

Figure 6: Right main wheel leaving the paved runway surface at approximately 720 m from Threshold Runway 13 (Shown as “Image 4” in the airport layout in Figure 3)

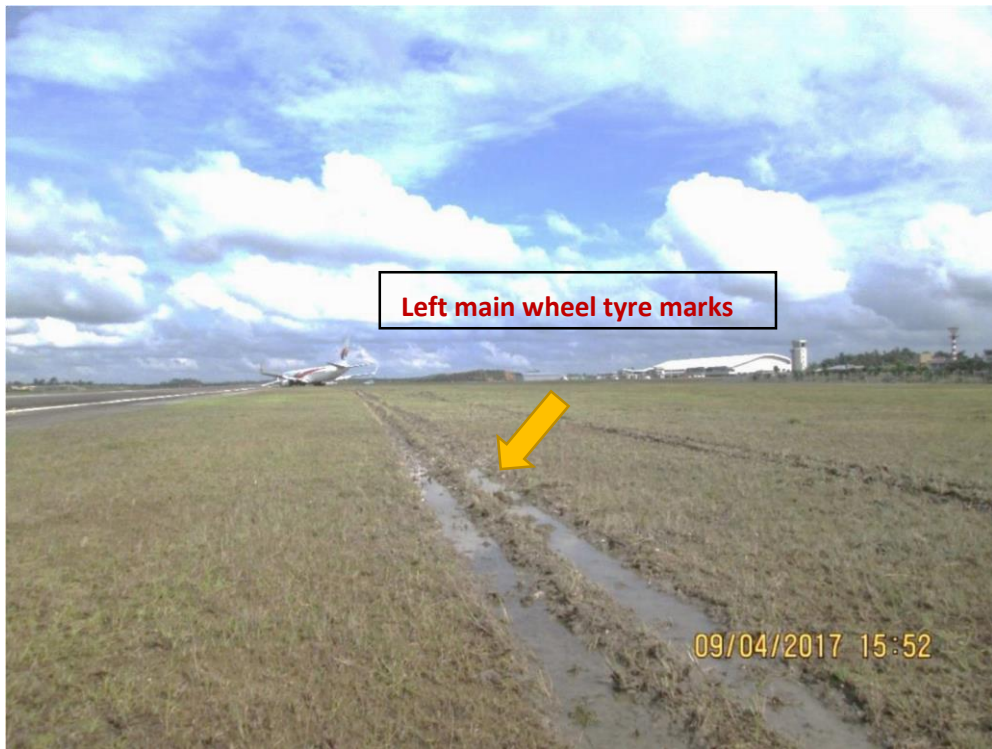
Figure 7: Wheel track on the soft ground approximately 20 m parallel with the runway (Shown as “Image 5” in the airport layout in Figure 3)

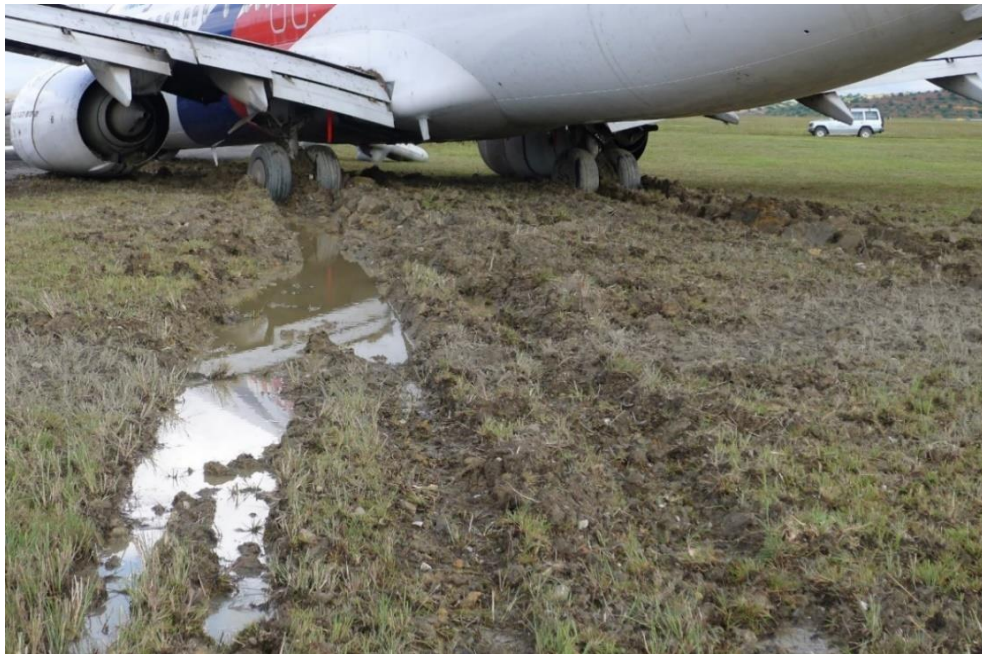
Figure 8: Approximate location of nose gear collapse (Shown as “Image 6” in the airport layout in Figure 3)

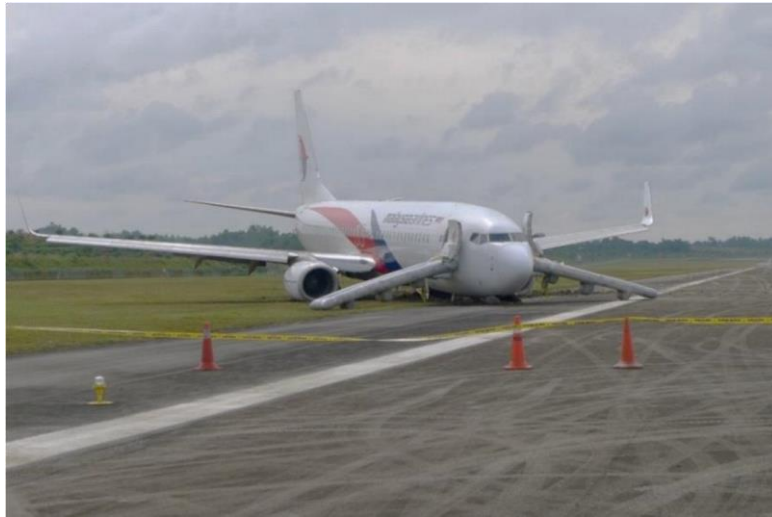
Figure 9: Final aircraft location – 1,260 m from Threshold Runway 13 (Shown as “Image 7” in the airport layout in Figure 3)

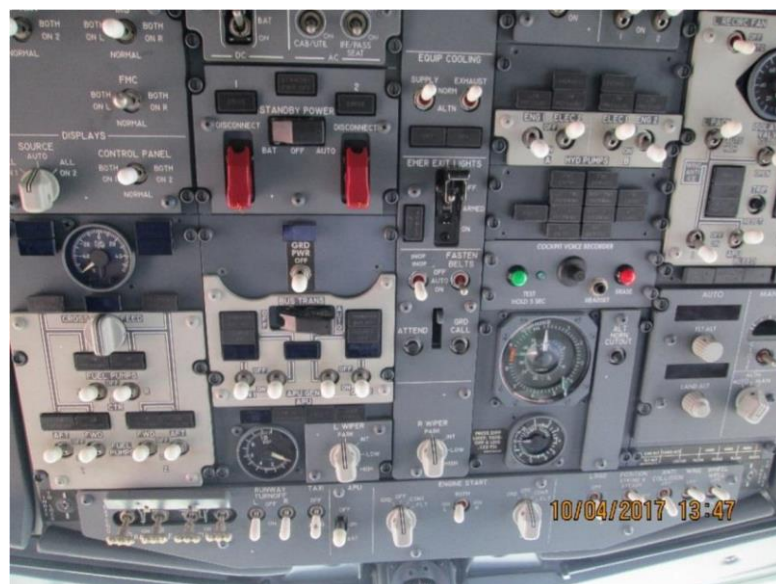
Figure 10: Photograph of Overhead Cockpit P5 Panel

1.13.1 Overhead Cockpit P5 Panel. The positions of the following switches are noted (as shown in Figure 10):

- 1.13.1.1 Electric Hydraulic Pumps – OFF.
- 1.13.1.2 APU – ON.
- a. 1.13.1.3 Fuel Pump – OFF.
- b. 1.13.1.4 Pack – OFF.

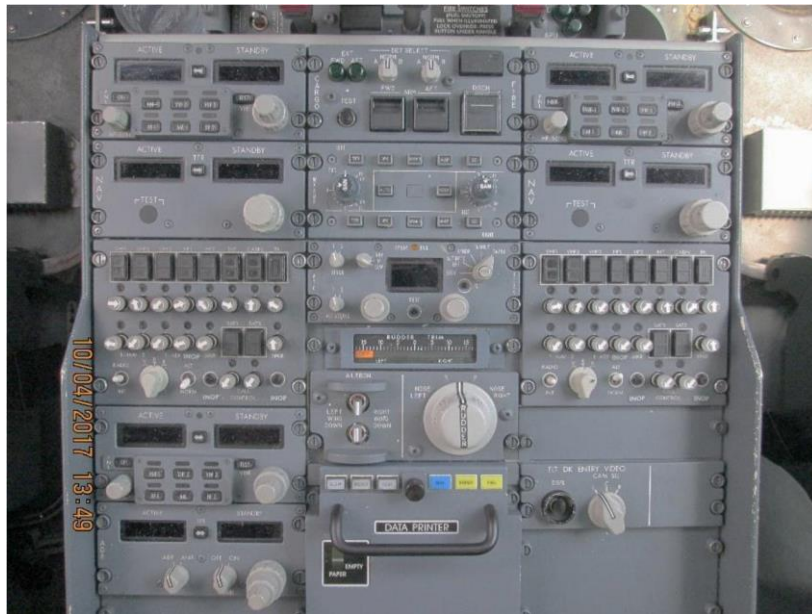
Figure 11: Photograph of Center pedestal

1.13.2 Center Pedestal. With the complete power down, the position (Left or Right) and the units of rudder trim could not be established, as shown in Figure 11.

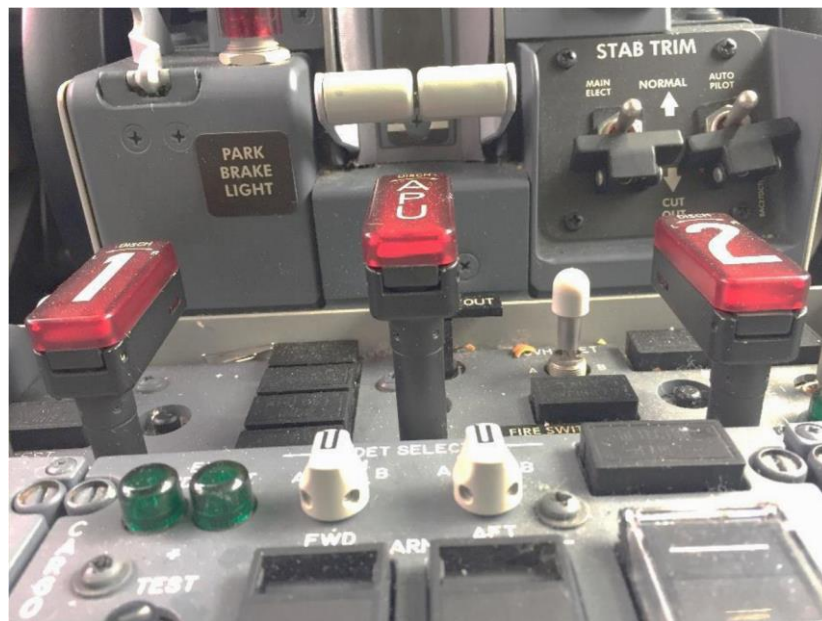
Figure 12: Photograph of Engine and APU Fire Panel

1.13.3 **Engine and APU Fire Panel.** The APU Fire handle was pulled whereas the Engine 1 and 2 Fire handles were in normal position (not pulled) as shown in Figure 12.

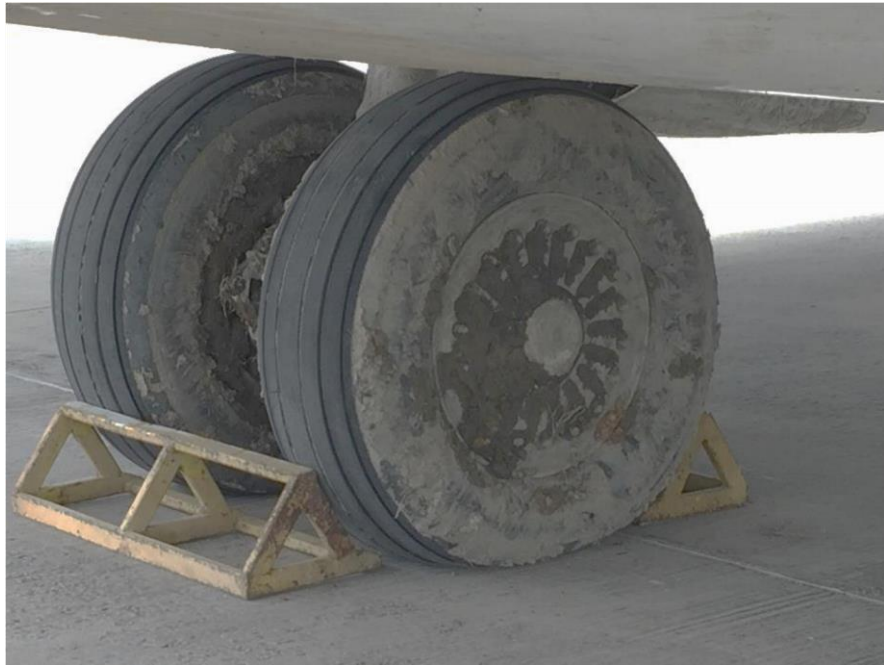
Figure 13: Photograph of Left Main Wheel

1.13.4.1 **Left Main Gear Wheels.** The left wheel tyres and other components appeared to be covered in mud following the excursion. There were minor damages evident on various components and flight control surfaces. However, the conditions of the tyres were inspected and they appeared to be in compliance with manufacturer's recommendation.

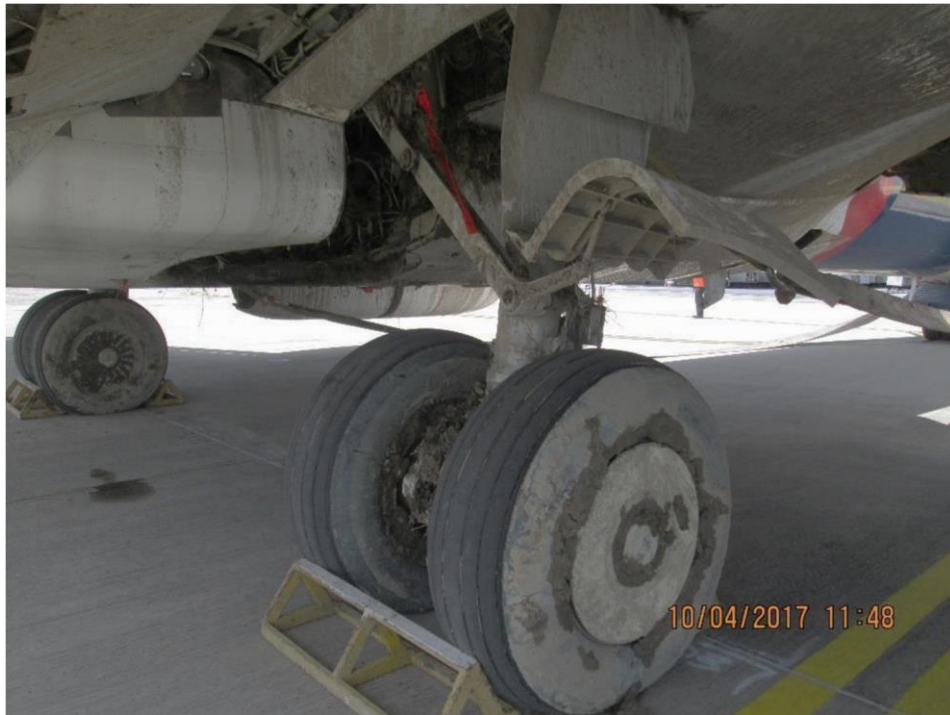
Figure 14: Photograph of Right Main Wheel

1.13.4.2 **Right Main Gear Wheels.** Similar to the left wheels, the right wheels and the other landing gear components were also covered in mud following the excursion. Tyres condition were examined and found to be in compliance with manufacturer's recommendation as shown in Figure 14.

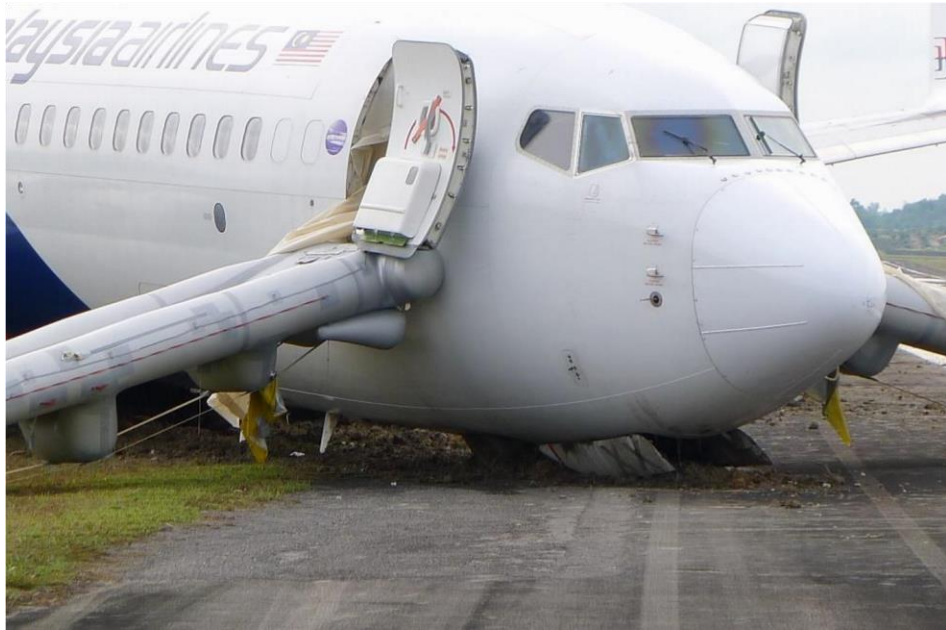
Figure 15: Photograph of Nose Wheel (Collapsed)

1.1.63 Based on initial assessment, the aircraft sustained damages to the nose gear assembly and the lower fuselage aft of the nose gear, while areas around the flaps, engine cowling and fan bypass areas sustained minor damages.

1.13.4.3 **Nose wheel (collapsed).** The nose wheel and the nose landing gear components sustained significant damages following the collapse while travelling over the soft ground as shown in Figure 15.

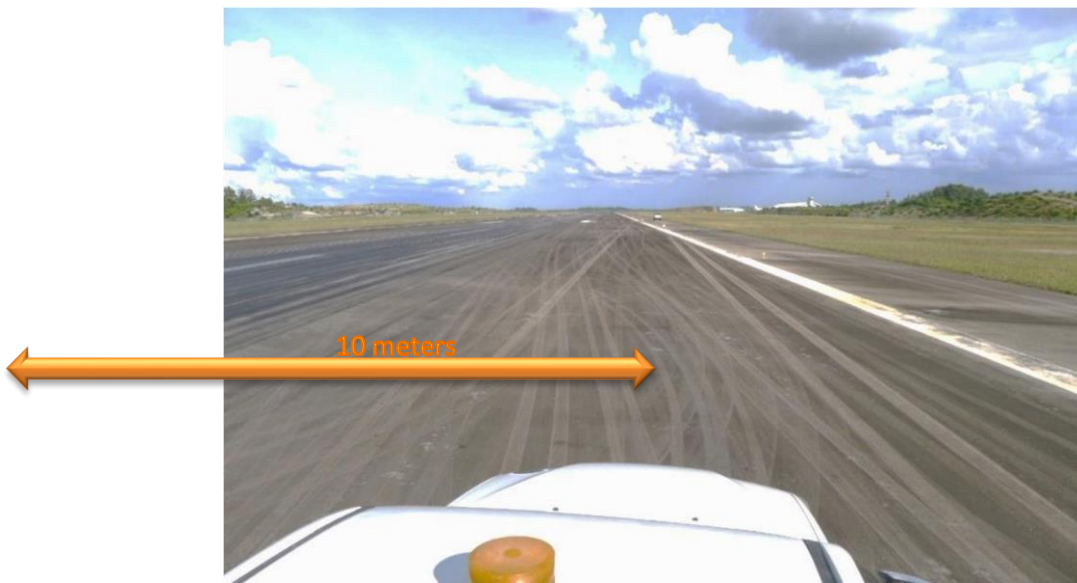
- a. The right wheel contacted the runway first at a distance of 540 m from Threshold Runway 13. This was followed by left wheel touchdown at distance of 620 m from Threshold Runway 13. The FDR data confirmed 1 second lapse between the right and left wheel touchdown.
- b. Lateral displacement of right wheel touchdown position from runway centerline was measured to be approximately 13 m to right of centerline. Given the wheel base of B737-800 of 5.7 m, the lateral displacement of the aircraft from normal touchdown position was approximately 10 m to the right (Refer to Figure 16 below).

Figure 16: Photograph showing aircraft touchdown position relative to runway centerline.

- c. The nose wheel touched the ground at approximately 4 seconds after the main wheel touchdown. The prolonged holding of the aircraft pitch following main gear touchdown prevented positive directional control that would have normally been achieved from nose gear contact on the runway. Based on the tyre tracks, the point of nose wheel touchdown was on the soft ground.
- d. The elevated pitch attitude observed after the touchdown might have caused the pilot to have the reduced visibility of the runway situation. In addition, this maneuver had reduced the weight on main landing gear and thus decreased the braking and cornering effectiveness.

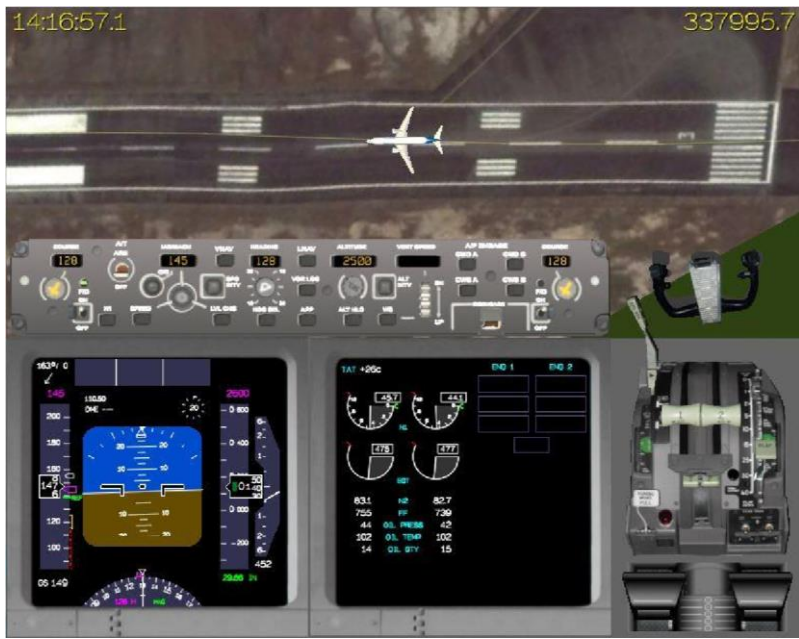
Photograph 3: Aircraft began to drift from centerline below 20ft RA. A slight bank is visible at this point. Heading was 130°.

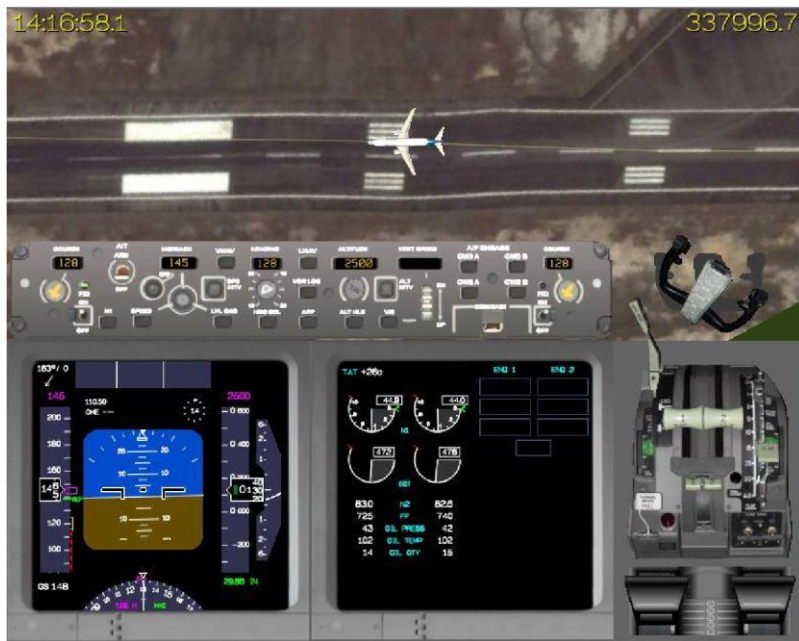
Photograph 4: More bank was induced by the PF. Heading was increasing to 131°.

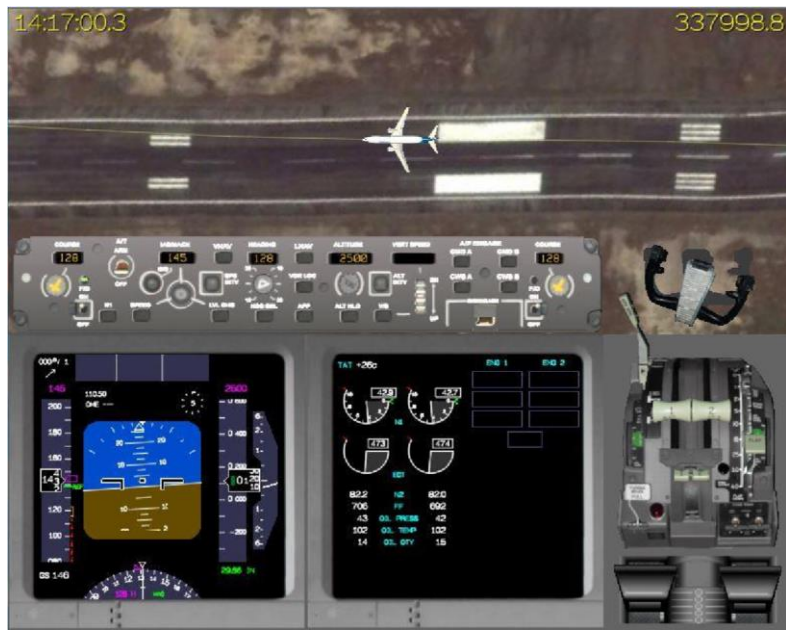
Photograph 5: Bank angle was increasing with aircraft turning towards the right. Heading now is at 132°.

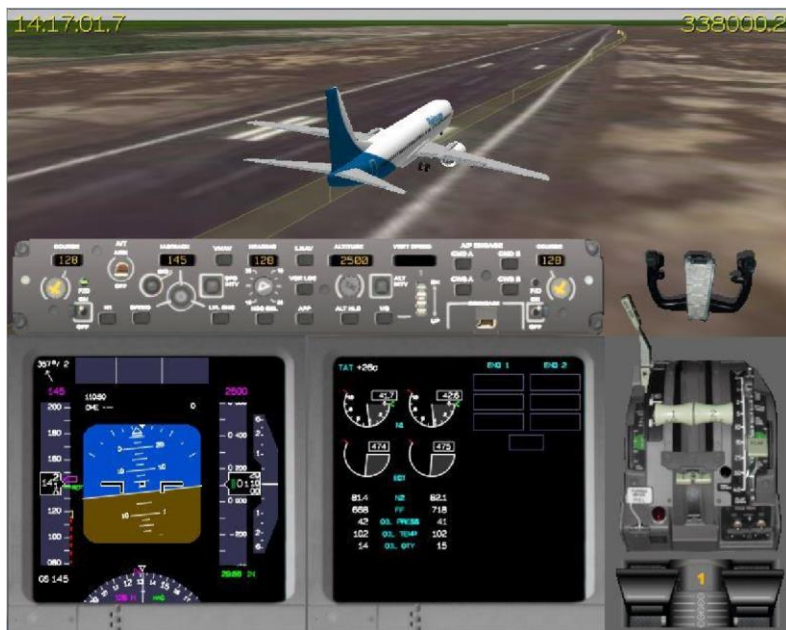
Photograph 6: Aircraft was about to touch down on Runway 13. Bank angle was increasing to 4°.

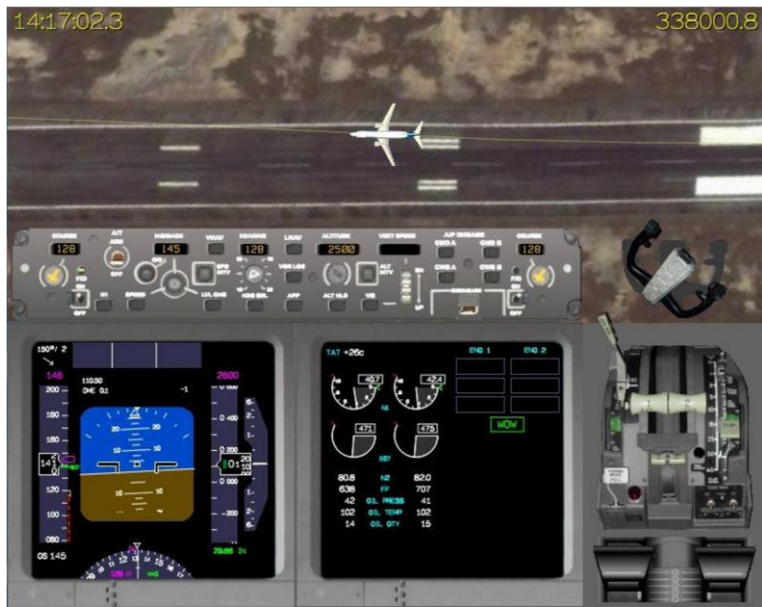
Photograph 7: First point of touchdown (on Right main wheel) at 540 m from Threshold Runway 13.
 Aircraft heading was 132°.
 Bank angle was approximately 4° with heading 133°.

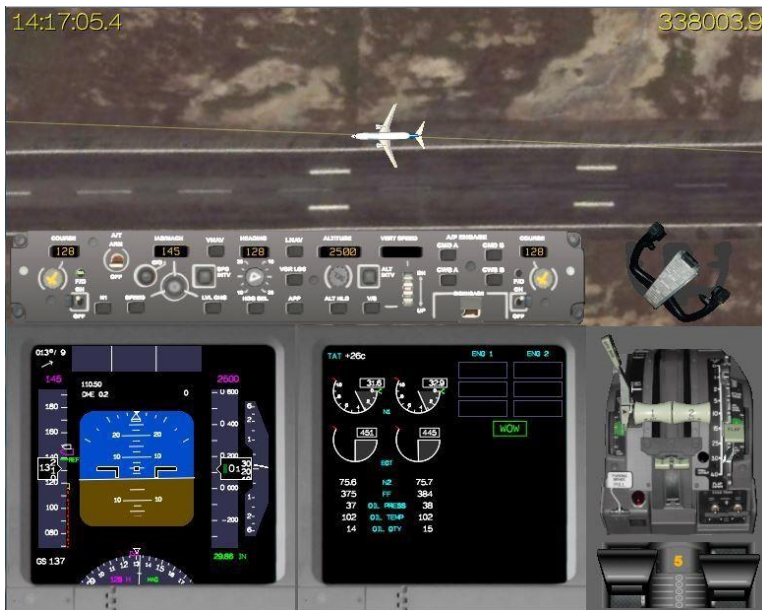
Photograph 8: Aircraft vacated the runway surface at approximately 780 m from Threshold Runway 13.

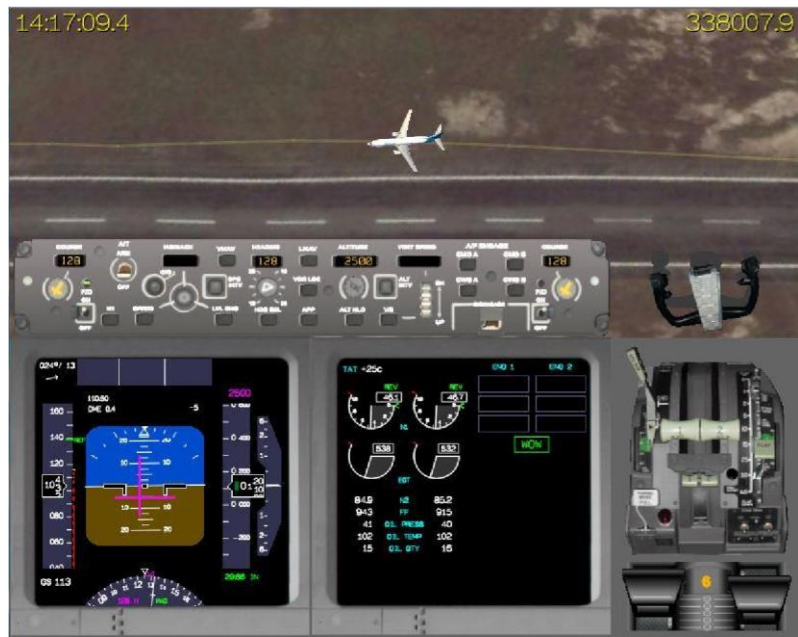
Photograph 9: Aircraft was on soft grounds, parallel to the runway.

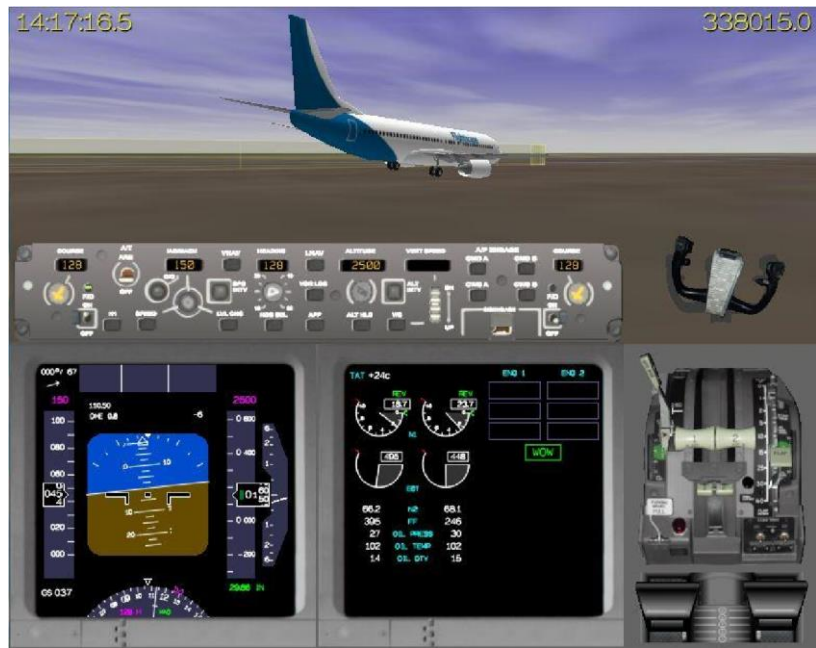
Photograph 11: Nose gear collapsed at this point (14 seconds after touchdown).

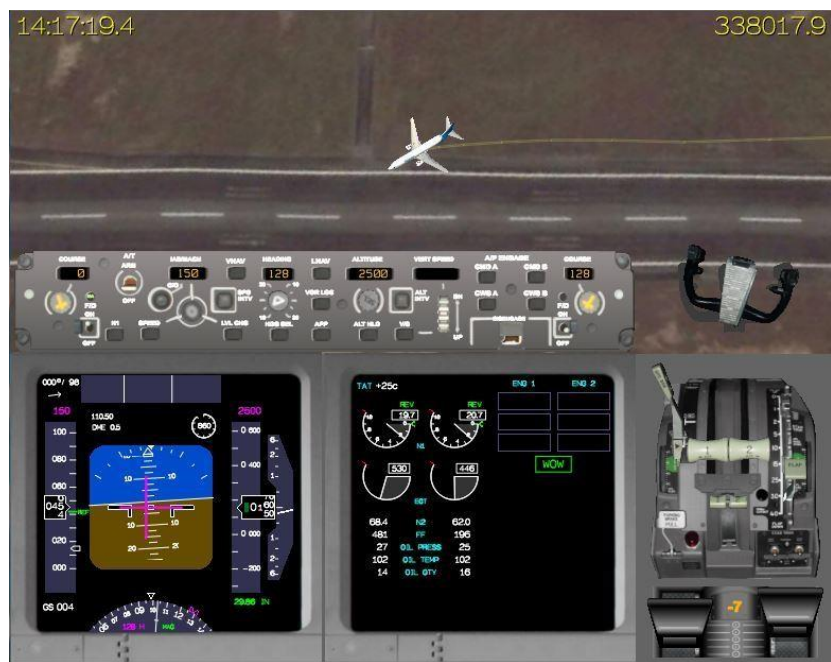
Photograph 12: Aircraft's final stop, approximately 1,260 m from Threshold Runway 13.

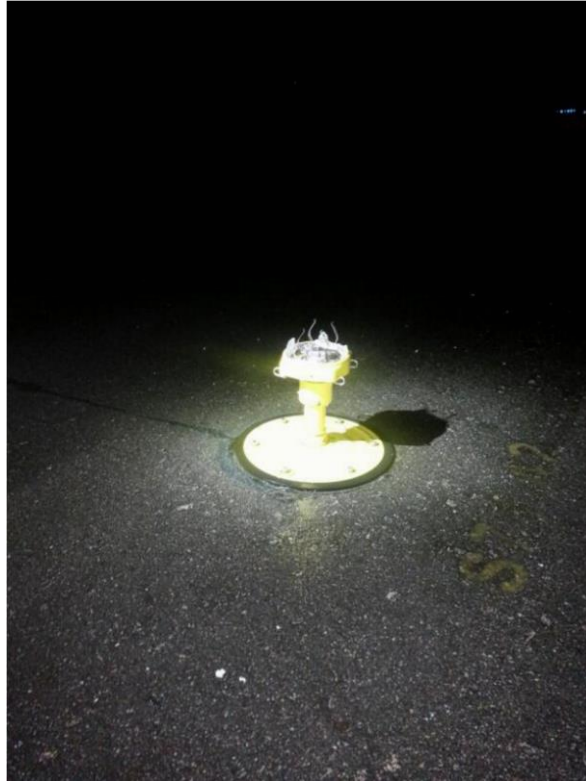
(12th edge light is approximately 720 m from Threshold Runway 13)

Runway 12th Edge Light that was damaged
