AIRCRAFT SERIOUS INCIDENT REPORT SI 08/17

SERIOUS INCIDENT INVOLVING HORNBILL SKYWAYS AIRCRAFT, SUPER KING AIR B200GT, REGISTRATION 9M-WSK AT KUCHING INTERNATIONAL AIRPORT, SARAWAK ON THE 24 SEPTEMBER 2017

SERIOUS INCIDENT REPORT NO.: SI 08/17

AIRCRAFT TYPE : SUPER KING AIR B200GT

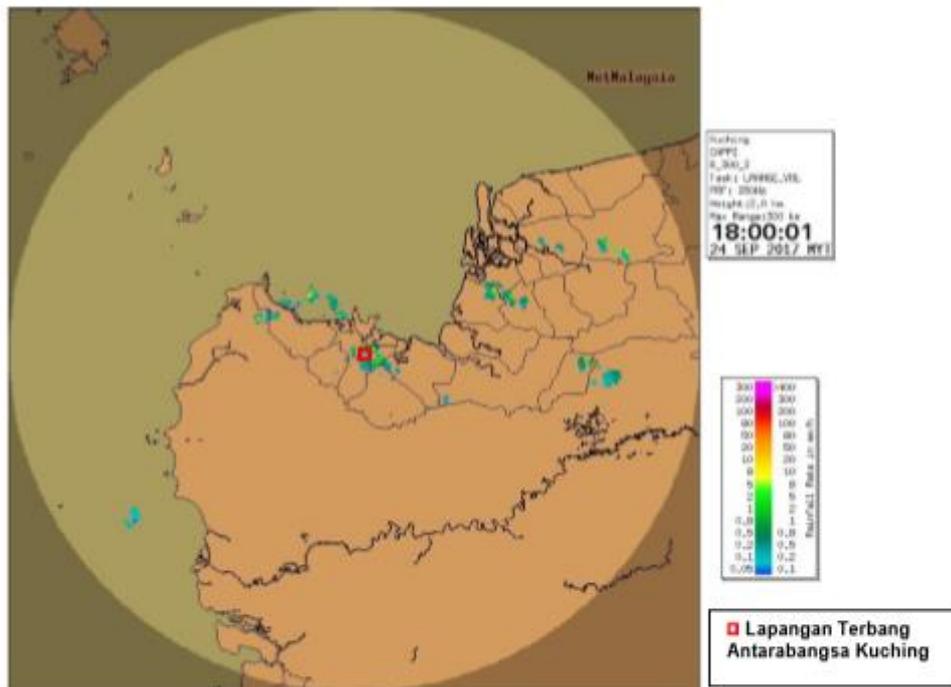
Figure 1: Radar echoes at 1800 LT indicated active patches of clouds formation above Kuching Airport

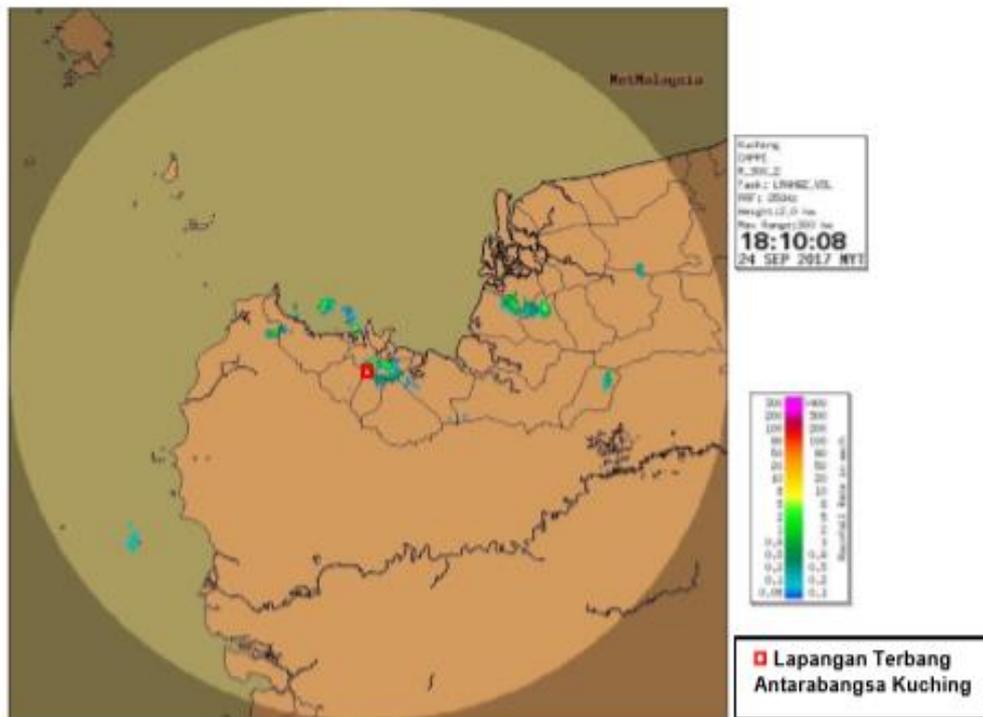
Figure 2: Radar echoes at 1810 LT indicated active patches of clouds formation above Kuching Airport

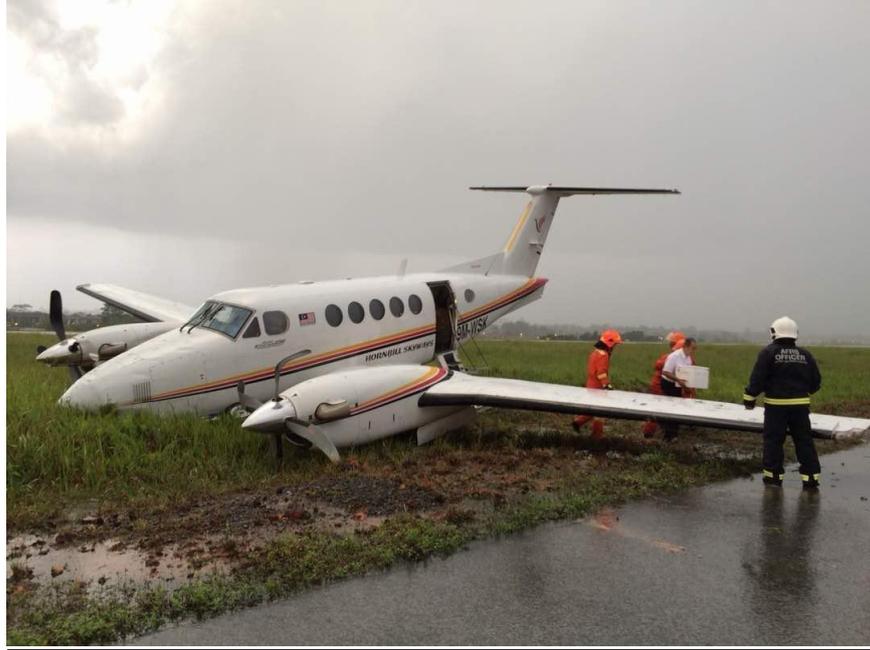
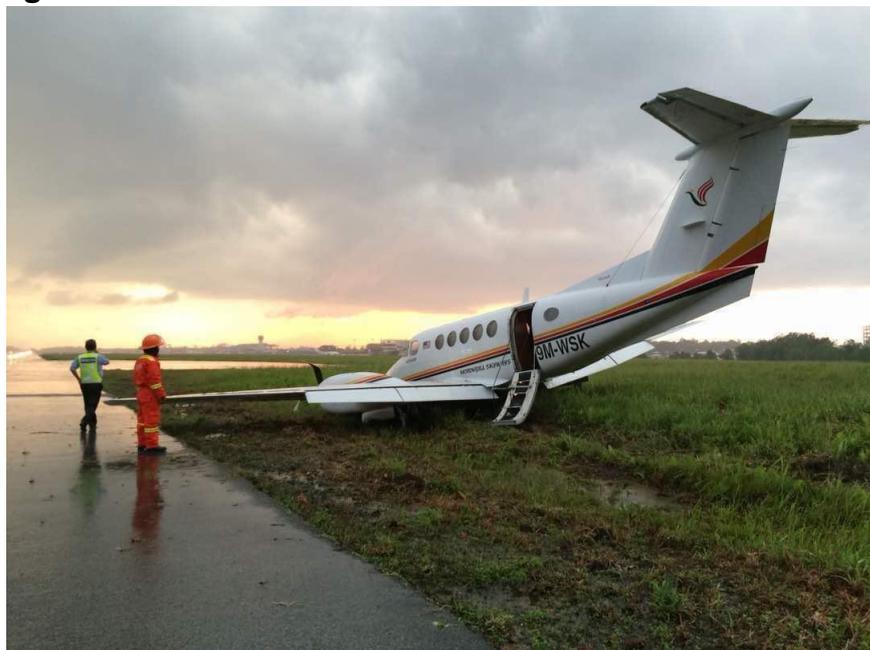
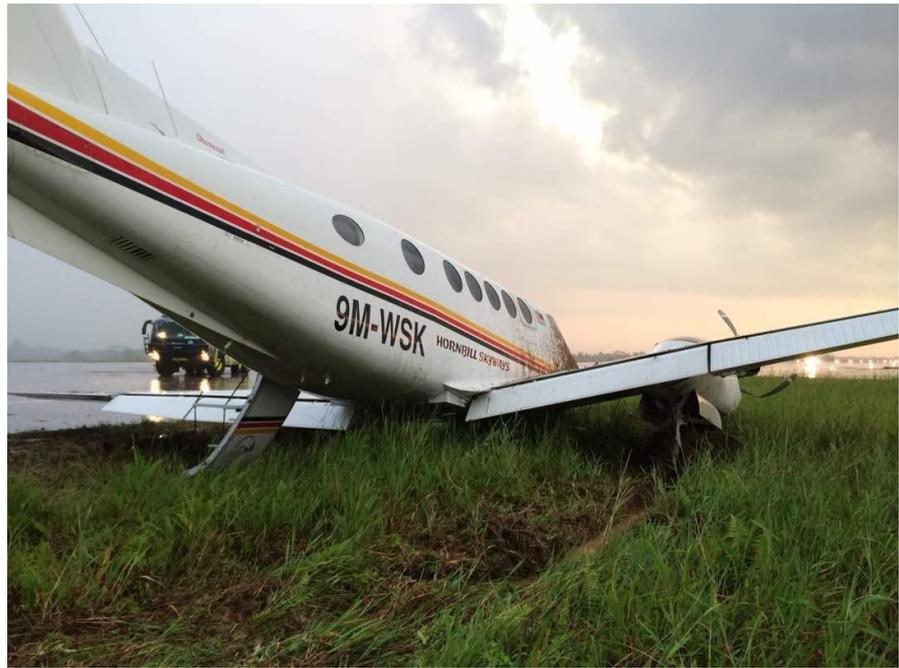
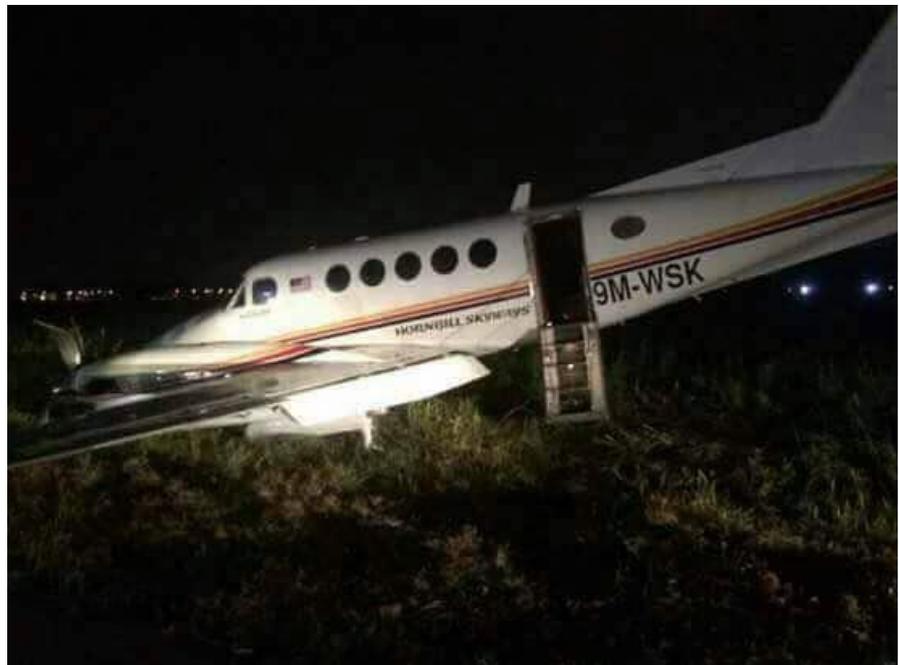
1.3.1 Initial inspection found that the fuselage nose section area between Station Number 14 and 94 was severely damaged. The nose radome which housed the weather radar was deformed and distorted due to impact with the ground. The nose landing gear attachment bolts were found broken with the support structure badly damaged due to the nose landing gear collapsing. The nose landing gear doors were found totally damaged and detached from their attachment fittings. The forward fuselage section area skin had signs of wrinkling and buckling thus causing difficulty in opening up the side access panels to gain access to the forward avionics compartment. Both the pitot probes located near the radome were also found damaged.

The four images below show the condition of the aircraft after the incident.

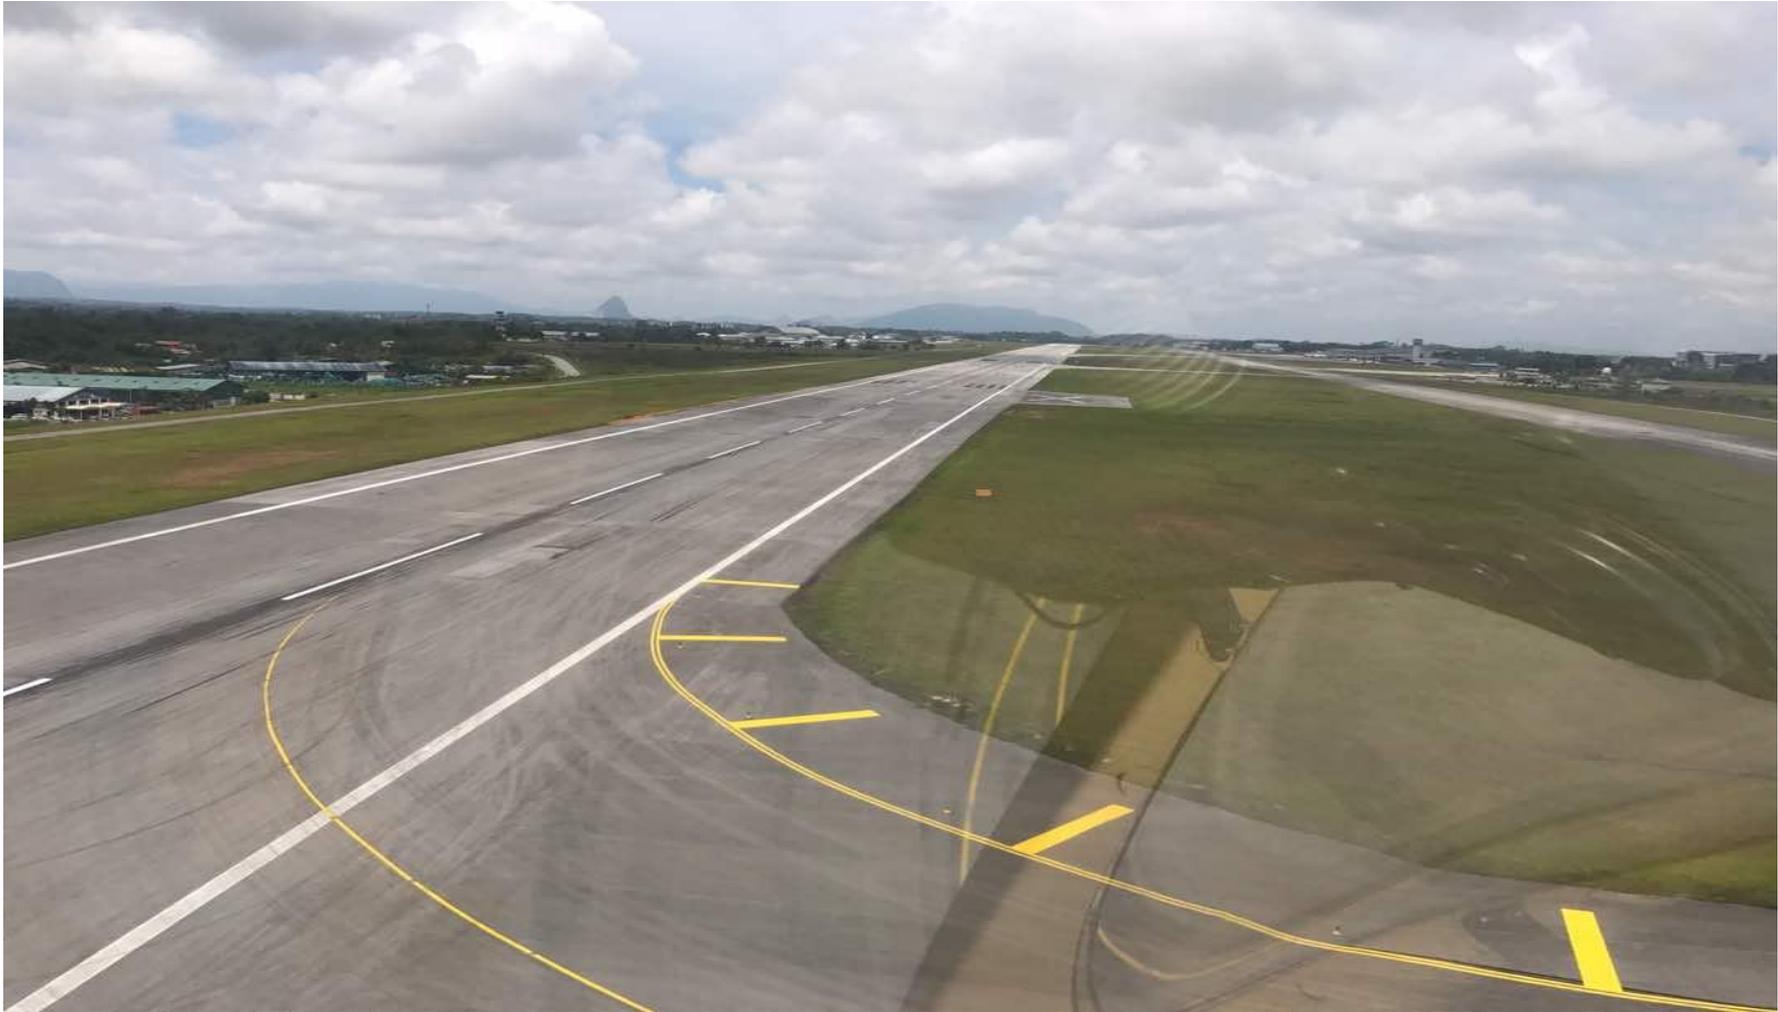
APPENDIX B, FIGURE 1 RUNWAY VIEW DURING SHORT FINAL

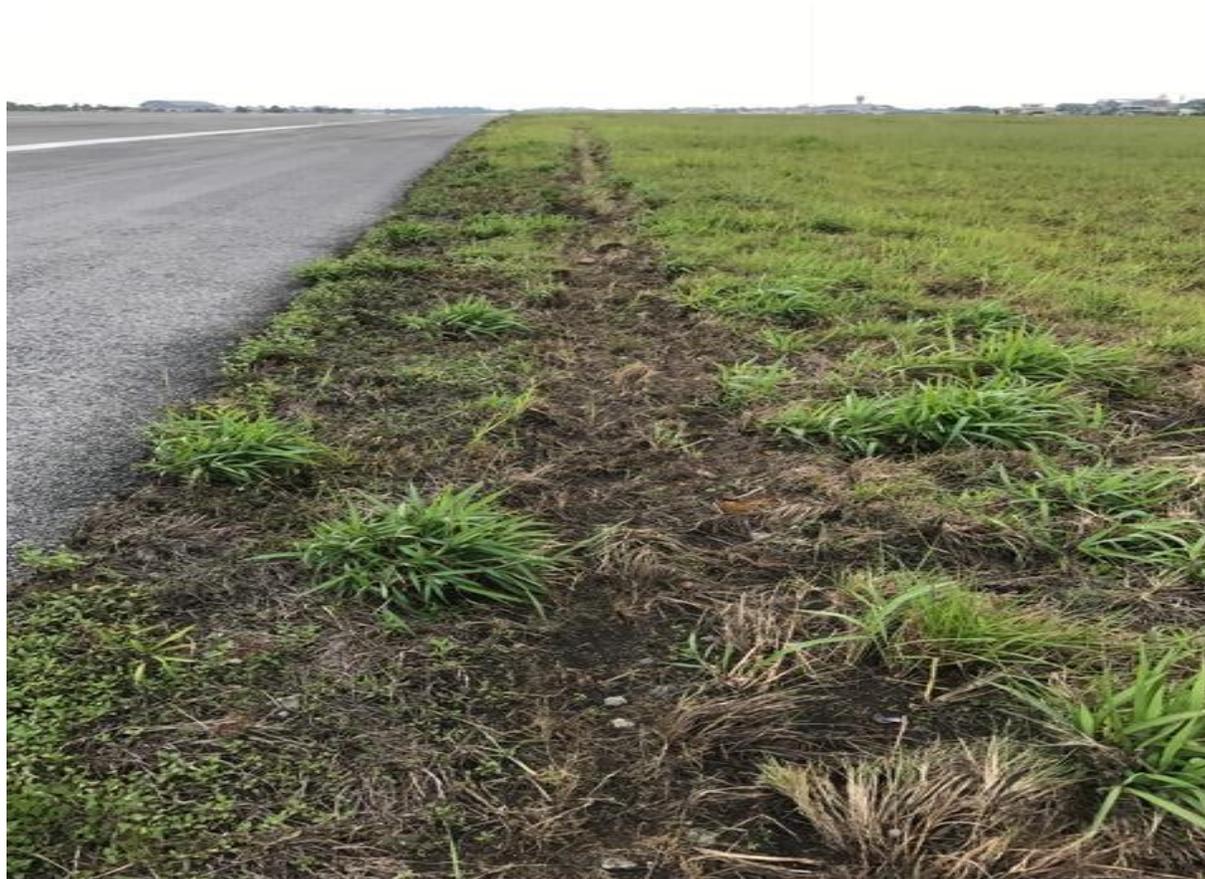
3.1.13 During the runway excursion, the right main wheel entered the grass area first followed by the left main wheel unchecked. The nose and main wheels dragged into the soft ground and stopped completely after about 600 Meters roll. The nose wheel assembly, nose fuselage area and both the proper assembly blades damaged substantially.

APPENDIX B, FIGURE 2 WHEELS MARKS ON THE GRASS

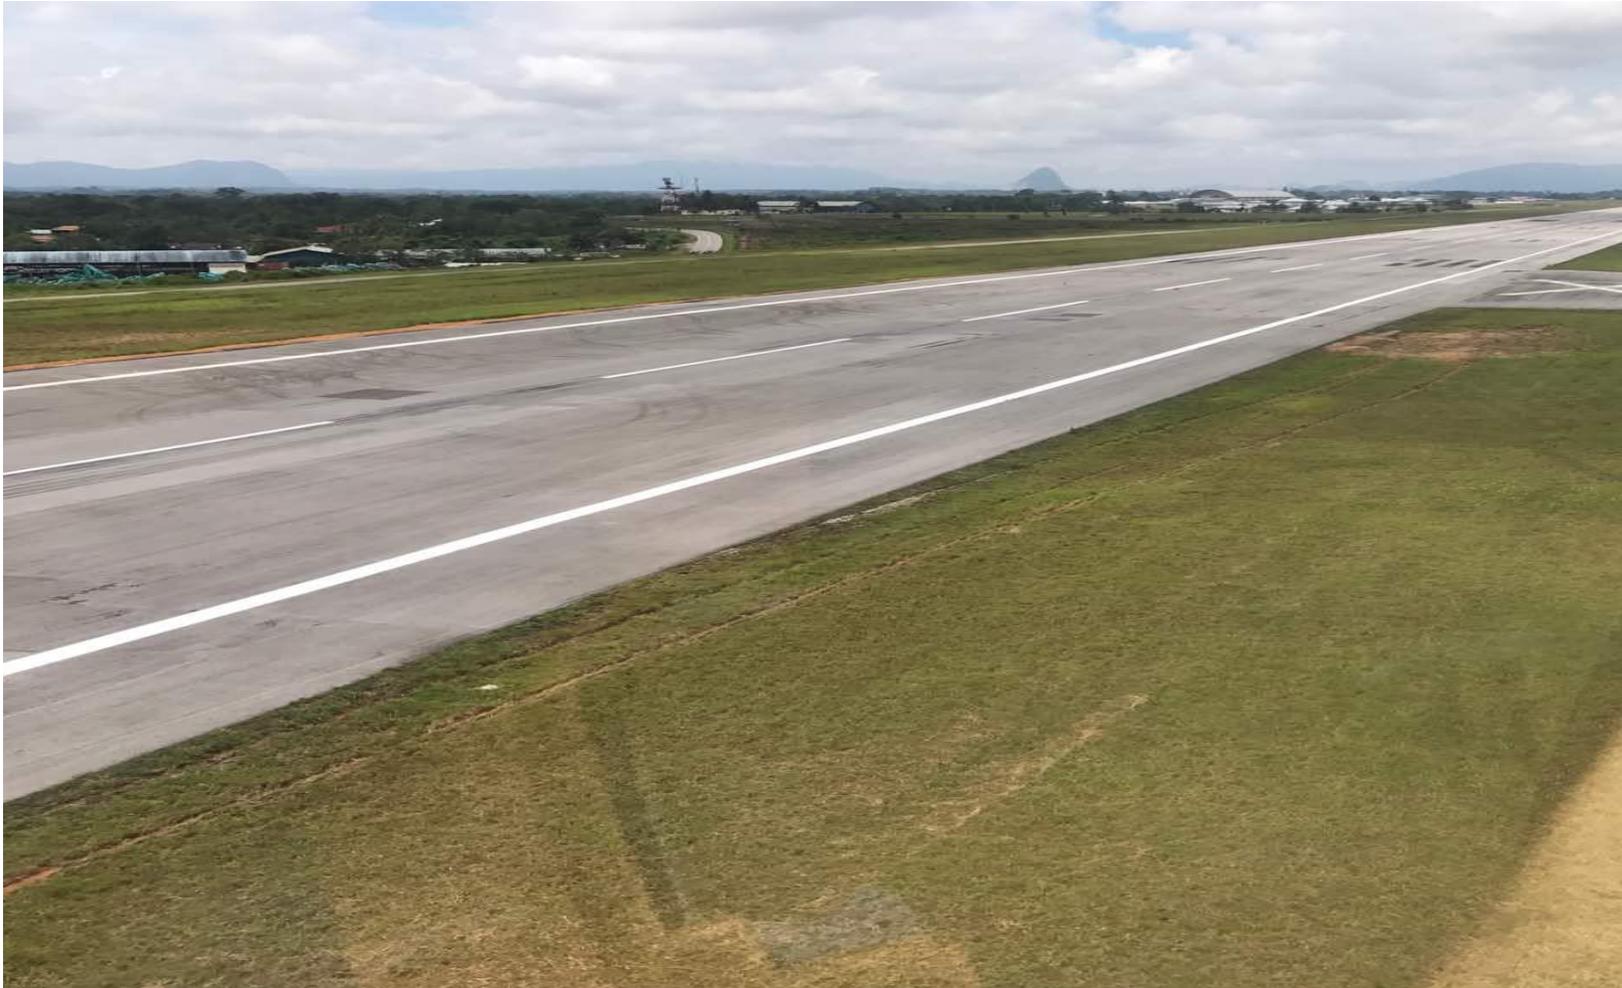
APPENDIX B, FIGURE 3 WHEELS MARKS ENTERING GRASS

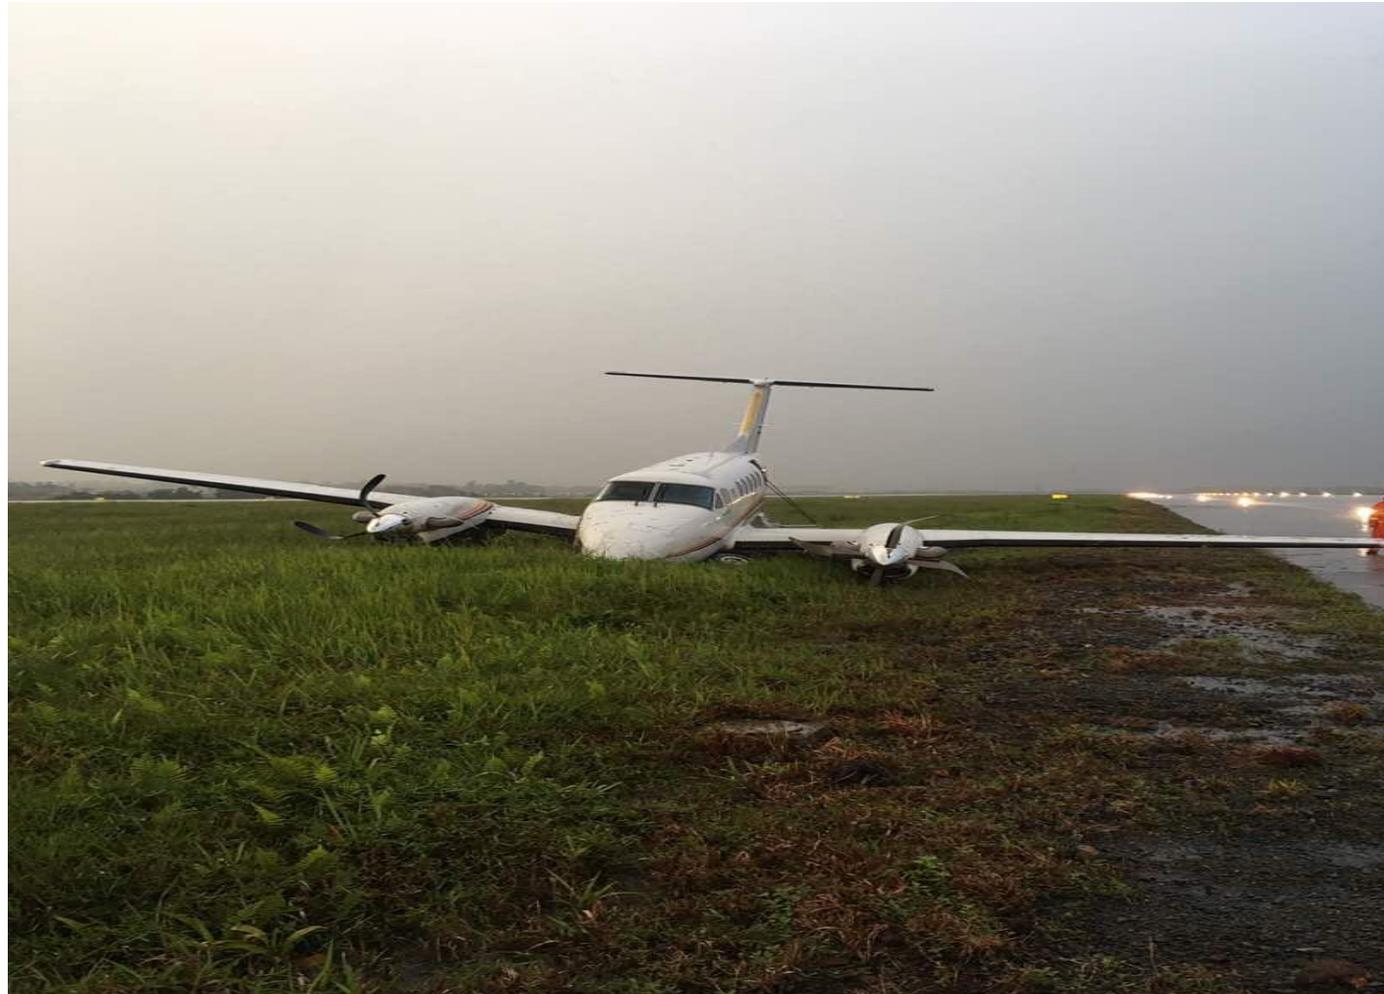
APPENDIX B, FIGURE 4 AC STOPPED NEAR A2 INTERSECTION

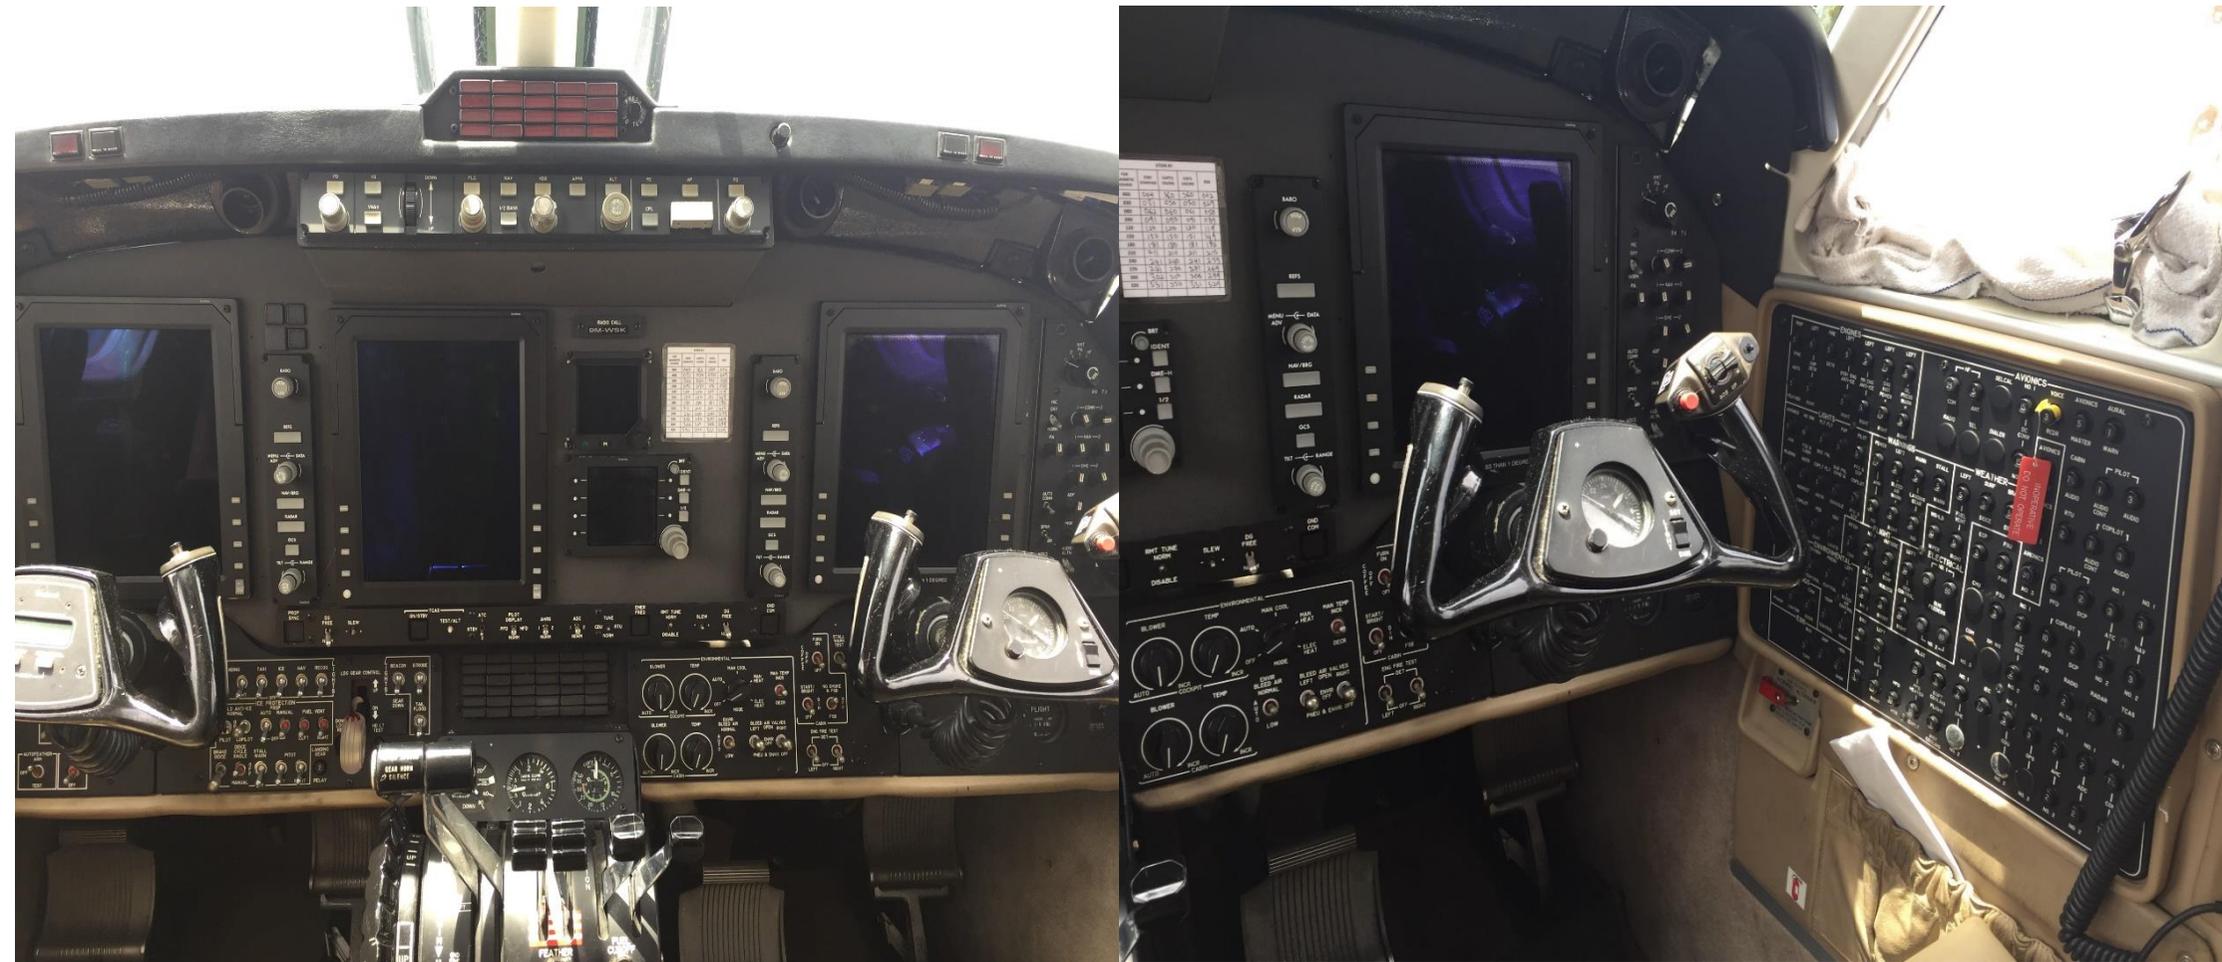
APPENDIX C, FIGURE 1 VIEW OF THE COCKPIT AREAS

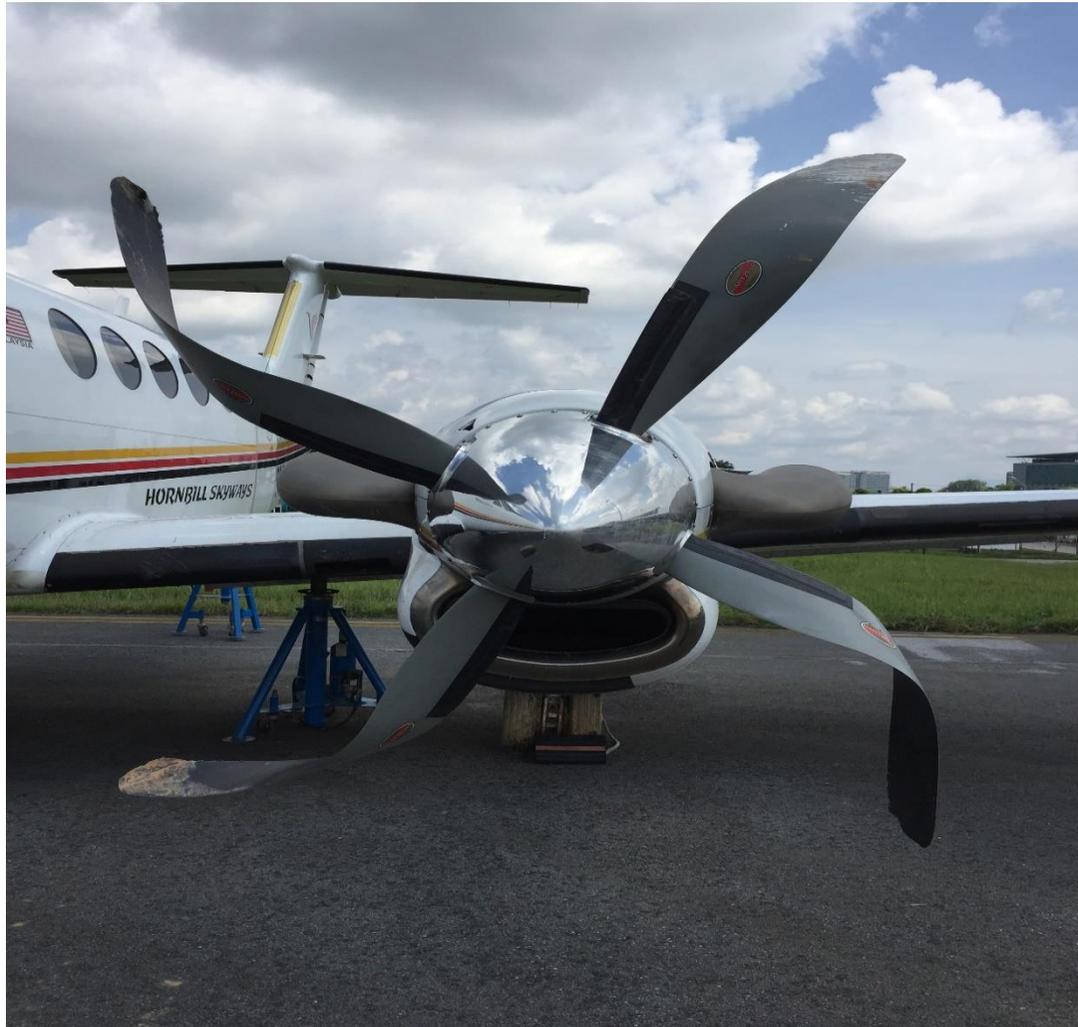
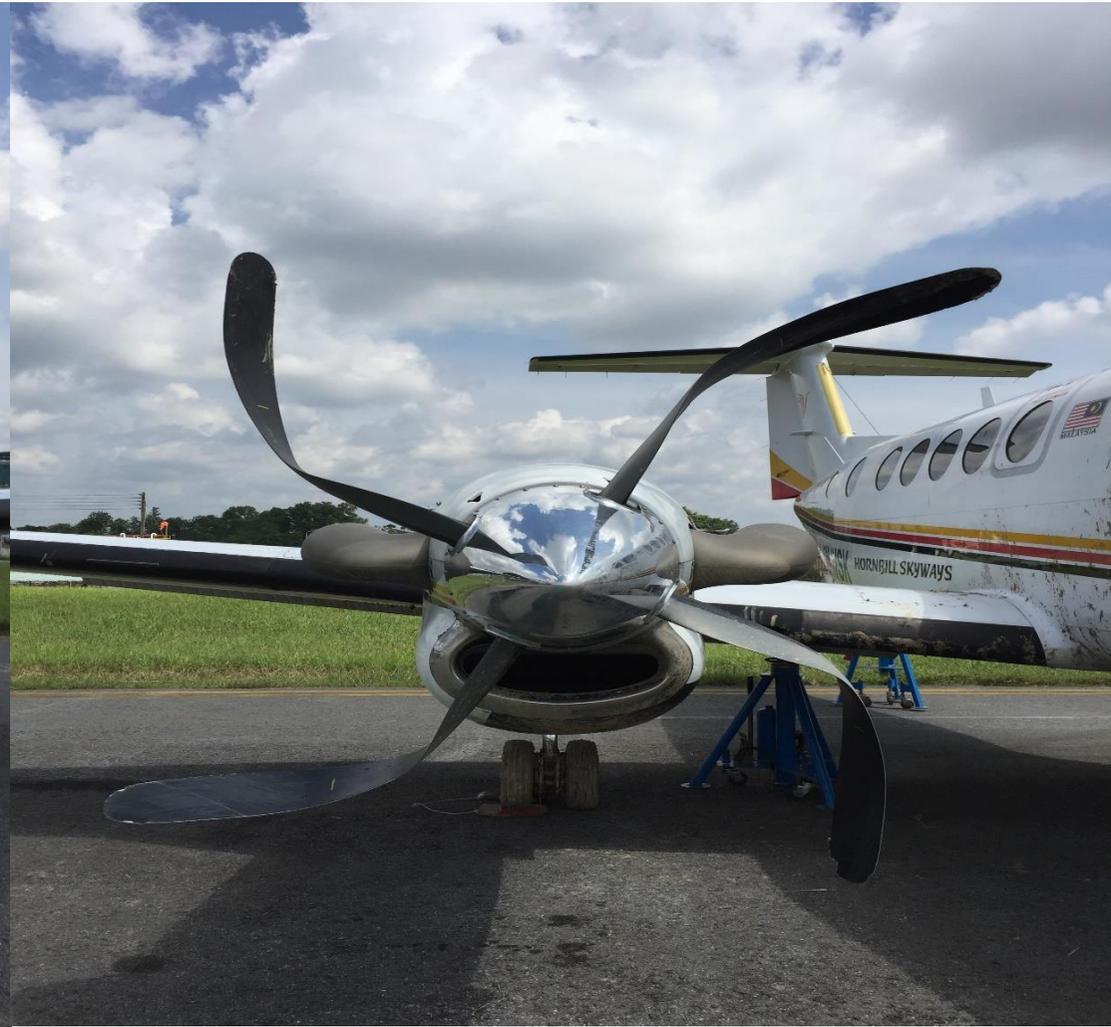
APPENDIX C, FIGURE 2

1.3.2 The left propeller assembly blades were found bent and deformed due to the engine sudden stoppage upon impact with the ground. The left engine nose cowl had traces of mud and soil got into the engine intake. The right propeller assembly blades also suffered similar damage where all the blades bent and deformed. The right engine also had traces of mud and soil got into the engine intake. There was no visible sign of fuel or oil leak from both engines.

Port and starboard propellar

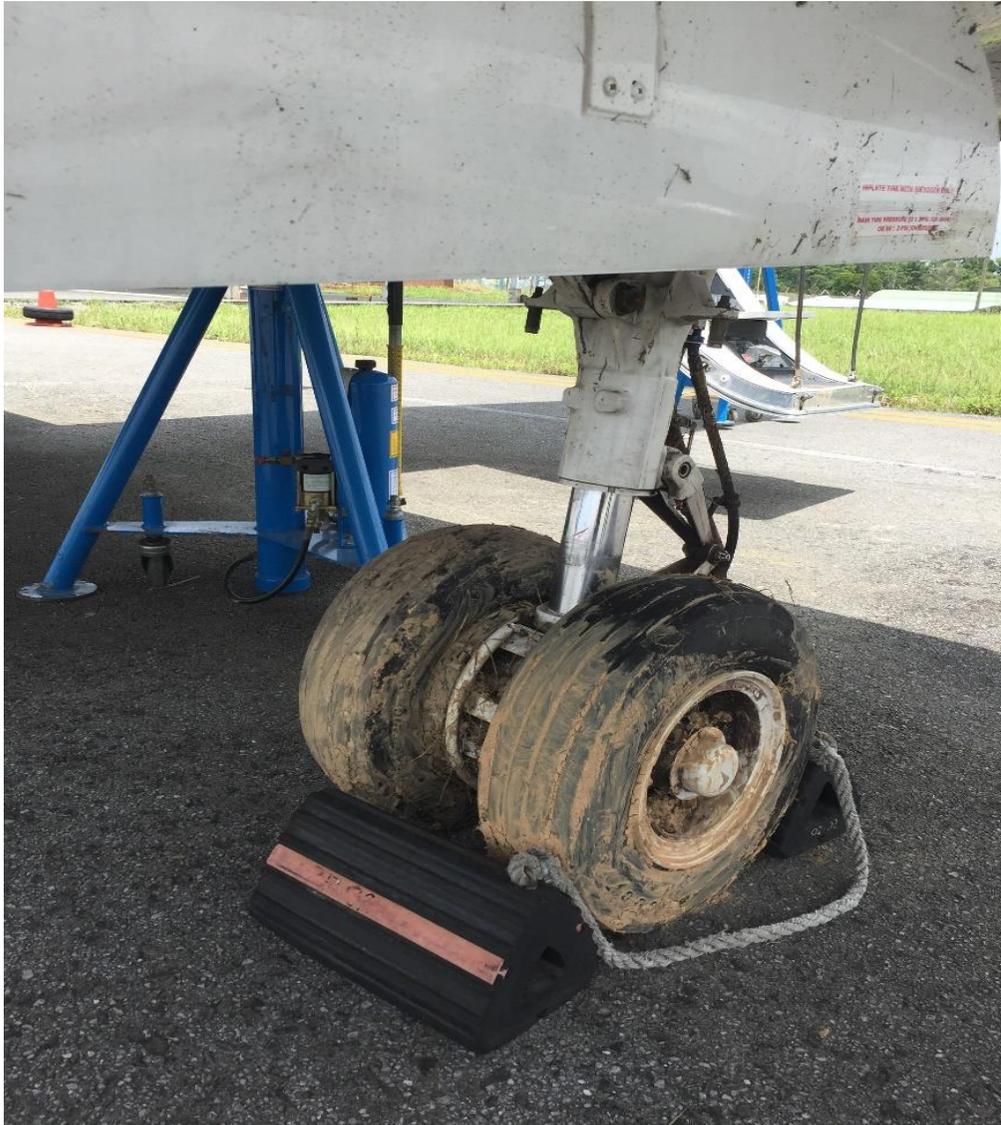
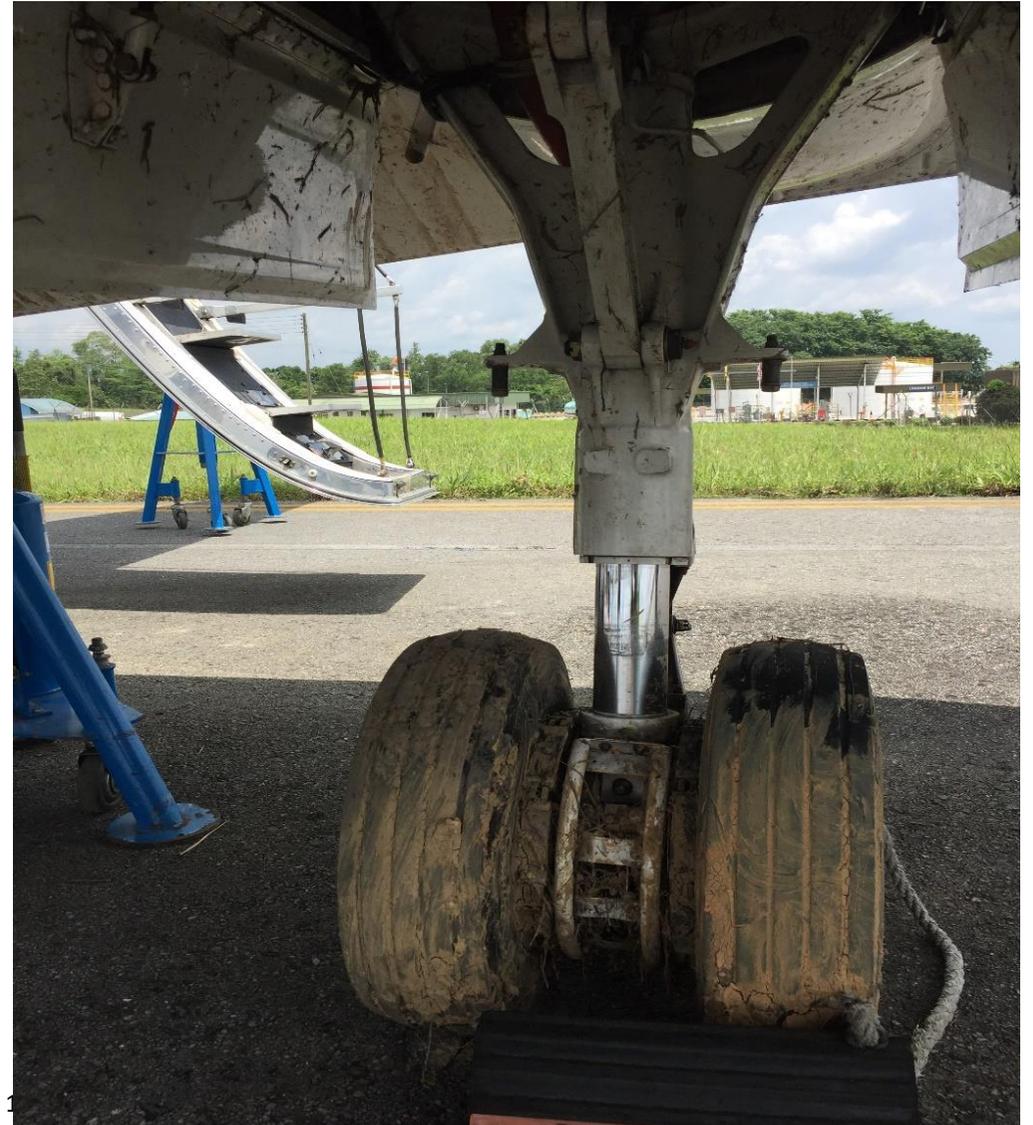
APPENDIX C, FIGURE 3

1.3.3 The left and right main landing gear assemblies including wheels and brakes were all covered by mud. There was no visible sign of fuel leak at the main landing gear wheel well area. Both the left and right wing section also had no signs of fuel leak from the wing tank access panels. Visual inspection carried out on the aft fuselage section found normal except the rudder was deflected

Port undercarriage

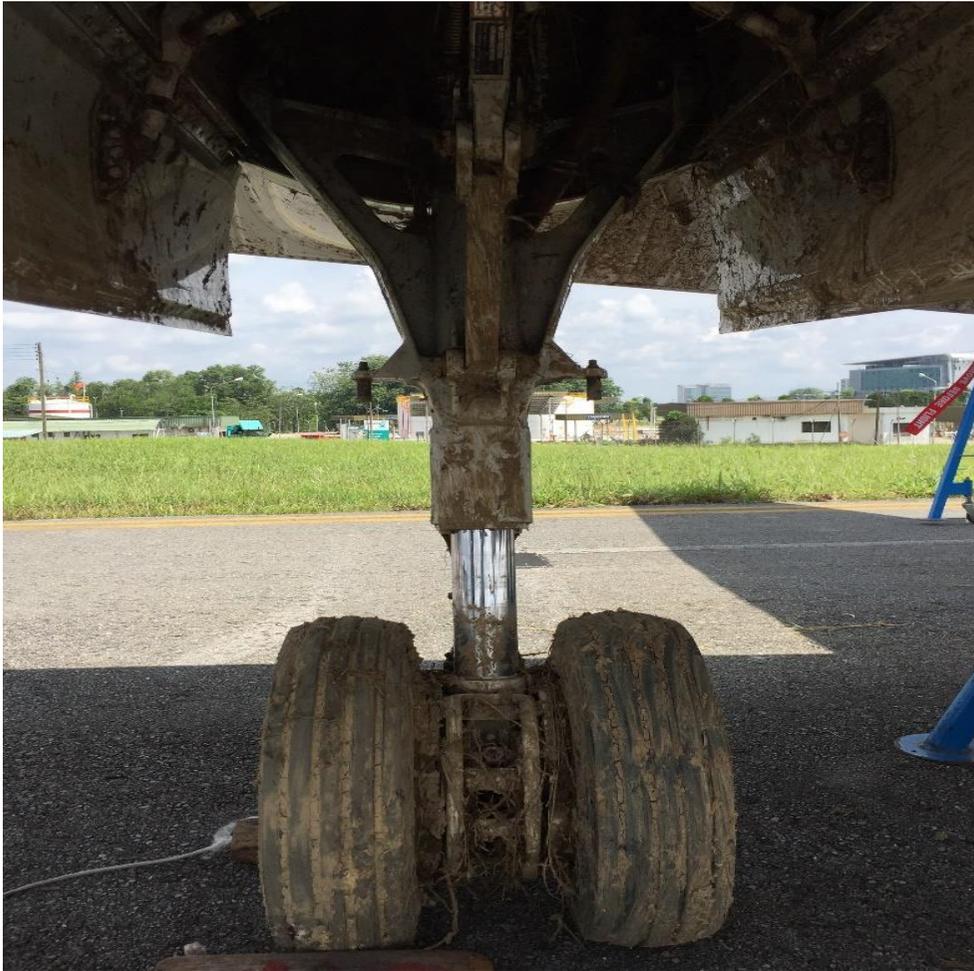
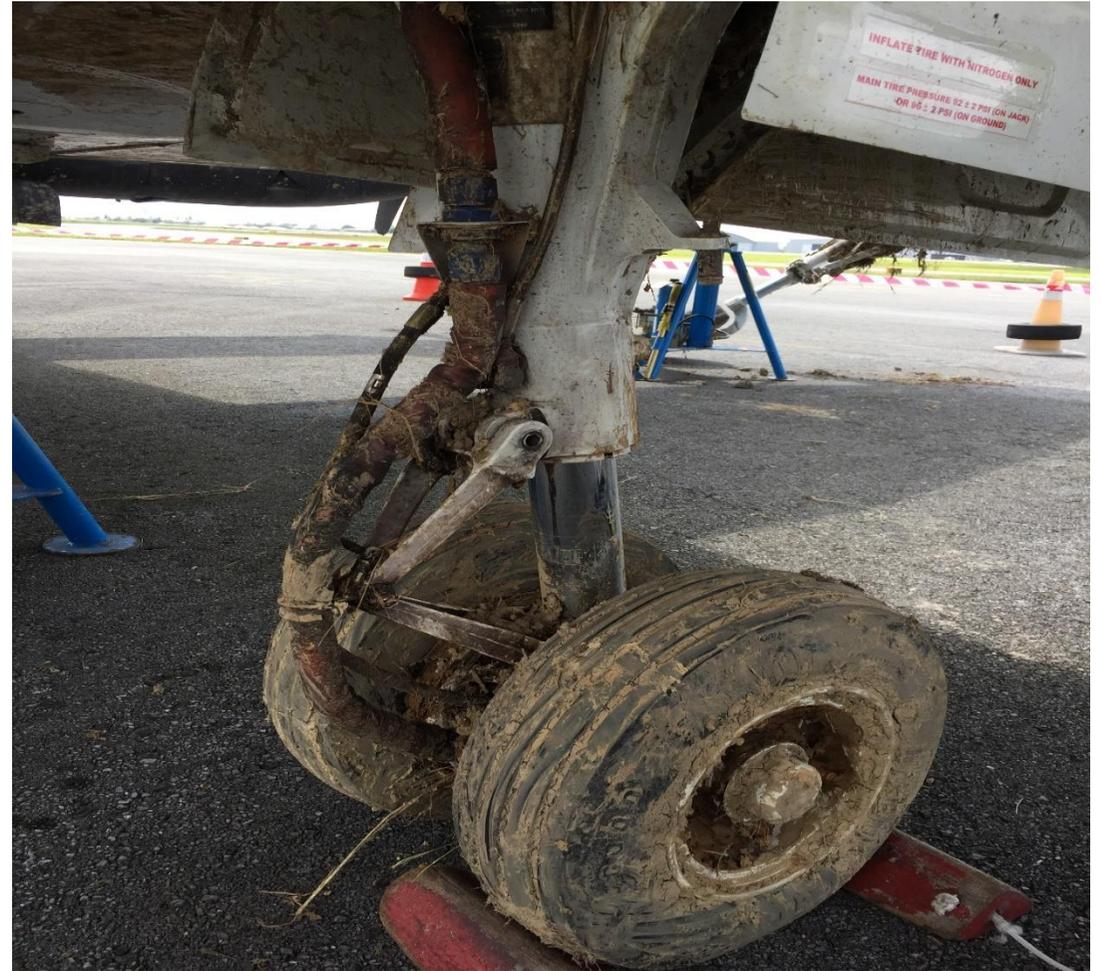
APPENDIX C, FIGURE 4

Starboard undercarriage

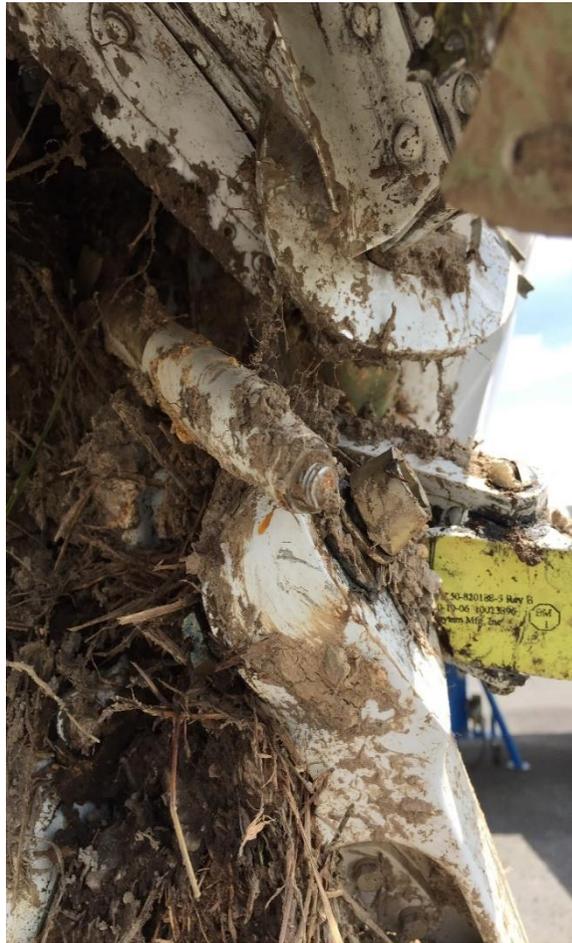
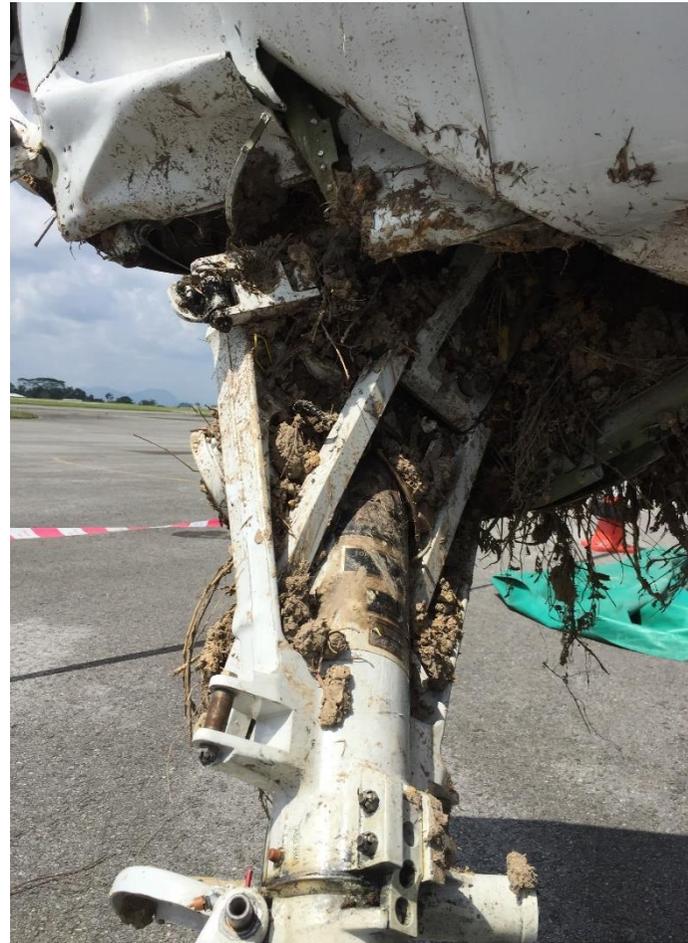
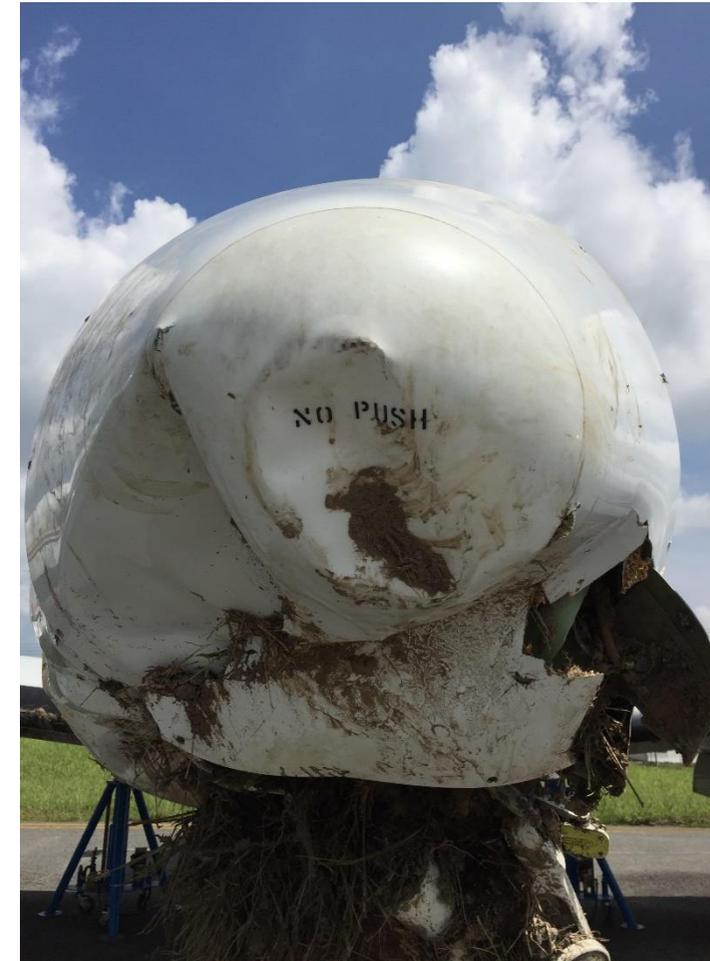
APPENDIX C, FIGURE 5

Damaged nose wheel assembly

to the right due to the nose landing gear collapsed and detached from its attachment mount. Through special detailed structural inspection is required to determine the extent of the damage.

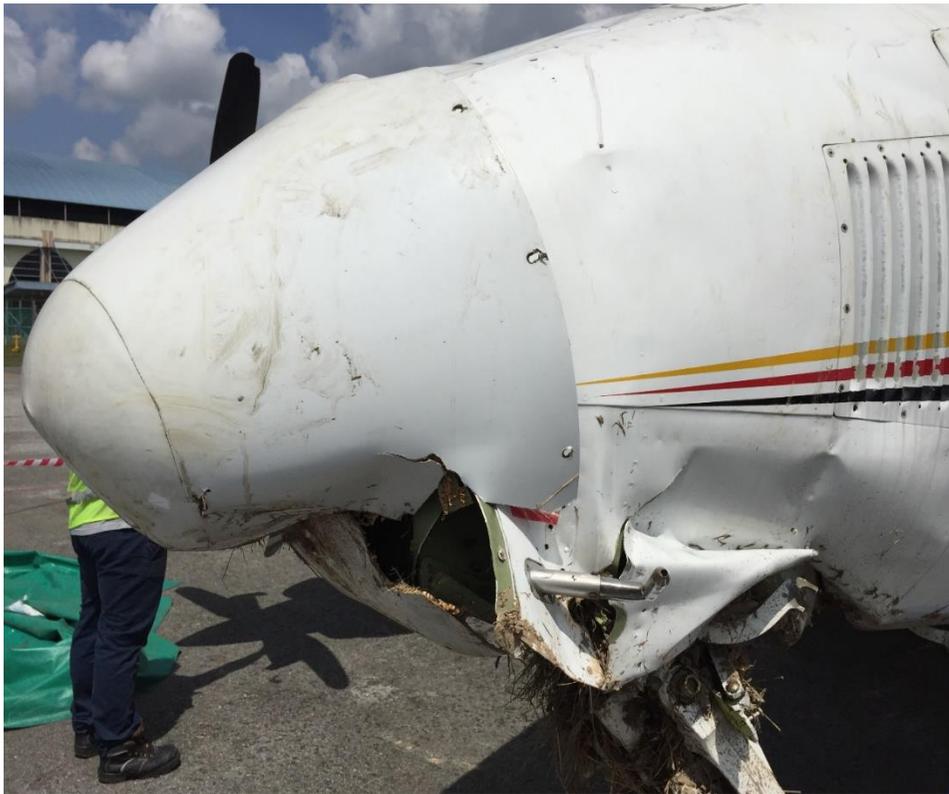
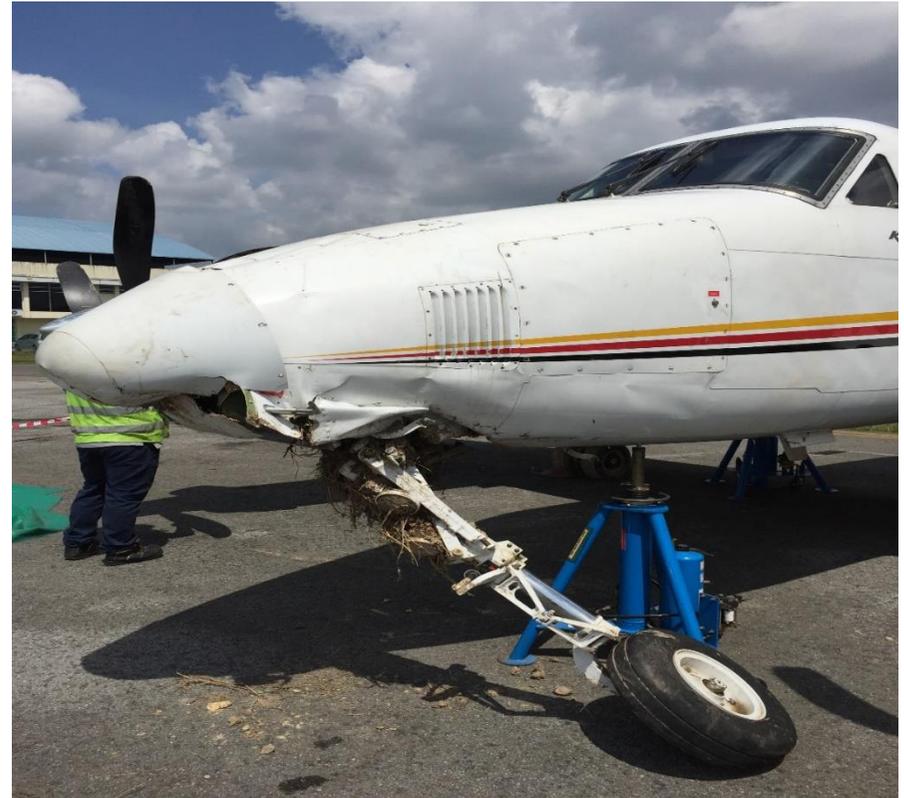
APPENDIX C, FIGURE 6

Nose compartment
