**AIRCRAFT SERIOUS INCIDENT
FINAL REPORT
SI 04/18**

**Serious Incident involving Fixed wing aircraft Boeing B737-900
Registration 9M-LNJ
Runway Excursion at Tribhuvan International Airport,
Kathmandu, Nepal
on the 19th April 2018**

SERIOUS INCIDENT REPORT NO. : SI 04/18

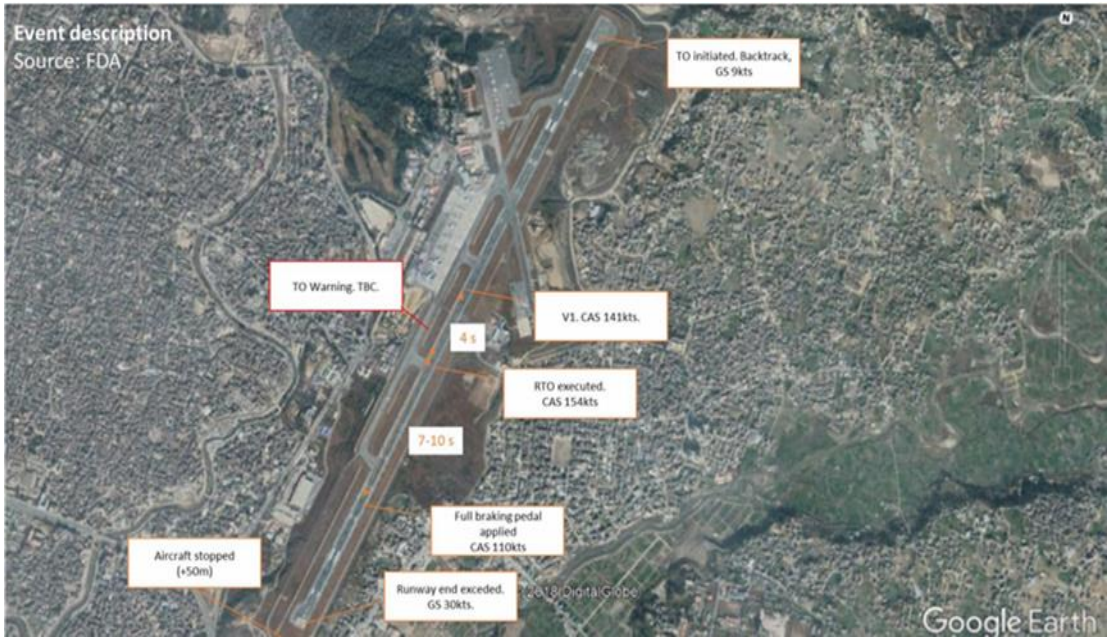
Diagram 2: Sequence of events during take-off roll and RTO
(Source FDA/Google Earth)

Flight data analysis provides a comprehensive description of the sequence of events, as shown in Diagram 2 and 3. A Bowtie of the event is detailed in Diagram 1.

According to the flight data the RTO was initiated 4 seconds after V1, at a CAS 154kts. There is no evidence of TO Warning during the take-off roll recorded. The RTO was performed initially with autobrake, and it was disconnected immediately after by applying pressure on the brake pedals by the CPT. Flight data shows a progressive movement of the braking pedals from 30% to close to 90% in 10 seconds (see Figure 3). After that point, constant maximum pressure was applied until aircraft came to stop. Runway excursion occurred at Groundspeed 30kts, and the aircraft was stop close to 50m after the RWY02 threshold.

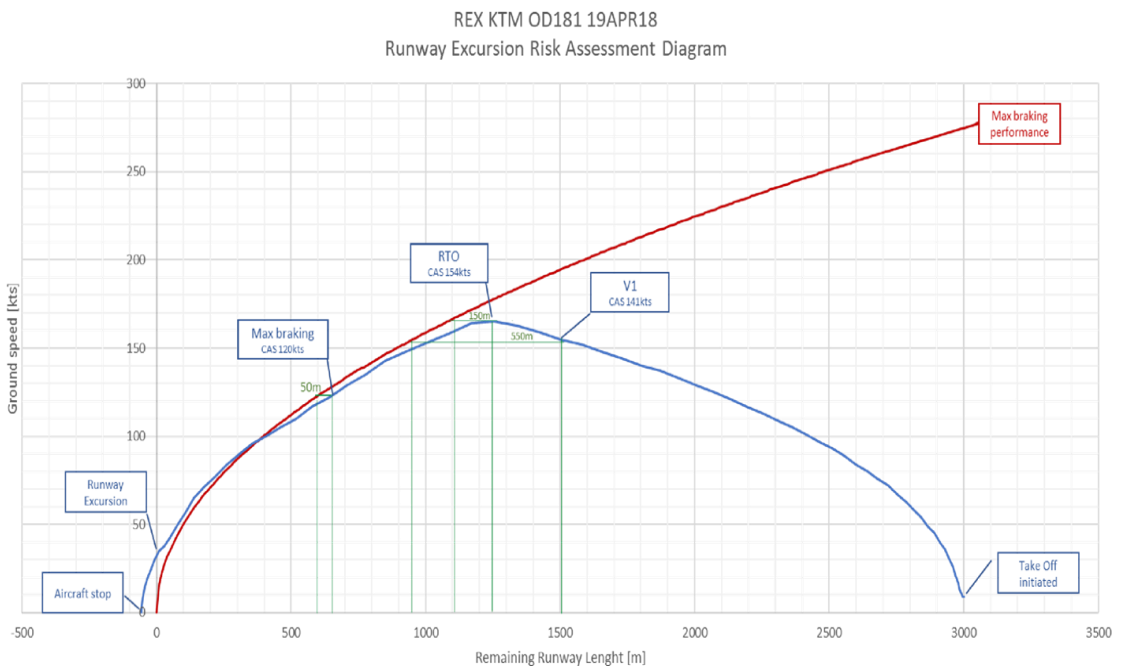
Diagram 3: Runway Excursion Risk Assessment Diagram (Source: FDA)

Runway Excursion Risk Assessment Diagram: This diagram has allowed the investigation team to assess the impact on the safety margin by every action taken during the Take-Off roll and Rejected Take-Off.

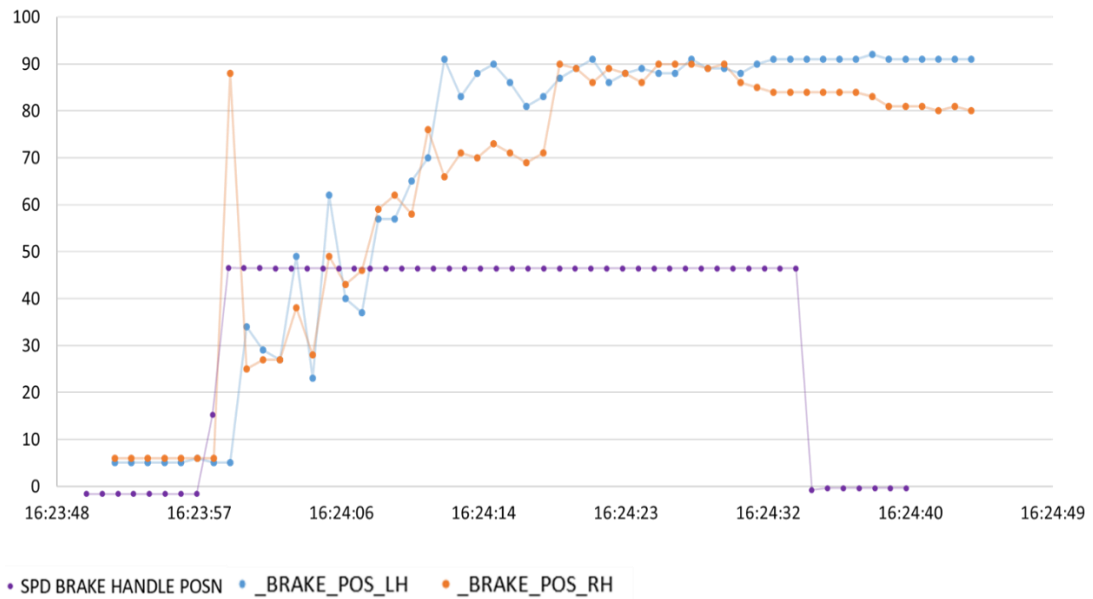
Diagram 4: Braking pedal and speed brake handle position during RTO (Source: FDA)

3.1.5 Autobrake was disconnected immediately after the RTO was initiated. However, no maximum braking was applied during manual braking until 10 seconds after the RTO was initiated.
