BRIEFING to MEDIA

**The Malaysian ICAO Annex 13 Safety Investigation Team for MH370
30th July 2018**

**SAFETY INVESTIGATION REPORT
MALAYSIA AIRLINES BOEING B777-200ER (9M-MRO)
8th March 2014**

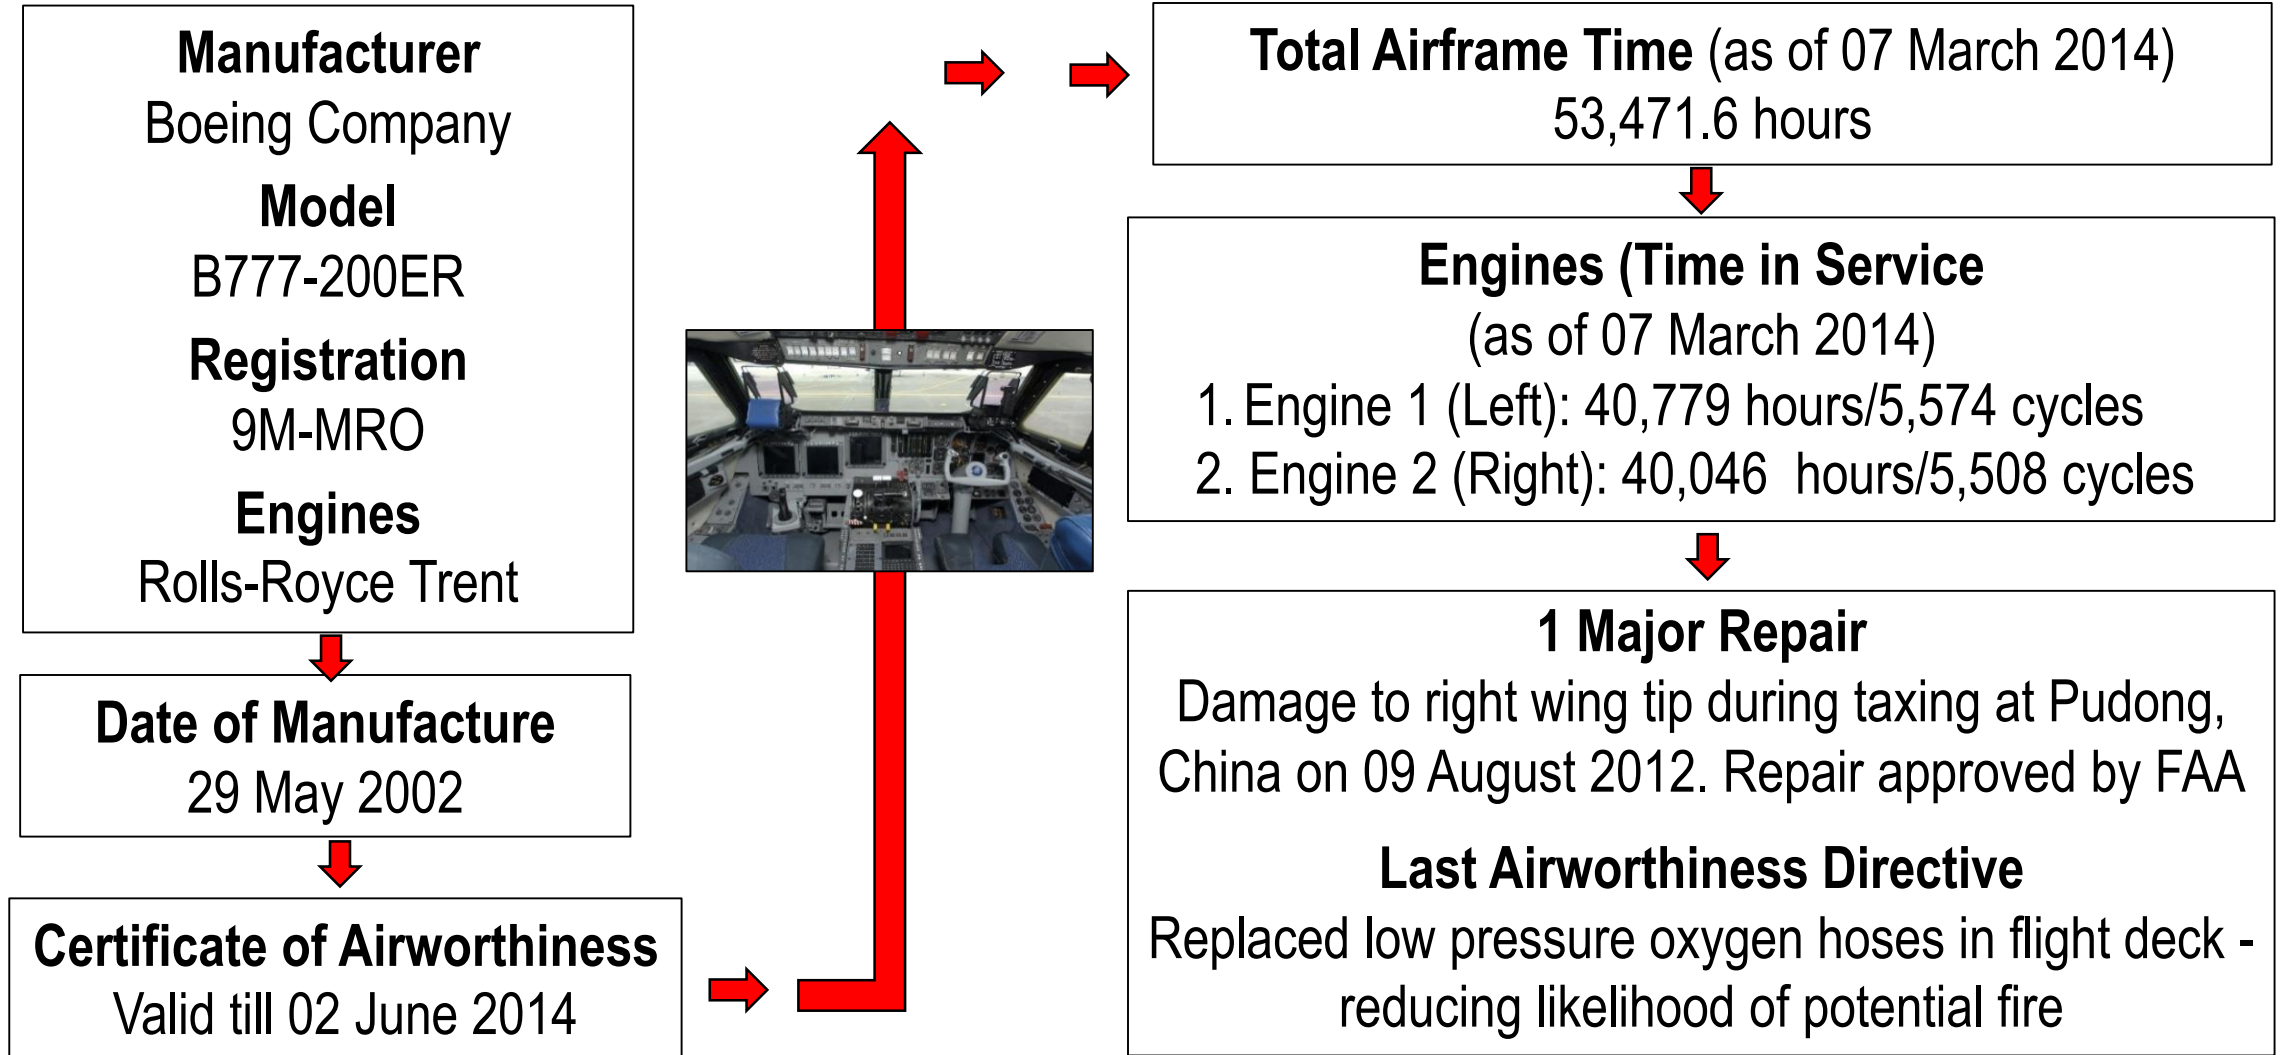
AIRWORTHINESS & MAINTENANCE AND AIRCRAFT SYSTEMS

- 1) Records show all Airworthiness Directives (mandatory inspections and modifications) had been complied with
- 2) Technical Log Review since last D Check in June 2010 shows no significant defect trends
- 3) Engine Health Monitoring (EHM) trend reports over last 3 months show no evidence of unusual engine behaviour
- 4) Two EHM reports, (Take-off and Climb) were transmitted. Both show no unusual engine behaviour)

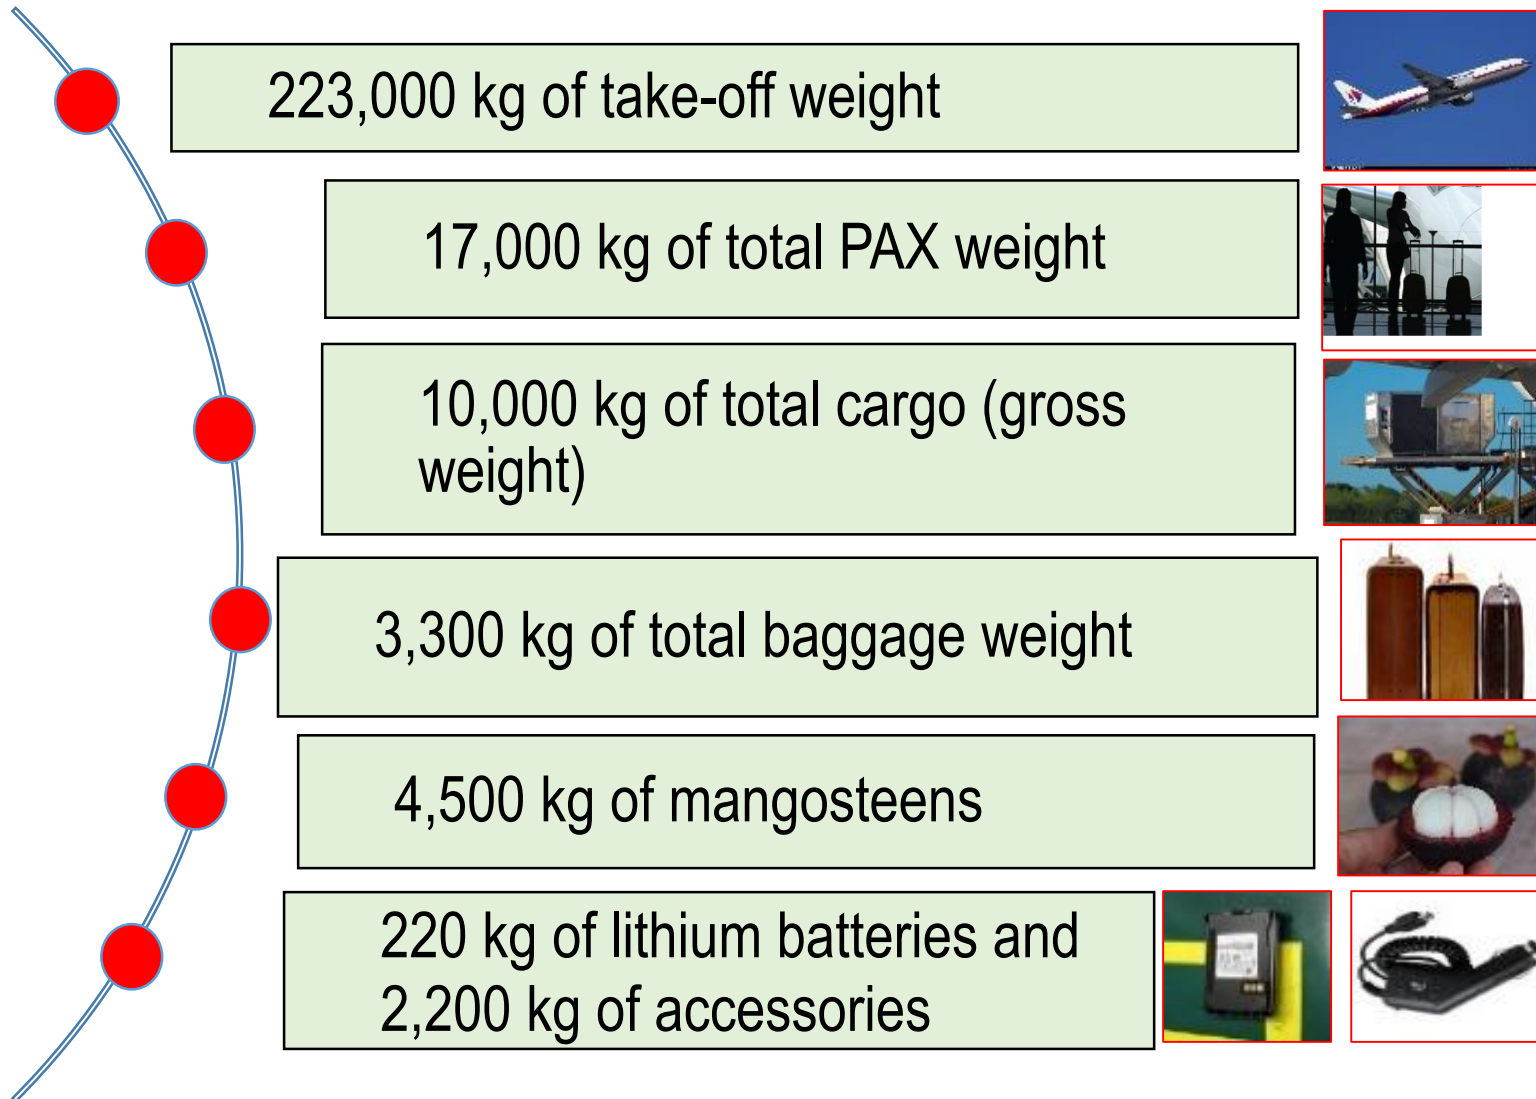
CARGO CONSIGNMENT

- 1) Assembled on 07 March 2014, packed and placed on wooden pallets
- 2) From Motorola forwarder NNR Global Logistics sent shipment to MASkargo Penang
- 3) Battery shipment physically inspected by MASkargo staff but not screened by MAS Security using x-ray machine (then no available x-ray machine large enough to screen cargo in Penang)
- 4) Also went through Customs inspection and clearance
- 5) Li-Ion batteries not classified as dangerous goods because packing adhered to the Guidelines stipulated in the Lithium Battery Guidance Document

- 1) 2,500 kg - Poh Seng Kian from Muar, the rest from Sumatra
- 2) Mangosteens placed in plastic baskets (8 to 9 kg per basket), sponge soaked with water put on top of baskets to maintain freshness. Loaded onto trucks and sent to MASkargo, KLIA
- 3) MAS provided Unit Load Device (ULD) to the forwarding agent
