AIRCRAFT ACCIDENT REPORT A 02/18

**Air Accident Investigation Bureau
Ministry of Transport, Malaysia**

**Final Report on the Accident Involving
Fixed Wing Aircraft M-18A Dromader Registration VH-FOS
In Keratong, Pahang, Malaysia
On The 25th February 2018**

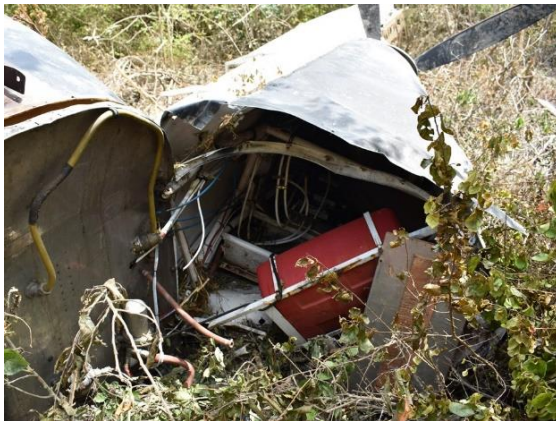
Picture 5
Engine separated from airframe

Engine separated from the airframe, bend and twisted to the left

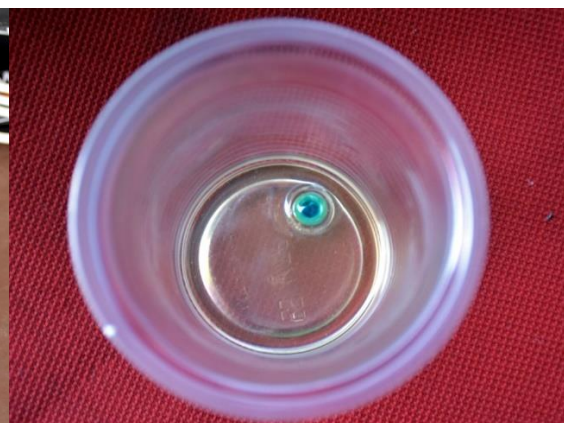
Picture 15

Fuel sample from FCU filter. The colour of the tablet changed

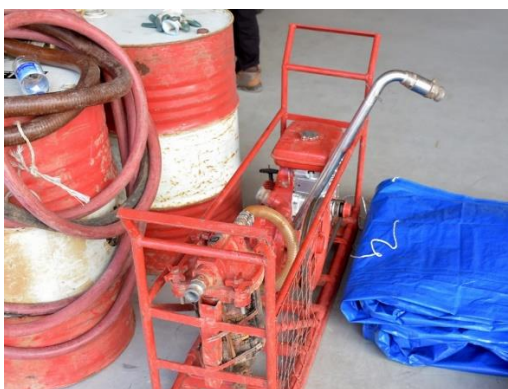
Picture 16

The hose is made up of a few hoses joint together using the hose clamp. This hose found to be dry with no sign of water during the inspection.

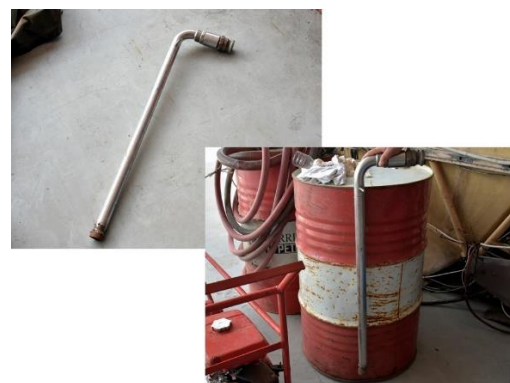
Picture 17

The stainless pipe used (dipped into the fuel drum) has been modified with a stopper bars on the side as to ensure the pipe did not goes all the way to the bottom of the drum. This is the procedure use by the ground handler as to ensure some of the fuel at the bottom will be left in the drum as a precautionary to ensure if there is a water contamination, it will remain in the drum.
