**FINAL  
AIRCRAFT ACCIDENT REPORT  
19 APRIL 2016**

**AIRBUS 330 9M-MUC  
HITS LAMP POST DURING TAXI AT ASTANA  
ASTANA INTERNATIONAL AIRPORT  
29 JUNE 2014**

**AIR ACCIDENT INVESTIGATION BUREAU OF MALAYSIA  
MINISTRY OF TRANSPORT  
MALAYSIA**

**ACCIDENT REPORT NO.: 07/2014**

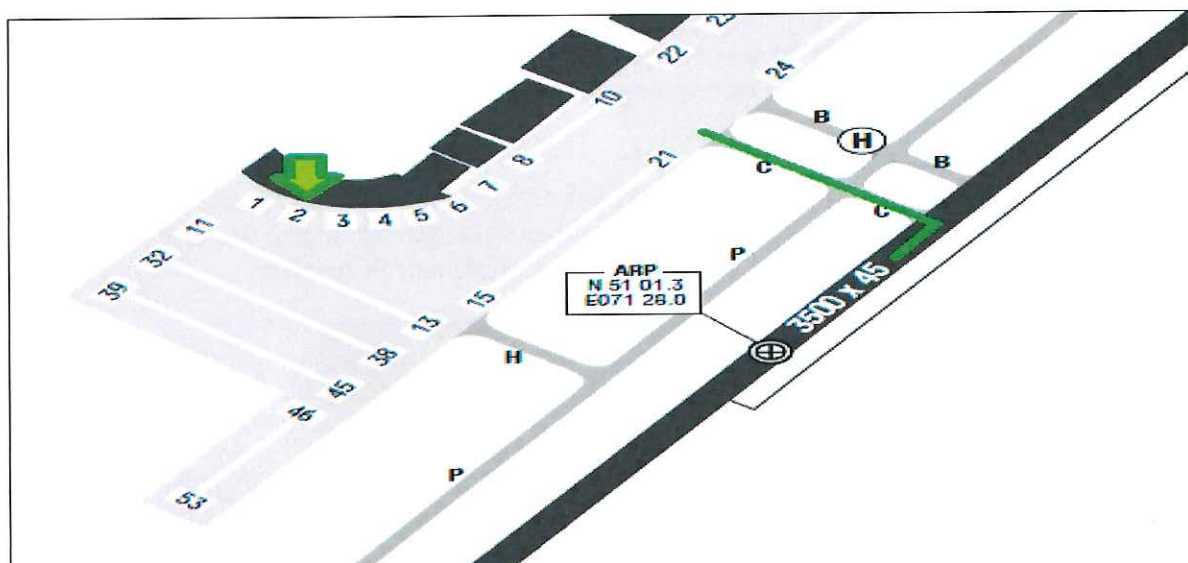
**Figure 1: Section of Lido AGC of Astana Airport 24 April 2014**

Note: LIDO Airport Ground Chart (AGC) did not depict the outer and inner lines on the apron.

- 4.1 It is recommended that the LIDO chart provider to amend the TSE AGC chart to reflect the restriction on the taxiway.
- 4.2 It is recommended that the Kazakhstan Authority is to update the Astana International Airport AIP with the relevant taxiways and routings.

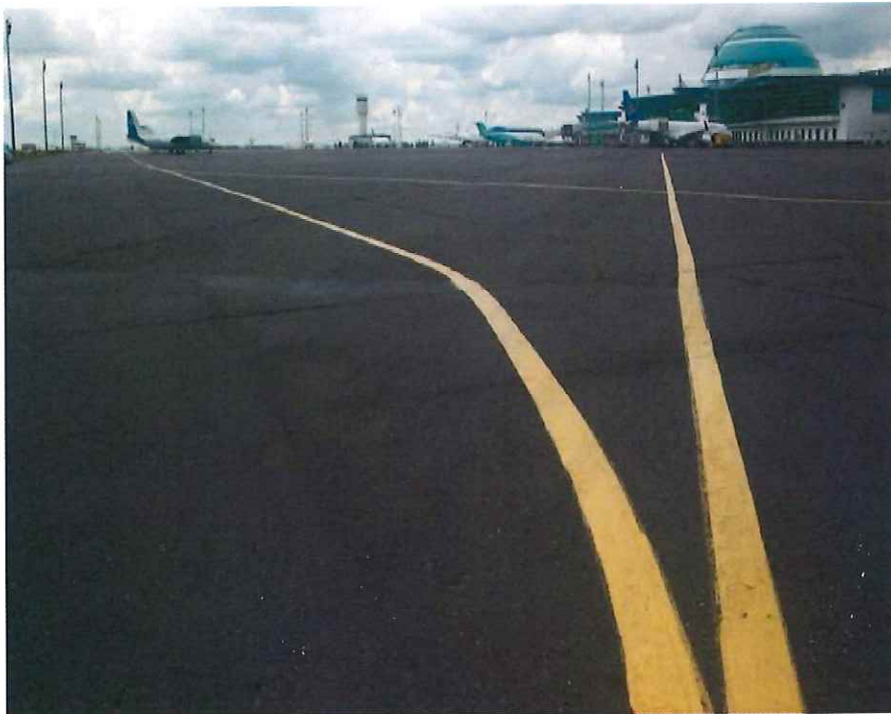
**Figure 3: Ground level view of taxiways branching outer and inner**

- 1.1.4 Upon entering the Apron area, the crew observed that there were 2 separate taxi lanes adjoining Taxiway 'C'; one leading towards the main terminal and the other towards the opens bays across the terminal. These taxi lanes were not given any specific designation (name), either on the ground or on the airport charts that were provided. (see Figure 3).

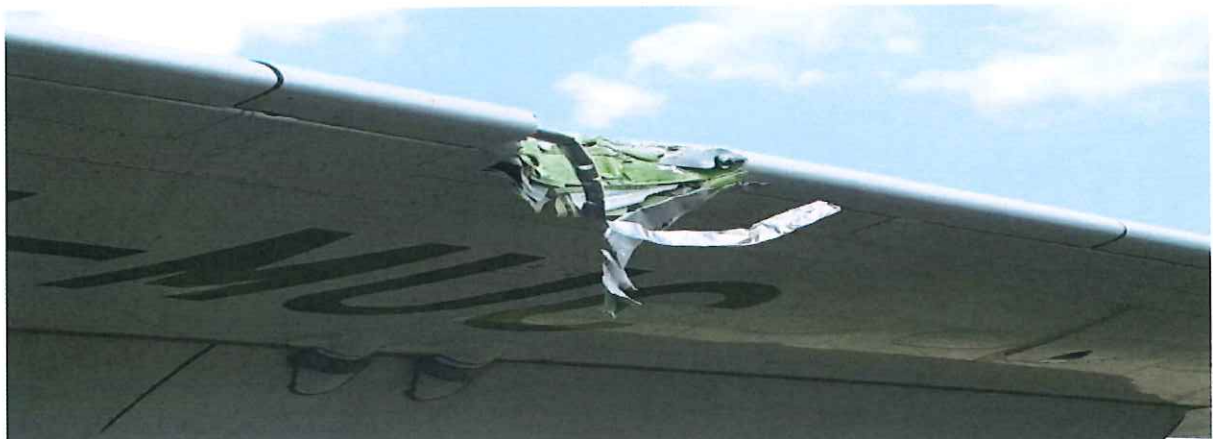
**Figure 4: Left Wing No. 6 Slat Damage**

9M-MUC Number 6 slats damage

Aircraft left wing came into contact with the light pole approximately 7.3meters from the left wingtip. The aircraft continued forward approximately another 7 meters before coming to a stop.

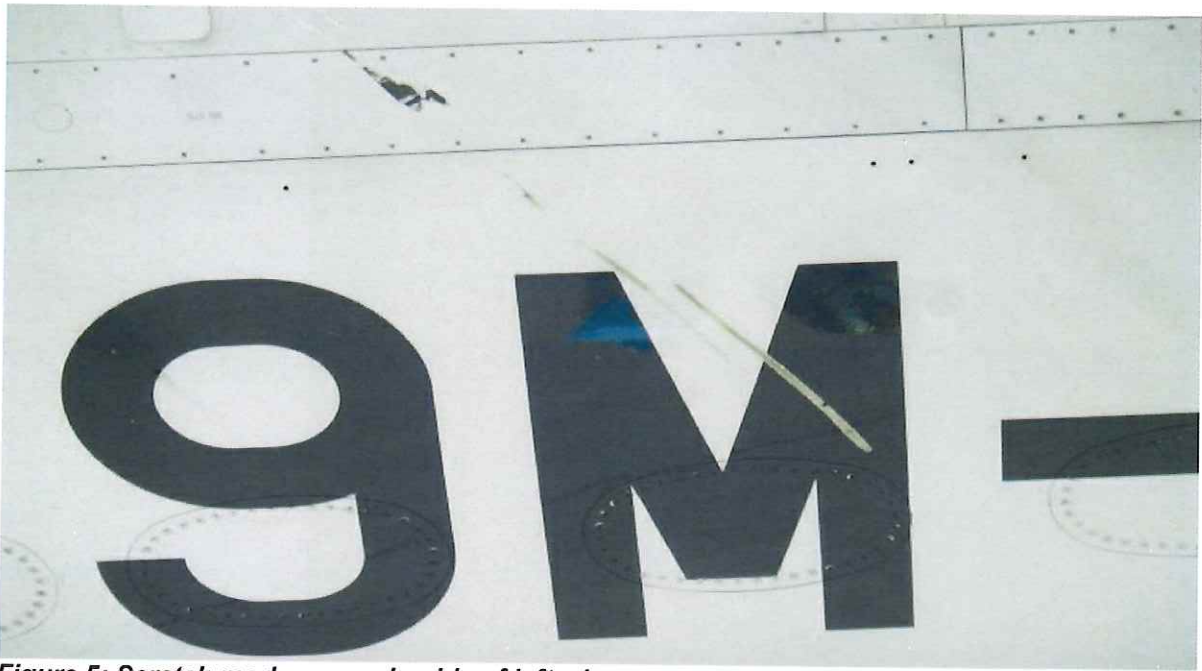
**Figure 5: Scratch marks on underside of left wing**

1.3.1.2 Left underwing scratched by 2nd post (CCTV post)

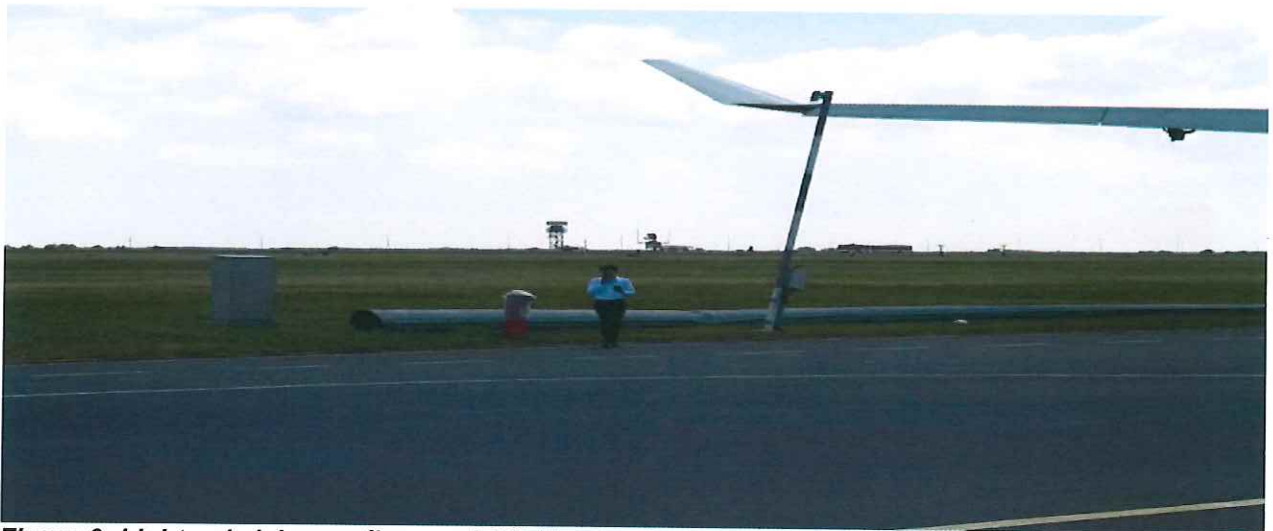
**Figure 6: Light pole lying on floor and CCTV pole slanted**

1.4.1. Light Pole is being knocked down

1.4.2. CCTV knocked off 2nd shorter pole

The light pole is located 4.2 meters from the edge of the taxiway. The CCTV pole is located 5 meters after the light pole.

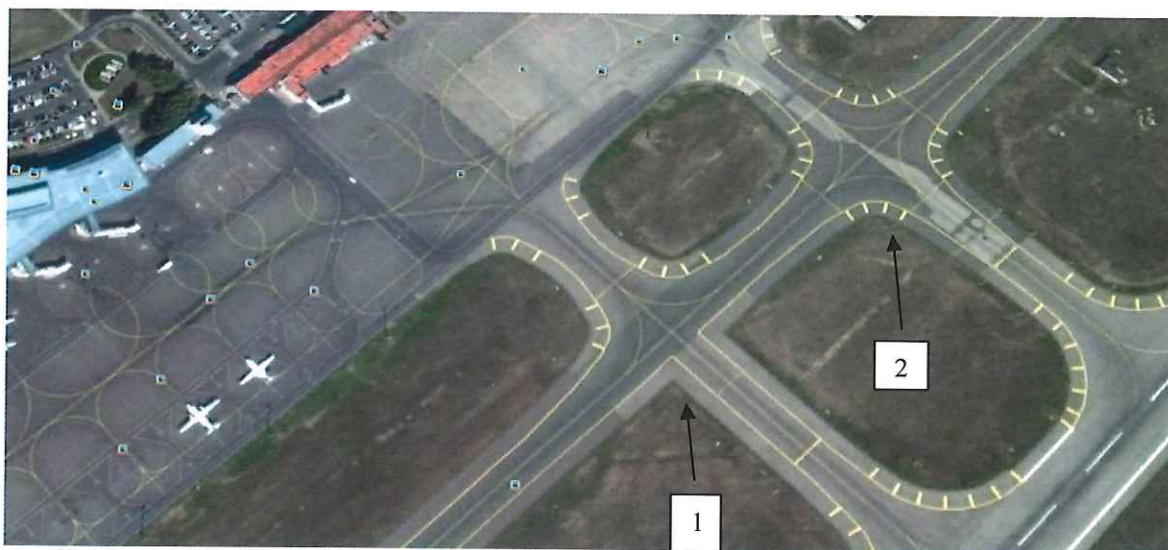
**Figure 10: Google Earth picture of taxiway B and C with taxi markings sourced on 30 June 2014**

- 2.1.7 Reference to Figure 10 below, (box 1), there are no taxiway lines for turns onto Taxiway 'P' at the intersection of Taxiway 'C' and Taxiway 'P' on the side closest to the runway. The taxiway markings also do not allow left turn into Taxiway 'P'. This means that all aircraft vacating the runway using Taxiway 'C' will have to route via the apron. Aircraft vacating using Taxiway 'B' has the option of either turning left on

Taxiway 'P' or continuing via the apron. (Box 2). This information is not shown on the LIDO AGC chart that was developed based on information from AIP for Astana International Airport.
