# AIRCRAFT SERIOUS INCIDENT FINAL REPORT

SI 08/14P

**Airbus A330-200F, Registration 9M-MUC  
at Astana International Airport, Kazakhstan  
on 29 June 2014**

**OPERATOR : MALAYSIA AIRLINES**  
**AIRCRAFT TYPE : AIRBUS 330**  
**NATIONALITY OF AIRCRAFT : MALAYSIA**  
**REGISTRATION : 9M-MUC**  
**PLACE OF OCCURRENCE : ASTANA INTERNATIONAL AIRPORT  
KAZAKHTAN**  
**DATE AND TIME : 29 June 2014 AT 1046 LT**

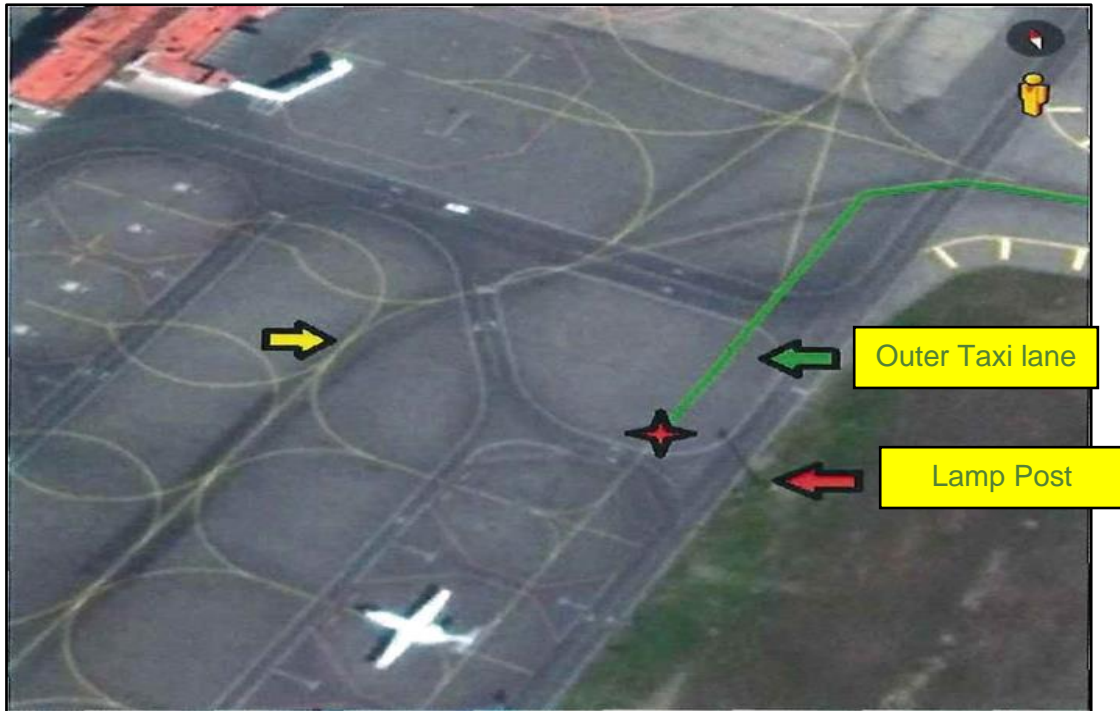
Figure 2: Map of Astana Airport's Apron sourced on 30 June 2014

The left wing of the aircraft had hit a lamp-post and caused it to topple. Apart from the light pole, the aircraft wing also came into contact with another smaller pole with a CCTV mounted. The CCTV was knocked off and the pole scratched the underside of the wing. The impact resulted in the number 6 slat leading edge being damaged. Refer Figure 2 below for view of the Apron area that was involved.

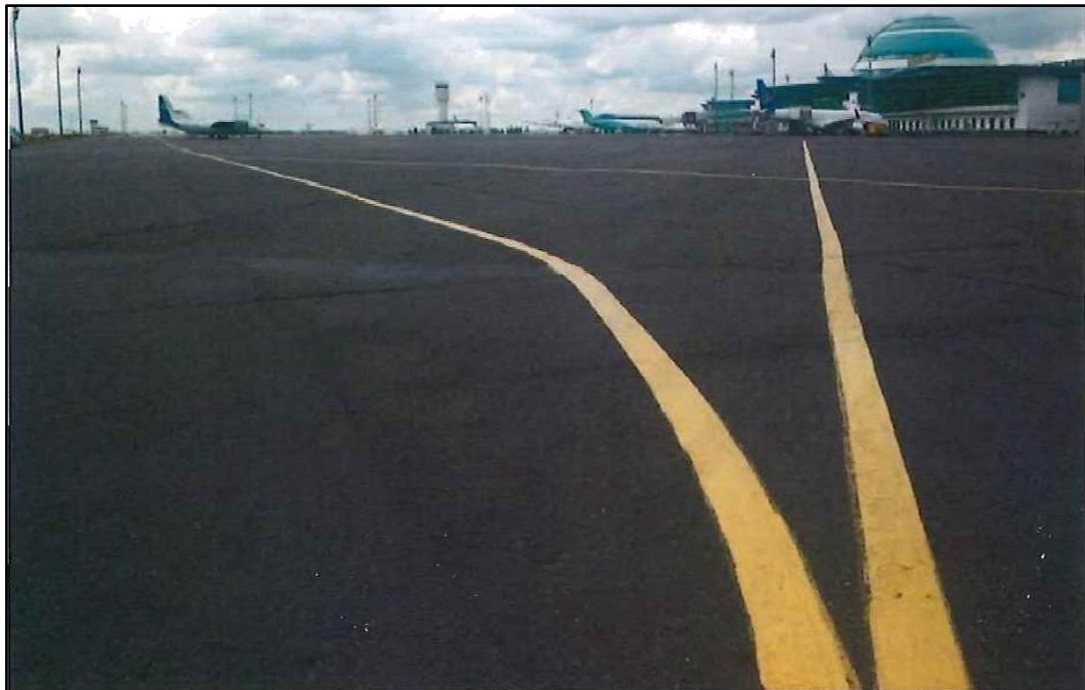
Figure 3: Ground level view of taxiways branching outer and inner

Upon entering the Apron area, the crew observed that there were 2 separate taxi lanes adjoining Taxiway 'C'; one leading towards the main terminal and the other towards the open bays across the terminal. These taxi lanes were not given any specific designation (name), either on the ground or on the airport charts that were provided. (see Figure 3).

As Taxiway 'C' joins the apron, there are multiple branches of taxiways that were not depicted on the charts. These taxiways are not named or labelled on the charts and on the ground. There is also no information provided with regards to taxiway limitations on the apron area.

4.3 It is recommended that the Kazakhstan Authority is to look at naming the various taxiways.

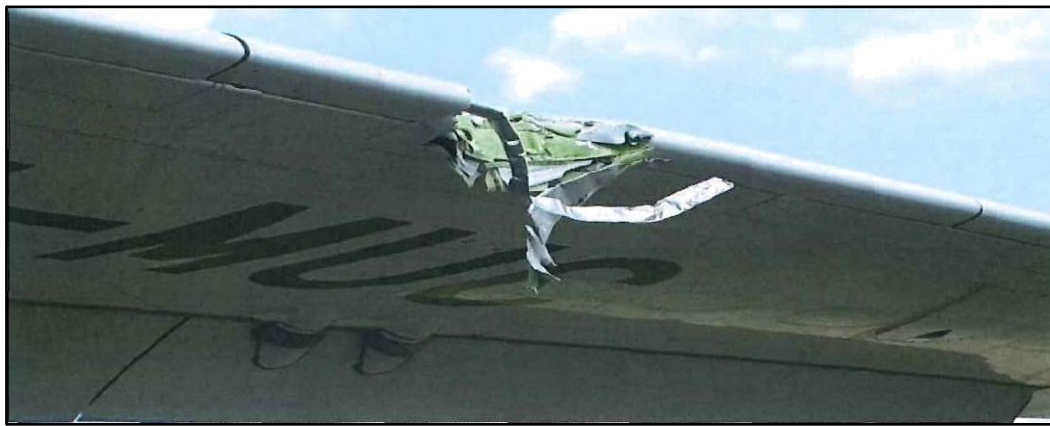
Figure 4: Left Wing No. 6 Stat Damage

9M-MUC Number 6 slats damage

Aircraft left wing came into contact with the light pole approximately 7.3 meters from the left wingtip. The aircraft continued forward approximately another 7 meters before coming to a stop.

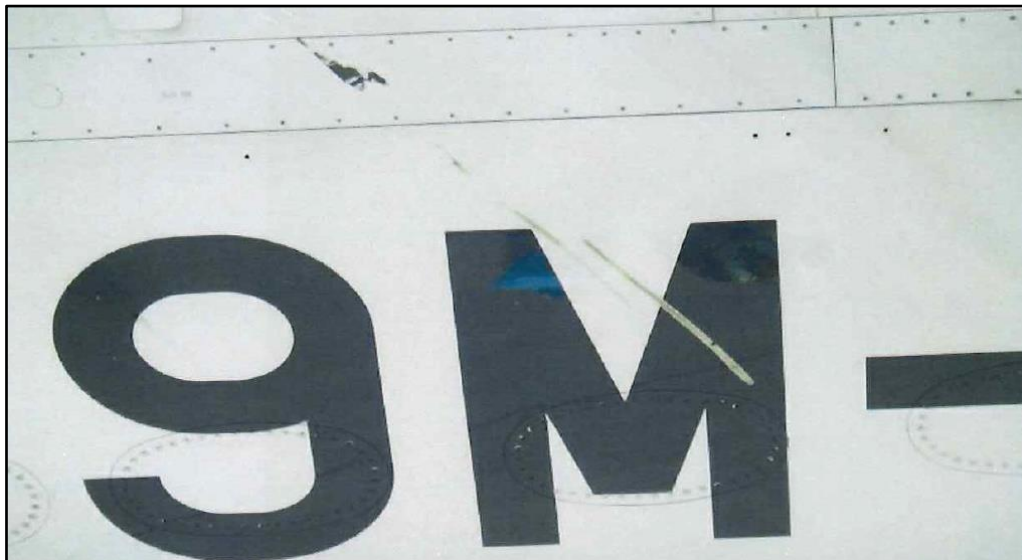
Figure 5: Scratch marks on underside of left wing

Left underwing scratched by 2nd post (CCTV post)

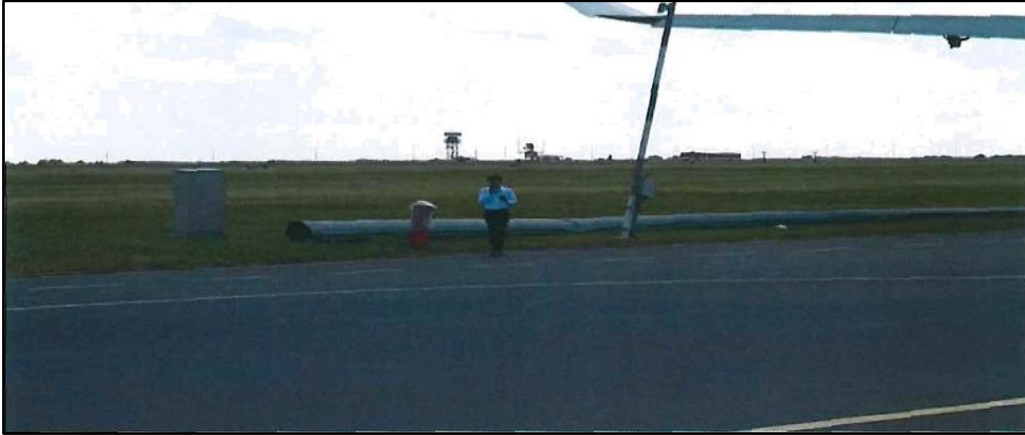
Figure 6: Light pole lying on floor and CCTV pole slanted

Light Pole is being knocked down and CCTV knocked off 2nd shorter pole.

The light pole is located 4.2 meters from the edge of the taxiway. The CCTV pole is located 5 meters after the light pole.

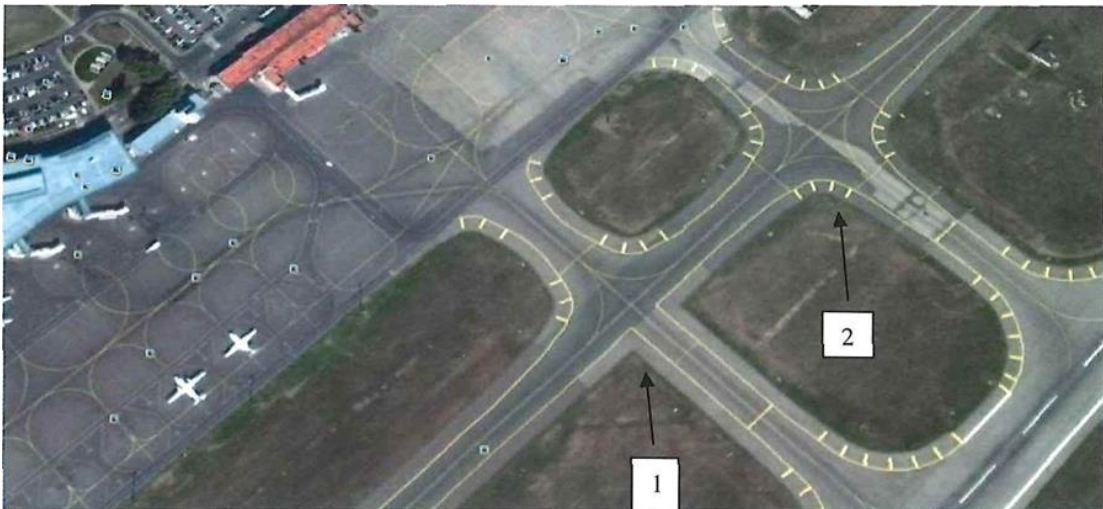
Figure 10: Google Earth picture of taxiways B and C with taxi markings sourced on 30 June 2014

2.1.7 Reference to Figure 10 below, (box 1), there are no taxiway lines for turns onto Taxiway 'P' at the intersection of Taxiway 'C' and Taxiway 'P' on the side closest to the runway. The taxiway markings also do not allow left turn into Taxiway 'P'. This means that all aircraft vacating the runway using Taxiway 'C' will have to route via the apron. Aircraft vacating using Taxiway 'B' has the option of either turning left on Taxiway 'P' or continuing via the apron. (Box 2). This information is not shown on the LIDO AGC chart that was developed based on information from AIP for Astana International Airport.

4.1 It is recommended that the LIDO chart provider to amend the TSE AGC chart to reflect the restriction on the taxiway.
