## **SAFETY INVESTIGATION REPORT**

**Malaysia Airlines Boeing B777-200ER (9M-MRO)  
08 March 2014**

**The Malaysian ICAO Annex 13 Safety Investigation Team for MH370**

Issued on 02 July 2018  
MH370/01/2018

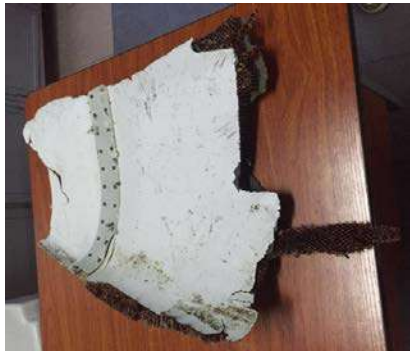
| Ref. | Date Found | Debris | Location | Remarks |
|---|---|---|---|---|
| Item 8 | 24 May 2016 | <p>No. 1 Flap Support Fairing Tail Cone</p> | <p>Gris Gris Beach,<br/>Mauritius</p> | <ul style="list-style-type: none"> <li>• Examination showed that part is <i>highly likely</i> from MH370</li> <li>• Refer to <i>Appendix 1.12F</i></li> </ul> |

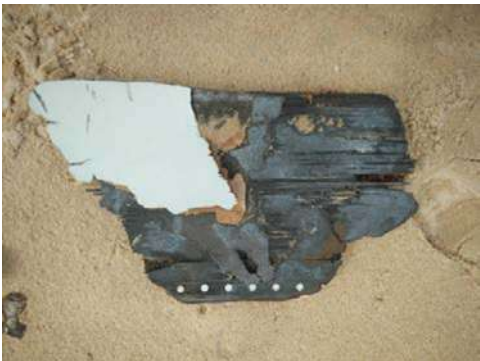
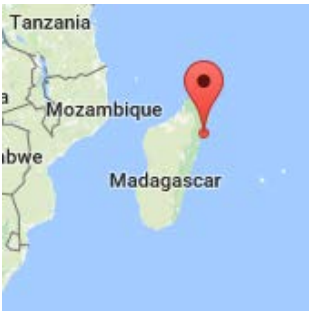
| Ref. | Date Found | Debris | Location | Remarks |
|---|---|---|---|---|
| Item 13 | 12 June 2016 | <p>Unidentified part</p> | <p>Riake beach, Nosy Boraha Island, Madagascar</p> | <ul style="list-style-type: none"> <li>• Not identifiable</li> <li>• Refer to <i>Appendix 1.12K</i></li> </ul> |

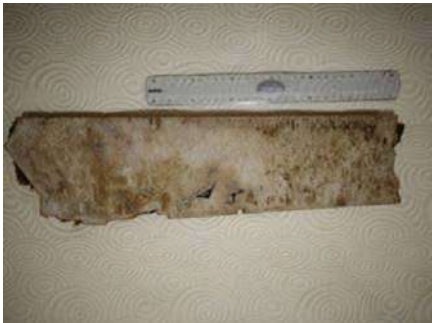
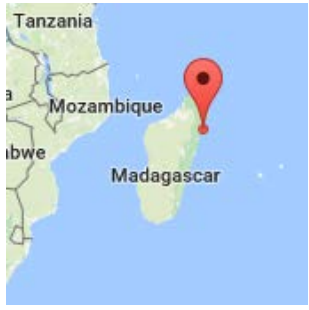
| Ref. | Date Found | Debris | Location | Remarks |
|---|---|---|---|---|
| Item 14 | 12 June 2016 | <p>Unidentified part</p> | <p>Riake beach, Nosy Boraha Island, Madagascar</p> | <ul style="list-style-type: none"> <li>• Not identifiable</li> <li>• Refer to <i>Appendix 1.12L</i></li> </ul> |

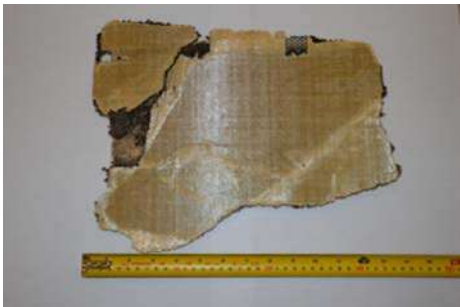
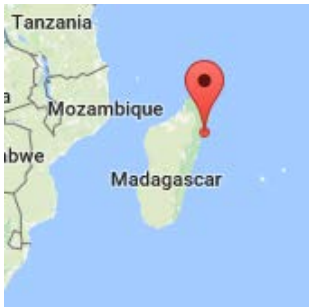
| Ref. | Date Found | Debris | Location | Remarks |
|---|---|---|---|---|
| Item 17 | 12 June 2016 | <p>Unidentified part</p> | <p>Antsiraka beach,<br/>Madagascar</p> | <ul style="list-style-type: none"> <li>• Not identifiable</li> <li>• Refer to <i>Appendix 1.12M</i></li> </ul> |

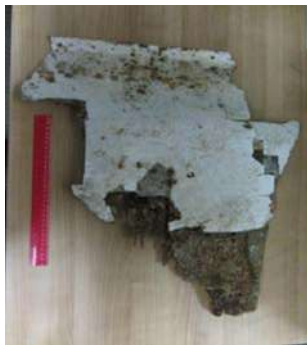
| Ref. | Date Found | Debris | Location | Remarks |
|---|---|---|---|---|
| Item 21 | 18 July 2016 | <p>Unidentified Part</p> | <p>Northern Kwa Zulu Natal,<br/>South Africa</p> | <ul style="list-style-type: none"> <li>• Not identifiable</li> <li>• Refer to <i>Appendix 1.12Q</i></li> </ul> |

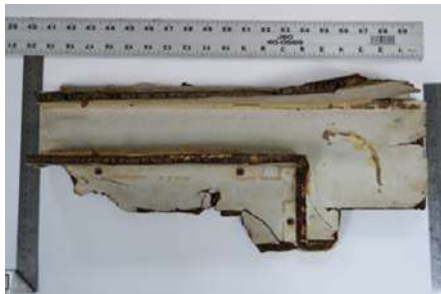
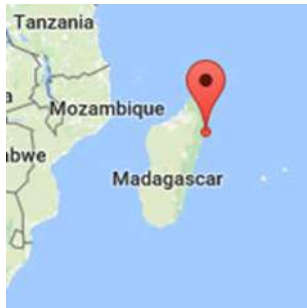
| Ref. | Date Found | Debris | Location | Remarks |
|---|---|---|---|---|
| Item 23 | October 2016 | <p>Unidentified Part</p> | <p>Riake beach, Nosy Boraha Island, Madagascar</p> | <ul style="list-style-type: none"> <li>• Not identifiable</li> <li>• Refer to <i>Appendix 1.12S</i></li> </ul> |

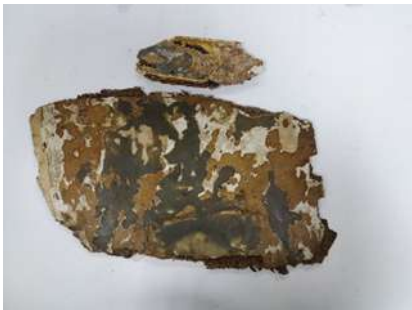
| Ref. | Date Found | Debris | Location | Remarks |
|---|---|---|---|---|
| Item 24 | February 2016 | <p>Unidentified Part</p> | <p>Saint Luce, Madagascar</p> | <ul style="list-style-type: none"> <li>• Not Identifiable</li> <li>• Refer to <i>Appendix 1.12T</i></li> </ul> |

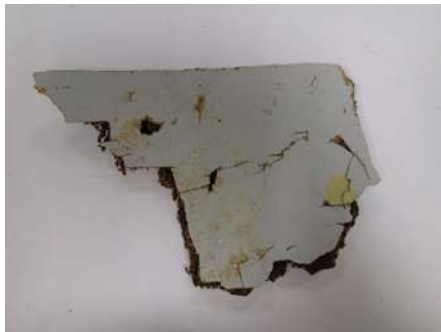
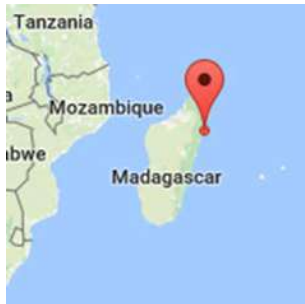
| Ref. | Date Found | Debris | Location | Remarks |
|---|---|---|---|---|
| Item 25 | July 2016 | <p>Unidentified Part</p> | <p>Riake beach, Nosy<br/>Boraha Island,<br/>Madagascar</p> | <ul style="list-style-type: none"> <li>• Not identifiable</li> <li>• Refer to <i>Appendix 1.12U</i></li> </ul> |

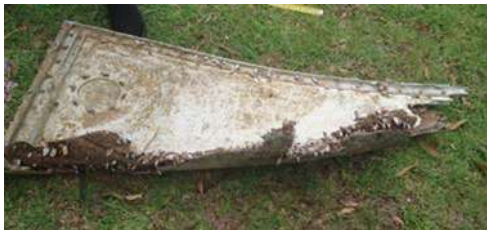
| Ref. | Date Found | Debris | Location | Remarks |
|---|---|---|---|---|
| Item 27 | 27 January 2017 | <p>Right Wing No. 7 Flap Support Fairing</p> | <p>Mpame Beach,<br/>South Africa</p> | <ul style="list-style-type: none"> <li>• Examination showed that part is <i>highly likely</i> from MH370</li> <li>• Refer to <i>Appendix 1.12W</i></li> </ul> |
