Aircraft Owner : MG Kinabalu Leasing Limited, Ireland
Aircraft Operator : MASwings Sdn. Bhd
Air Operator Certificate Number : 38
Air Operator Certificate Expiry Date : 30 September 2016
Aircraft Type : DHC6-400 Twin Otter
Aircraft Serial Number : 894
Aircraft Registration : 9M-SSE
Nationality : Malaysian
Flight Number : MH3525
Flight Sector : Lawas (LWY) – Miri (MYM)
Type Of Flight : Scheduled Passenger
Total Hours : 1812
Total Cycles : 2615

Inadvertent Opening of the Passenger Door In Flight Dated 10 July 2015.

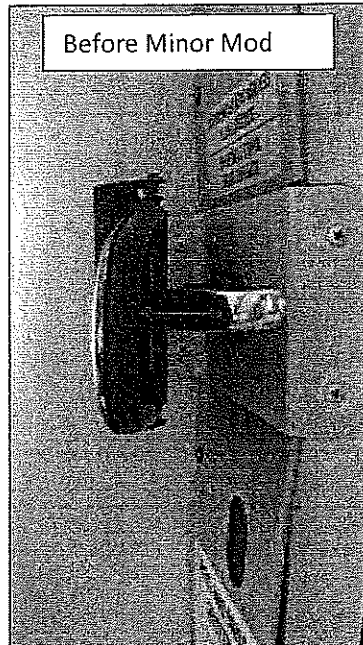
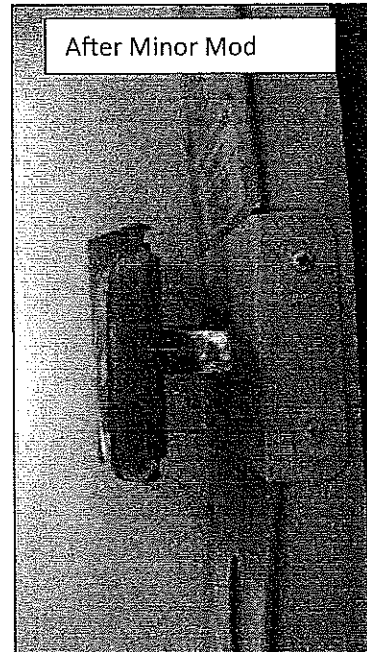
- 5.1 The closing of the door whilst the aircraft was on transit at Lawas was performed by MASwings appointed ground handler, Green Valley Sdn. Bhd. The staff who was on duty to perform the task was En. Jospser.

- 5.11 Upon further inspection, the flapper guard assembly was found to be 'lifting' occasionally, hence resulting in the passenger's knee being able to pass through the gap between the door structure and the flapper guard assembly and eventually coming into contact with the door handle.

- 5.12 The inherent design deficiency was highlighted to Viking Canada following which a minor modification on the flapper guard assembly was introduced through Viking instruction HQ-98297 which has been duly accomplished on all 6 of MASwings' DHC6-400 Twin Otters, bearing registration 9M-SSA thru 9M-SSF.

- 6.1 The opening of the door was a result of the inadequate spring tension on the door guard to positively cover the door handle from inadvertent operation.
- 6.2 The deficiency had been corrected as per the recommendation by Viking Canada as the OEM for DHC6-400 Twin Otters..

- 7.1 Viking Canada had indicated a new design of the guard assembly. The retrofit of the new guard assembly is to be adopted as soon as it is made available.
