# **AIRCRAFT ACCIDENT REPORT NUMBER 15/15**

**AIR ACCIDENT INVESTIGATION BUREAU  
MINISTRY OF TRANSPORT  
MALAYSIA**

**ENGINE FAILURE IN-FLIGHT INVOLVING, N9297N, PA-28-181  
AT SENAI AIRPORT GOLF COURSE, JOHOR, MALAYSIA  
15 NOVEMBER 2015**

**ACCIDENT REPORT NO.: 15/15**

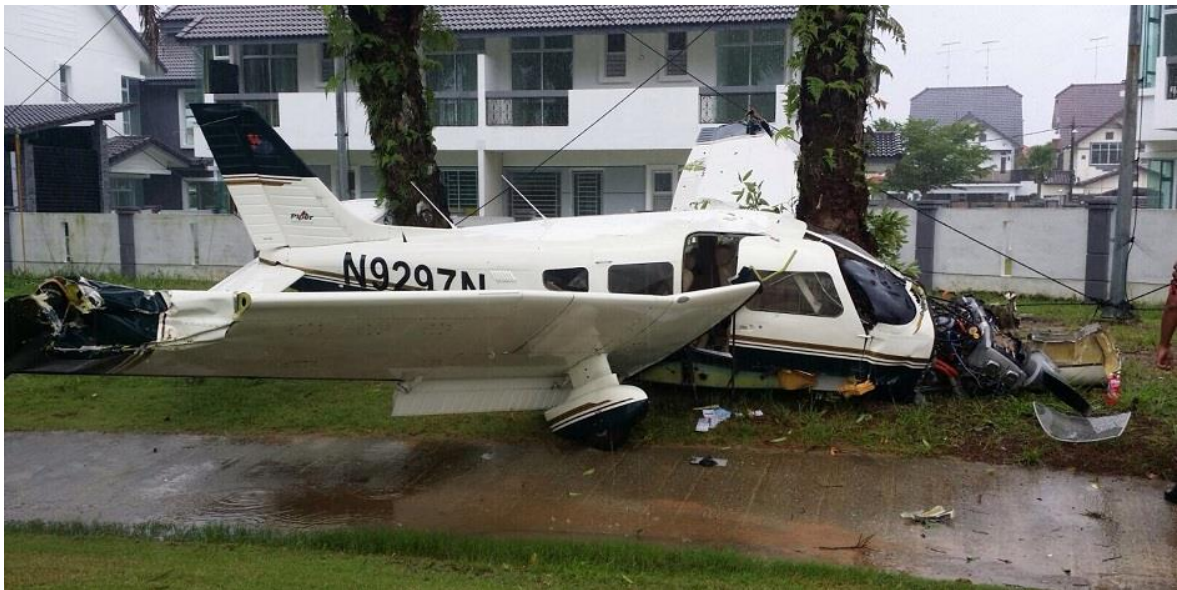
N8287N was totally damaged during the final collision with the tree, ie. N9297N aircraft suffered total lost.

Figure 1: Damaged N9297N Aircraft

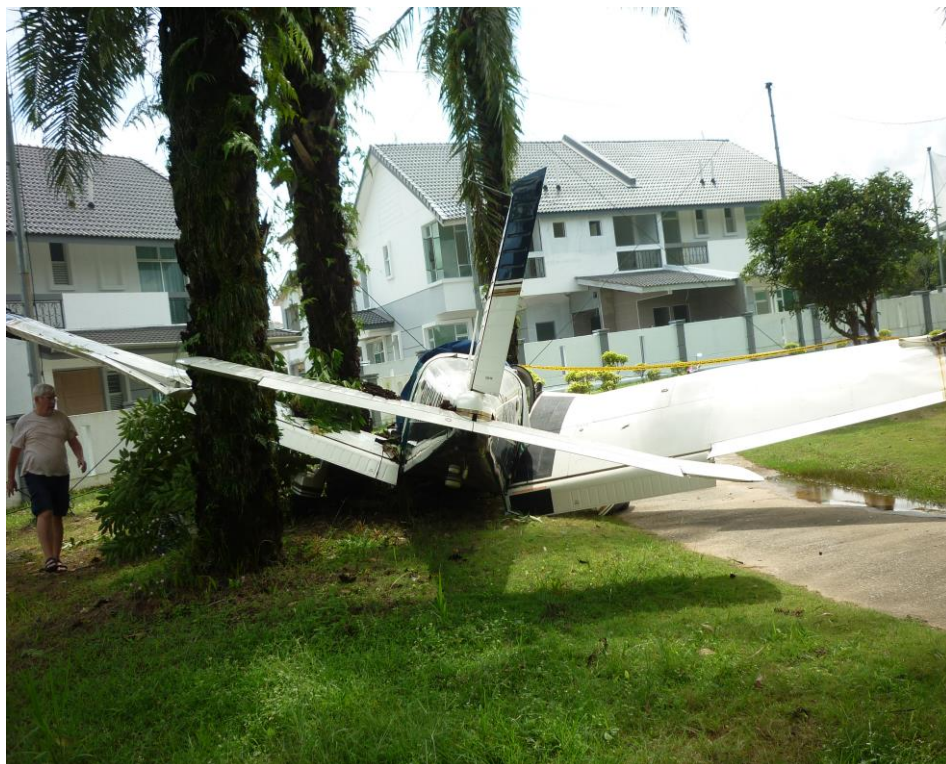
1.4.1 N9297N aircraft was severely damaged during the forced landing. However, the Captain only sustained minor injury.

Figure 3: Real View of Damaged N9297N Aircraft
