AIRCRAFT ACCIDENT REPORT SI 05/15

**Air Accident Investigation Bureau
Ministry of Transport, Malaysia**

**Final Report on the Serious Incident involving
Fixed wing aircraft ATR72-600 Registration 9M-LMG
in Penang, Malaysia on 28th May 2015**

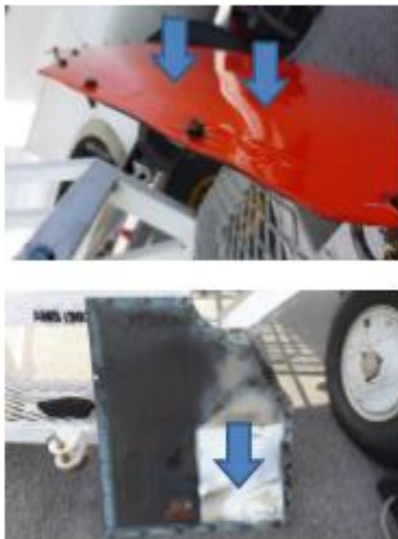
| Photo | Description |
|---|---|
| | The rear RH cowl was delaminated. Observed sign of overheating on the inner pane. |

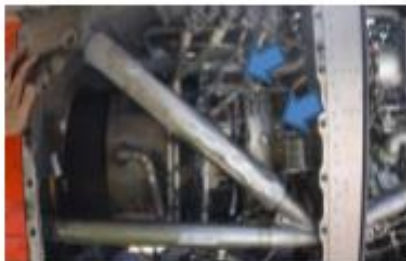
| Photo | Description |
|---|---|
| | Sign of burn mark on the engine harness near the fuel nozzle adapter #3 and #4. |

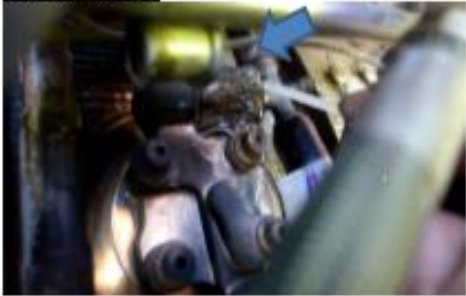
| Photo | Description |
|--|---|
| <p>Fuel Nozzle No. 3</p> | <p><u>Step 1:</u> Nitrogen leak check at 150 psi and Snoop leak detector applied.</p> <p><u>Result:</u> All fuel nozzle connections (except fuel nozzle no. 3) to the primary and secondary fuel manifolds were verified and no bubbles were observed.</p> <p>Fuel nozzle no. 3 found with bubble leak at secondary manifold.</p> |

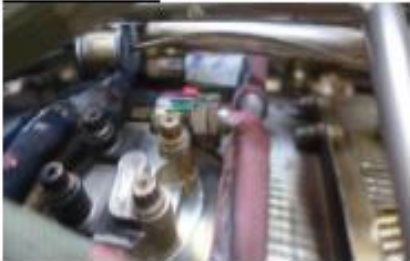
| Photo | Description |
|--|---|
| <p>Fuel Nozzle No. 3</p> | <p><u>Step 2:</u> Torque check using torque wrench PWC45200</p> <p><u>Result:</u> Found the B-nut able to turn more than 120 degree without much resistance. B-Nut was sheared.</p> |

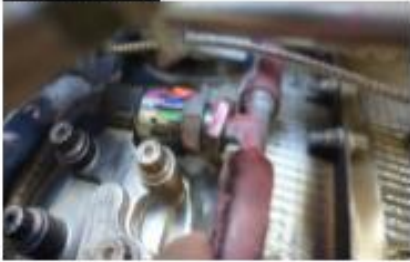
The probable cause of the engine fire is due to the fuel leak from No. 3 fuel nozzle manifold 'B' nut.

| Photo | Description |
|--|---|
| <p>Fuel Nozzle No. 3</p> | <p>B-nut completely sheared.</p> |

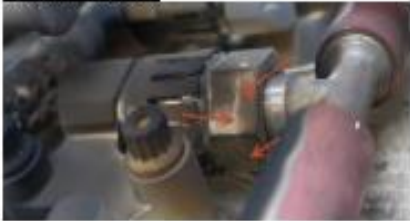
| Photo | Description |
|--|---|
| <p>Fuel Nozzle No. 3</p> | <p><u>Step 3:</u> Review of <u>previous</u> photo prior to torque check.</p> <p><u>Result:</u> Found the B-Nut was already cracked.</p> |

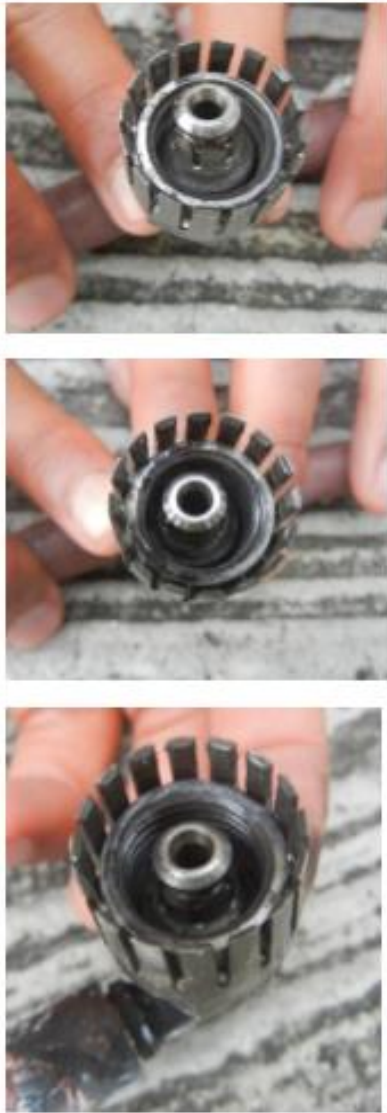
| Photo | Description |
|--|--|
| | <p>Inspect B-nuts threads at fuel manifolds for anti-seize presence.</p> <p><u>Result:</u> Found residual of black substance alike at the thread area.</p> |

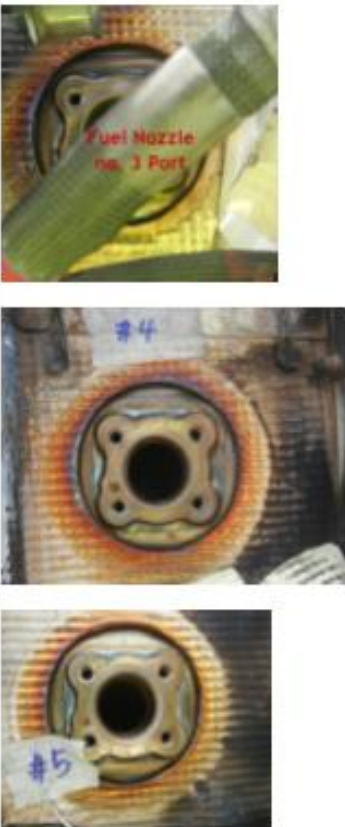
| Photo | Description |
|--|---|
| | <p>Fuel nozzle #3, #4, and #5 ports.</p> |

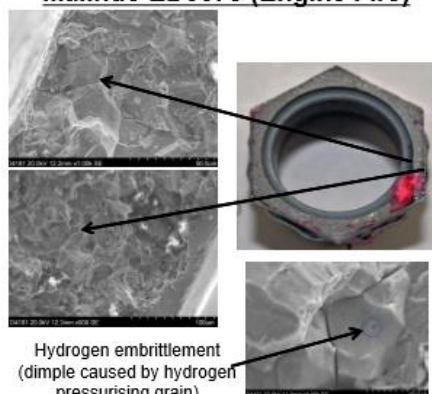
Malindo ED0673 (Engine Fire)

Magnified view of the brittle intergranular fracture

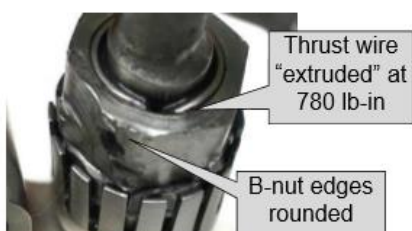
TORQUE TEST – PERFORMED AT P&WC

Tests performed to validate design margin

B-nut inspected per FPI. No crack found

Unable to replicate observed failure mechanism, overtorque ruled out

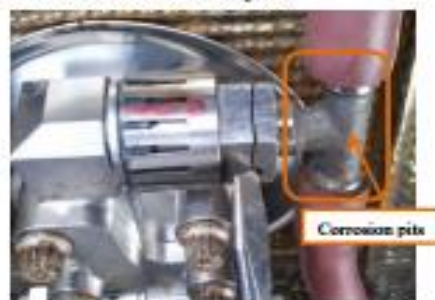
Figure 1 : Cracked B-nut

P&WC investigated two cases of flexible manifold B-nut reported cracked (Ref. Figure 1). Both cases were reported by the same operator group and the review of the material confirmed hydrogen embrittlement.

Hydrogen embrittlement occurs when hydrogen diffuses into the metal. It changes the material properties and the exposed metal becomes brittle. In the case of the flexible manifold, the B-nut may become susceptible to cracking in service, thus potentially causing an external fuel leak. The fractured surfaces analyzed by P&WC show no signs of a crack propagating by fatigue and suggests a sudden fracture mechanism.

P&WC would like to remind all customers of the importance to use the products recommended in the Engine Maintenance Manual "EMM" (Ref. 72-01-40, FUEL SYSTEM) for fuel nozzles and fuel manifolds removal, installation and cleaning. P&WC also confirms that all products approved by P&WC and listed in the EMM will not cause Hydrogen Embrittlement.

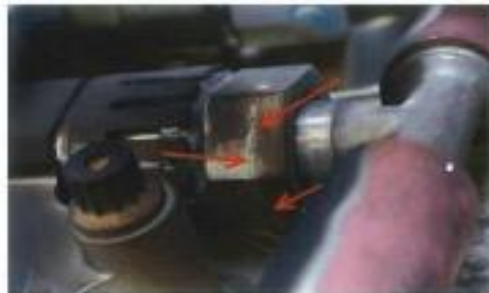
Image above shows one of the findings of B-nut crack.

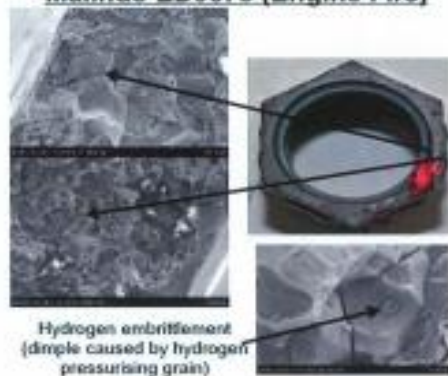
Malindo ED0673 (Engine Fire)

Image above shows magnified view of brittle intergranular fracture confirming on Hydrogen embrittlement.
