AIRCRAFT ACCIDENT REPORT 02/15

Report on the accident to Helicopter Bell 206BIII Registration 9M-LLM,
On the grass near helipad 'H' at Kota Kinabalu International Airport

AIRCRAFT ACCIDENT FINAL REPORT 02/15

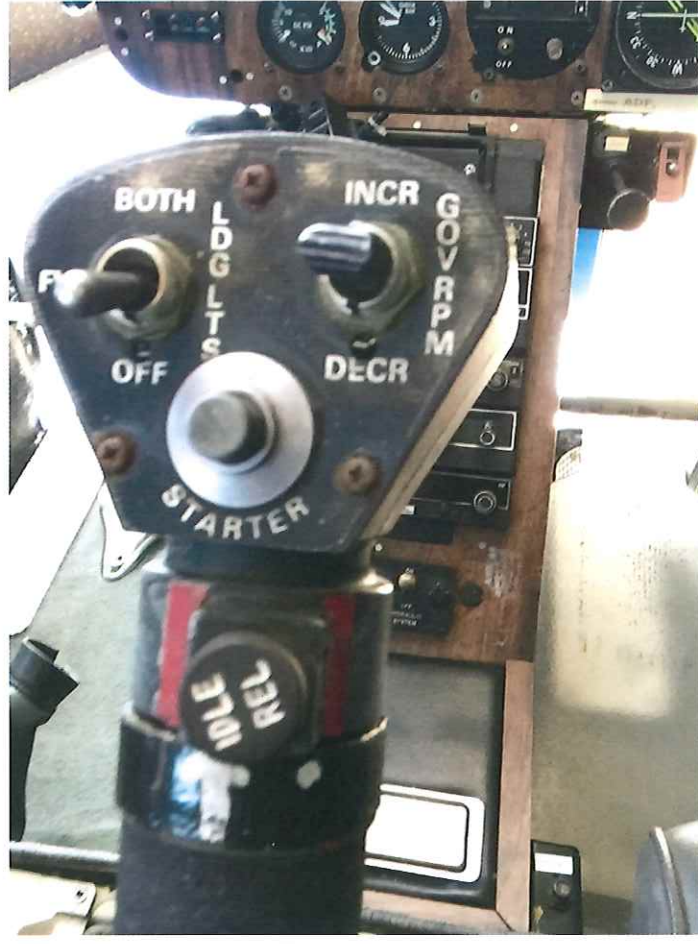
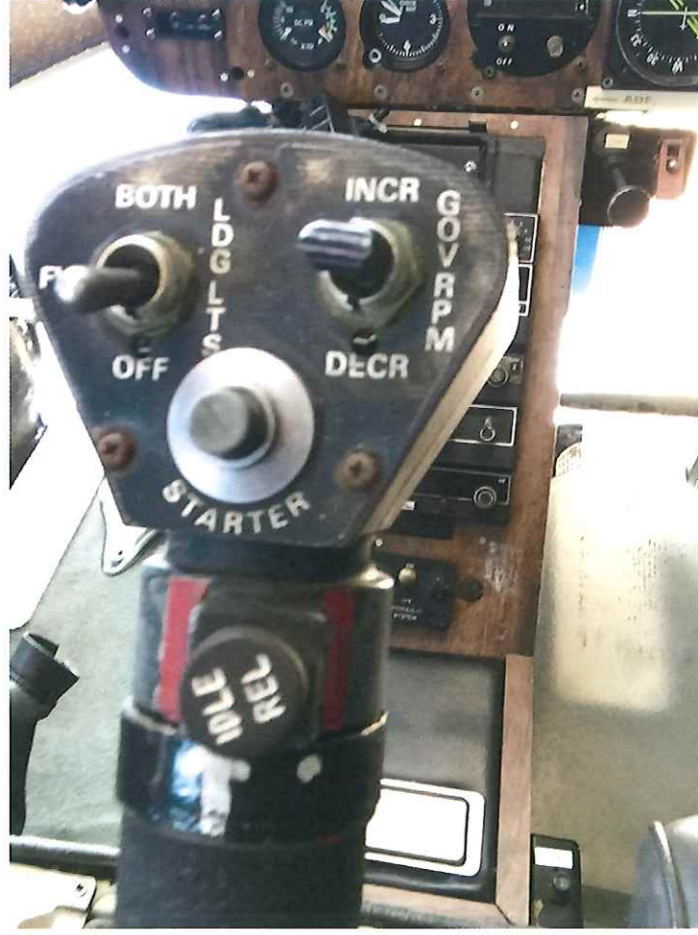
APPENDIX B Fig 1

Collective lever and throttle position

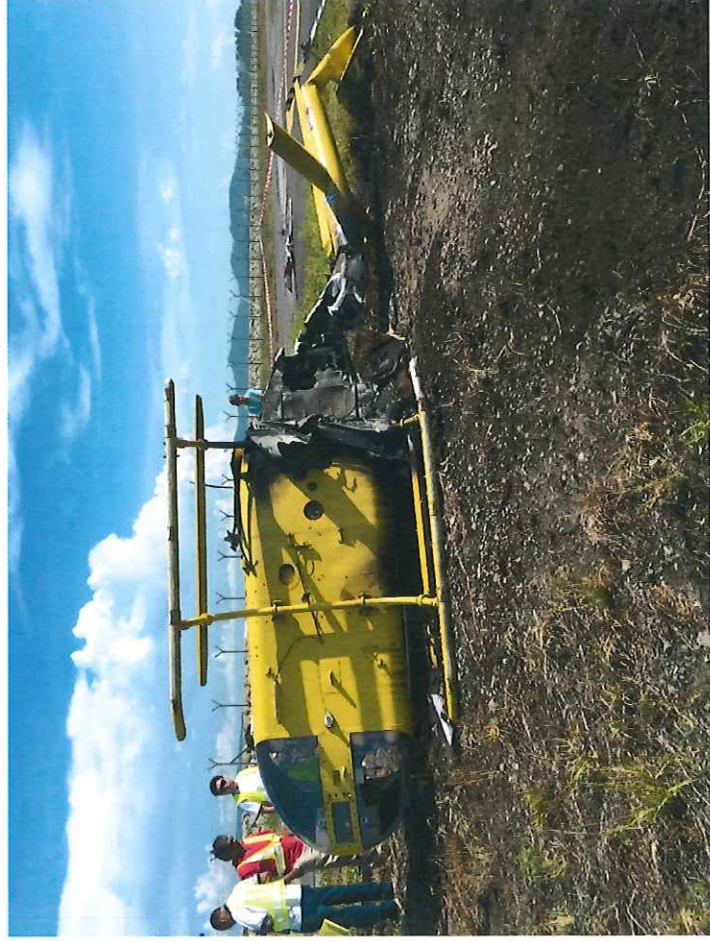
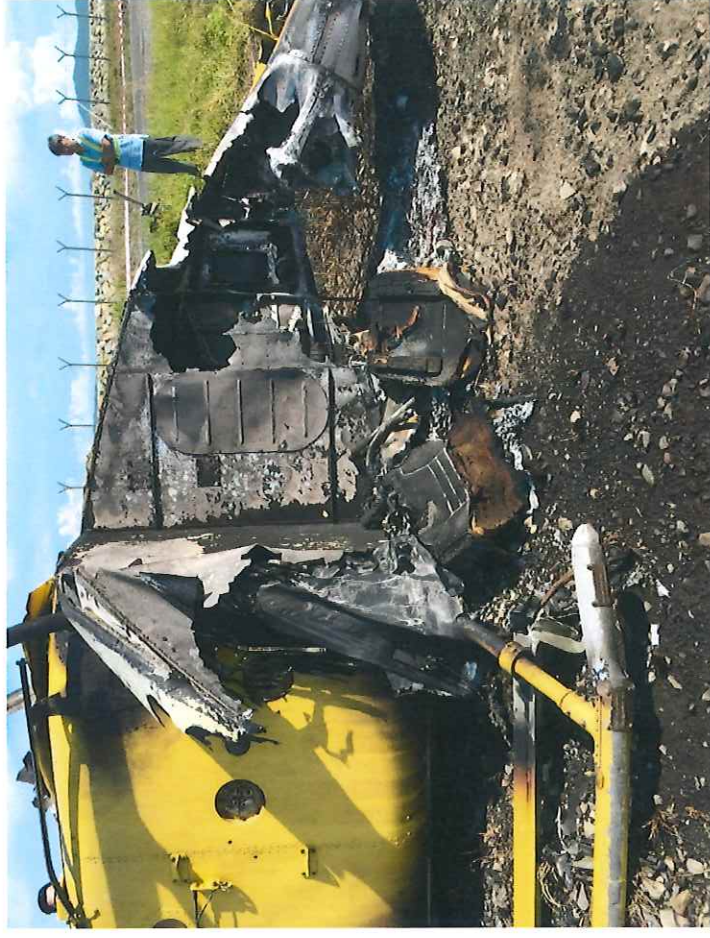
APPENDIX B, Fig. 2

Fuselage rested on its right side

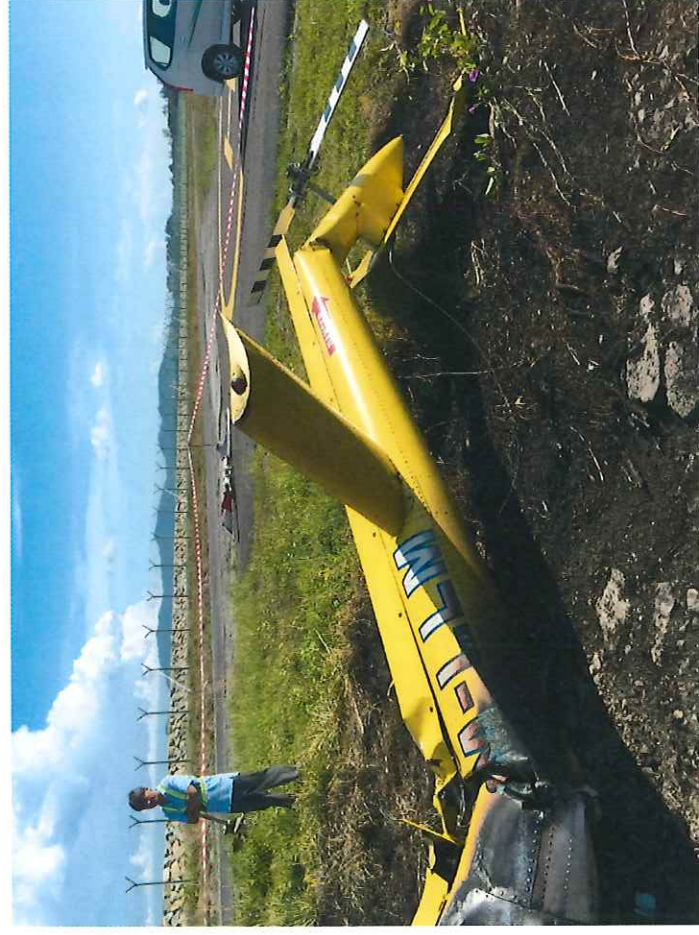
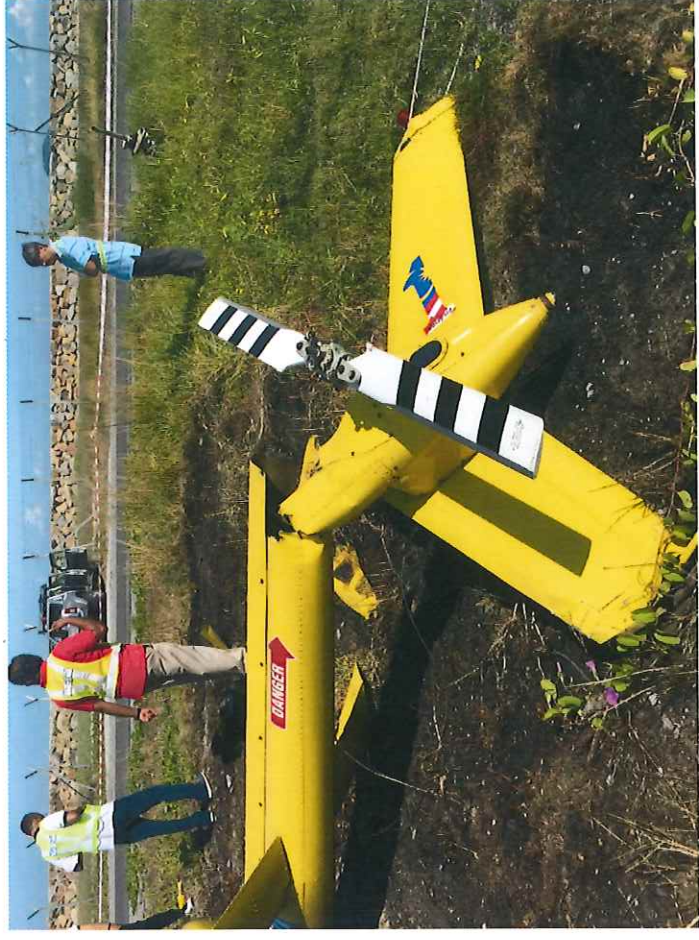
APPENDIX B, Fig.3

The helicopter crashed close to the helipad. The tail rotor was still intact and the tail boom was detached from the fuselage on impact. The main rotor blades strike the helipad and broke into pieces indicating rotating with high energy. The main gearbox came out of its attachment and thrown away about 10 meters from the main wreckage. The engine was removed and sent to Heli Holland Technics for a tear down examination. (see detail report at Appendix B)

Tail rotor and tail boom condition

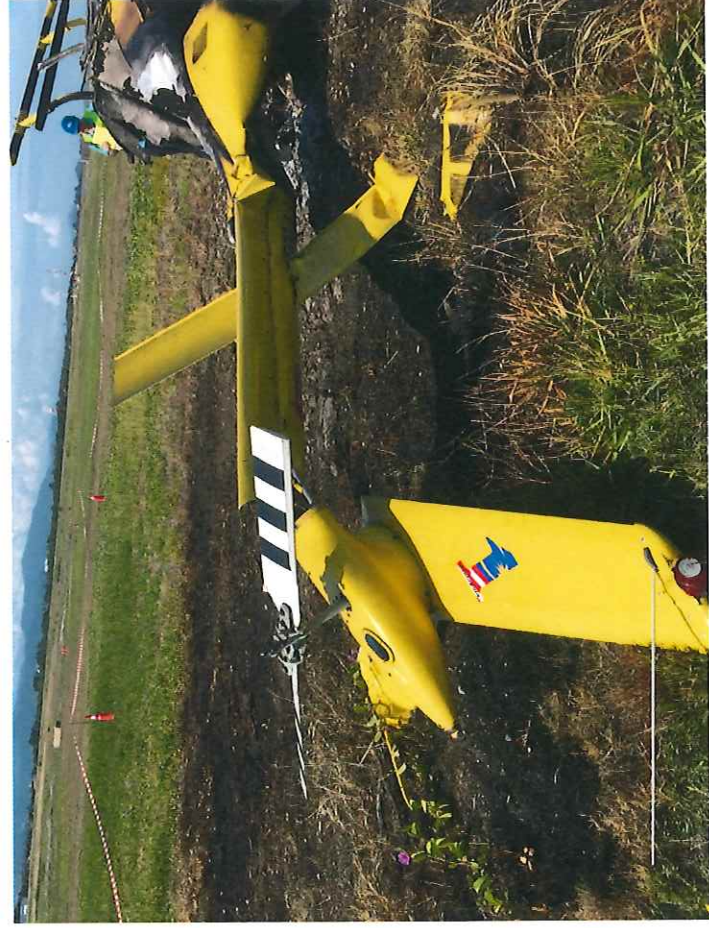
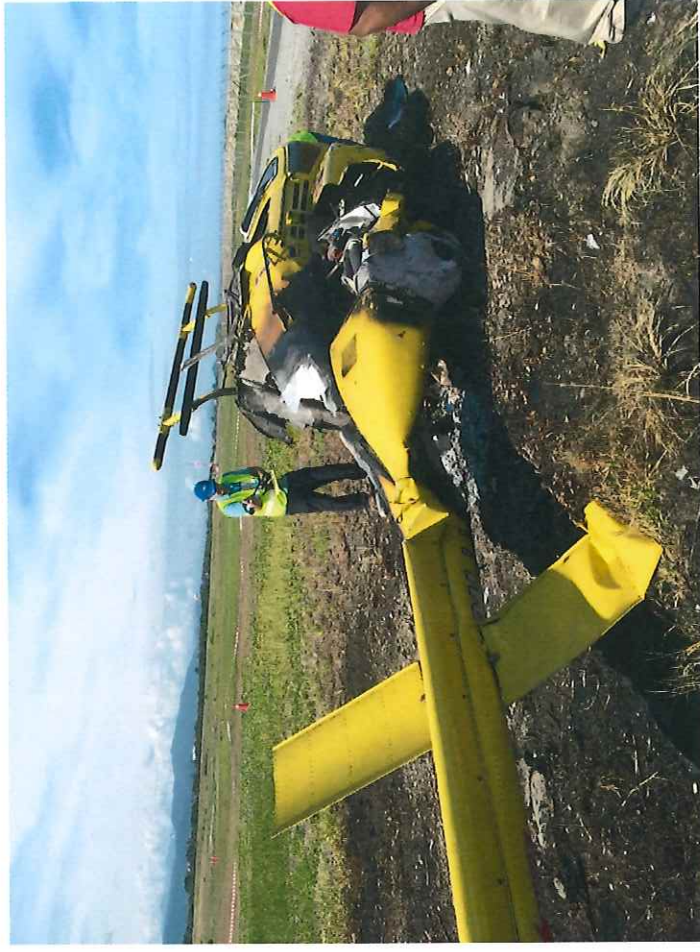
APPENDIX B, Fig. 4

Wreckage from the tail

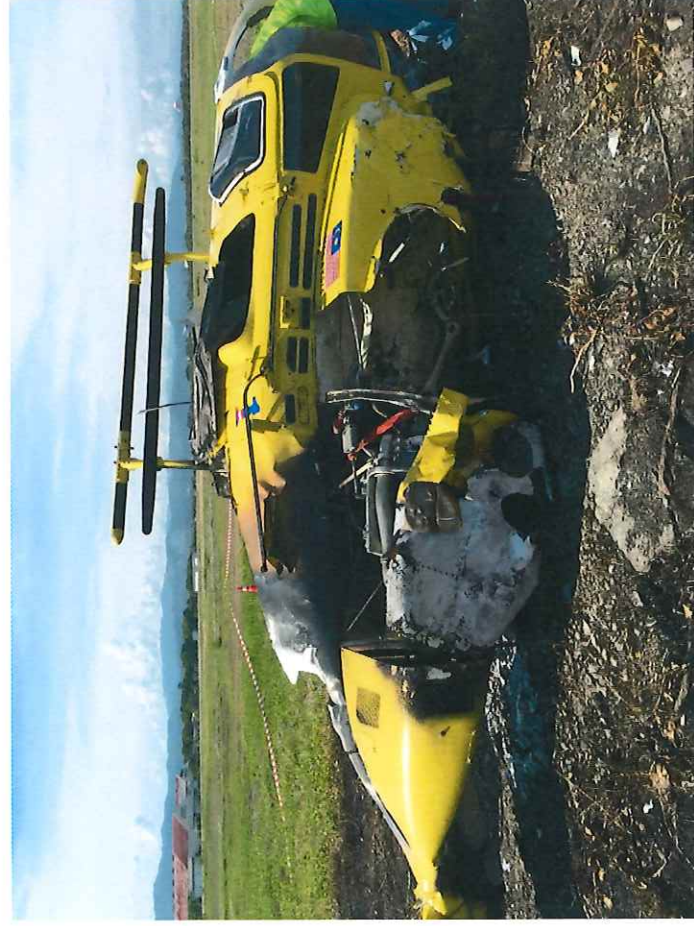
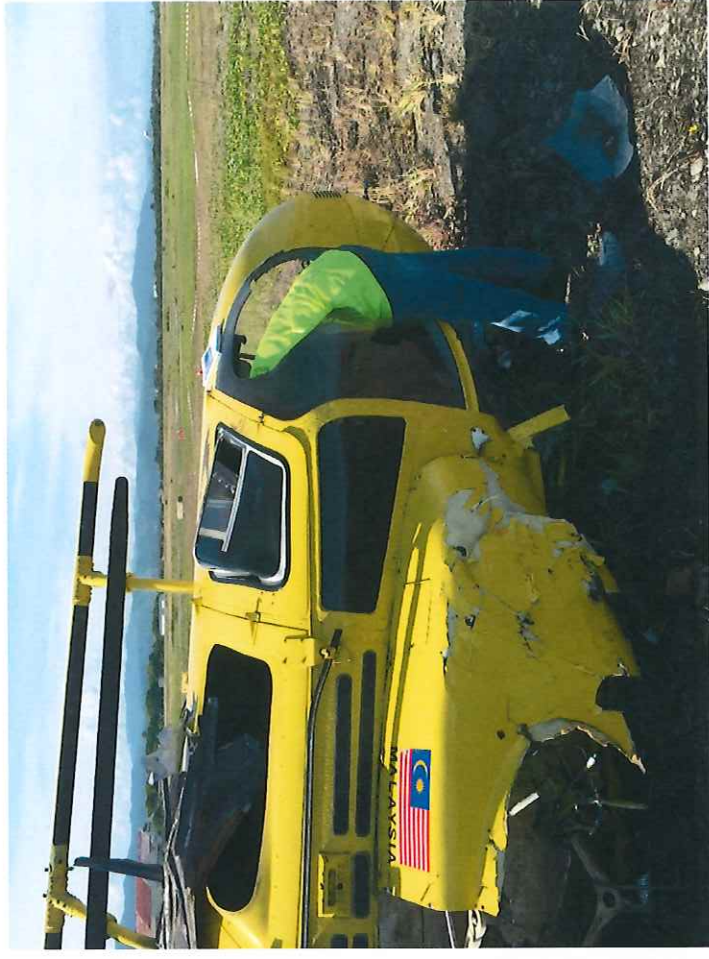
APPENDIX B, Fig 5

There was fire after the impact which started from the baggage compartment.

Fire started from the baggage compartment

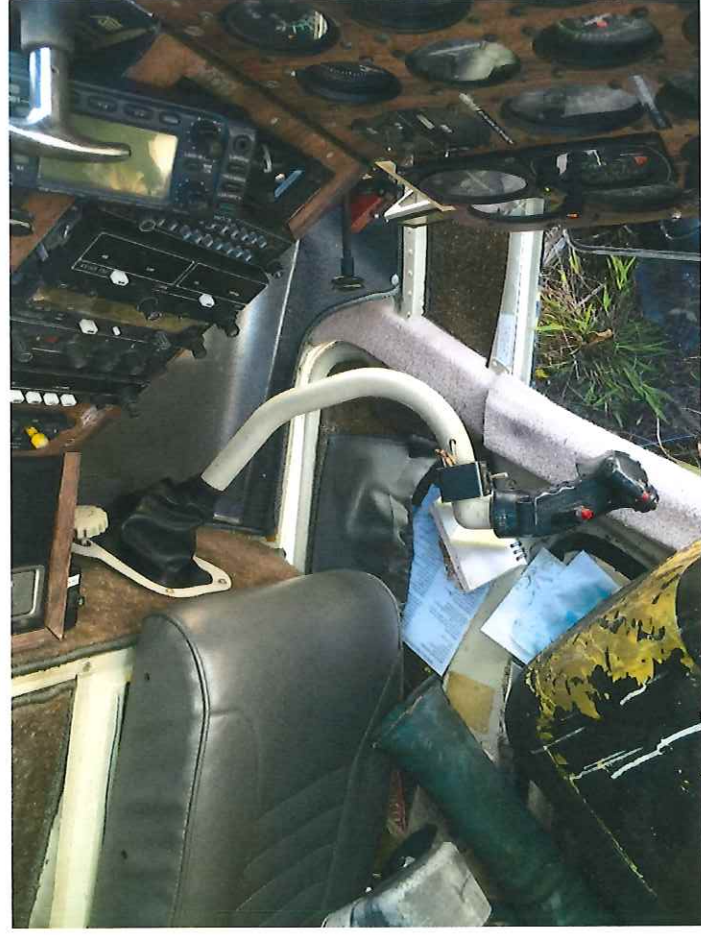
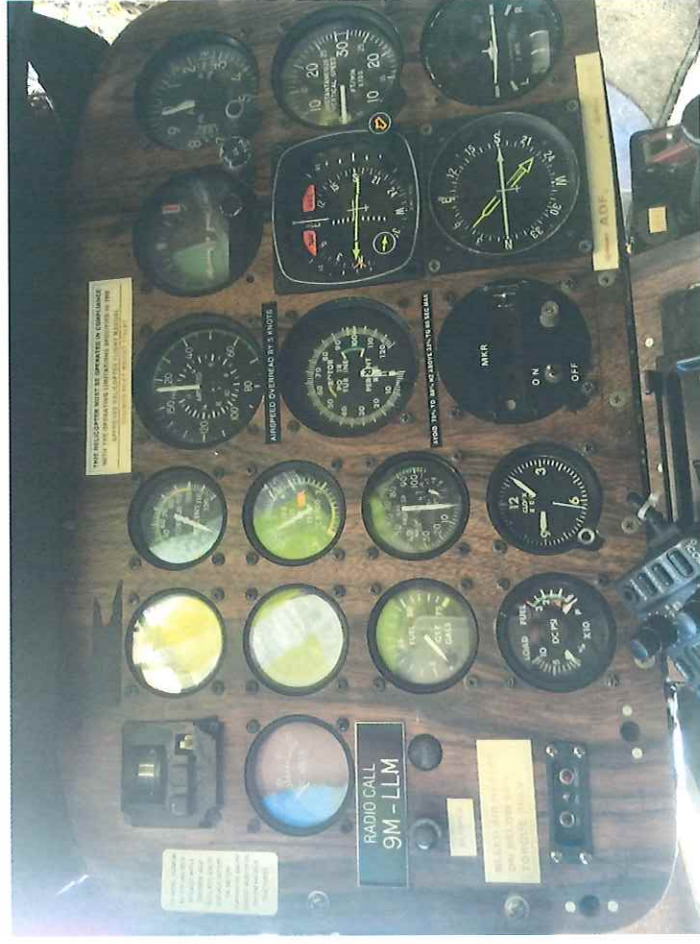
APPENDIX B, Fig.6

Helicopter instrumentation

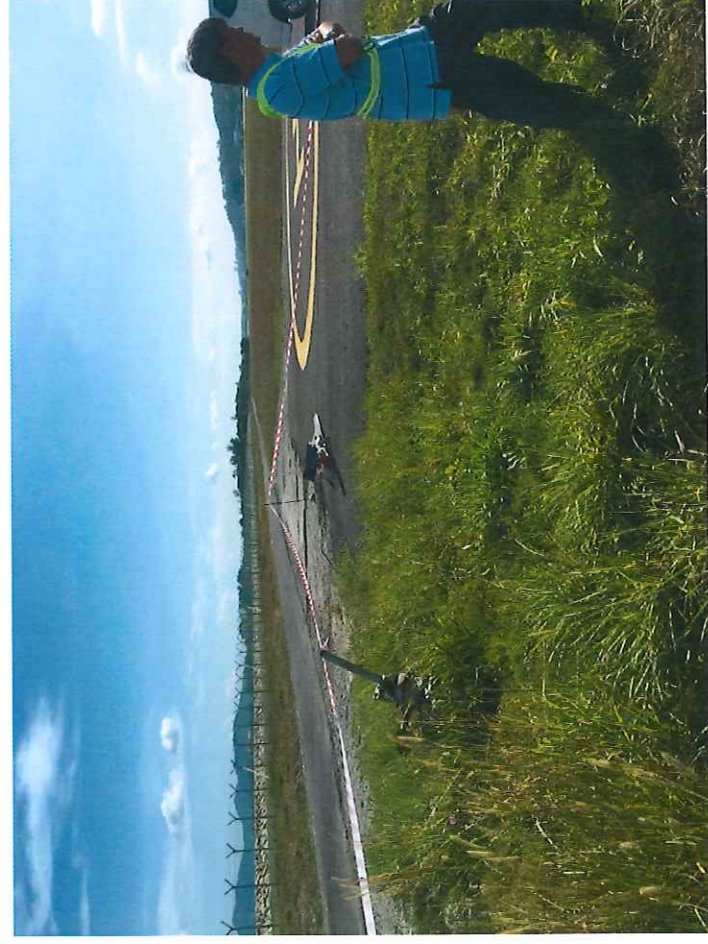
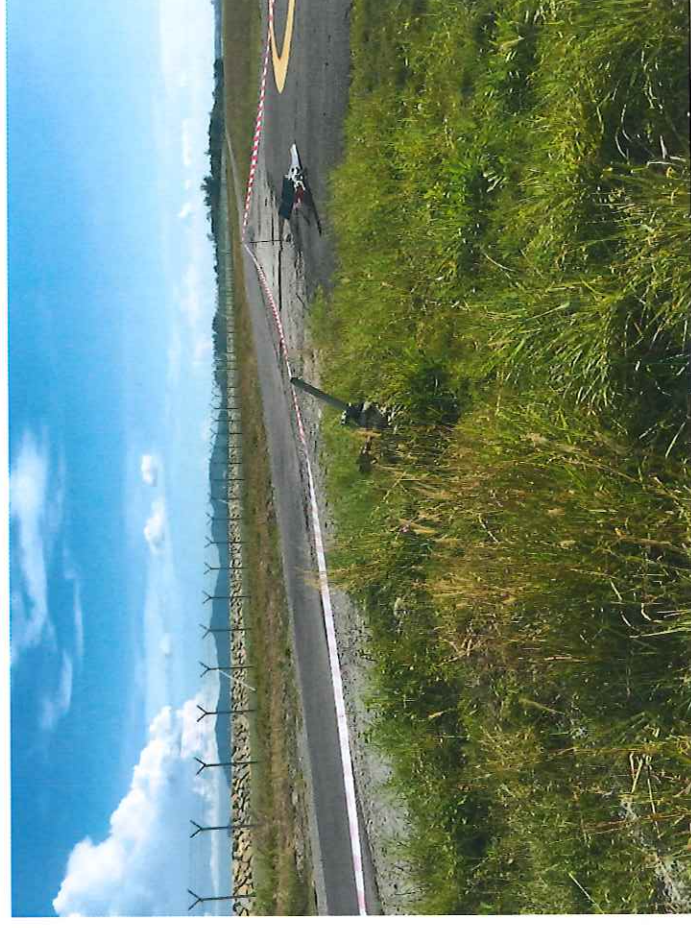
APPENDIX B, Fig.7

The main gearbox detached from the fuselage

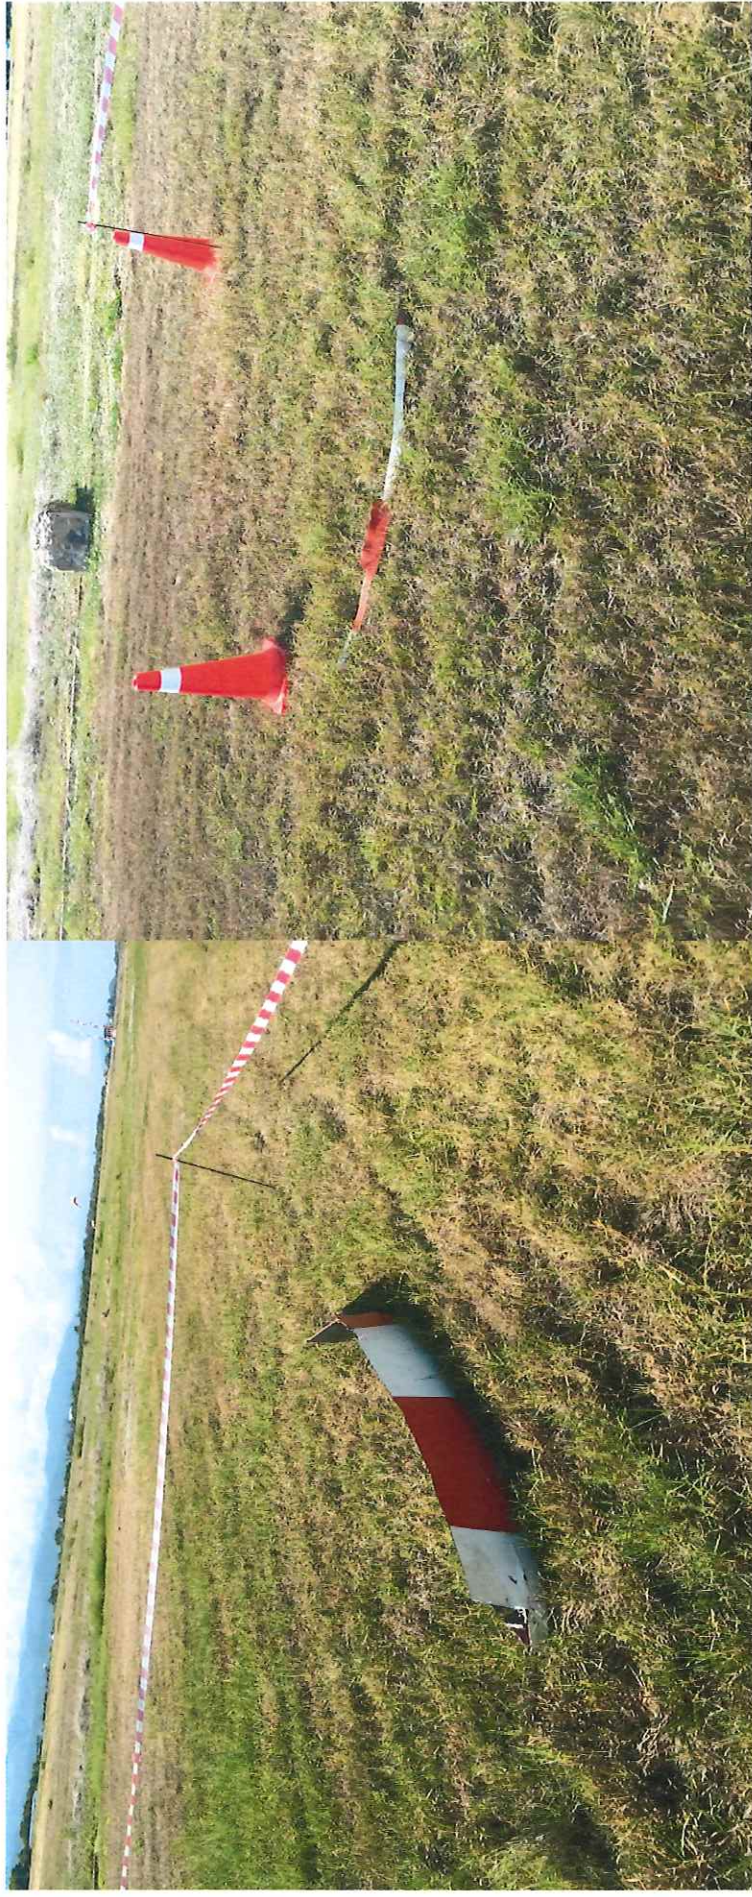
APPENDIX B, Fig. 8

Main rotor broken off due to high rotor energy

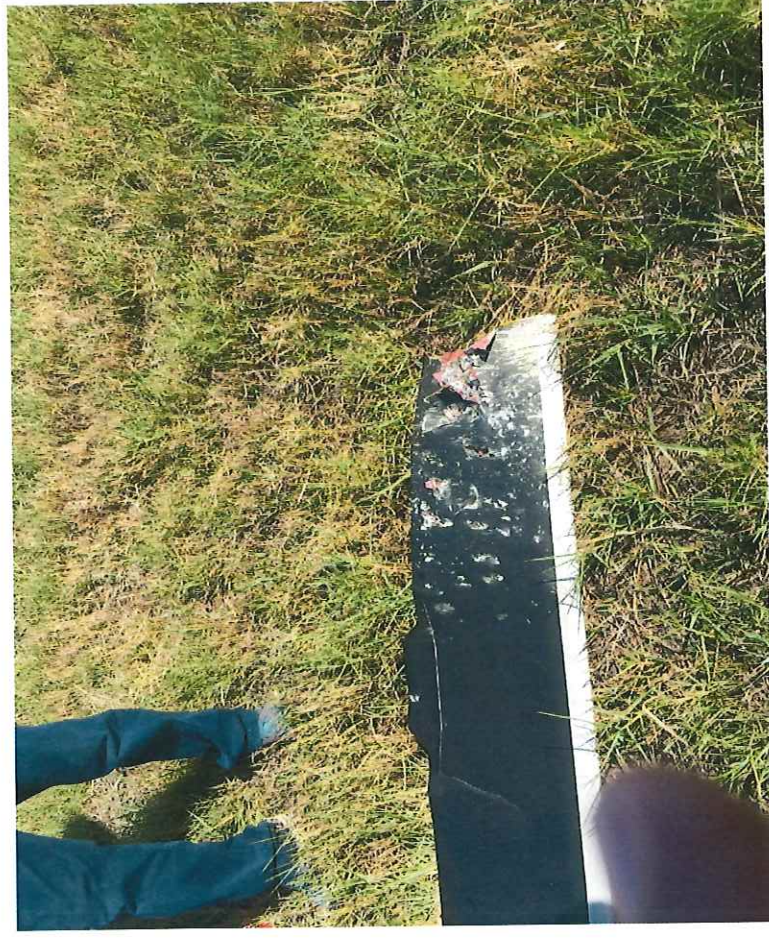
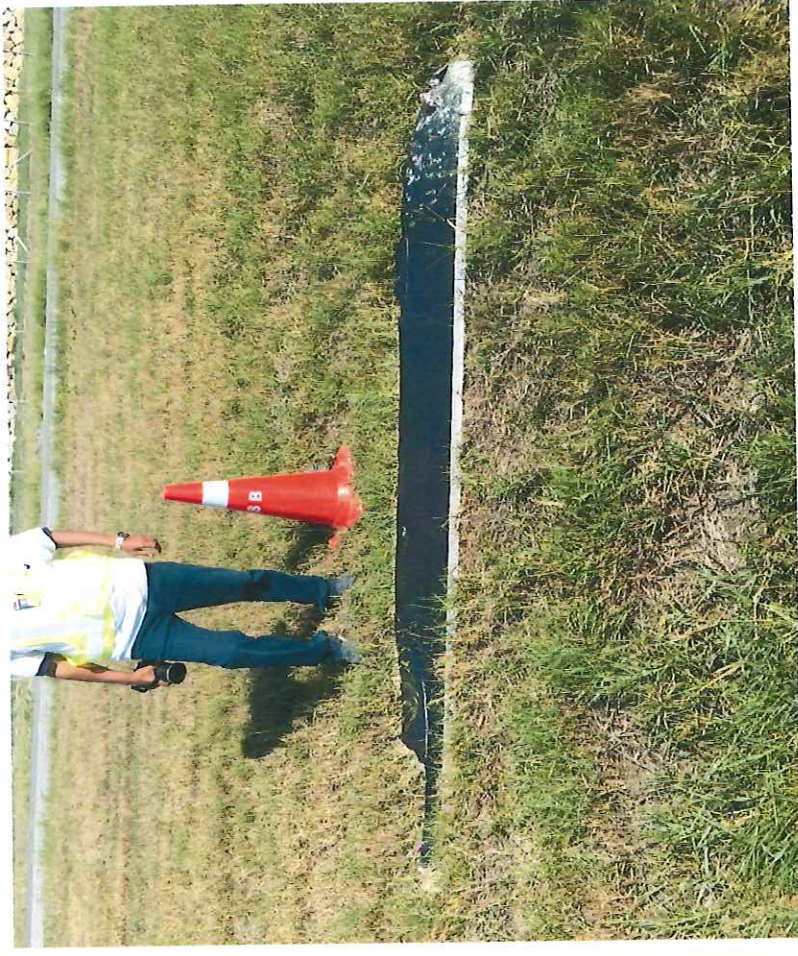
APPENDIX B, Fig. 9

Main rotor blades damage

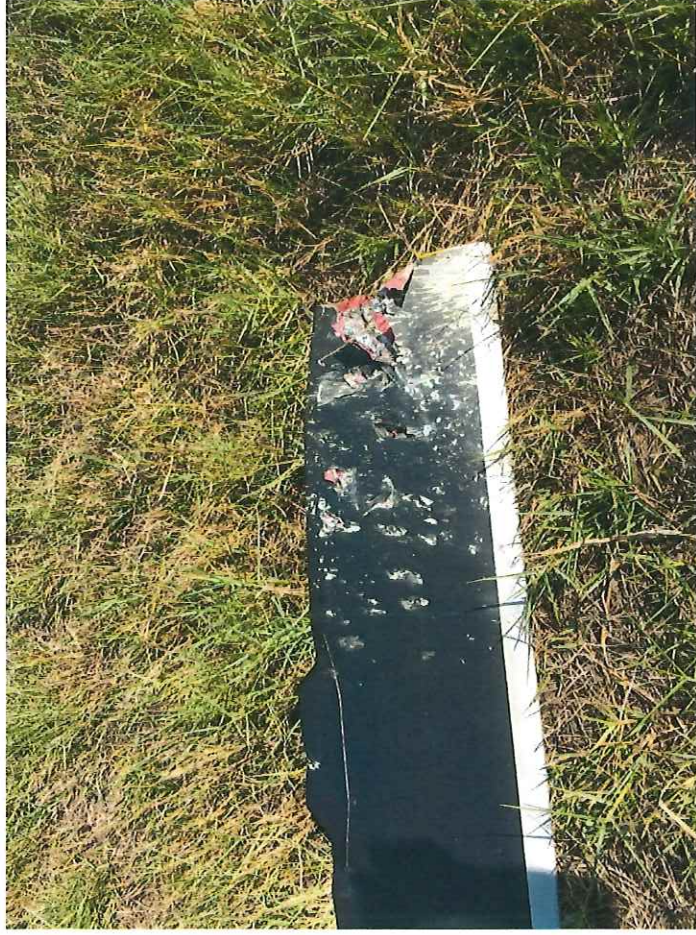
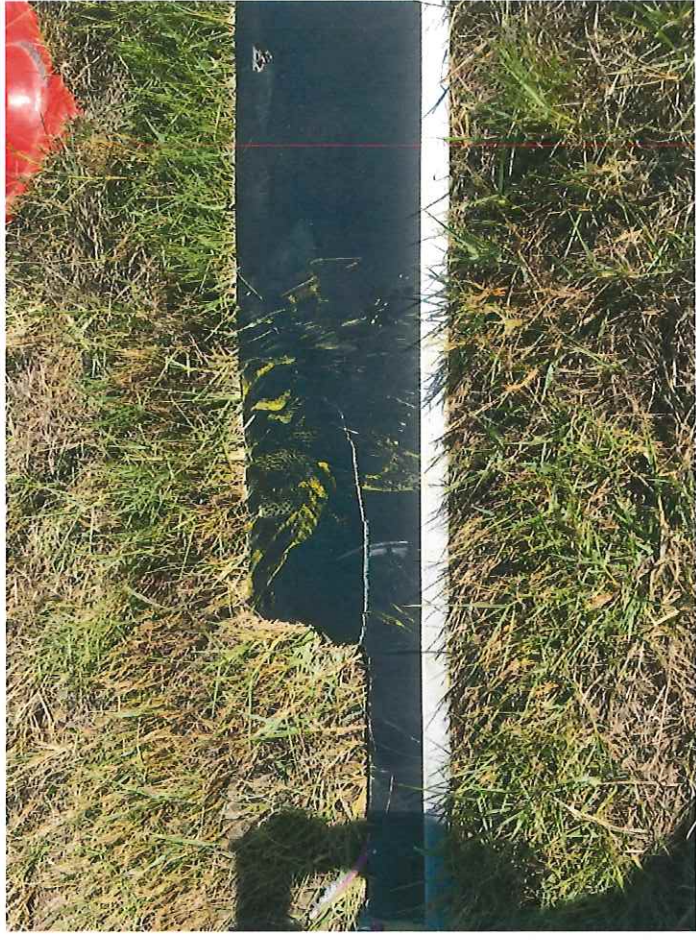
APPENDIX B, Fig 10

Close look at the main rotor blade tips

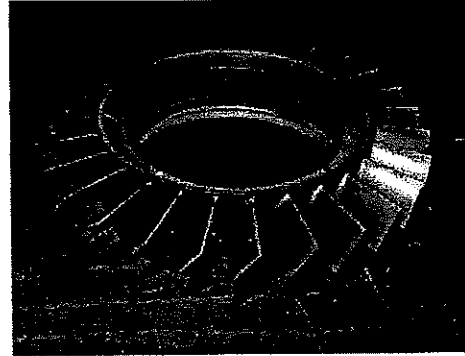
5th Stage Compressor Wheel
Part No. 23057115
S/N: E60099

Damaged vanes due to the FOD

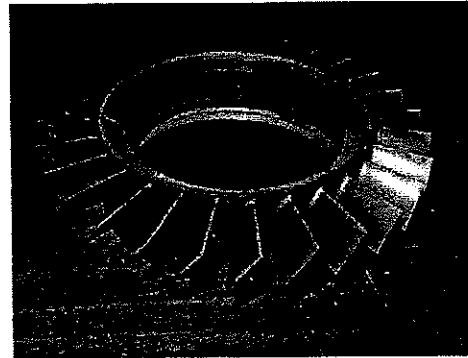
6st Stage Compressor Wheel
Part No. 23057116
S/N: KR58292

Damaged vanes due to the FOD

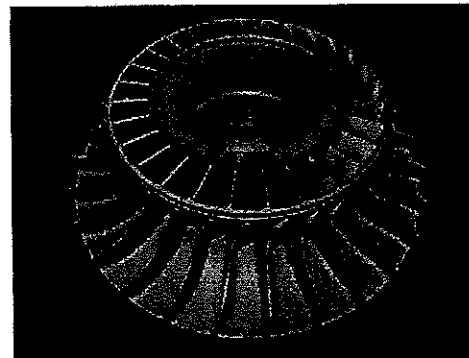
Impeller Assy
Part No. 23058147
S/N: KR96571

Damaged due to the FOD

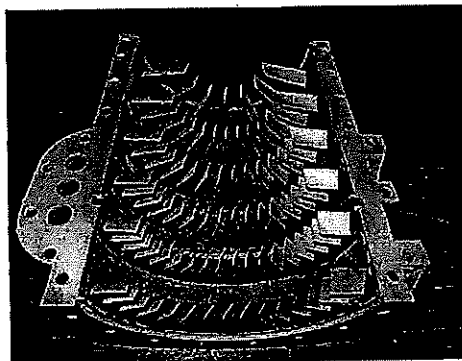
Half cases
Part No. 23057142
Set 25003

Damaged coating due to the FOD

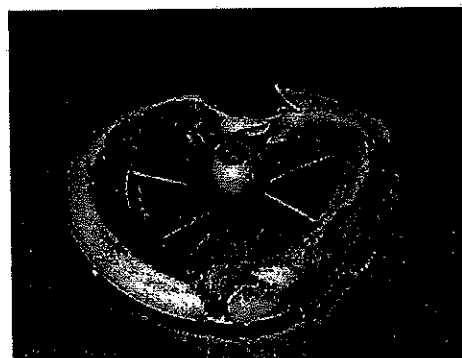
Compressor Front Support

Damaged due to the FOD.
