AIRCRAFT ACCIDENT REPORT 03/15

**Report on the accident to Helicopter Dauphin,
AS 365 N3 Registration 9M-IGB near Subang Airport,
40 Nautical Miles South East of Subang Airport,
MALAYSIA**

Aircraft Type	:	Eurocopter Dauphin
Model	:	AS 365N3
Owner	:	Orion Corridor Sdn. Bhd.
Nationality	:	Malaysian
Year of Manufacture	:	1990
Aircraft Registration	:	9M-IGB
Serial Number	:	6374
State of Registration	:	Malaysia
State of Operator	:	Malaysia
Place and State of Occurrence	:	40 Nautical Miles SE of Subang Airport, MALAYSIA (N 03 00.64 E101 51.19)
Date and Time of Accident	:	04 April, 2015 at 1654 hours (Local Time)

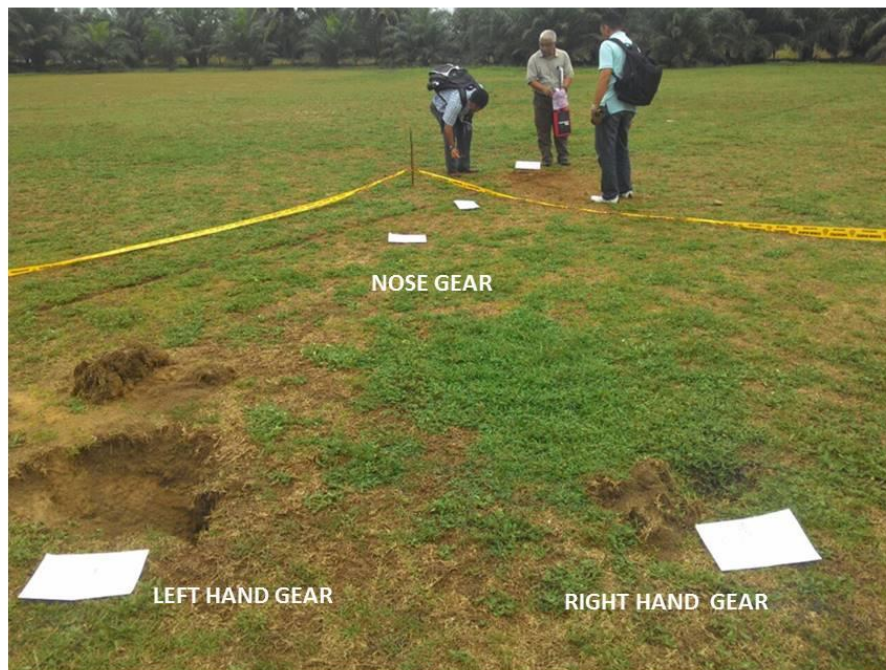
Fig 9

The helicopter made an unscheduled landing at SKLBK. While landing at the school field, the Left Hand (LH) Landing Gear sunk into the ground. The photo below shows the sunk hole on the ground due to the landing gear.

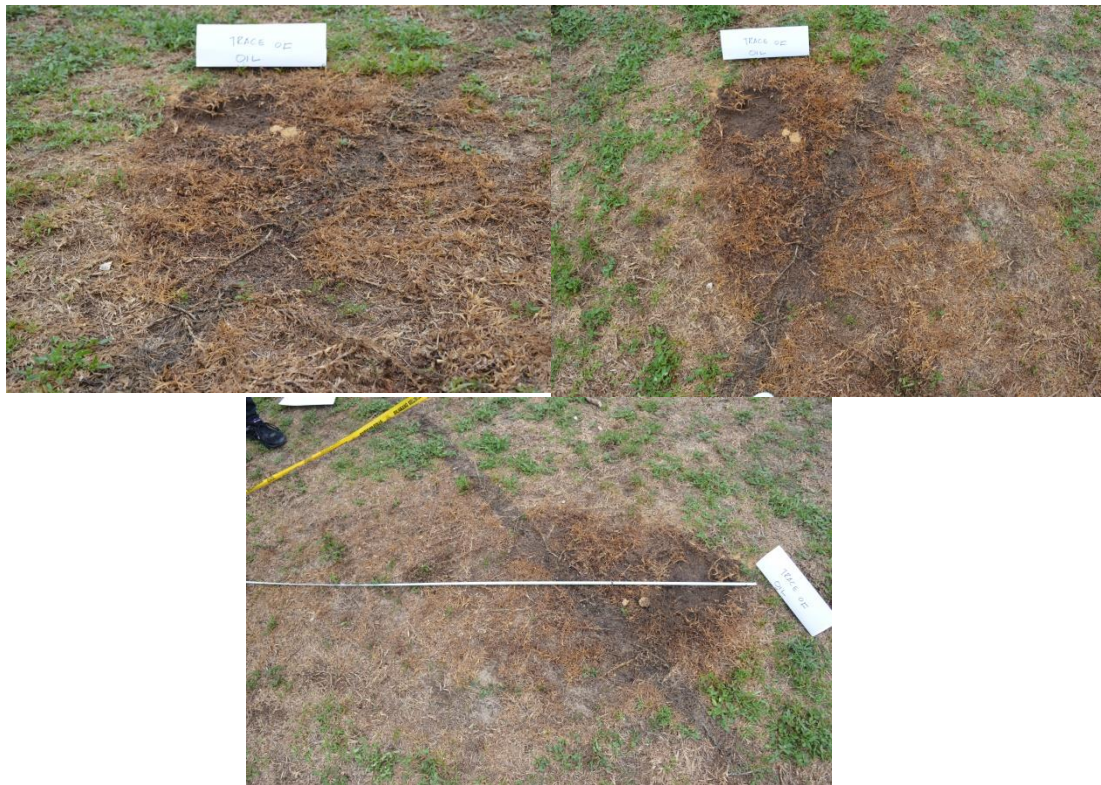
Fig. 10

The photos below show the oil traces on the field at Sekolah Kebangsaan Ladang Kota Bahagia.

The hydraulic fluid may indicate evidence of some leakage from the helicopter hydraulic system at the field where the aircraft landed.

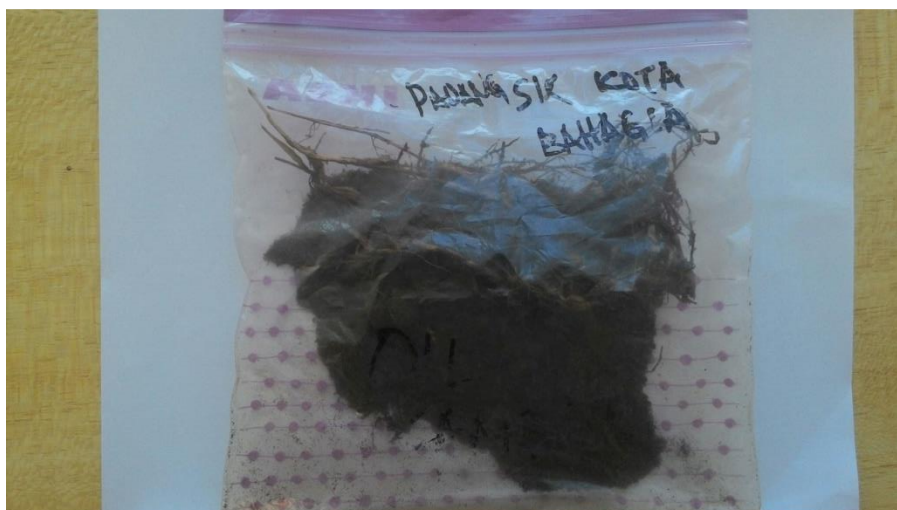
Fig. 11

The traces of earth with oil sample was placed in a plastic bag and sent to Chemist Department of Malaysia for detailed analysis. See Fig. 11.

Test result from the Chemistry Department of Malaysia shows that the sample taken at the SK Ladang Kota Bahagia is consistent with the Mobil Jet Oil II (Synthetic) of the AS365N3 helicopter hydraulic fluid specification.

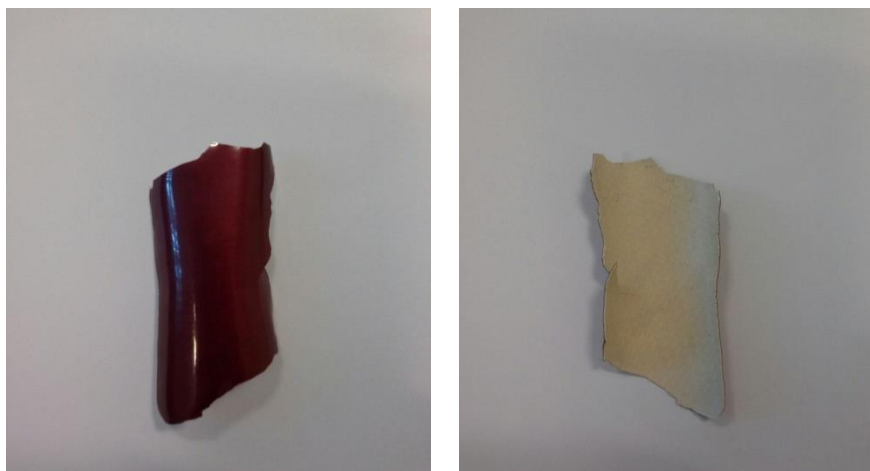
Fig. 13

During subsequent visit to at SKLKB, the investigator found a piece of chipped-off paint which is similar to the colour of the helicopter leading edge of the horizontal stabiliser. (Fig 13)

The above photo shows the piece of chipped-off paint was sent to Chemist Department for analysis. There was no conclusive result obtained on the analysis of the piece of sample. Further test was carried out by matching the paint contents and feature from the chipped off part and the paint from the helicopter. The Left Hand Horizontal Stabilizer was missing; however, the RH Horizontal Stabiliser was found together with the wreckage and the piece of chipped-off paint matched the colour and countour of the aerodynamic profile of the horizontal stabiliser leading edge.

As the LH Landing Gear sunk into the ground, the vertical fin of the LH Horizontal Stabilizer had contacted the ground and may have caused premature structural damage to the LH Horizontal Stabiliser. The piece of chipped-off paint found on the field provides the evidence that LH Horizontal Stabiliser and helicopter structures has been badly distorted causing the dislodgement of the piece of paint.

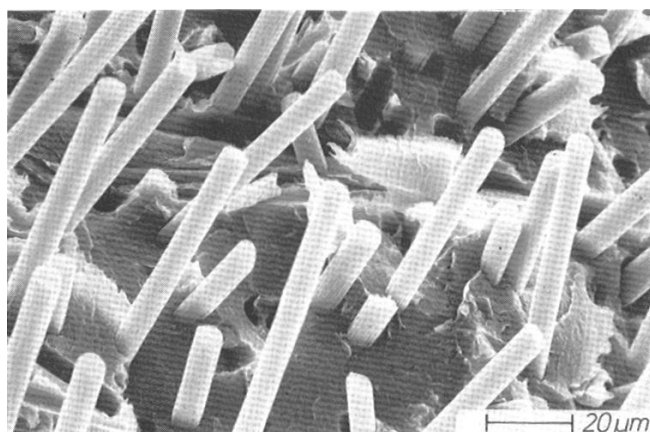
Fig 14

The following photo shows the fiber pullout resulted from tensile load on the structure.

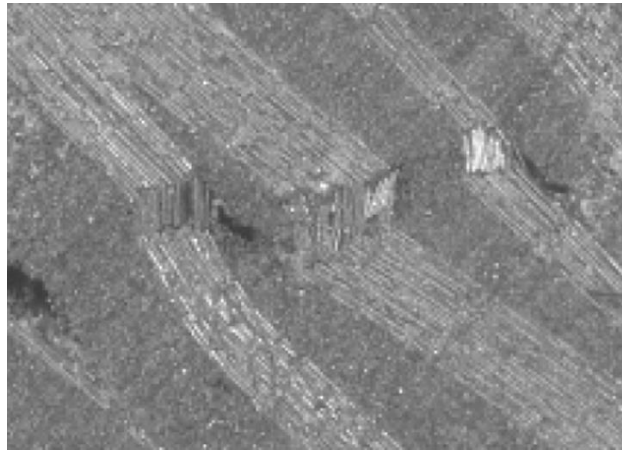
Fig 15

The kinking of fibers shown in FIG 15 indicate results of compressive loads on the structure, with some applied load translated into all the fibers. It also shows the kinking of fibers in the direction of compressive load.

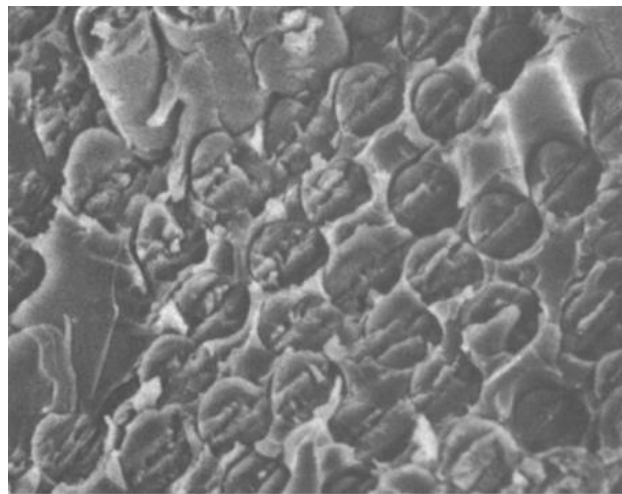
Fig 16

The following photo shows there was evidence of chop marks on the ends of broken structure which indicate that the fibers had buckled and failed under compressive load as well.

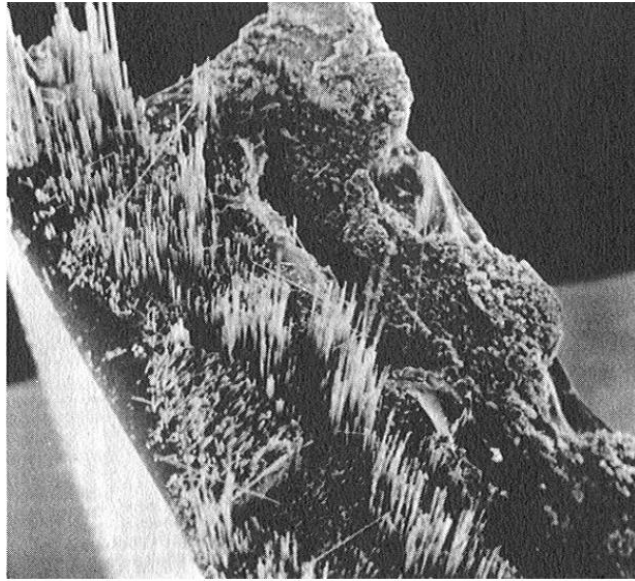
Fig 17

The following photo provides evidence of failure on the composite structure due to bending forces. See Fig. 16 – The relative rough area, visible strands of fibers and tension area and the smooth region as shown in photos indicate failure by compression.

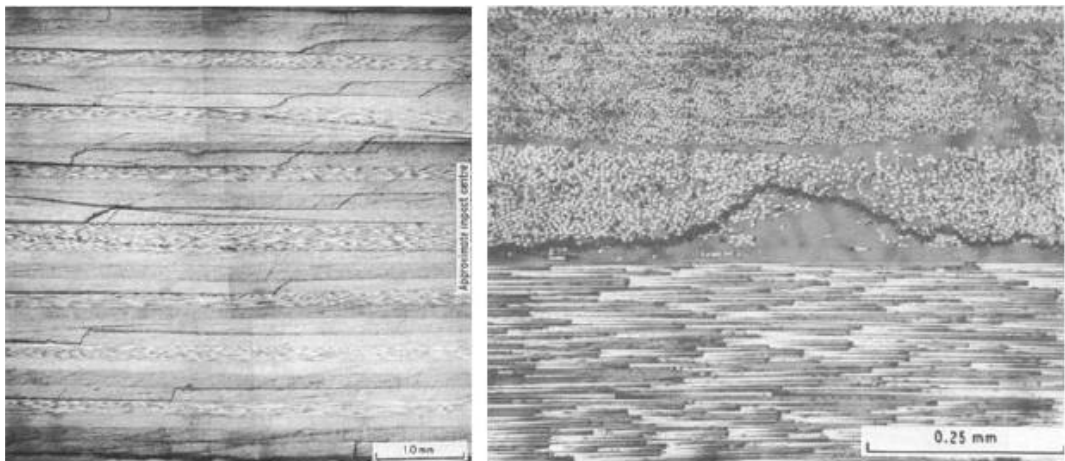
Fig 18

The following photos show the delamination between the composite plies which could attribute to pre or post impact.

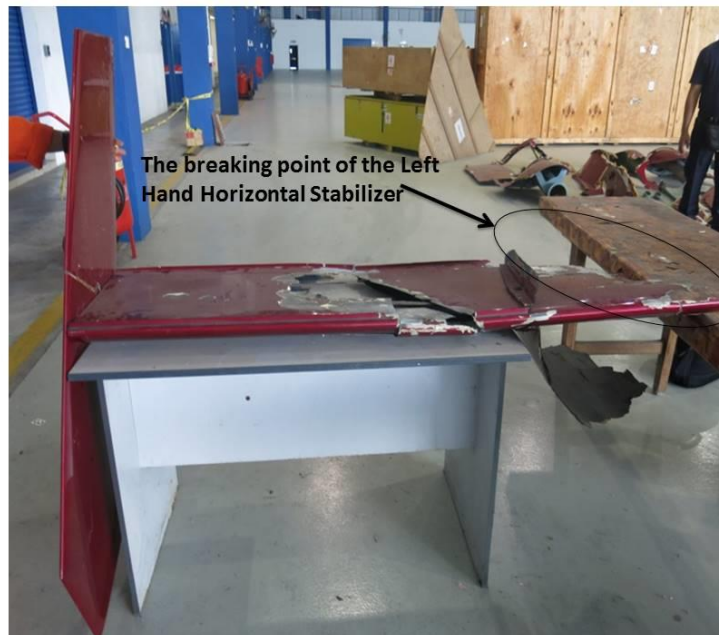
Fig 19

The above photo shows the reconstruction of the horizontal stabilizer assembly. The Left Hand Horizontal Stabilizer was missing.

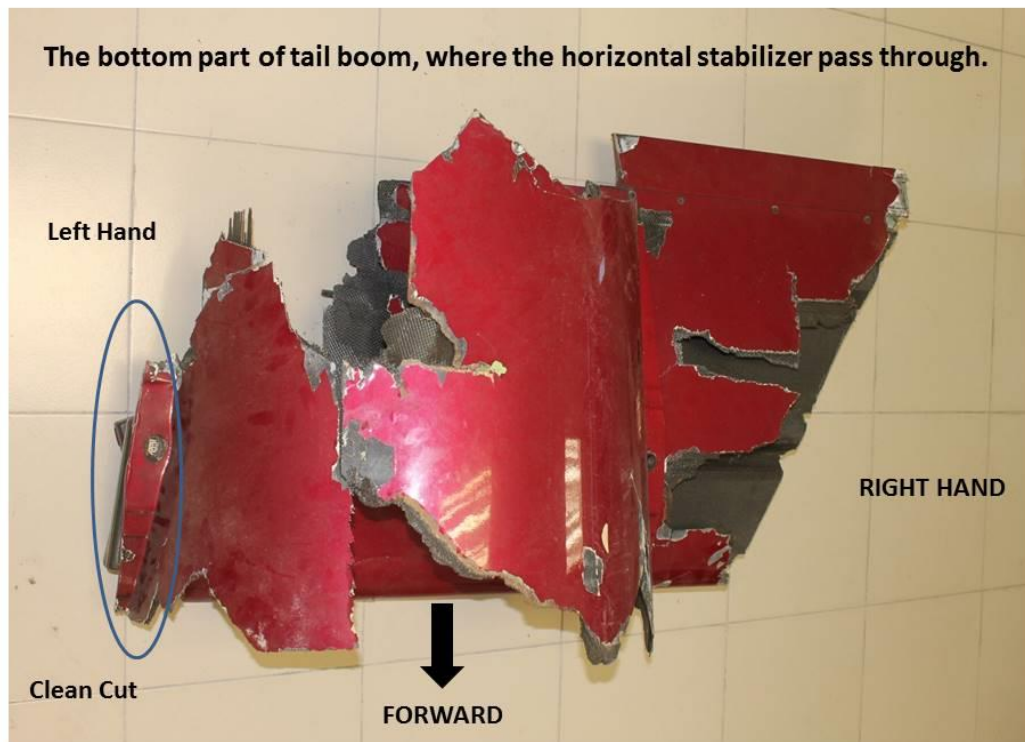
Fig 20

The tail boom section was reconstructed and each failure point was examined. The above photo shows the failure of the tail boom section after the wreckage of the tail boom and part of the horizontal stabilizer were reconstructed.

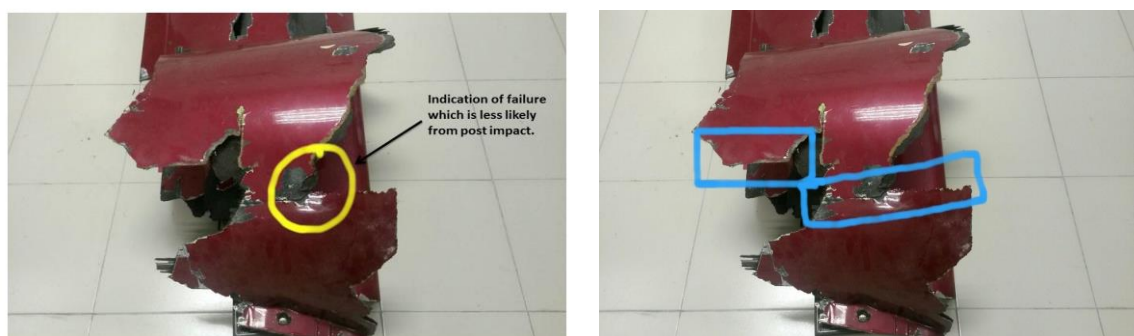
Fig 21

The tail boom section was examined in detailed and the failure points show a clear cut on the tail boom skin parallel to the helicopter longitudinal axis, as shown. (See Fig 20 and Fig 21)

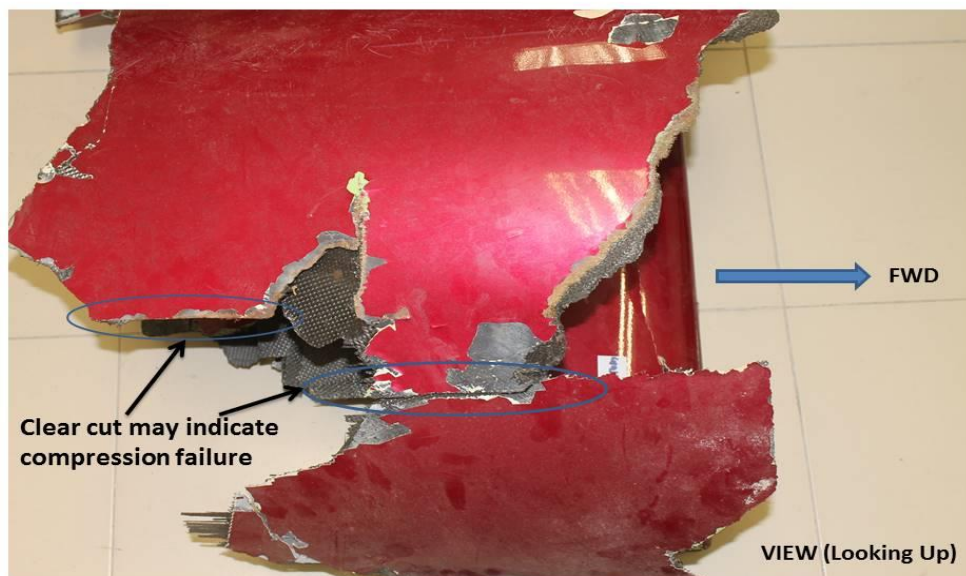
Fig 22

A straight line failure may indicate failure due to compression load. A detailed closed up examination had shown a clean cut failure in a straight line direction (See Fig 22).

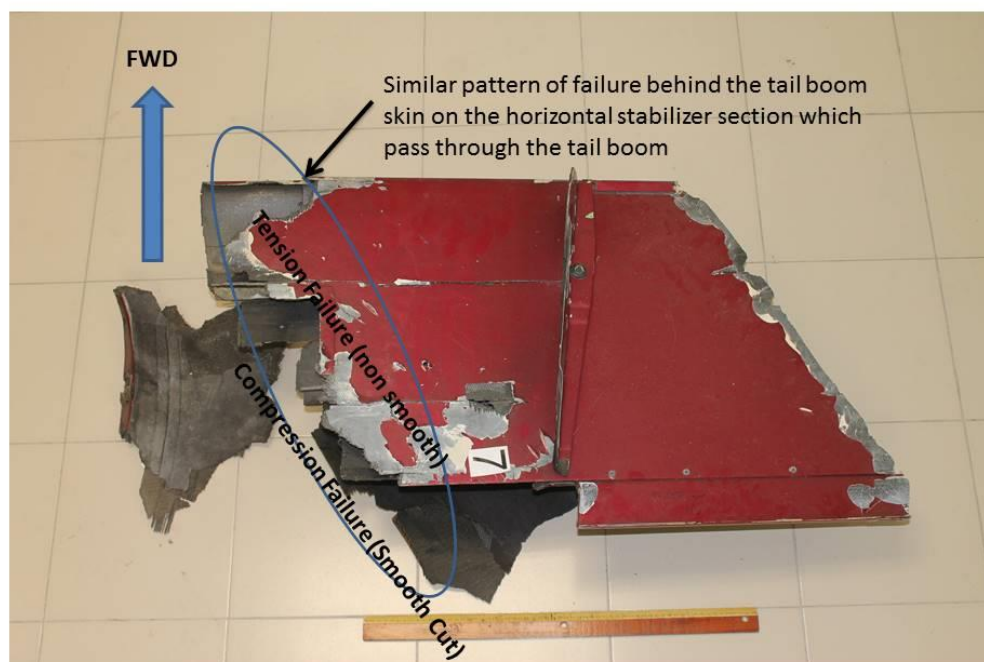
Fig 23

The examination continued with the section of the horizontal stabilizer. As the tail boom section is removed, the horizontal stabilizer section at the breaking point is visible as shown in Fig 23.

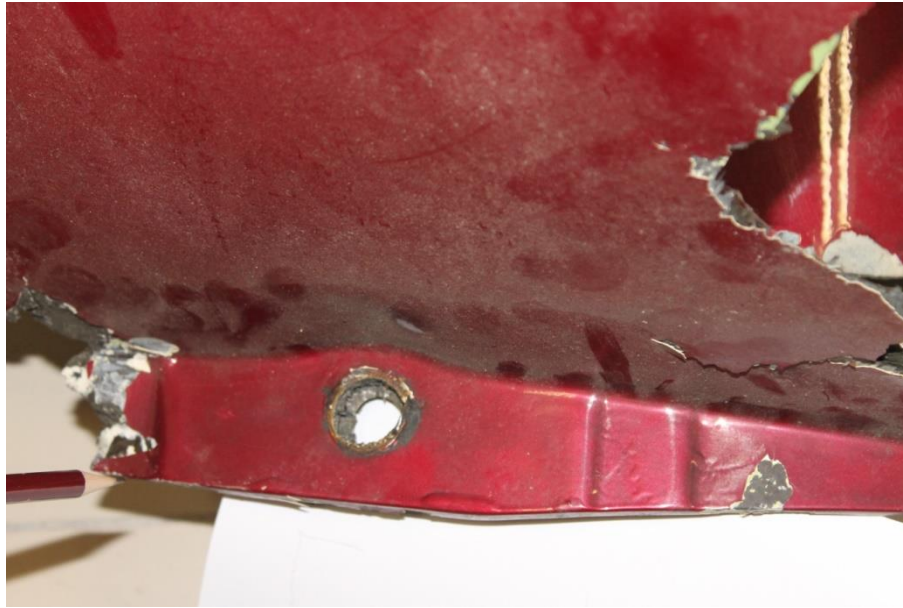
Fig 24

The top skin of the horizontal stabilizer had smooth cut which indicates it had failed under compression load whilst the bottom skin of the horizontal stabilizer had jagged edges failed under tension load. (See Fig 24)

The inconsistency on the LH Horizontal Stabilizer failure pattern showing the top skin under compression and bottom skin under tension might suggest that there could be a premature failure on the LH Horizontal Stabiliser structure as the vertical fin hit the ground when the helicopter landed and the LH Landing Gear subsequently sunk into the ground at SKLKB. As the LH vertical fin hit the ground, the LH Horizontal Stabilizer will bend upwards and will hinge at the mid span of the LH Horizontal Stabilizer as shown by the failure line parallel to the tailboom attachment.

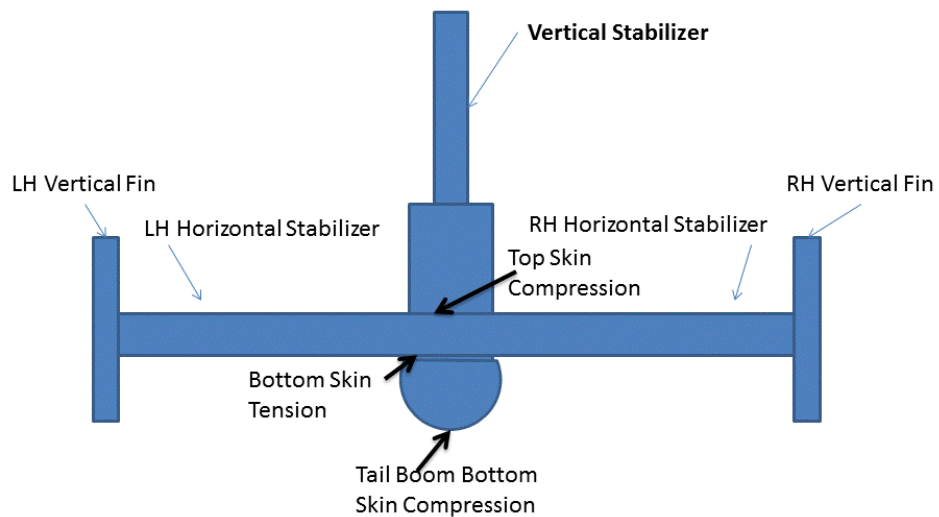
Fig. 25

The tail boom attachment to the horizontal stabilizer indicates a pulled through failure. A review the structure failure lines is shown in the following diagram (See Fig 25).

skin of the tail boom appears consistent with the failure mode of the LH Horizontal Stabilizer bending downward as evidence from the clean fracture line along the tail boom. (See Fig. 25)

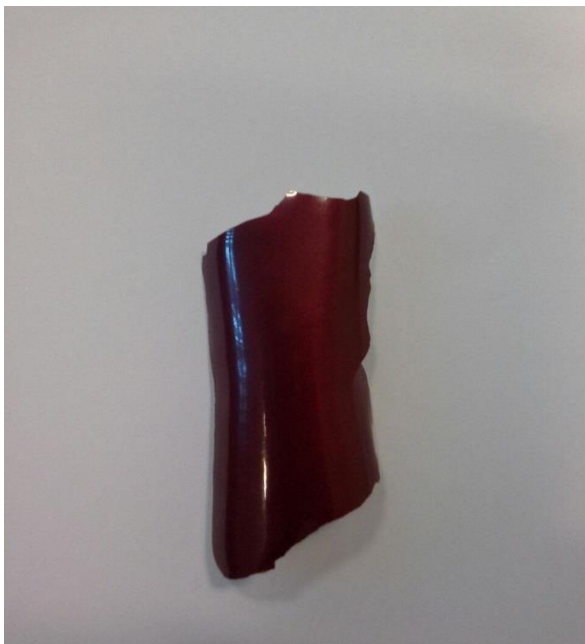
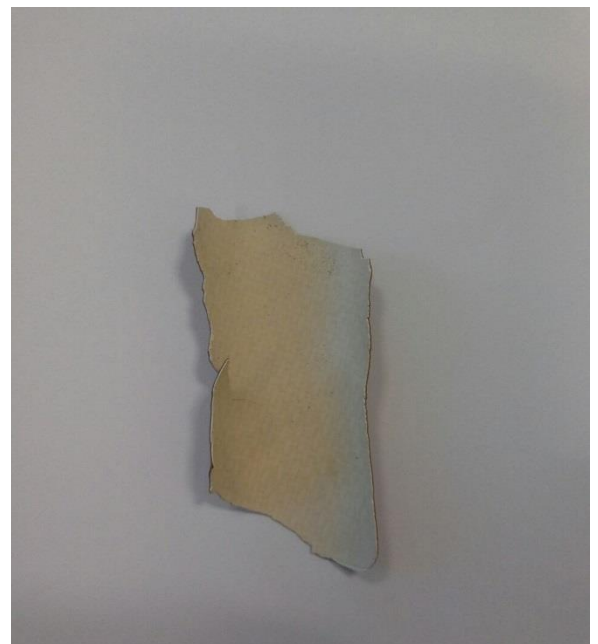
A small chip off paint was found at the last landing field on the second visit by the investigation team. The chip was curvature in nature and having the colour of the horizontal stabiliser on the outer and white colour with cross grain in the inside. This paint chip most probably came from the missing left horizontal stabiliser because the right stabiliser was found intact. When the critical area of the leading edge was subjected to bending, and when the outboard fin contacted the ground, the critical area experienced compressive stress to buckling. In these conditions, delamination and failure of fibres on one of several plies can occur causing it to buckle. The paint could have chipped off from the left stabiliser which had been weakened by the bending stress. (See Fig 28 and Fig 30)
