AIRCRAFT ACCIDENT FINAL REPORT
A 04/15P
Air Accident Investigation Bureau (AAIB)
Ministry of Transport Malaysia

Helicopter Bell 206B III, Registration 9M-LLM
at Kota Kinabalu International Airport, Kota Kinabalu, Sabah
on 28 May 2015

REPORT NO.: A 04/15P

OPERATOR : LAYANG-LAYANG HELICOPTER ACADEMY
AIRCRAFT TYPE : BELL JETRANGER III
MODEL : B 206 B III
NATIONALITY OF AIRCRAFT : MALAYSIA
REGISTRATION : 9M-LLM
**PLACE OF OCCURRENCE : KOTA KINABALU INTERNATIONAL AIRPORT
KOTA KINABALU, SABAH**
DATE AND TIME : 28 MAY 2015 AT 1151 LT

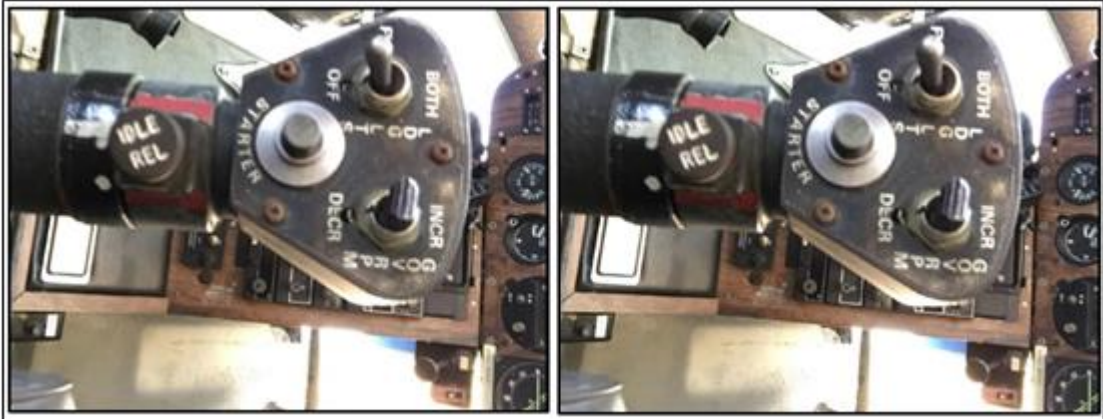
Figure 3: Collective lever and throttle position

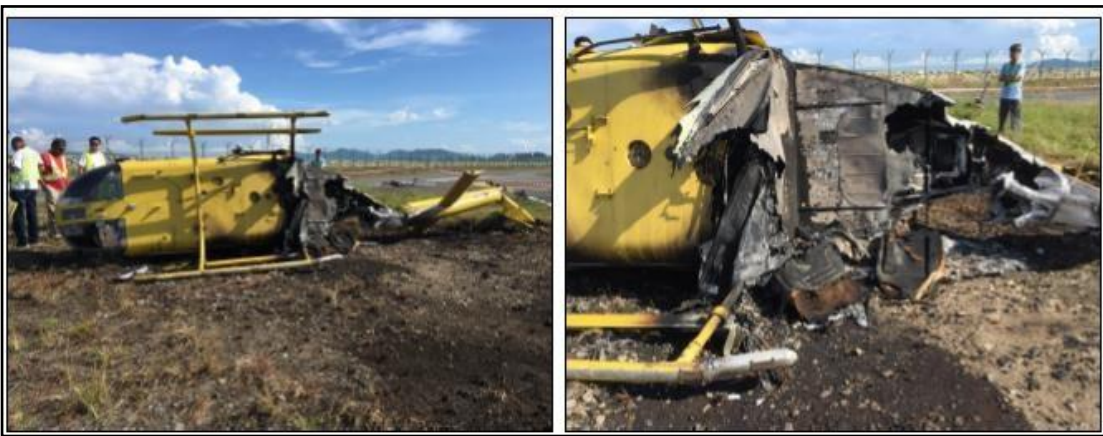
Figure 4: Fuselage rested on its right side

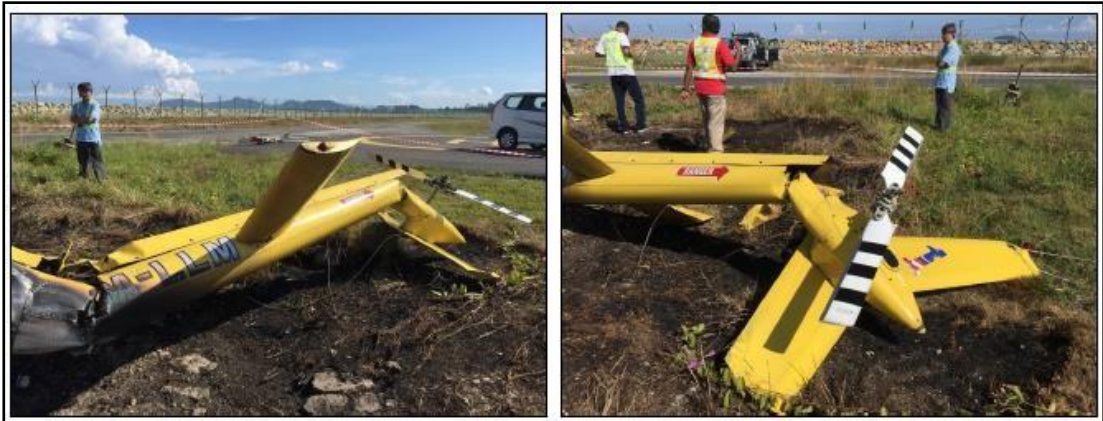
The helicopter crashed close to the helipad Marker H. The tail boom was severely bent towards the tail rotor section and almost broken off at the aft fuselage attachment section upon impact with the ground. The main rotor blades struck the helipad and broke into several pieces. The main rotor head had sheared off from its main mast indicating high energy rotation. The main gearbox was detached and flung about 10 meters away from the main wreckage. The engine was removed and sent to Heli Holland Technics for tear-down examination.

Figure 5: Tail rotor and tail boom condition

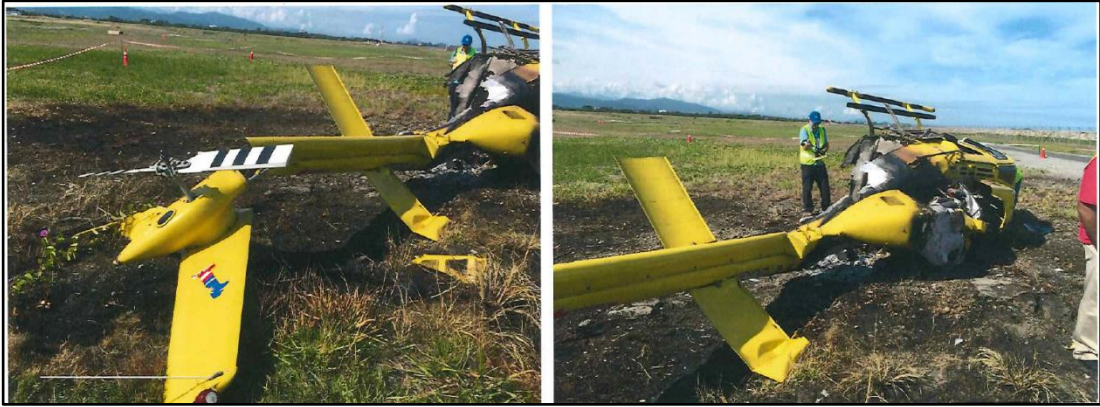
Figure 6: Wreckage from the tail

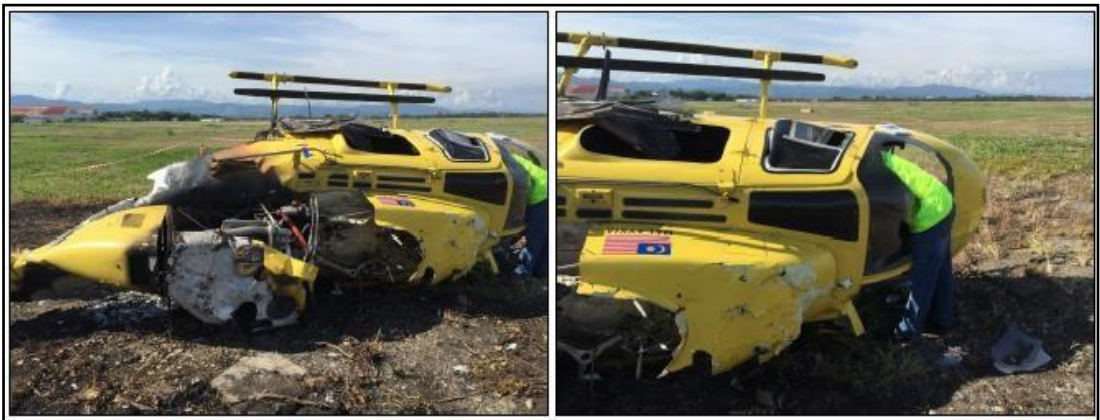
Figure 7: Fire started from the baggage compartment

There was post impact fire which destroyed the aft baggage compartment, upper and aft fuselage area.

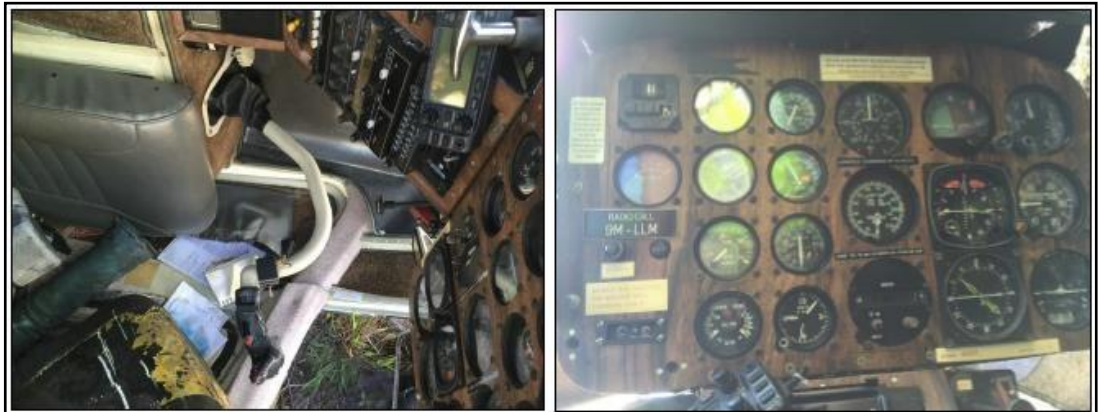
Figure 8: Helicopter instrumentations

The dual tachometer P/N 206-075-681-3 and S/N T1722 was removed from the wreckage and tested on 9M-LLH helicopter during an engine run and hover check on 9 June, 2015. The tachometer was found to function normally.

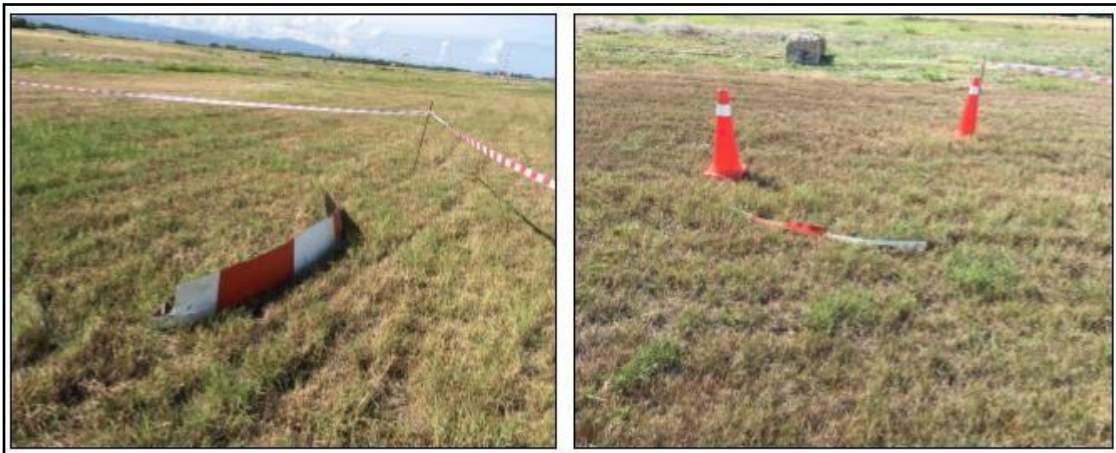
Figure 10: Main rotor broken off due to high rotor energy

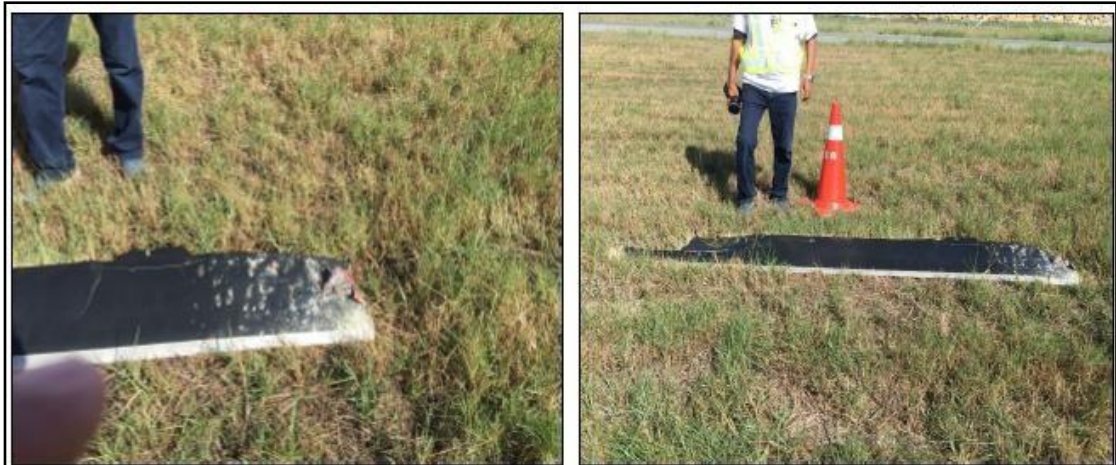
Figure 11: Main rotor blades damage

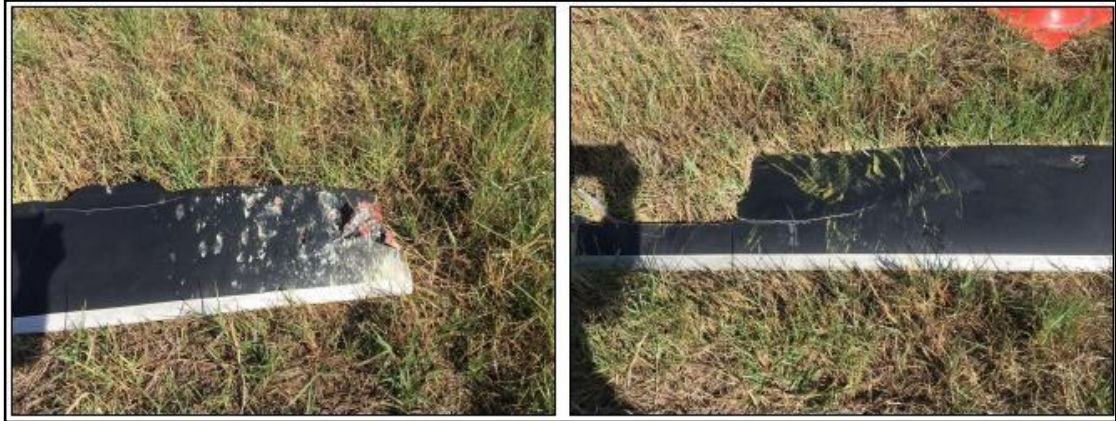
Figure 12: Close look at the main rotor blade tips
