AIRCRAFT ACCIDENT FINAL REPORT
A 14/15
Air Accidents Investigation Bureau (AAIB)
Ministry of Transport

Accident Involving a Piper PA-32-300
Registration 9M-AVN
at Pangkor Airport (WMPA), Perak, Malaysia
on the 15 November 2015

FINAL REPORT A 14/15

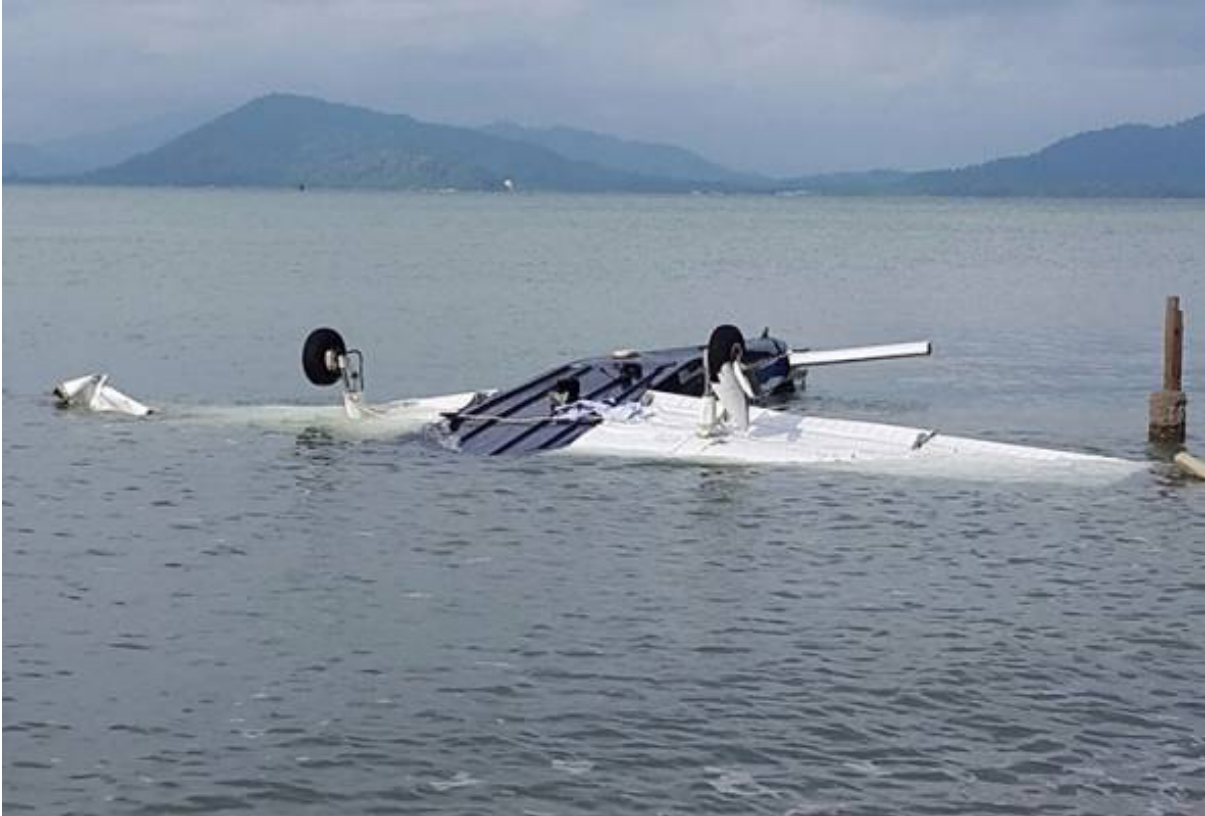
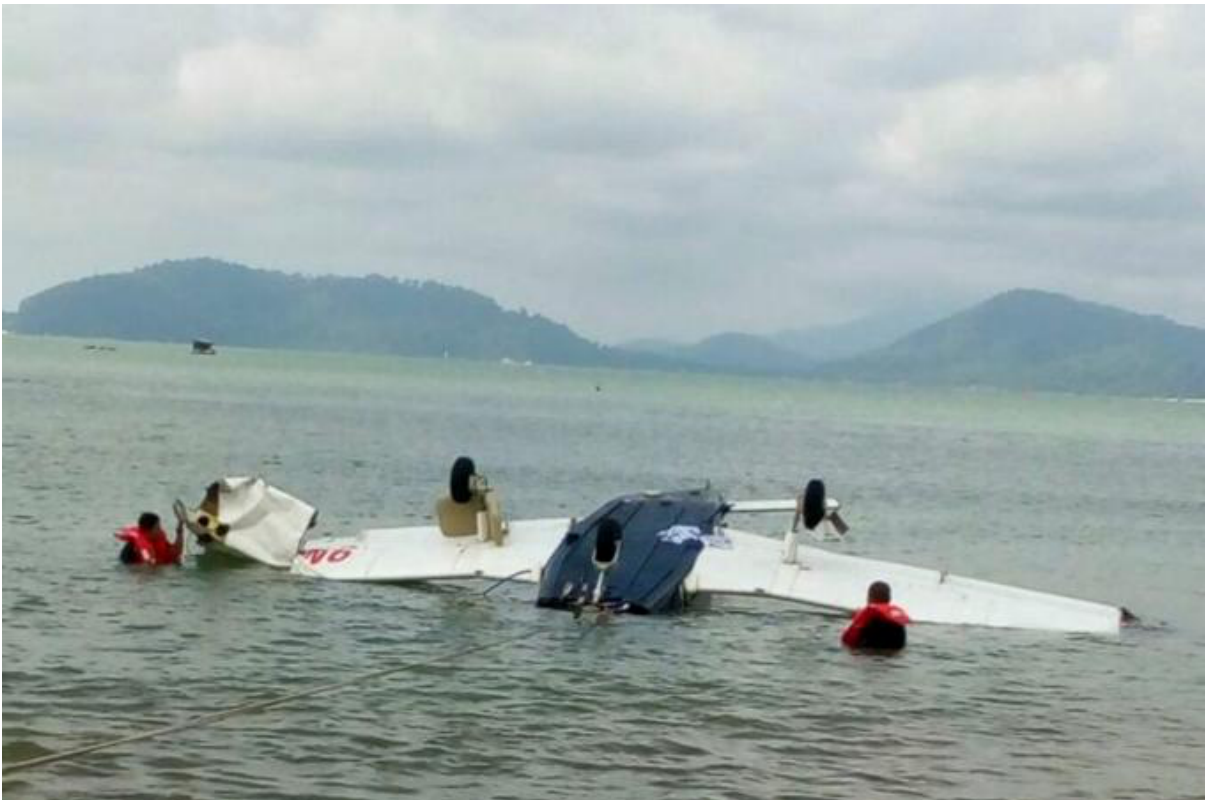
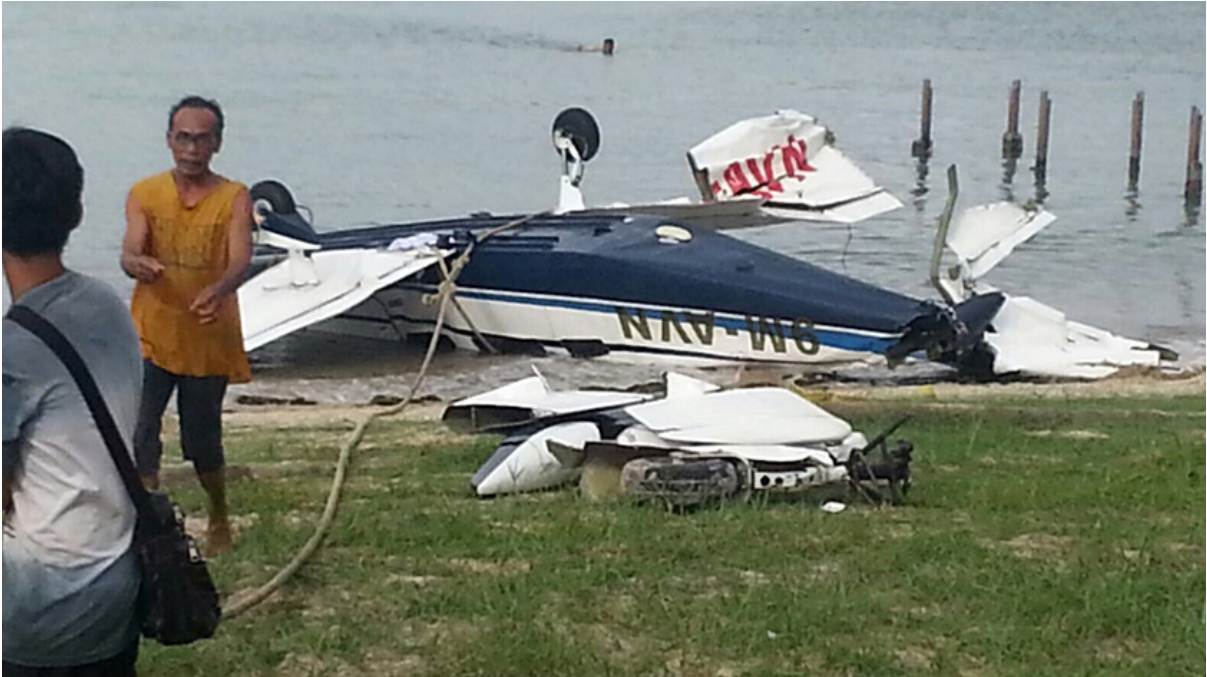
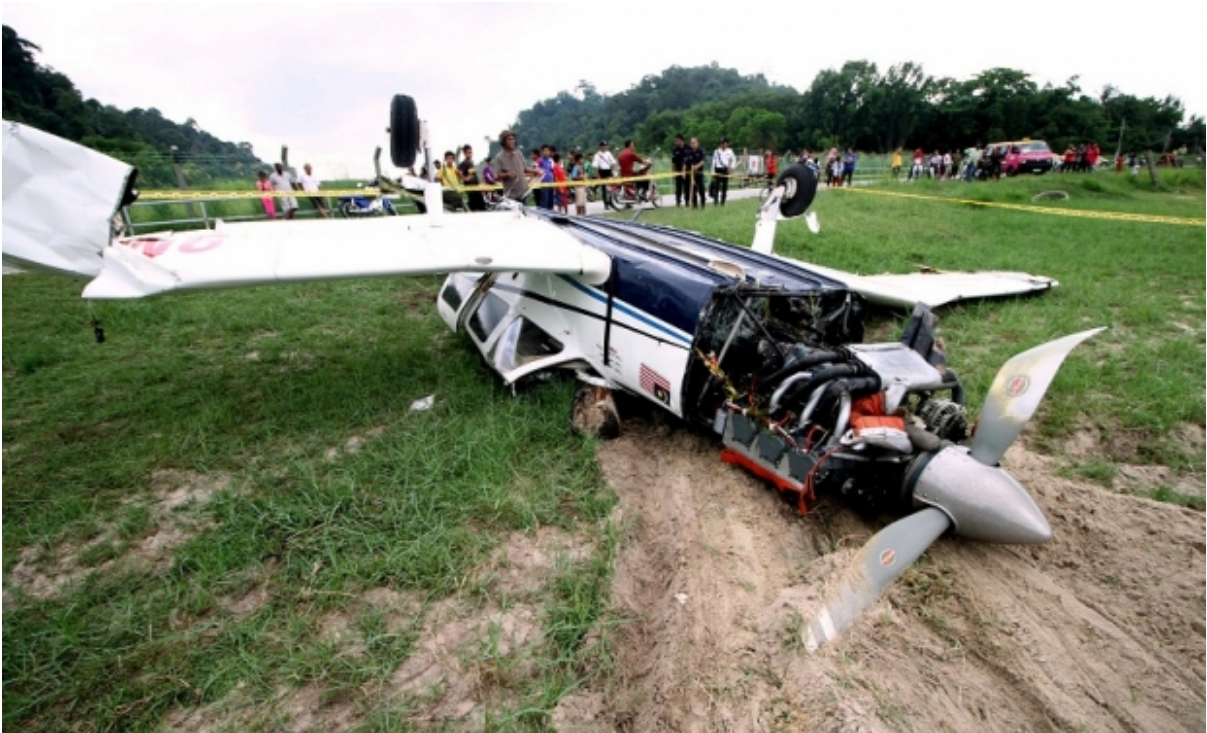
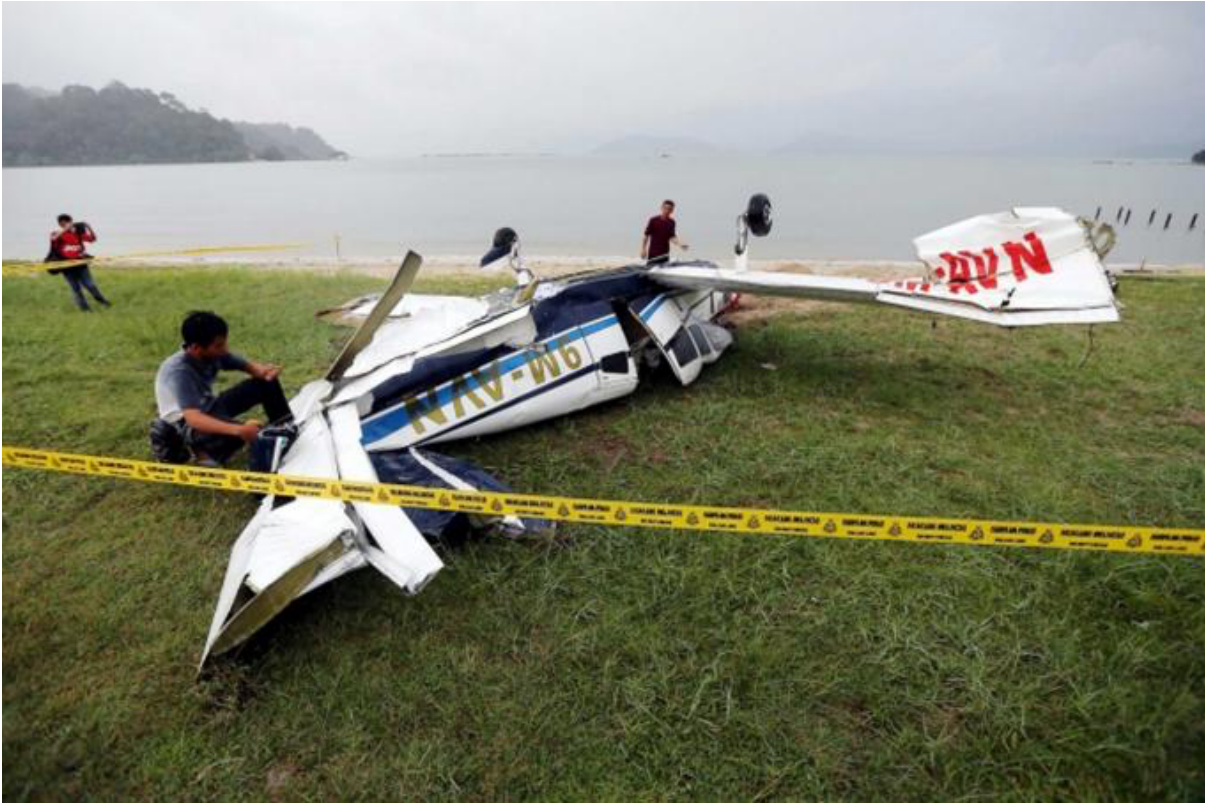
DAMAGE ASSESSMENT (IMAGES ON-SITE)

The aircraft came to a rest inverted in about two meters of water at the surf's edge. Its propellers were bent and the left wingtip was heavily damaged. Debris from the tail section was also found scattered on the roadside and beach due to it striking the airport perimeter fencing. The cabin however was basically intact which is why the passengers were able to egress from the aircraft via its doors.

It must be noted that additional damage to the nose-wheel assembly, engine cowlings and tail section of the aircraft were due to the recovery efforts and not from the accident itself. For images of damage to the aircraft on-site please refer to **APPENDIX A**.

The wreckage was inverted in about two meters of water. Recovery of the aircraft was carried by local authorities employing a back-hoe to pull it out of the water by attaching a rope to the nose landing gear. During the recovery process, the nose-wheel assembly as well as the engine cowlings were damaged.

The rope was then fastened to the tail section of the aircraft to pull it further up the beach. This unfortunately resulted in further damage to the tail section. Additionally, the local authorities in their attempt to lighten the aircraft before transporting it by lorry back to the airport for storage also drained all the fuel and fluids from the aircraft.
