# **FINAL REPORT**

## **PIPER PA34-220T SENECA III, REGISTRATION 9M-RBI LANDING ACCIDENT IN SELETAR AIRPORT 1 JANUARY 2016**

**AIB/AAI/CAS.120**

**Transport Safety Investigation Bureau  
Ministry of Transport  
Singapore**

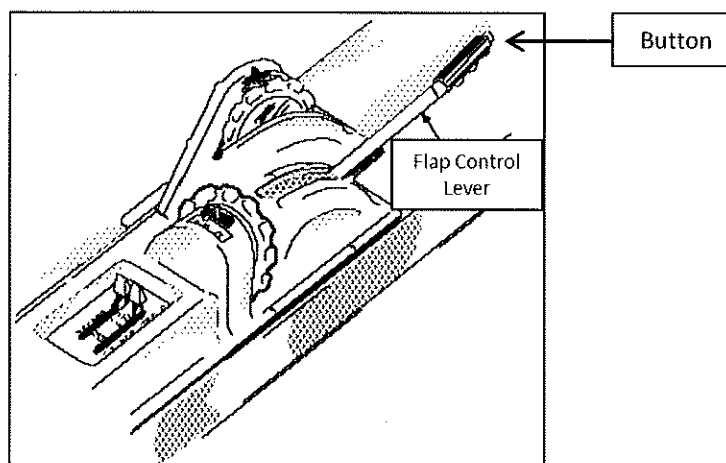
Figure 1. Flap control lever

- 1.1.5 According to the PIC, the landing gears were lowered at the downwind leg and he did not notice any anomalies about the landing gear system. He also did not notice any landing gear warning horn annunciation<sup>1</sup>. The PIC selected full flaps (40°) as the aircraft turned for base leg. The flap selection was made by depressing a button (plunger plug) on the end of the flap control lever<sup>2</sup> (**Figure 1**) and shifting the lever to the desired flaps indicator. The PIC said he had felt a sticky resistance when he tried to depress the button, but he managed to depress the button and engage the flaps.

- 1.1.7 For the go-around, the PIC applied full power and increased the aircraft pitch. He tried to retract the flaps but he could not depress the button (plunger plug). The flaps were stuck at 40°. This caused drag on the aircraft and the PIC decided to raise the landing gears to reduce drag. He raised the landing gears without first verifying that the aircraft was having a positive climb<sup>3</sup>. Despite all this, the aircraft sank. The PIC attempted to lower the gears again. The aircraft contacted the runway before the landing gears could be extended again and the aircraft came to a halt eventually.

2.8.1 The PIC indicated that he could not depress the button (plunger plug) to change the flaps setting when he carried out the go-around. However, the operation of the button appeared normal during post-accident tests of the flap. The investigation team is unable to determine the reason for the difficulty experienced by the PIC.

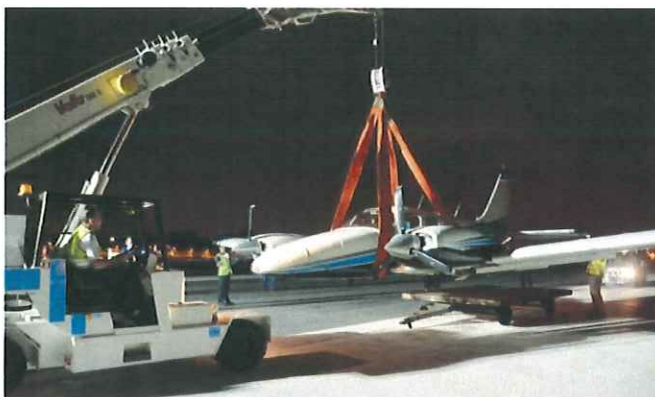
Figure 2. Recovery of disabled aircraft

- 1.1.11 The disabled aircraft was subsequently recovered and moved to a hangar facility on a dolly (**Figure 2**).

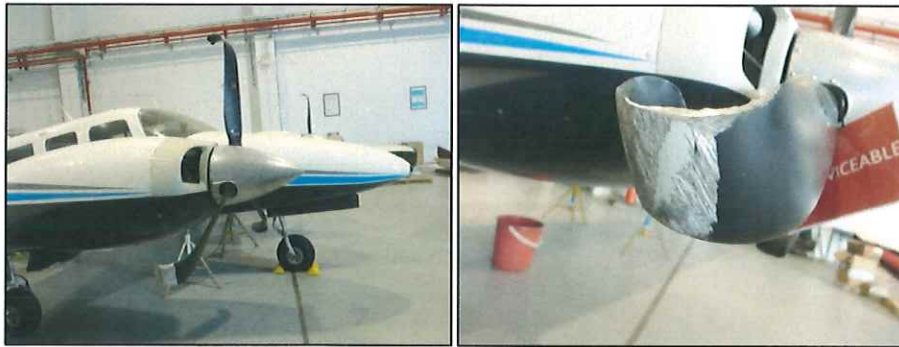
Figure 3. Propeller tip bent forward

- 1.3.2 The tips of all three propeller blades on each engine were bent forward (**Figure 3**). This suggests that the propeller was being driven under positive power from the engine and that the propeller revolutions per minute (RPM) is relatively high<sup>4</sup>.

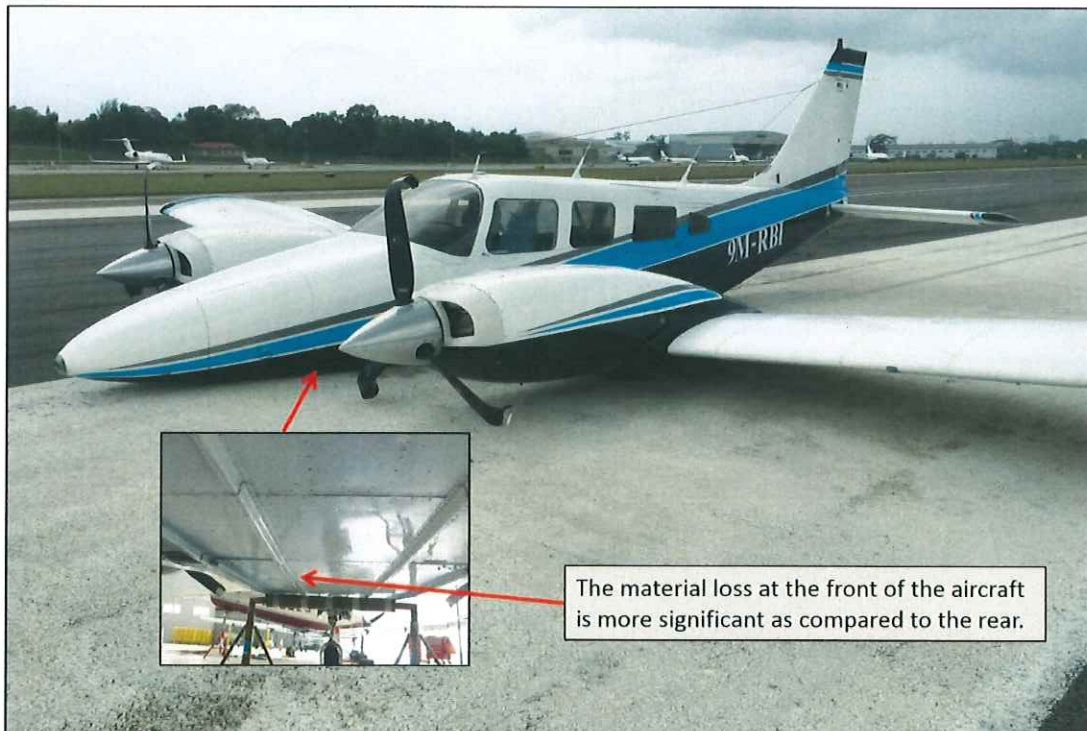
Figure 4. Damage at the belly of the aircraft

- 1.3.3 The material loss at the aircraft's belly area due to the aircraft's contacting the runway was more pronounced at the front of the aircraft than at the back (Figure 4).

2.4.2 The rear of the aircraft was not damaged and the abrasions in the belly area were limited which suggested that the impact energy was low. In addition, the abrasions in the belly area were more pronounced in the front than the rear area. This indicates that it is very likely that the front part of the aircraft had contacted the runway before the rear. This is consistent with a flat aircraft pitch attitude, which is not a normal aircraft configuration during landing. In a normal landing configuration, the aircraft is pitched at a nose up attitude to flare for landing. The nose up pitching would normally result in the main landing gears contacting the runway before the nose landing gear. A belly landing situation would have caused more damages at the rear due to the higher energy impact and more abrasion at the rear of the belly. Should the aircraft come in with landing gears retracted during the first approach; the

damage on the aircraft should be more pronounced in the rear part of the aircraft.

2.5.1 As regards the attitude of the aircraft at the moment of the belly contact with the runway, the damage at the belly area suggests that the aircraft did not have much of a positive attitude, if it had a positive attitude at all.

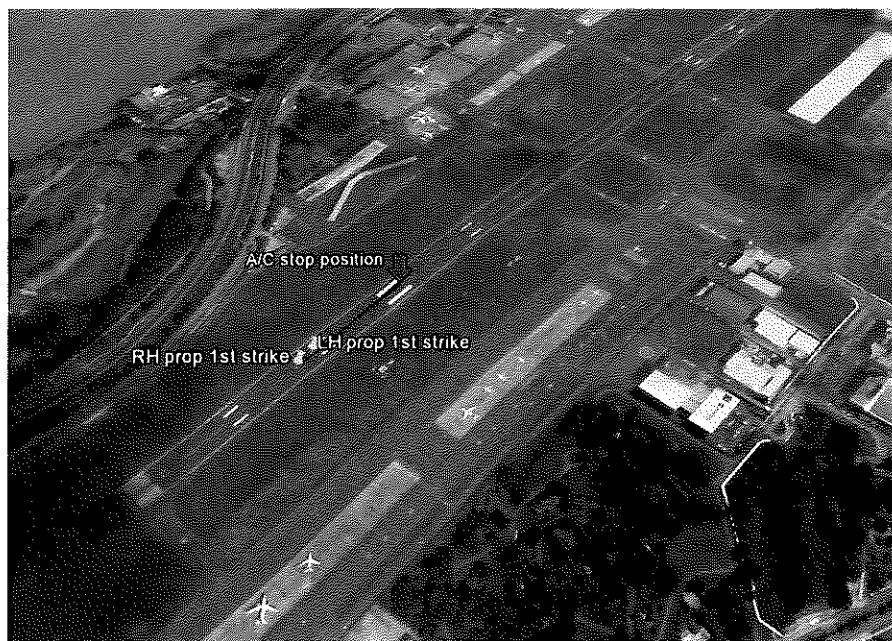
Figure 5. Showing the positions of aircraft final stop; first strike marks of right propeller and the left propeller.

1.6.1 The aircraft came to a rest about 600m from the start of Runway 03, with a heading of about 030° (i.e. in the direction of Runway 03). There were ground marks on the runway of the right and left propellers. **Figure 5** shows the positions of aircraft and the ground marks.

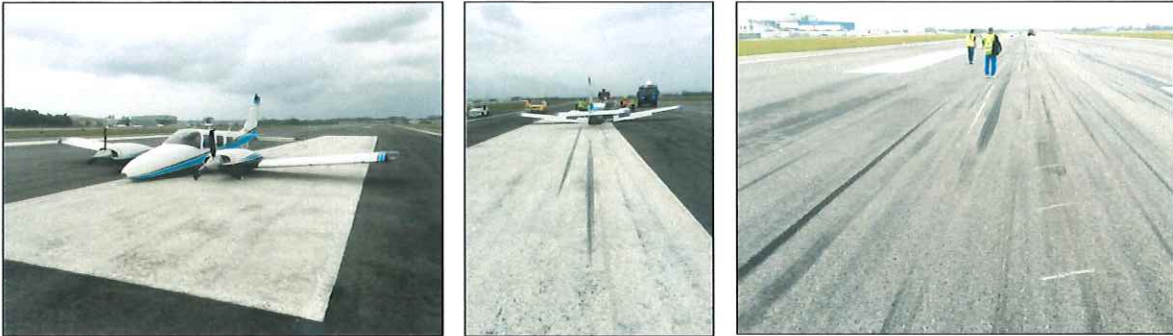
Figure 6. Position of the aircraft and impact marks

1.6.2 The propeller ground marks suggested that right propeller had struck the runway tarmac before the left propeller (**Figure 6**).

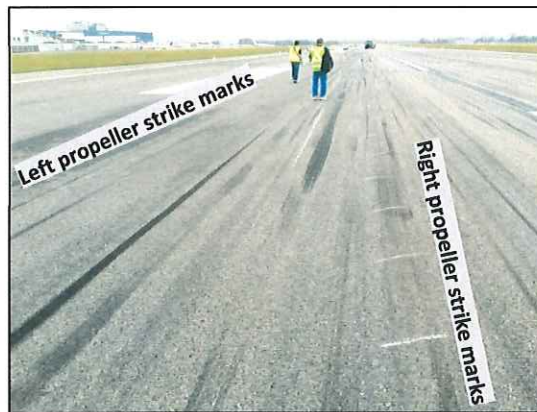
Figure 7. Distance between right and left engines propeller first strike marks (30m)

- 1.6.3 The distance between the right engine propeller first strike mark and left engine propeller first strike mark was 30m (**Figure 7**).

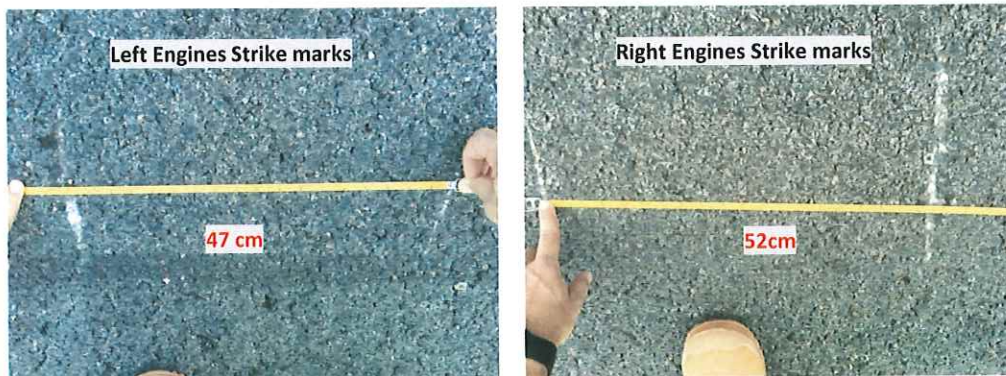
Figure 8. Measurements taken between the propellers for the left and right engines

- 1.6.4 The distances between the propeller strike marks for the left and right engines were as follows (**Figure 8**):

For the left engine:

- (a) Distance between the first and second strike marks – 47cm
- (b) Distance between the second and third strike marks – 48cm

For the right engine

- (c) Distance between the first and second strike marks – 52cm
- (d) Distance between the second and third strike marks – 55cm

2.7.2 The aircraft approached Seletar Airport at a speed of about 85kts. The speed would be reduced after the aircraft's bounce on the runway. The application of the full power during the go-around might increase the speed somewhat but the increase is likely to be marginal. If we assume that the speed after the bouncing to be of the order of 80-90kts, then the RPM would be of the order of 1,550-1750 for the right engine and 1750-1950 for the left engine. These RPM values are consistent with the pilot's power application for the go-around.
