**SOCATA TB 20, 9M-SOM**  
**CONTROLLED LANDING WITH UNDERCARRIAGE UP**  
**AT SUBANG AIRPORT**  
**10 OCTOBER 2016**

**SERIOUS INCIDENT REPORT NO.: SI 09/2016**

**AIRCRAFT TYPE : SOCATA TB 20**

**REGISTRATION : 9M-SOM**

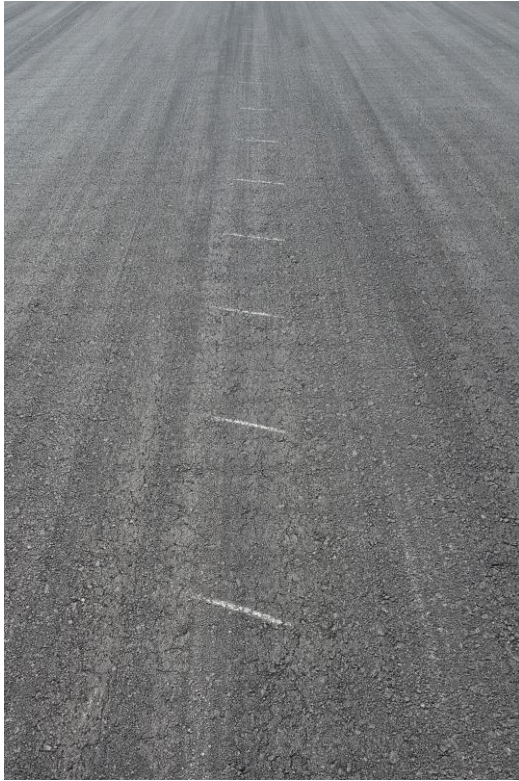
1.12.1 The aircraft came to a rest about 780 meters from the threshold of runway 15 with a heading of about 330 degrees. There were ground marks on the runway surface. Fig 1 shows the ground mark and approximate position of the aircraft.

Photo of skid marks on runway

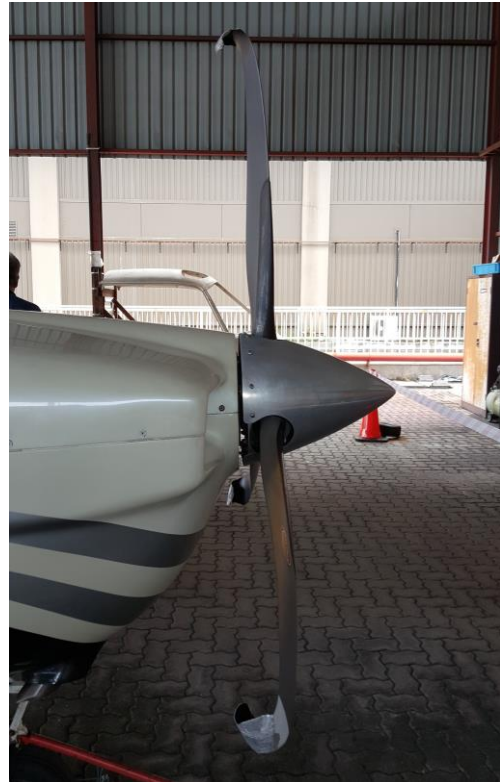
Photo of damaged propeller

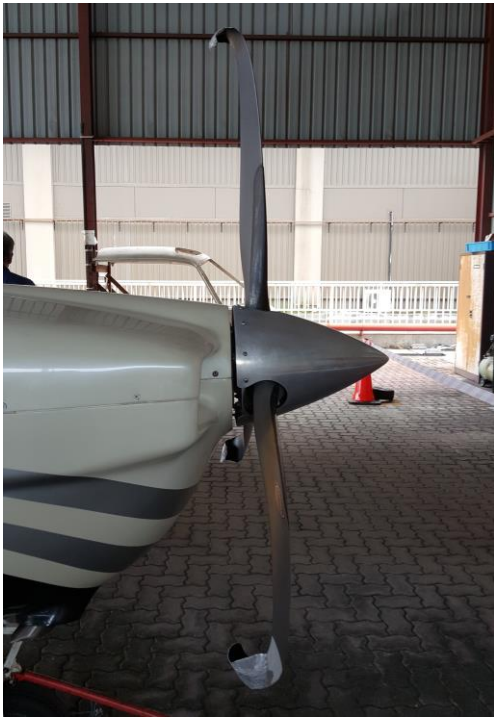
- 1.3.1 All propeller tips found bended due to sudden strike against runway during the controlled landing. (Figure 1)
- 1.3.2 Exhaust found distorted due to rubbing action against the runway. (Figure 2)

Figure 1 - Propeller tip bend

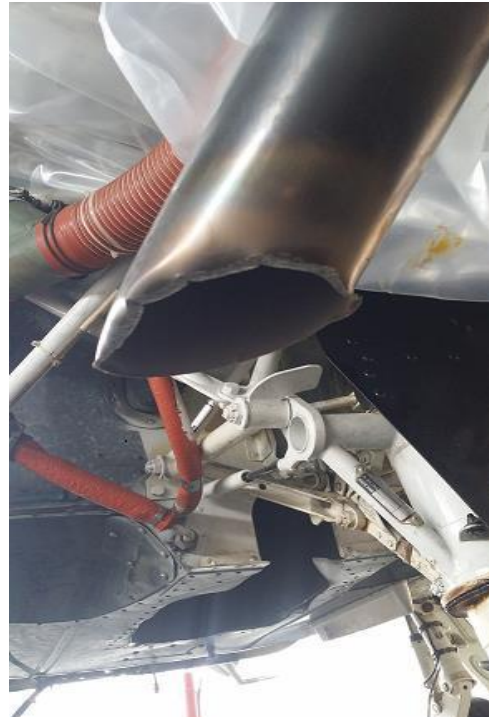
Figure 2 – Exhaust distorted

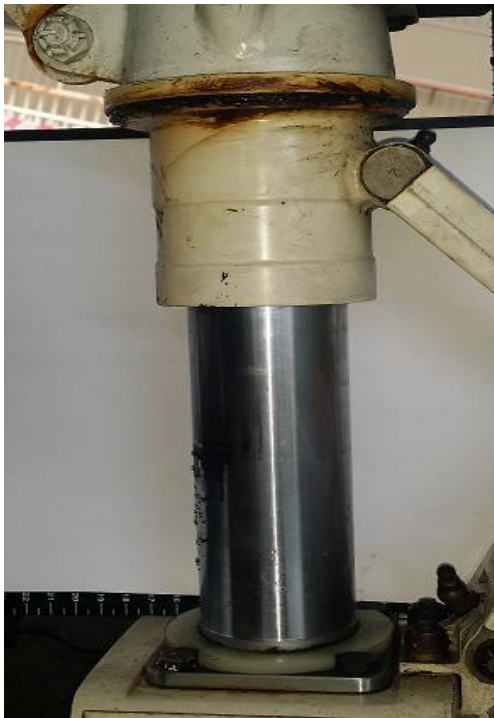
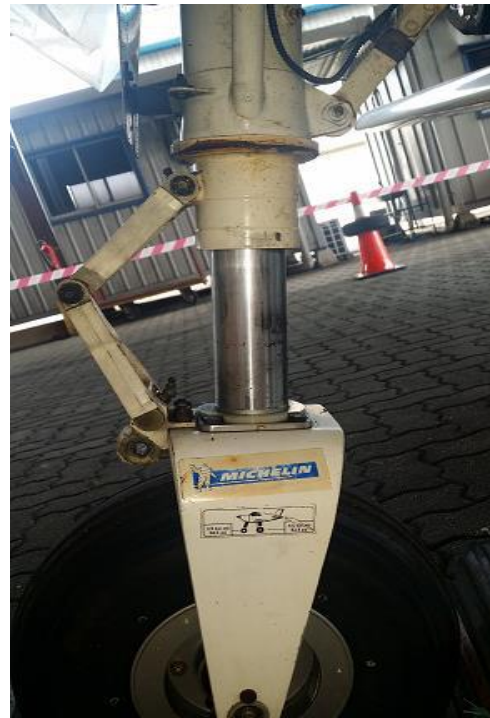
- 1.3.3 Nose landing gear oleo inner ram found misalign with respect to the outer body. (Figure 3 & 4)
- 1.3.4 Axle found damaged due to rubbing against runway during landing. (Figure 5)

Figure 3 – Nose LG misalignment (1)

Figure 4 – Nose LG misalignment (2)

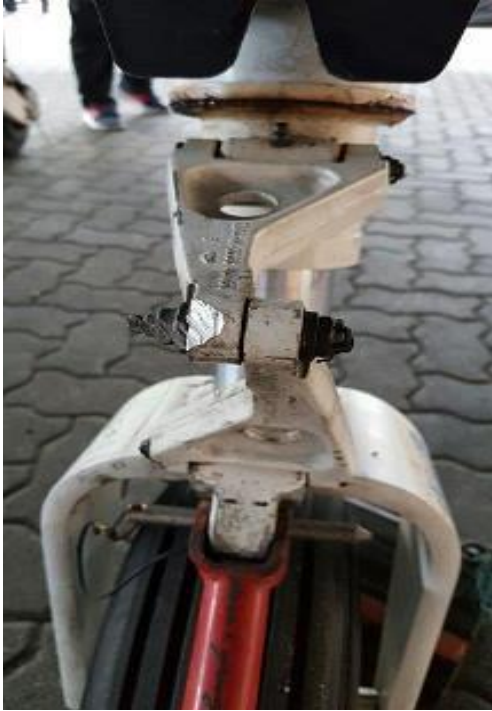
Figure 5 – Axle damaged

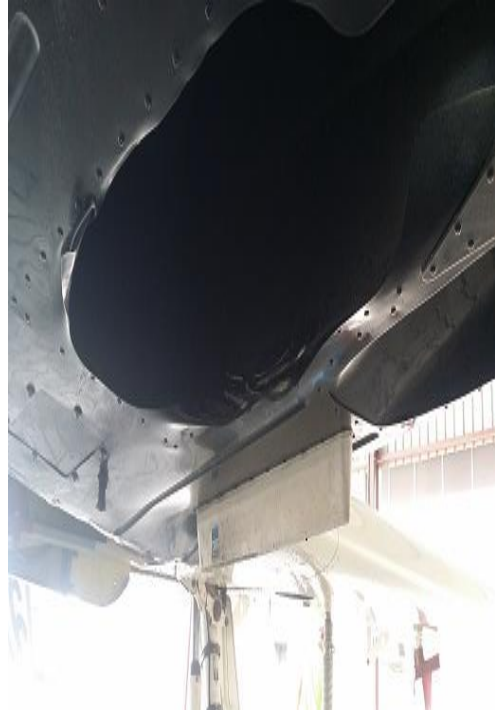
- 1.3.5 Nose gear bay frame and outer skin found distorted. (Figure 6)
- 1.3.6 Integrity of the nose gear actuator and linkages cannot be determined.
- 1.3.7 Steering linkages cannot be determined for any damages.

Figure 6 – Nose LG bay frame distorted

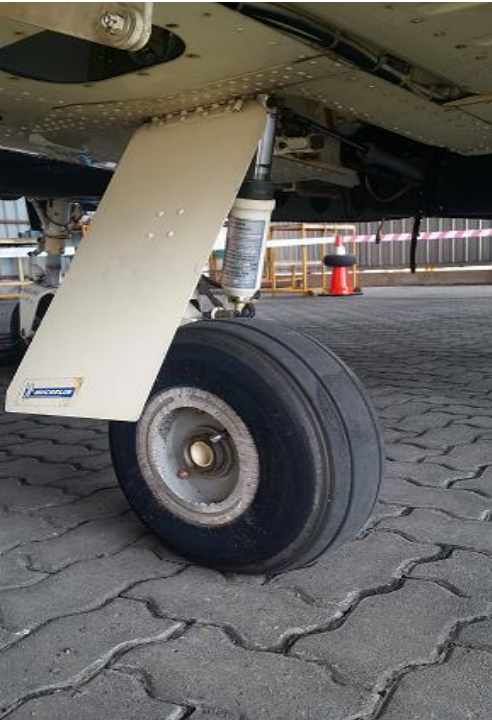
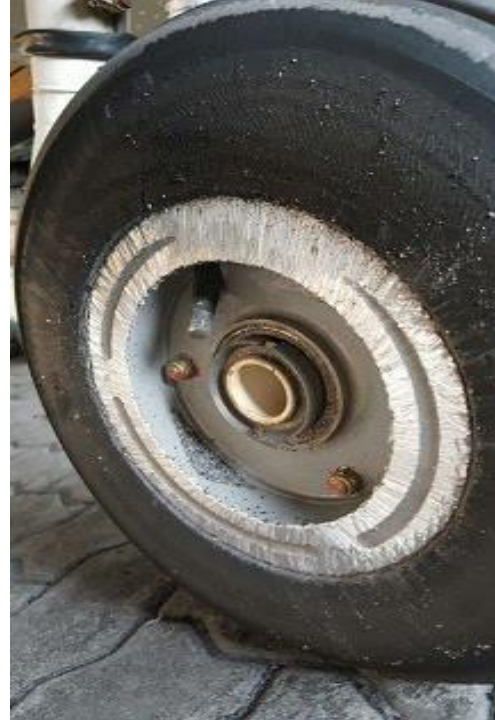
- 1.3.8 Based on visual inspection, retraction and extension of Landing Gear found to be satisfactory in term of its functionality.
- 1.3.9 Both Right and Left Main Gear wheel hub badly scratched due to impact during landing. (Figure 7 & 8)

Figure 7 – LH MLG scratched

Figure 8 – Wheel hub damaged

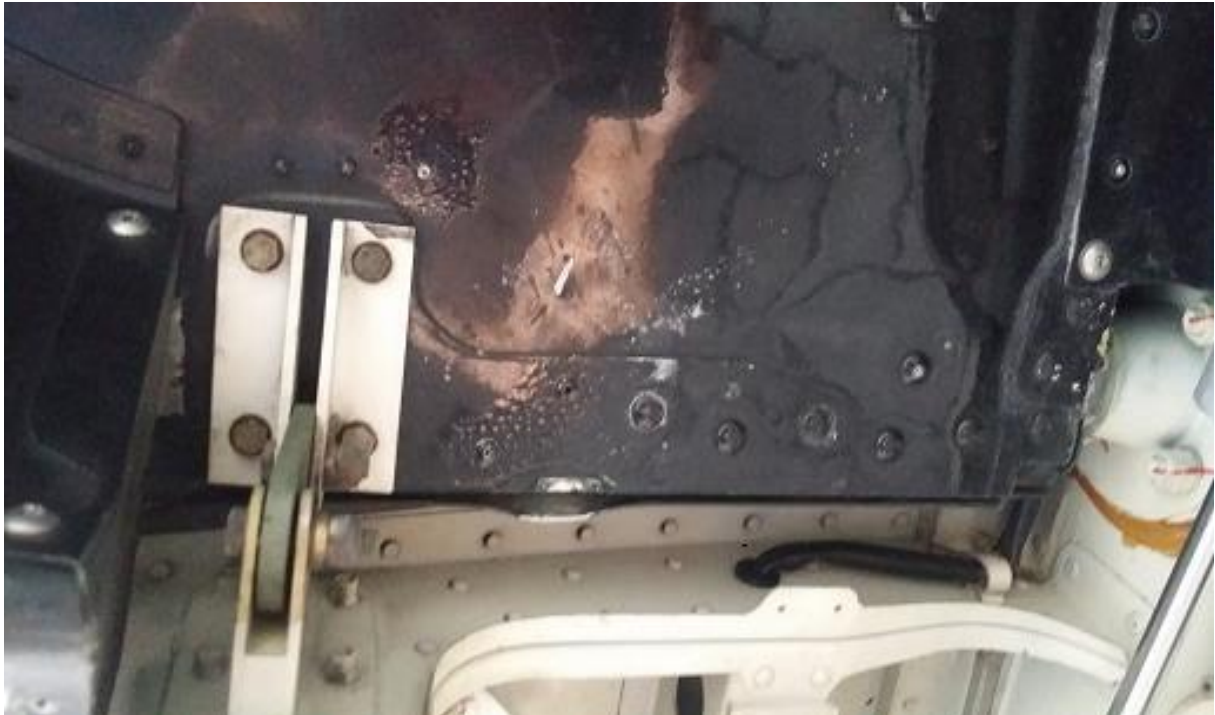
- 1.3.10 Main Gear bay area found to be dented and badly scratched. (Figure 9)
- 1.3.11 Integrity of the nose gear actuator and linkages of the Main Gear cannot be determined.

Figure 9 – MLG bay area dented

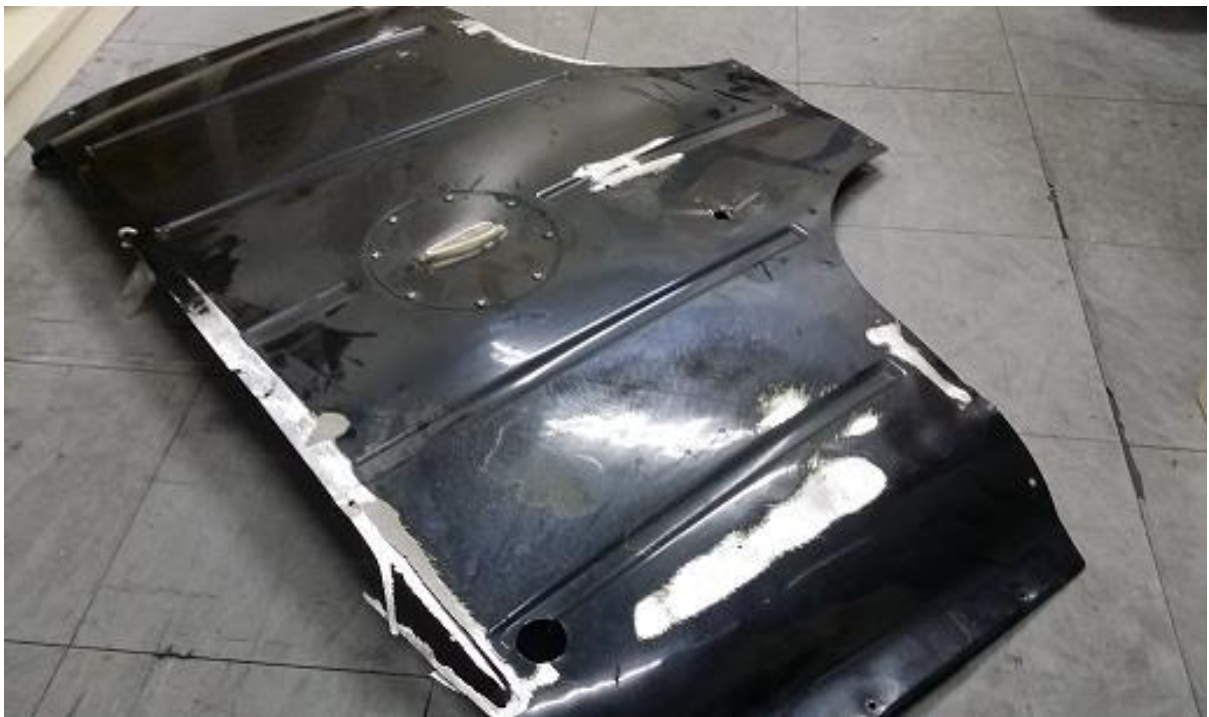
- 1.3.12 The whole bottom cowling found to be badly scratched. (Figure 10)
- 1.3.13 Dented found at antenna attachment area to the bottom skin. (Figure 11)

Figure 10 – Bottom cowling scratched

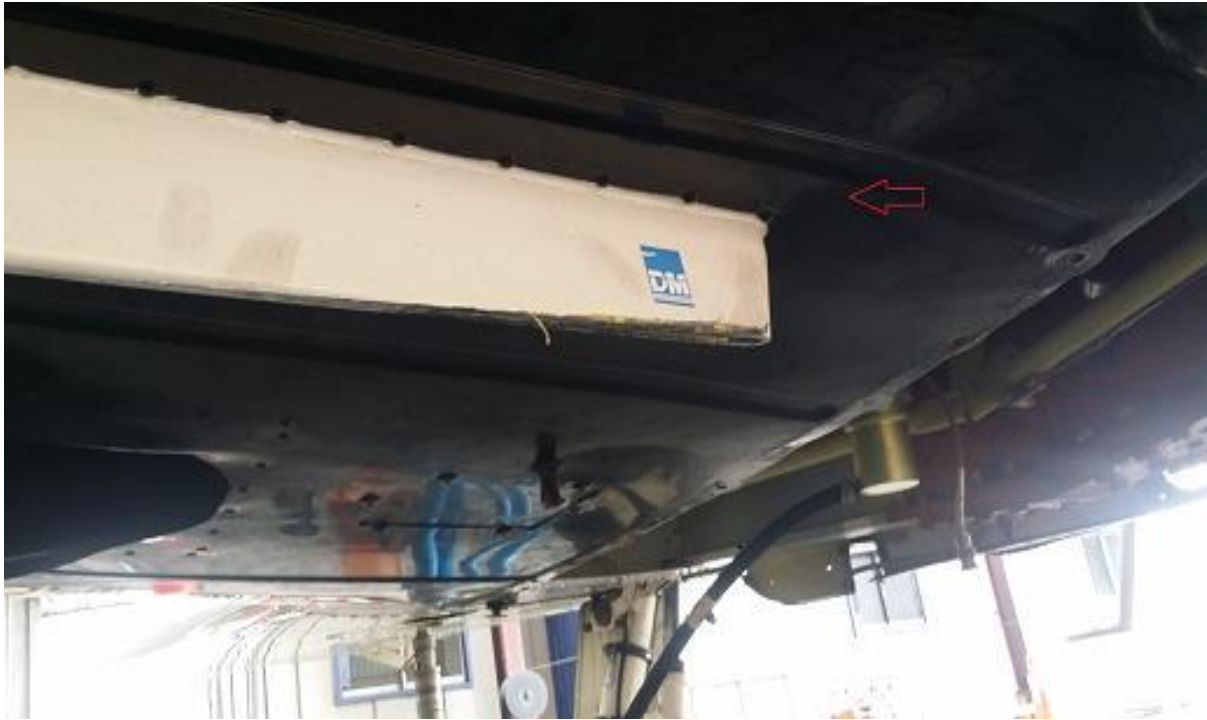
Figure 11 – Antenna attachment area dented

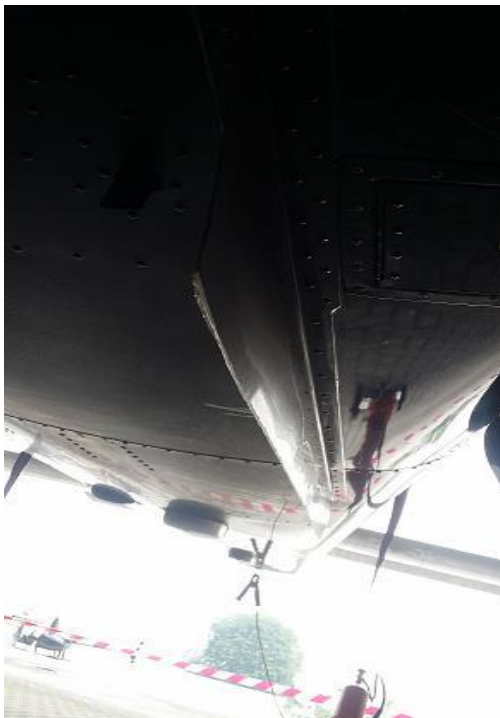
- 1.3.14 Body fins found scratched. (Figure 12)
- 1.3.15 Integrity of the wing attachment and wing spar cannot be determined.
- 1.3.16 Right and Left Hand Flaps and its linkages found damaged. (Figure 13 & 14)

Figure 12 – Bottom fin scratched

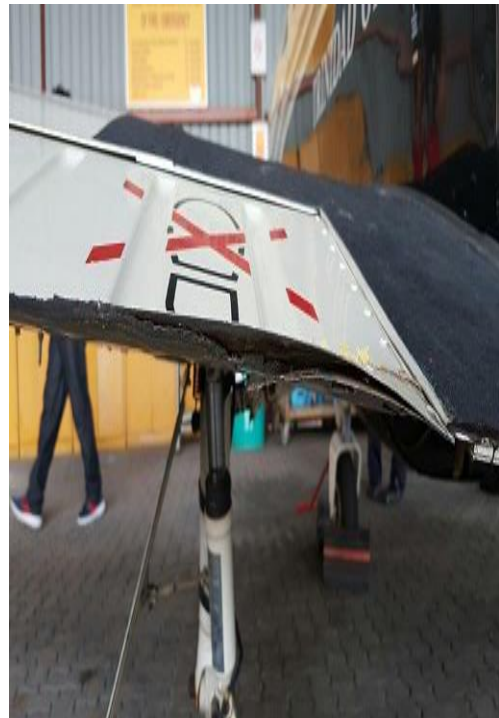
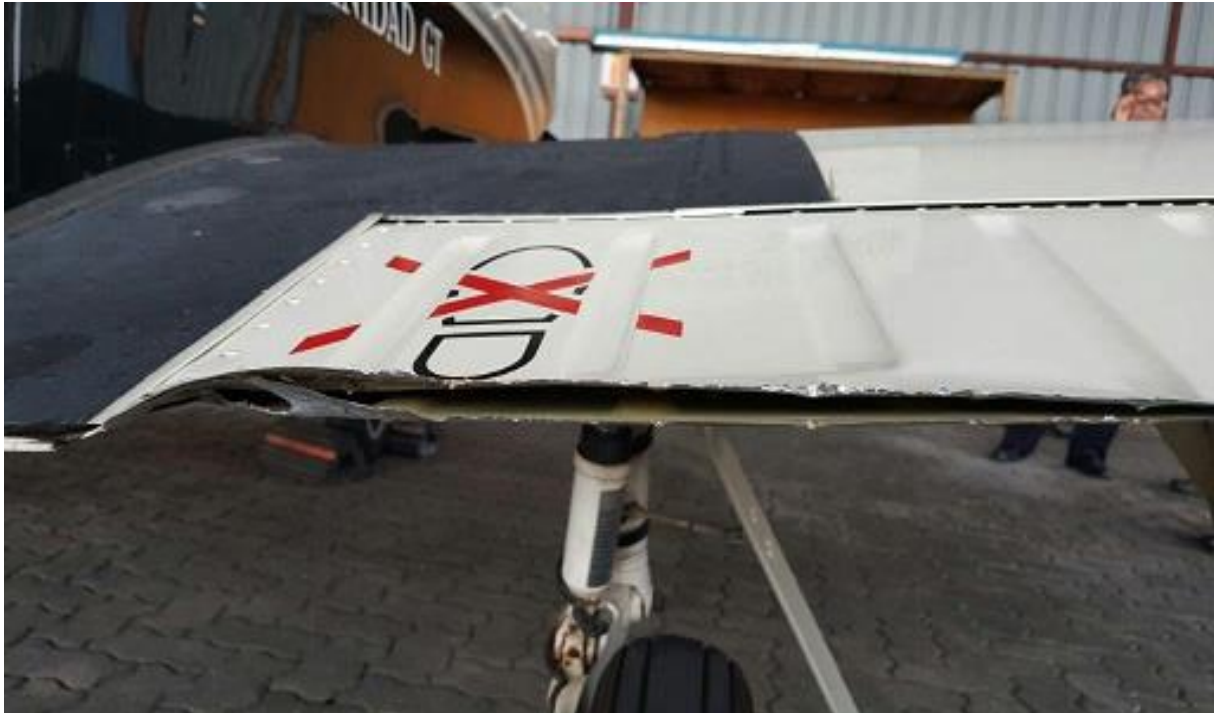
Figure 13 – LH flap damaged

Figure 14 – RH flap damaged

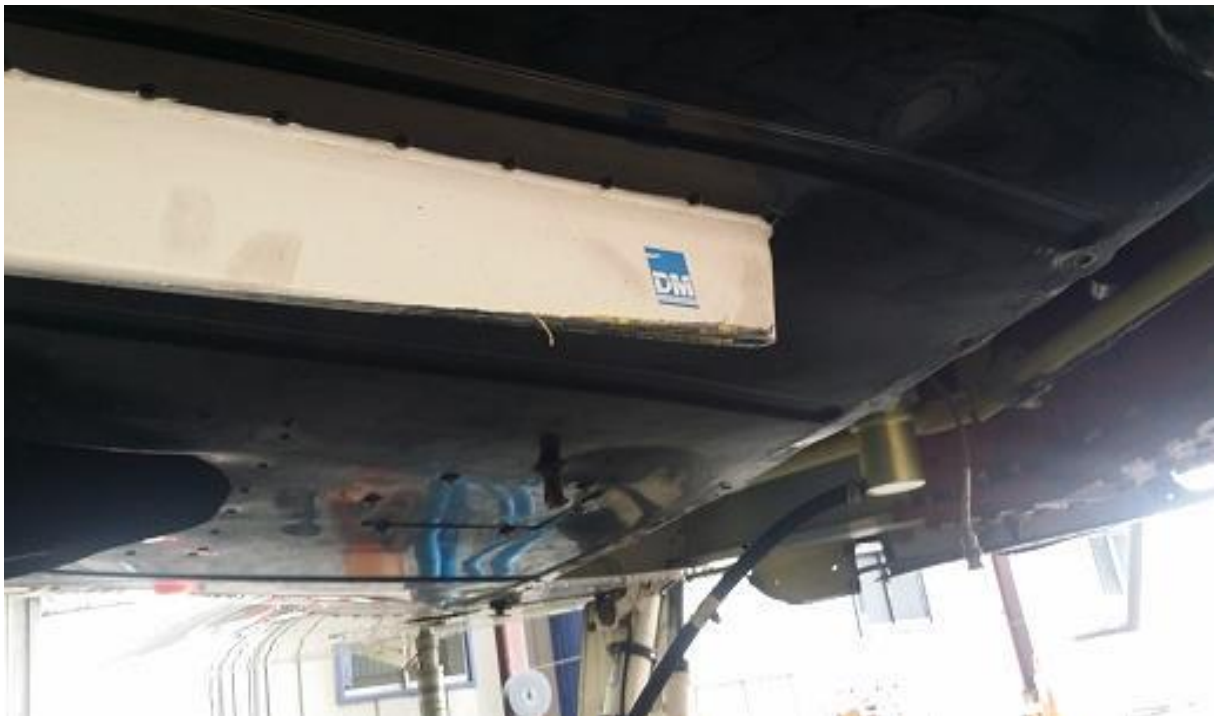
- 1.3.17 Fuel drain valve found to be broken.
- 1.3.18 Bottom antenna found to be scratched. (Figure 15)

Figure 15 – Bottom antenna scratched
