# Ground handling occurrence involving Airbus A330, 9M-MTB

Melbourne Airport, Victoria | 31 March 2016

**ATSB Transport Safety Report**  
Aviation Occurrence Investigation  
AO-2016-028  
Final – 13 September 2016

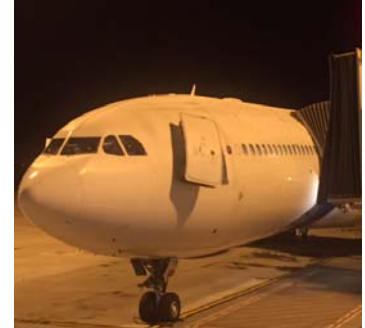
On 31 March 2016, an Airbus A330-323, registered 9M-MTB and operated by Malaysia Airlines Berhad (Malaysia Airlines), was being prepared and boarded for a flight from Melbourne Airport, Victoria, to Kuala Lumpur, Malaysia. The captain engaged the aircraft's park brake before carrying out an external inspection of the aircraft. The resulting lit park brake indicator light on the nose landing gear led the aircraft maintenance engineer to assume that the park brake would remain on. Thinking that the aircraft would remain secure, the maintenance engineer removed the main landing gear chocks out of sequence with the relevant procedure and without informing the others in the ground crew. The ground crews did not check the main gear chocks before removing the nose gear chocks to attach the tow tractor to the nose gear. Unaware that no chocks were in place, and out of sequence with the relevant procedure, the captain released the park brake on return to the flight deck. The aircraft rolled back about 3 m and struck the aerobridge. The aircraft's forward-left door and hinges, and the aerobridge were damaged. There were no injuries.

Damaged door of 9M-MTB

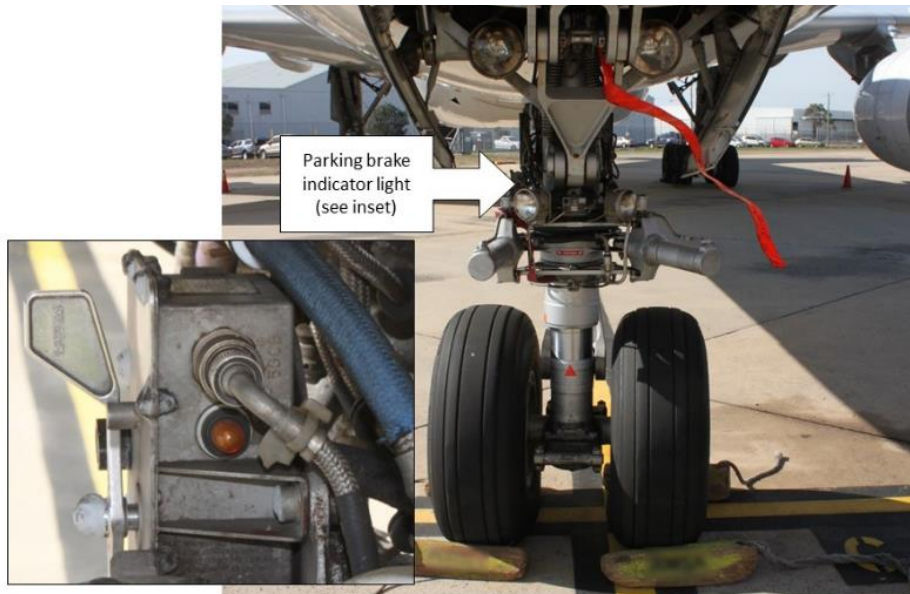
- nose landing gear chocks were installed
- park brake indicator light on the nose landing gear had been on when it was recently checked by the AME, consistent with the brake being engaged (Figure 1).

**Figure 1: Nose landing gear showing the aircraft's park brake indicator light (note the wheel chocks in place)**

The aircraft's park brake was set for the captain's external inspection of the aircraft. The resulting illumination of the park brake indicator light on the nose landing gear led the aircraft maintenance engineer to assume that it would remain set, though this was not confirmed with the flight crew. Thinking that the aircraft would remain secure, the aircraft maintenance engineer removed the main landing gear chocks.

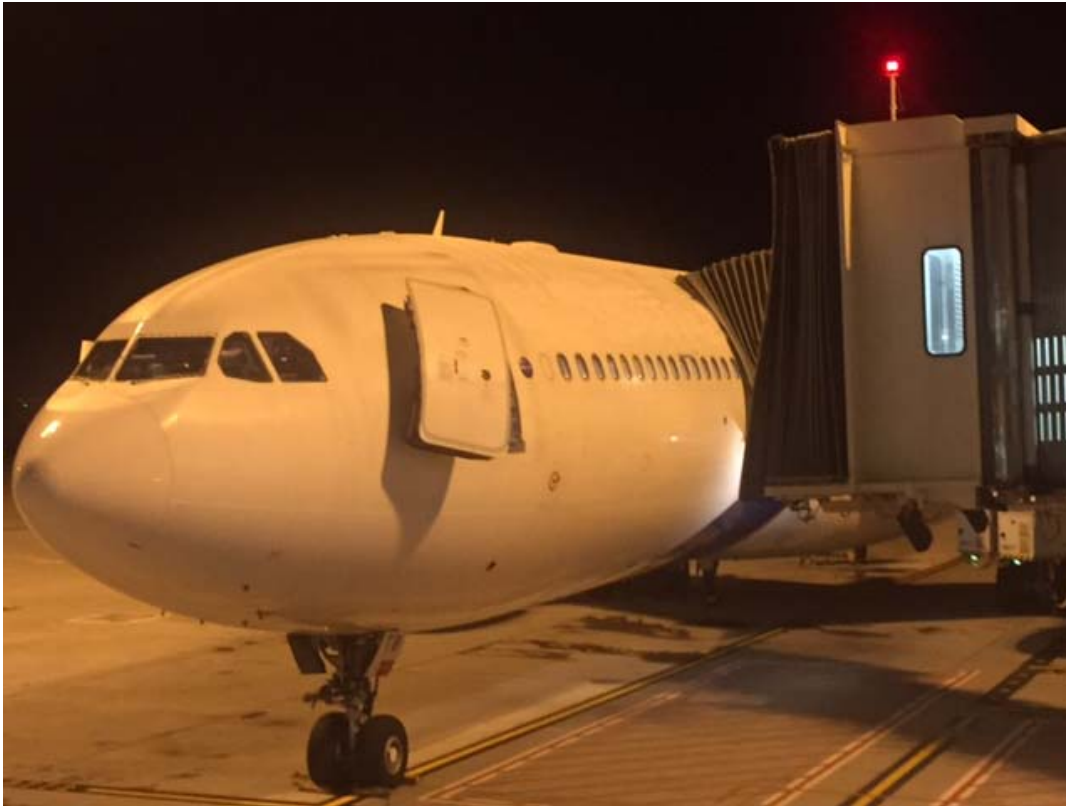
The aircraft's slow movement was not immediately obvious to the flight or ground crews. The aircraft stopped after coming into contact with the aerobridge, having rolled backwards about 3 m in 22 seconds. Hearing the noise and realising that the aircraft had moved, the LAME radioed the flight crew to set the park brake. The captain completed this action at 0052:09.

The aircraft's forward-left door was dislocated by the contact with the aerobridge (Figure 2). The door, hinges, and aerobridge were damaged and there was slight indentation of the fuselage skin forward of the door. There was no major structural damage. There were no injuries.

**Figure 2: The aircraft’s forward fuselage showing the dislocated forward-left door. The slight indentation in the fuselage skin forward of the door is not visible. The aerobridge is shown retracted from its position when struck by the aircraft**

- The engineering team that day received retraining in pre-departure and pushback operations. This included familiarisation with documented procedures, practical assessment and a requirement to perform a team safety brief on lessons learned.
- AMSA began introducing standard aircraft arrival, turnaround and departure procedures to all ports. This will ensure that practices are standardised and that they are over and above client's requirements.
- AMSA commenced periodic operational safety inspections at all ports. These inspections include assessments of the standard procedures to identify opportunities for improvement.
