AIRCRAFT ACCIDENT FINAL REPORT NUMBER A05/2016

**ACCIDENT INVOLVING EUROCOPTER AS350 B3e REGISTRATION RP-C6828
AT BATANG LUPAR, SARAWAK
05 MAY 2016**

ACCIDENT REPORT NO.: A05/2016

**AIRCRAFT TYPE : EUROCOPTER AS350 B3e
(ECUREUIL)**

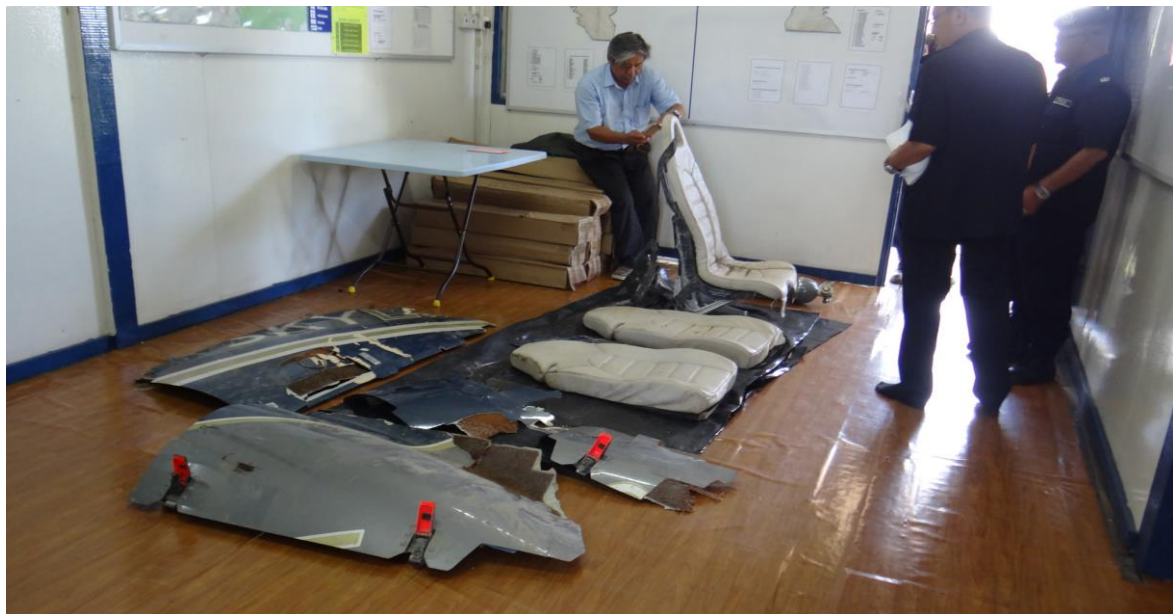
Figure 6 – Parts collected and stored at Lingga Police Station

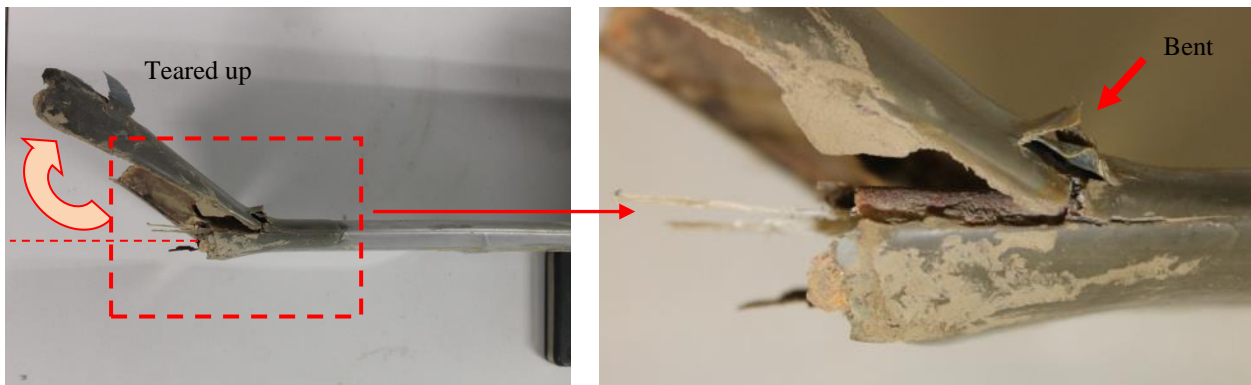
(a)

Figure 14 shows several locations of damage occurred. It was observed that the leading edge of the tail rotor blade was torn up (Figure 14 (a)) at the root section caused by high impact force. From the cross section of Figure 14 (b), it was evident

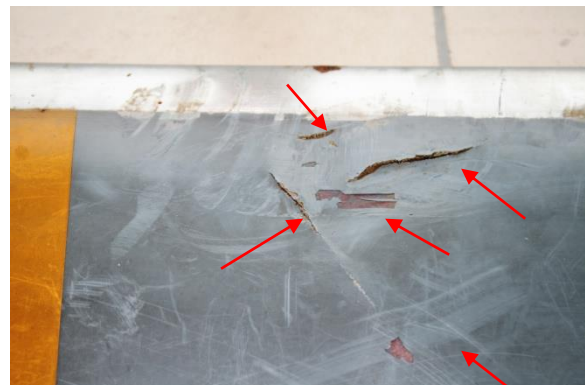
Figure 15: Damage at inner and outer skin of tail rotor blade

Examination on the inner and outer skin of the tail rotor blade showed, several locations of peeled off paint, scratched and dented marks as shown in Figure 15 (a) and 15 (b). This is due to impact from foreign or unknown outside object.

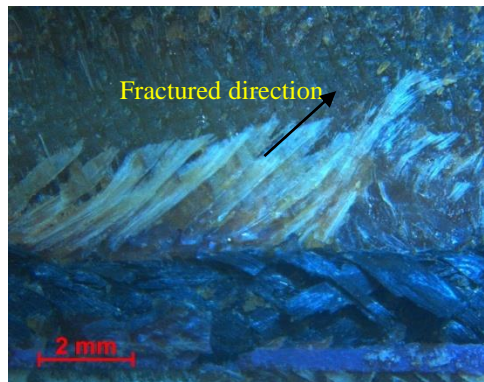
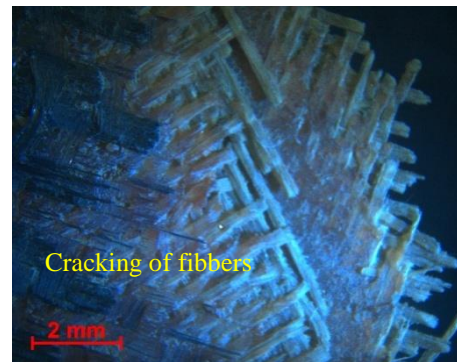
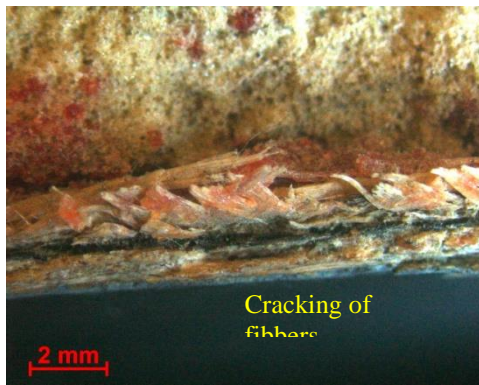
Figure 17: Tail Rotor Blade fracture direction due to the impact

Further analysis was done using Zeiss Stereo Microscope for macroscopic examination. Six locations were marked based from the severe condition as shown in Figure 16. At Location 1, the arrow shows the direction of bending forces which acted along the leading edge of the blade. The marking from the high impact force are shown by the striation lines at the damaged hole at Location 2. Sign of fractured along the trailing edge of the blade indicates a consistent upward direction of high impact at Location 3. Cracking traces of fibers are the result of high impact at Location 4 and 5. Severe damage showed that high impact happened at the outer skin and middle part of the span near the trailing edge. As a result, the skin and the fibers were twisted and pressed downwards from that deep impact in Location 6.

1.19.2.5 Macroscopic examination could suggest the impact and fractured direction of the blade during the separation. Examined on the several locations of the carbon fiber and composite plies showed similarities in direction resulted from the high

impact of the adjacent object (could be tail boom). Carbon fiber and glass epoxy has fractured in multi directional to indicate the incident load is higher than the ultimate strength of the material. Twisted and disoriented carbon fiber material indicates high impact coupled with the rotating tail rotor blade during the impact.
