AIRCRAFT ACCIDENT FINAL REPORT
A 08/16
Air Accidents Investigation Bureau (AAIB)
Ministry of Transport

Accident Involving a Piper PA-28-161
Registration 9M-SKE
at Malacca International Airport (WMKM), Melaka, Malaysia
on the 14 July 2016

ACCIDENT REPORT NO. : A 08/16

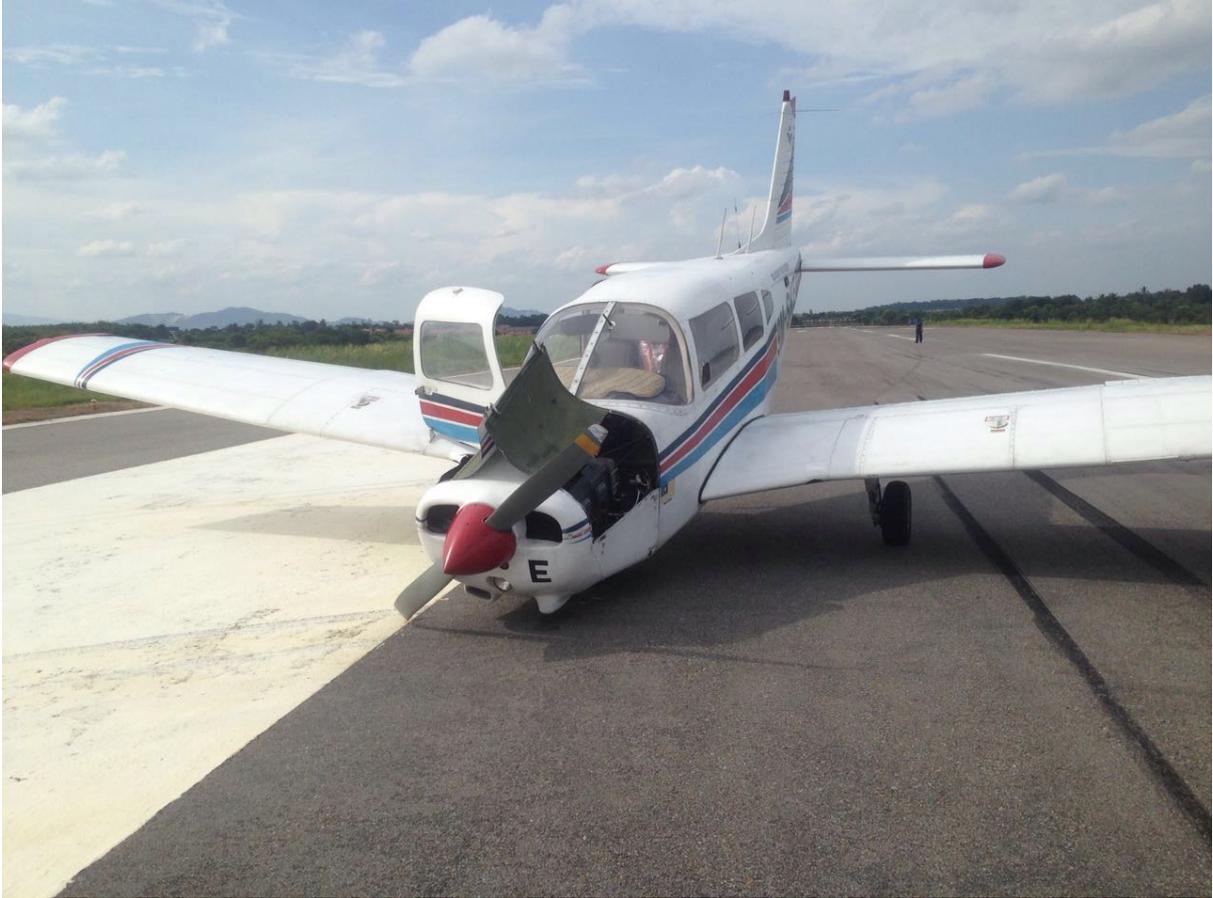
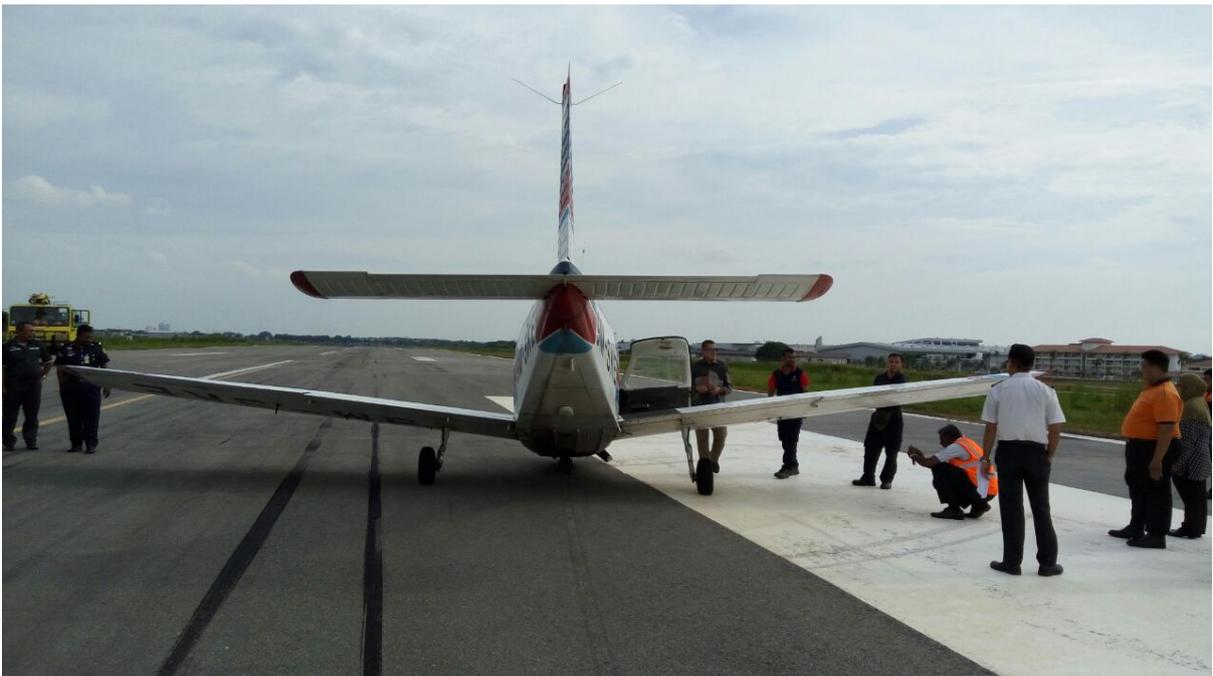
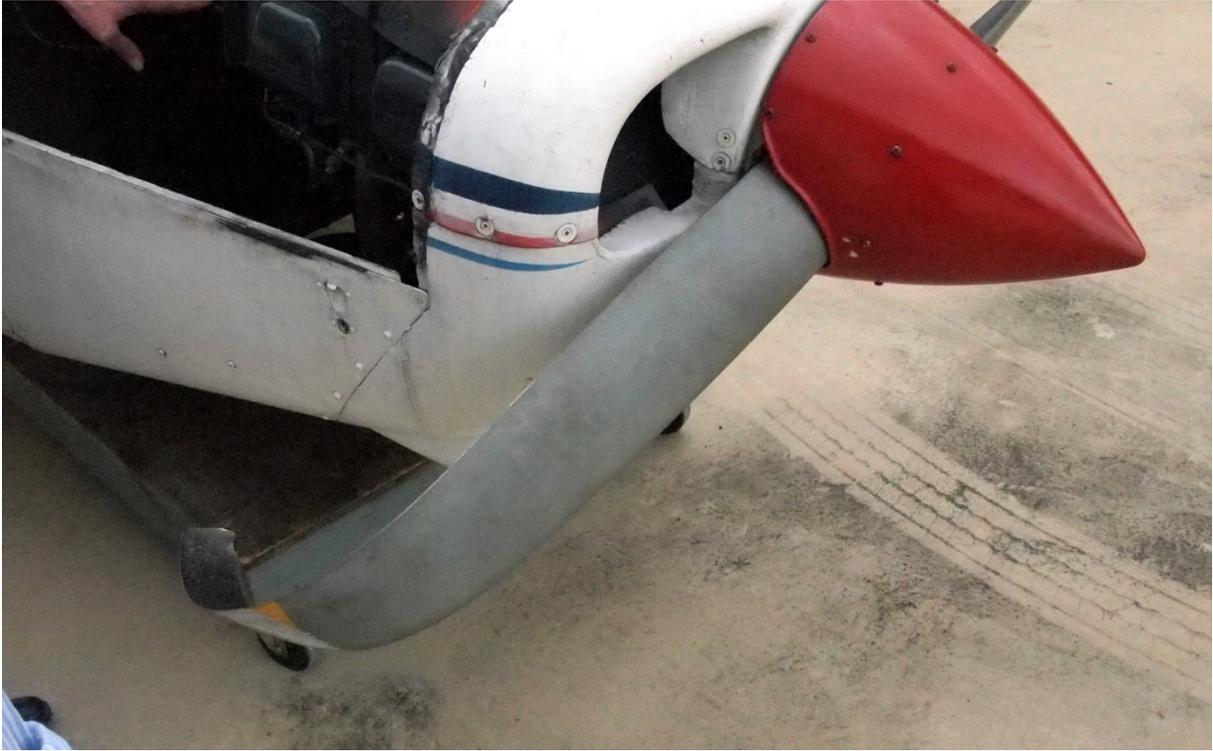
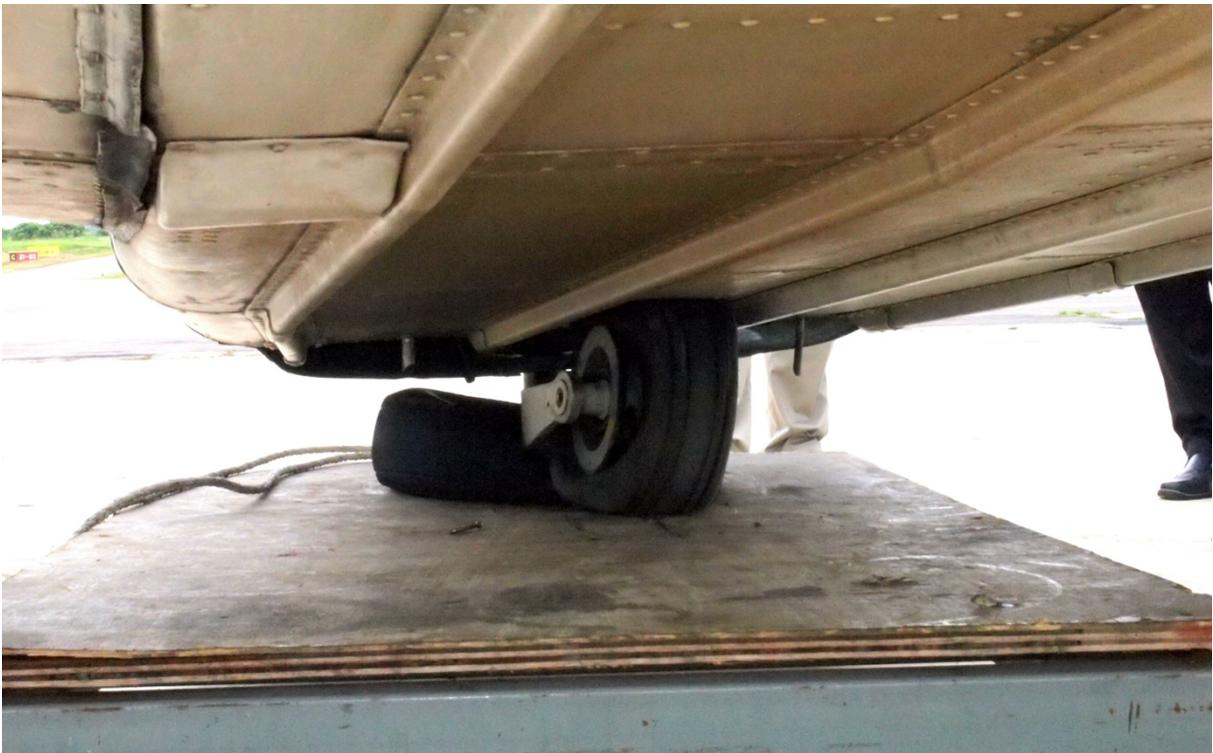
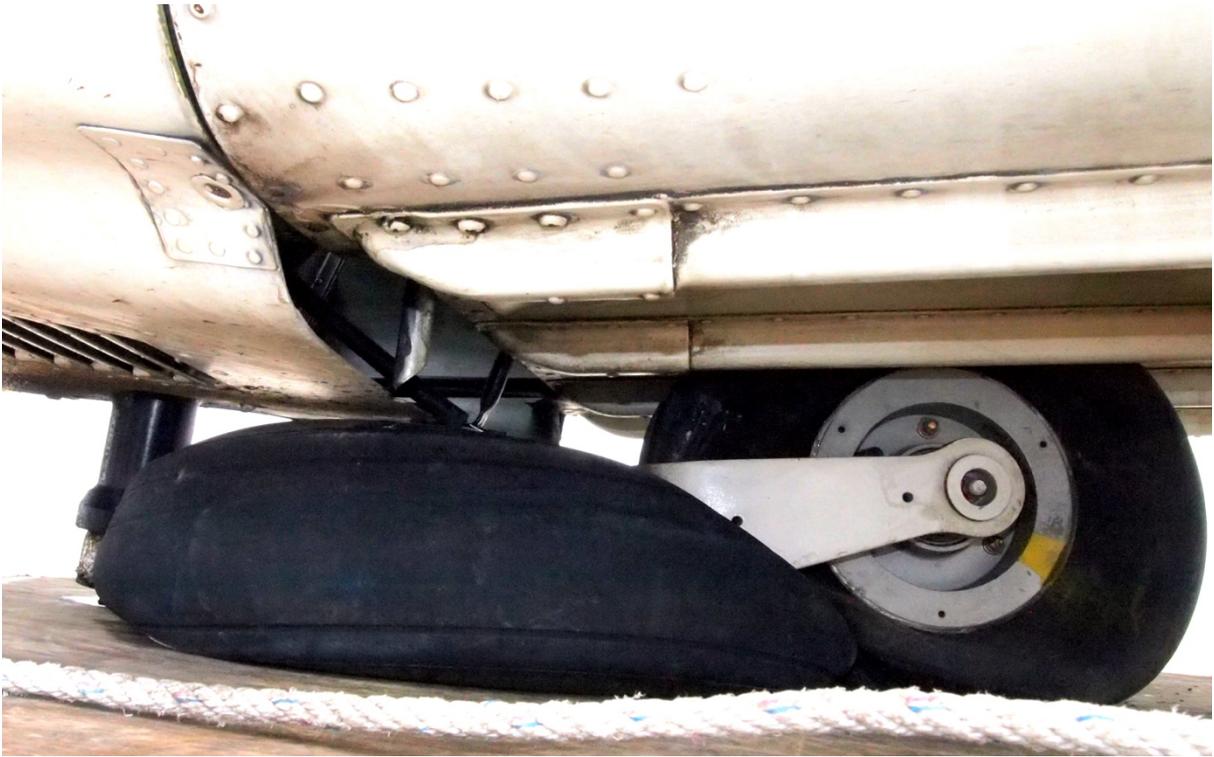
DAMAGE ASSESSMENT (IMAGES ON-SITE)

An assessment of damage to the aircraft revealed that the nose-wheel gear assembly had been substantially damaged along with damages to the propeller.

The wreckage was secured and brought back to the operator's hangar. Scuff marks on the runway was consistent with a hard landing and nosewheel collapse.

2.3 Unfortunately for her the retardation of power made the aircraft pitch down instead making the aircraft land nose-wheel first leading to the third bounce before the aircraft settled nose-down on the runway due to the fact that its nose-wheel had collapsed.

The operator is to ensure that the correct techniques for good landings including the proper corrective actions to overcome bad ones are continuously impressed upon their instructors and students to overcome this training hazard.
