**AIRCRAFT SERIOUS INCIDENT FINAL REPORT**  
**SI 09/16**

**Serious Incident Involving a Piper PA-28-161**  
**Registration 9M-SKC**  
**at Malacca International Airport (WMKM), Melaka, Malaysia**  
**on the 4 August 2016**

**SERIOUS INCIDENT REPORT NO. : SI 09/16**

**OWNER / OPERATOR : MALAYSIAN FLYING ACADEMY SDN BHD**  
**AIRCRAFT TYPE : PIPER PA-28-161**  
**NATIONALITY : MALAYSIA**  
**REGISTRATION : 9M-SKC**  
**PLACE OF OCCURRENCE: MALACCA INTERNATIONAL AIRPORT,  
MELAKA, MALAYSIA**  
**DATE AND TIME : 4 AUGUST 2016 AT 1800LT**

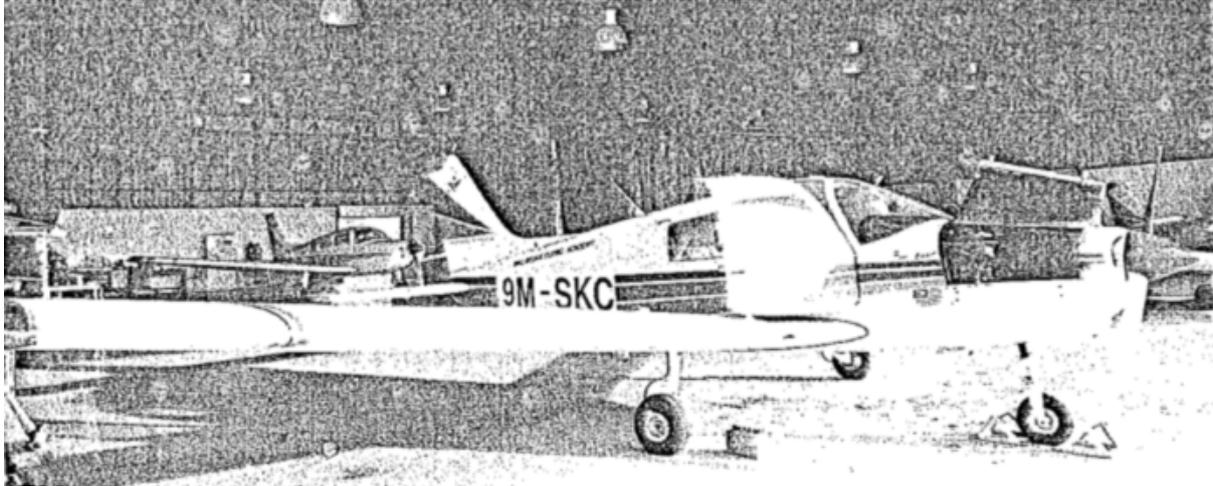
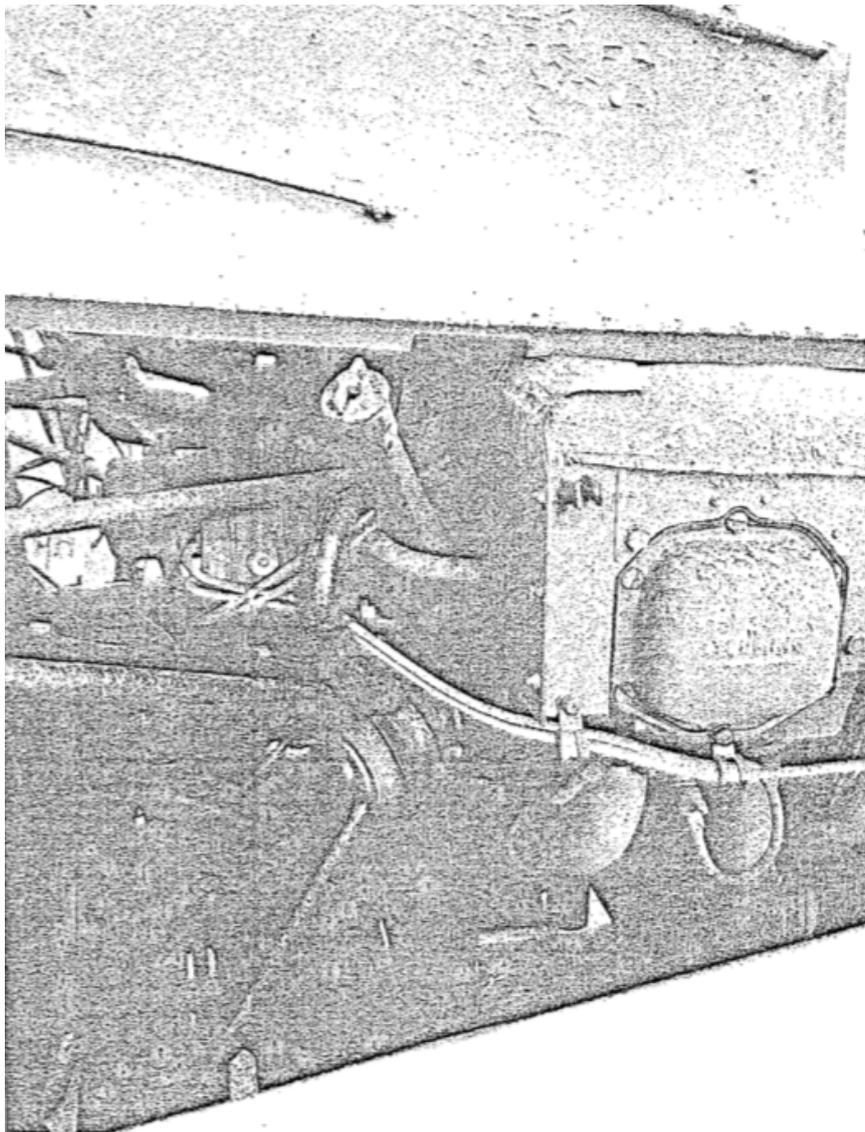
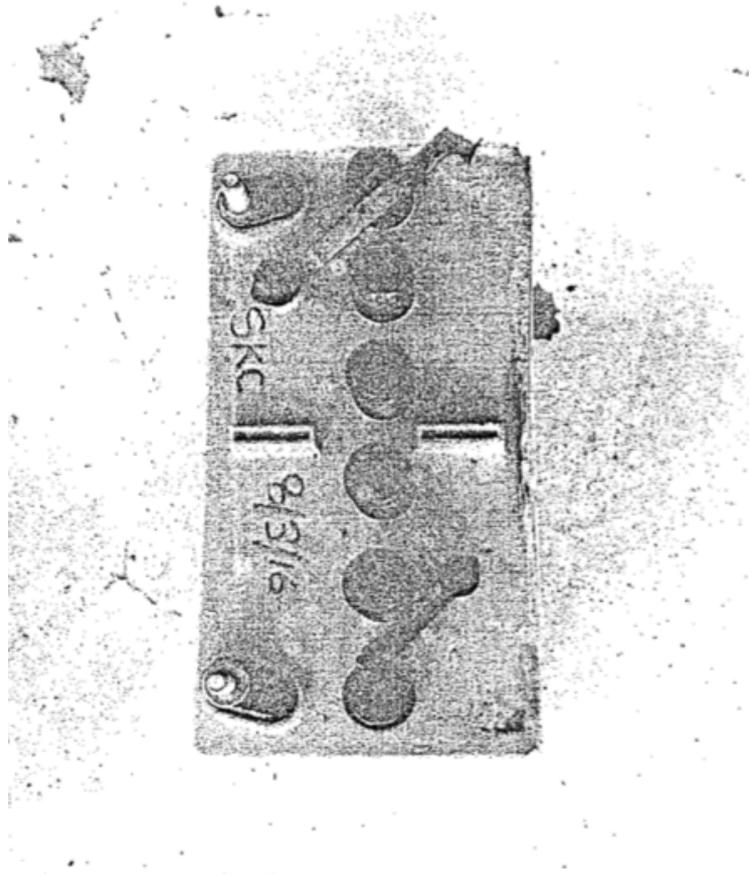
DAMAGE ASSESSMENT (IMAGES ON-SITE)

However the engine refused to start-up despite numerous attempts by the student pilot. On his last attempt the engine caught fire and he quickly shutdown the aircraft before vacating it. The ground crew who were present managed to extinguish the fire but not before substantial damage had been done to the aircraft.

2.1 The numerous attempts by the student pilot to start-up the aircraft apparently led to the engine being flooded with fuel. A subsequent attempt led to the ignition of fuel that had somehow leaked out causing a fire which spread throughout the engine compartment very quickly.

2.2 The fire caused substantial damage to the engine and airframe. This and other operational factors led the operator to decide that 9M-SKC was beyond economical repair. The aircraft was subsequently scrapped and the registration number was later transferred to another airframe.

The operator is to ensure that correct techniques are applied by all pilots in the event an engine fails to start-up on a first attempt. This is to avoid a recurrence of this serious incident.
