# **AIRCRAFT SERIOUS INCIDENT REPORT SI 08/17**

## **SERIOUS INCIDENT INVOLVING HORNBILL SKYWAYS AIRCRAFT, SUPER KING AIR B200GT, REGISTRATION 9M-WSK AT KUCHING INTERNATIONAL AIRPORT, SARAWAK ON THE 24 SEPTEMBER 2017**

### SERIOUS INCIDENT REPORT NO.: SI 08/17

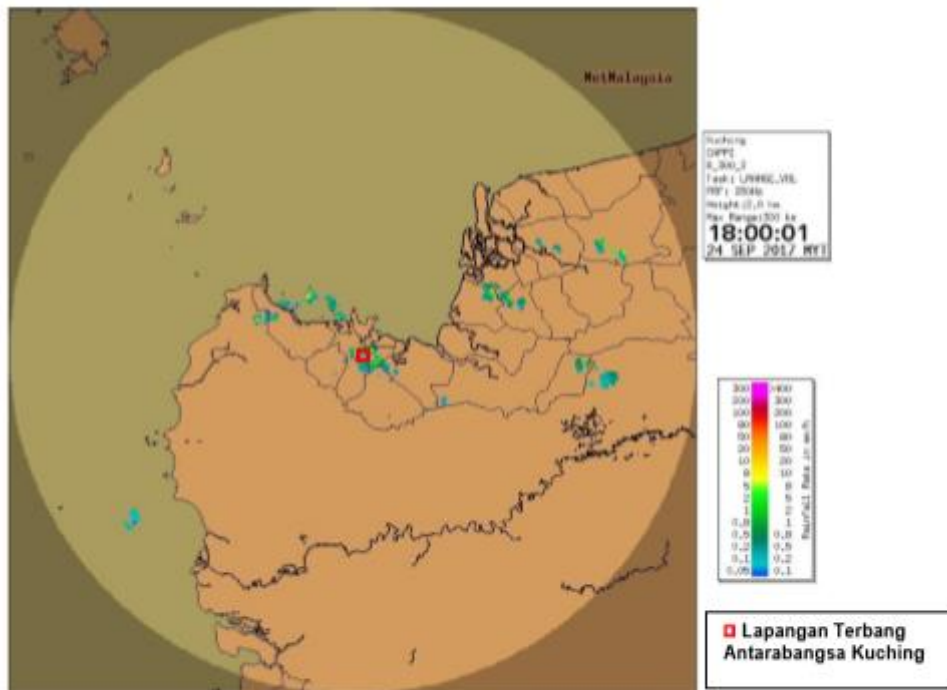
Figure 1: Radar echoes at 1800 LT indicated active patches of clouds formation above Kuching Airport

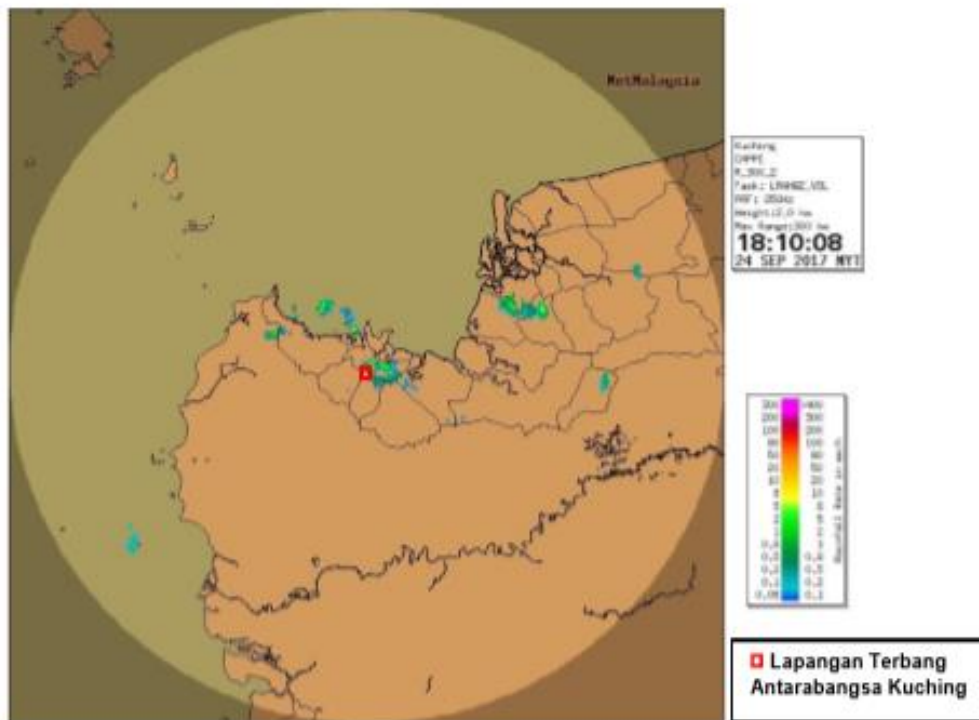
**Figure 2: Radar echoes at 1810 LT indicated active patches of clouds formation above Kuching Airport**

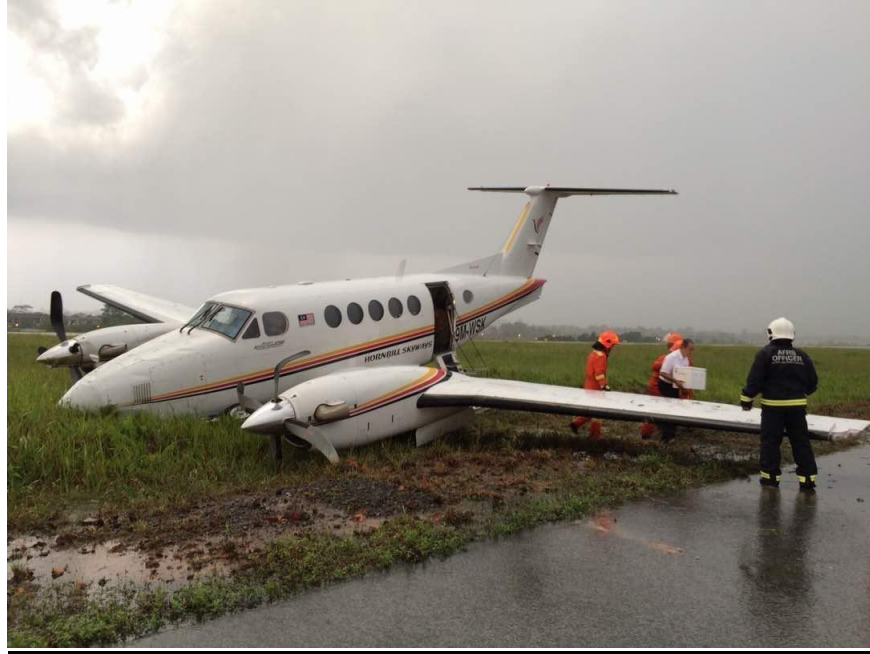
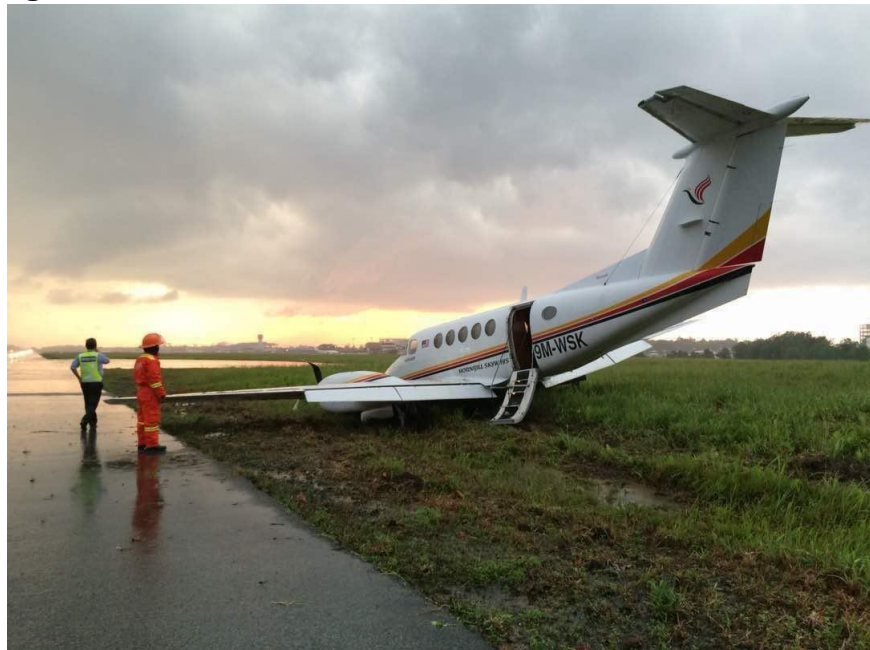
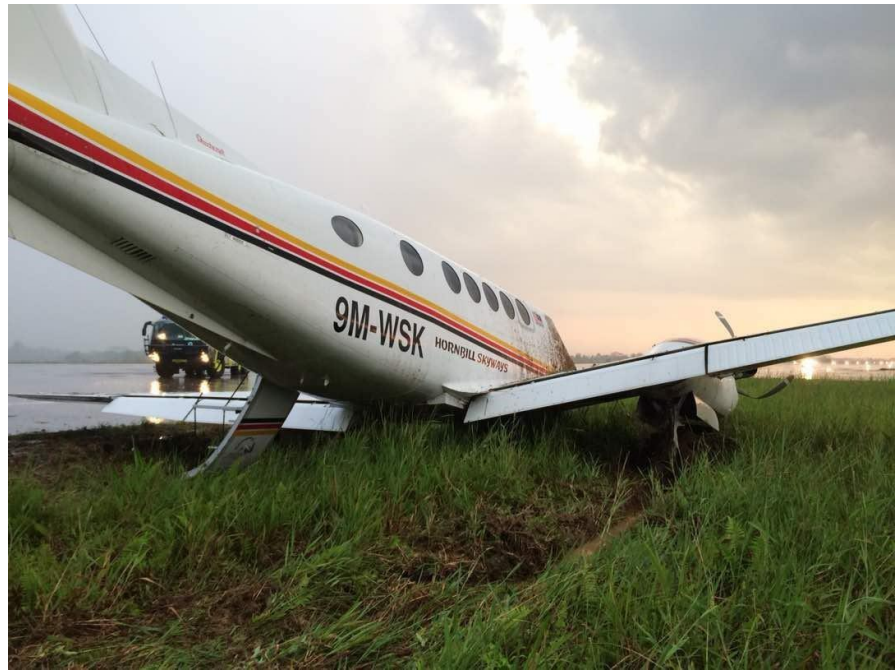
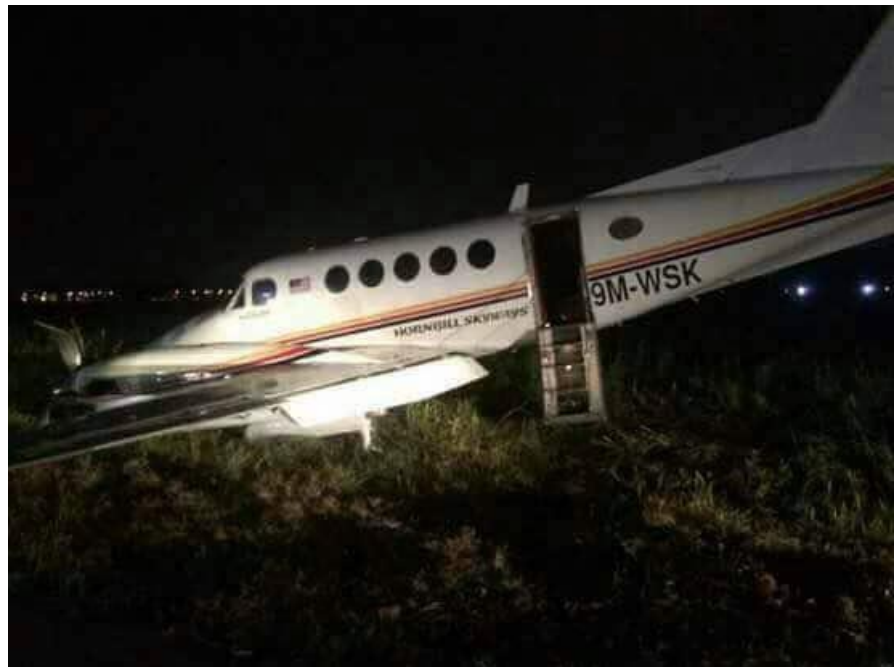
1.3.1 Initial inspection found that the fuselage nose section area between Station Number 14 and 94 was severely damaged. The nose radome which housed the weather radar was deformed and distorted due to impact with the ground. The nose landing gear attachment bolts were found broken with the support structure badly damaged due to the nose landing gear collapsing. The nose landing gear doors were found totally damaged and detached from their attachment fittings. The forward fuselage section area skin had signs of wrinkling and buckling thus causing difficulty in opening up the side access panels to gain access to the forward avionics compartment. Both the pitot probes located near the radome were also found damaged.

The four images below show the condition of the aircraft after the incident.

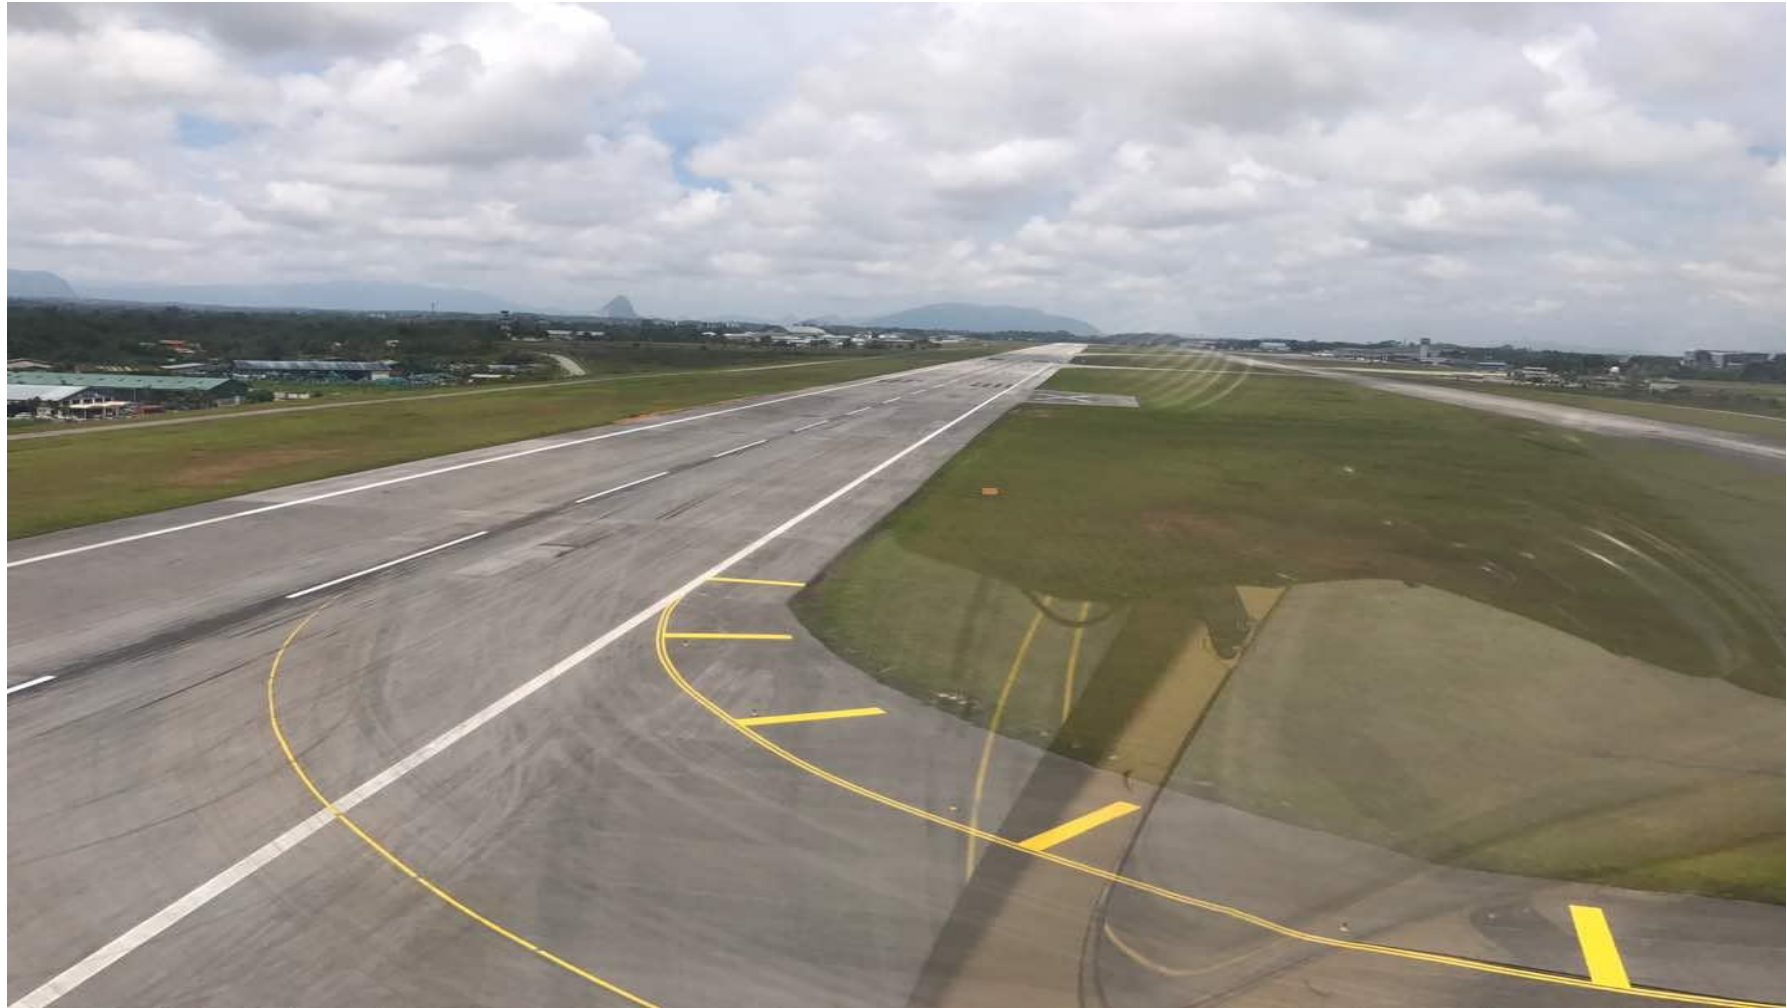
# APPENDIX B, FIGURE 1 RUNWAY VIEW DURING SHORT FINAL

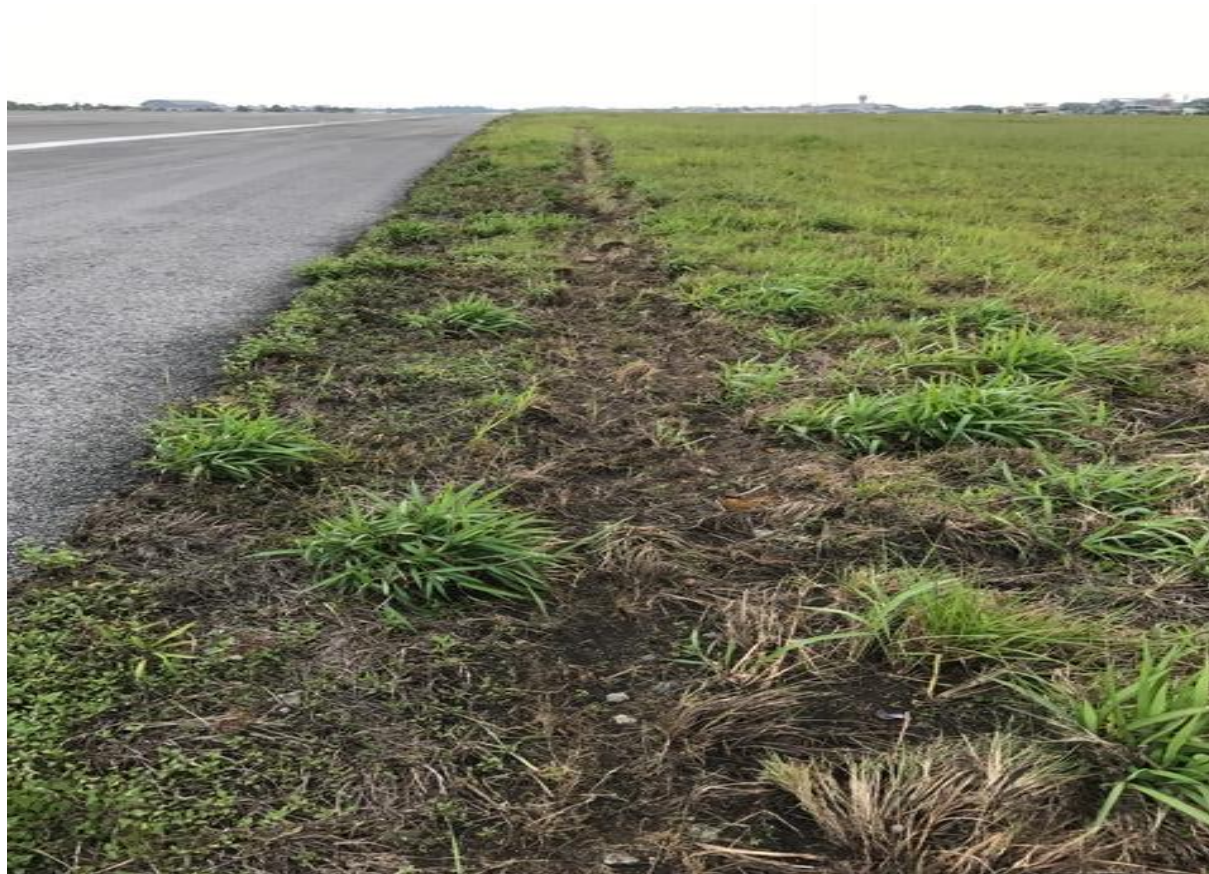
# APPENDIX B, FIGURE 2 WHEELS MARKS ON THE GRASS

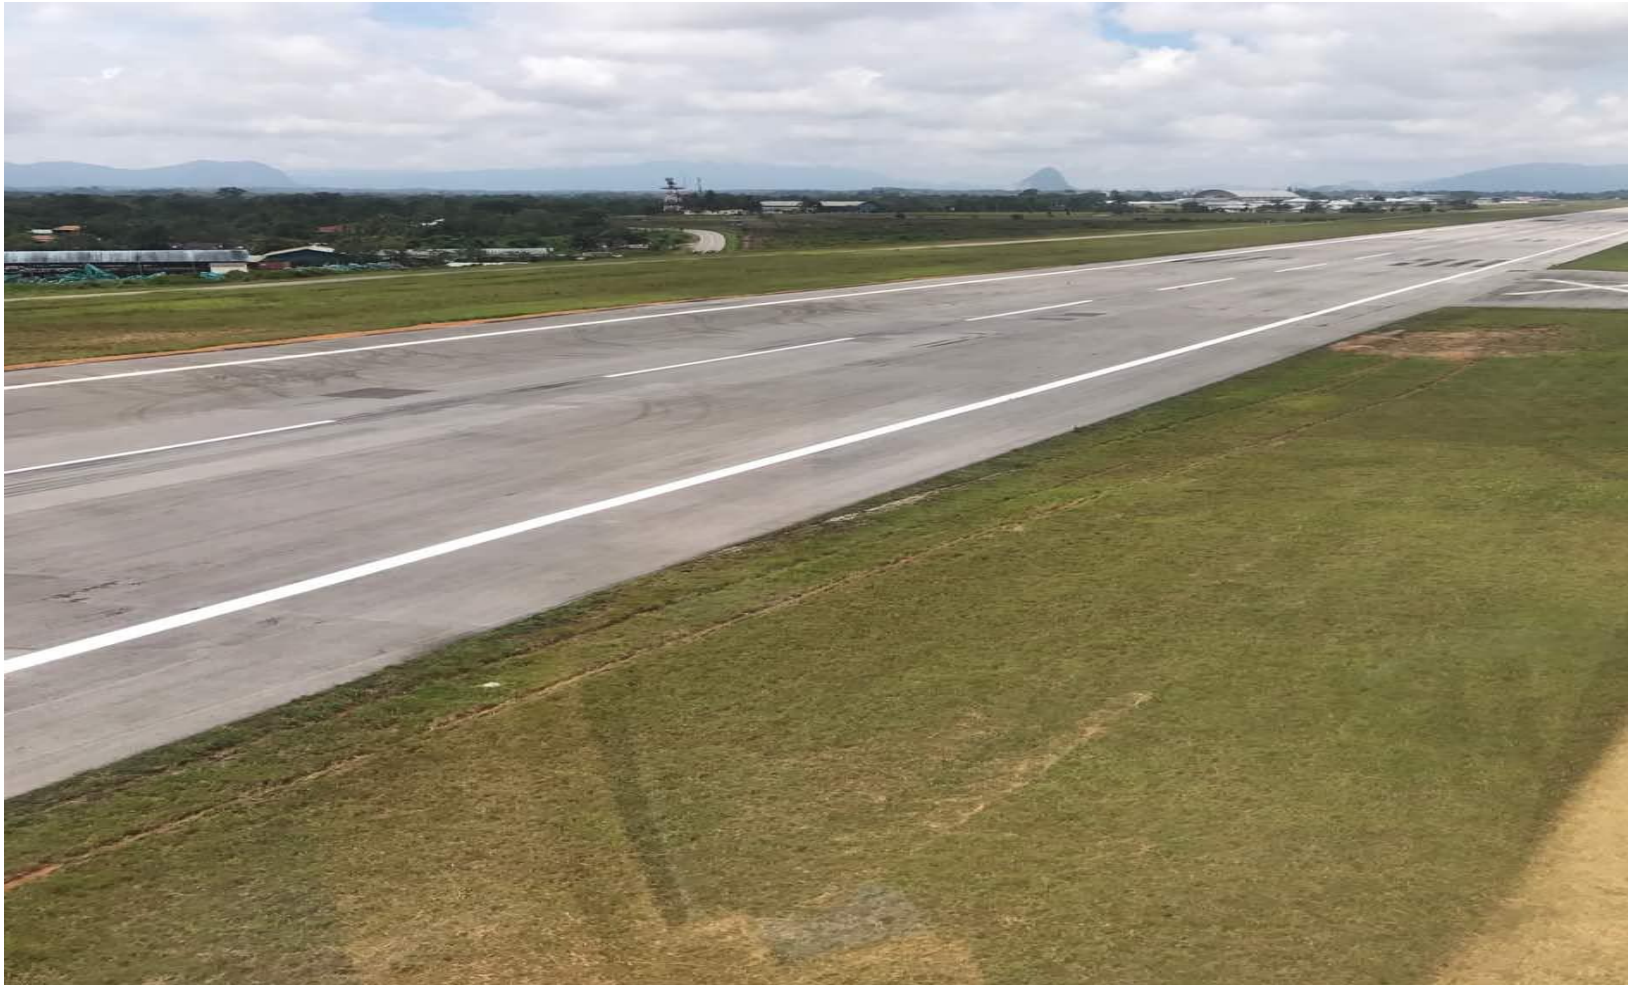
3.1.13 During the runway excursion, the right main wheel entered the grass area first followed by the left main wheel unchecked. The nose and main wheels dragged into the soft ground and stopped completely after about 600 Meters roll. The nose wheel assembly, nose fuselage area and both the proper assembly blades damaged substantially.

# APPENDIX B, FIGURE 3 WHEELS MARKS ENTERING GRASS

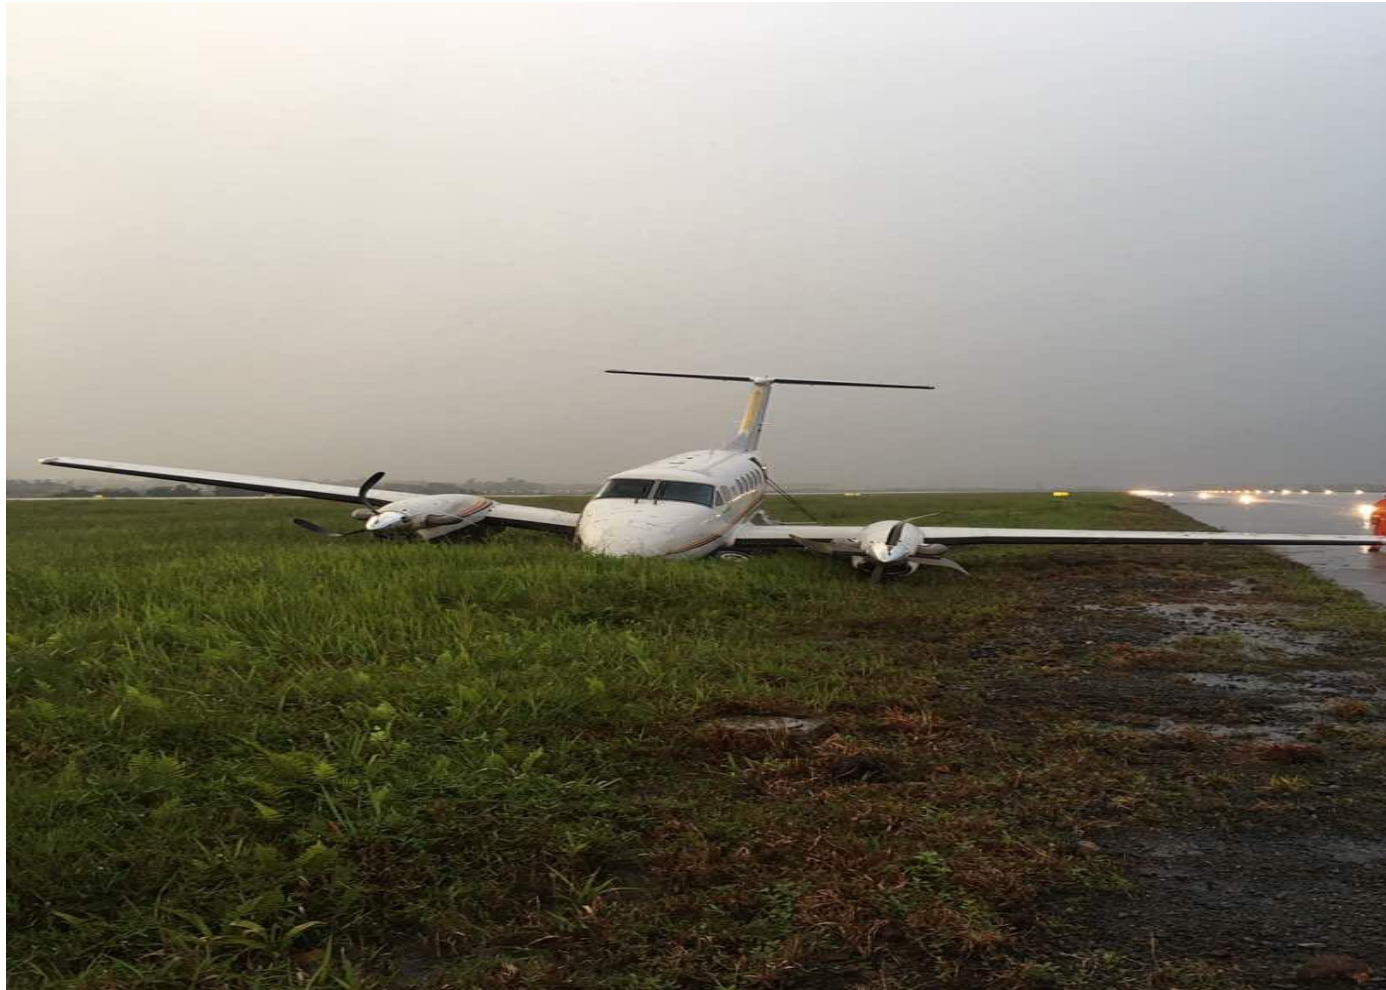
right at an angle of about 10 to 15 degrees. PF applied maximum left rudder in order to manoeuvre the aircraft back to centre of the runway, however, the action failed and the aircraft continued its direction to the grass parallel with the runway. The aircraft came to a complete stop on the soft ground parallel to the runway in between Taxiway A1 and A2 (closer to Taxiway A1) with both the engines still running.

# APPENDIX B, FIGURE 4 AC STOPPED NEAR A2 INTERSECTION

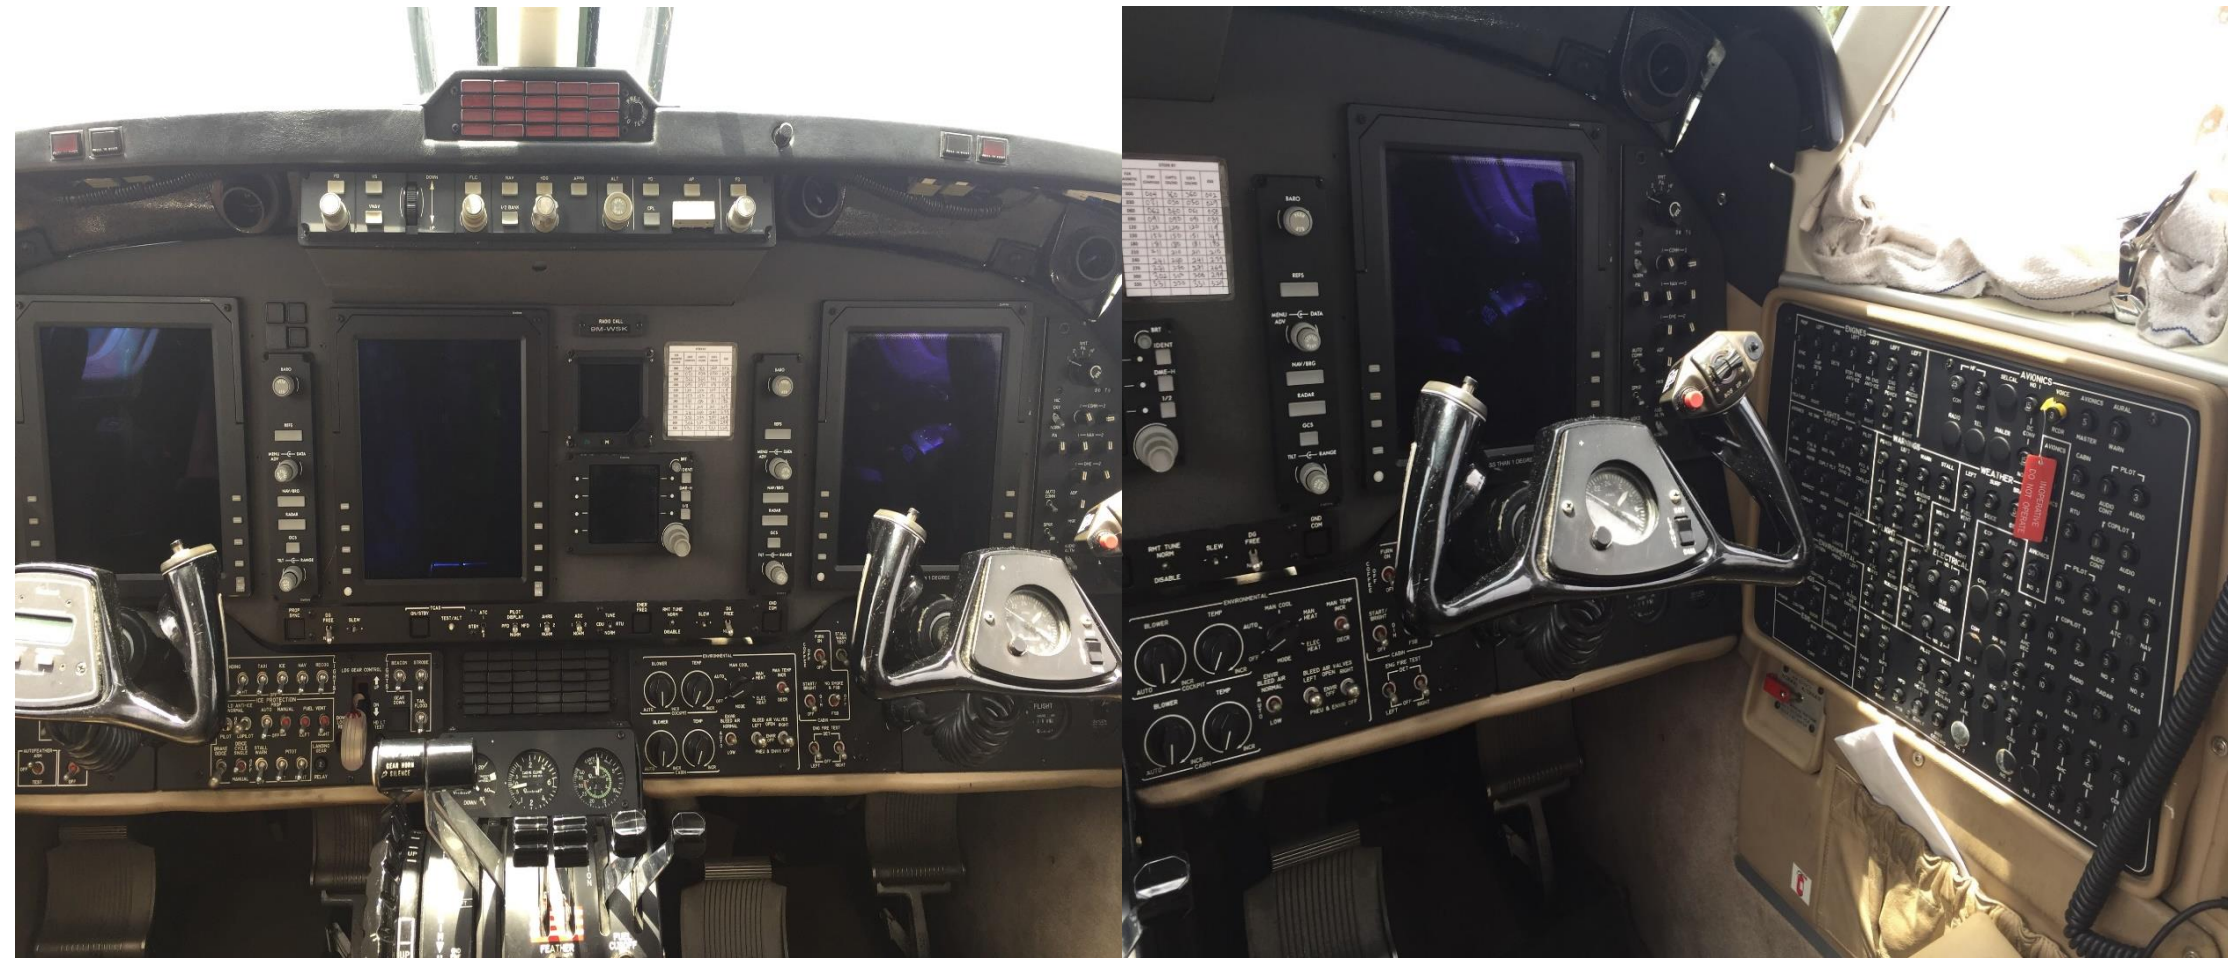
# APPENDIX C, FIGURE 1 VIEW OF THE COCKPIT AREAS

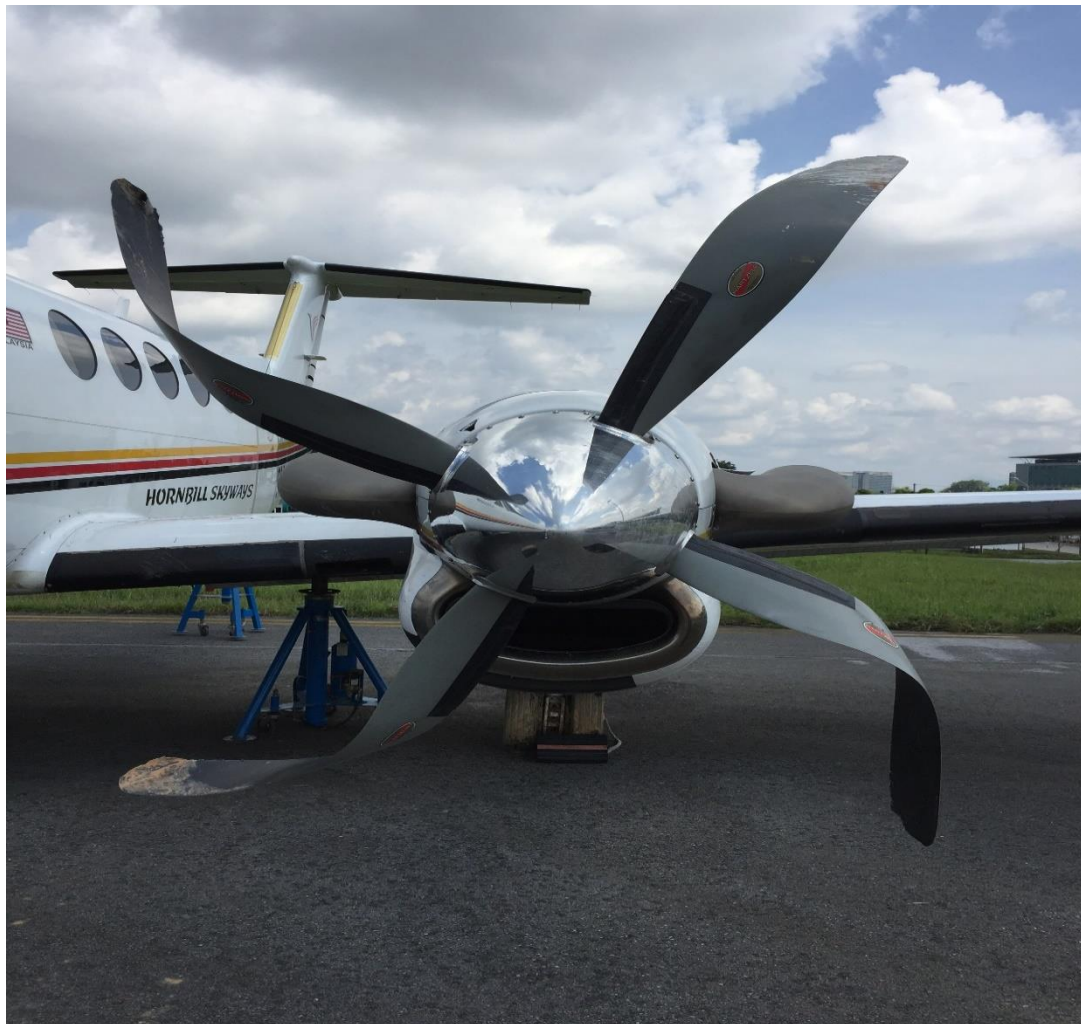
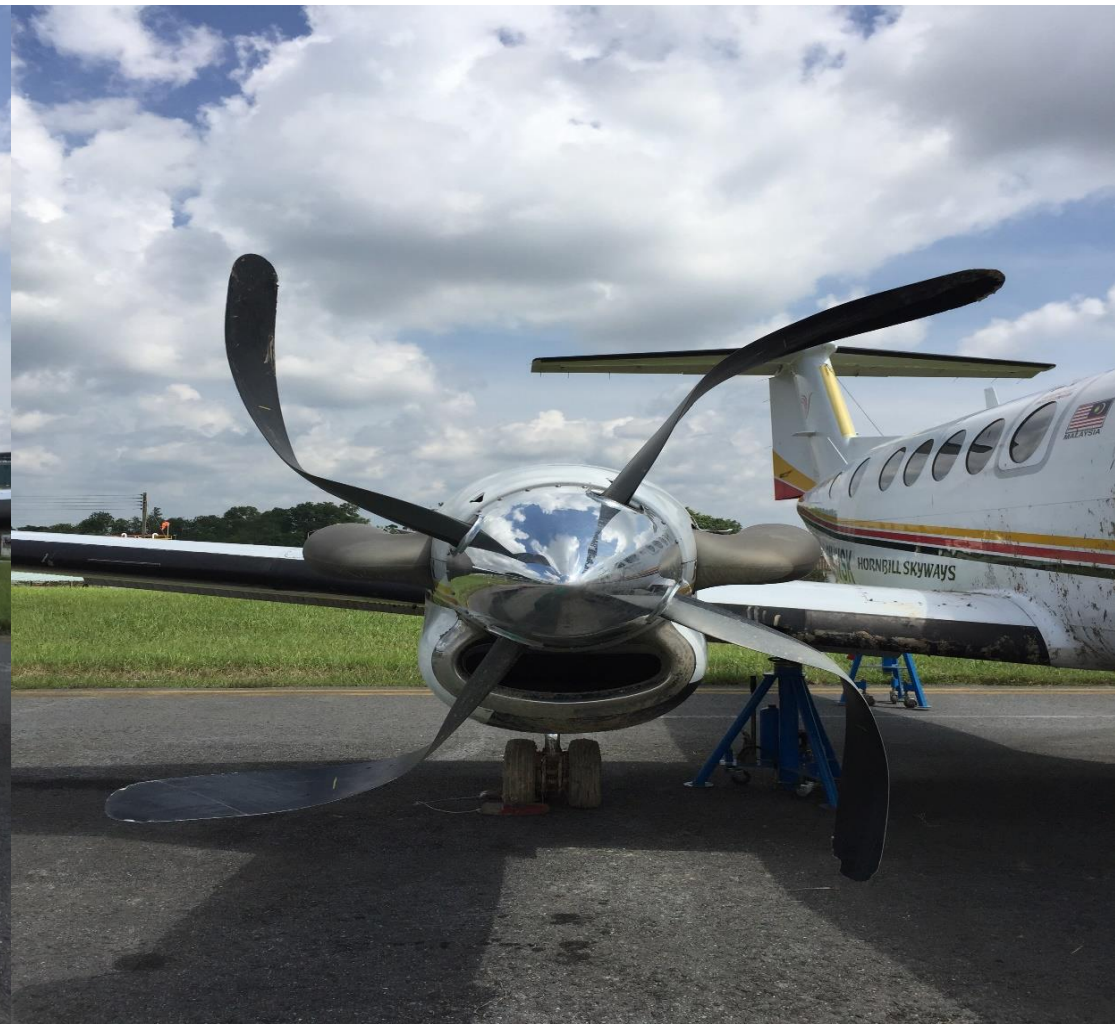
# APPENDIX C, FIGURE 2

1.3.2 The left propeller assembly blades were found bent and deformed due to the engine sudden stoppage upon impact with the ground. The left engine nose cowl had traces of mud and soil got into the engine intake. The right propeller assembly blades also suffered similar damage where all the blades bent and deformed. The right engine also had traces of mud and soil got into the engine intake. There was no visible sign of fuel or oil leak from both engines.

## Port and starboard propellar

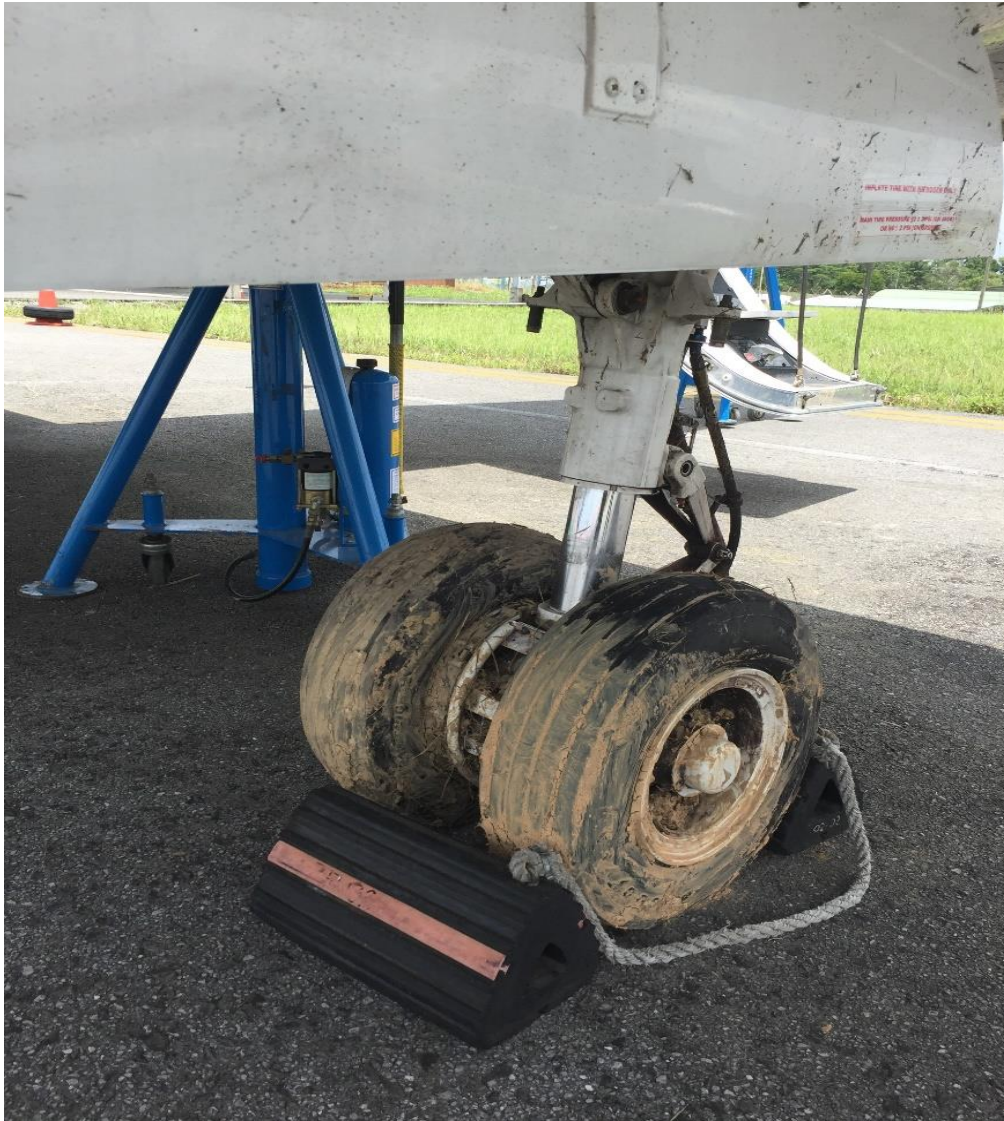
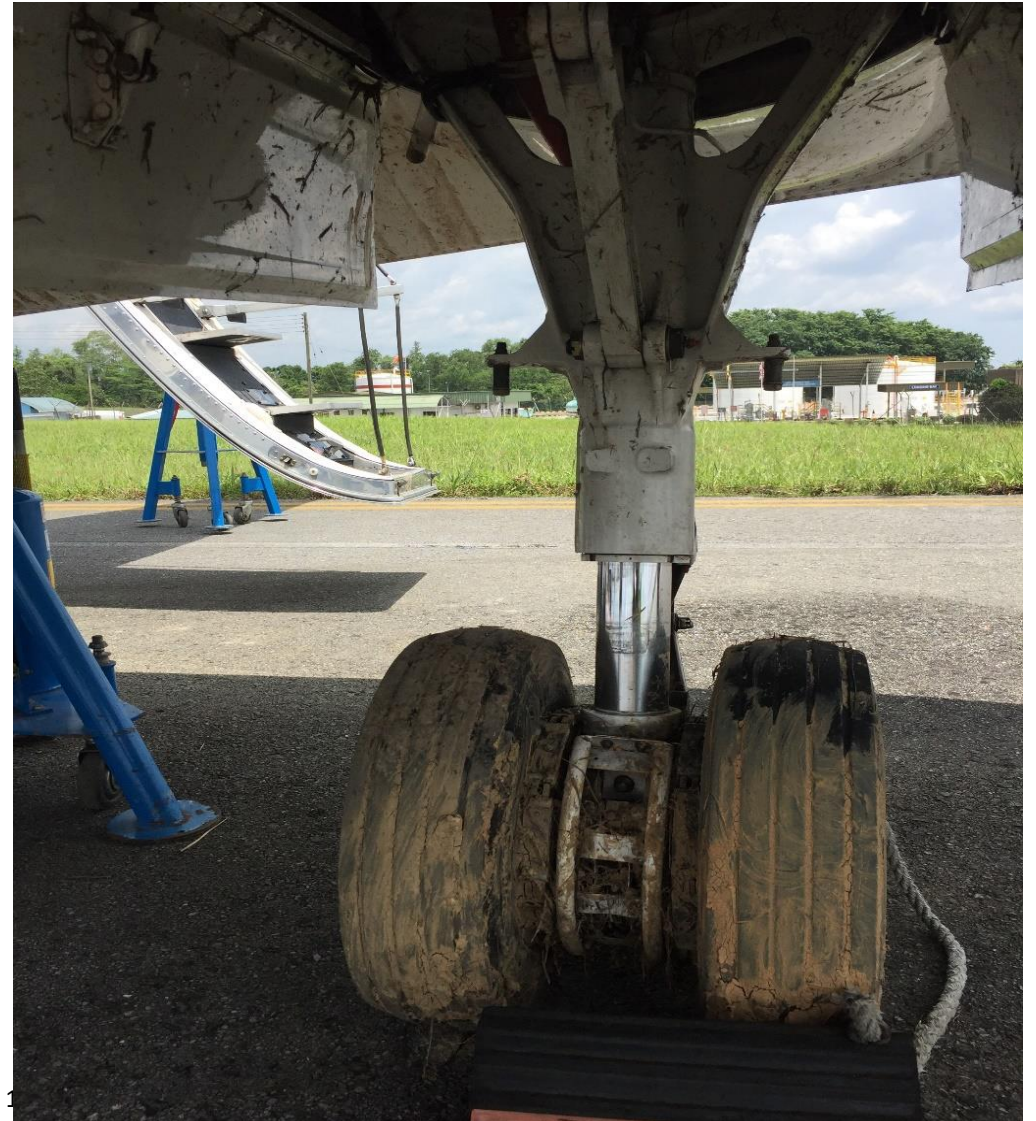
# APPENDIX C, FIGURE 3

1.3.3 The left and right main landing gear assemblies including wheels and brakes were all covered by mud. There was no visible sign of fuel leak at the main landing gear wheel well area. Both the left and right wing section also had no signs of fuel leak from the wing tank access panels. Visual inspection carried out on the aft fuselage section found normal except the rudder was deflected

## Port undercarriage

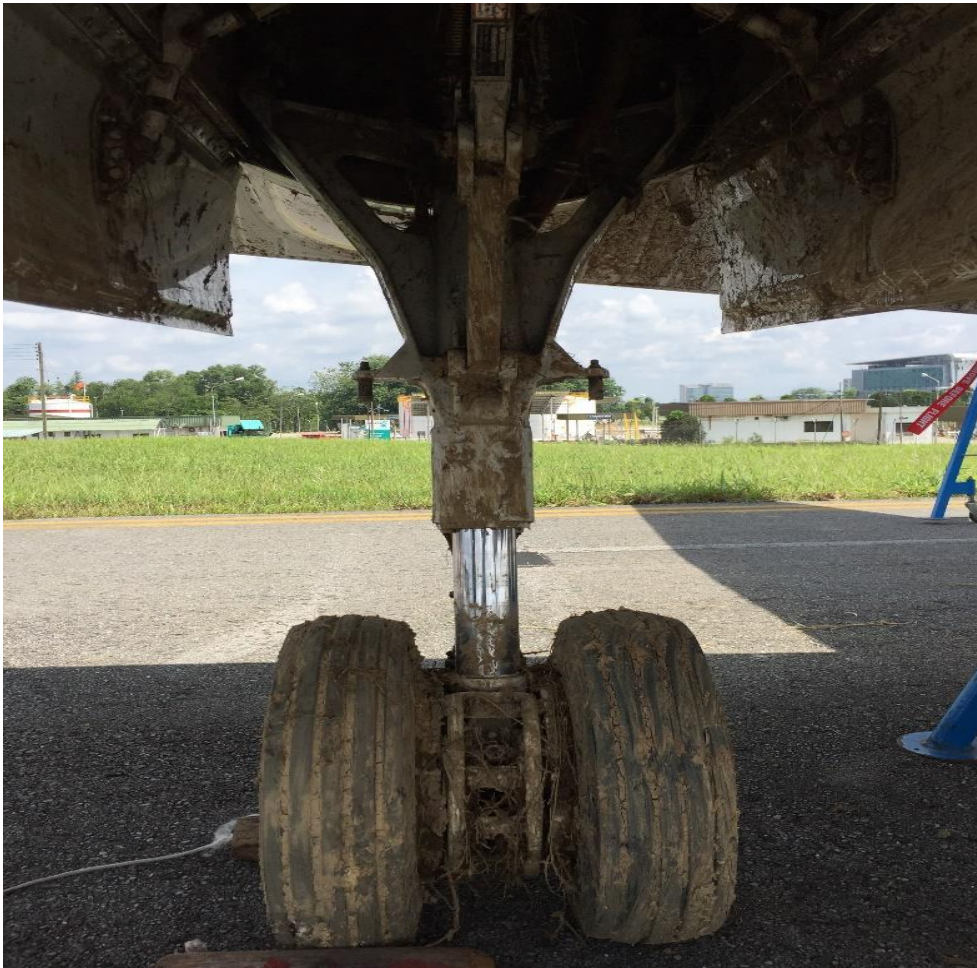
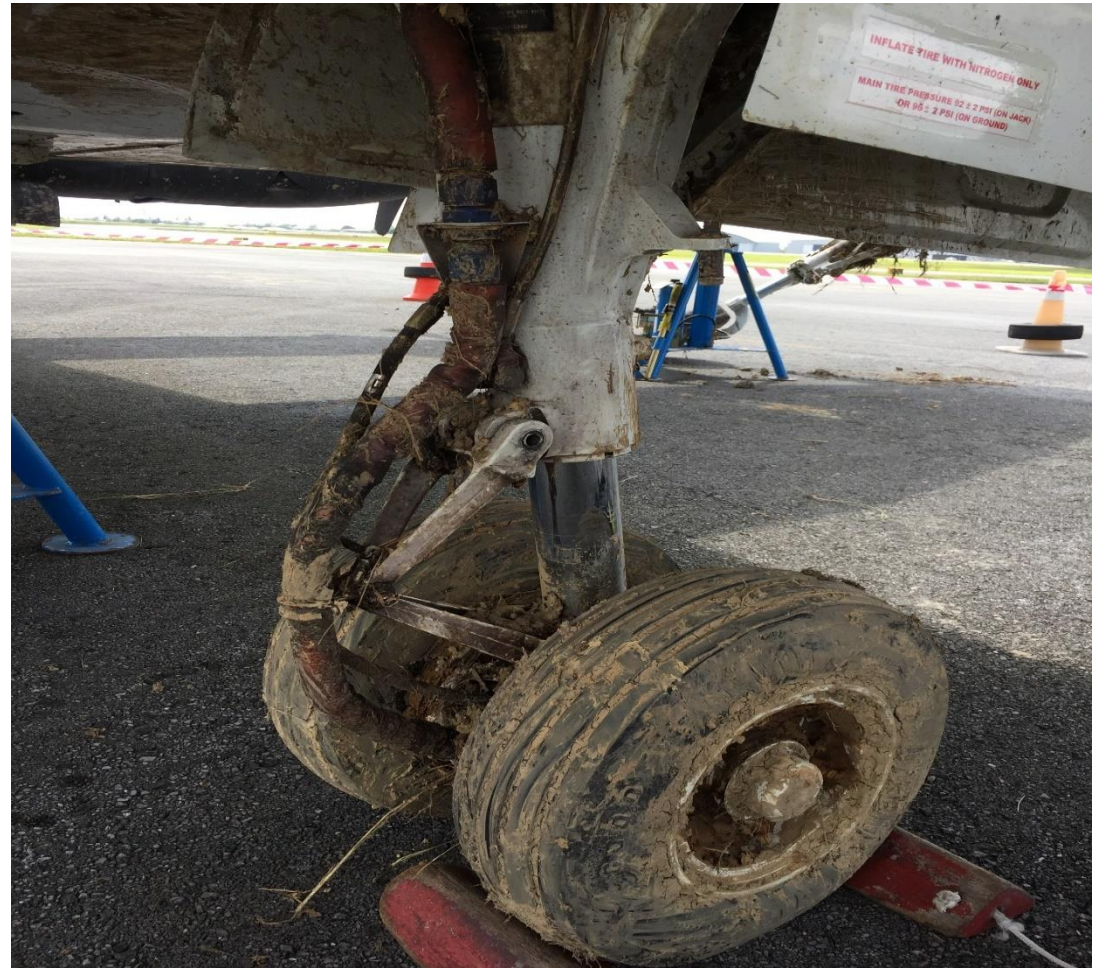
# APPENDIX C, FIGURE 4

## Starboard undercarriage

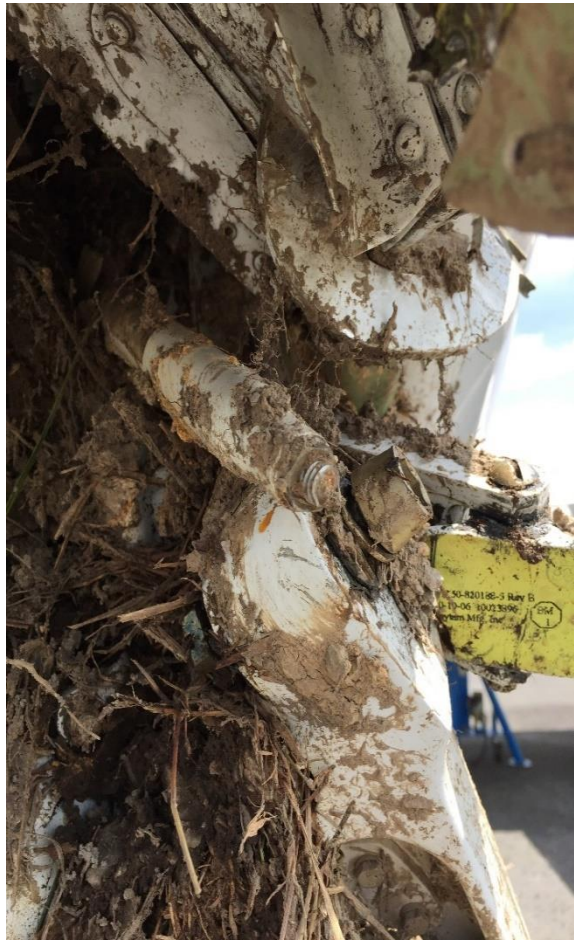
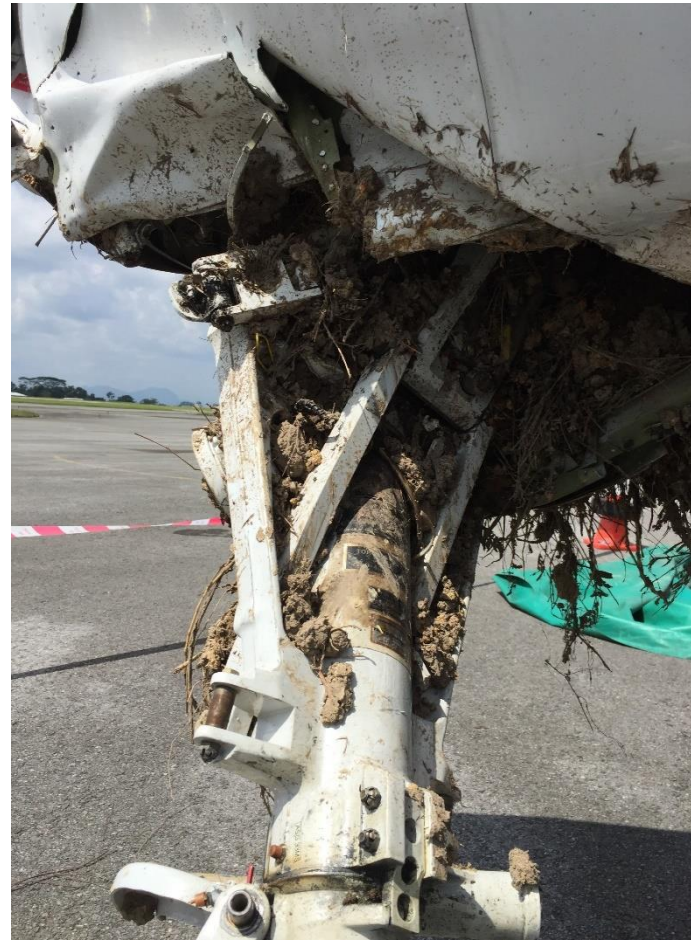
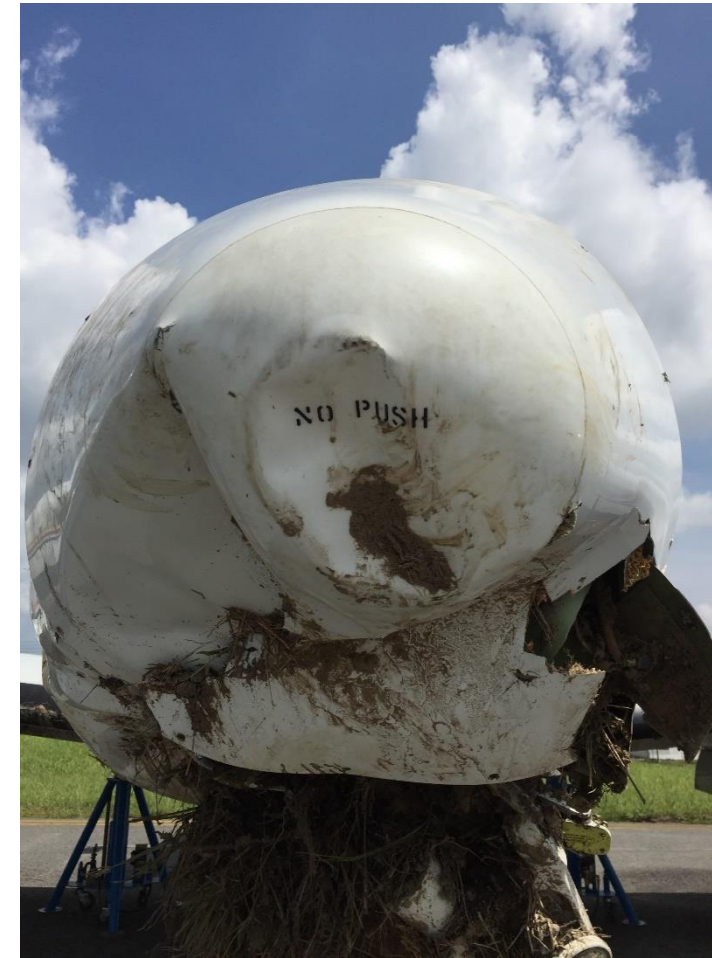
# APPENDIX C, FIGURE 5

to the right due to the nose landing gear collapsed and detached from its attachment mount. Through special detailed structural inspection is required to determine the extent of the damage.

## Damaged nose wheel assembly

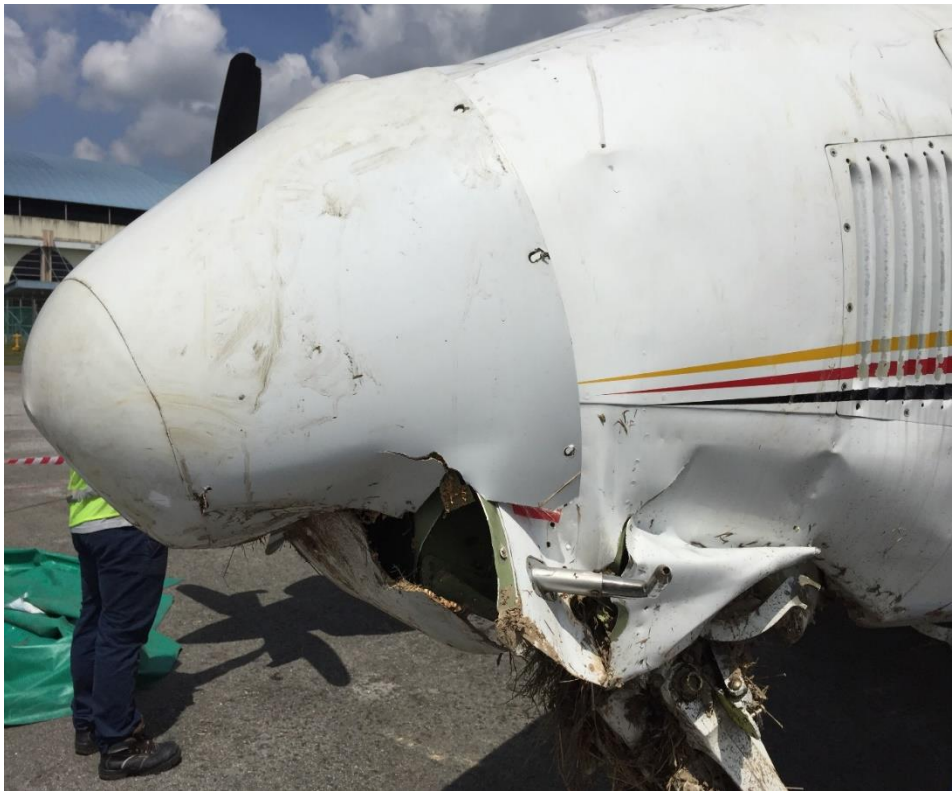
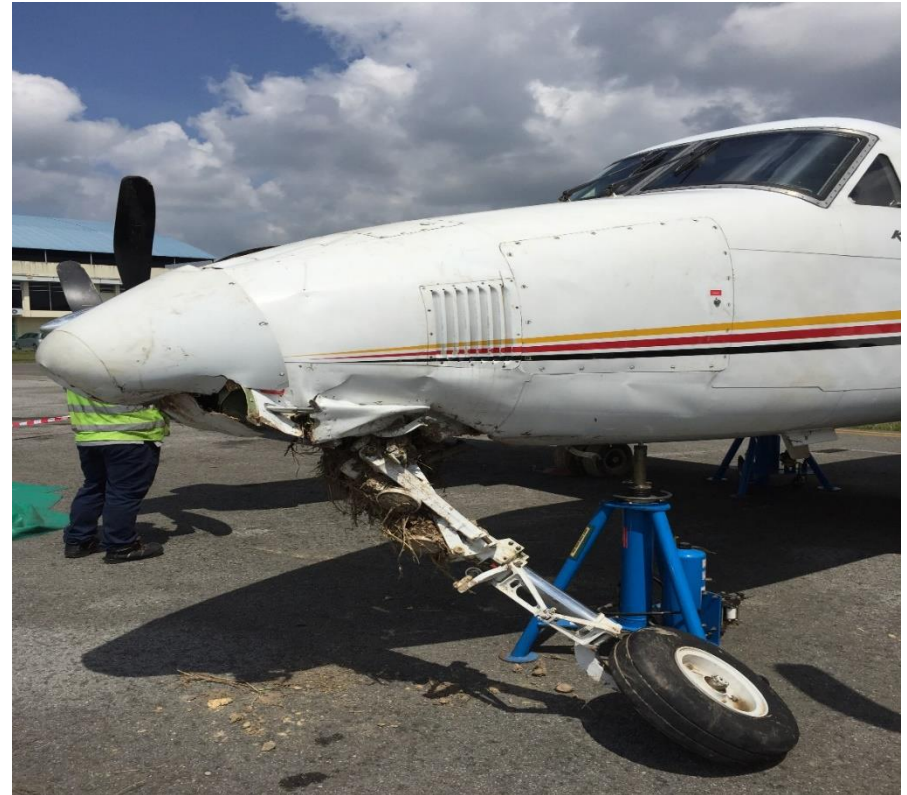
# APPENDIX C, FIGURE 6

## Nose compartment
