**AIRCRAFT ACCIDENT FINAL REPORT**  
**A 10/17**  
**Air Accidents Investigation Bureau (AAIB)**  
**Ministry of Transport**

**Accident Involving a Eurocopter AS355 F2**  
**Registration 9M-SSZ**  
**at Kota Kinabalu International Airport (WBKK), Sabah, Malaysia**  
**on the 15 November 2017**

Issued on 15 November 2018

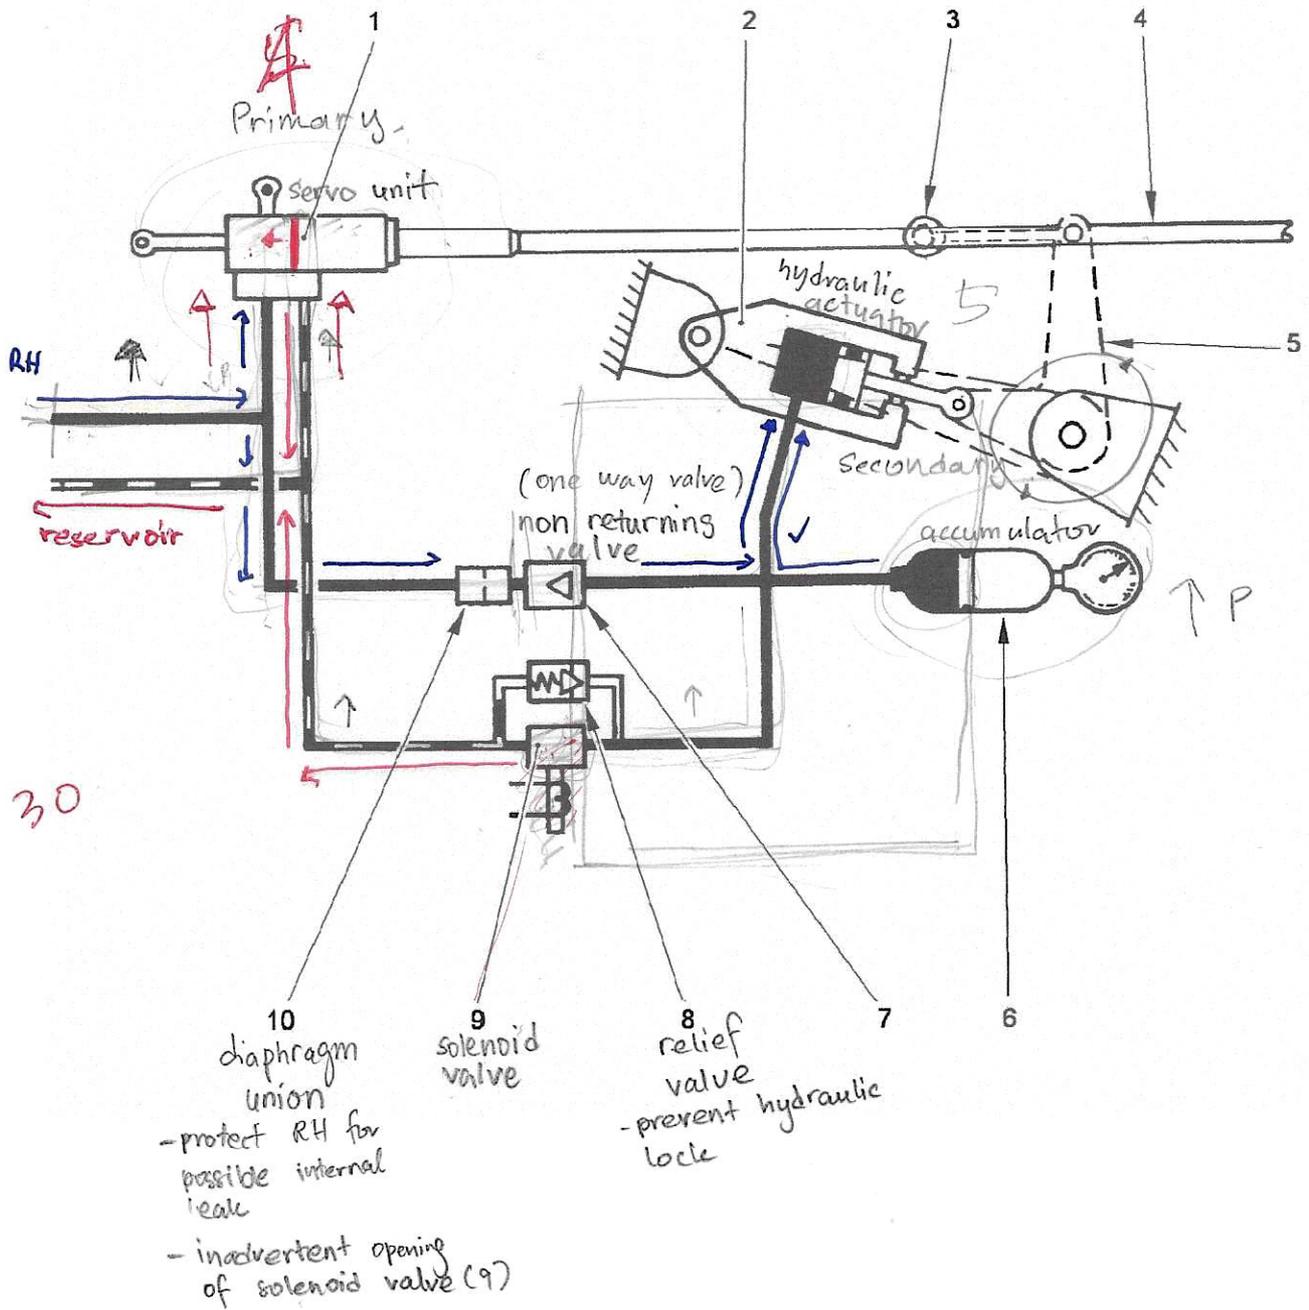
**Figure 1**

A solenoid-valve (9) controlled by a push-button allows the accumulator (6) pressure to drop in the tail servo-unit return line.

A diaphragm-union (10) protects the RH hydraulic generation system against a possible internal hydraulic leak or an inadvertent opening of solenoid-valve (9).

A relief-valve (8) prevents hydraulic locking.
