**AIRCRAFT SERIOUS INCIDENT
FINAL REPORT
SI 04/18**

**Air Accident Investigation Bureau (AAIB)
Ministry of Transport, Malaysia**

**Serious Incident involving Fixed wing aircraft Boeing B737-900
Registration 9M-LNJ
Runway Excursion at Tribhuvan International Airport,
Kathmandu, Nepal
on the 19th April 2018**

SERIOUS INCIDENT REPORT NO. : SI 04/18

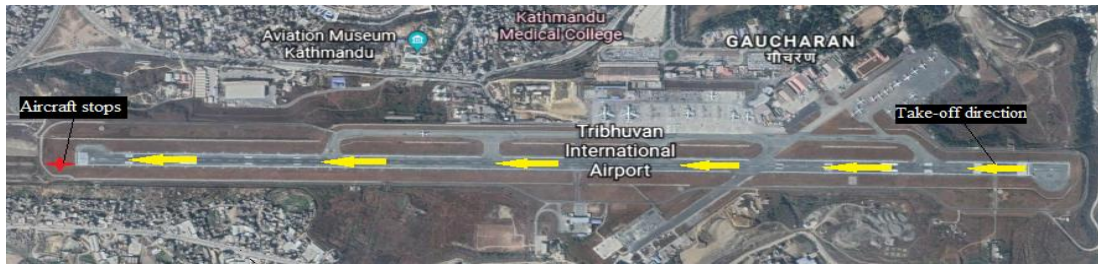
The aircraft was found on soft ground about 50 meters after the runway threshold.

Picture 1: Take-off direction and aircraft stops location.

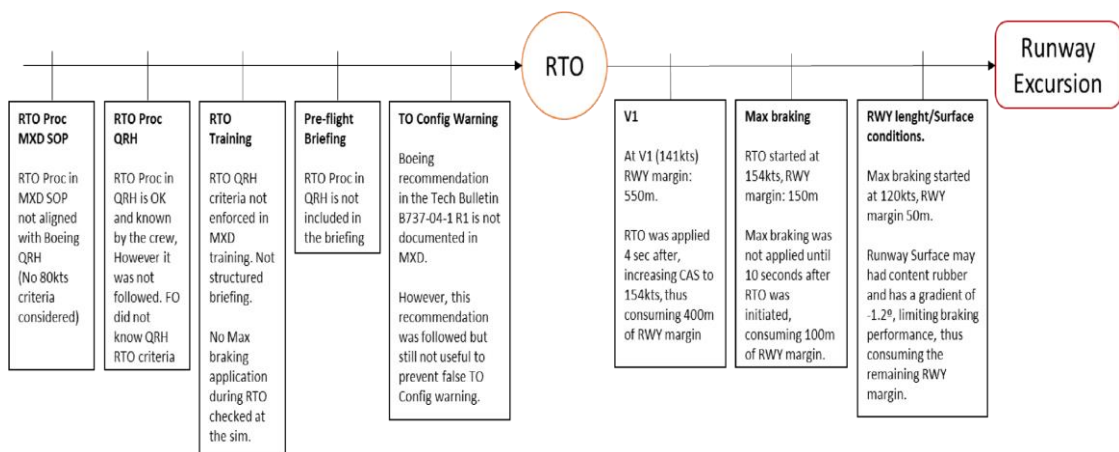
Flight data analysis provides a comprehensive description of the sequence of events, as shown in Diagram 2 and 3. A Bowtie of the event is detailed in Diagram 1.

Diagram 1: Bowtie analysis of the incident.

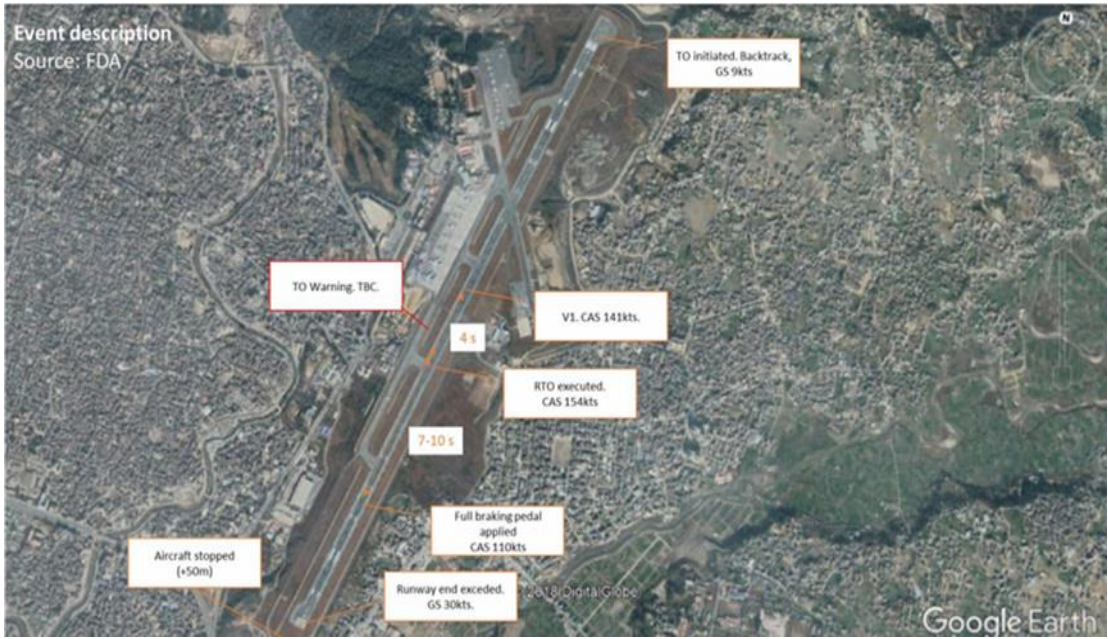
According to the flight data the RTO was initiated 4 seconds after V1, at a CAS 154kts. There is no evidence of TO Warning during the take-off roll recorded. The RTO was performed initially with autobrake, and it was disconnected immediately after by applying pressure on the brake pedals by the CPT. Flight data shows a progressive movement of the braking pedals from 30% to close to 90% in 10 seconds (see Figure 3). After that point, constant maximum pressure was applied until aircraft came to stop. Runway excursion occurred at Groundspeed 30kts, and the aircraft was stop close to 50m after the RWY02 threshold.

Diagram 2: Sequence of events during take-off roll and RTO
(Source FDA/Google Earth)

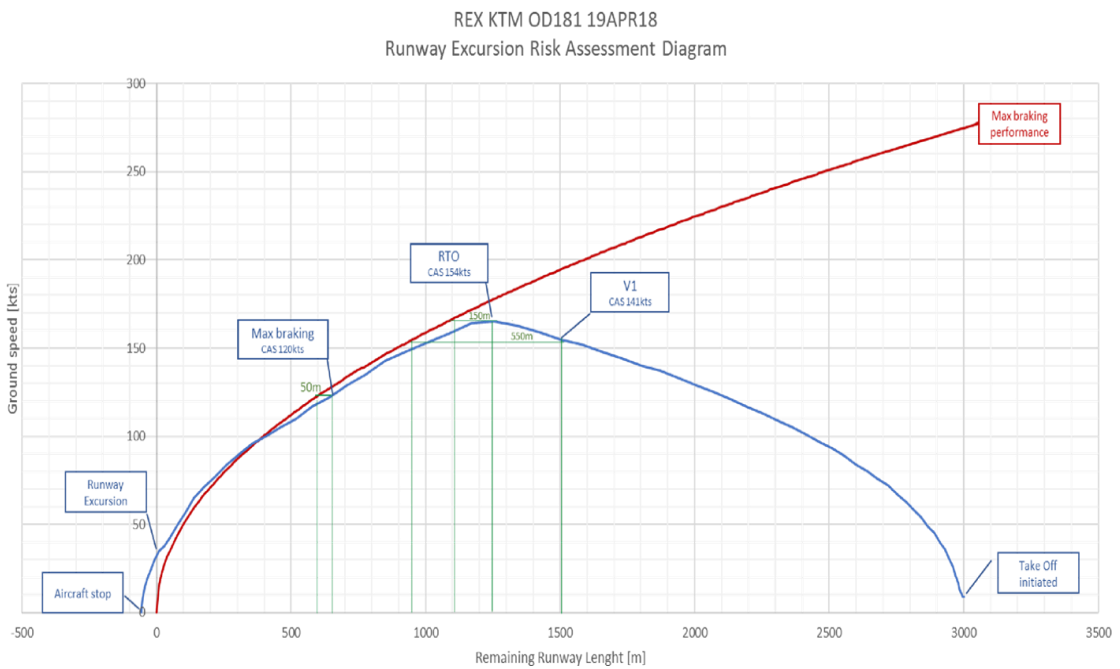
Diagram 3: Runway Excursion Risk Assessment Diagram (Source: FDA)

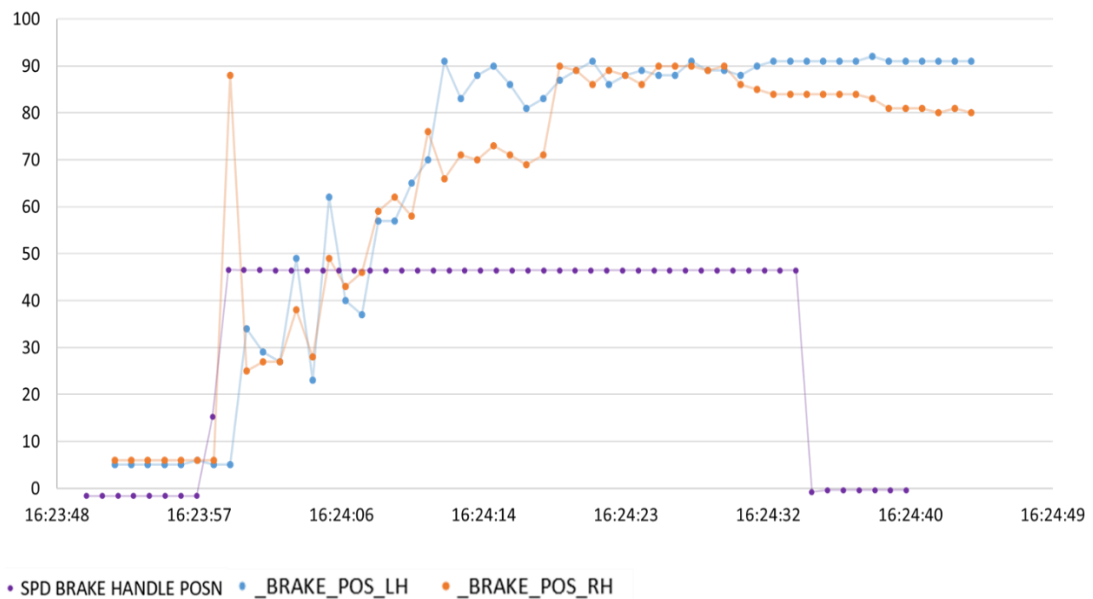
Diagram 4: Braking pedal and speed brake handle position during RTO (Source: FDA)

3.1.5 Autobrake was disconnected immediately after the RTO was initiated. However, no maximum braking was applied during manual braking until 10 seconds after the RTO was initiated.

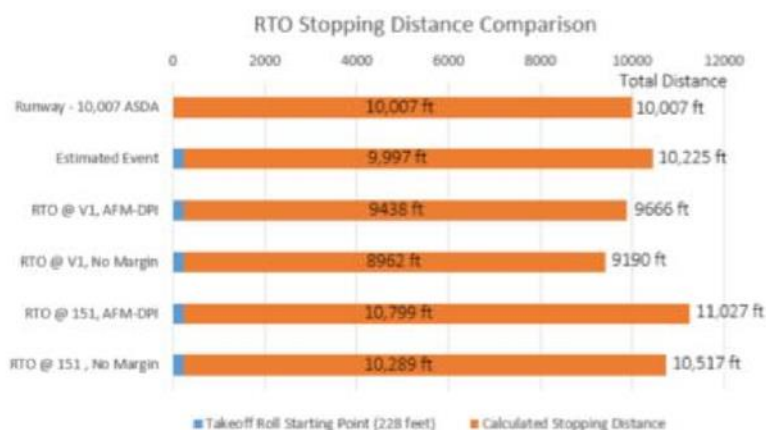
The following is a chart that shows the runway ASDA, estimated event stopping distance, along with the ASD calculations assuming RTO initiation at a V1 of 141 knots and RTO initiation at the event RTO speed of 151 knots. Along with the ASD calculations, the stopping distance is included at both speeds without the 2 second margin that the AFM-DPI includes. The assumptions that went into these calculations were based on the event conditions which were: maximum takeoff thrust, outside air temperature of 18 degrees Celsius, airport pressure altitude of 4350 feet, average runway slope of -0.75%, and a wet runway surface.

The ASDA of RWY 20 is defined as 10,007 feet. Based on the assumptions defined above, the dispatch ASD that would have been provided to the crew for an RTO at V1 is 9438 feet, which includes the AFM-DPI 2-second distance pad. The takeoff roll began at approximately 228 feet. The data show that had the RTO been initiated at V1, using the deceleration device utilization assumptions without the 2-second margin, the airplane would have stopped on the runway by approximately 9190 feet, leaving 817 feet of runway remaining. Initiation of the RTO at 151 knots, 10 knots faster than V1, would have required 10,289 feet to accelerate and stop, without the added margin included in the ASD calculations. Given that the takeoff roll started at 228 feet, the airplane would have stopped at 10,517 feet had there been available runway to accommodate that distance. The estimated stopping location of the airplane was 10,225 feet, 218 feet beyond the ASDA for RWY 20 and 292 feet shorter than the calculated AFM-DPI distance of 10,517 feet. The 292-foot difference between the calculated distance and the actual estimated location of the airplane can be accounted for by the increased friction provided by the soft ground that the airplane encountered after overrunning the end of RWY 20. Figure 3 shows the location of the AFM-DPI accelerate-stop distance if the RTO had been initiated at V1, red "X," using the takeoff initiation as the starting point.

The QAR data indicated that maximum takeoff thrust was used during the takeoff run; however the engine performance that resulted from the operational condition assumptions resulted in an engine %N1 that was approximately 1.0% higher than what was recorded (recorded engine %N1 = 100.25%). The stopping distances were produced using the higher AFM-DPI engine %N1. Using the recorded engine %N1 increases the distances by 400 to 500 feet.
