AIRCRAFT ACCIDENT FINAL REPORT
A 03/18
Air Accidents Investigation Bureau (AAIB)
Ministry of Transport

Accident Involving an Eurocopter AS355N

Registration 9M-PHJ

on 13 March 2018

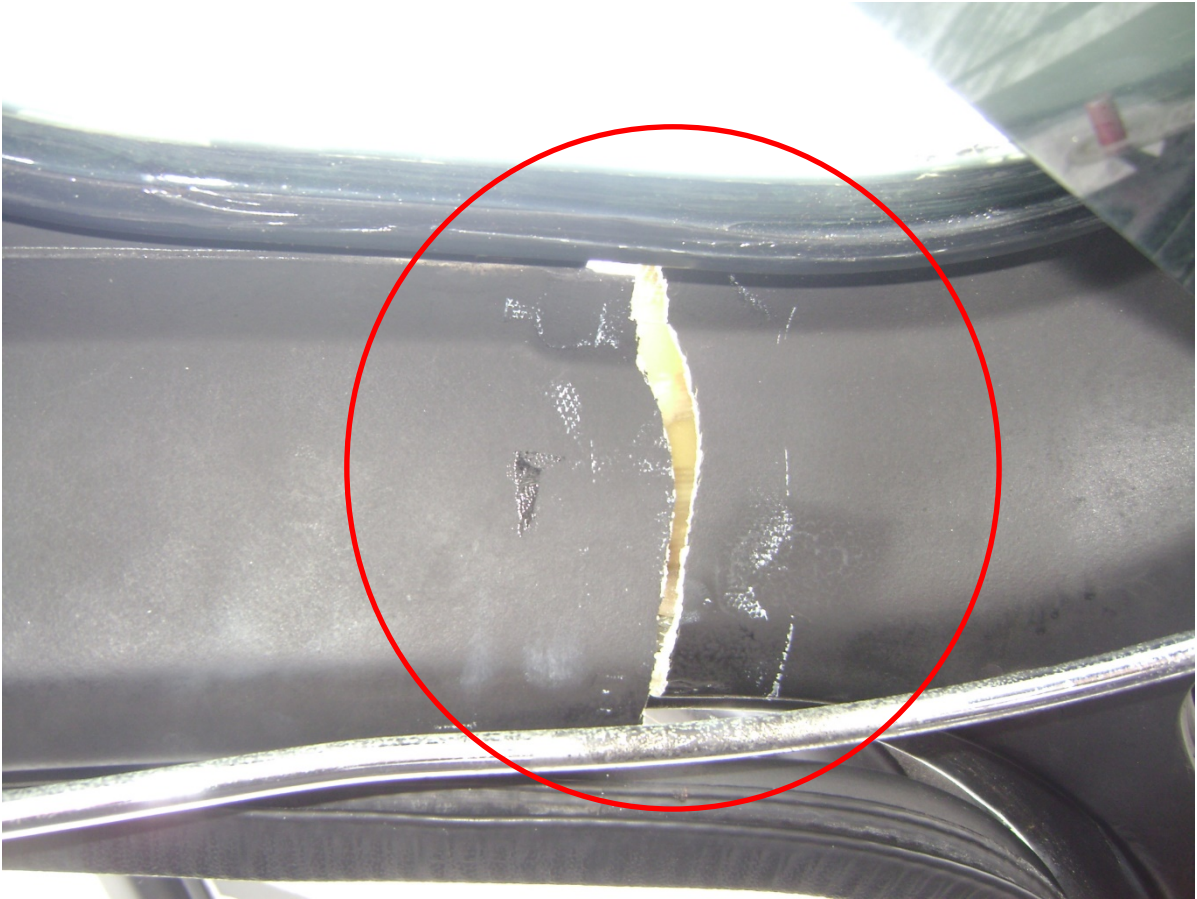
1. Inside the Cockpit - both top LH and RH above crew door on the canopy side was cracked (as photos 01)
2. Inside the Cockpit – Center overhead console, LH side cracked (as photo 02)

PHOTO 01 - Left Hand Side Top Canopy

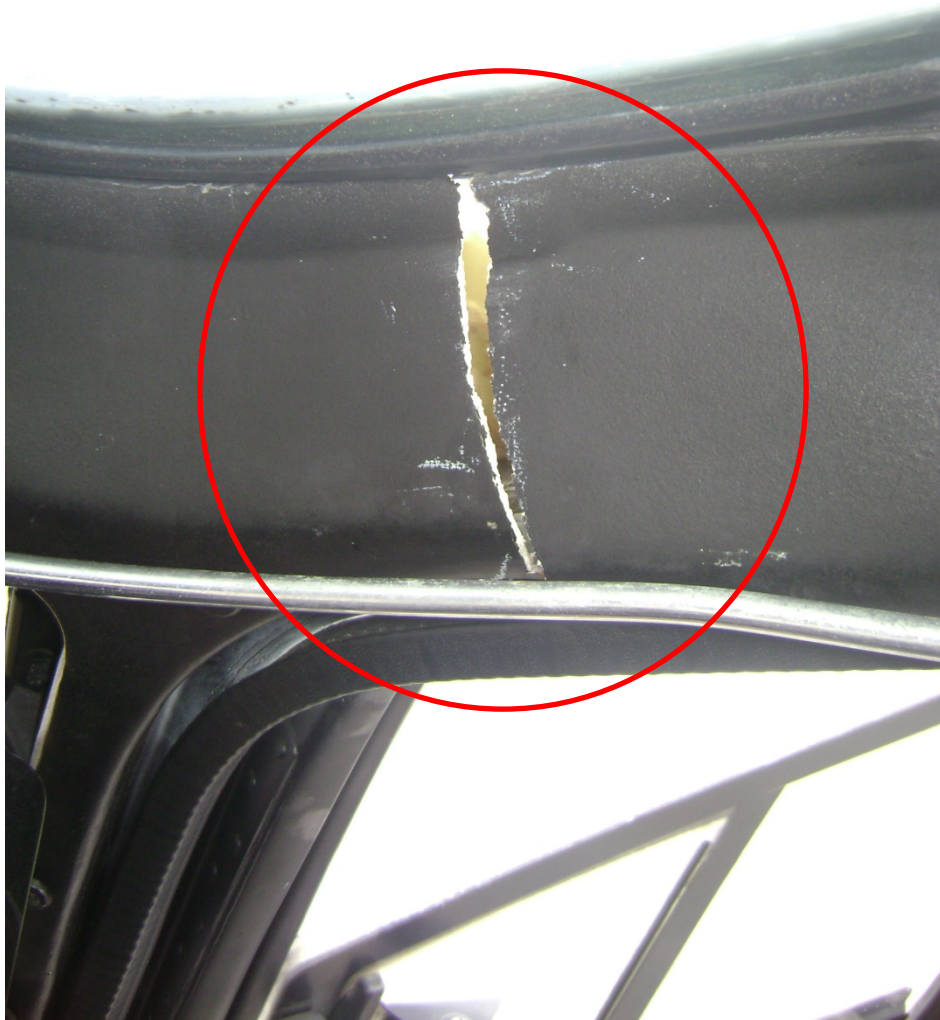
PHOTO 01 – Right Hand Side Top Canopy

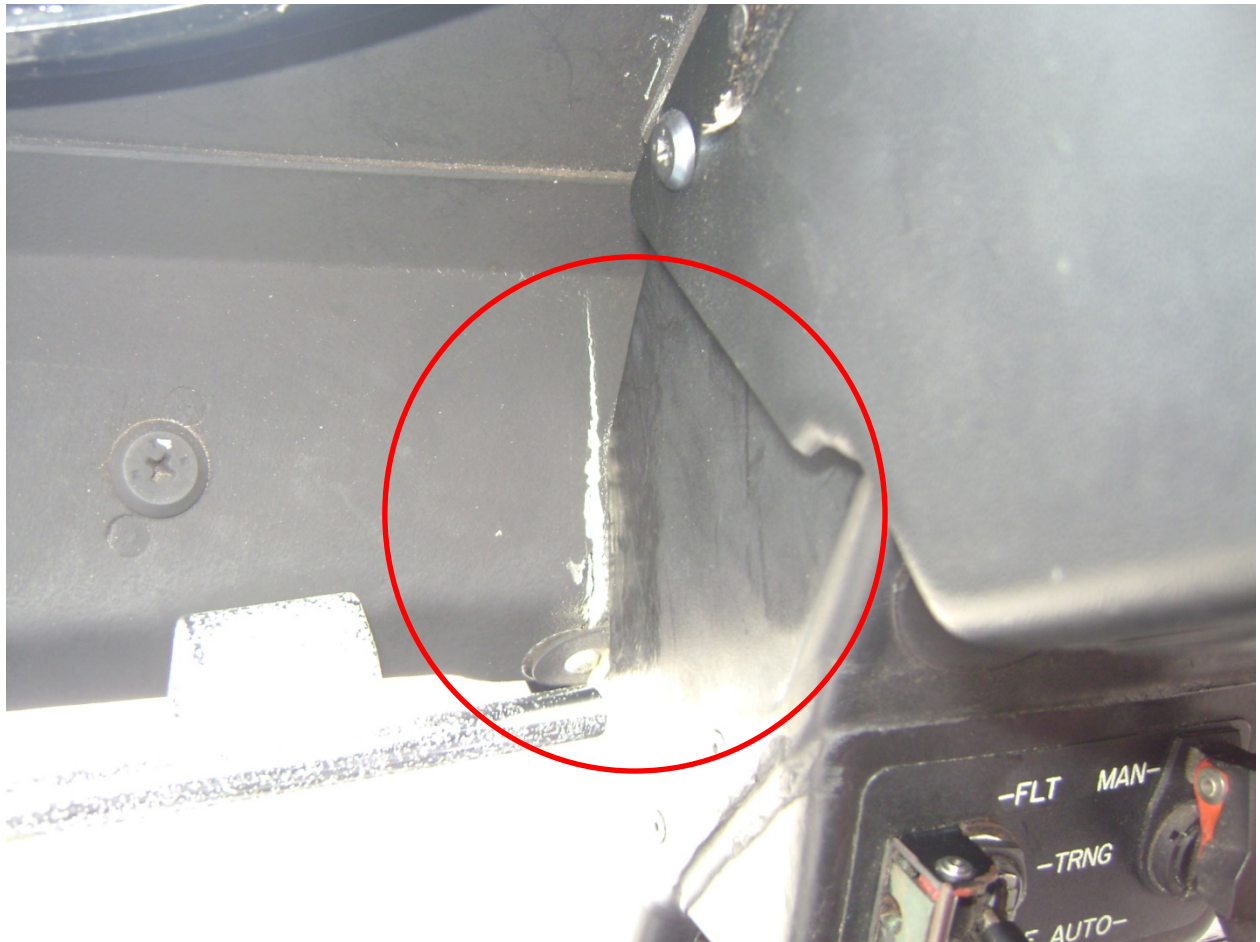
PHOTO 02 – Left Hand Side Center Console Top Canopy

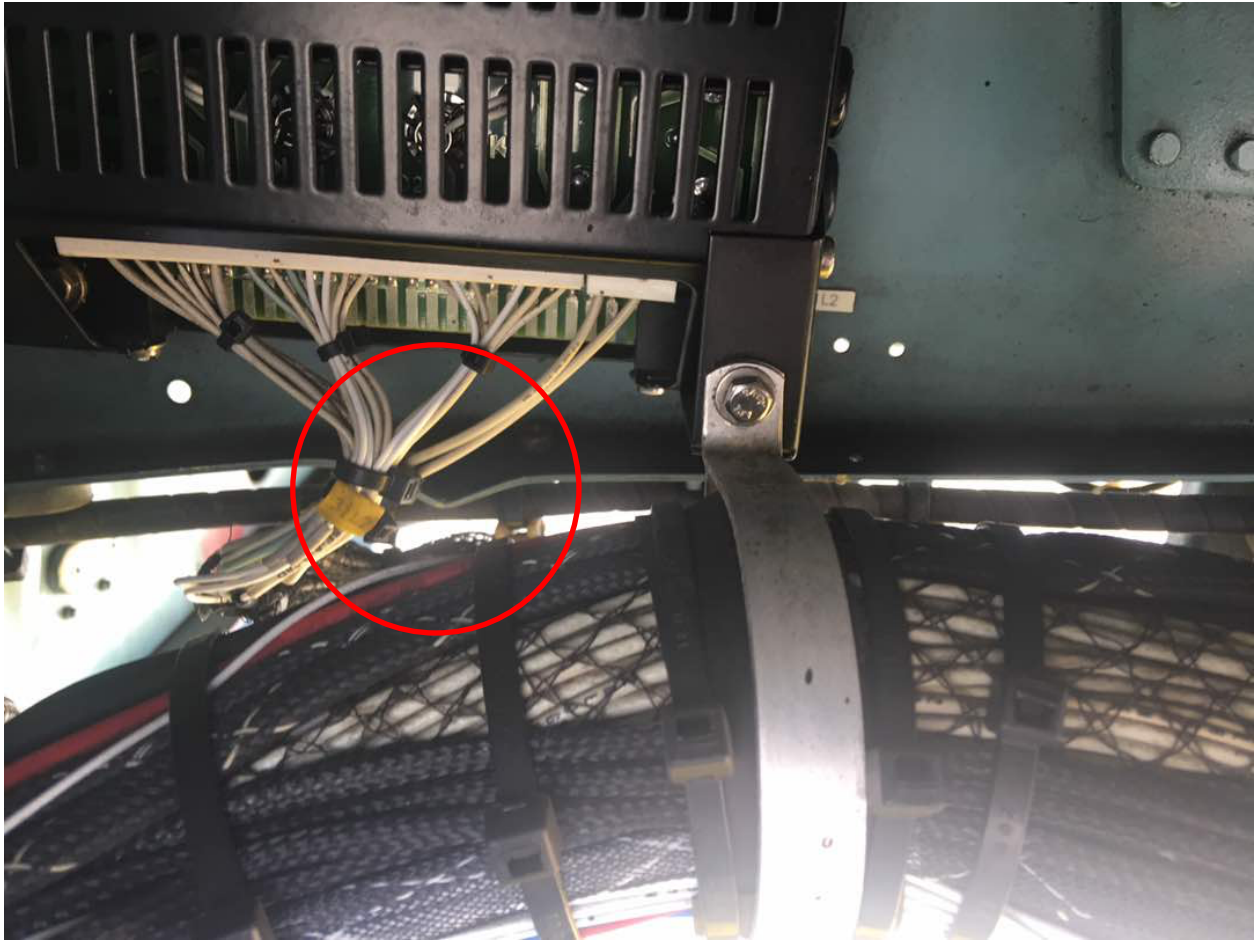
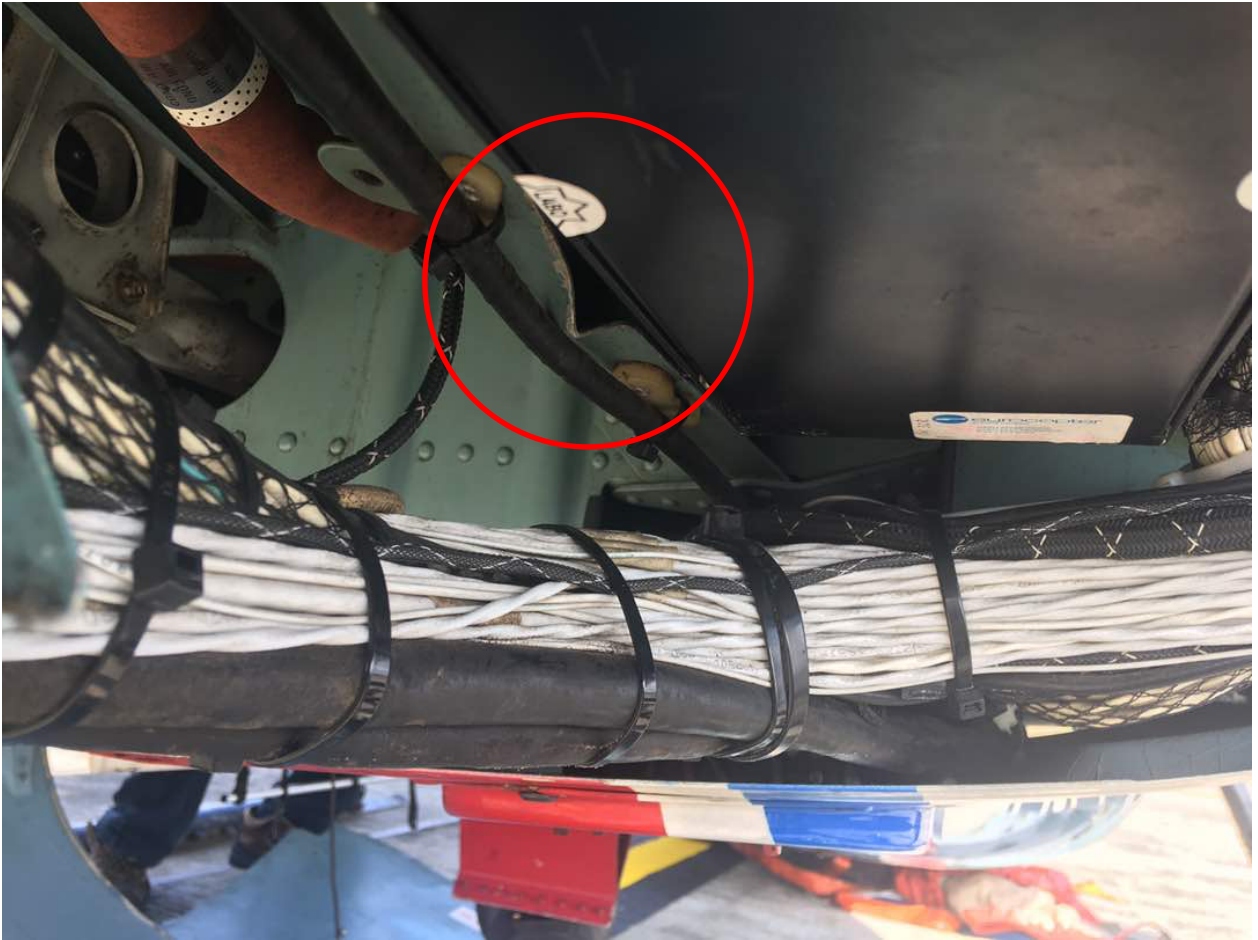
3. Sliding door both side LH and RH resistance in movement during opening and closing the door due to canopy has dropped.
4. Outside below cockpit – at the control area rods the LH and RH underfloor beam bend (as photo 03)

PHOTO 03 – Underfloor Beam

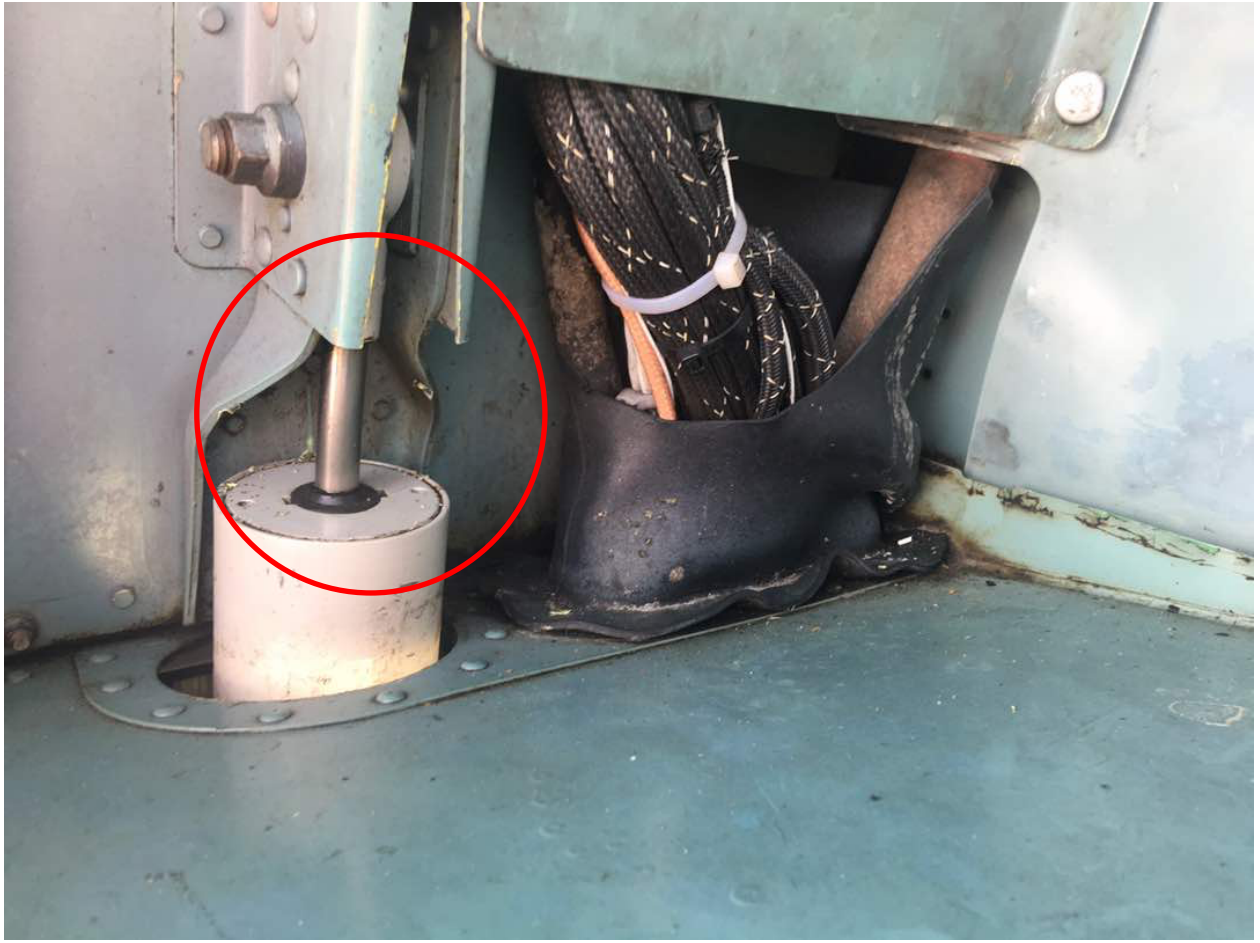
5. LH and RH damper/absorber for Rear Cross Tube the chrome plunger bend (as photo 04)
6. Cowling/shroud at area around LH and RH Cross Tube mounting were damaged (as photo 05)

PHOTO 04 – Left Hand Rear Cross Tube Damper/Absorber

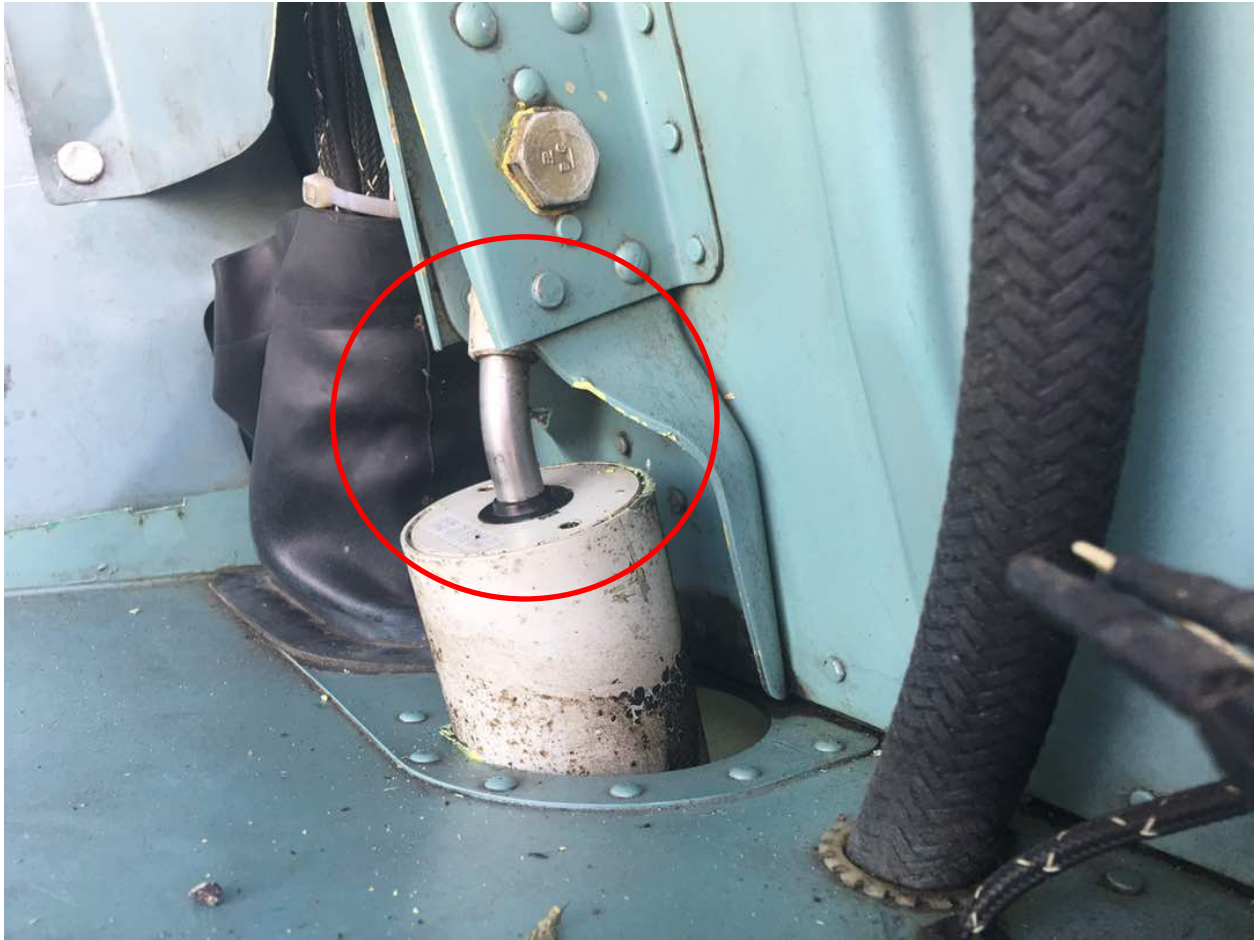
PHOTO 04 – Right Hand Rear Cross Tube Damper/Absorber

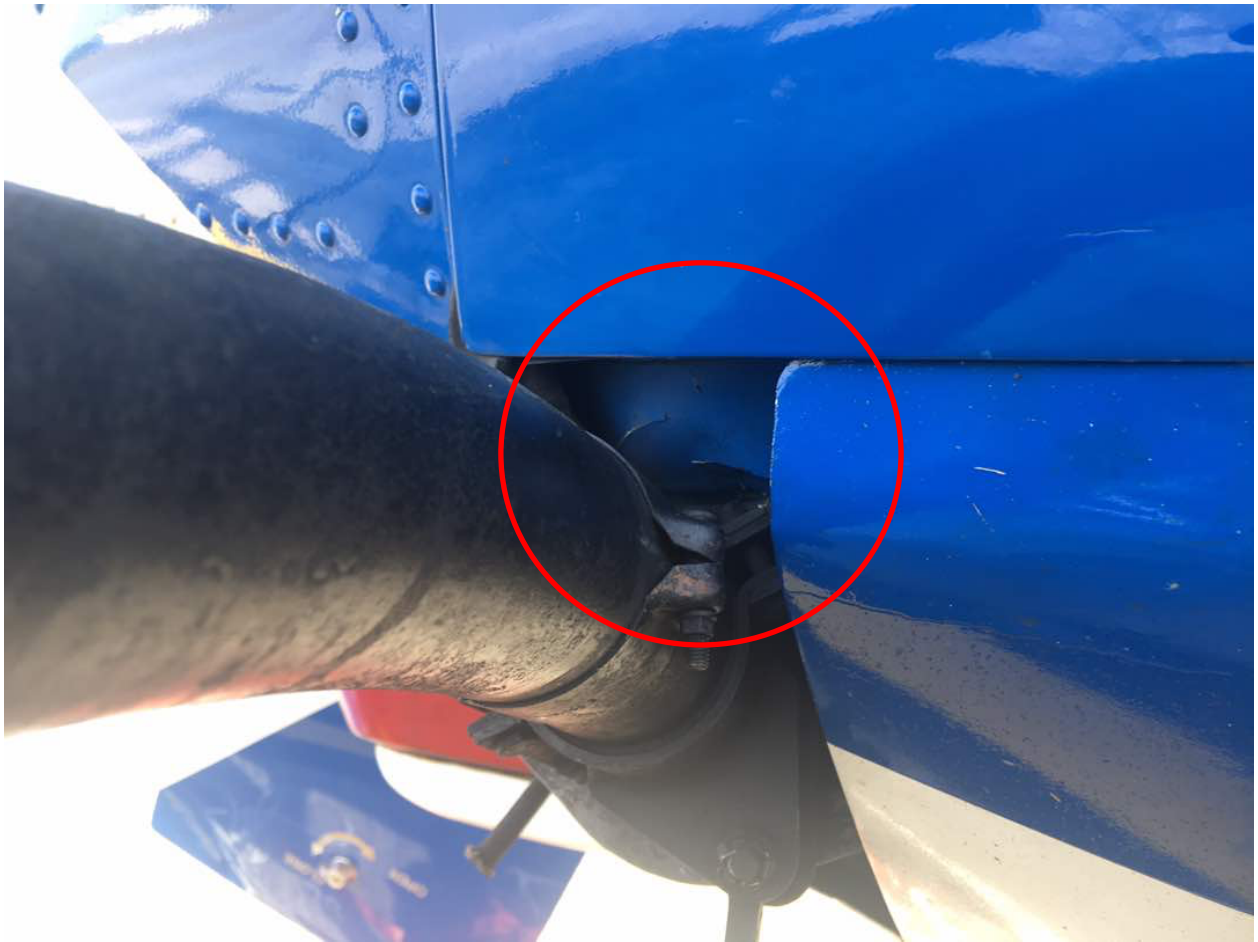
PHOTO 05 – Left Hand Front Skid Cowling

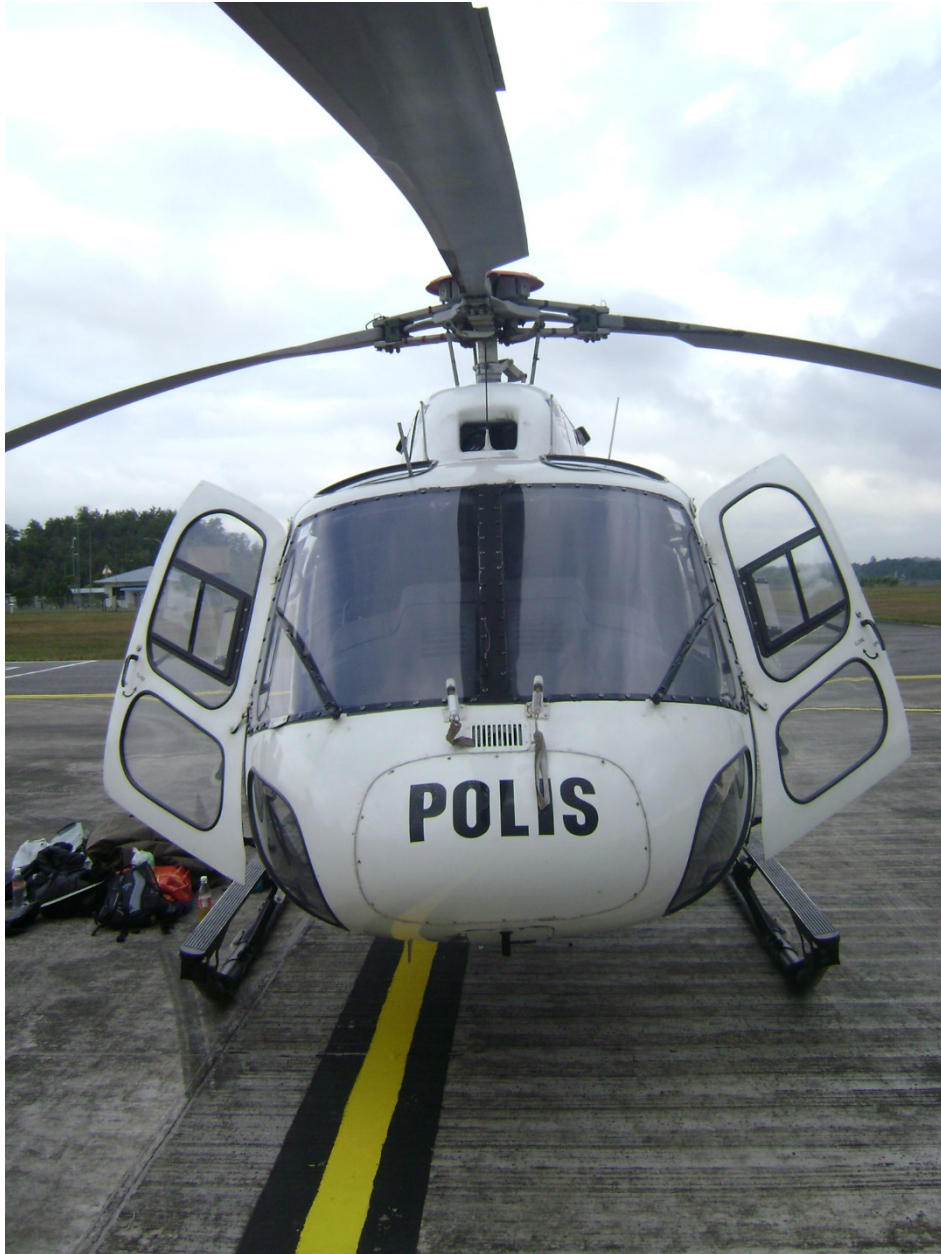
7. Both LH and RH skid were bend outwards (as photo 06)
8. All 4 speaker screws sheared and speaker dangling with only holding by it wiring only.
9. Aircraft is tilting to right side due to heavy impact on RH skid on ground before LH skid touches the ground.

PHOTO 06 - Skid

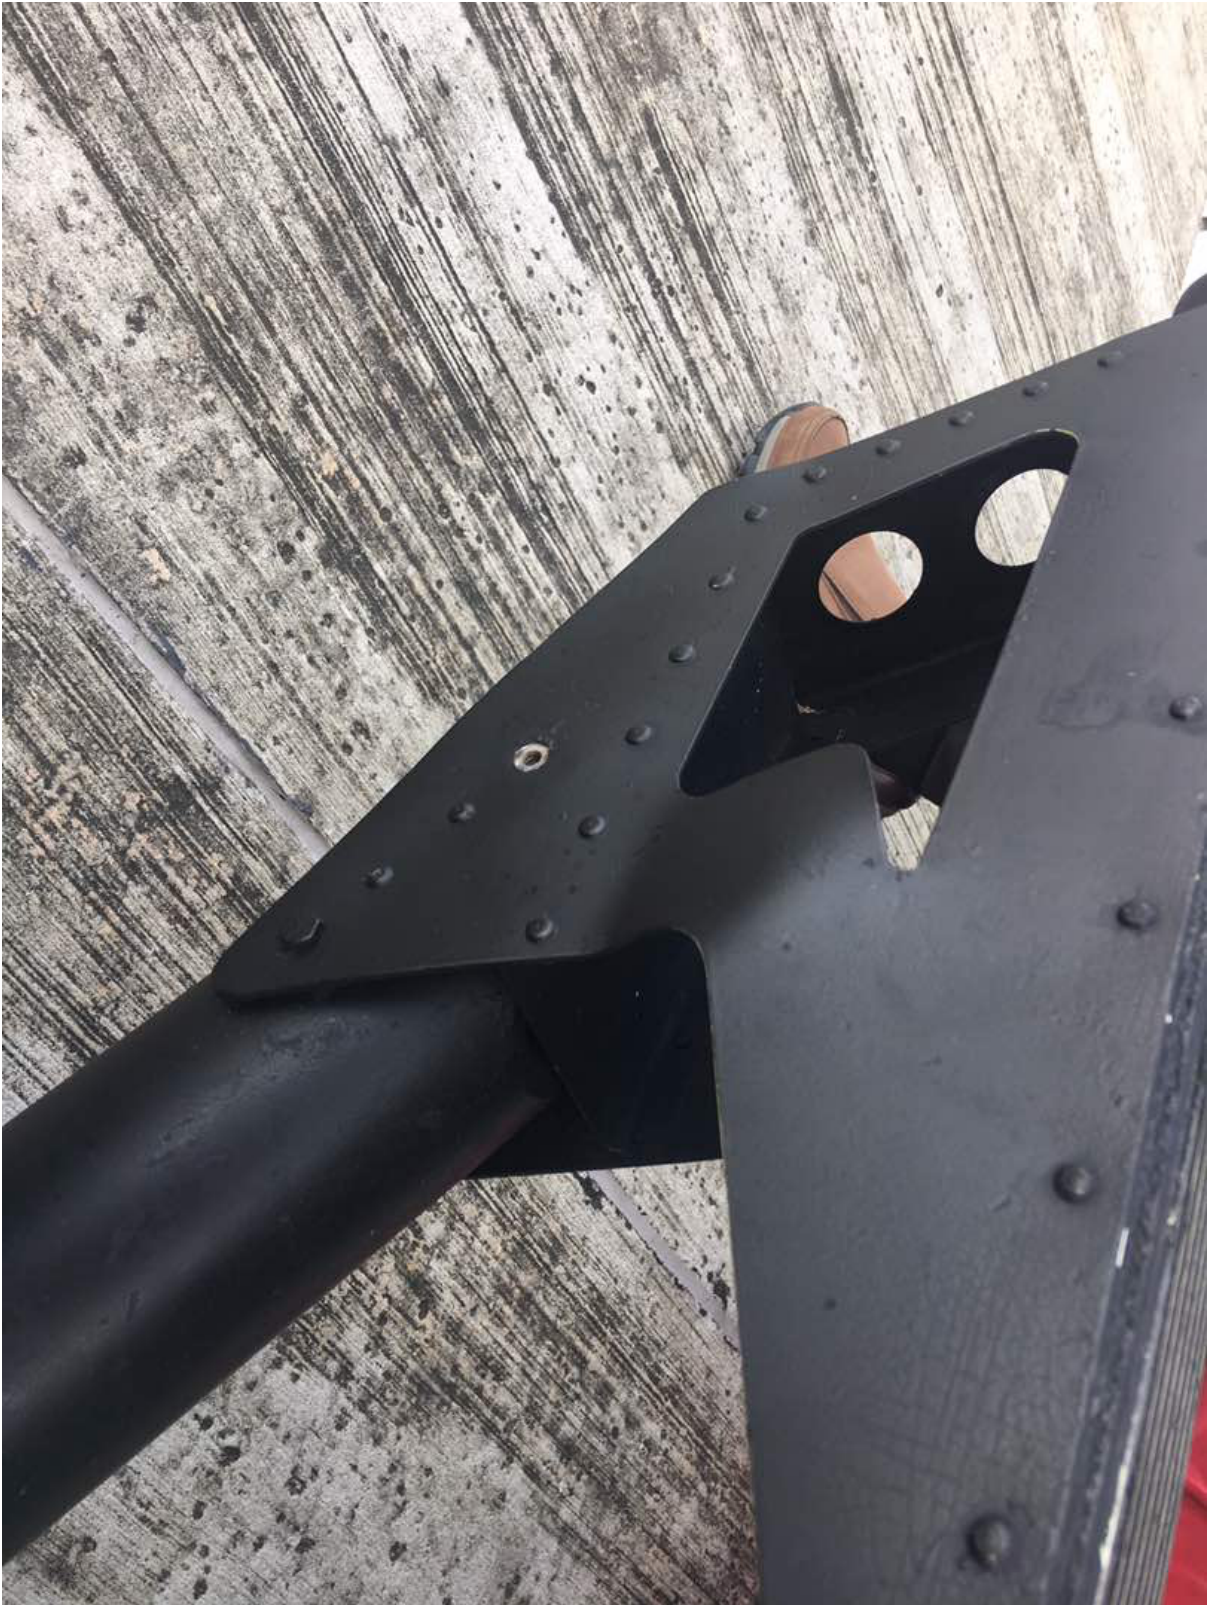
10. Pull Rivet at the skid (as photo 07)
11. DECU reading nil defect and the rest of the aircraft (main rotor, tail rotor, main gearbox, spider, tail boom) are comfortably reliable.

PHOTO 07 – Skid Pulled Rivet
