AIRCRAFT ACCIDENT

FINAL REPORT

Super Petrel LS Registration 9M-ETC

at Marina Island Lumut Perak

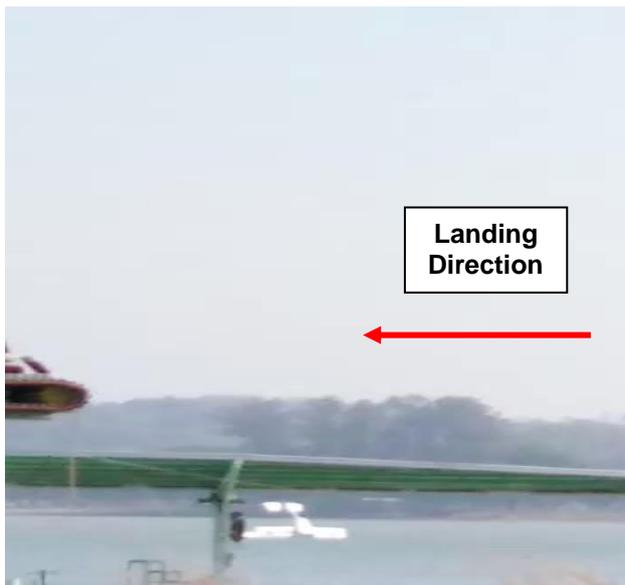
Figure 3: Aircraft veered 90⁰ right from direction of landing and came to a halt with the nose section submerged in water and tail section vertically up.

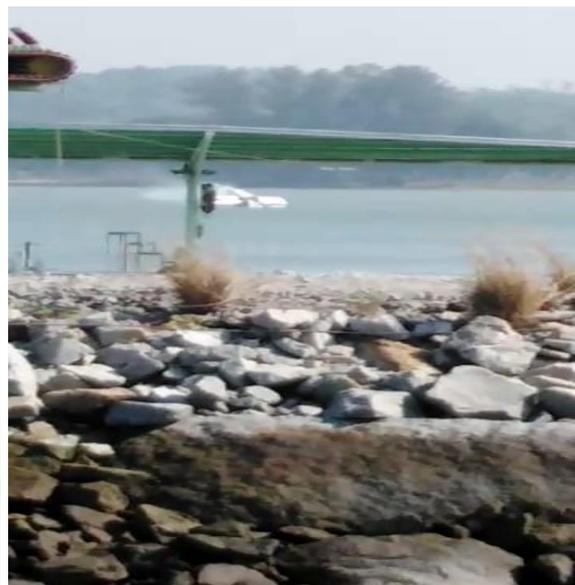
Figure 4: Water splash as tail section toppled into water after being forced by the pusher-propeller engine full power.

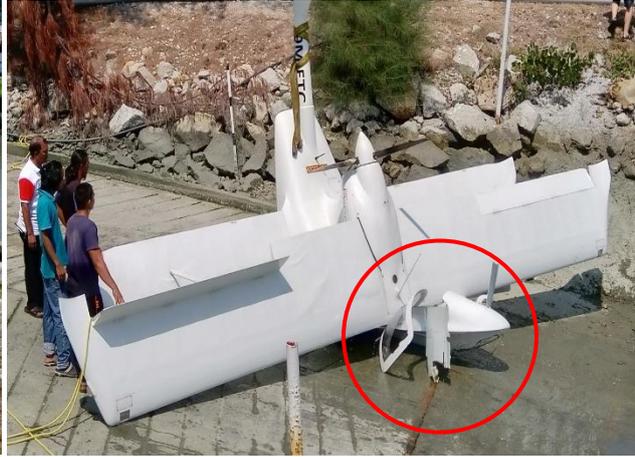
Figure 9: Significant damage to the cockpit and nose section when the aircraft wreckage was lifted and lowered to the upright position by a crane.

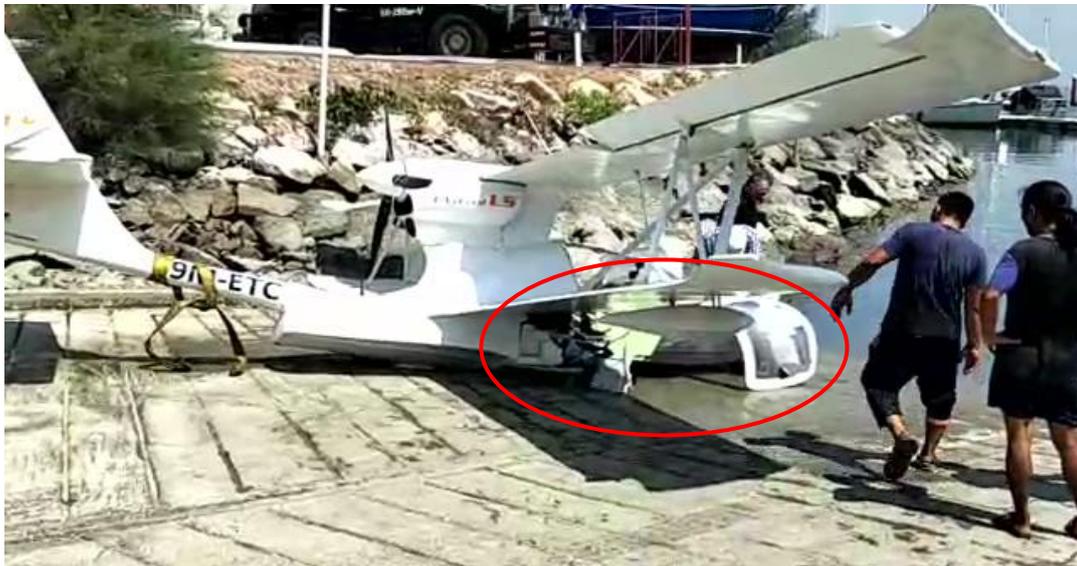
Figure 10: Aircraft wreckage in upright position with fuselage broken into two pieces. Cockpit area and nose section heavily damaged during lowering process by the crane onto the ramp.

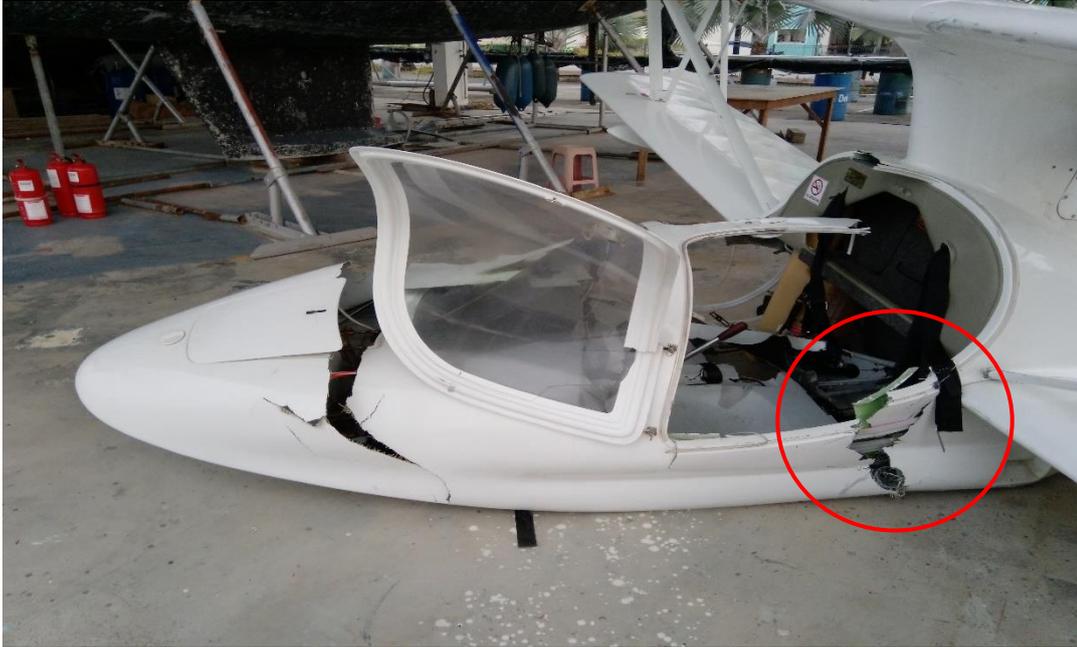
Figure 11: Port Side - Aircraft broke into two through the fuselage and hull just in front of the bulkhead dividing the cockpit and tail section. Window and door are still attached and in relative position. Pilot seat relatively intact.

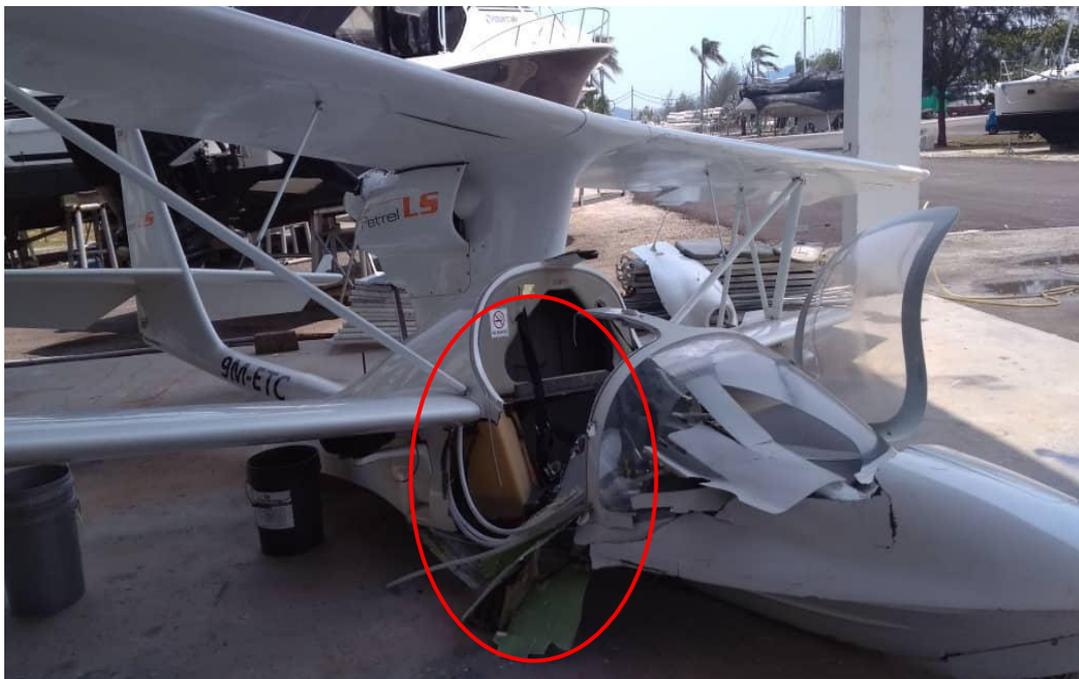
Figure 12: Starboard Side - Fuselage and hull sustained heavy damage with a big tear in front of the bulkhead. Right window and door broke off. Passenger seat broke and collapsed to cockpit floor.

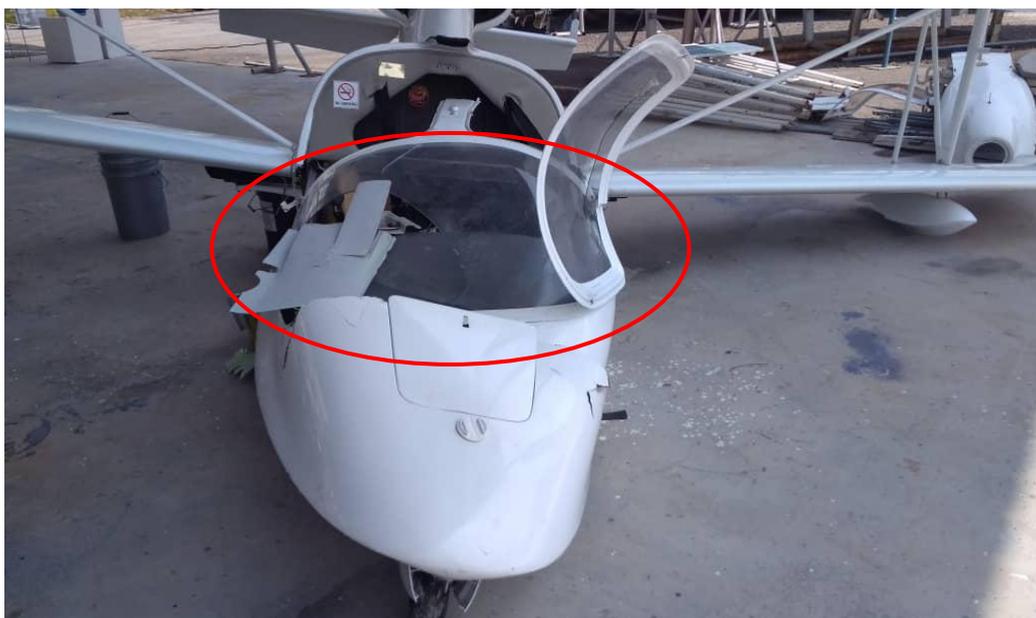
Figure 13: Nose - Damage to the windscreen and nose section during wreckage salvage operations.

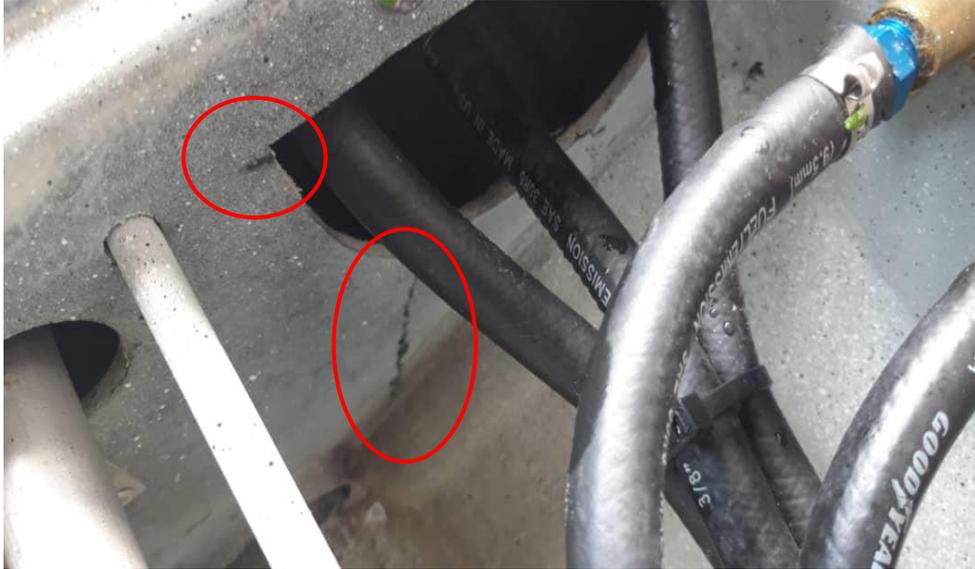
During the 100 hours' inspection on the 06 June 2019, two small cracks were found under the passenger seat frame (Figure 21) and were patched repaired satisfactory in accordance with Repair Scheme Super Petrel LS Chapter 3 Airframe Damage, paragraph 3.2.5 Damage Rear Rib of Seat Pan.

Figure 21: Crack under passenger seat frame.

The repair work was carried out by the approved engineer and was recorded in the 100 Hours Inspection Form.

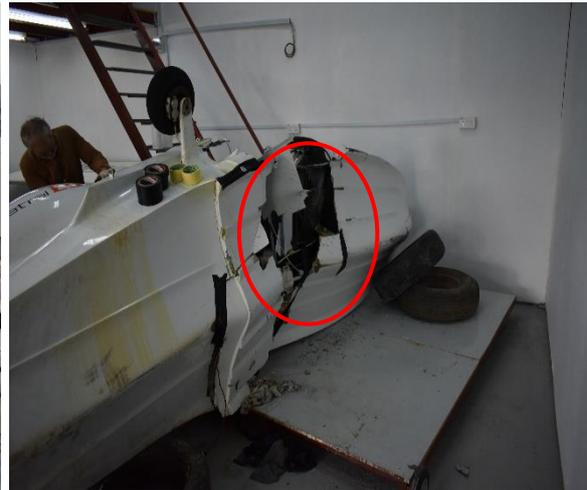
Three main pieces were gathered and put to their relative position for further investigation. Many pieces had broken off and were missing during the accident leaving a big gaping hole at the right hull section.

Figure 36: Missing pieces leaving a big gaping hole at the right hull section

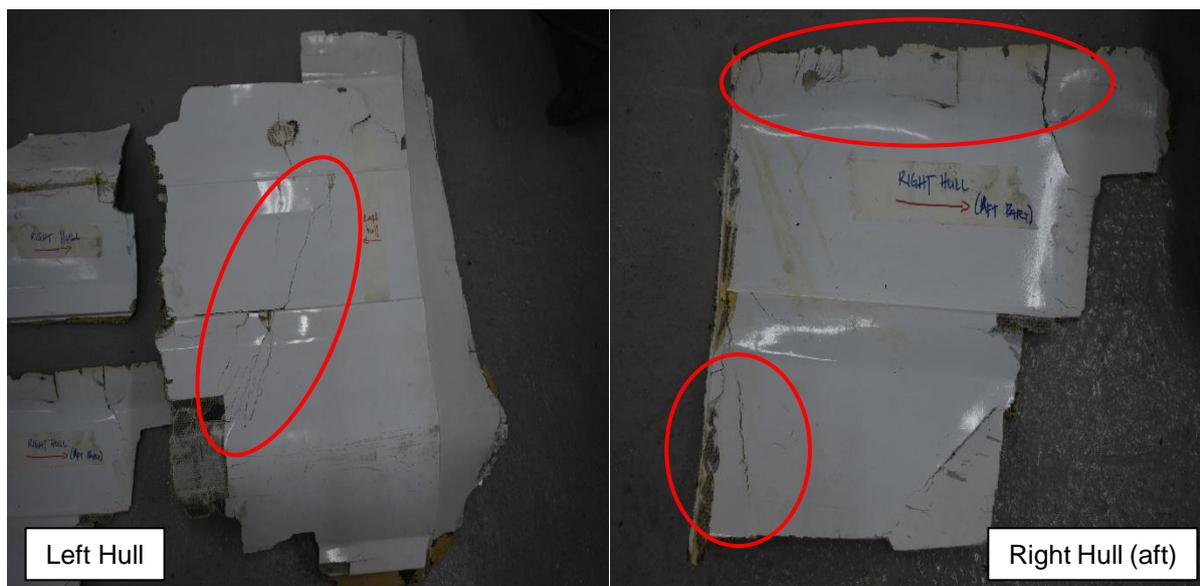
Examination on the left hull and the right hull (aft) shows clear dented marks and branching cracks (Figure 37).

Figure 37: Left Hull and Right Hull (aft) with dented marks and branching cracks

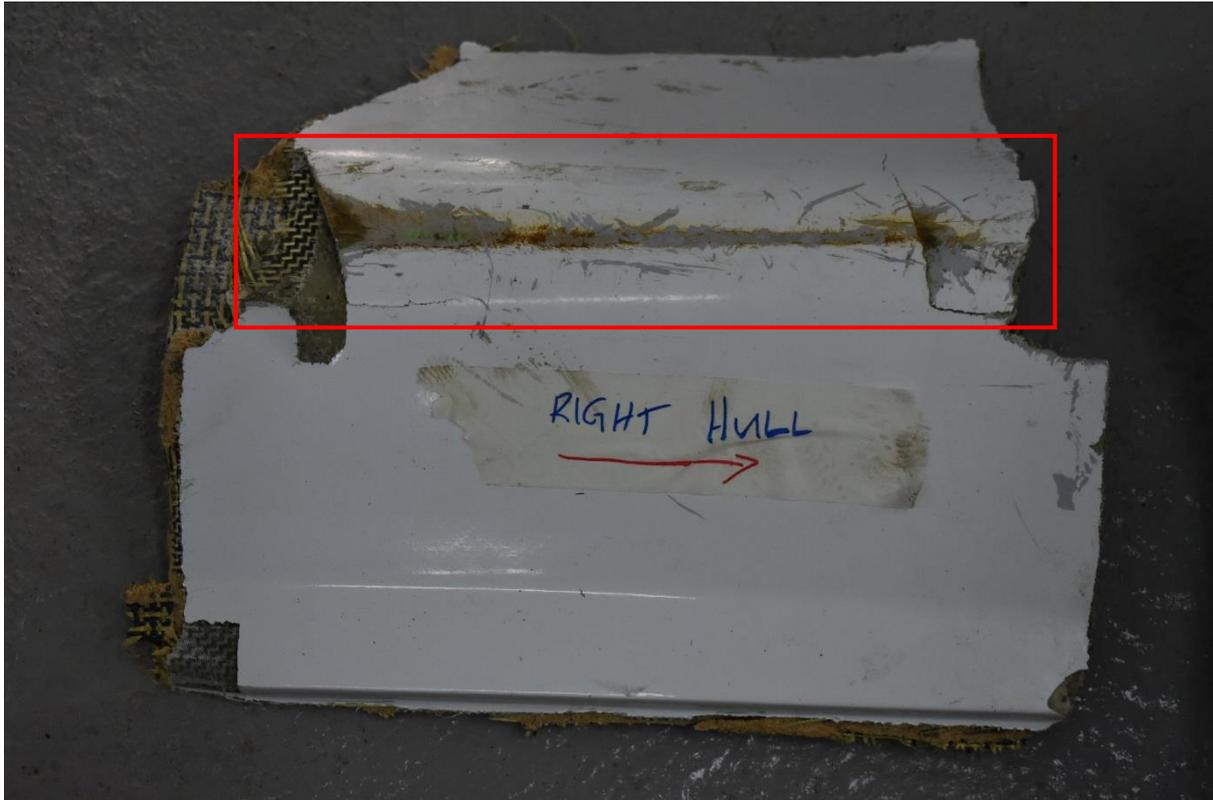
Examination on the right hull shows there are brown trailing impact marks which could be seen clearly on the centre axis of the bottom hull (Figure 38).

Figure 38: Right Hull with brown trailing impact marks

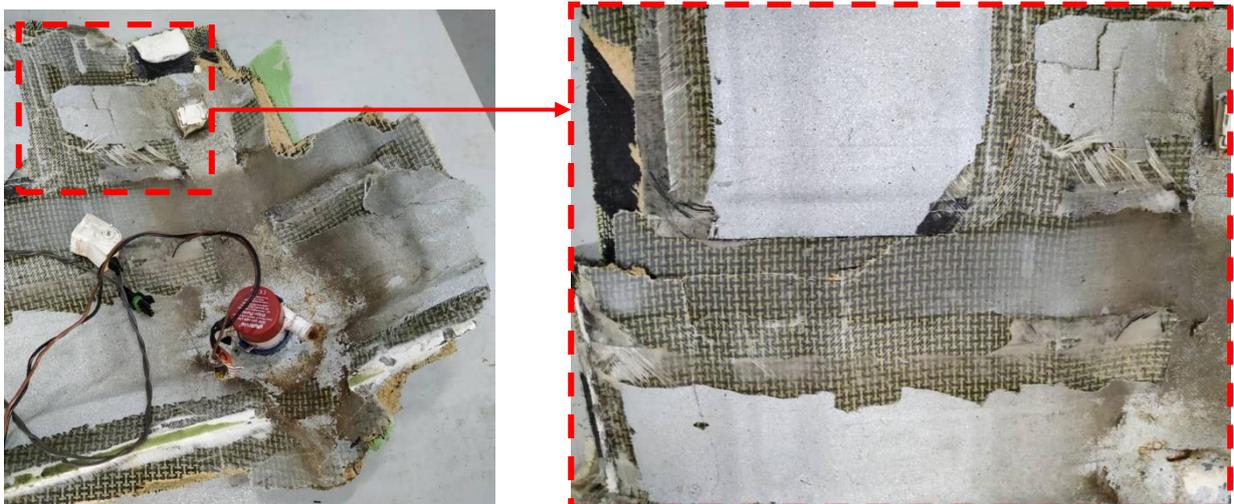
Examination on the inner side of the left hull discovered that some of the composite layers had delaminated and peeled off due to impact forces reacting on the adjacent broken hull (Figure 39).

Figure 39: Delaminated & peeled off inner layer of the left hull

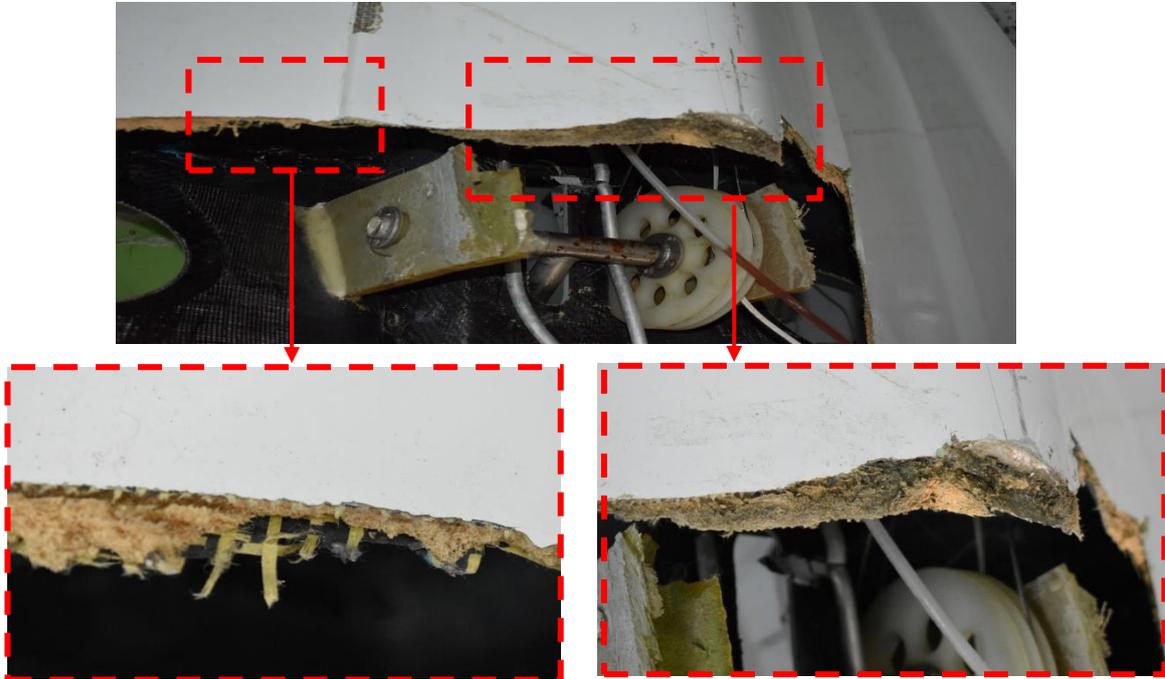
Closed-up examination of the fractured surface of the hull did not find any abnormalities or premature crack. Fractured surface of the hull showed the impact was in the shear and tension mode (Figure 40).

Figure 40: Fractured surface of the hull shows the impact was in the shear and tension mode

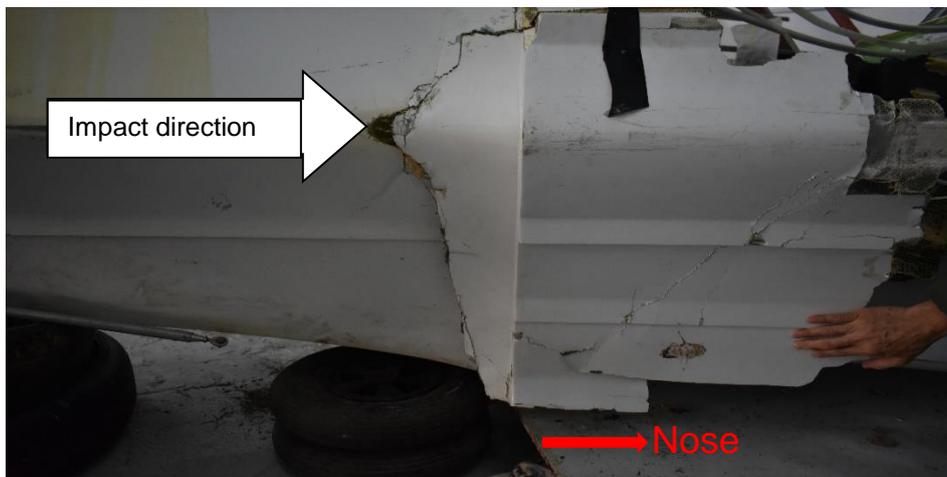
Other impact damage marks observed were at the centre bottom aft hull between the tail and cockpit section (Figure 41). The impact mark is consistent with the hull hitting a hard and sharp object.

Figure 41: Impact mark on the centre bottom aft hull

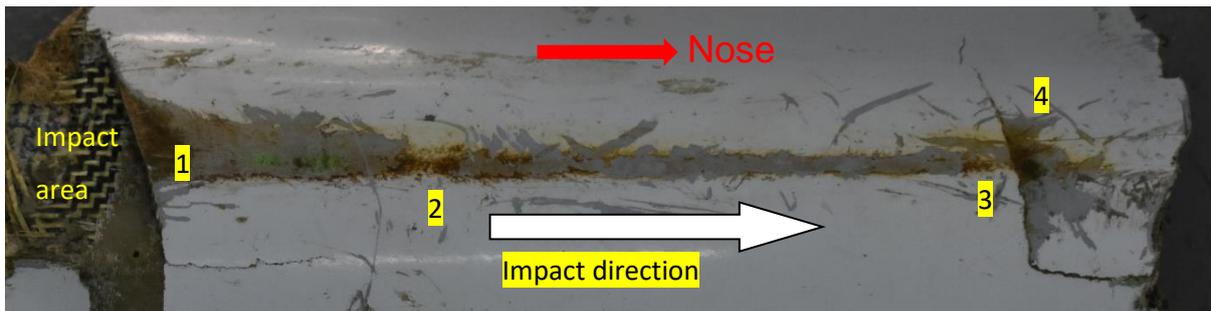
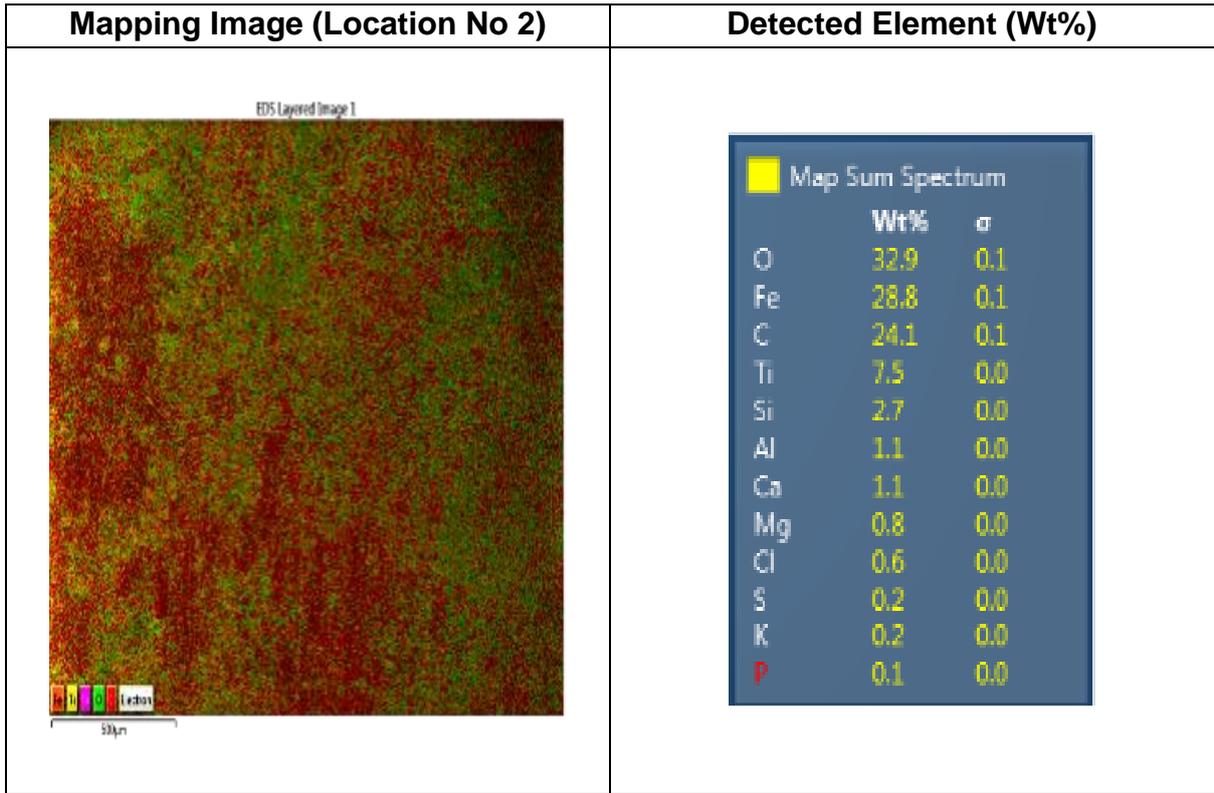
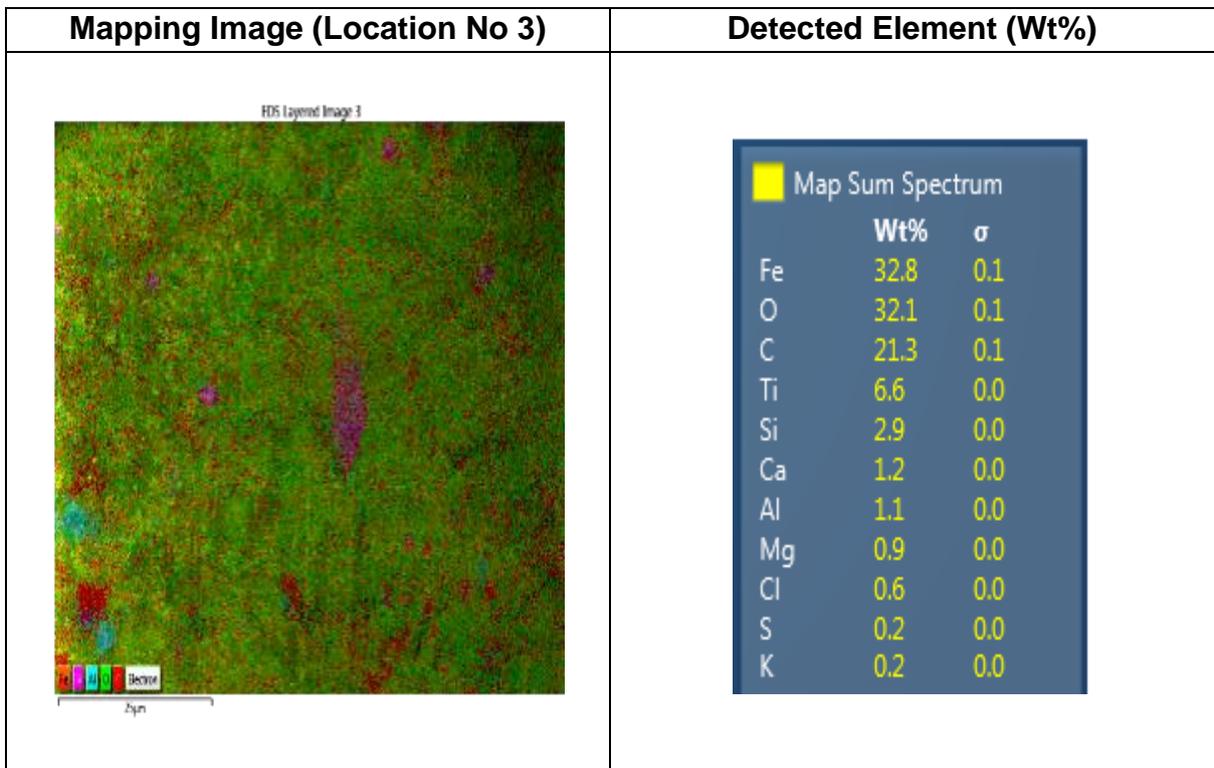
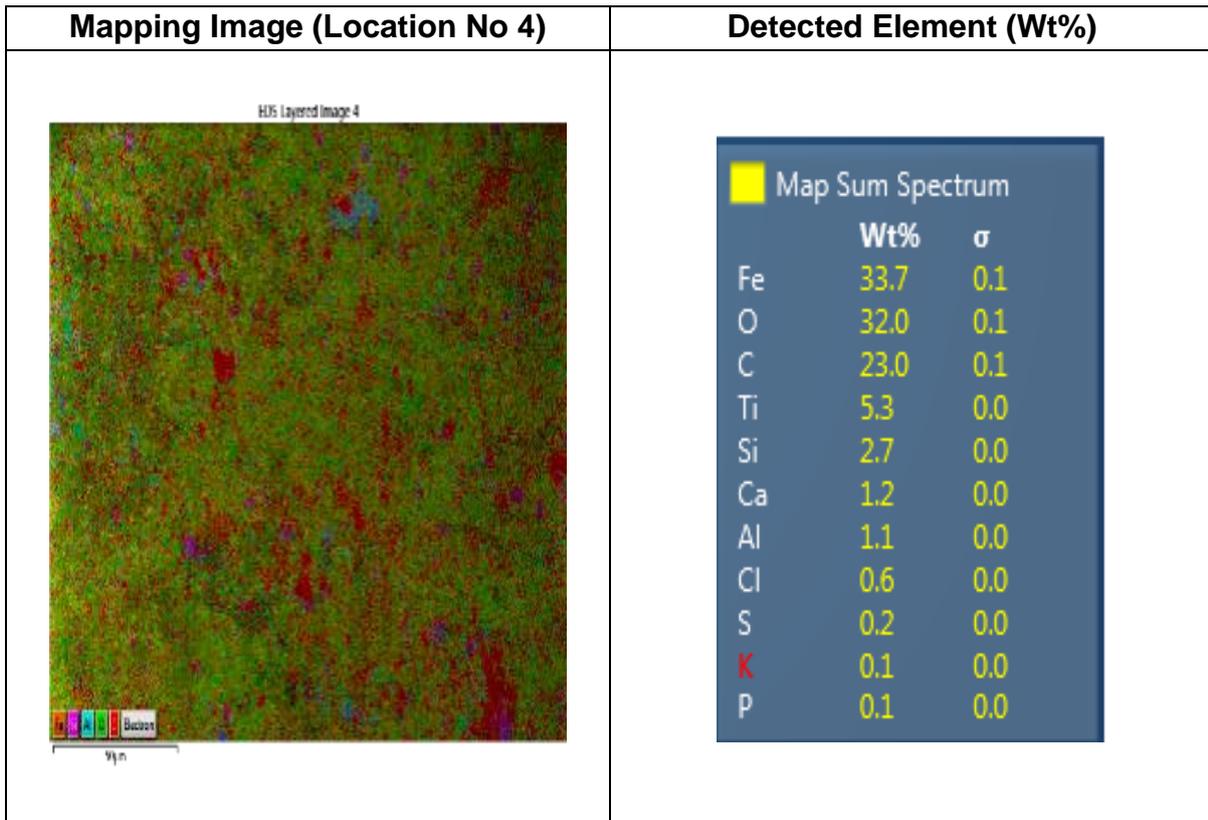
FESEM-EDX mapping analysis on the discolouration impact mark had traced several numbers of metal elements such as aluminium (Al), magnesium (Mg) and iron (Fe) as the major element that overlap with the oxygen (O) to form a brown corrosion product (FeO_2) indicating the oxidation process had occurred on that particular surface. The FeO_2 and other metals elements detected indicated the aircraft hull had made contact with an unknown object in the accident.

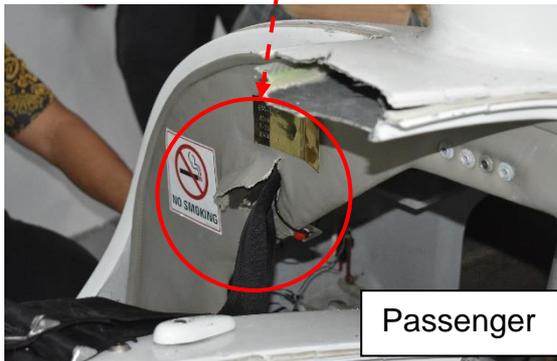
Figure 49: Passenger seat belt harness frame crack due to rapid deceleration G forces during impact

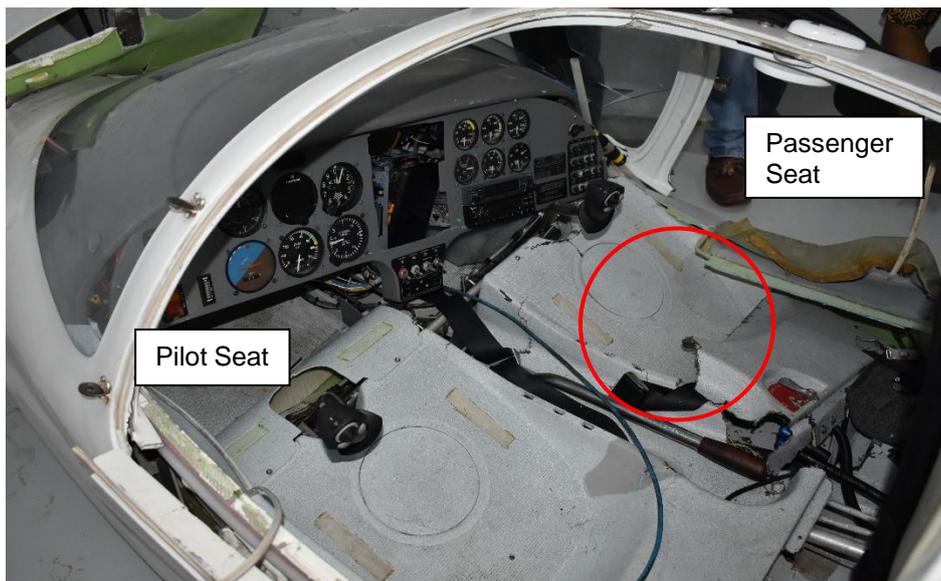
Figure 51: Pilot seat still intact while passenger seat broke and collapsed downward due to broken right hull during impact

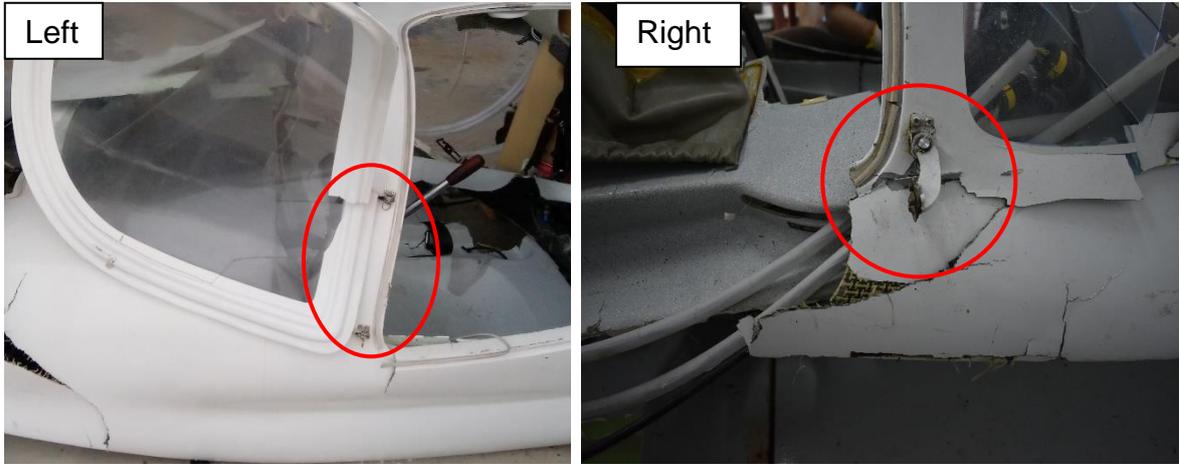
Figure 52: Left window and door hinge still intact

Figure 53: Right window missing and door hinge broke during impact

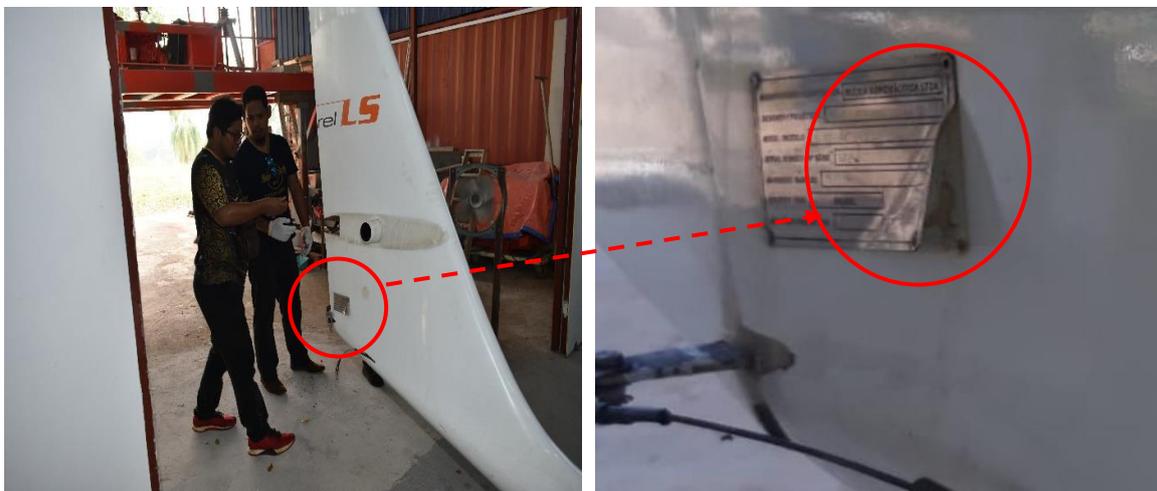
Figure 54: Aircraft registration metal plate on the right tail fuselage section dislodged most probably caused by either boat towing or crank lifting process during salvage operations

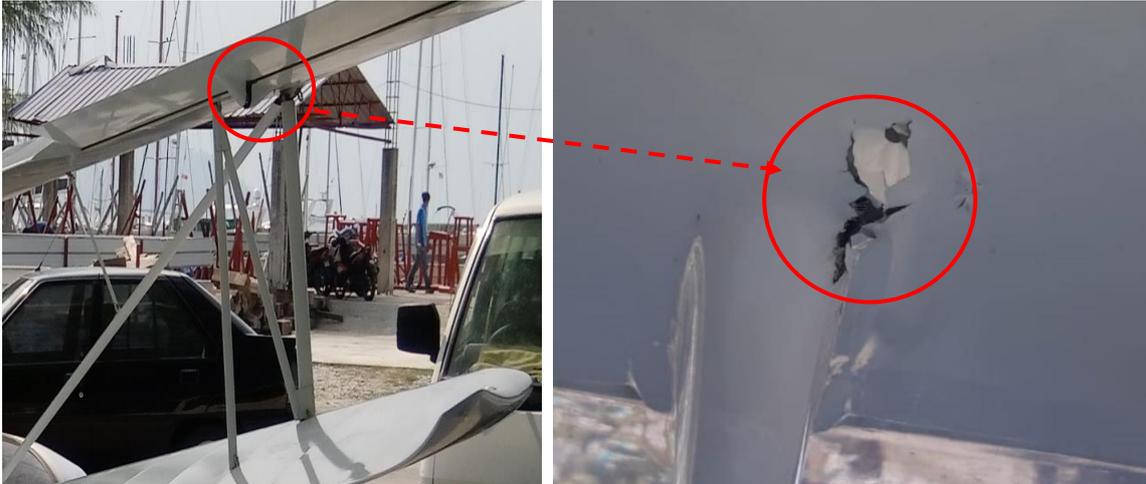
Figure 55: Torn skin underside of the upper right wing aileron fairing most probably caused by an object impact when right wing dropped and impacted the water

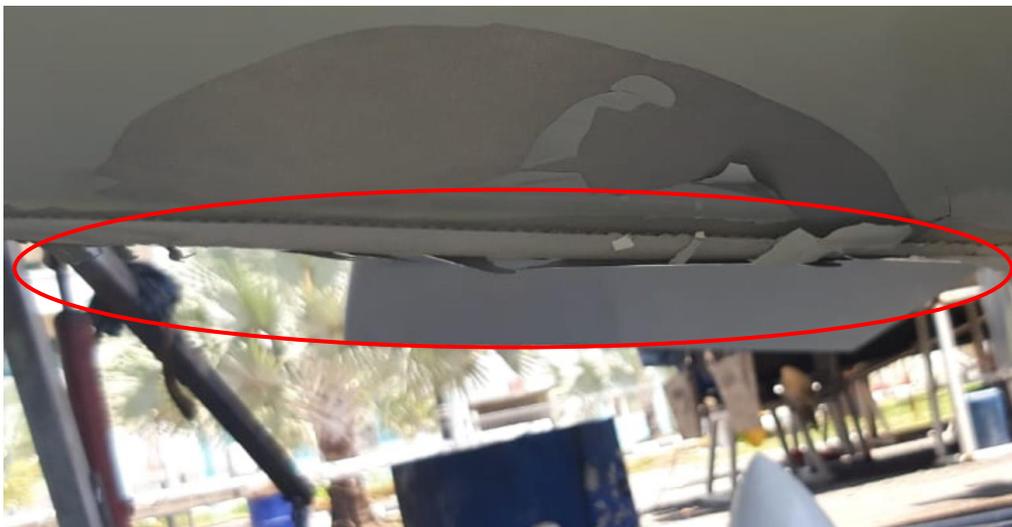
Figure 56: Bulged surface underside of lower right wing most probably caused by water impact at speed when right wing dropped into water creating a dragging force and veering the aircraft to the right

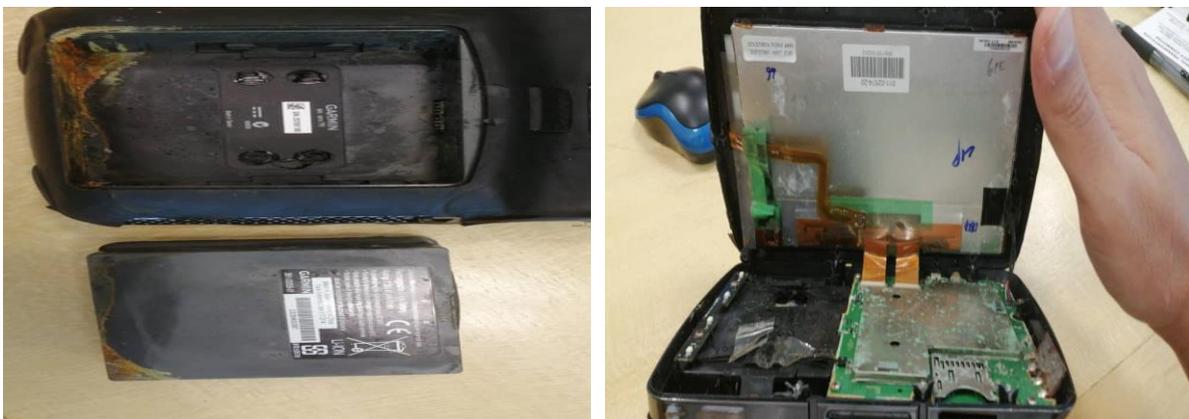
The onboard GPS was sent to the laboratory to recover the flight data information stored. Due to impact and corrosion damage to the Printed Circuit Board (PCB), the laboratory personnel were unable to retrieve any data from the GPS to provide valuable information on the aircraft performance during the pilot's approach and landing.

Figure 59: Condition of the GPS after recovery from the wreckage

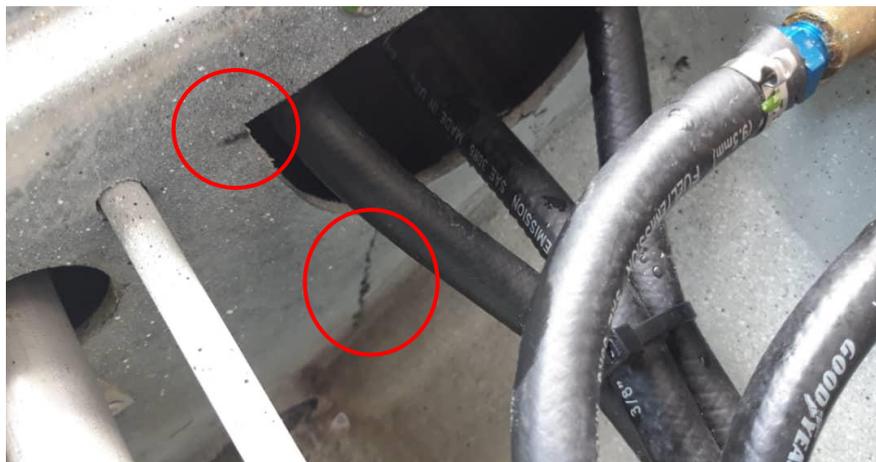
The two small cracks found under the passenger seat frame during 100 Hours Inspection (Figure 61) were patched and repaired satisfactory in accordance with Repair Scheme Super Petrel LS Chapter 3 Airframe Damage, paragraph 3.2.5 Damage Rear Rib of Seat Pan. The passenger seat frame was still intact after the accident although the passenger seat had collapsed during the accident due to the weight of the passenger and likely generated by an identified hard metal object whose marks and material particulars were found on the hull analysed broken parts via dedicated laboratory analysis.

Figure 61: Cracks at passenger seat frame before accident

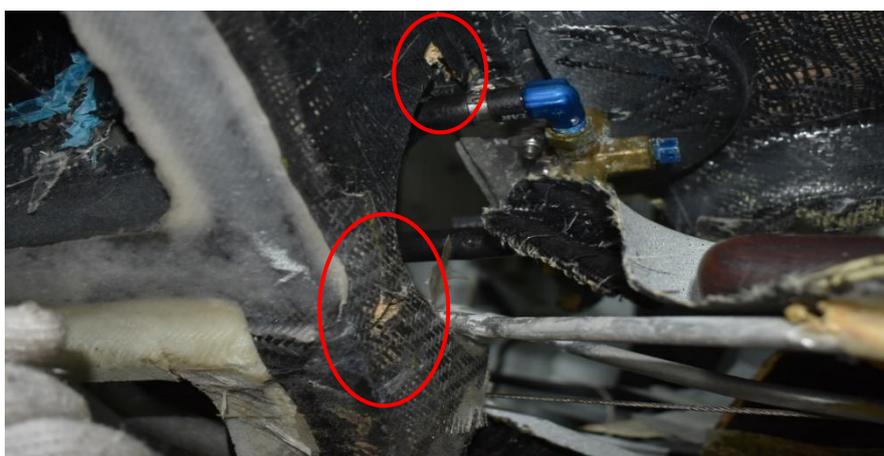
The patch scheme of repair after the accident is still intact, as shown in Figure 62.

Figure 62: Patched repaired cracks at passenger seat frame still intact after accident (reverse side)
