### **FINAL REPORT**

**SI 01/20**

**Twin Otter DHC6-400, Registration 9M-SSE**

**at Miri Airport, Sarawak**

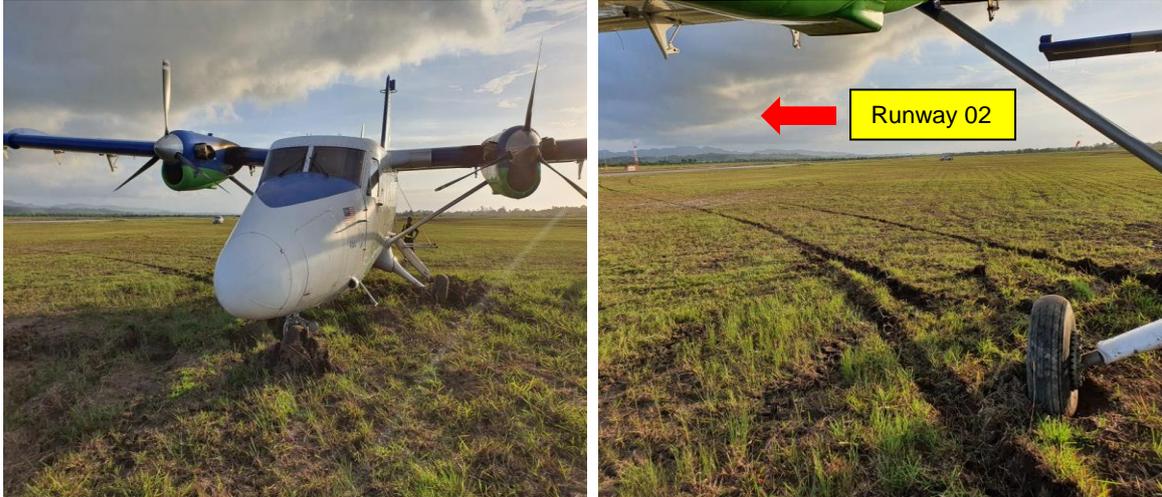
There was no damage found to the aircraft's structure. All wheels and main wheels' brake units were covered with mud (Figure 2). The nose wheel was found with a heavy spot wear and some heavy wear marks.

Figure 2: Aircraft final position and skid marks from runway edge

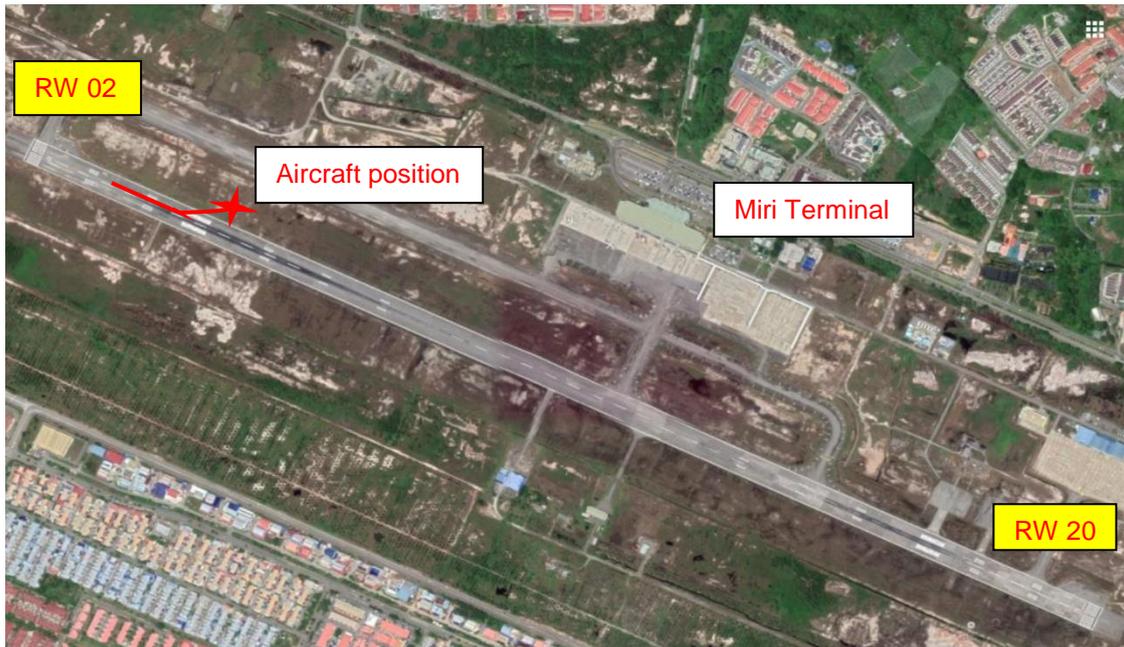
Figure 7: Aerial View of Aircraft Position at Miri Aerodrome (Not according to scale)

The aircraft was intact after the incident. It came to rest at about 40m perpendicularly from the runway edge. The aircraft was stuck in soft ground and was extricated later that evening by Operator's Engineering Team with assistance from the airport authorities.

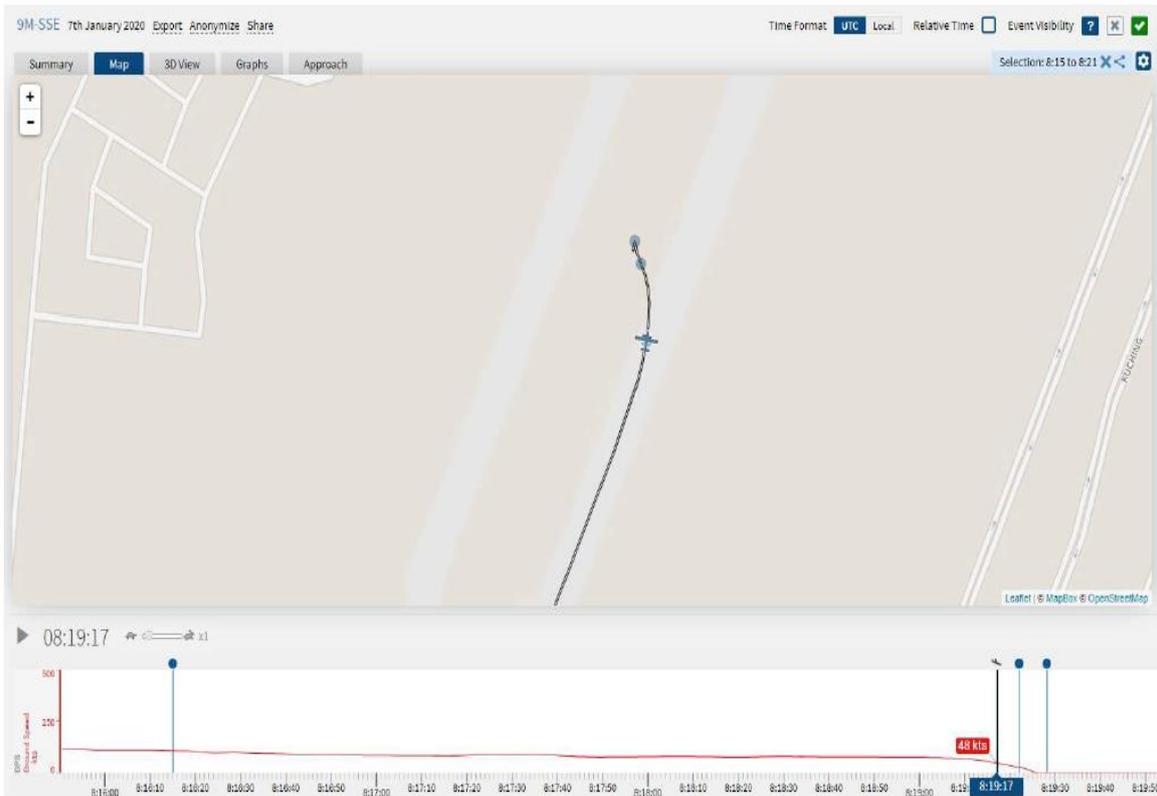
Figure 9: QAR Data Final Approach to Aircraft Complete Stop – Aircraft Veered Left after Touch Down

QAR data shows that the aircraft had stabilized at 500ft during the approach to land in accordance to the DHC-6 Series 400 SOP. The data also found no significant event during the approach to land phase (Figure 8). The incident occurred after the aircraft touchdown on the runway

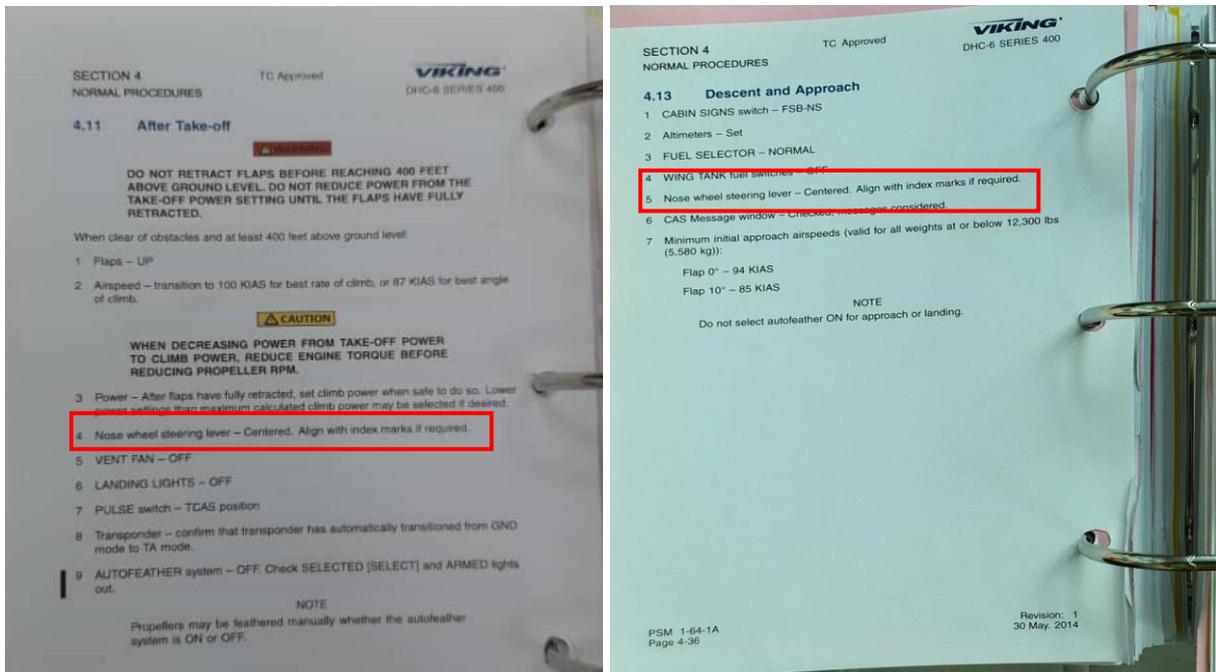
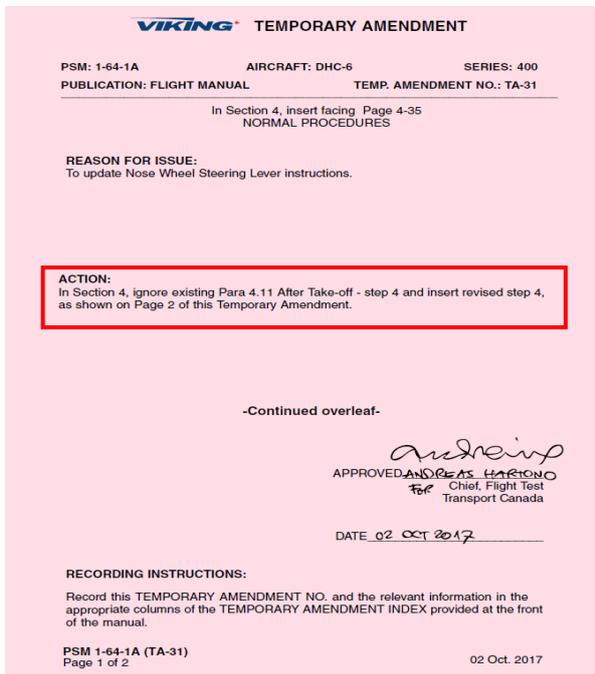
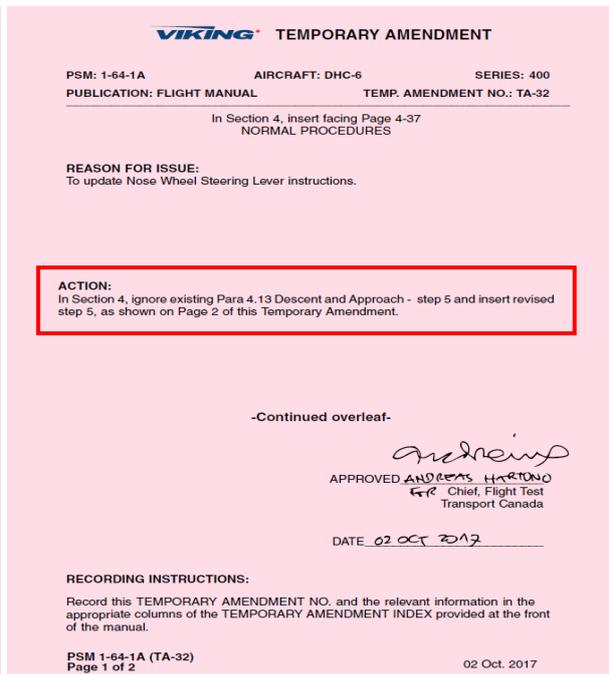
It was observed that the paper checklist in use by the pilots were not updated (Figure 10). The temporary amendment to the checklist was omitted although the amendment was issued by the manufacturer dated 02 October 2017. The checklist amendment concerned an update on the Nose Wheel Steering Lever for After Take-off (temporary amendment no: TA-31) and Descend/Approach Checks (temporary amendment no: TA-32) (Figure 11).

Figure 10: Checklist – After Take-off and Descent/Approach Checklist before Amended Procedure

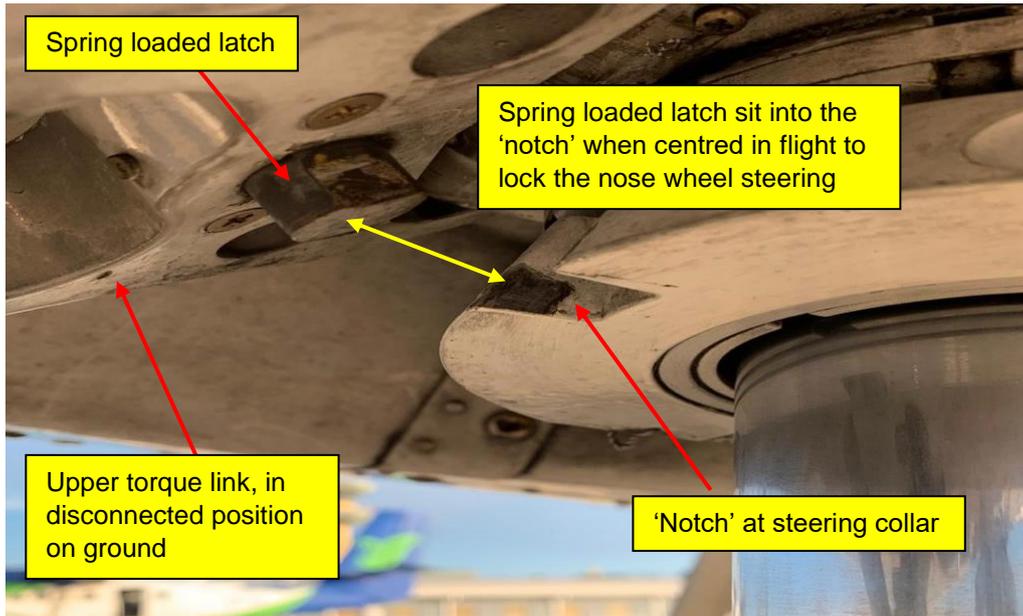
The aircraft nose wheel is not the self-centring type. The nose-wheels must be centred into a “notch” after the aircraft is airborne. A spring-loaded tab will fit into a recession in the steering collar. This is done manually by the pilot by manipulating the nose wheel steering lever to the left and right, once after take-off and again, before descent as a fail-safe. The convention is that if the nose wheel is not in the notch due to be off-set from centre, moving the nose wheel steering will place it in the notch (Figure 26).

Figure 26: Nose wheel steering centring mechanism

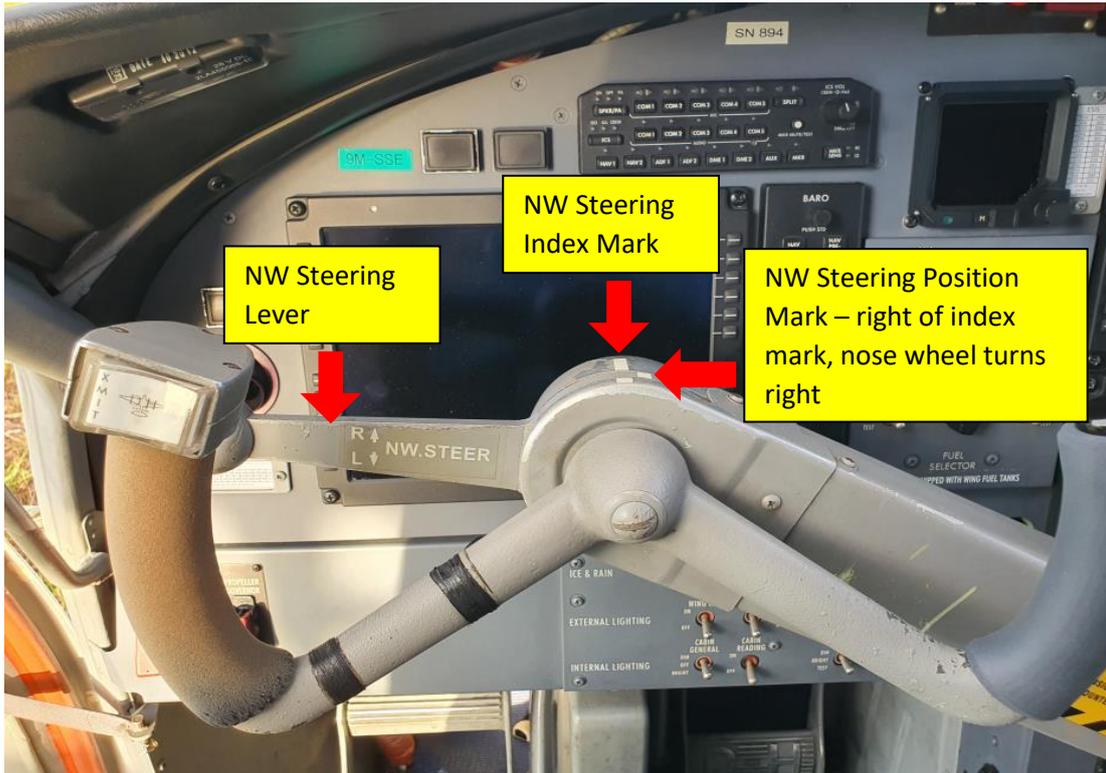
The technique taught during conversion and recurrent training to pilots to centre the nose wheel steering was to wiggle the lever (Figure 27). Pilots must be train on how to operate the lever with emphasis on the correct technique and a standard method as the wiggle action is very subjective.

It is noted that the wiggle action was practice as the amendment instructions to apply upward and downward pressure on the nose wheel steering lever was omitted and not amended.

Figure 27: Nose Wheel Steering Lever Centre Index Mark and Position Mark

To mitigate these unsafe supervisions, more emphasis is to be given to improve the nose wheel system knowledge of the pilots during ground training. During flight training, correct and standardise technique to centre and lock the nose wheel steering lever as instructed by the amendment to the checklist must be taught and practice by all pilots to prevent similar future incidents.

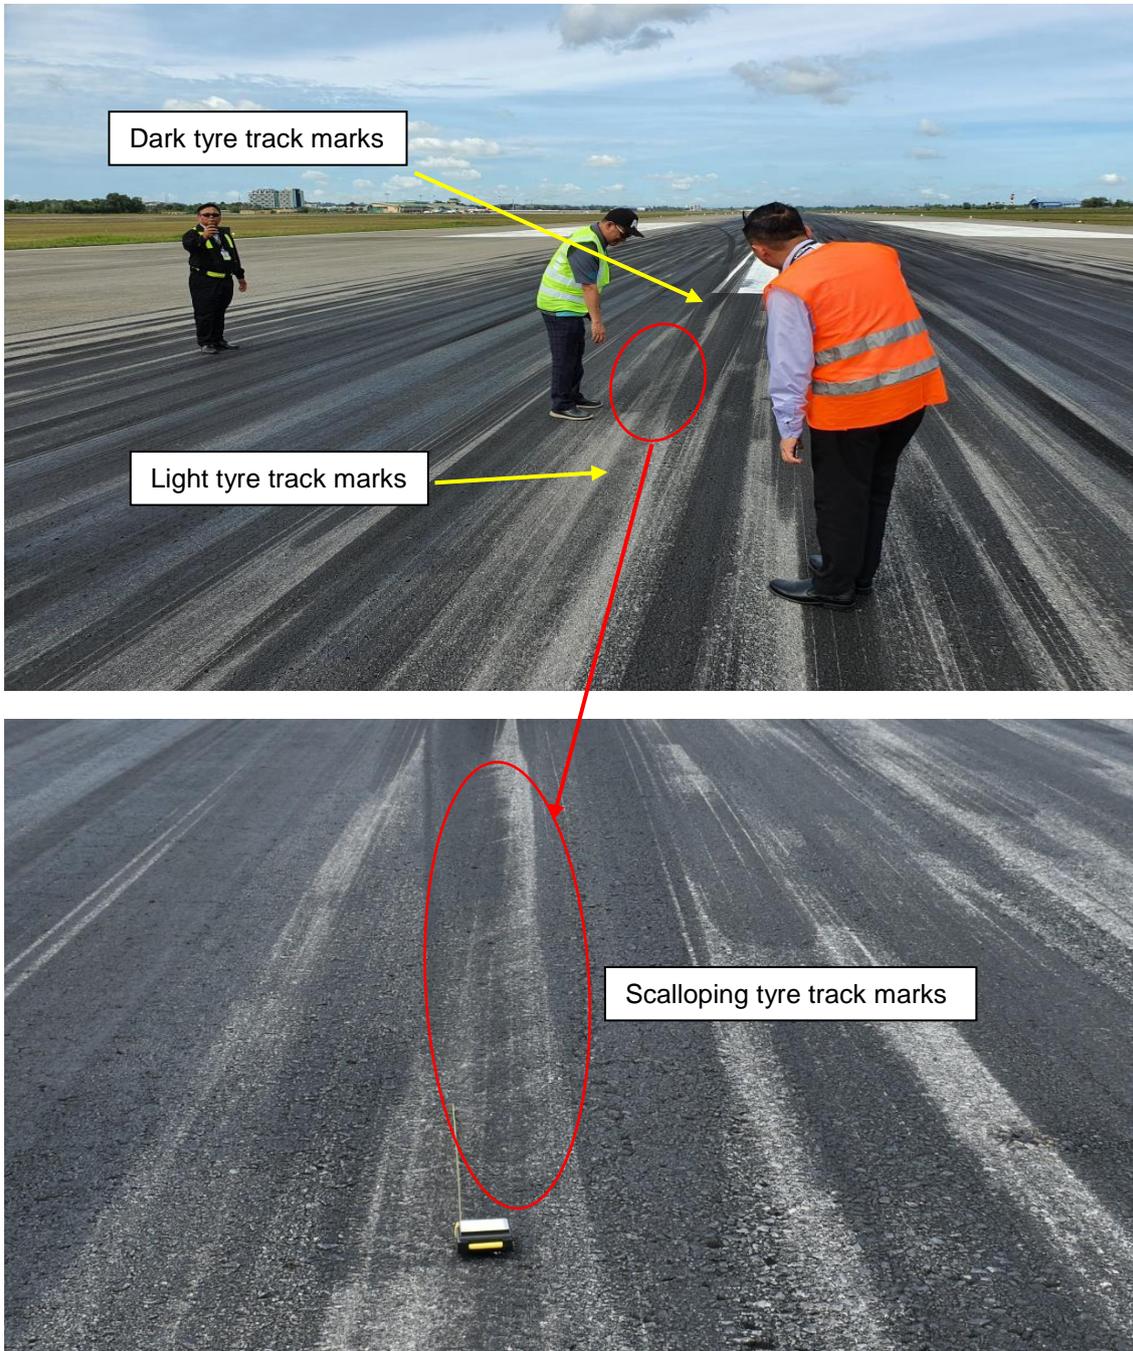
Figure 30: View of the nose wheel tyre track marks near touchdown point. Note how the nose wheel tyre track marks transit from light to dark, increasing in thickness as the veering worsened. The initial scalloping marks indicate possible nose wheel off-set off-centre during landing.

Evidence from on-site investigation found prominent tyre track marks close to the touch down area. The nose wheel tyre marks begin with light marks followed by light scalloping marks. It progresses to darker marks followed by heavier scalloping marks as the aircraft veered more to the left. The scalloping mark stop just before the aircraft exited the runway. The aircraft continue roughly on a straight track before stopping on soft ground turning slightly right.

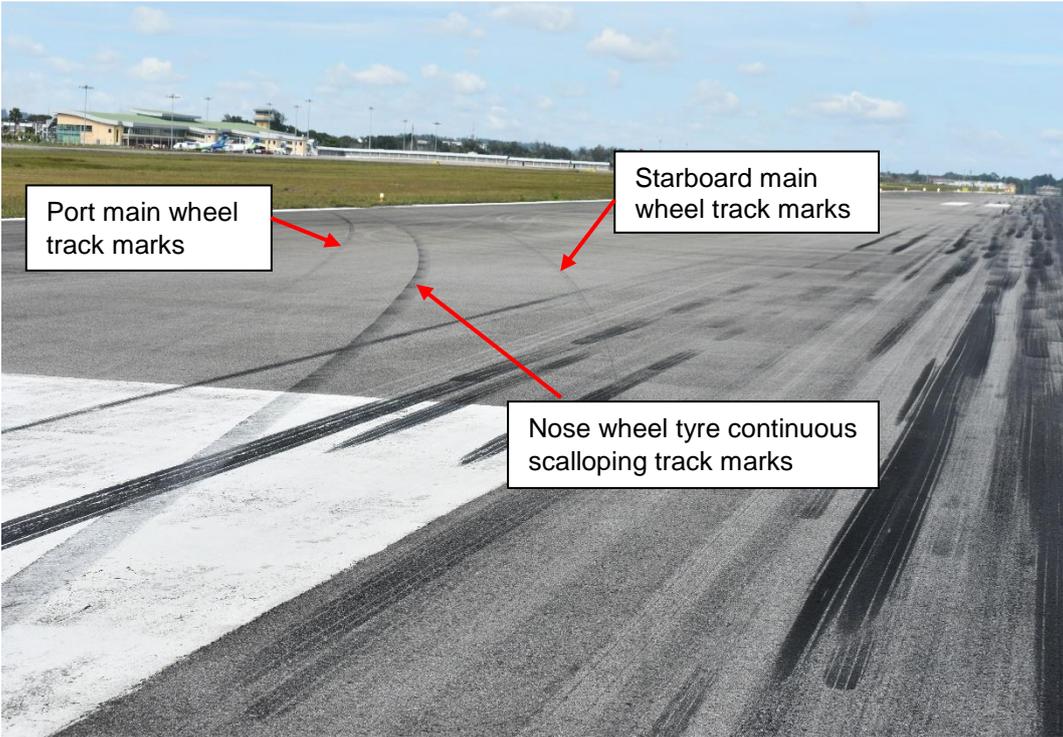
Figure 31: The nose wheel tyre scalloping marks continued before exiting the runway.

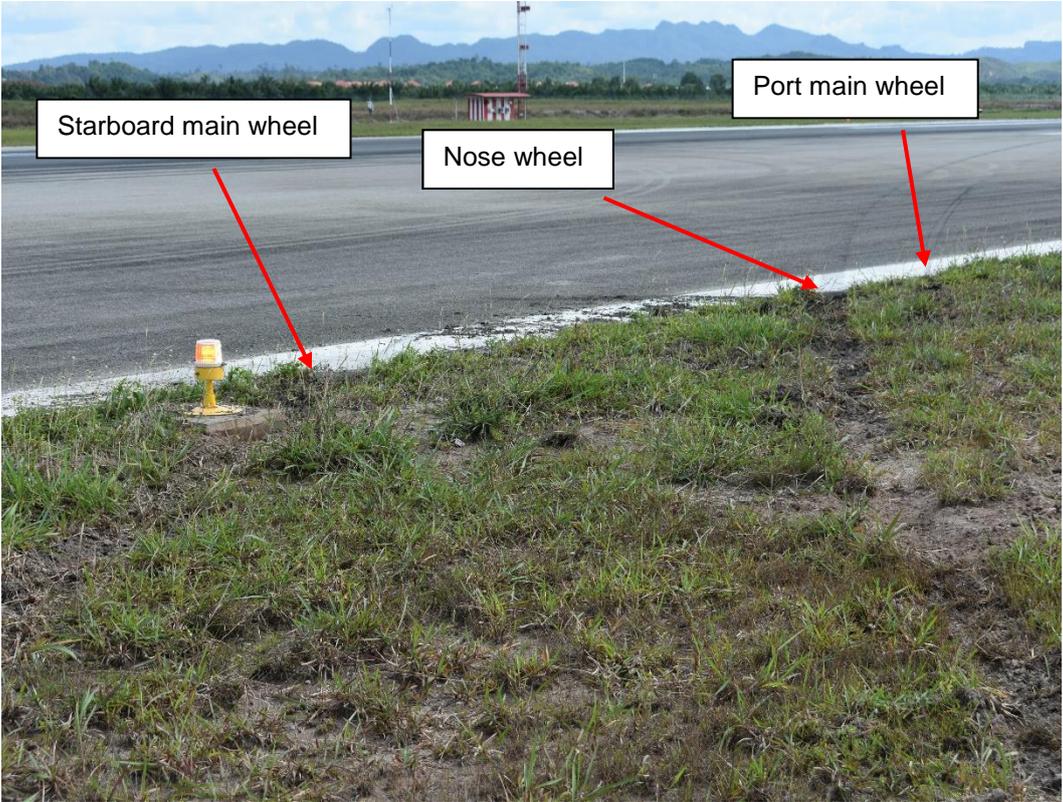
Figure 32: Aircraft tyre marks exiting runway into grass.

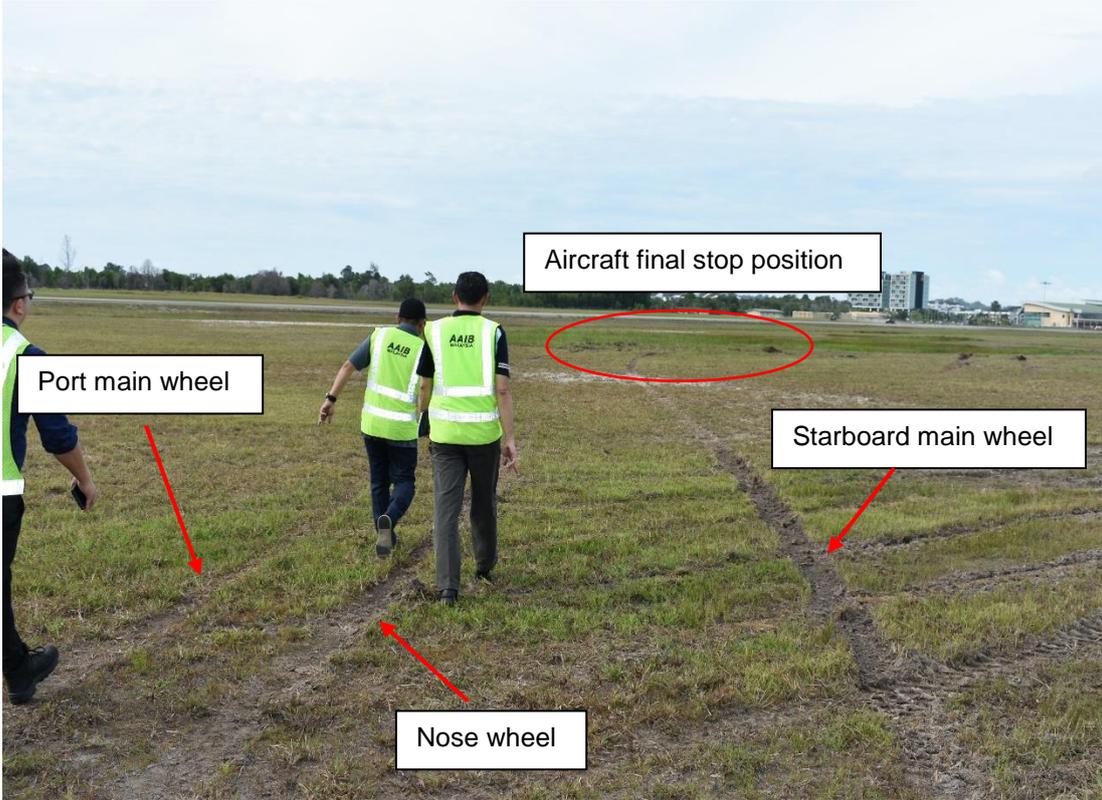
Figure 33: Tyre marks after exiting runway towards aircraft final stop position.

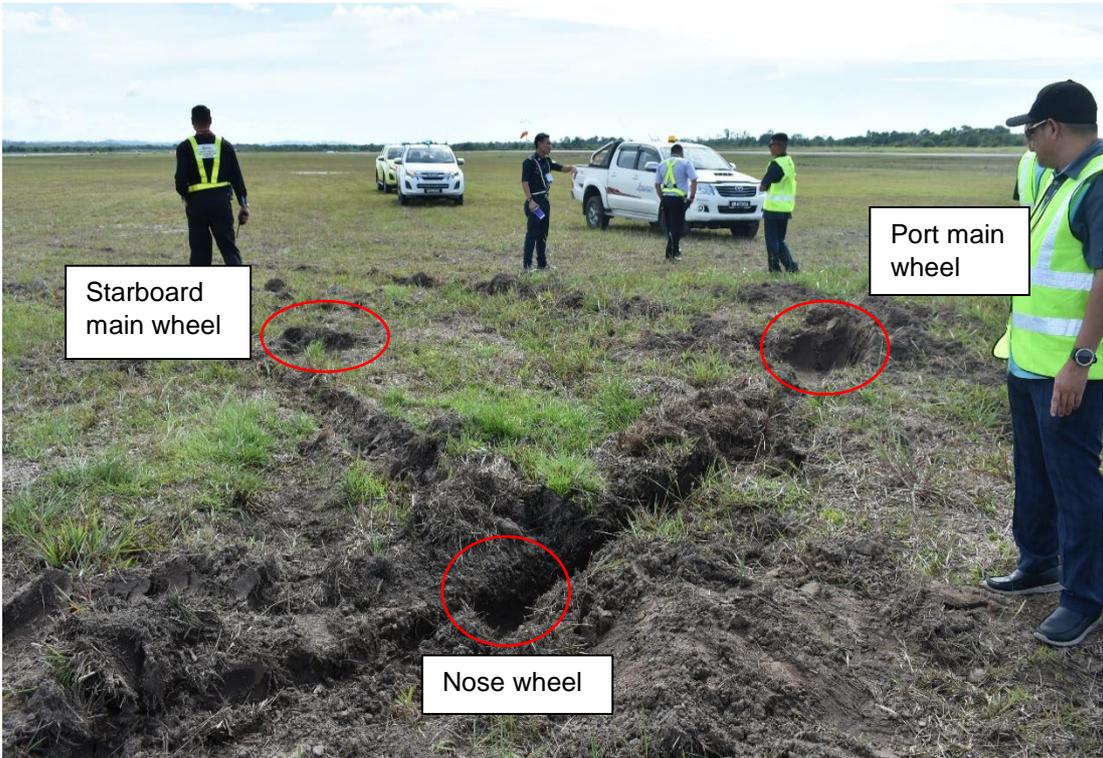
Figure 34: Tyre marks at aircraft final stop position.

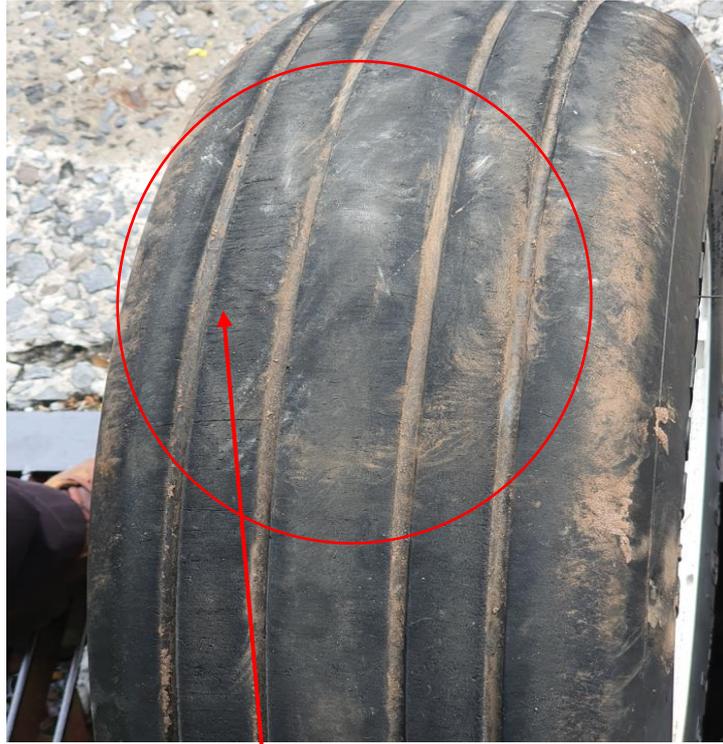
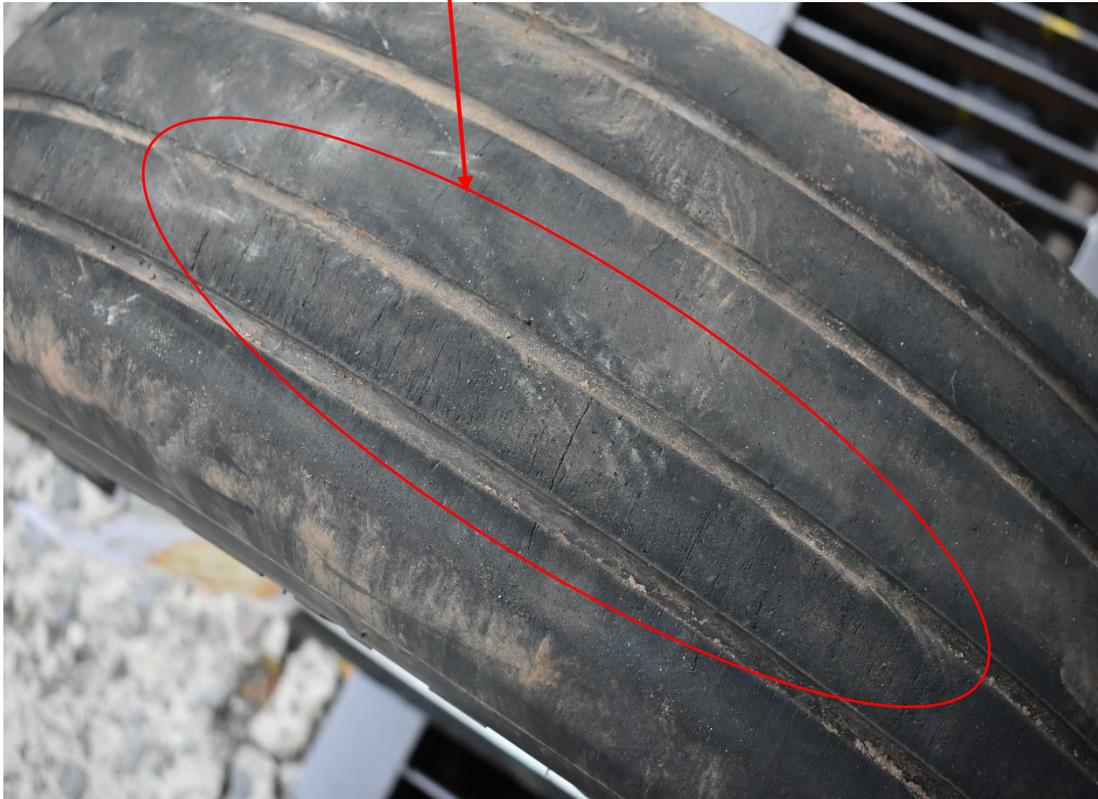
Figure 37: Heavy wear spot mark on the nose wheel tyre consistent with scalloping marks seen on the runway.

Inspection on the nose wheel tyre shows a heavy wear spot mark consistent with the scalloping tyre marks observed on the runway (Figure 37).
