AIRCRAFT ACCIDENT FINAL REPORT
A 02/20
Air Accidents Investigation Bureau (AAIB)
Ministry of Transport

Accident Involving a Bell 206L-3
Registration 9M-AZK
at LP43 on the Malaysia – Brunei Border
on 1 February 2020

FINAL REPORT A 02/20

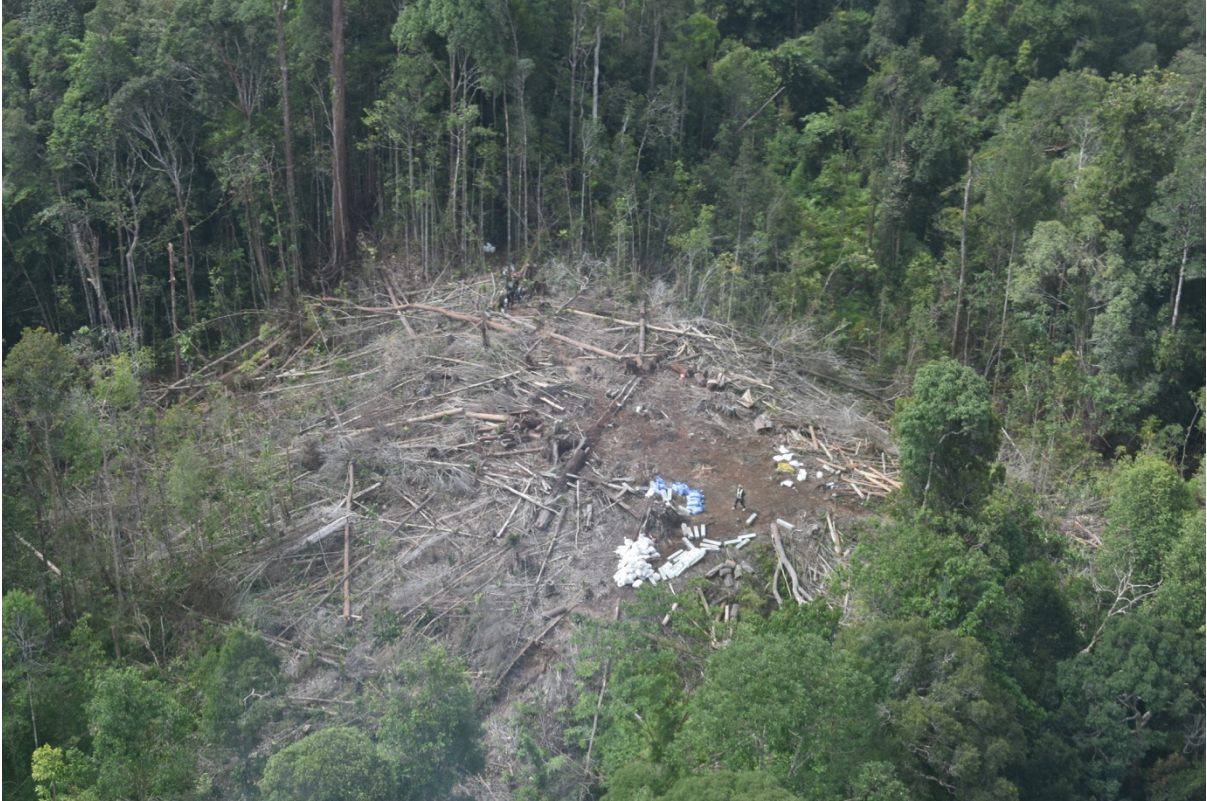
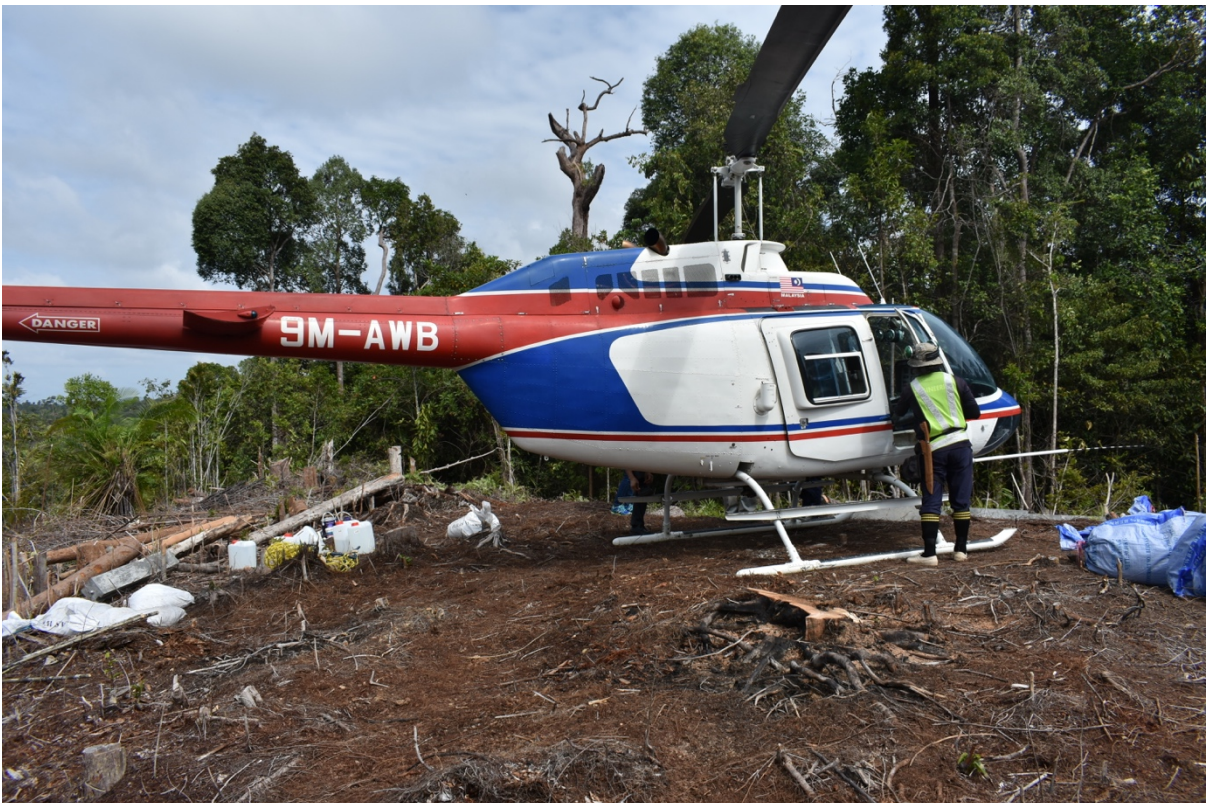
LP43 (Fig 1 & 2)

Upon the initial arrival at LP43 both pilots saw that the LP was not well prepared by the Brunei Team. Building materials were haphazardly placed around the LP leaving only a small space for the helicopter to land. **[See APPENDIX A (Fig 1 – 4)]** The PIC nonetheless decided to continue with the tasking but made a note to complain about the state of the LP after the tasking was completed.

2.4 However all that effort was tarnished by the fact that the building materials (border markers, sand & concrete plus containers of water) were haphazardly placed around the LP restricting the amount of useful space available for the helicopter to land and carry out underslung operations.

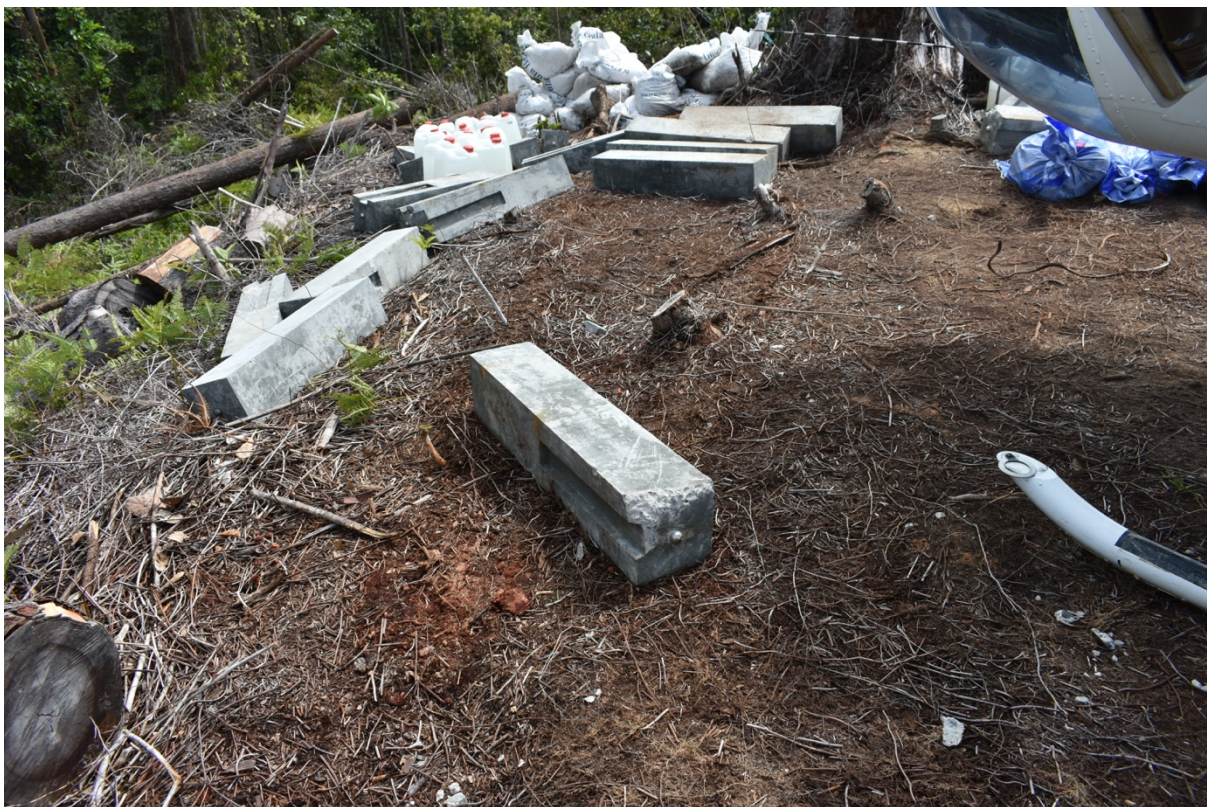
LP43 (Fig 3 & 4)

During the second pick-up of an underslung load from LP43 things went horribly wrong. Due to the lack of space on the LP itself, the prepared underslung load (two concrete markers in a cargo net) was placed hardly two feet from the left skid of the aircraft. **[See APPENDIX**

A (Fig 4)] The concrete marker in the picture is placed at the approximate position where the underslung load was.

2.5 This caused the placement of the underslung cargo net to be too close to the helicopter and more importantly out of sight from the PIC which ultimately led to the accident.

The helicopter operator in this case is required to ensure that a really comprehensive joint briefing to all stakeholders involved in such a tasking is carried out. This would include personnel from JUPEM, their contractors on the ground and especially the team preparing the LP.

- a. Educate everybody on the safety aspects with regards to helicopter underslung operations.
- b. Ensure that the minimum specifications required of a Landing Point is met, and
- c. Stressing the point that if these specifications are not met the tasking will not be carried out.

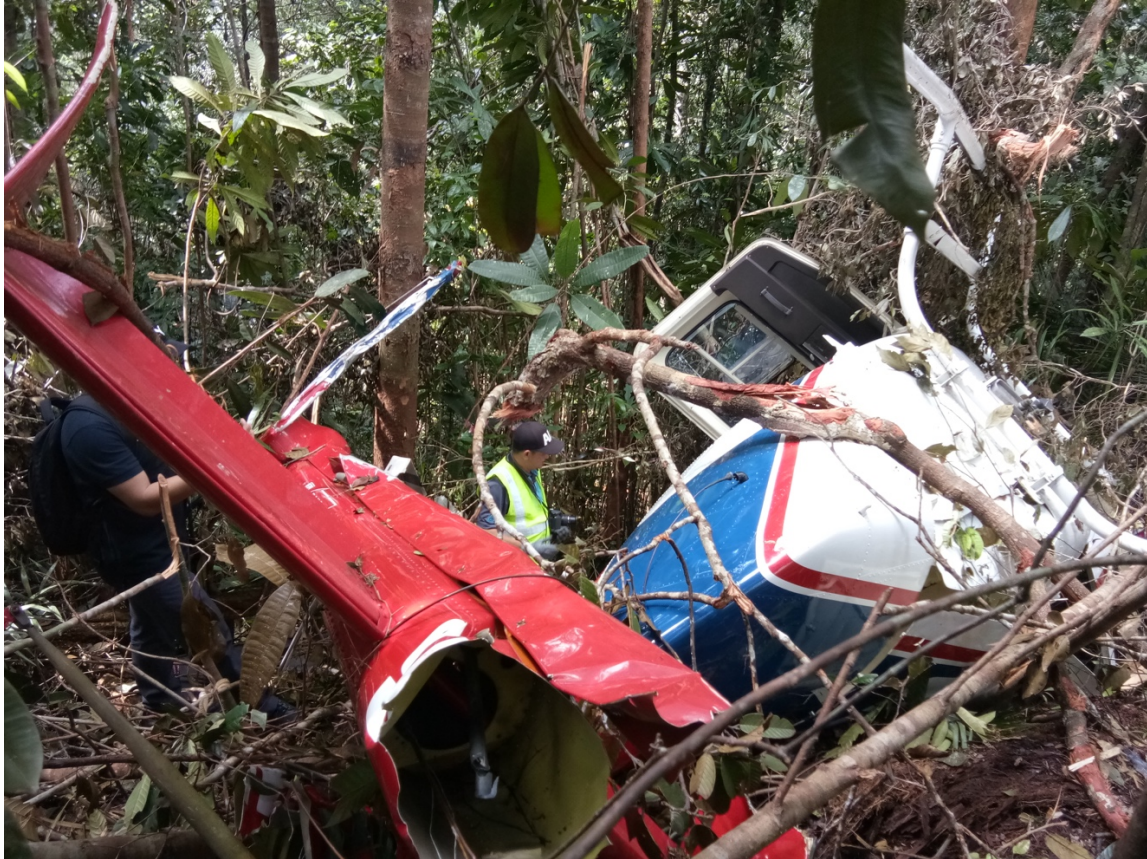
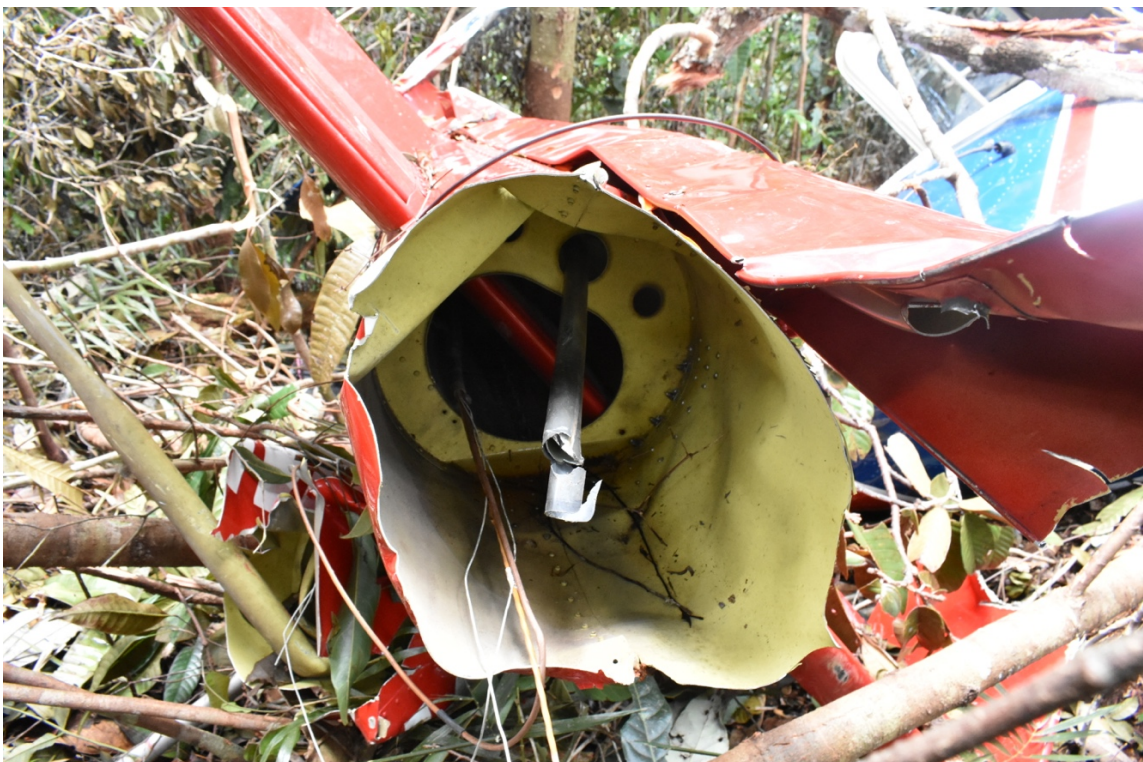
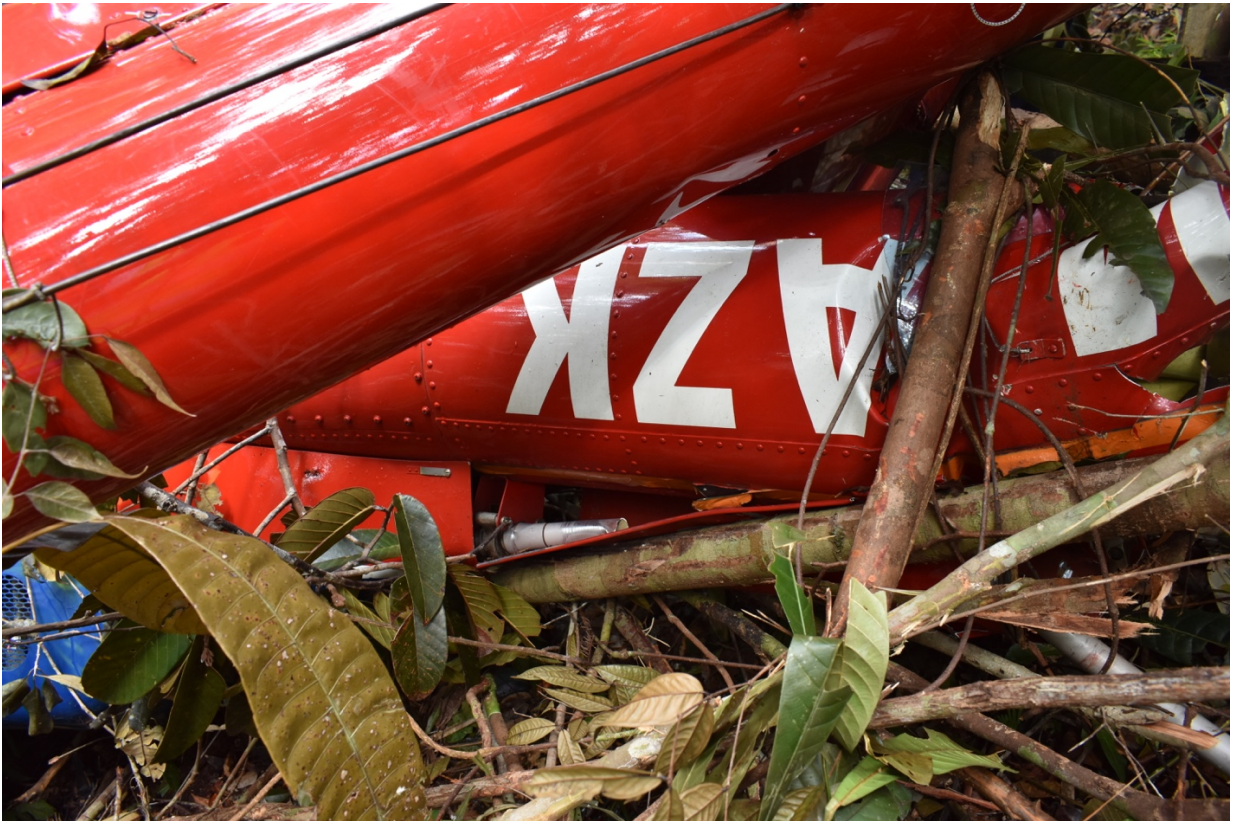
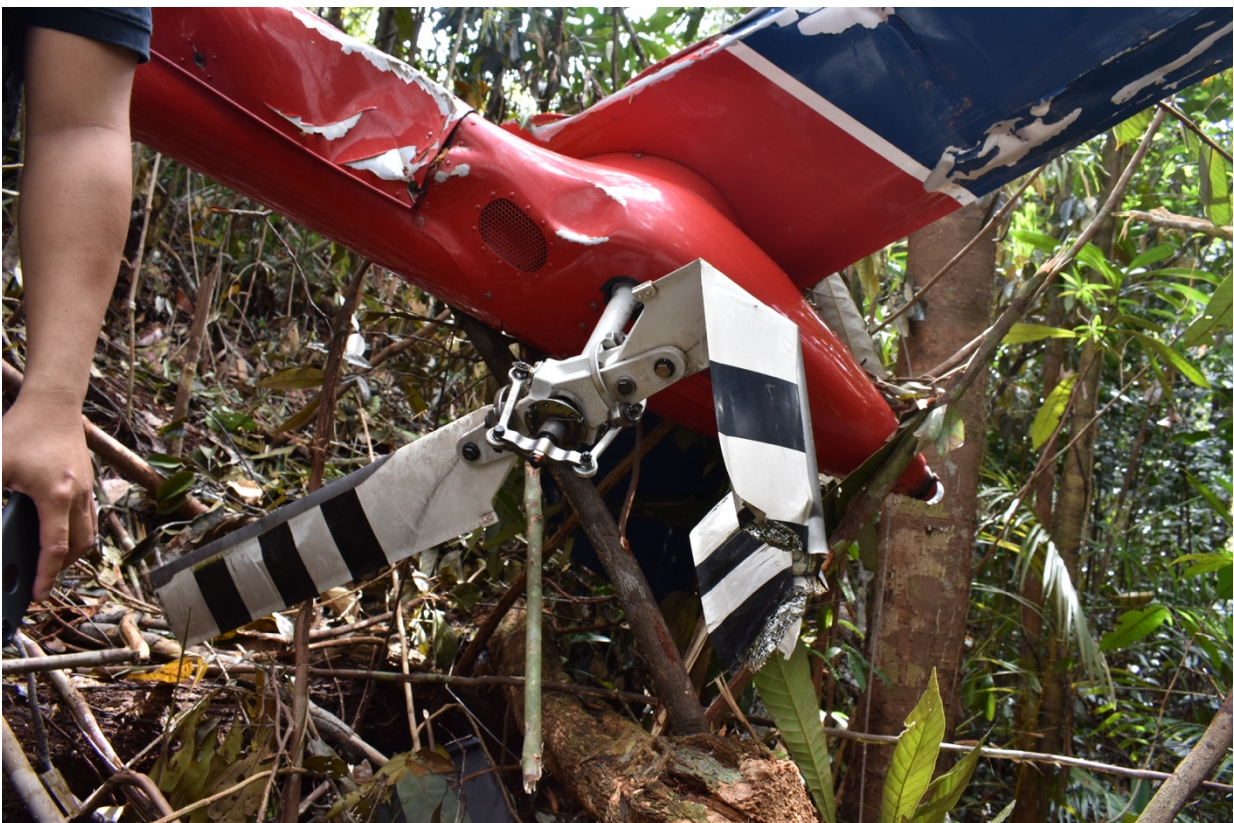
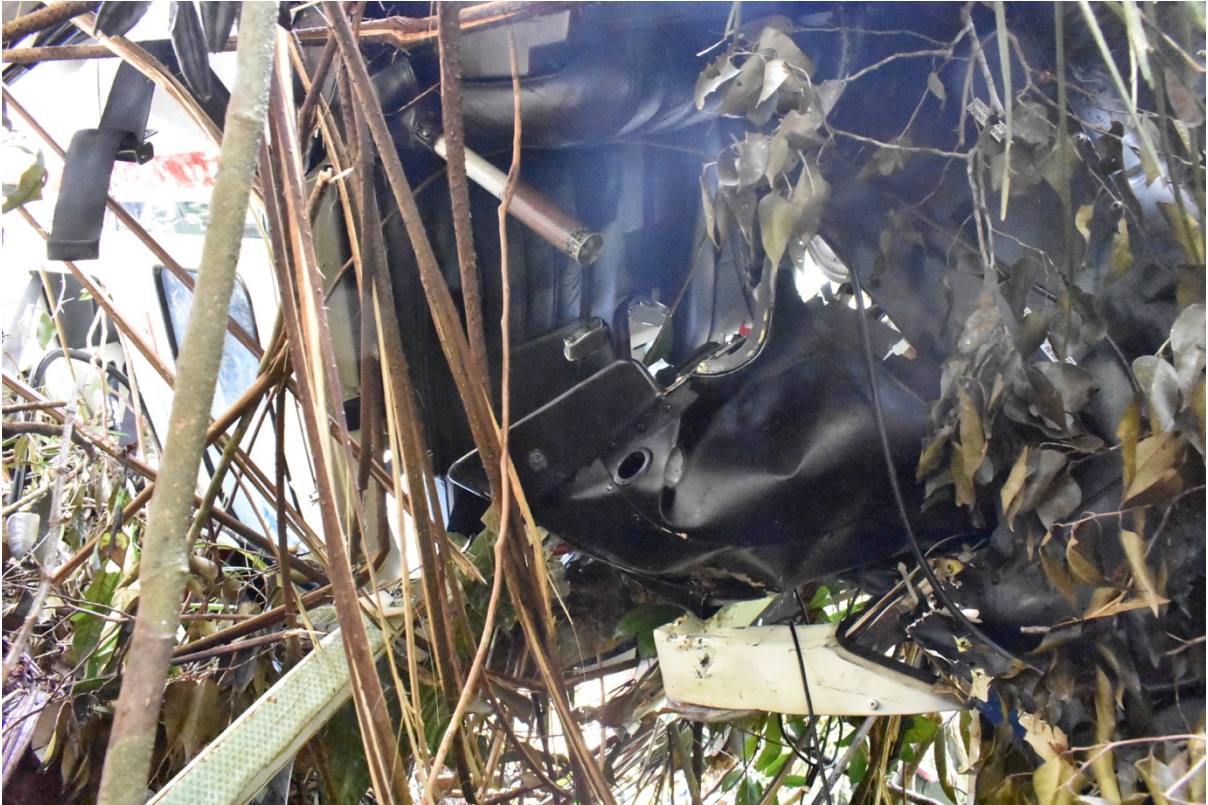
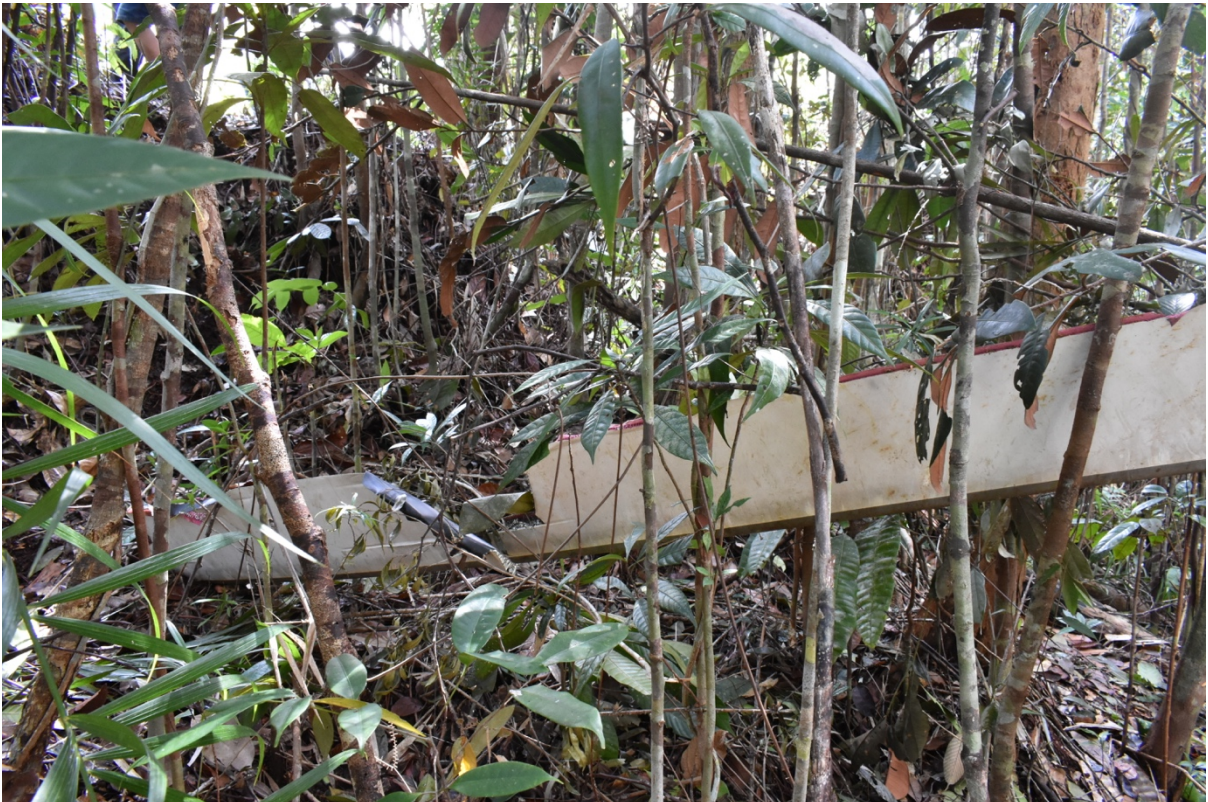
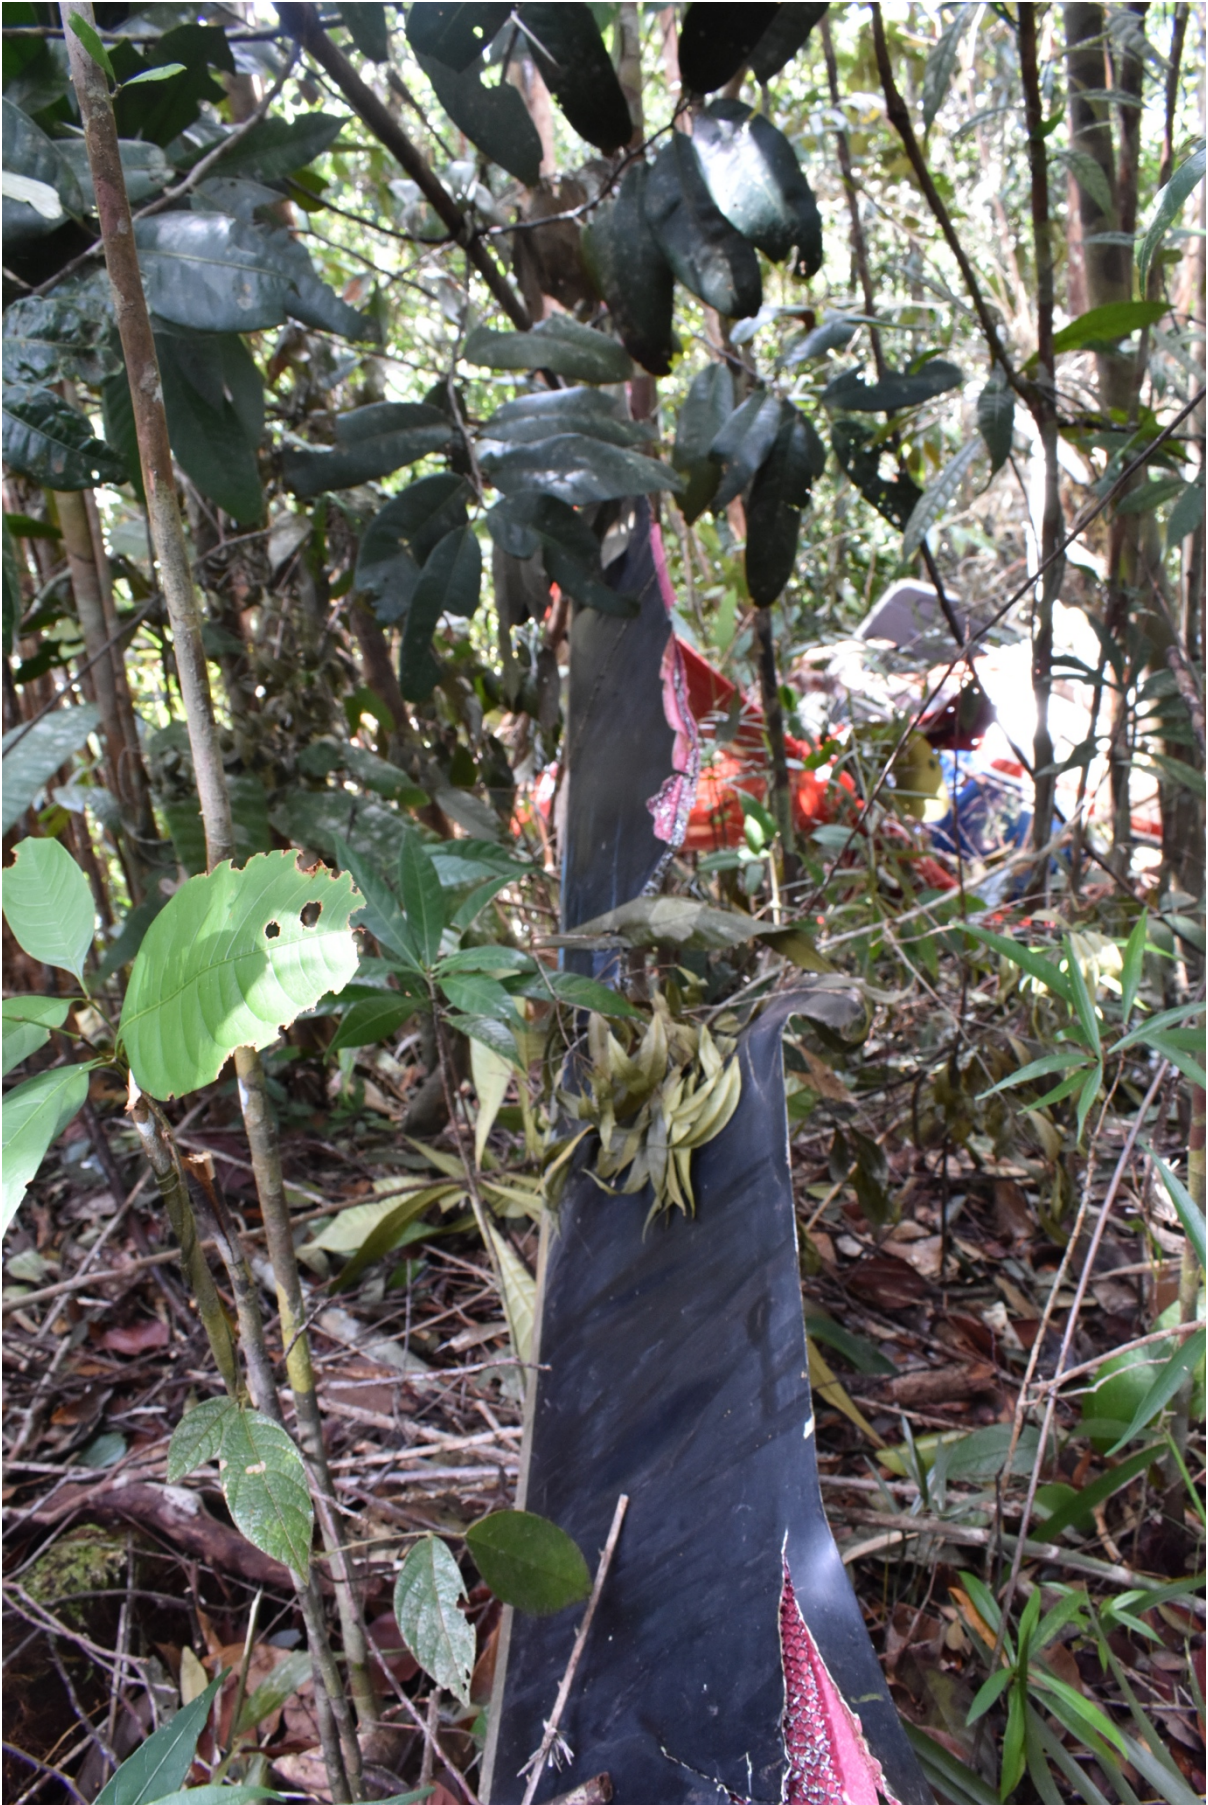
For images of damage to the aircraft on-site please refer to **APPENDIX B**. The aircraft was deemed as a total write-off.

A visual assessment of the crash site revealed that 9M-AZK's rotor blades impacted the surrounding trees first before separating from the main rotor hub. The fuselage then came to a rest in an inverted position with its tail boom folded into two. See **APPENDIX B**.
