AIRCRAFT SERIOUS INCIDENT

SI 05/20

Twin Otter DHC6-400, Registration 9M-SSC

at Long Seridan, Sarawak

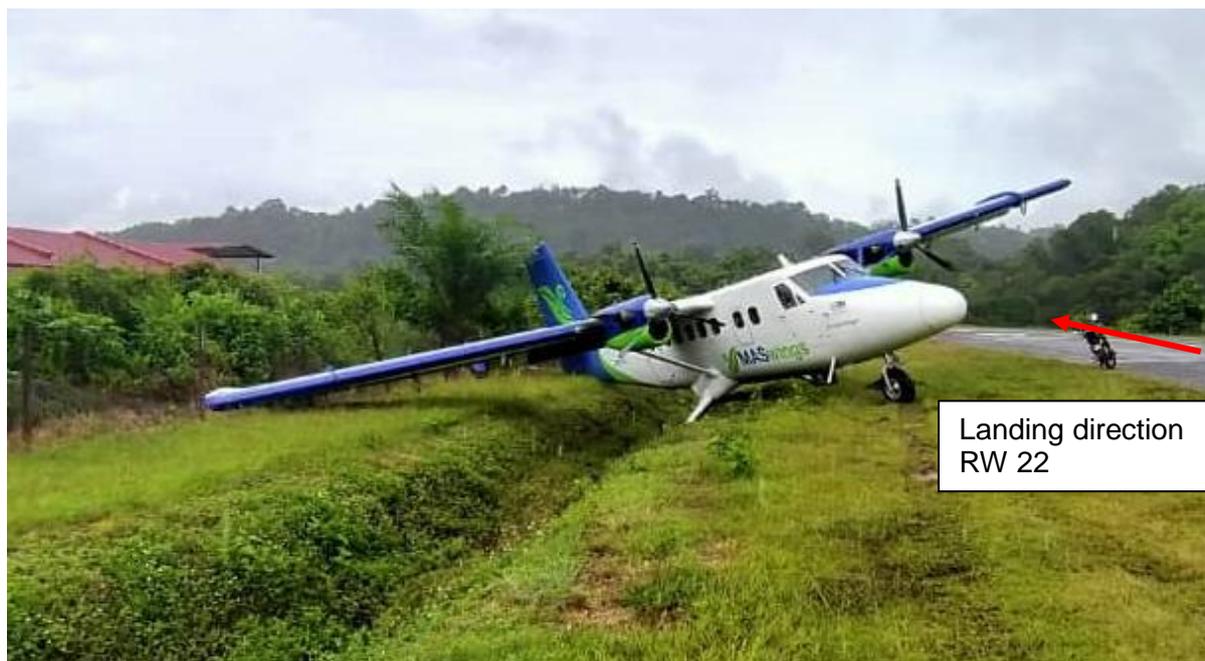
1.3.2 The starboard outboard fore flap and aileron badly damaged.

1.3.3 The starboard wing tip was dented. Upper starboard wing skin wrinkled outwards to the wing tip.

1.3.4 Flap and control wheel stuck in position due to damage on outboard fore flap, elevator and aileron.

Figure 2: Aircraft final position on left side of Runway 22 at Long Seridan

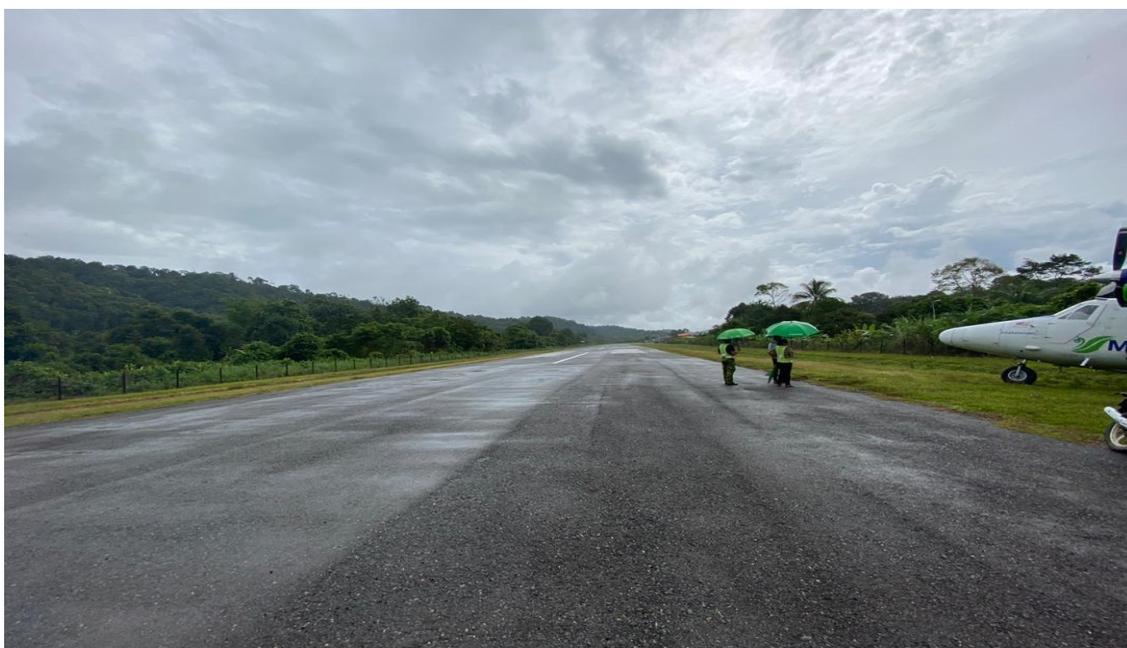
Figure 6: Low cloud on the approach path of Runway 22 view from Runway 04 taken after the incident. Note the wet runway after rain.

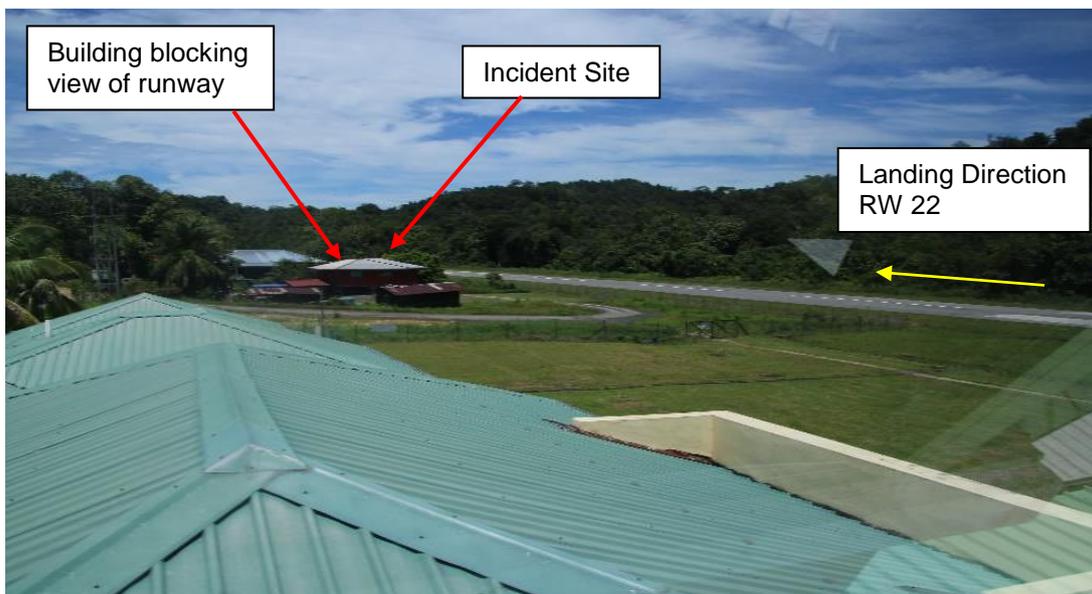
Figure 15: View from the airfield tower. Building blocking the view of incident site and threshold Runway 04

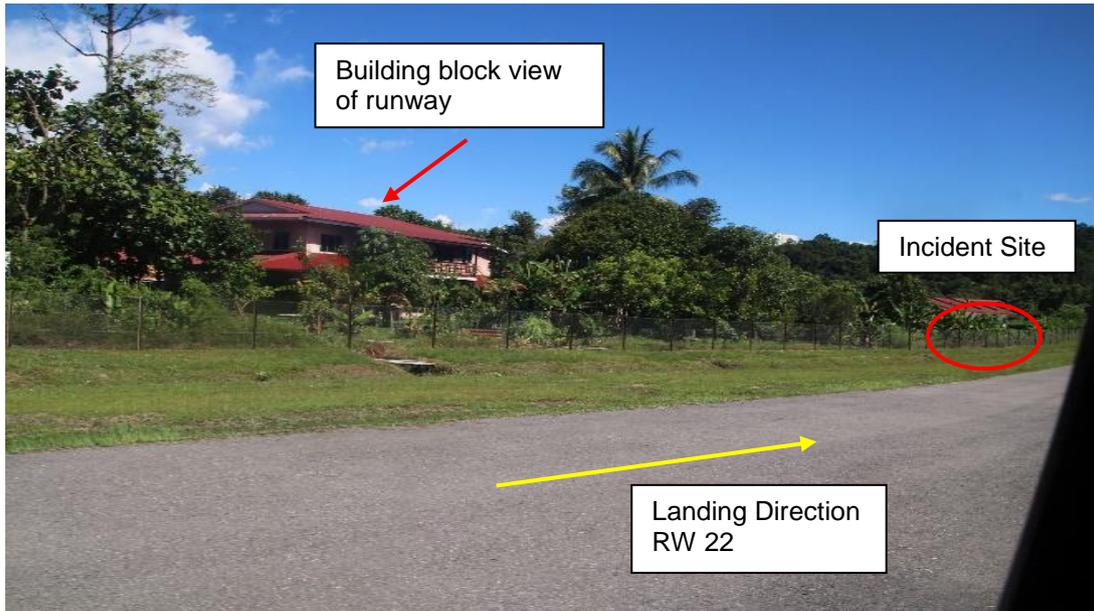
Figure 16: Building blocking the sight of the incident site

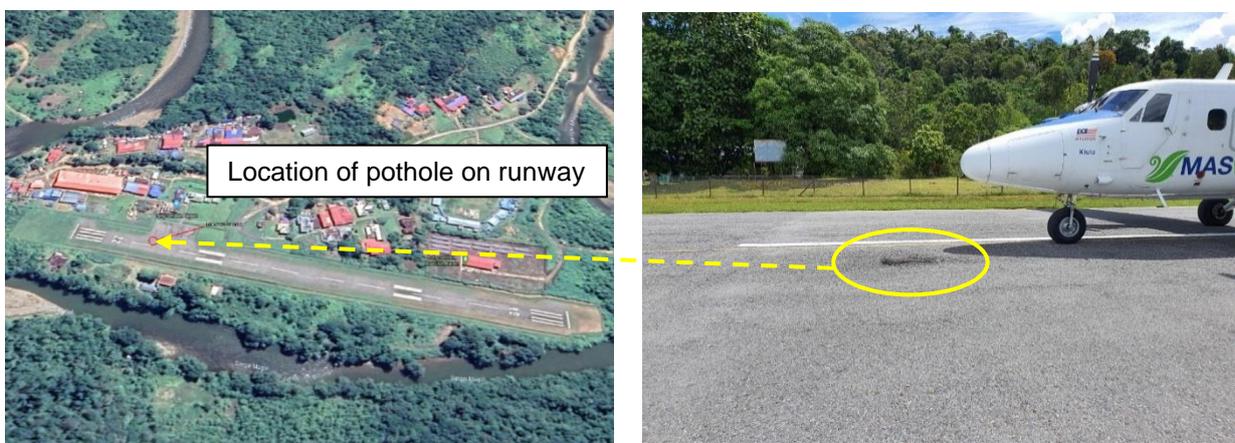
Figure 17: Aerial view of the location of the pothole and location of the pothole on the runway close to centreline

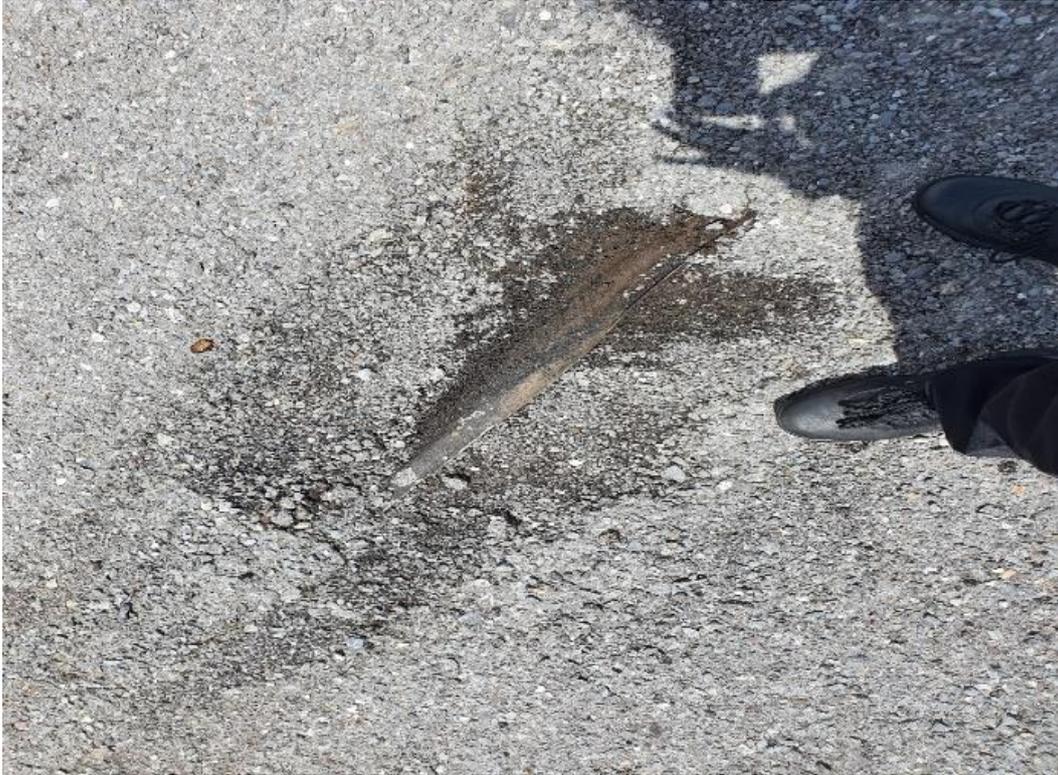
The pothole was observed to have appeared over time due to the distresses stated in paragraph 1.17.12 (Figure 18). There is no evidence that the operations assistant had raised a request for repair action to Miri Airport maintenance team in his daily routine runway inspection. Actions to repair the pothole was taken after an Air Safety Report was submitted by the aircraft operator. The repair work was carried out using 'Cool Mix Asphalt' by the aerodrome operator's personnel at Long Seridan (Figure 19). The repair work was carried out by non-competent personnel.

Figure 18: Close up view of the pothole. The pothole appears over time due to disintegration in asphalt pavement.

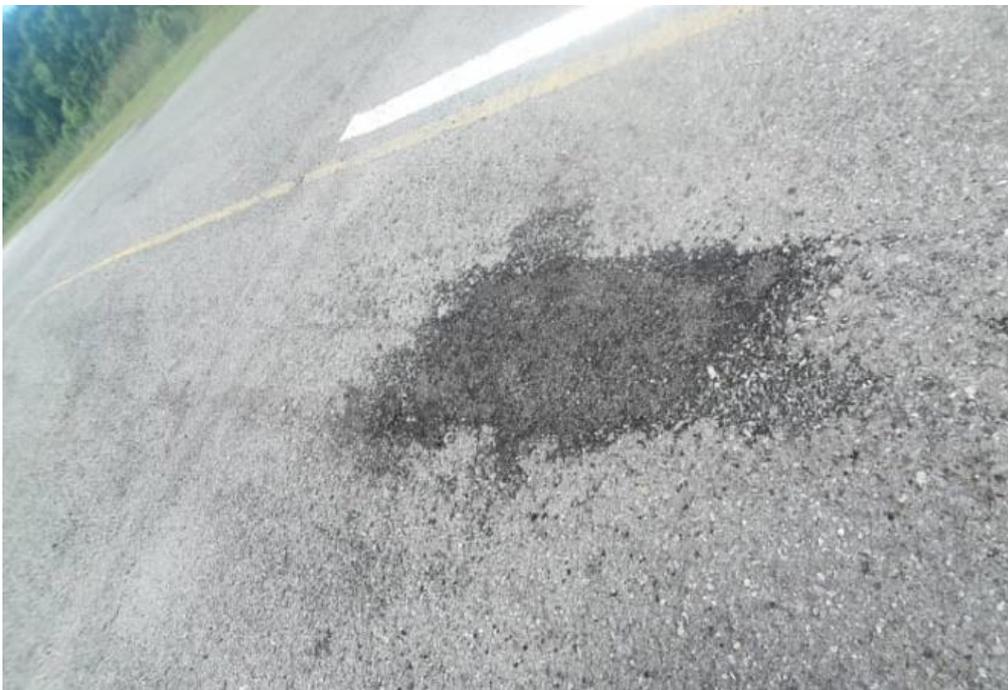
Figure 19: Repair carried out by Long Seridan staff using 'Cool Mix Asphalt'. Asphalt aggregate is observed to be loose and uneven.

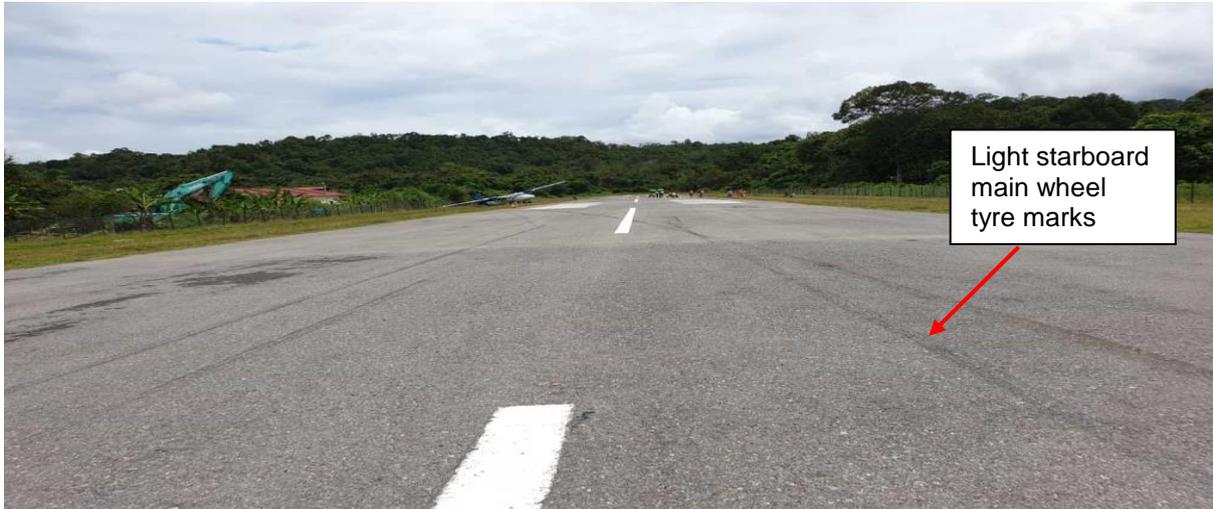
Figure 20: Aircraft landed on centreline and rolling straight after landing before starting to veered left. Pilot applied right rudder and right braking to counter left veering as seen in the initial light starboard main wheel tyre marks. No visible tyre marks for nose and port main wheel during initial veering.

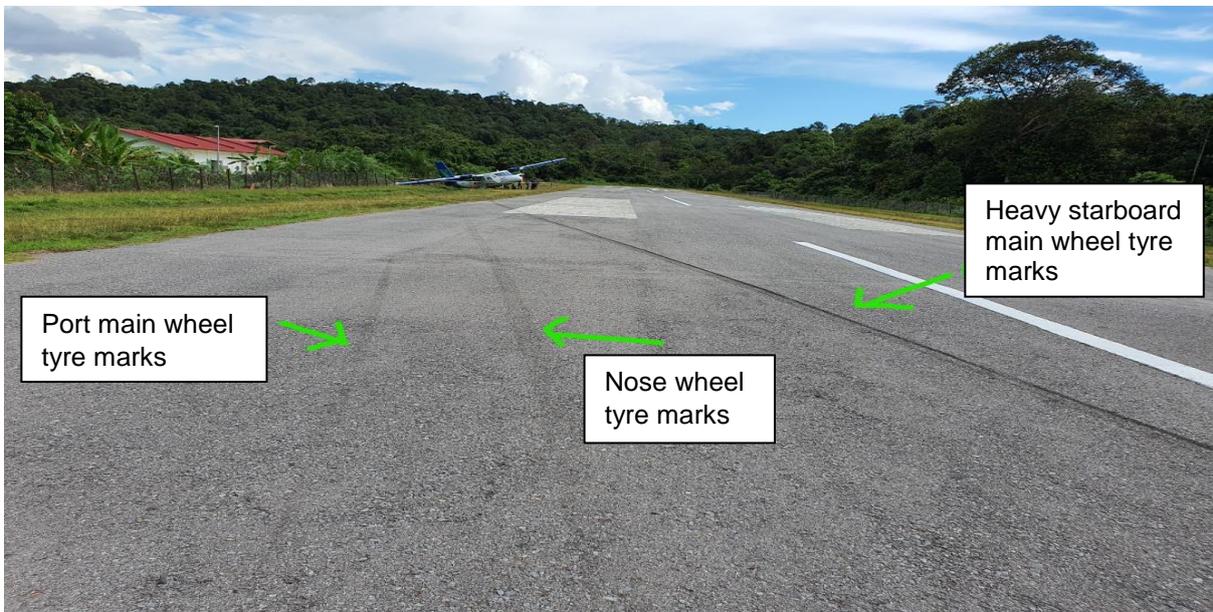
Figure 21: Pilot momentarily release and re-apply of both brakes was followed by heavier application of right brake in an attempt to steer the aircraft back to centreline. Aircraft continue to veer left and started to skid. Pilot maintain right rudder and continue to applied heavier braking on the starboard main wheel. Starboard tyre most probably locks up as seen in the heavy tyre marks on the runway. Visible nose wheel and port

main wheel tyre marks due to skidding as aircraft closing to exiting runway. No visible scalloping of nose wheel tyre marks which will indicate an off-centre (cock) nose wheel.

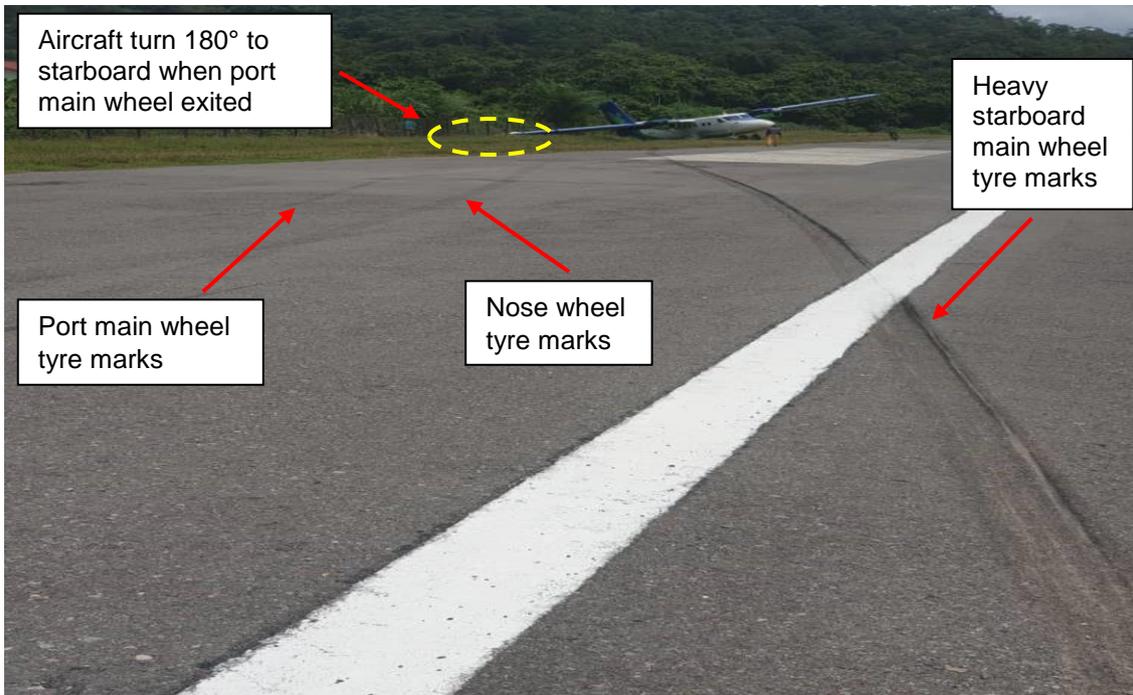
Figure 22: Aircraft continue veering left nearing to left edge of runway. Continuous heavy starboard main wheel tyre marks seen till aircraft exited runway. Light port main wheel tyre marks visible initially due skidding and disappear before wheel reach runway edge. This is probably due to port main wheel tyre momentarily regaining traction on the runway. Light nose wheel tyre marks visible till runway edge probably due to skidding. Aircraft turn 180° to the starboard when port main wheel regain traction just before exiting the runway.

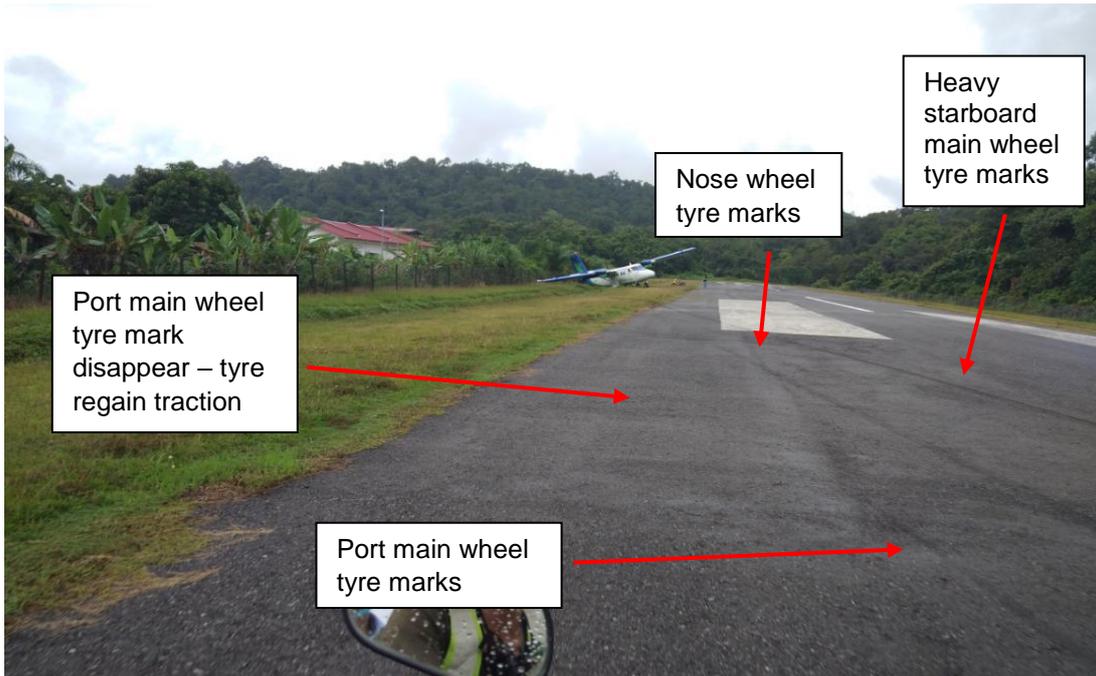
Figure 23: Port main wheel tyre marks which disappear just before aircraft exited runway indicating port main wheel tyre most probably regain traction just before aircraft exited runway.

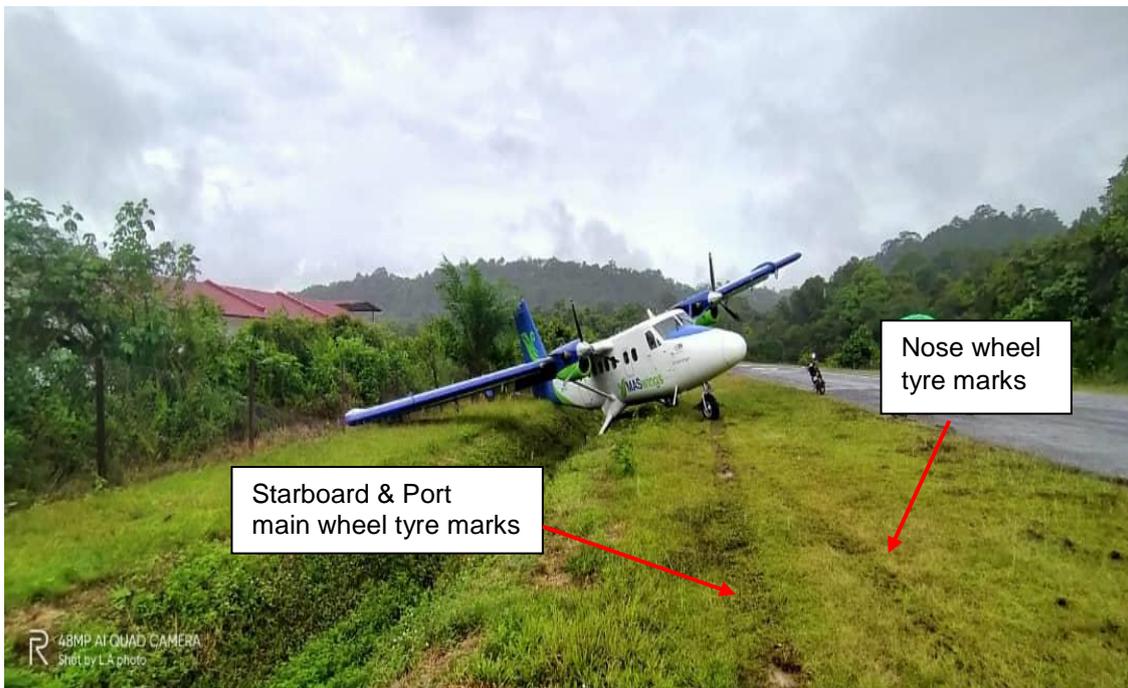
Figure 24: Aircraft continue with its forward momentum sliding sideways on the wet and soft ground to its final stop position facing close to the reciprocal heading of the landing direction.

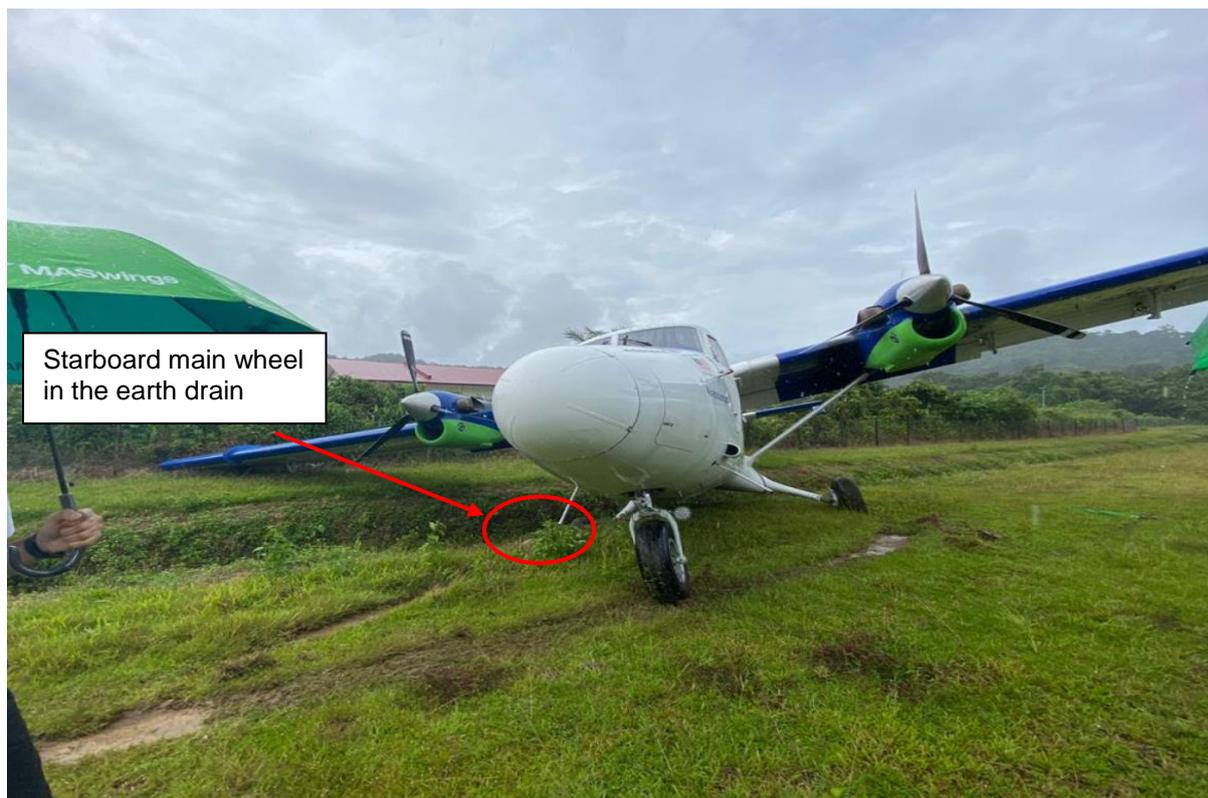
Figure 25: Aircraft final stop position after the starboard main wheel landed in the earth drain beside the runway.

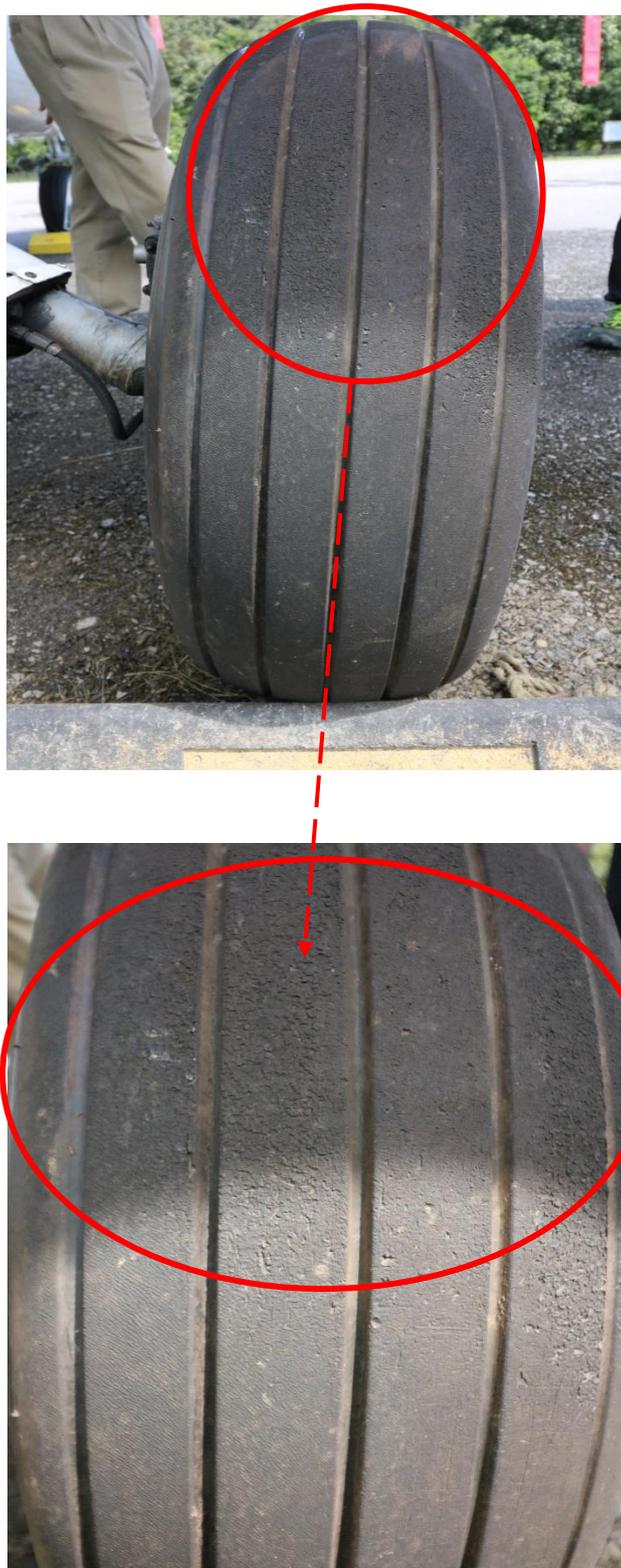
Figure 27: Heavy wear spot mark on the starboard main wheel tyre consistent with dark tyre marks seen on the runway.

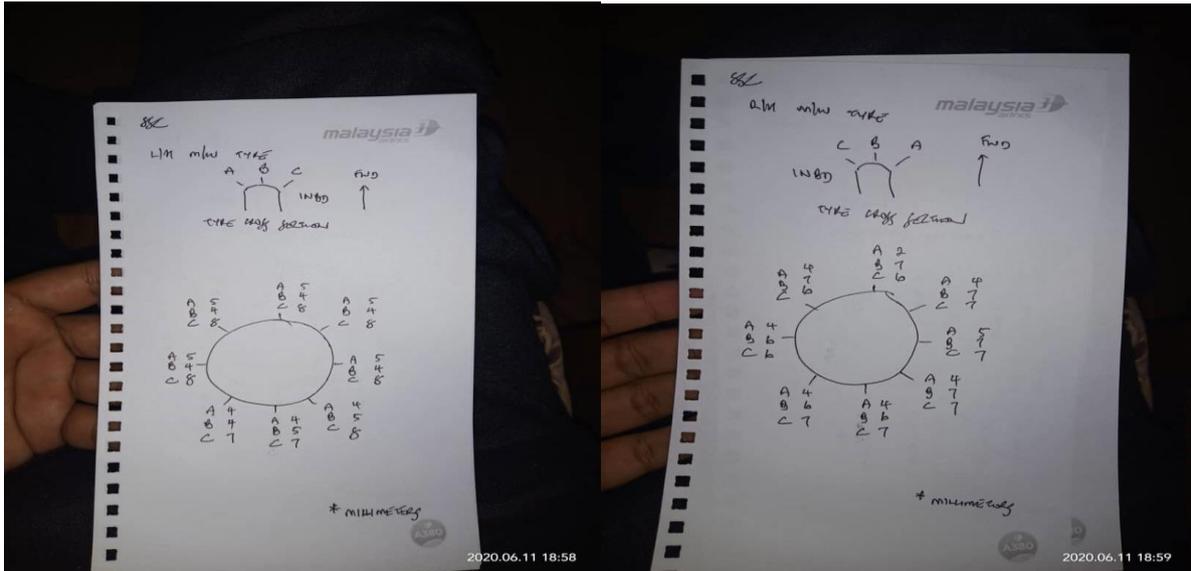
Figure 28: Port main tyre minimum tyre tread - 4 mm mid-section.

Figure 29: Starboard main tyre minimum tyre tread - 6 mm mid-section

It requires water film thickness of a minimum of 4mm or more to meet the dynamic hydroplaning conditions for the port main wheel tyre. It was observed that the nose wheel tyre meets the required dynamic hydroplaning condition if the water film thickness is a minimum of 4mm.

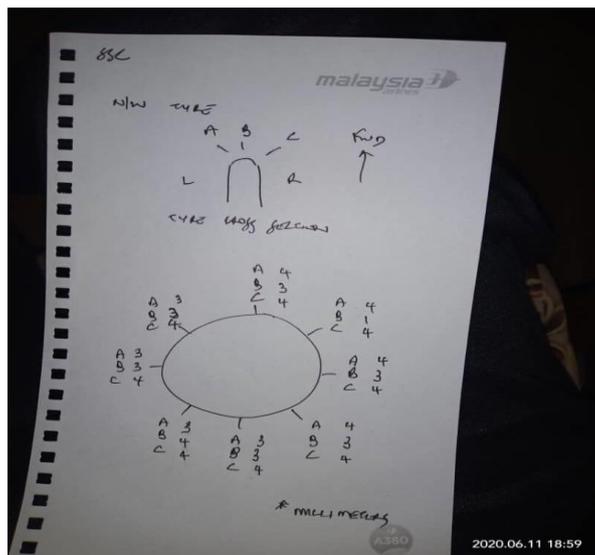
Figure 30: Nose tyre minimum tyre tread - 3 mm mid-section

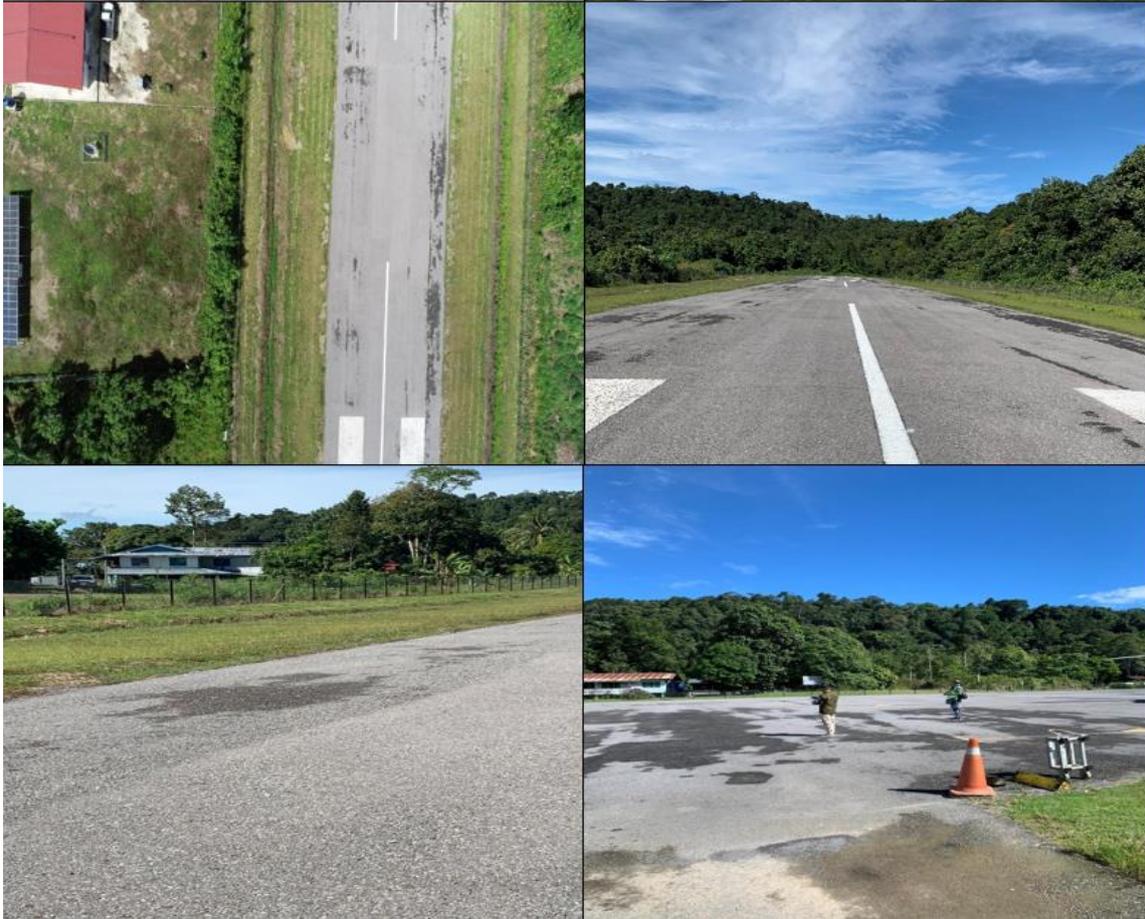
It is concluded that water bleeding distress is quite severe on Long Seridan runway. The distress is caused by inadequate drainage which will result in the poor drainage of run-off water and will contribute to low skid resistance of the runway.

Figure 32: Water bleeding (black spots) distress occurrence on Long Seridan runway

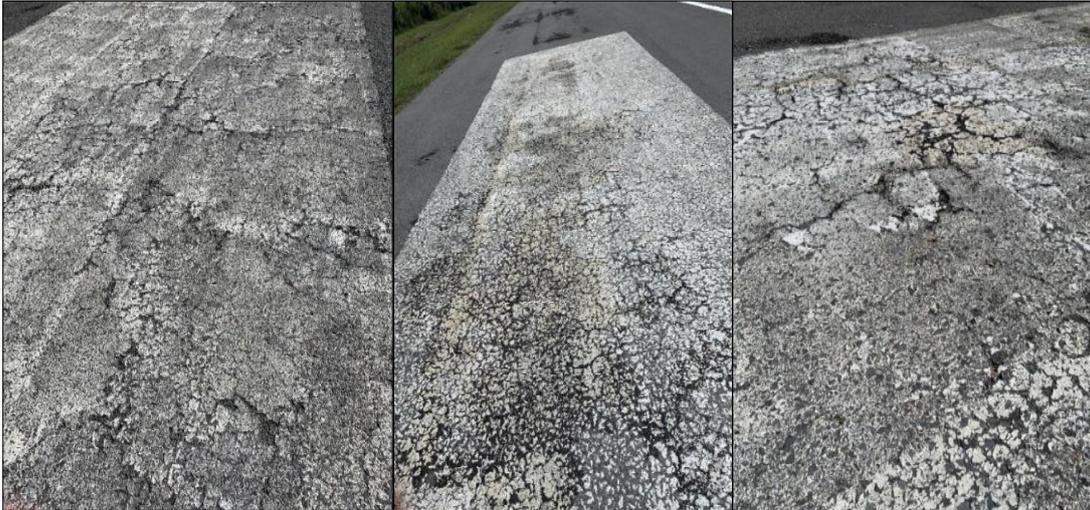
It is concluded that the Long Seridan asphalt pavement alligator cracks are severe and the cracks will continue to deteriorate until they are repaired. These cracks had allowed water to penetrate beneath the pavement and reach the base. When the water erodes the base, it allows areas of the pavement to sag or subside. The pavement sag will result in poor water drain-off on the runway surface which will contribute to low skid resistance of the runway.

Figure 33: Cracking distress on Long Seridan runway

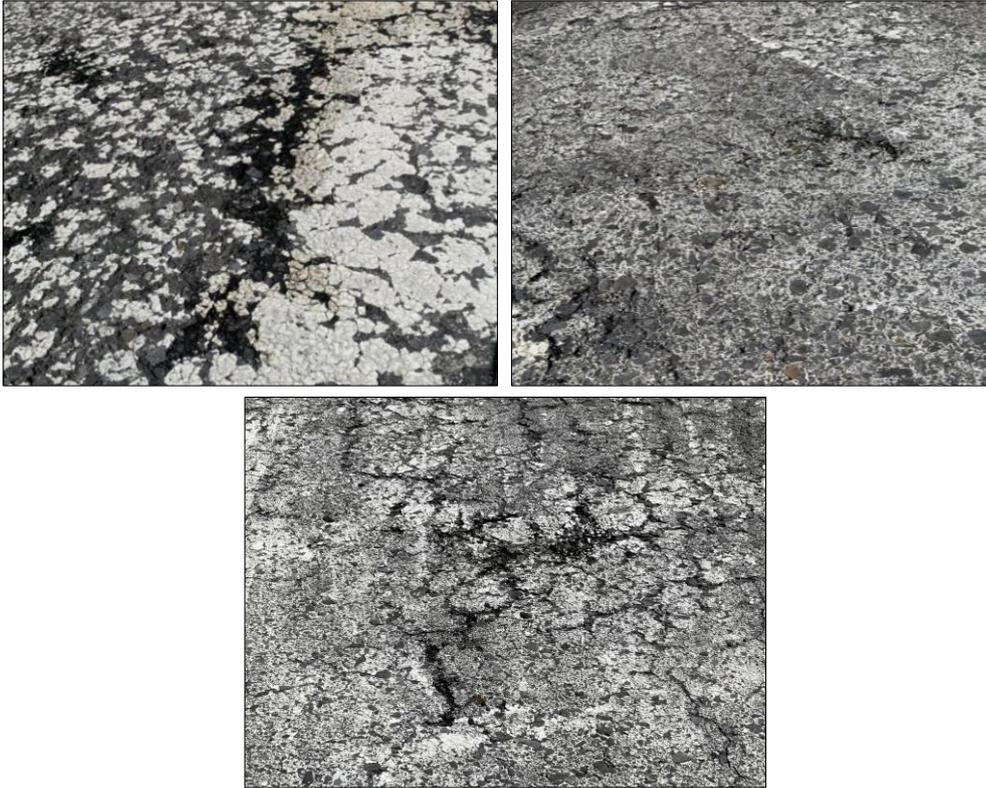
It is concluded that ravelling had occurred at many areas of the Long Seridan runway. Urgent rehabilitation and repair work are needed to ensure the runway retains the surface friction needed for safe aircraft operations especially during wet condition.

Figure 34: Ravelling distress on Long Seridan runway

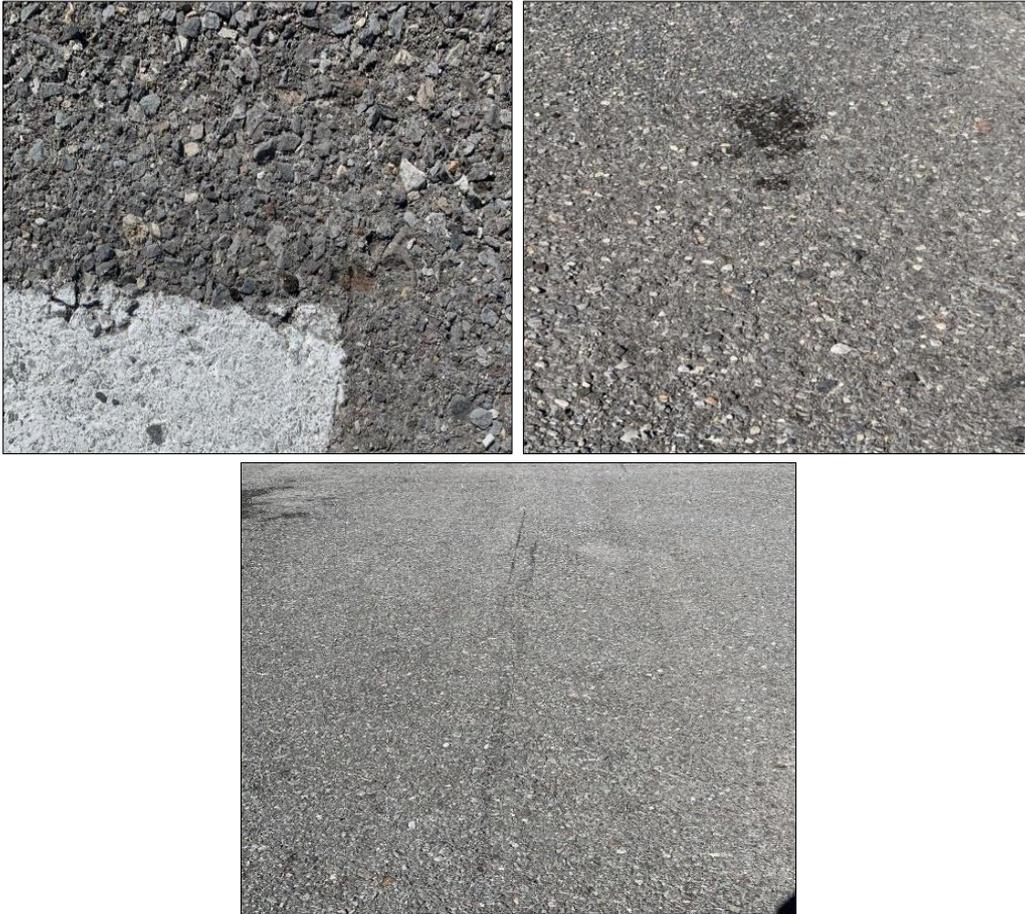
From Figure 35, it was observed that Long Seridan runway shows this distress where it is clearly seen that the portion of aggregate had extend above the asphalt. The distress surface will provide more area for water ponding which will contribute to poor pavement surface friction.

Figure 35: Polished aggregate distress on Long Seridan runway

It is concluded that the polished aggregate distress condition is severe at Long Seridan runway. The distress condition result in poor pavement surface friction which contributes to low skid resistance of the tyres during take-off and landing especially in wet conditions. With this distress condition, the probability of skidding incident occurring in dry conditions is also high as the pavement surface friction will be at very minimum level.

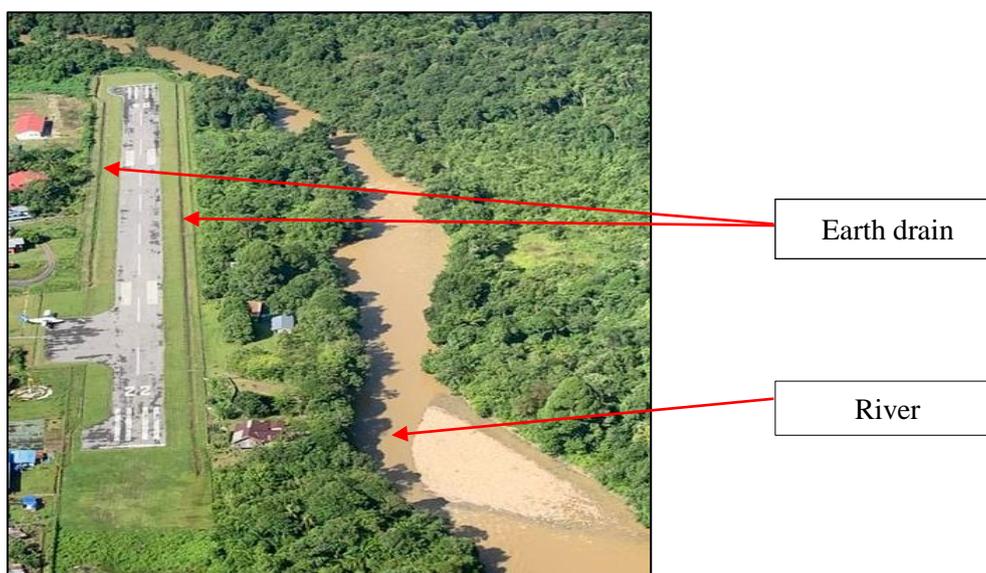
It was observed that earth drainage is located at both side of the runway, approximately 5m from the edge of runway with no proper water discharge identified. The area was surrounded by river and type of soil is believed to be sandy. Figure 36 showed the actual condition of Long Seridan runway captured from top view.

Figure 36. Long Seridan runway from top view

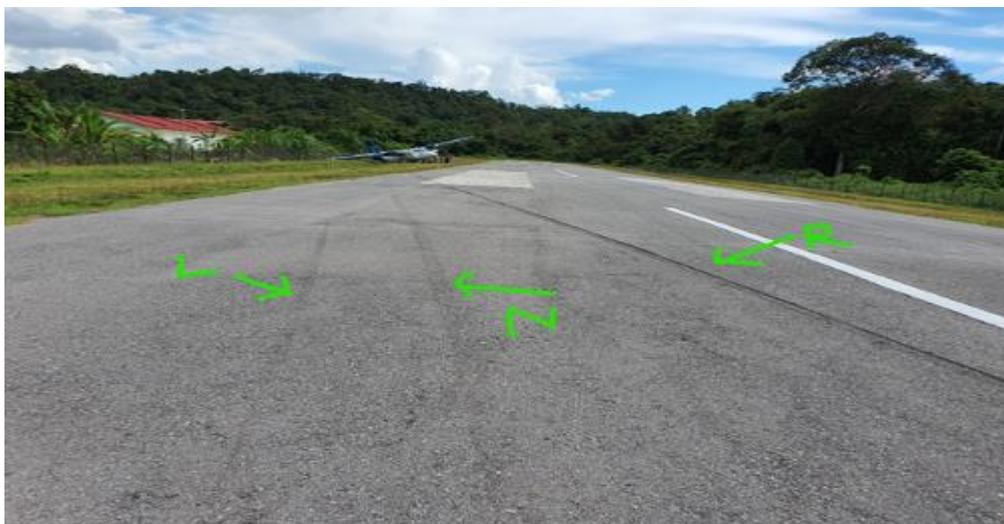
Figure 52: Photograph of the runway taken after the incident showing the tyre marks of the aircraft

To support dynamic hydroplaning speed analysis at paragraph 2.8, tyre marks are analysed to provide empirical evidence to support the above analysis that hydroplaning actually happened to the aircraft and caused the pilot to lose directional control on landing.
