**AIRCRAFT ACCIDENT FINAL REPORT**  
**A 04/20**  
**Air Accidents Investigation Bureau (AAIB)**  
**Ministry of Transport**

**Accident Involving a Leonardo AW139**  
**Registration 9M-PMC**  
**in Tawau, Sabah**  
**on the 27 February 2020**

# AIRCRAFT PRELIMINARY DAMAGE ASSESSMENT REPORT (9M-PMC) ADAR/ PMC/ 20/ 01

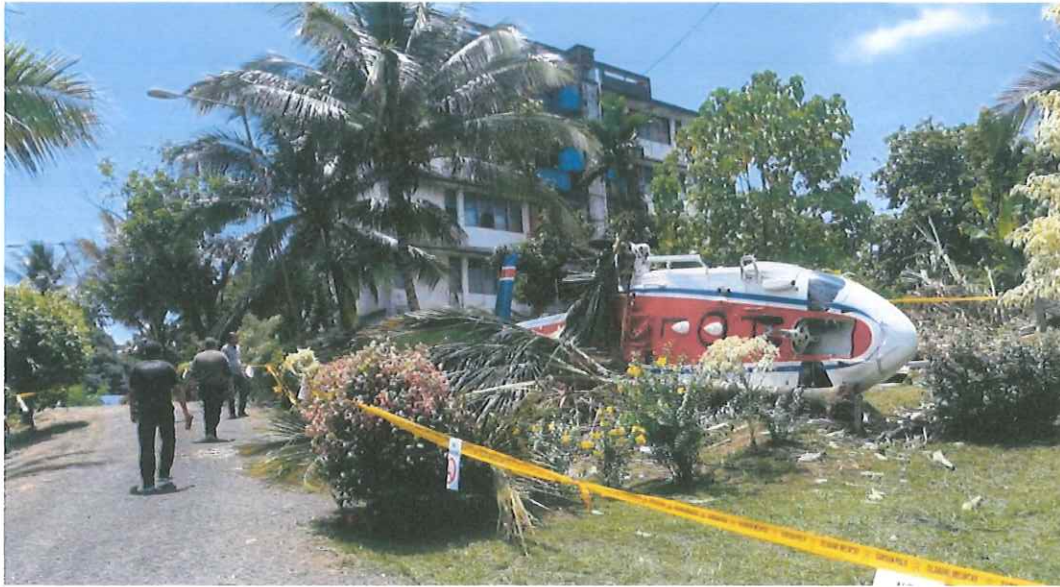
The aircraft came to rest on its port side, next to a fallen medium-sized coconut tree (about 4 m tall) presumably struck down by the impact. Substantial physical damage only found on port side of the helicopter with no sign of fuselage roll or tumble when it impacted ground.

*Figure 6: View of impact site facing heading SSW, as seen from PDRM Seksyen K9 access gate,*

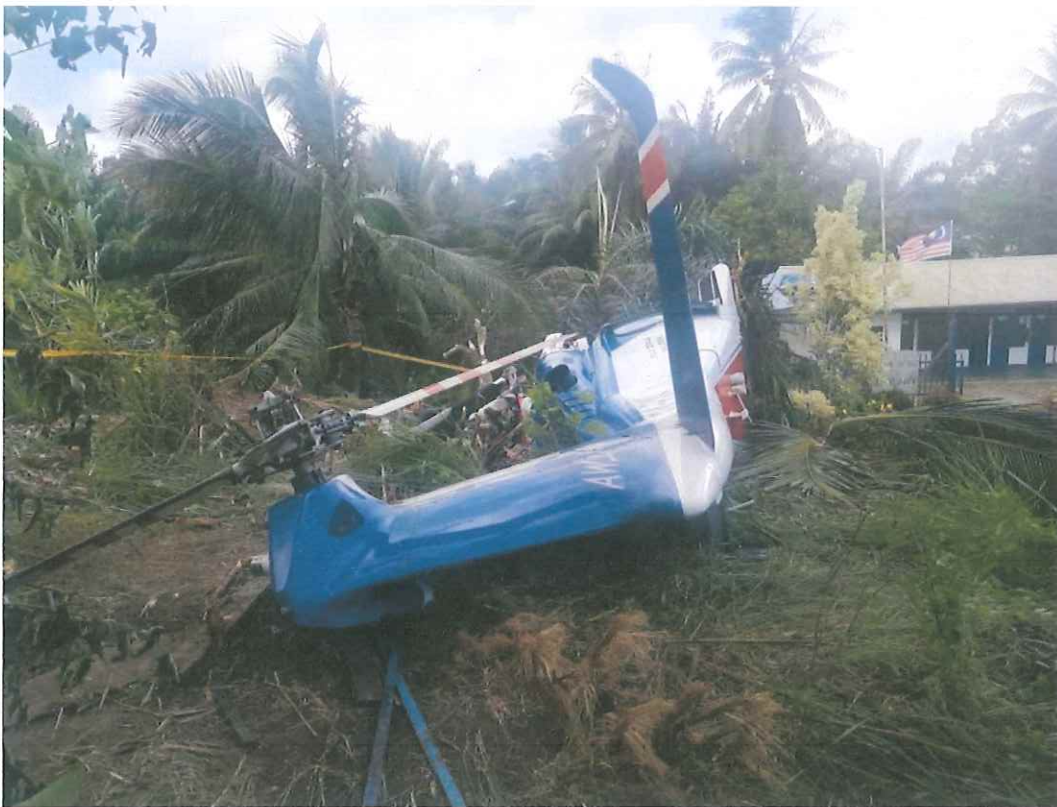
*Figure 7: View of impact site facing heading NNE as seen from PGA barrack.*

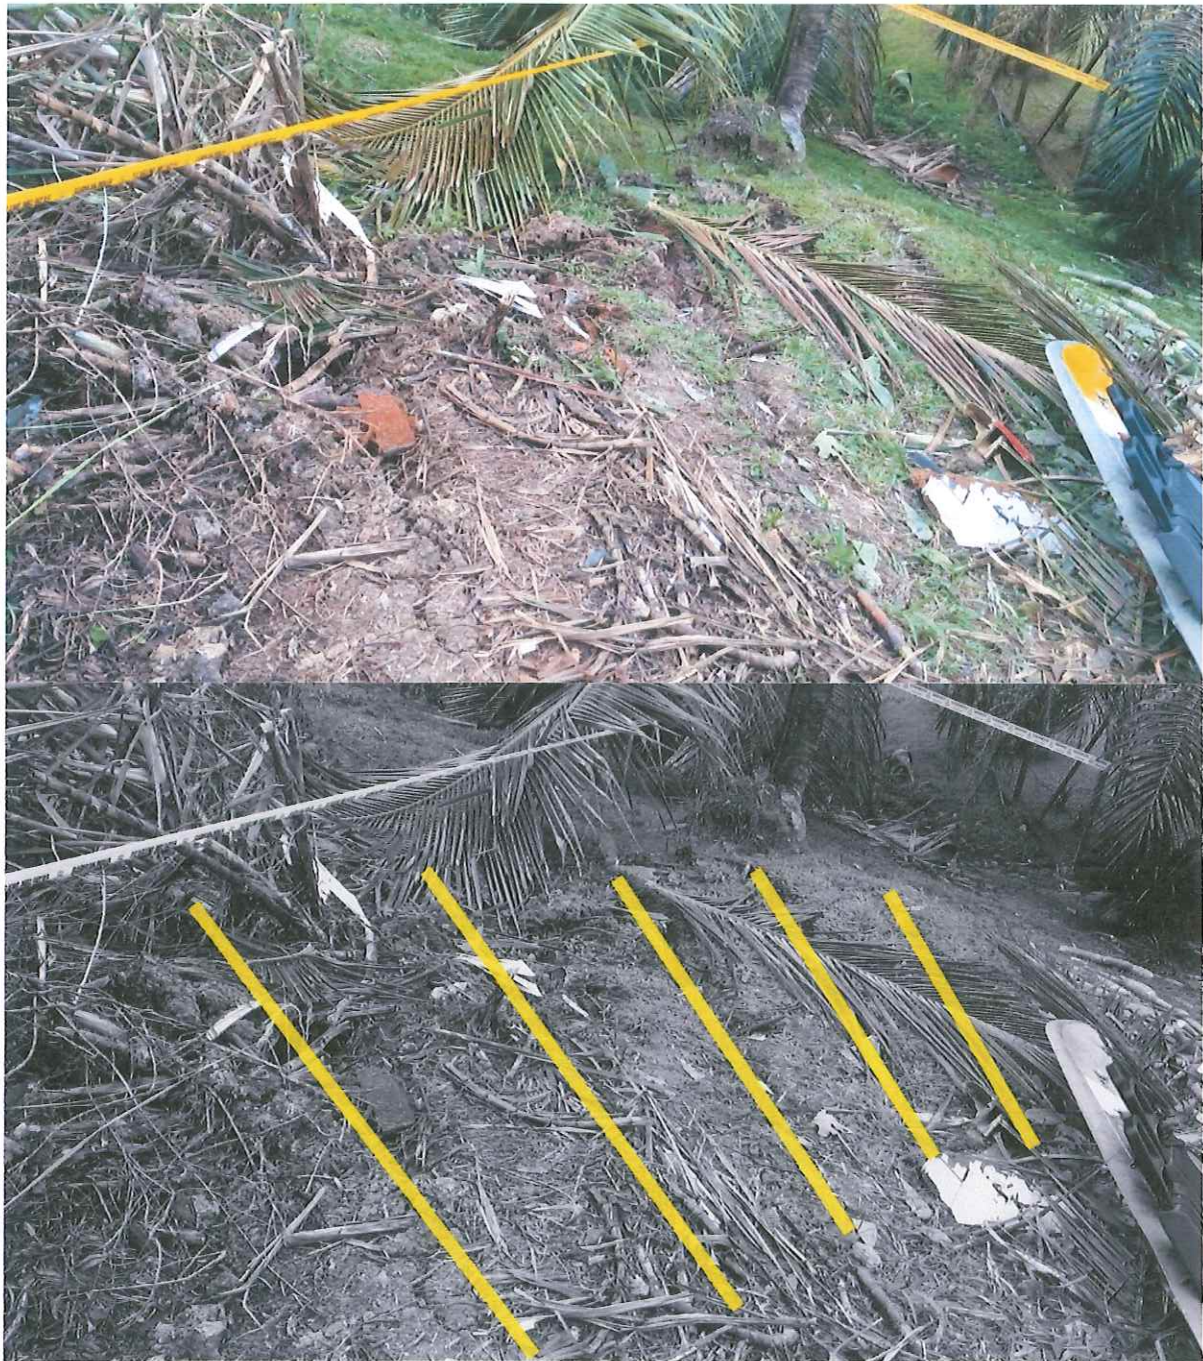
All 5 main rotor blade (MRB) found badly damage with 5 distinct marks of impact on the ground approximately 4 m away from the wreckage main rotor hub;

- MRB black found detached, 20 m away from the wreckage, impacted the roof of Seksyen K9 building and a transport.
- MRB red found detached 5 m away near the perimeter fence of the Seksyen K9 area.
- MRB blue, yellow and white found badly damage, partially connected with the wreckage.

*Figure 9: Top and bottom pictures exhibit 5 distinct marks of main rotor blades hitting the ground*

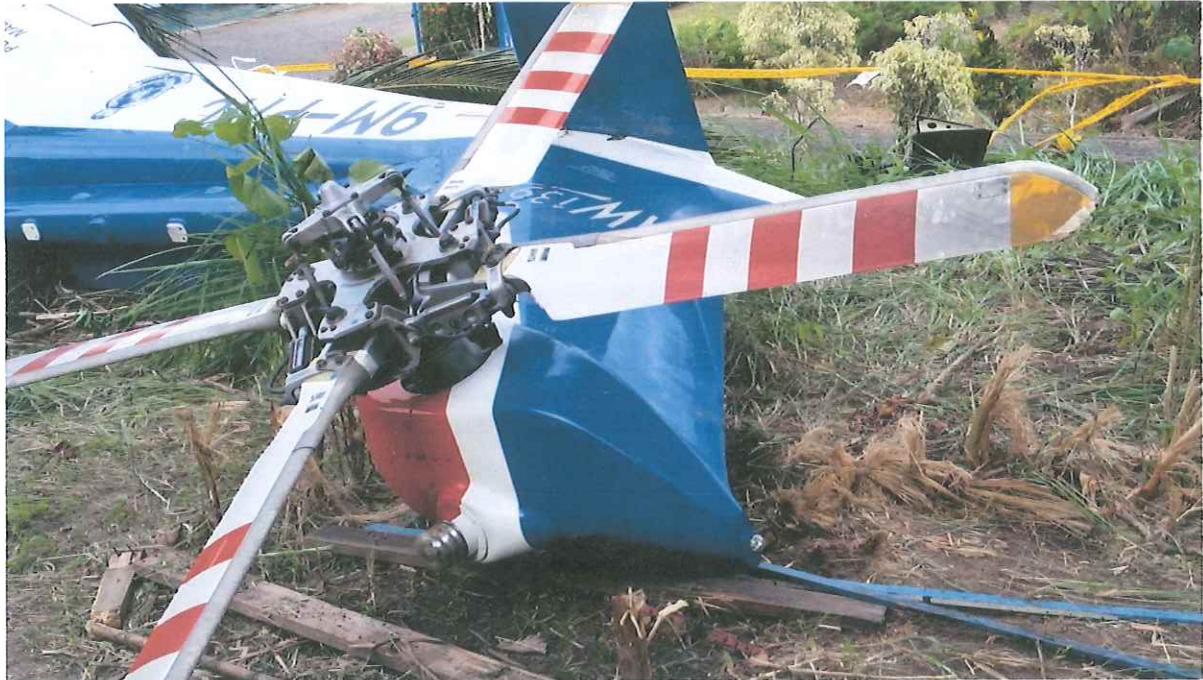
All 4 tail rotor blades were intact on aircraft with only its outer most tips damage with sign of impact with ground and vegetation. There is a significant damage on left side of tail rotor gearbox housing which also house the tail rotor servo, but no significant damage found the servo itself and associated tail rotor control rods.

*Figure 10: Intact tail rotor system with minor damage at the blade tips*

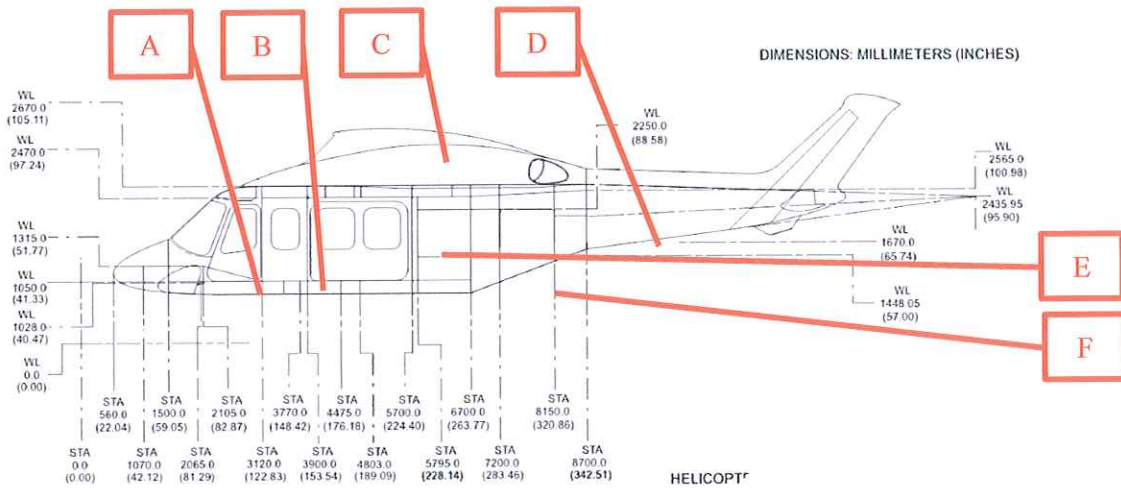
Figure 11: Substantial physical damage found as seen from port view.

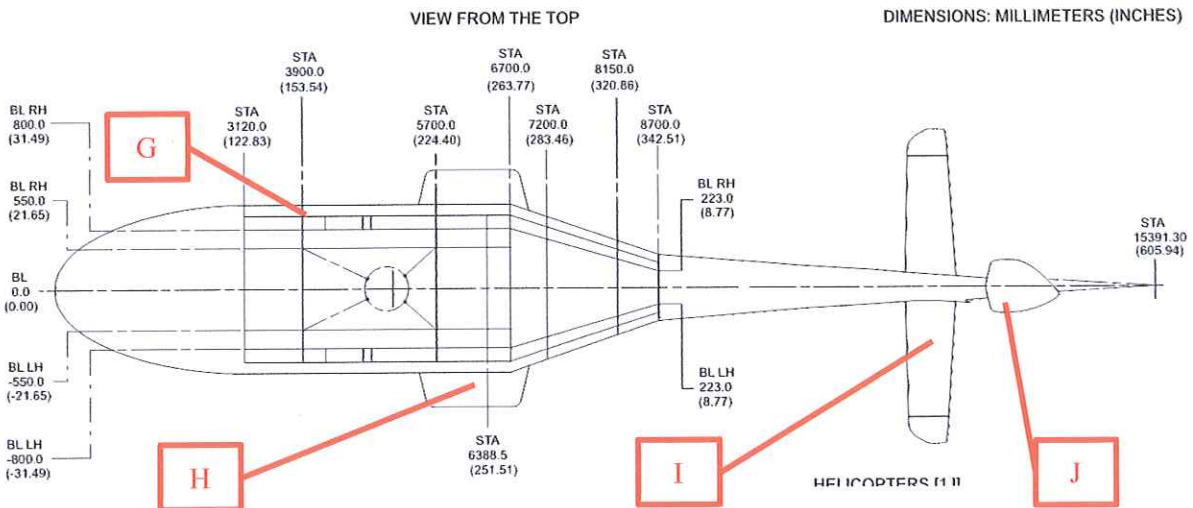
Figure 12: Substantial physical damage found as seen from top view.

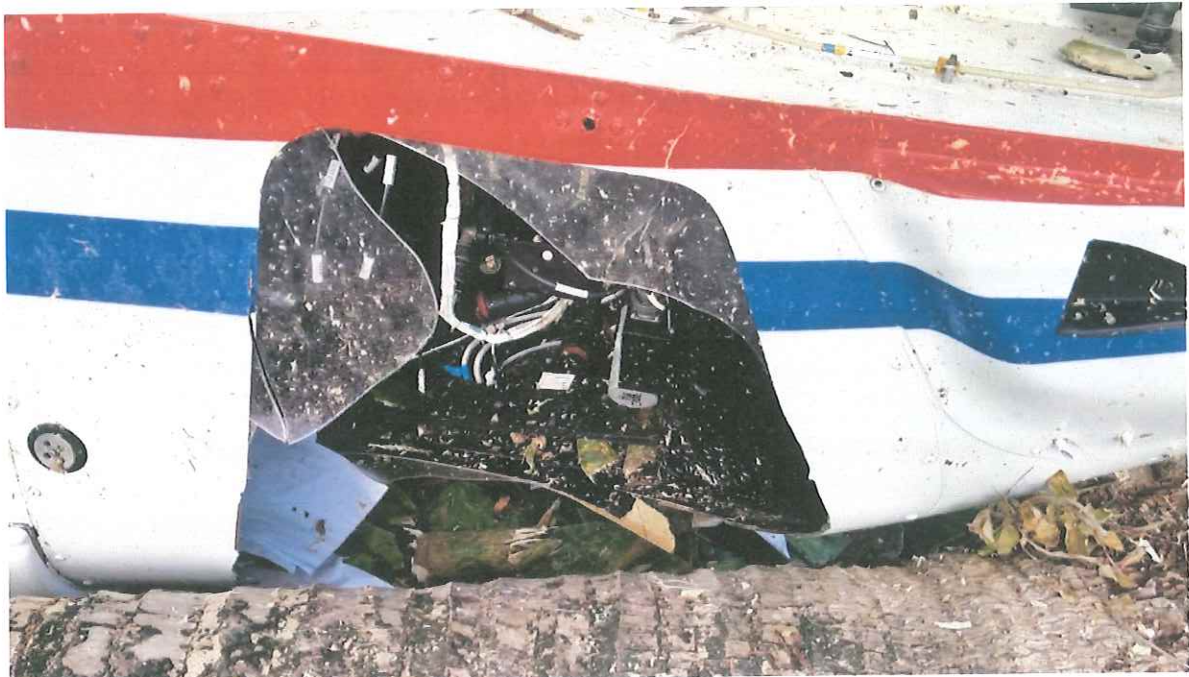
Figure 13 : Item A

Item	Description of damage	Observation	Remarks
A	Broken left nose window	Suspected impact with ground.	
B	Impacted left cockpit door, windows and STA3120 bulkhead.	Suspected impact with ground.	Crack appeared at STA3120 bulkhead.
C	Broken top sliding cowling	Suspected impact with disintegrated main rotor pitch links and main rotor blades.	
D	Heat marks the fuselage	Suspected heat from exhaust gas of running left engine right after impacting the ground.	Engines seems still running at impact moment
E	Impacted left cabin sliding door and windows.	Suspected impact with ground and damage during evacuation process.	
F	Impacted aft left jacking point and STA6700 bulkhead.	Suspected impact with ground or tree.	Severe crack appeared at STA6700 with exposed bladder tank
G	Impacted hoist and boom assembly.	Suspected impact with deformed rotating main rotor blades.	The only component damaged on the right side of the fuselage

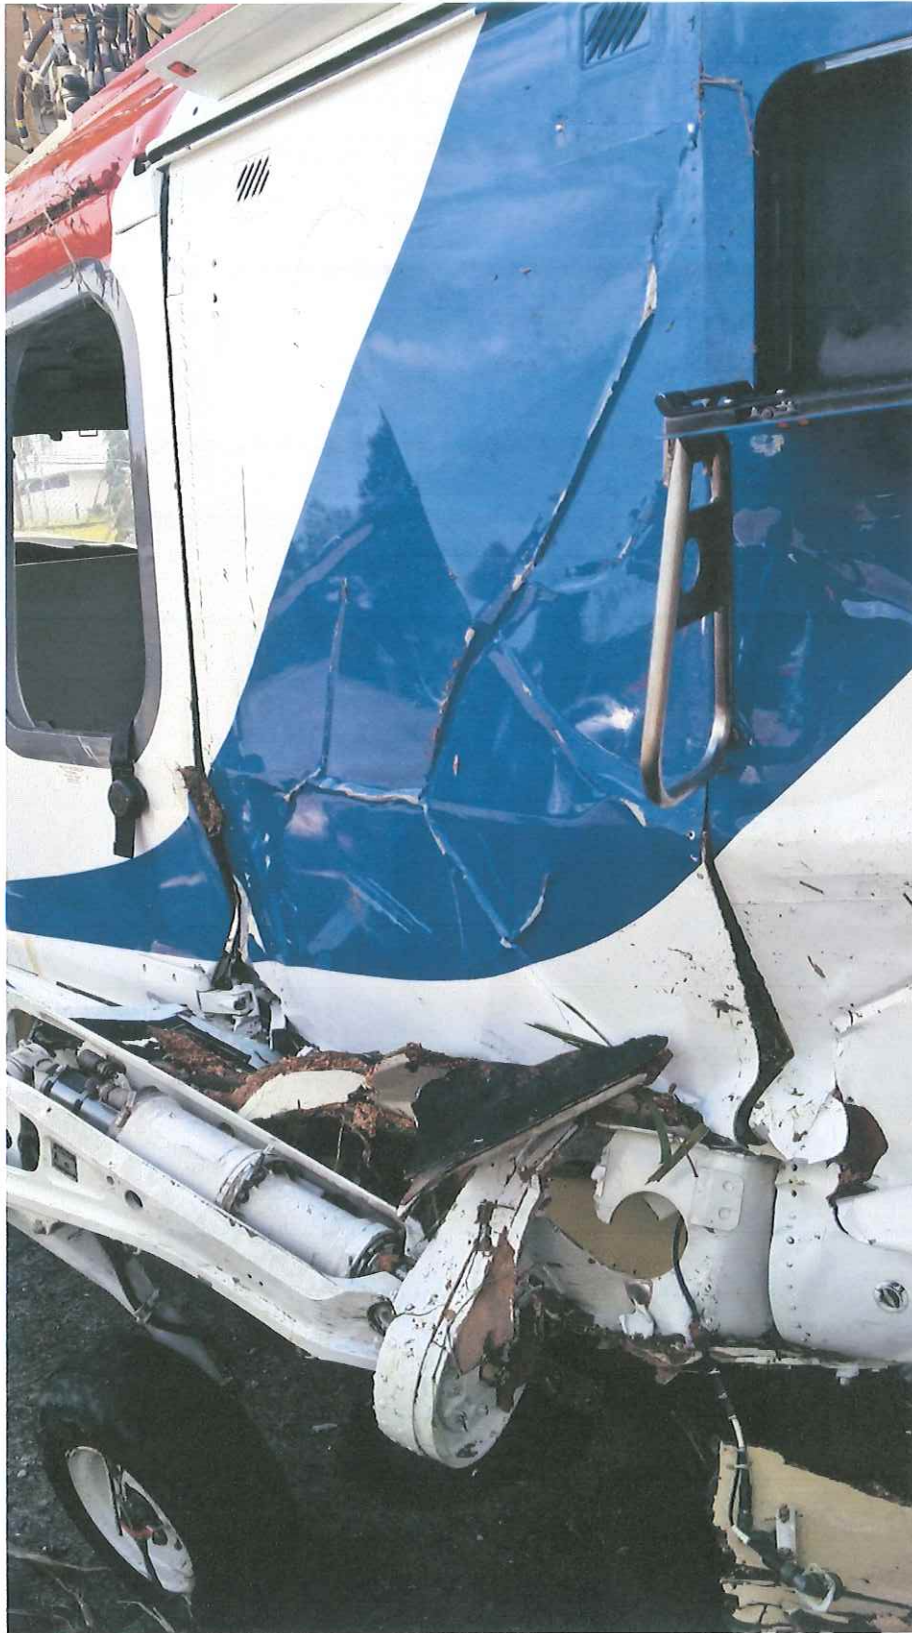
*Figure 20 : Item H*

H	Broken left sponson and left main landing gear assembly	Suspected impact with ground or tree.	Total damage on left sponson, left main landing gear and actuator.
I	Impacted left side of horizontal stabilizer	Suspected impact with ground.	The whole left side of the horizontal clipped off at root.
J	Impacted left side of tail rotor gearbox cowling	Suspected impact with ground.	Only the left side of the tail gearbox cowling broken apart at ground contact. Tail servo found in almost good condition with minimal hydraulic leak.
