AIRCRAFT ACCIDENT FINAL REPORT
A 06/20
Air Accidents Investigation Bureau (AAIB)
Ministry of Transport

Accident Involving Two Guimbal Cabri G2
Registration 9M-HCA & 9M-HCB
in Taman Melawati, Kuala Lumpur
on the 8 November 2020

FINAL REPORT A 06/20

OPERATOR	:	MY HELI CLUB
AIRCRAFT TYPE	:	GUIMBAL CABRI G2
NATIONALITY	:	MALAYSIA
REGISTRATION	:	9M-HCA & 9M-HCB
PLACE OF OCCURRENCE	:	TAMAN MELAWATI, KUALA LUMPUR
DATE AND TIME	:	8 NOVEMBER 2020 AT 1145 LT

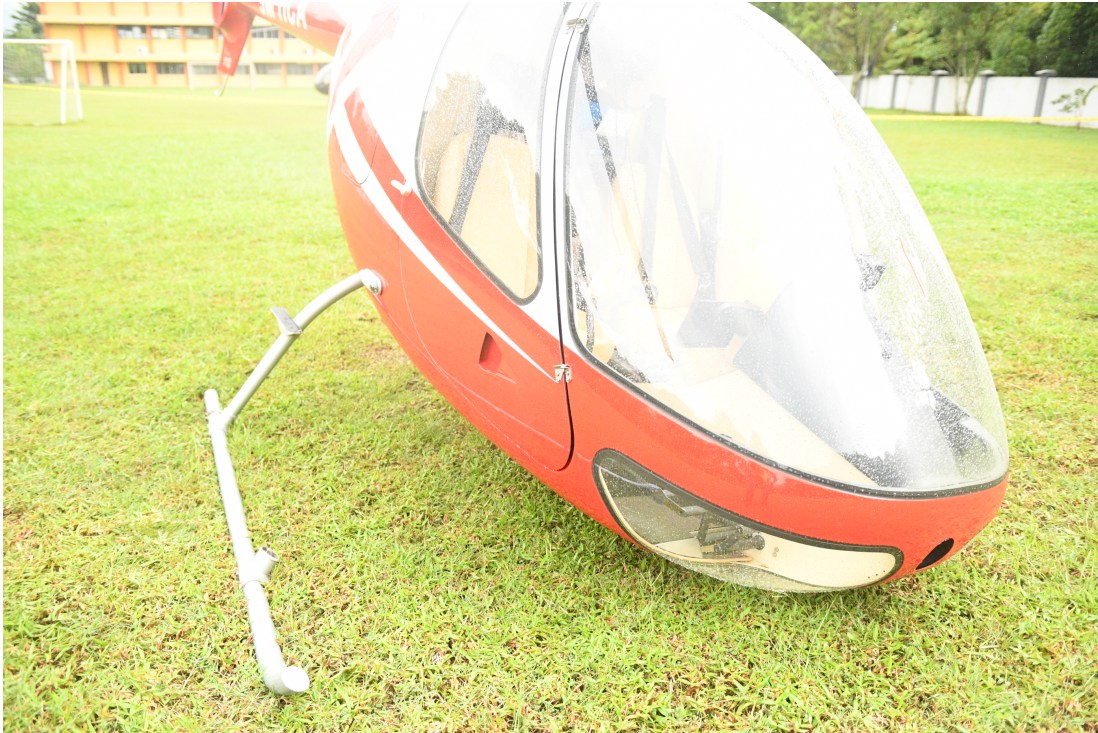
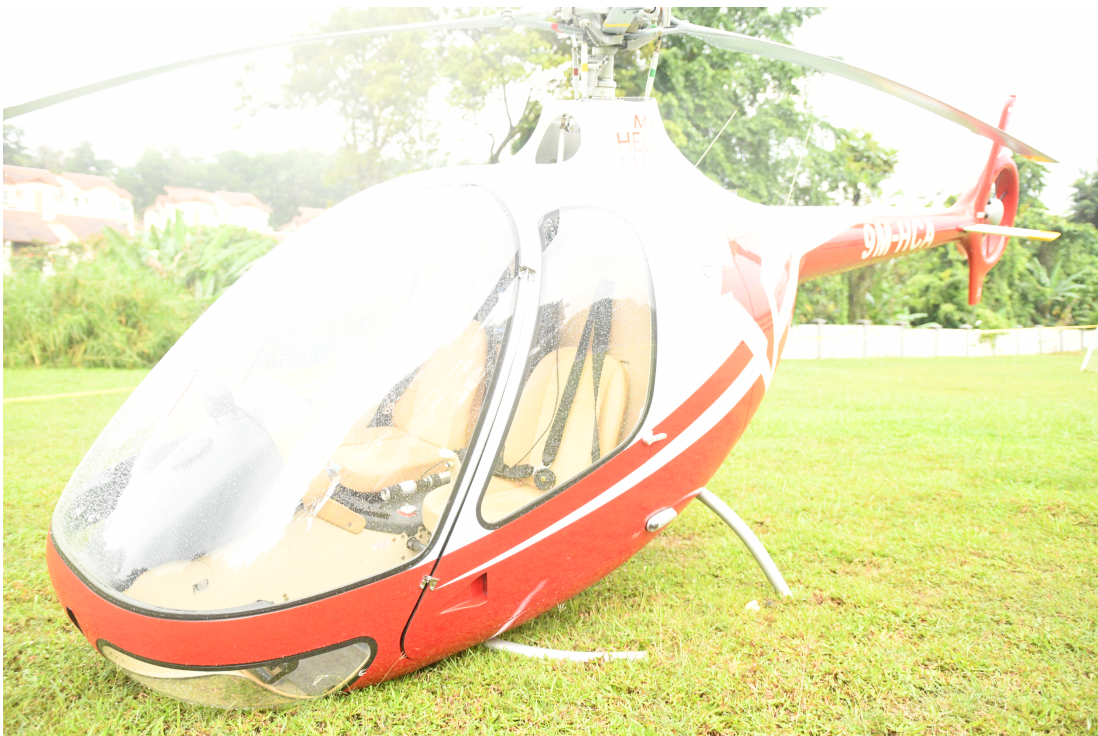
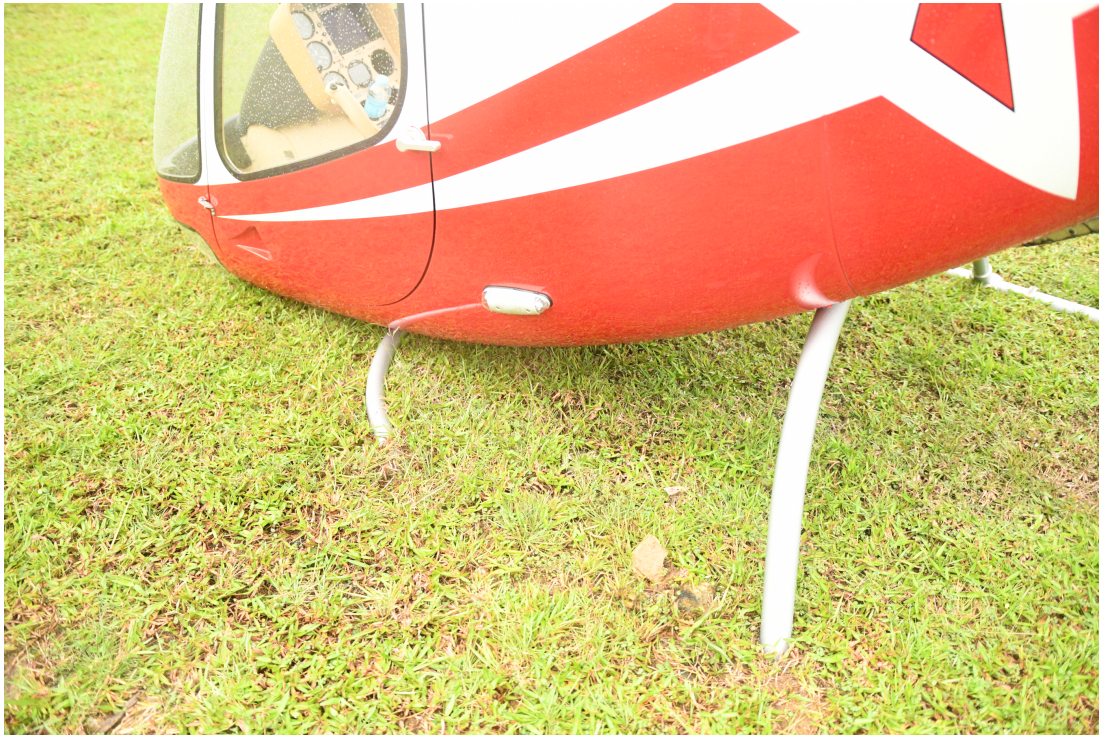
At approximately 1145 both helicopters collided with one another. The exact circumstances of the collision will be discussed in detail later in this report. 9M-HCA received damage to its landing skids but was still controllable and the pilot managed to land safely at a nearby school field.

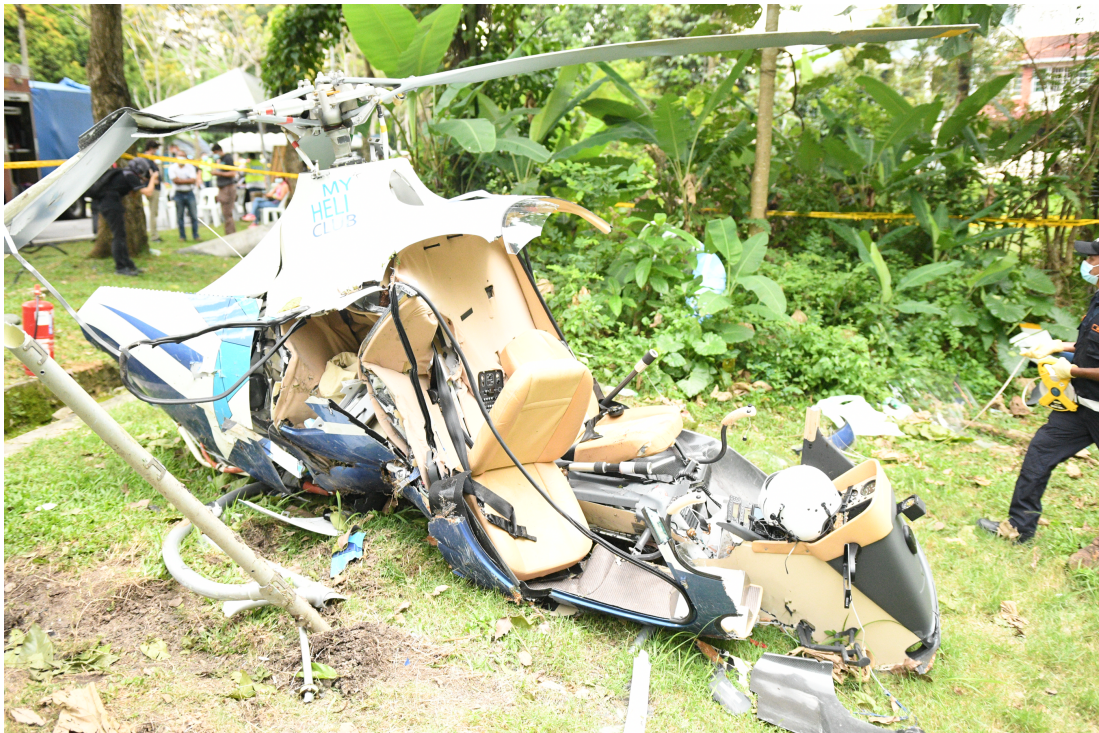
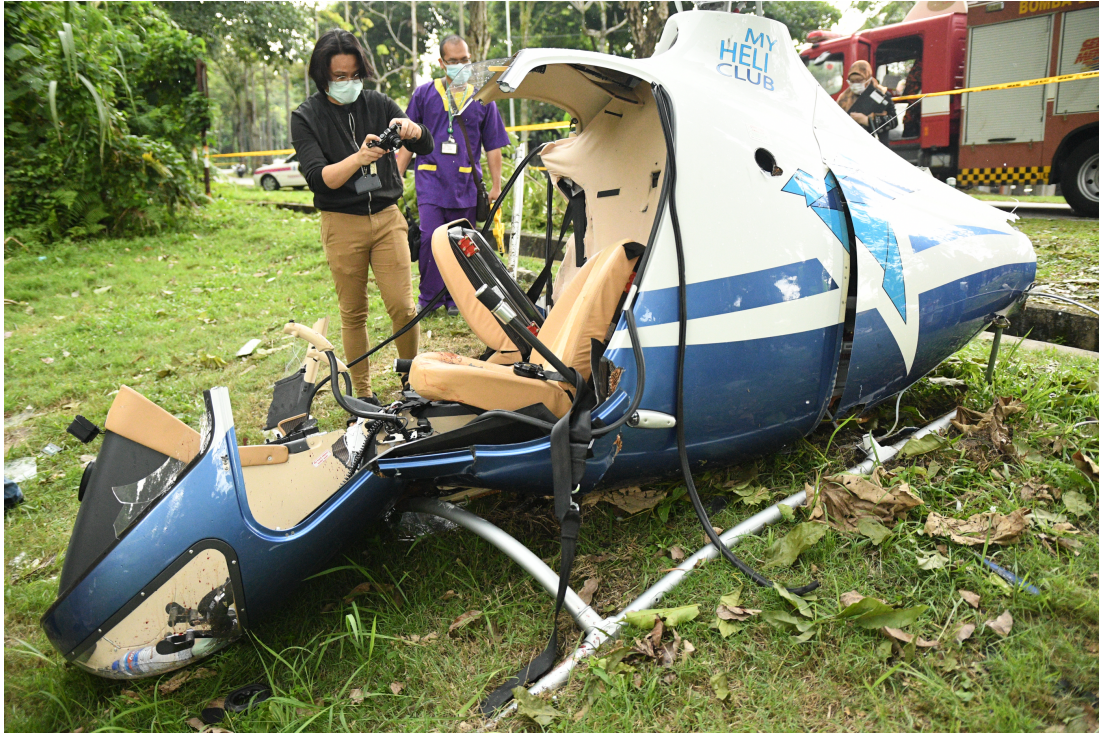
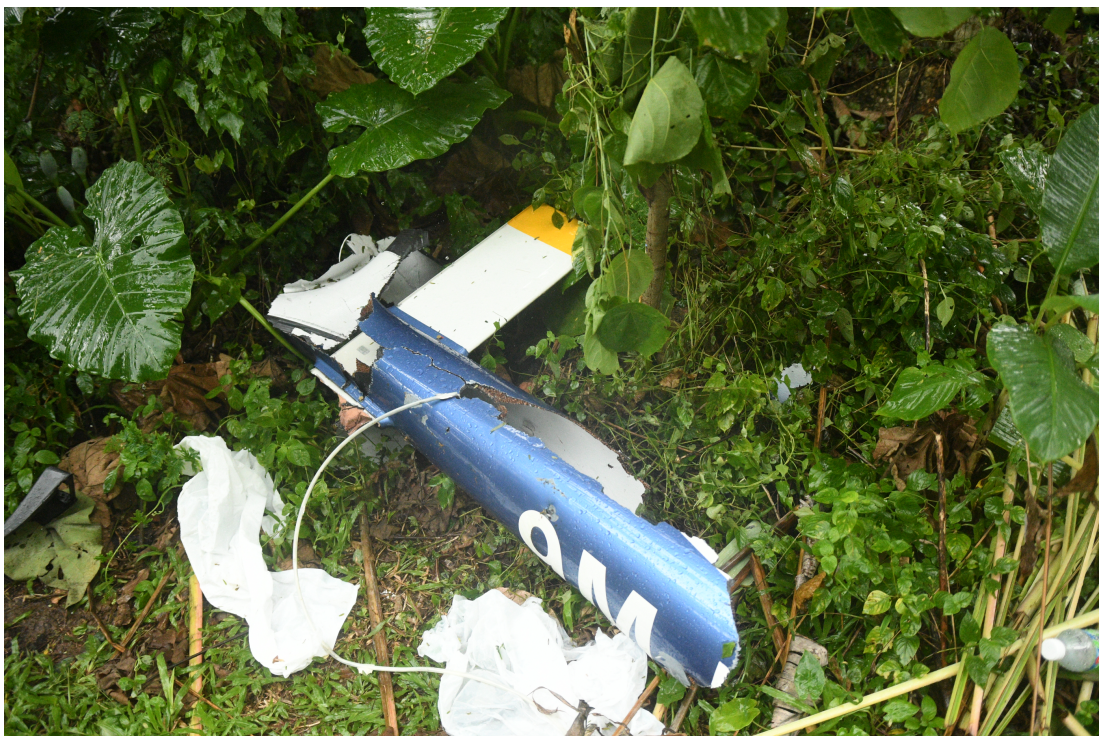
A visual assessment at the crash site revealed that 9M-HCB descended at a very steep angle. This was ascertained by its descent through and damage to a nearby tree to the point of impact.

From its final resting position and pattern of damages it can be deduced that 9M-HCB came down in a relatively level attitude with the right front quarter of the helicopter taking the brunt of the impact. There

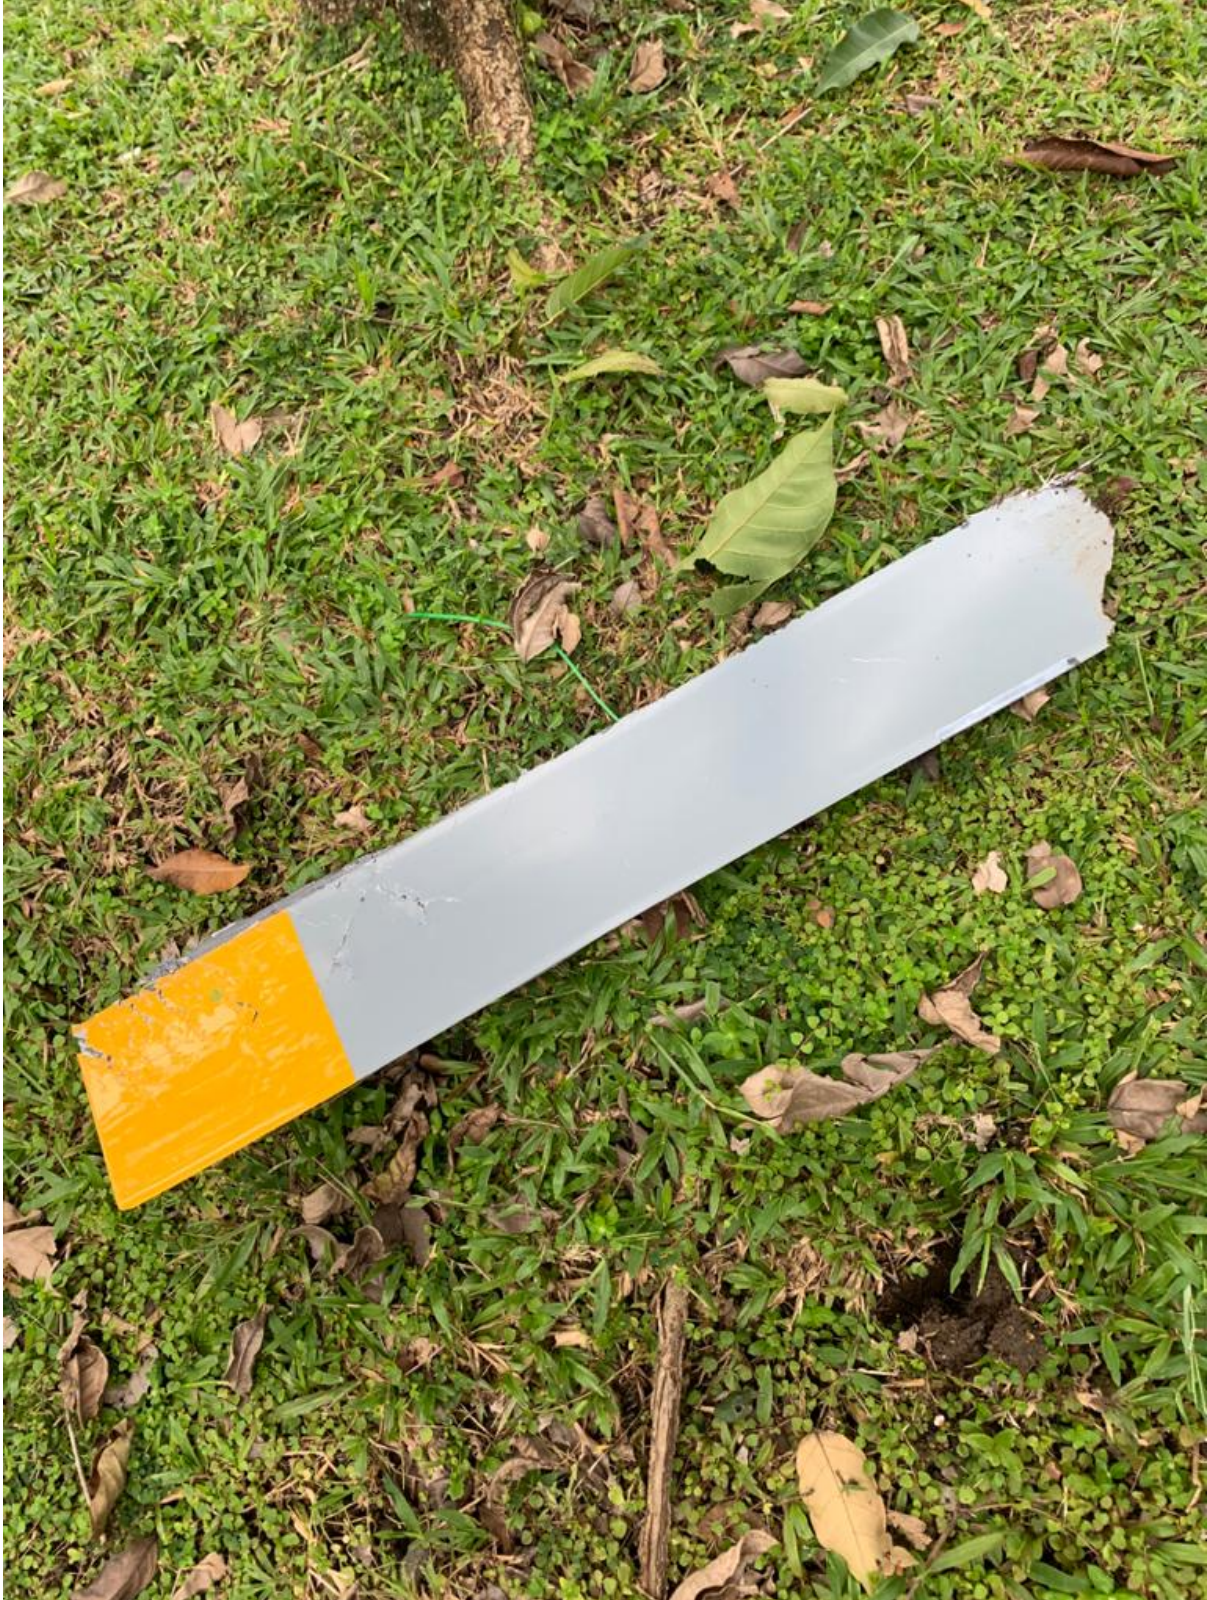
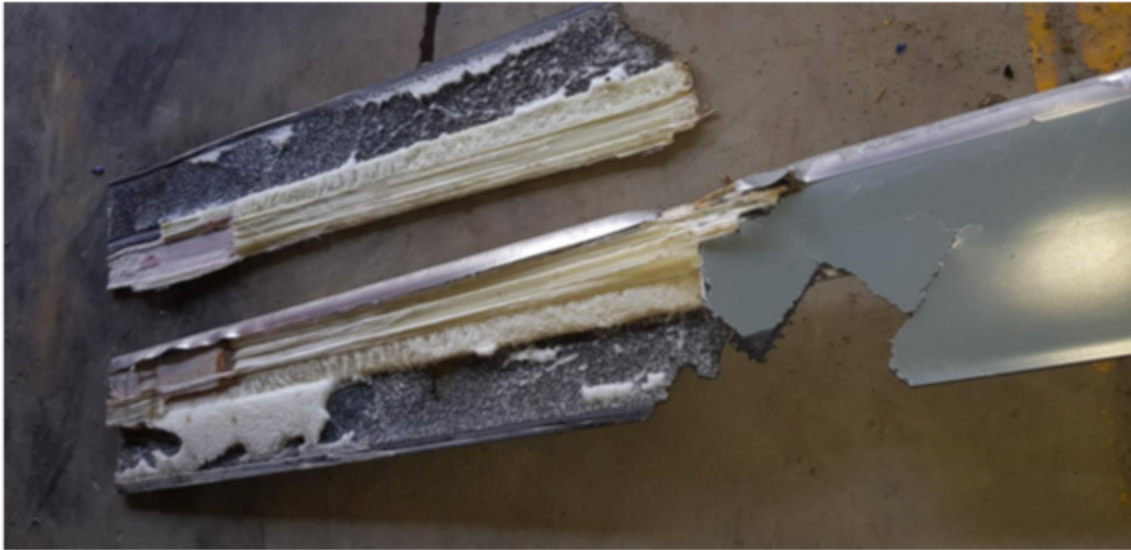
SEPARATED MAIN ROTOR BLADE (9M-HCB)

Picture 38 shows the broken piece of the upper section of the green main rotor blade. Some portion of the trailing edge also can be seen missing from the blade.

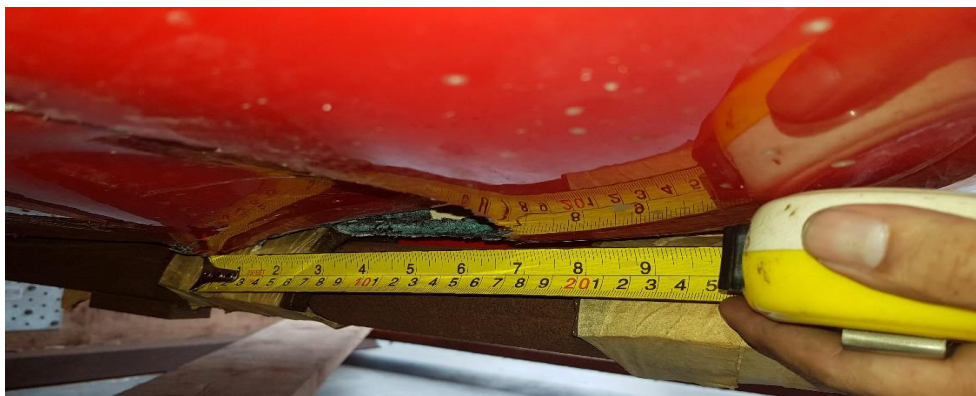
Picture 1 shows the crack on the Right-hand side of lower fuselage looking from aft of the aircraft. Measurement of the crack spanwise is at 7 inches.

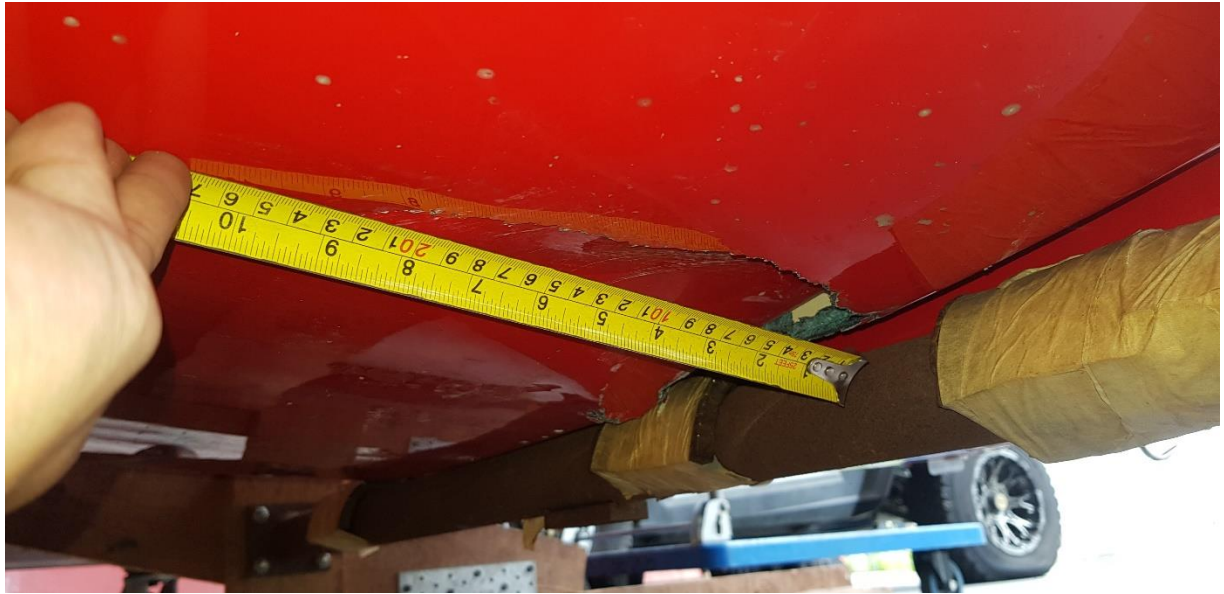
Picture 2 shows the measurement of the crack along the fuselage is at 8.7 inches.

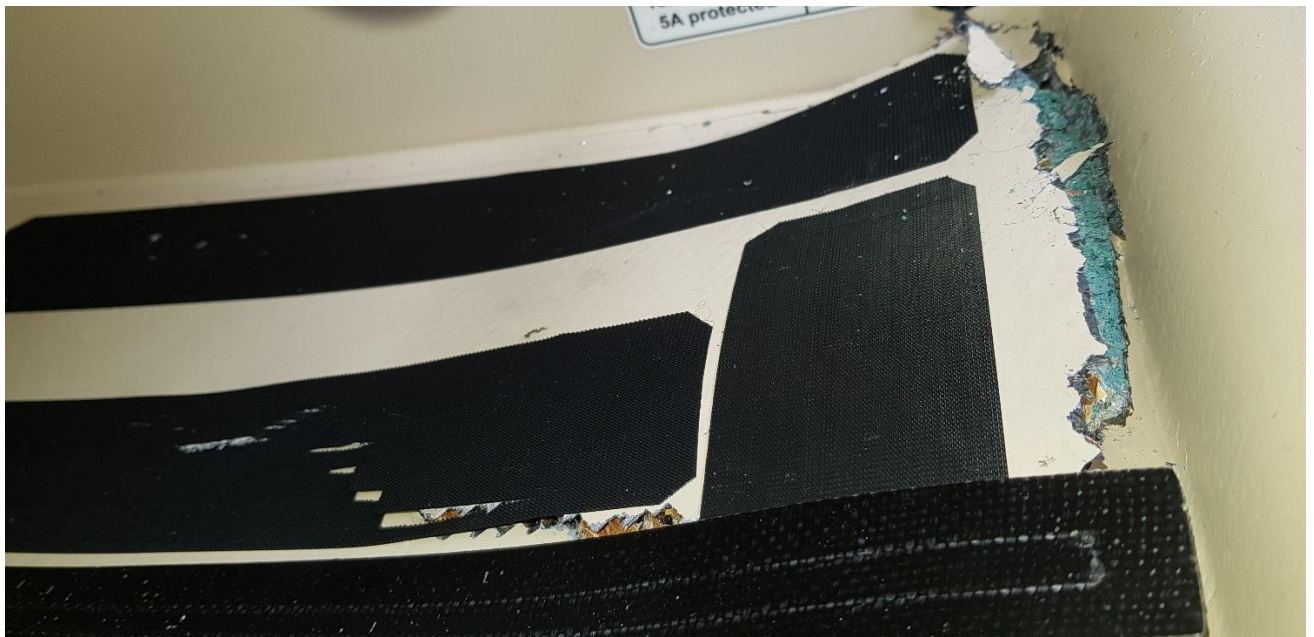
Picture 3 show the extensive damage of the crack, view inside of the cabin on the Pilot side (Left-hand seat).

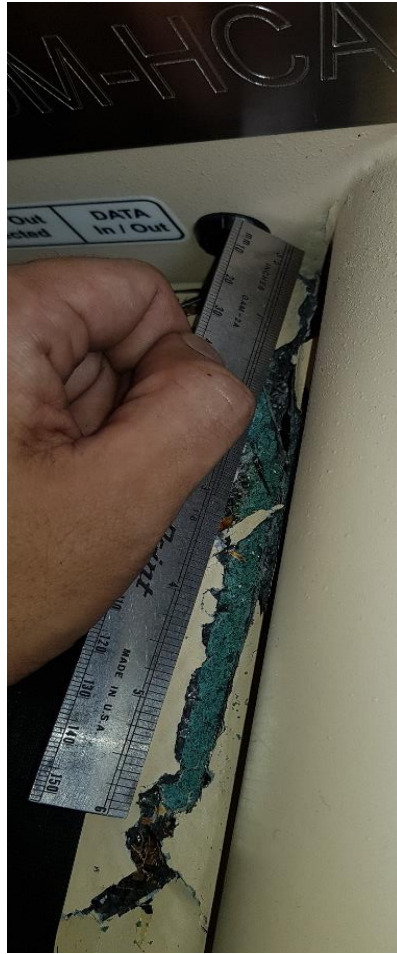
*Picture 4 shows the measurement of the crack view from inside of the cabin is measured more than 6 inches.
(Measurement taken show 7 inches).*

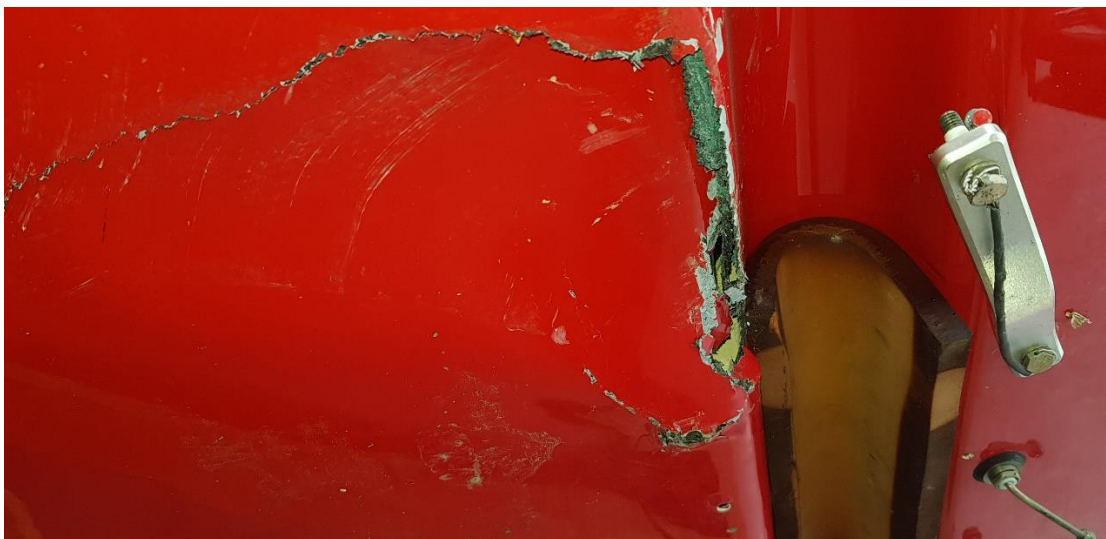
*Picture 5 shows the damage on the lower fuselage structure (top view).
The bent ATC transponder antenna could be seen on the lower left side of the picture.*

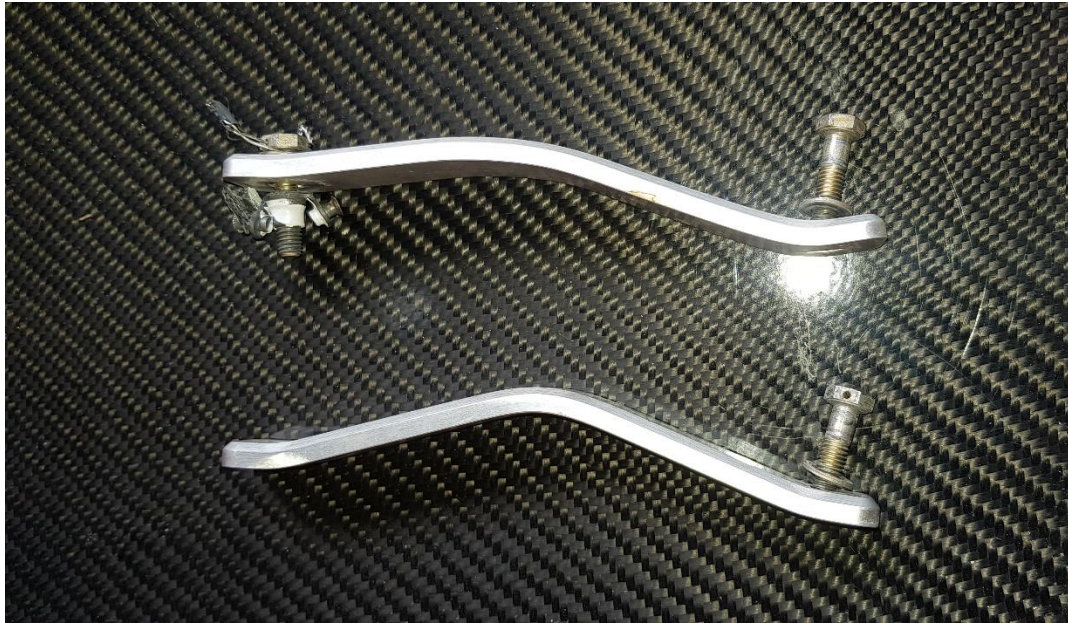
Picture 6 shows the two-damage front cross tube attachment bars of the aircraft.

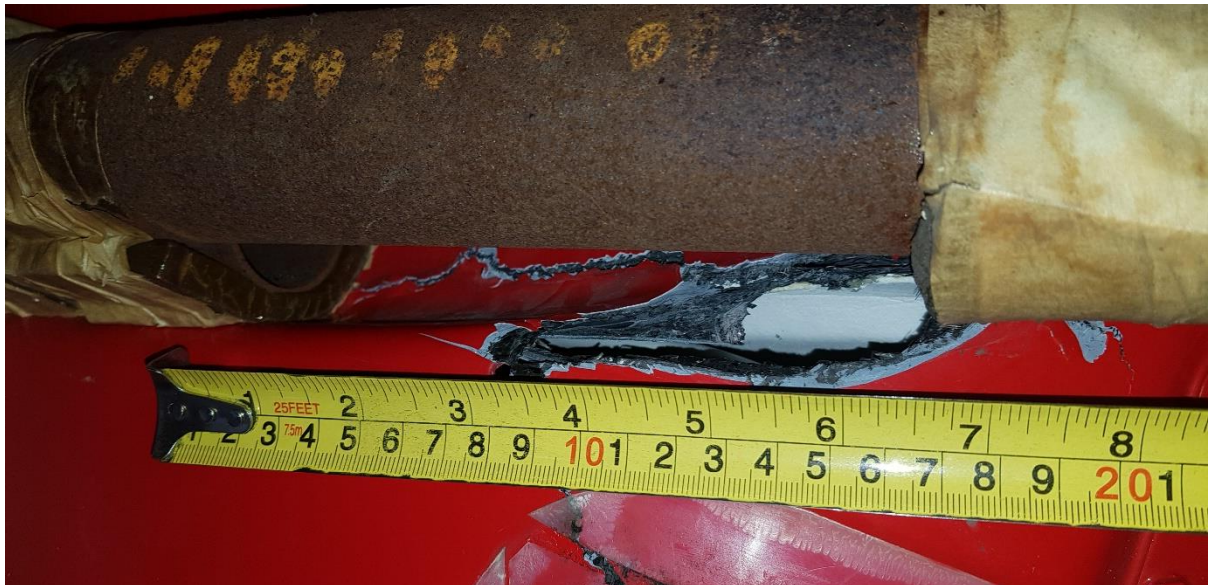
Picture 7 shows the aft left-hand lower fuselage punctured found during inspection. The hole is measured roughly at 4 inches spanwise. Length including the crack spanwise is roughly at 8 inches.

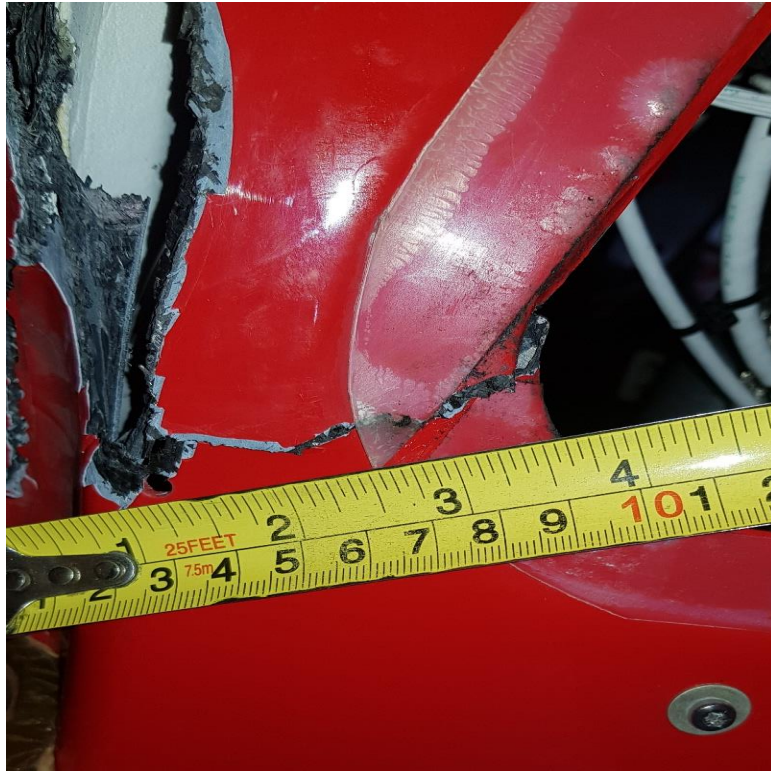
Picture 8 shows crack on the fuselage adjacent to the punctured area. Measurement of the crack is roughly 3.5 inches. View is taken from the left-side of the fuselage. (Near to left engine cowl door latch).

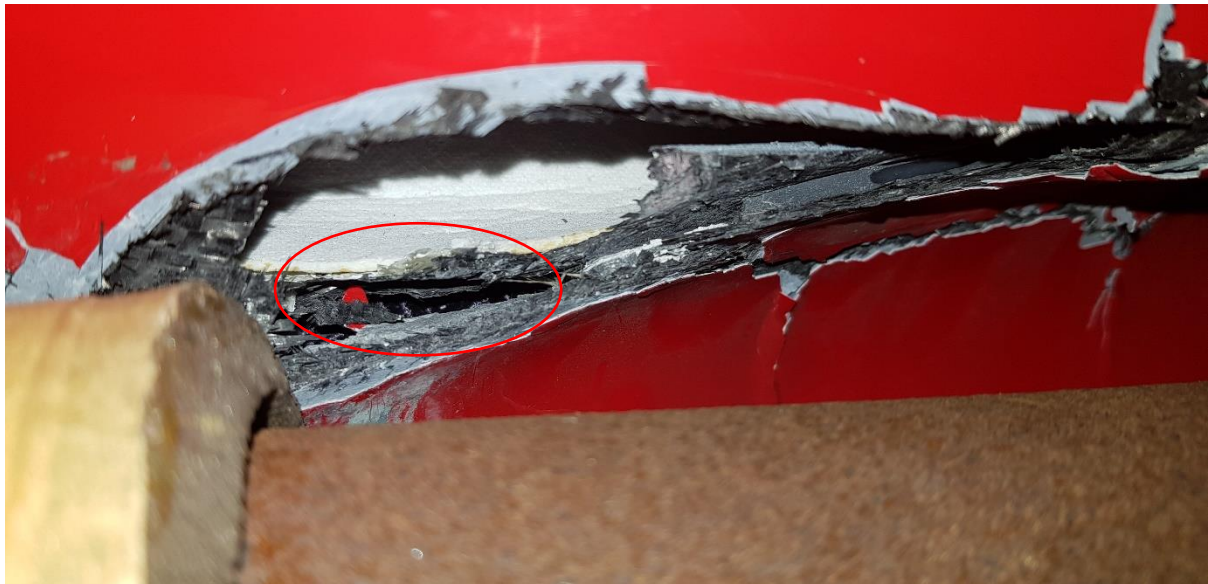
Picture 9 shows the view from aft to forward of the aircraft. The circle shown the area where the fuel bladder cell is slightly visible from the outside.

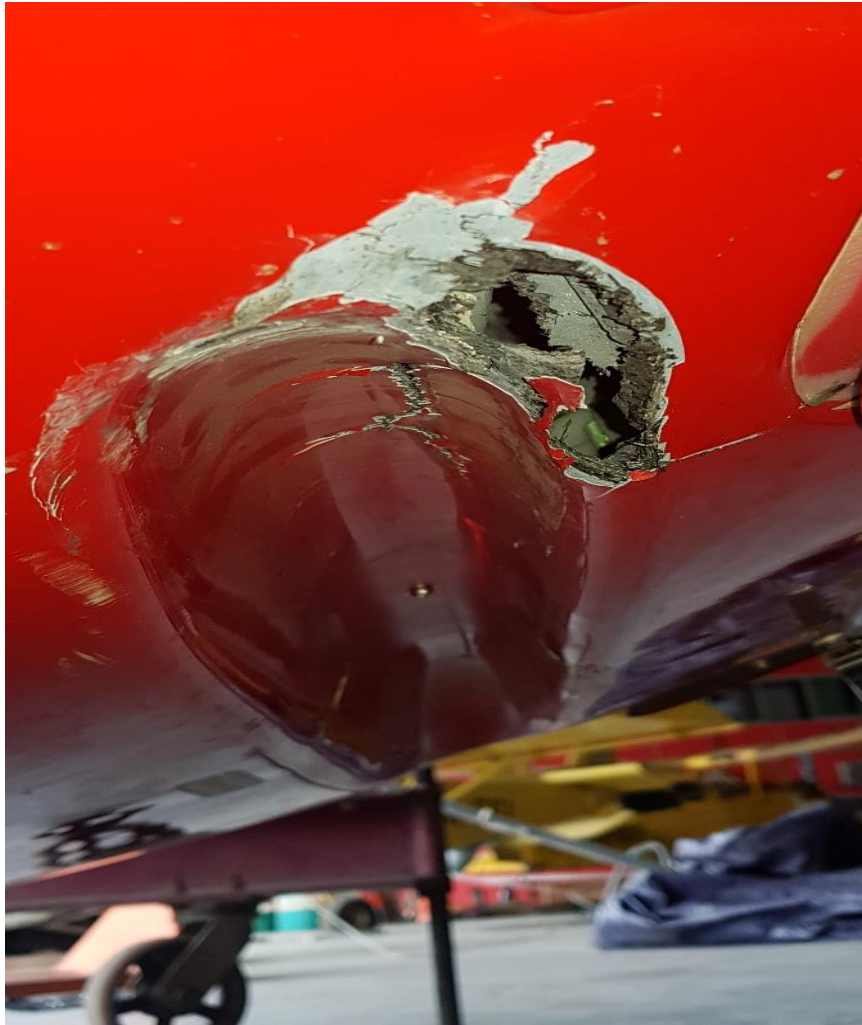
Picture 10 shows the hole from the left-hand side of the fuselage body adjacent to the skid attachment.

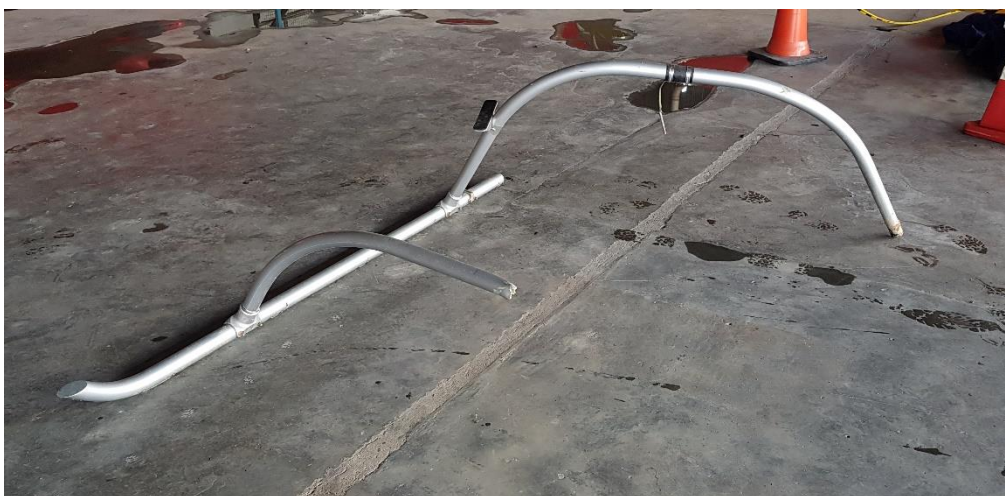
Picture 11 shows the condition of the aircraft skid after the incident (the left-hand skid missing)

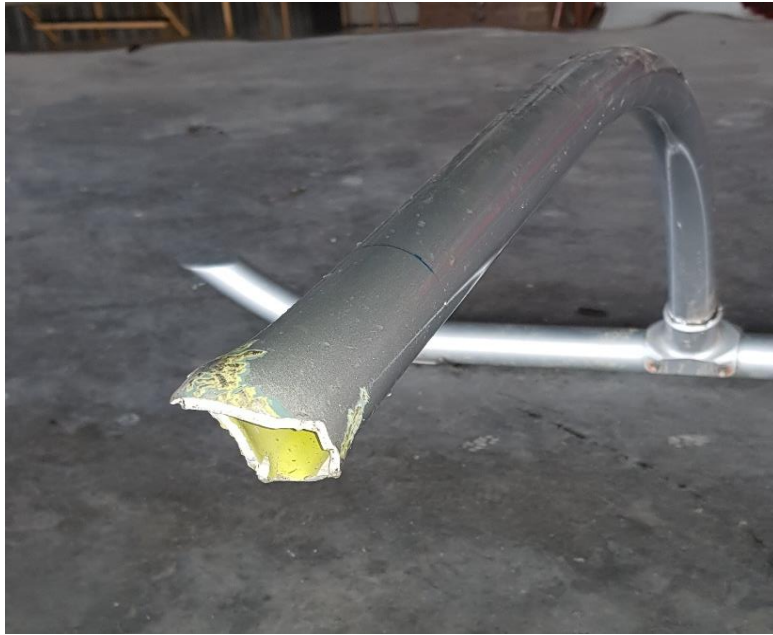
Picture 12 shows the damage on the Left-hand side forward cross tube on the landing gear.

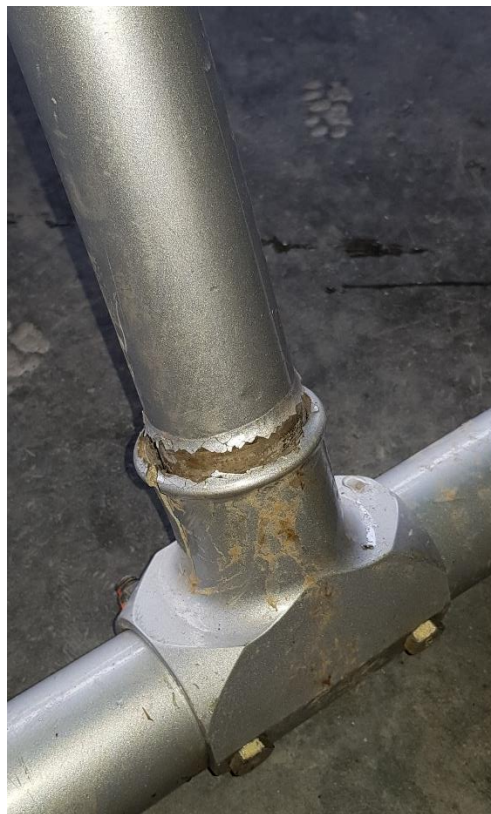
Picture 13 shows the damage on the right-hand side of the forward cross tube attachment to the right-hand skid.

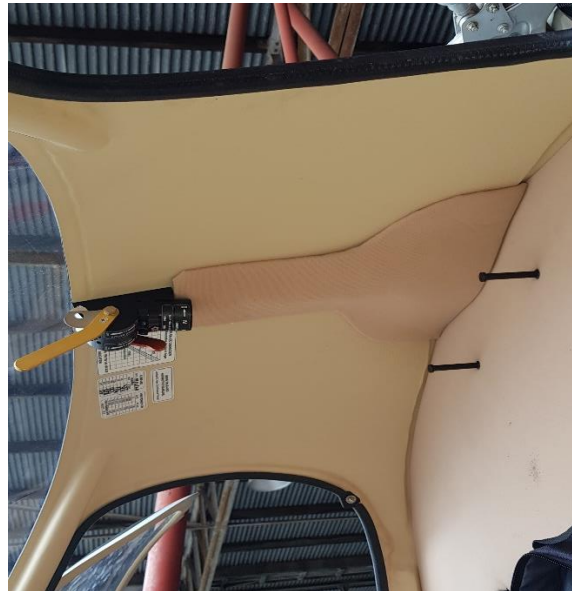
- i. Visual inspections on the insides of the cabin also has been carried out and found no cracks on the upper side of the cabin ceiling or on the aft wall.

Picture 14 shows the upper cabin ceiling of the cabin of the aircraft.

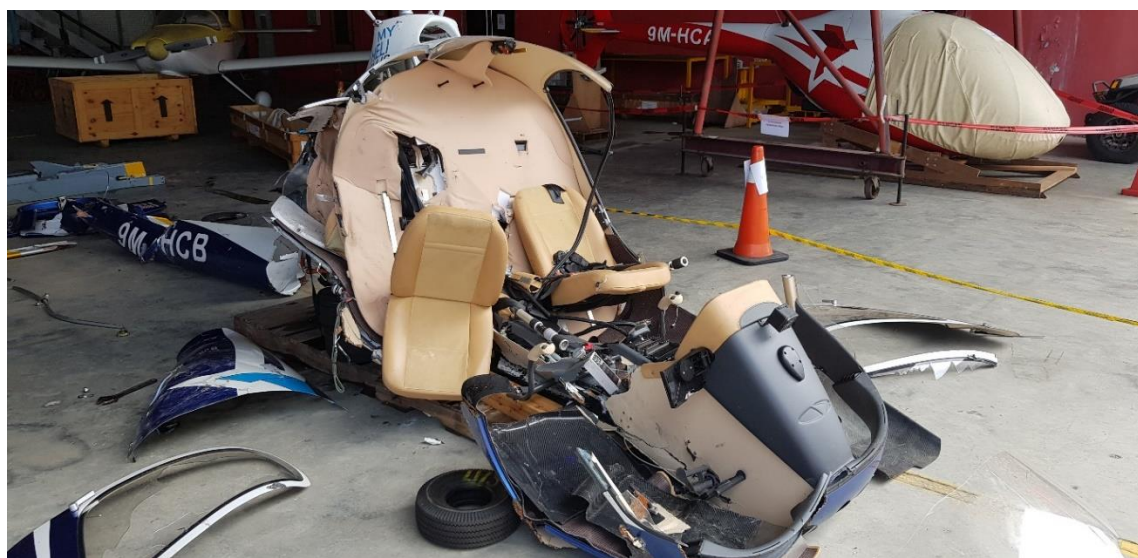
Picture 1 shows the extensive damage of the front section of the fuselage. The windscreen and the doors of the aircraft were found detach at the crash site.

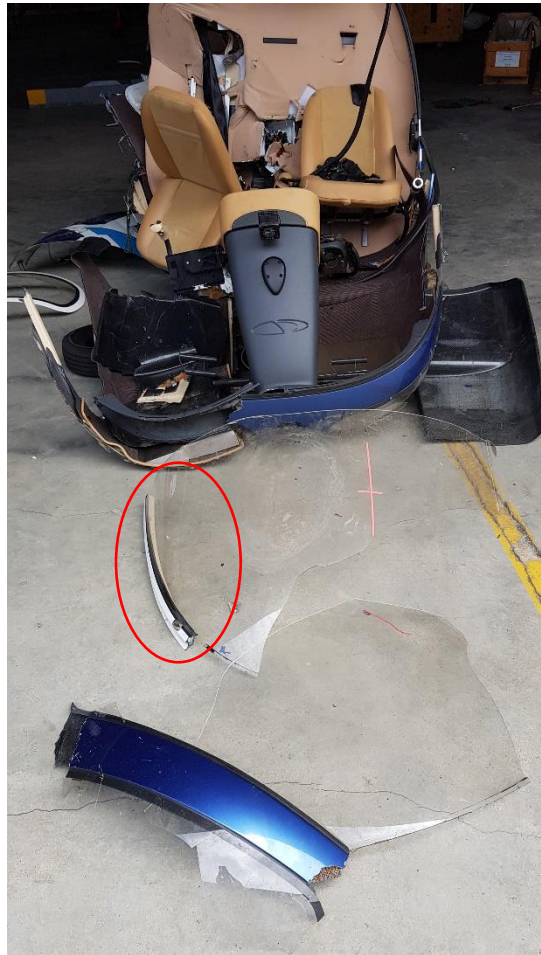
Picture 2 shows the portions of the windscreen and the forward left-hand side of the fuselage. Shown in the circle are the forward right-hand member of the front portion of the fuselage.

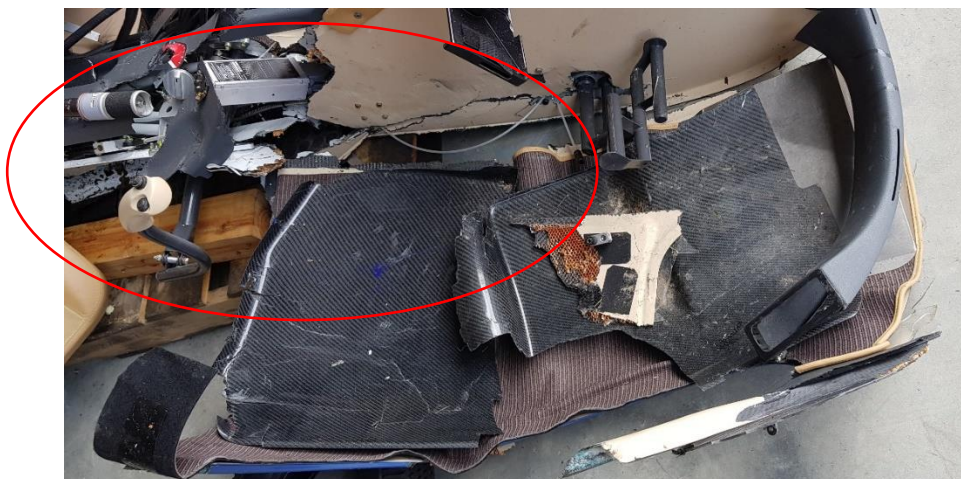
Picture 3 shows the right-hand side of the fuselage. The circle shown in the picture shows the substantial damaged to the airframe structure.

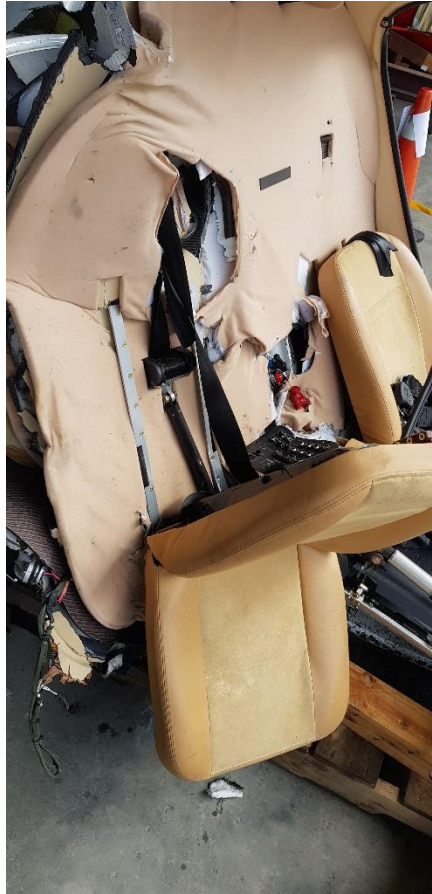
Picture 4 shows the pilot seat are mostly detach from the rails on the wall of the cabin. Can be seen in the picture also most of the right-hand side of the lower fuselage are destroyed due to the crash.

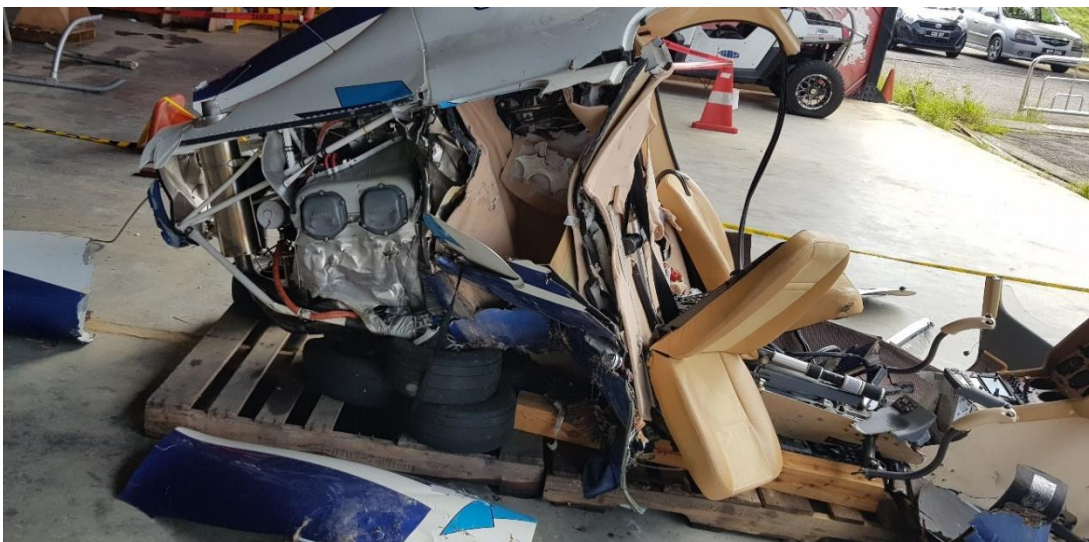
Picture 5 shows the right-hand side of the of aircraft fuselage. Most of the sections were destroyed due to the crash. Shown in the picture the right-hand engine cowling.

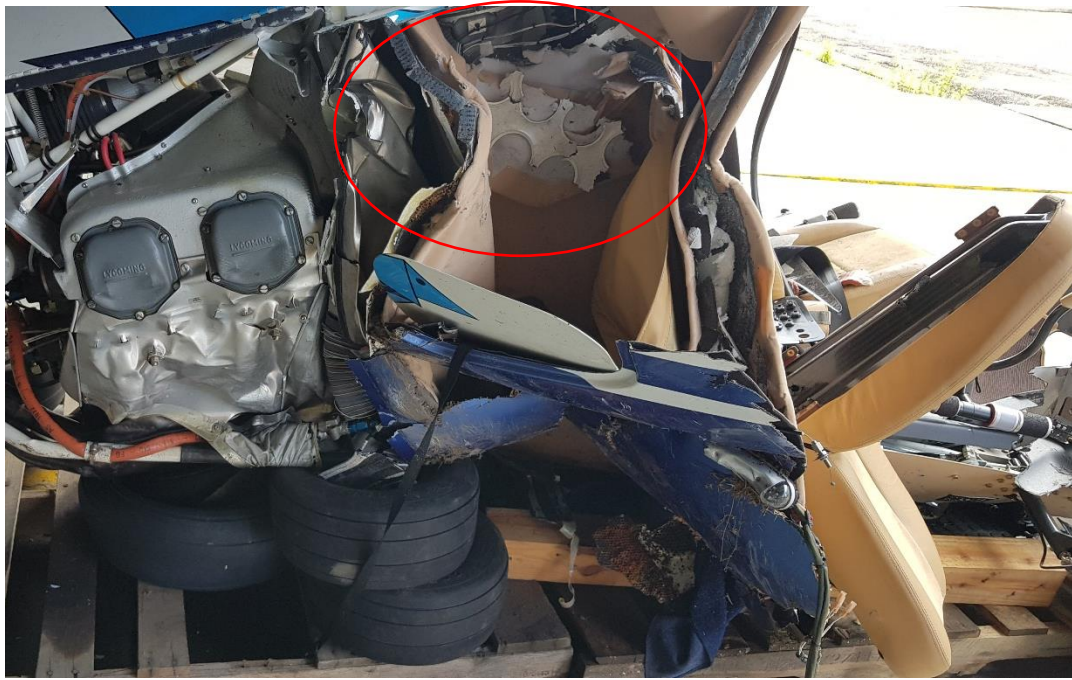
Picture 6 shows the right-hand side of the aircraft fuselage. The circle shown in the picture shows the damage luggage compartment of the aircraft. Some portion of the main gearbox could be seen also in this picture.

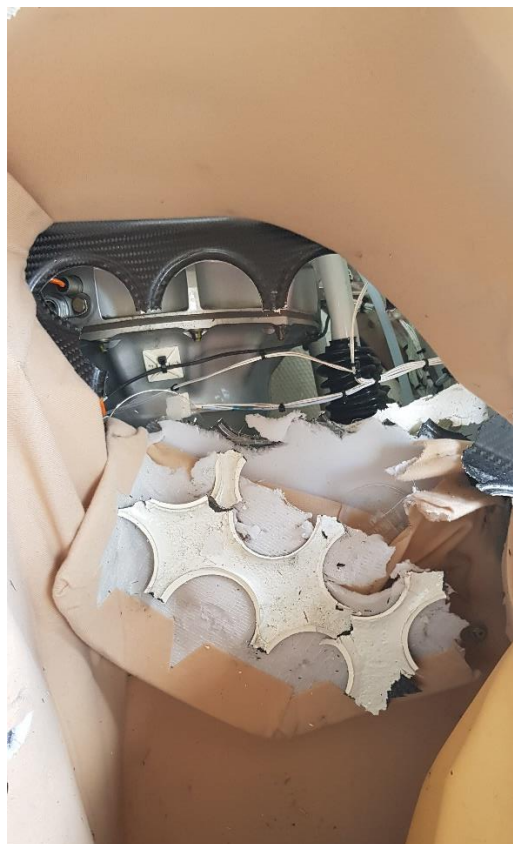
Picture 7 shows the broken wall section of luggage compartment. Can be seen in this picture the main gear box of the aircraft.

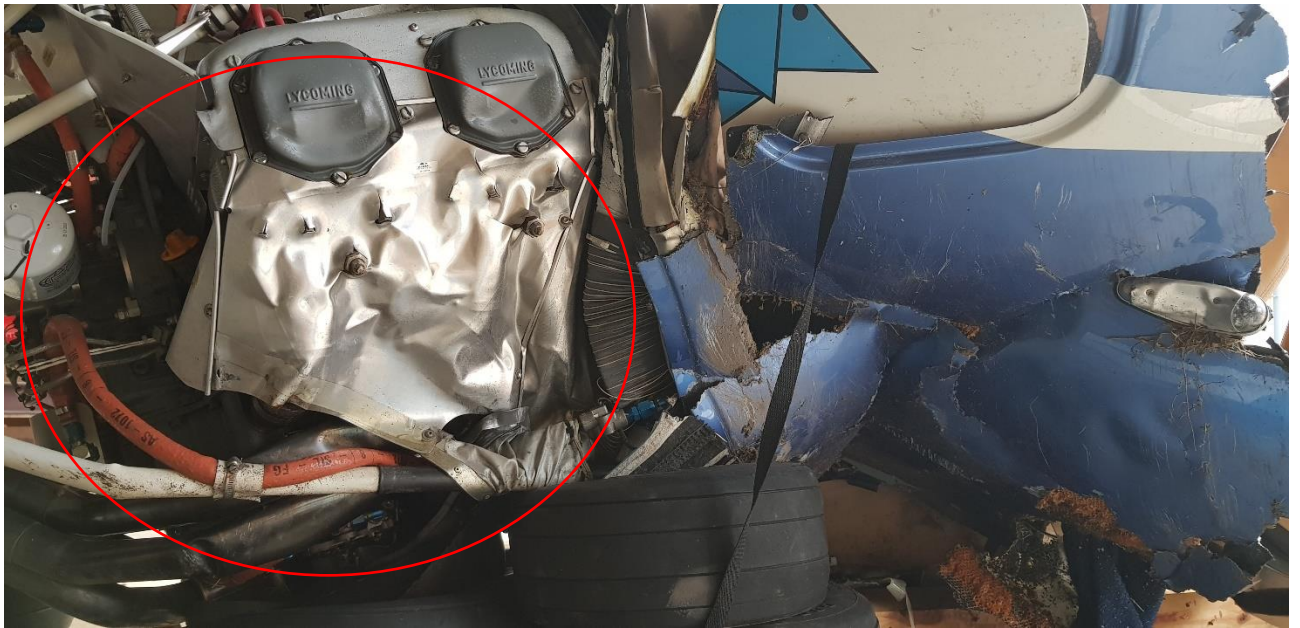
Picture 8 shows the right-hand side of the engine. Shown in the circle in this picture are the damaged lower engine baffled and the bent left-hand engine truss.

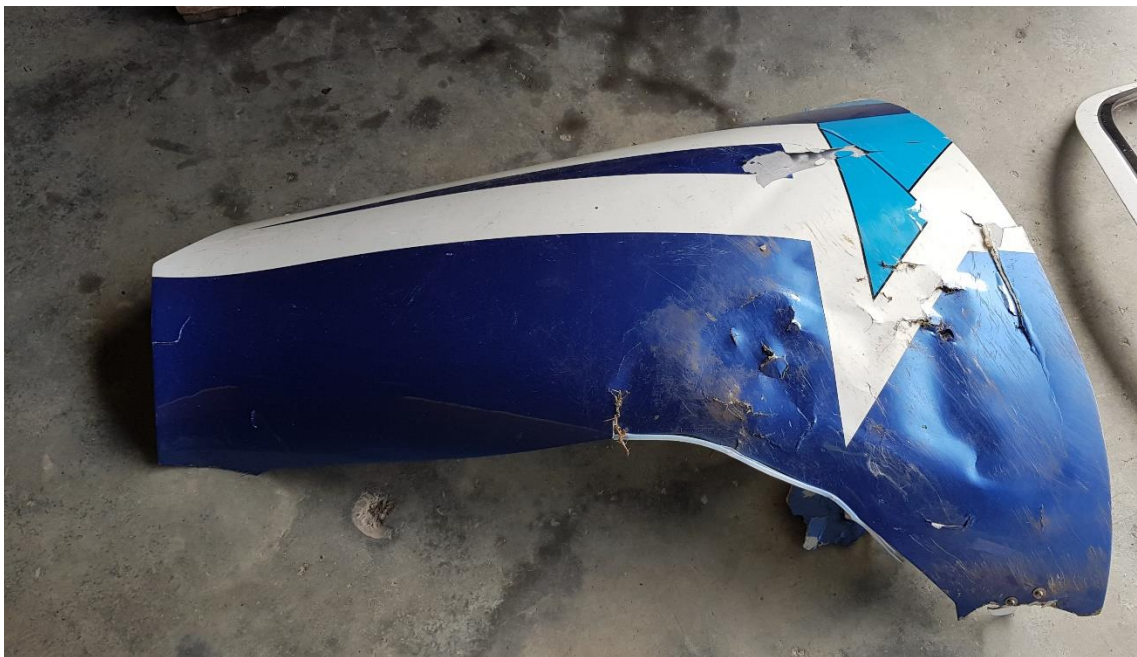
Picture 9 shows damaged right-hand side of the engine cowling.

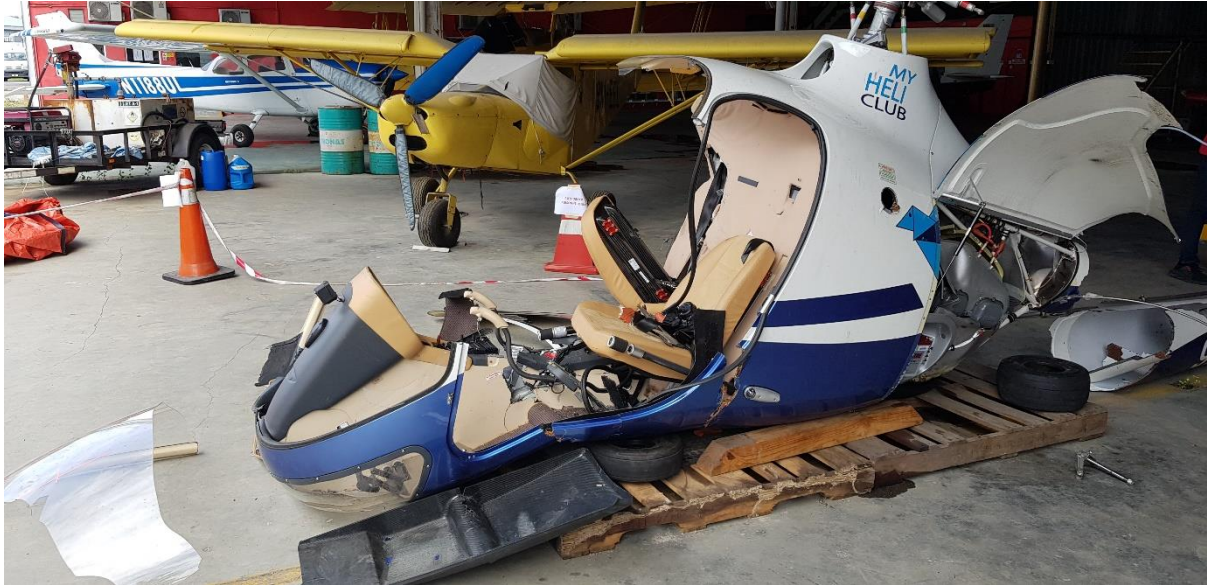
Picture 10 shows the left-hand side of the aircraft fuselage. In comparison to the left side, most of the structural parts of the aircraft are still attached. Can be seen in this picture, the co-pilot seat is still attached to wall of the cabin.
