AIRCRAFT ACCIDENT FINAL REPORT
A 06/20
Air Accidents Investigation Bureau (AAIB)
Ministry of Transport

Accident Involving Two Guimbal Cabri G2
Registration 9M-HCA & 9M-HCB
in Taman Melawati, Kuala Lumpur
on the 8 November 2020

FINAL REPORT A 06/20

OPERATOR	:	MY HELI CLUB
AIRCRAFT TYPE	:	GUIMBAL CABRI G2
NATIONALITY	:	MALAYSIA
REGISTRATION	:	9M-HCA & 9M-HCB
PLACE OF OCCURRENCE	:	TAMAN MELAWATI, KUALA LUMPUR
DATE AND TIME	:	8 NOVEMBER 2020 AT 1145 LT

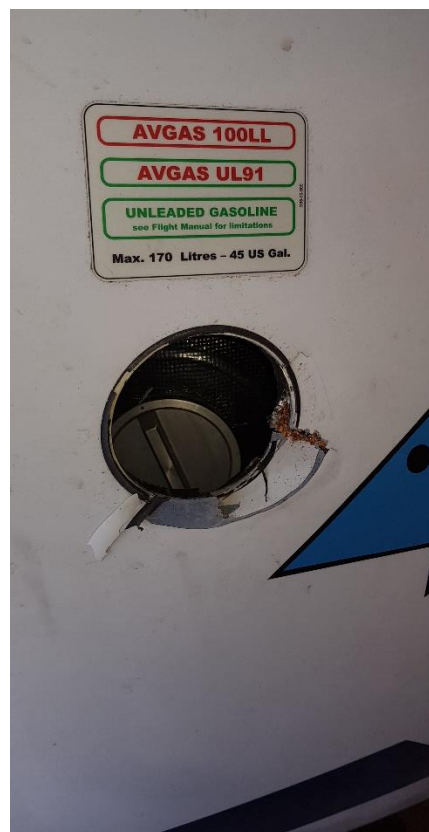
It must be noted that 9M-HCB's fuel tank survived the impact intact. There were no fuel leakages which could have led to a post-impact fire.

Picture 11 shows the left side of the aircraft where the fuel bladder is positioned. Can be seen the fuel cap is still attached to the fuel bladder and has moved inwards into the fuselage. The fuel bladder is still intact, and no leak was found.

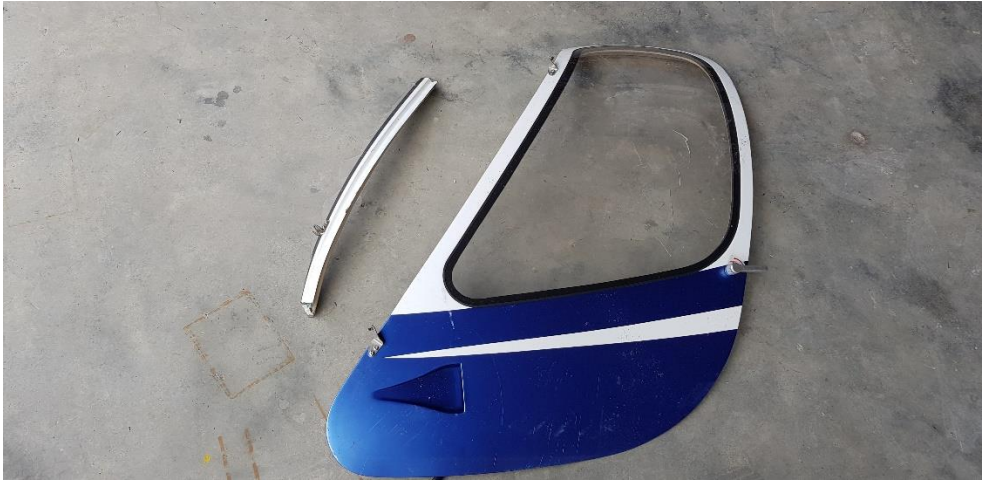
Picture 12 shows the left-hand side door with the left-hand side of the front member of the forward fuselage. These parts were found detached from the aircraft and were recovered at the crash site.

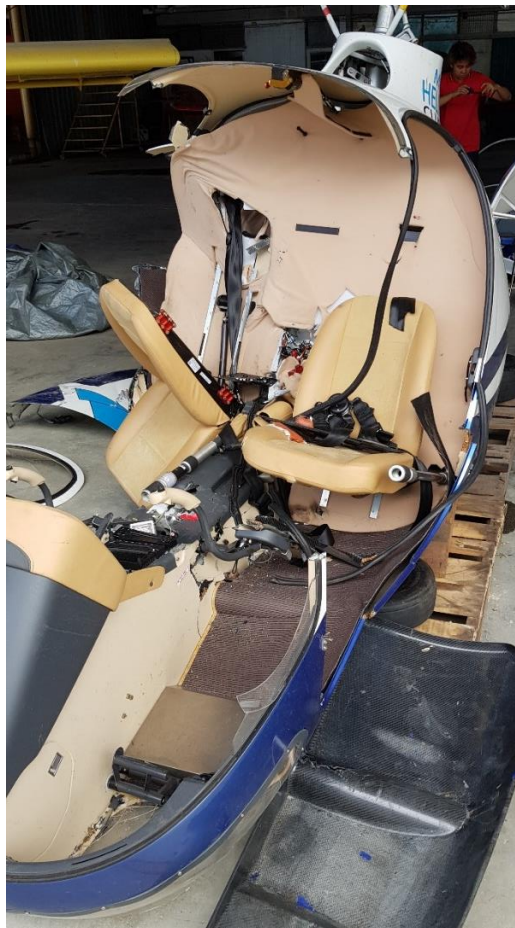
Picture 13 shows the front portion of the left-hand side of the aircraft. Can be seen in this picture the damaged center pedestal and detached pilot seat.

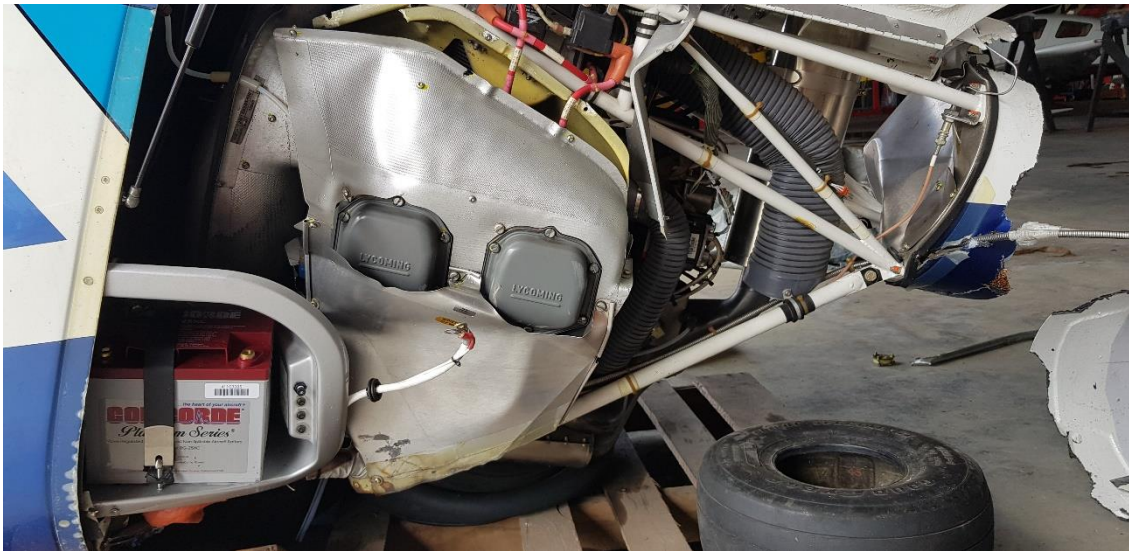
Picture 14 shows the left-hand side of the engine. Can be seen in this picture the damaged upper and lower baffles of the engine. Also, can be seen in this picture the point where the tail section believed to be broken off from the aircraft.

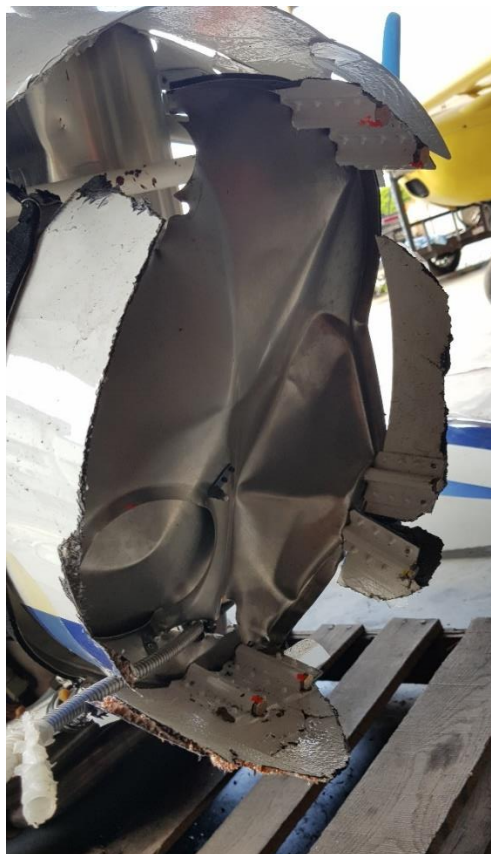
Picture 15 shows the aft engine firewall of the aircraft. Can be seen in this picture the tail attachments of the aircraft still attached to the truss structure.

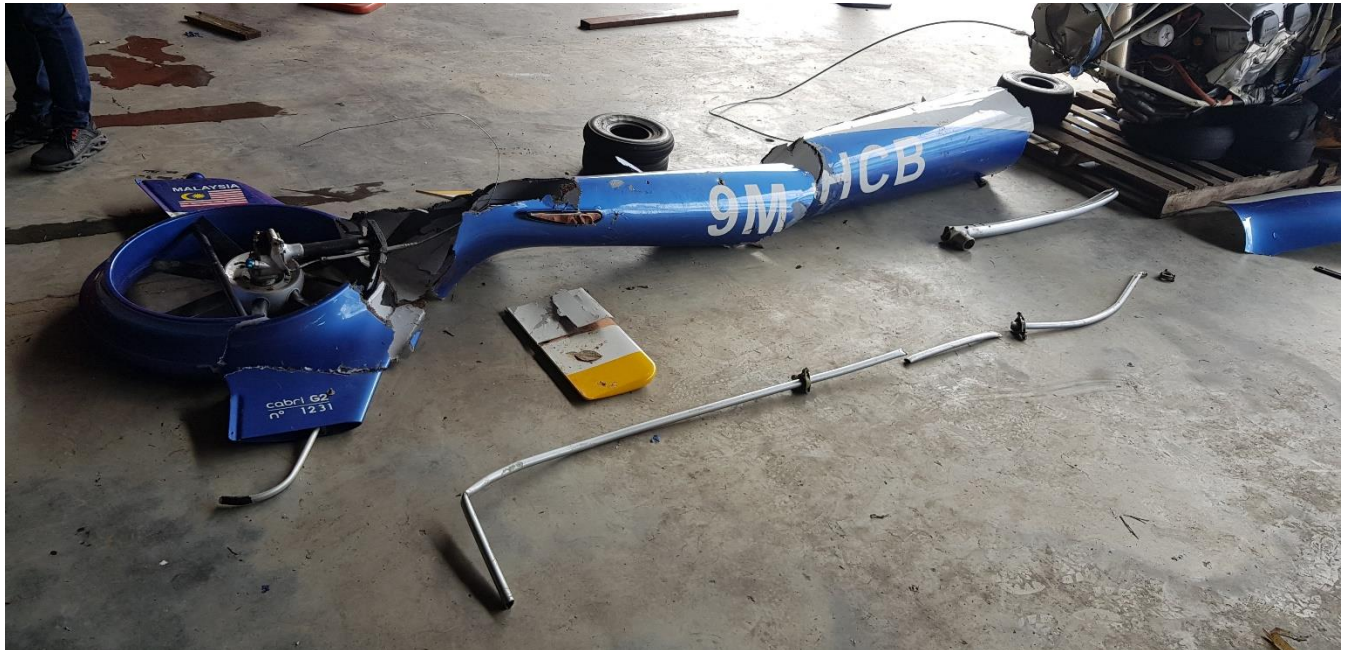
Picture 16 shows the tail section and the tail driveshaft of the aircraft. Most of the tail section are broken and were recovered at the crash site.

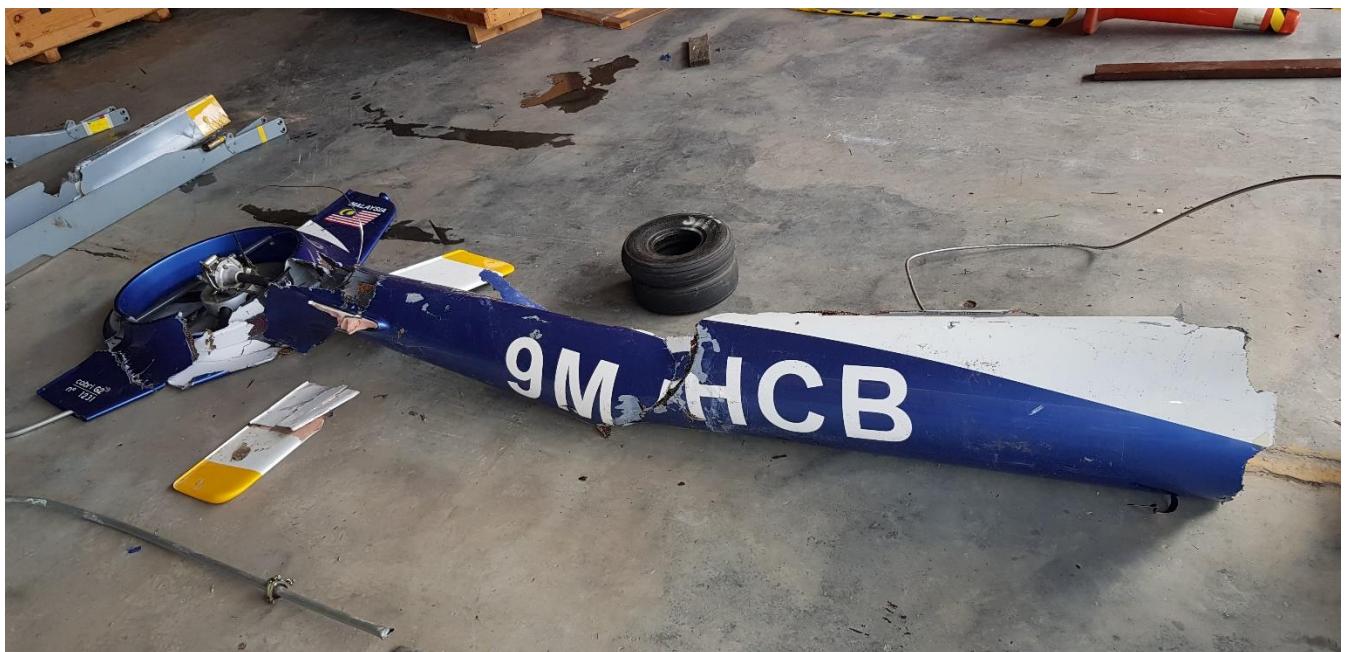
Picture 17 shows another angle of the broken tail section. Can be seen in this picture the broken right-hand side of the horizontal stabilizer.

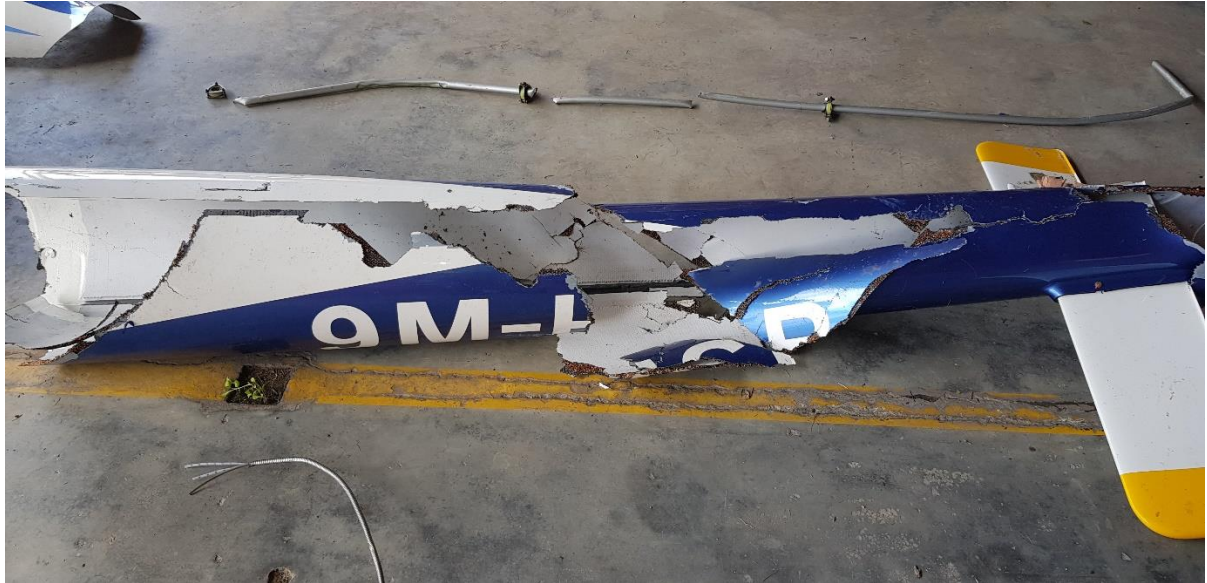
Picture 18 shows the left-hand side of the tail boom. Can be seen in this picture most of the tail boom are broken to several pieces.

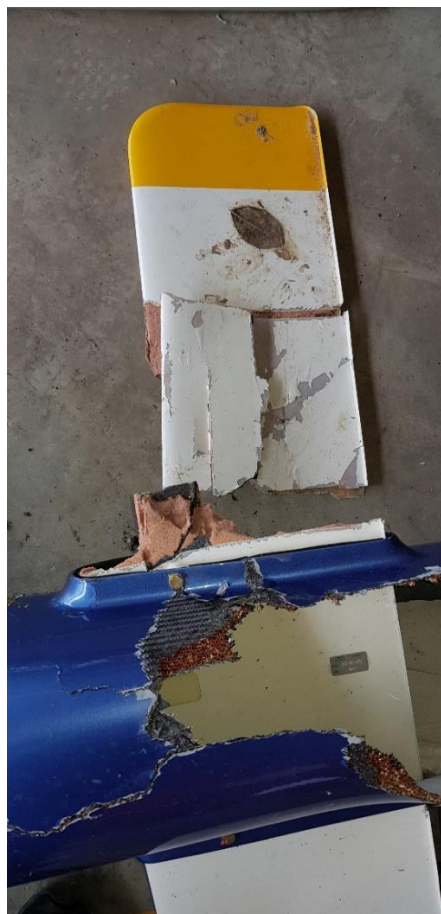
Picture 19 shows the broken horizontal stabilizer view from above.

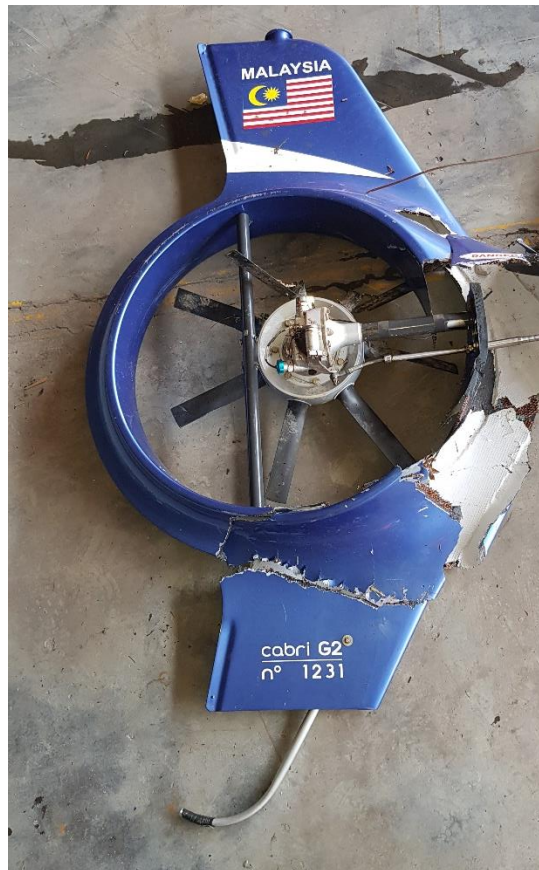
Picture 20 shows the fenestron of the aircraft. Can be seen in this picture most of the fin structure was broken and were recovered at the crash site.

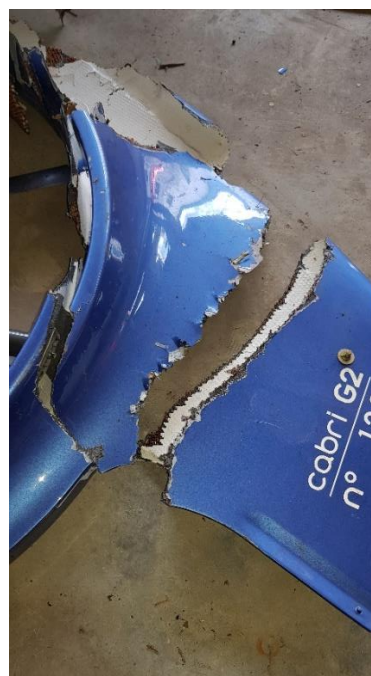
Picture 21 shows the broken lower fin of the tail section of the aircraft.

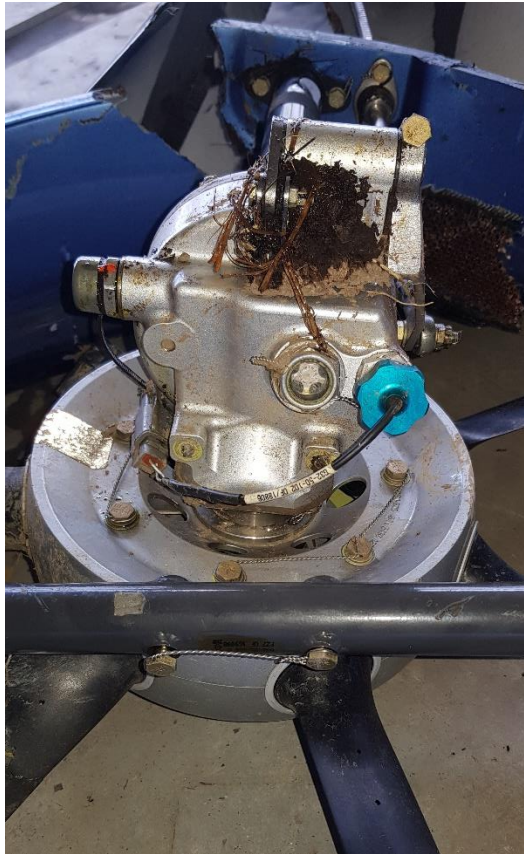
Picture 22 shows the tail gearbox of the aircraft. The tail gearbox was found detached from the aircraft were recovered at the crash site. Most of the engine oil have leak out upon recovering the gearbox.

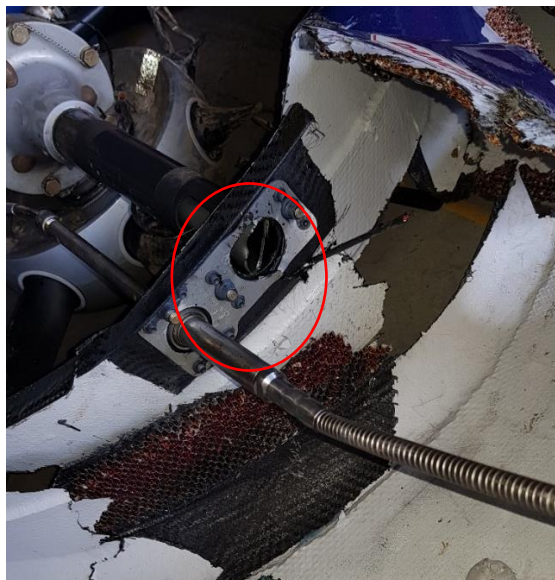
Picture 23 shows broken section of the entire fin. The circle shown in the picture shows the sheared portion of the tail rotor driveshaft.

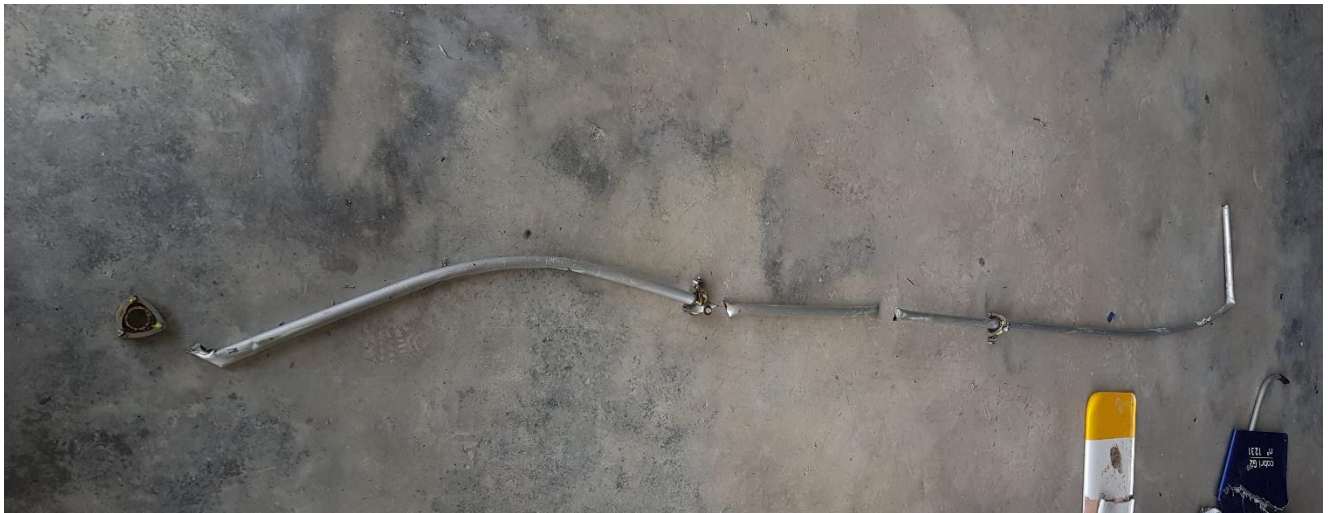
Picture 24 shows the broken pieces of the tail rotor driveshaft. Most of the driveshaft found evidence of torsional and shear damage. Can be seen also in this picture the hanger bearing that is detached from the aft engine firewall and were recovered at the crash site.

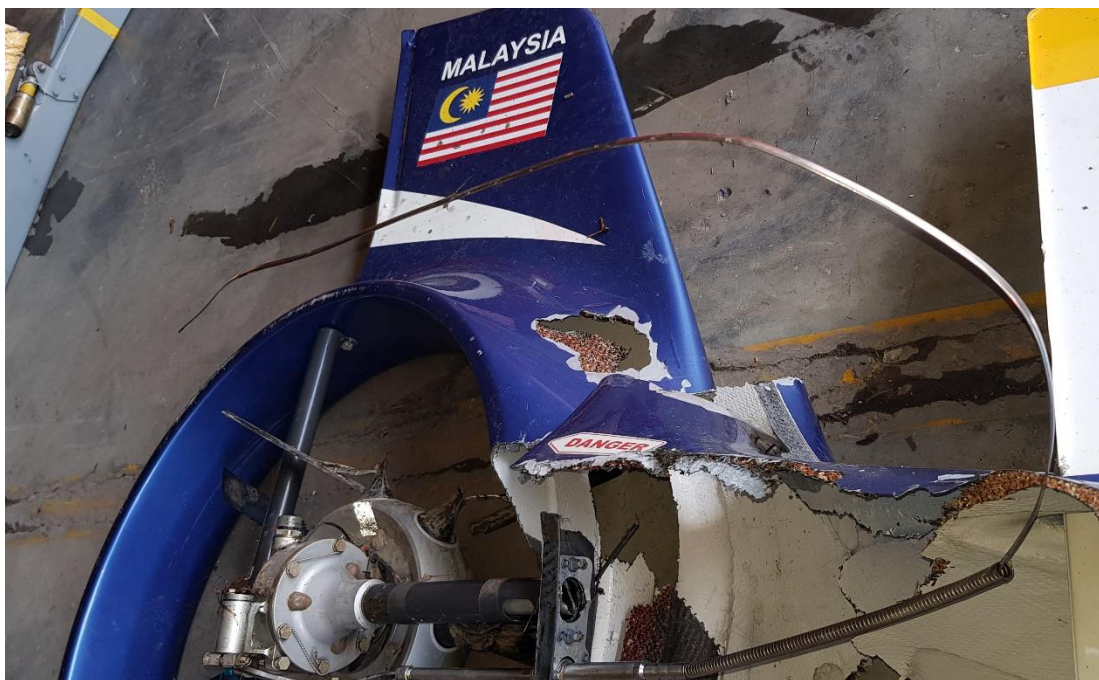
Picture 25 shows the damaged tail rotor cable. Half portion of the cable are found still attached to the fuselage of the aircraft. Can be seen also in this picture the damaged fin of the aircraft.

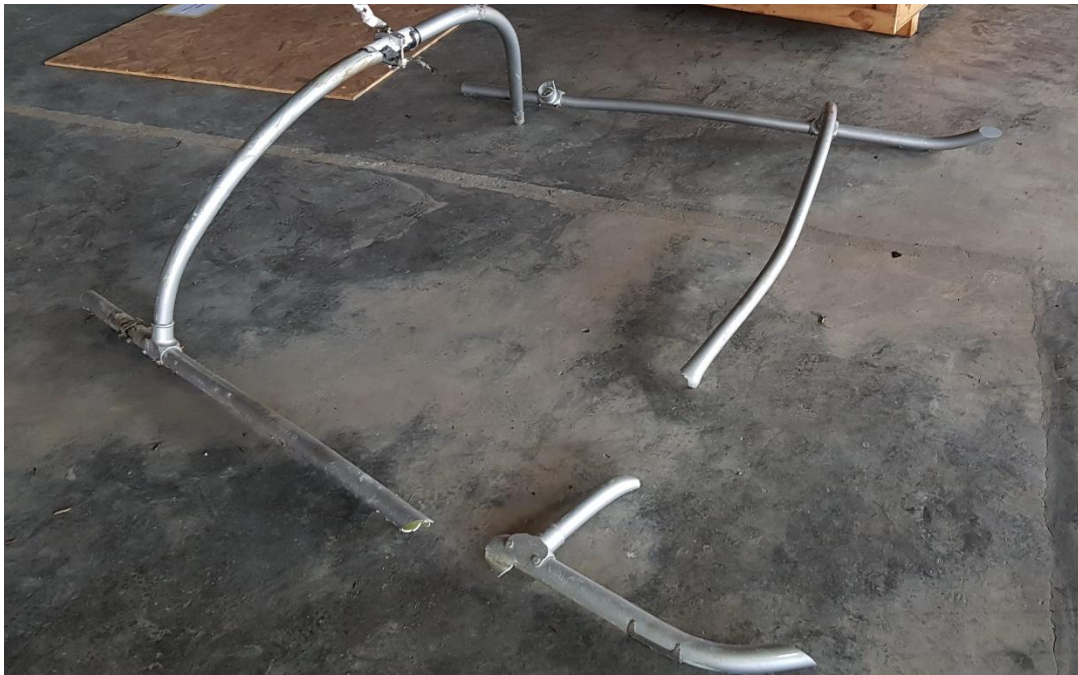
*Picture 26 show the broken landing gear of the aircraft. Can be seen in this picture the landing gear are broken to 3 pieces.
All the broken pieces were recovered from the crash site.*

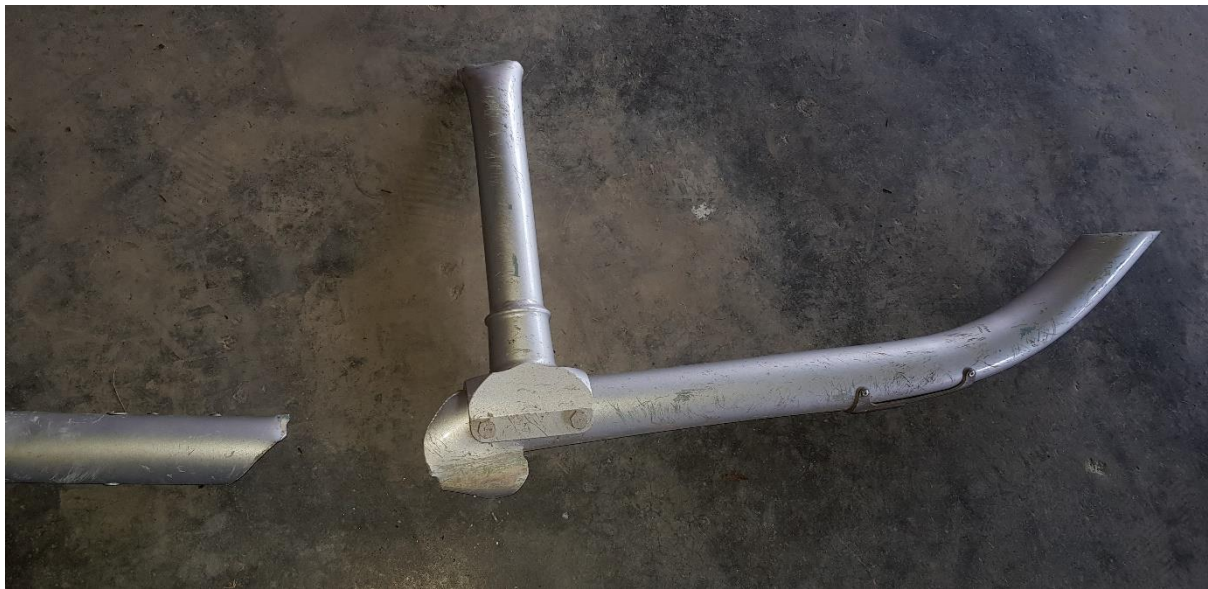
Picture 27 shows the broken piece of the right-hand skid assembly.

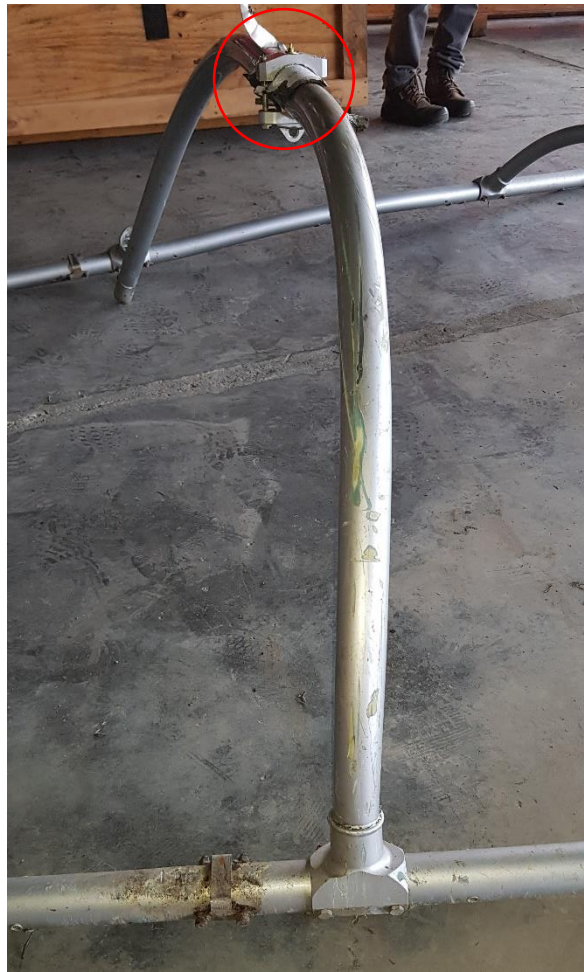
Picture 28 shows the aft bow of the landing gear assembly. Shown in the circle the rear bow attachment to the fuselage detached from the lower fuselage.

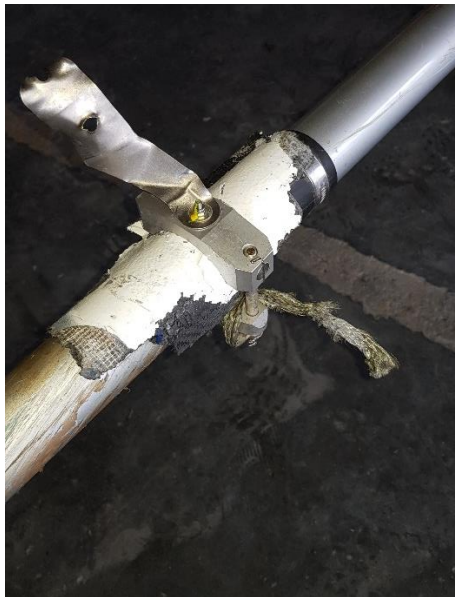
Picture 29 shows another angle of the rear bow landing gear attachment found detach from the lower fuselage.

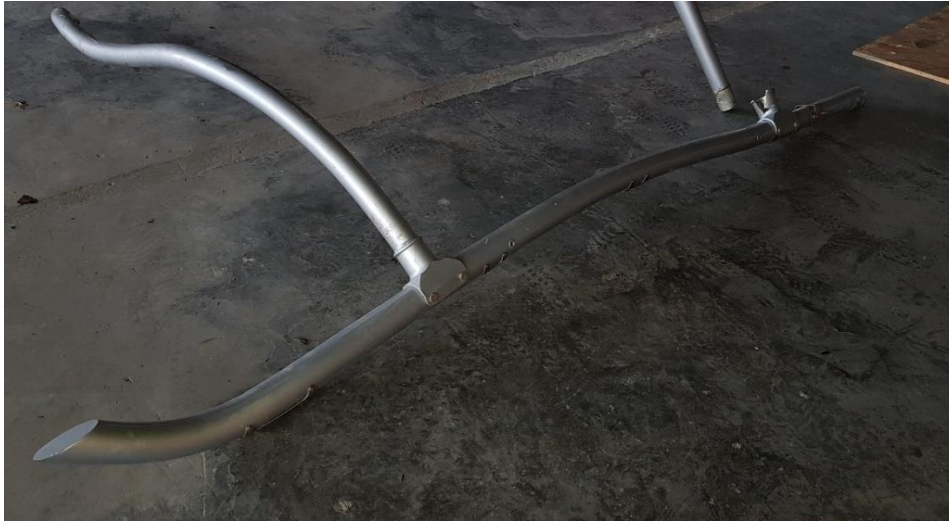
Picture 30 shows the left-hand skid of the landing gear assembly. Shown in the picture the landing gear is bent and the rear bow is detached from the attachment to the skid.

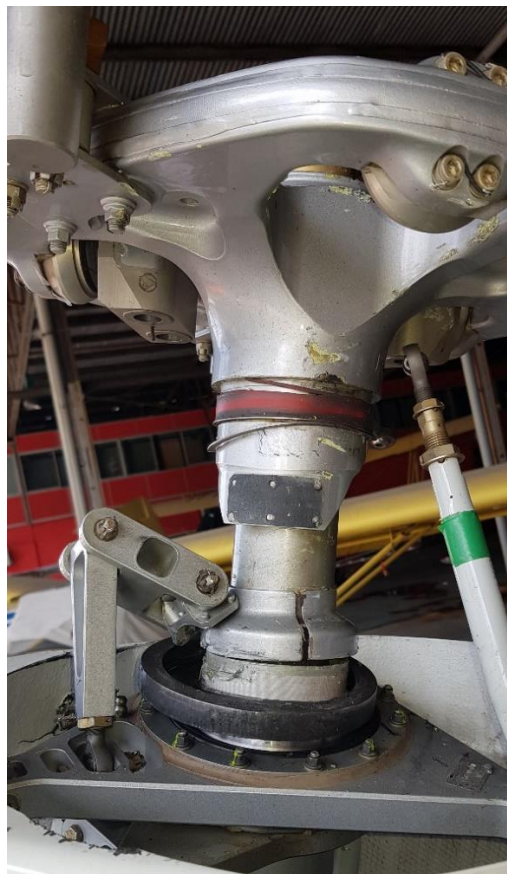
Picture 31 shows the extensive damage to the main rotor head. Shown in this picture the upper scissors fittings rivets are sheared off from the rotor head. Can be seen also the droop stop ring were detached from the main rotor head. All of the pitch links and main rotor blades were removed for ease of transportation from the crash site.

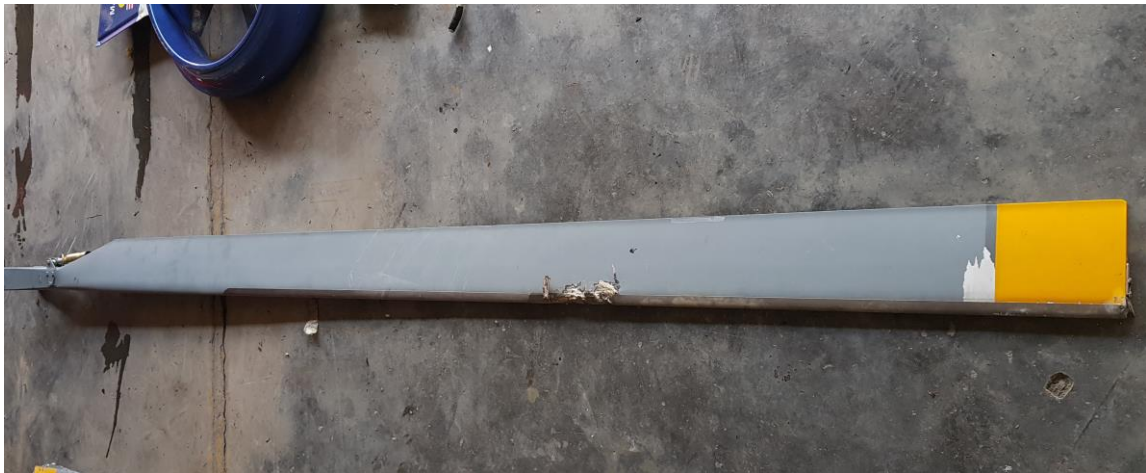
Picture 32 shows the yellow main rotor blade of the aircraft. The blade suffered substantial damage to the leading edge of the blade and delamination. The lead-lag damper was found detached from its body.

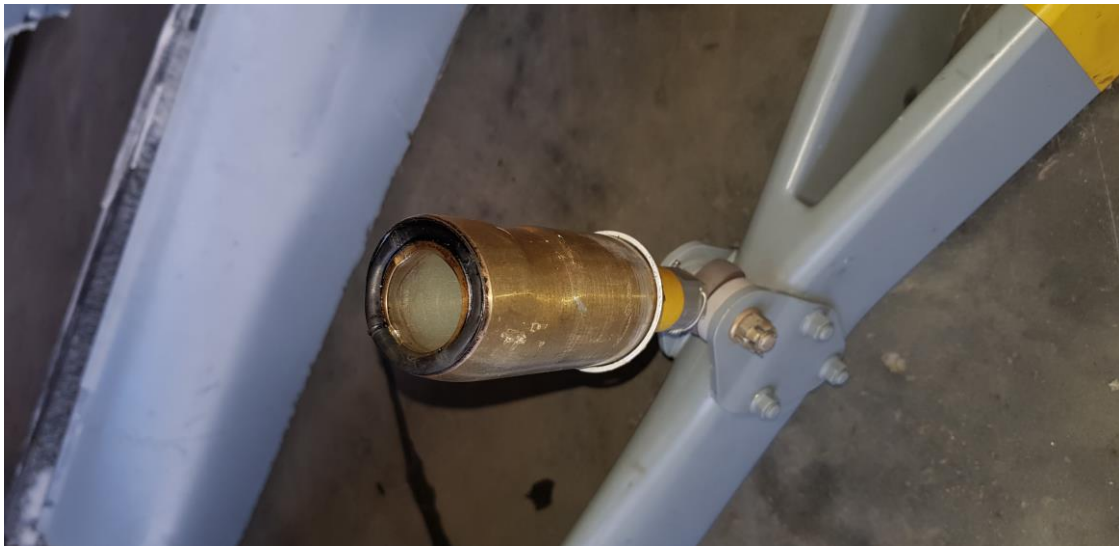
Picture 33 shows the half portion of the yellow lead-lag damper that is found detached from the body.

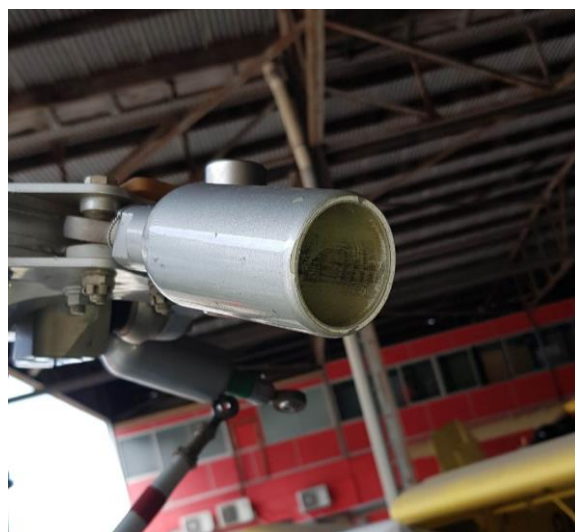
Picture 34 shows the body of the yellow lead-lag damper still attached to the main rotor head.

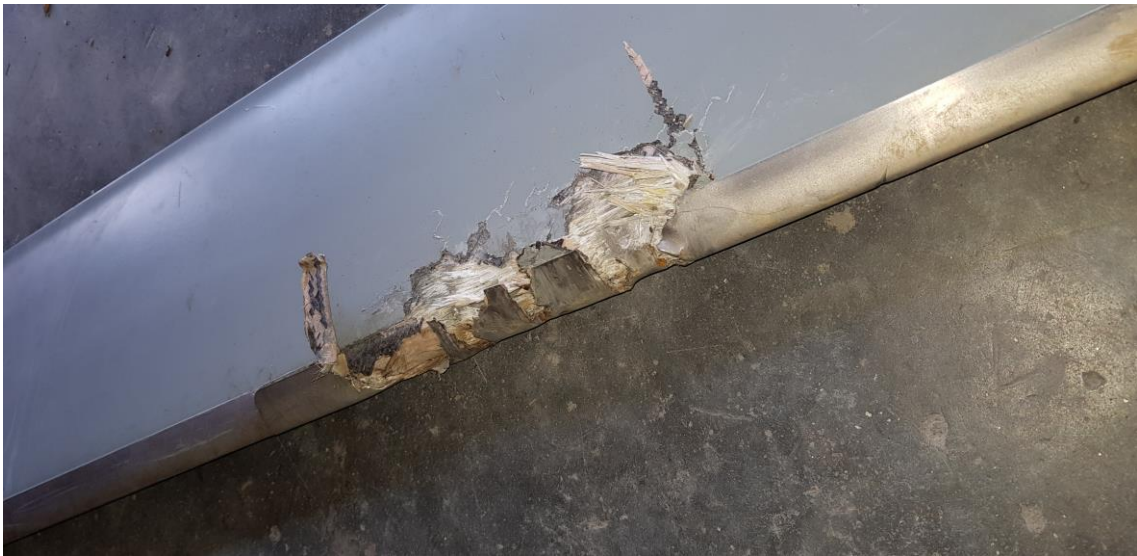
Picture 35 shows the damage portion of the leading edge of the yellow main rotor blade.

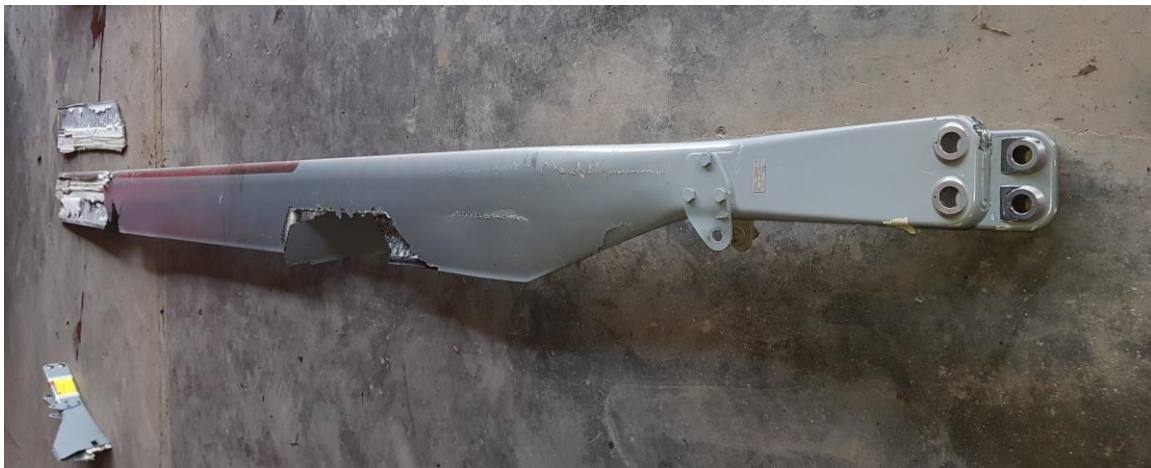
Picture 36 shows the green main rotor blade of the aircraft. Substantial damage on the blade could be seen in this picture

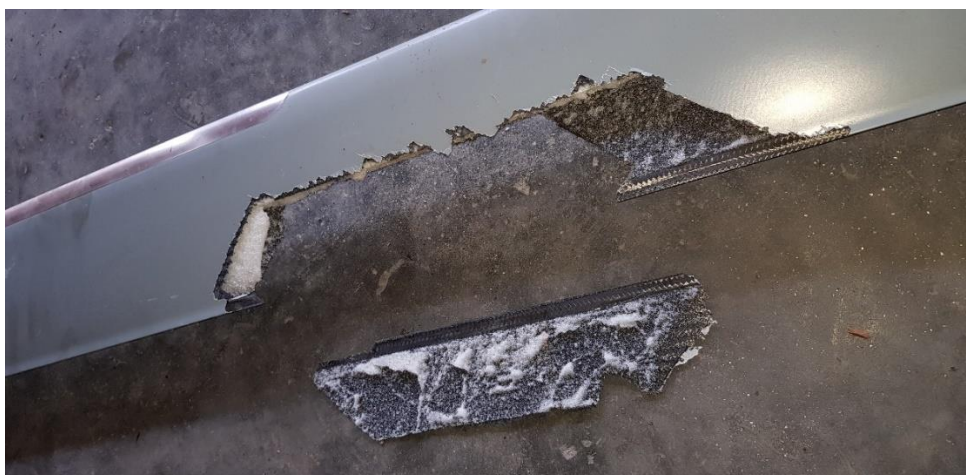
Picture 37 shows the broken portion of the trailing edge of the green main rotor blade.

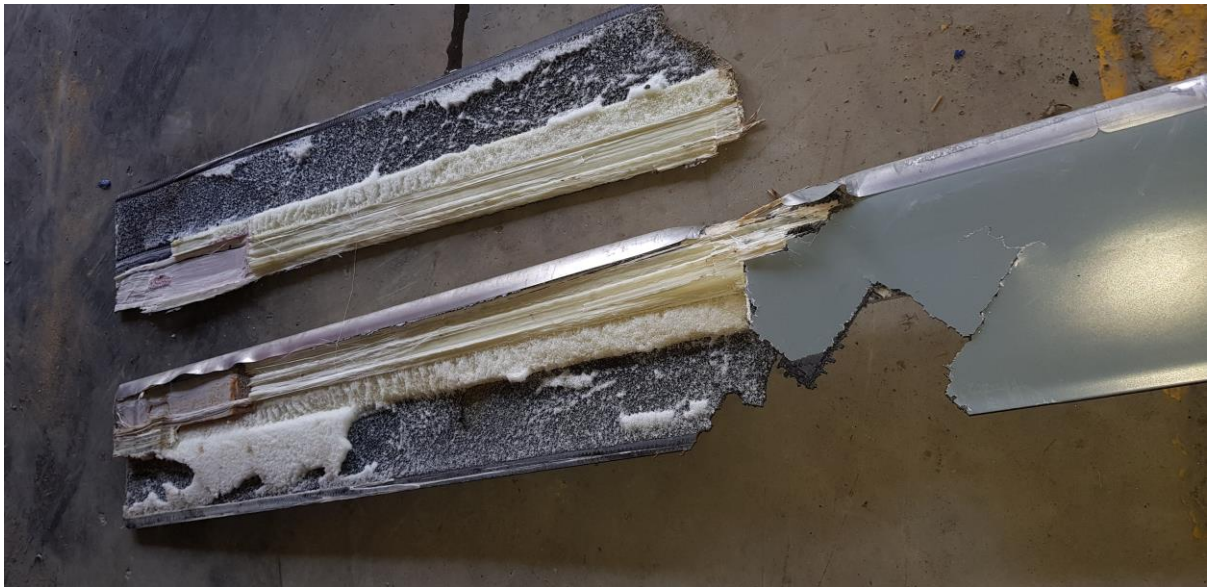
Picture 38 shows the broken piece of the upper section of the green main rotor blade. Some portion of the trailing edge also can be seen missing from the blade.

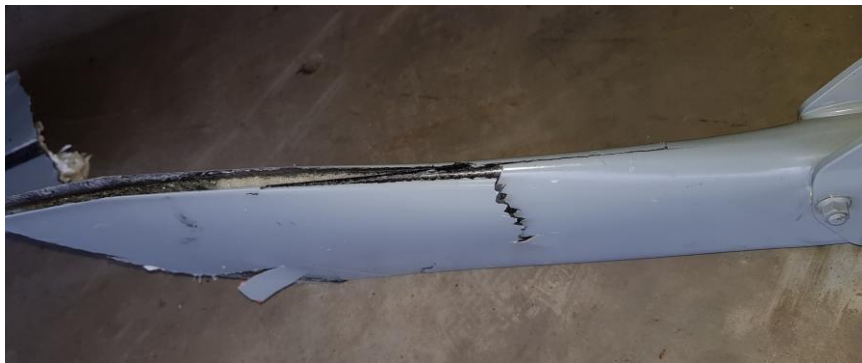
Picture 39 shows the damaged blade root of the red main rotor blade. The rotor blade was found partially attached at the crash site.

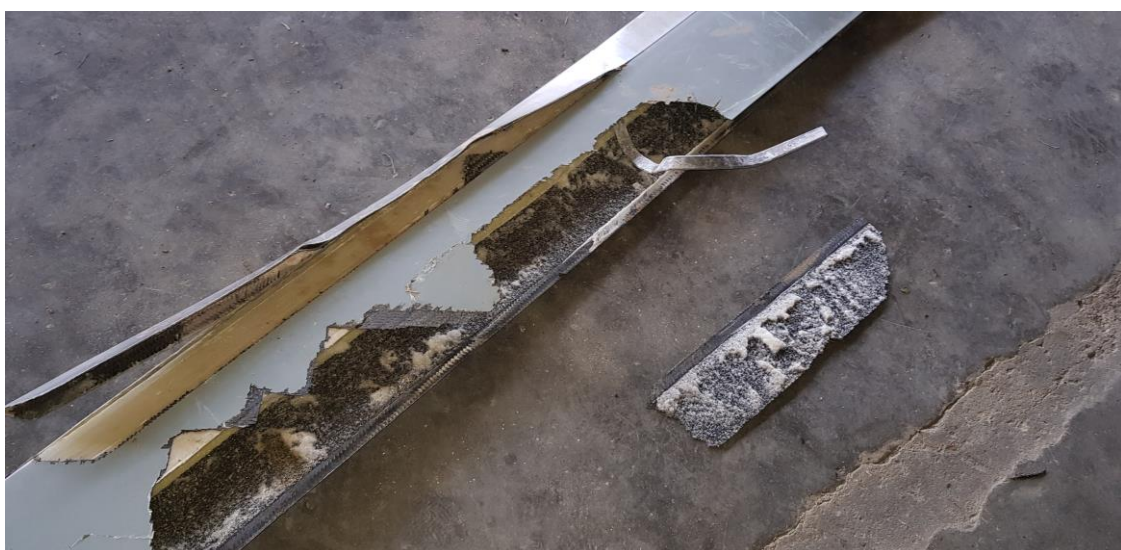
Picture 40 shows the damaged leading and trailing edge of the red main rotor blade.

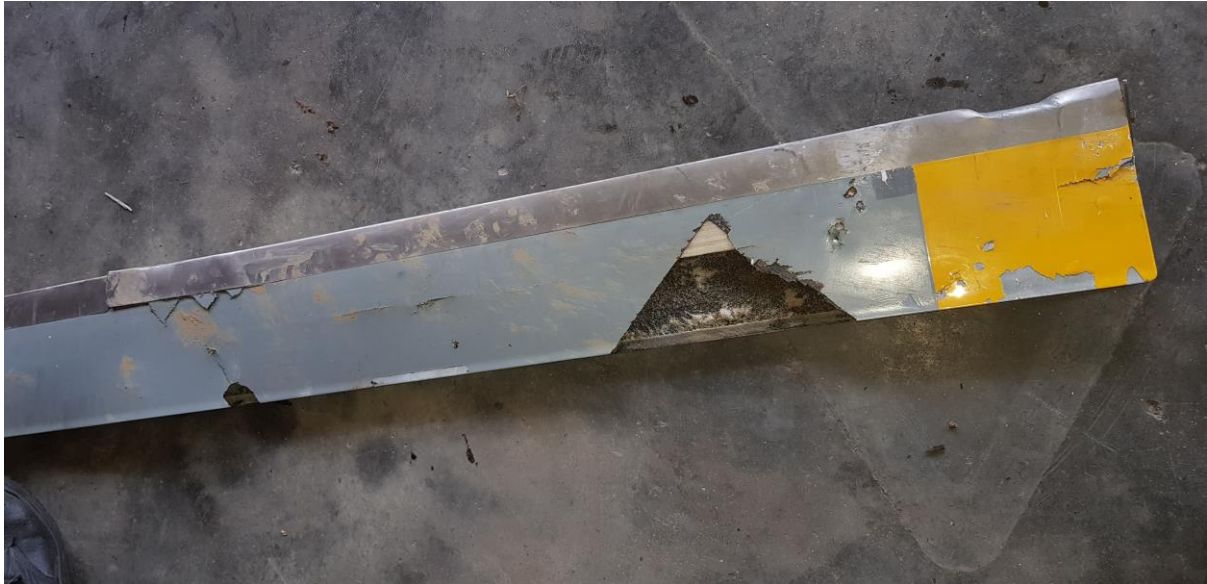
Picture 41 shows the damaged tip of the red main rotor blade. Can be seen in this picture also missing portion on the trailing edge of the blade.
