## **AIRCRAFT ACCIDENT**

**I 04/21**

**Incident Involving Fixed Wing Aircraft**

**Airbus 320-216, Registration 9M-AJN**

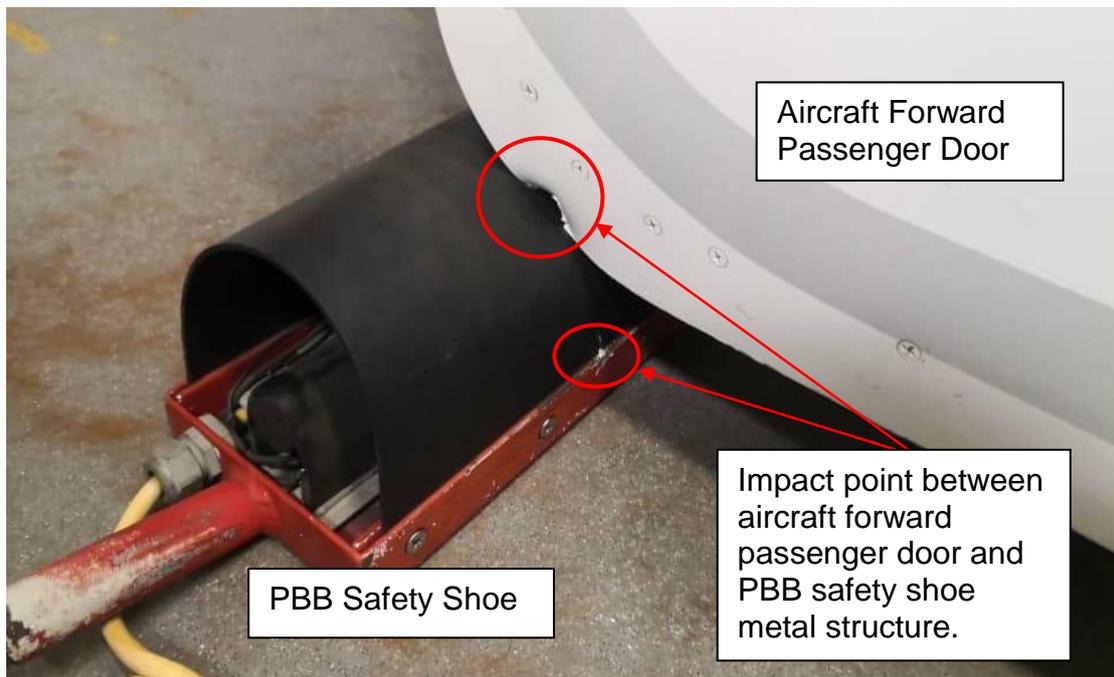
While passengers were disembarking, a sudden jolt was felt (vertical and lateral) and the PBB alarm sounded. Passenger disembarkation was temporarily halted and PBB Operator was immediately contacted. It was found that the Forward Passenger Door lower edge skin had contacted with the PBB safety shoe metal structure which caused a tear on the lower edge skin.

Figure 1: Impact point between aircraft forward passenger door and PBB safety shoe metal structure.

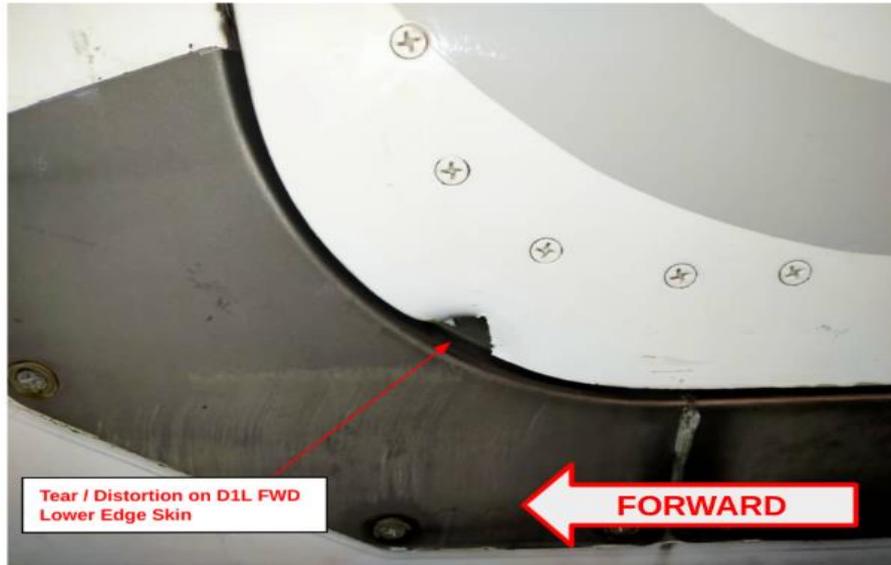
Post incident inspection revealed the Forward Passenger Door lower edge skin found torn.

Figure 3: Damage forward passenger door lower edge skin.

The temporary repair on the forward Passenger Door lower edge skin tear damage was successfully carried out by AirAsia Engineering Team on 11 November 2021 as authorised by Airbus in the Repair and Design Approval Form.

CAAM authorised a non-pressurised and non-revenue flight back to Kuala Lumpur to undergo permanent repair on the said tear damage. The permanent repair was completed on 16 November 2021 and aircraft returned to service as airworthy on 17 November 2021.

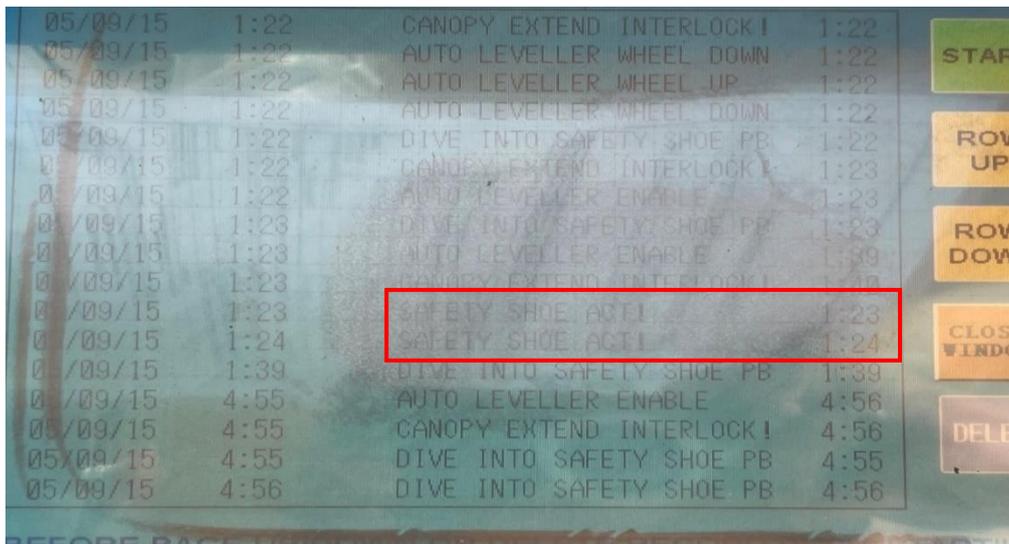
- a. Aircraft crew observed fault indication “Level Fault” at PBB LCD Touch Screen Display when the PBB siren was activated.
- b. Screen shot for record of event indicating Safety Shoe had been activated twice during the incident (Figure 12).

Figure 12: Screen shot of PBB LCD touch screen display showing safety shoe activated twice

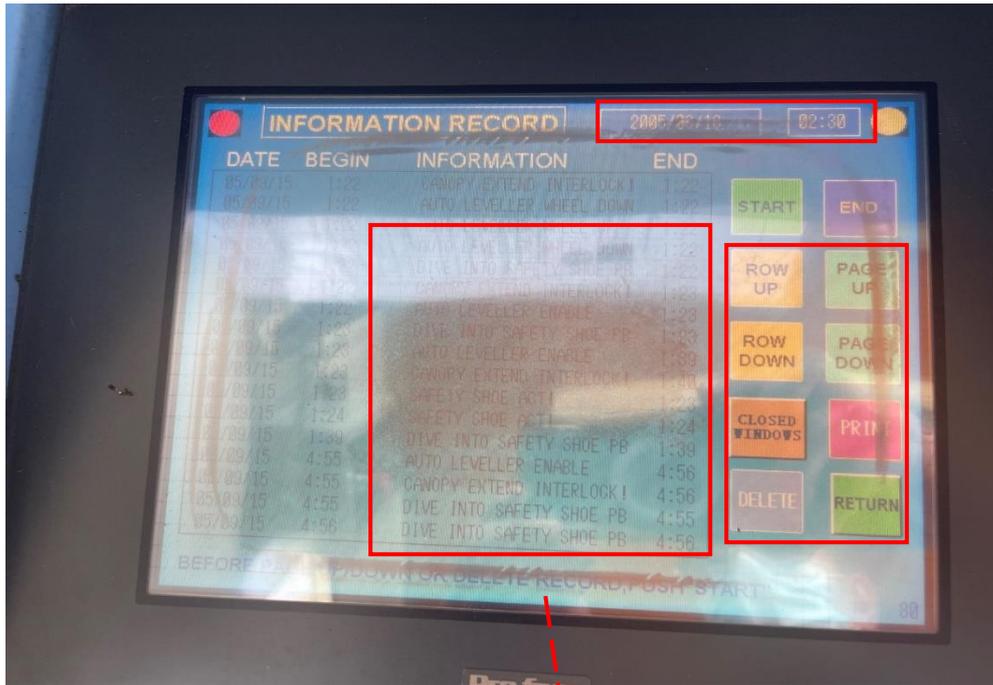
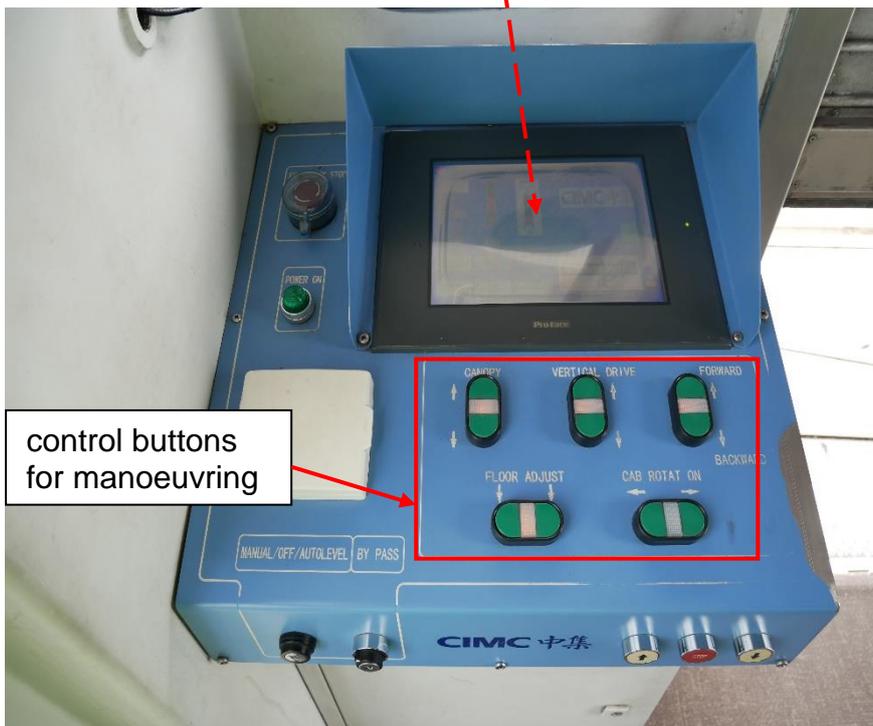
Nevertheless, it was observed that the PBB was still operating normally as the control buttons for manoeuvring the PBB are located separately below the touch screen display (Figure 13).

Figure 13: PBB Bay 1 LCD touch screen display after the incident (above) and control buttons for manoeuvring (below)

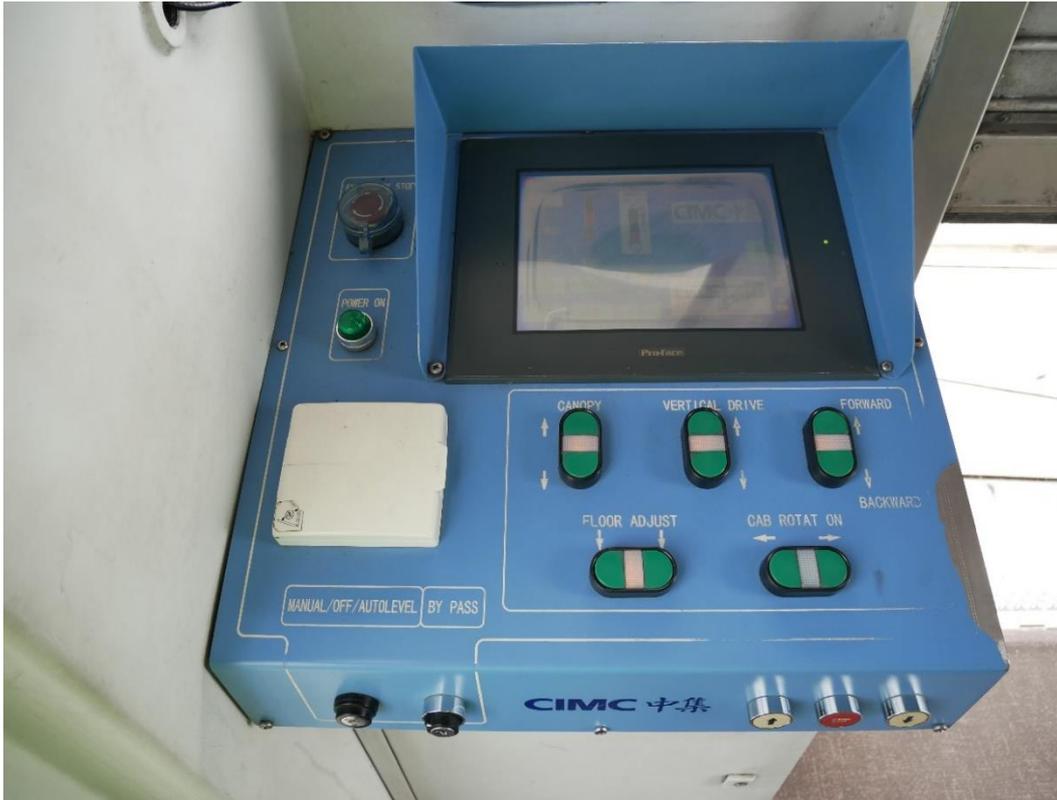
The investigation site inspection on the PBB status display area on recorded faults history page revealed that the LCD touch screen display had frozen at the last recorded event. The buttons in the button area could not be operated to scroll up or down. Other functions that needed the scroll function were not accessible too.

It was also observed that the screen time function cannot be set to actual date and time. Therefore, the history of event recorded in the status display area cannot be verified to actual date and time.

Figure 20: PBB Operating Console LCD Touch Screen Display PBB Bay 1

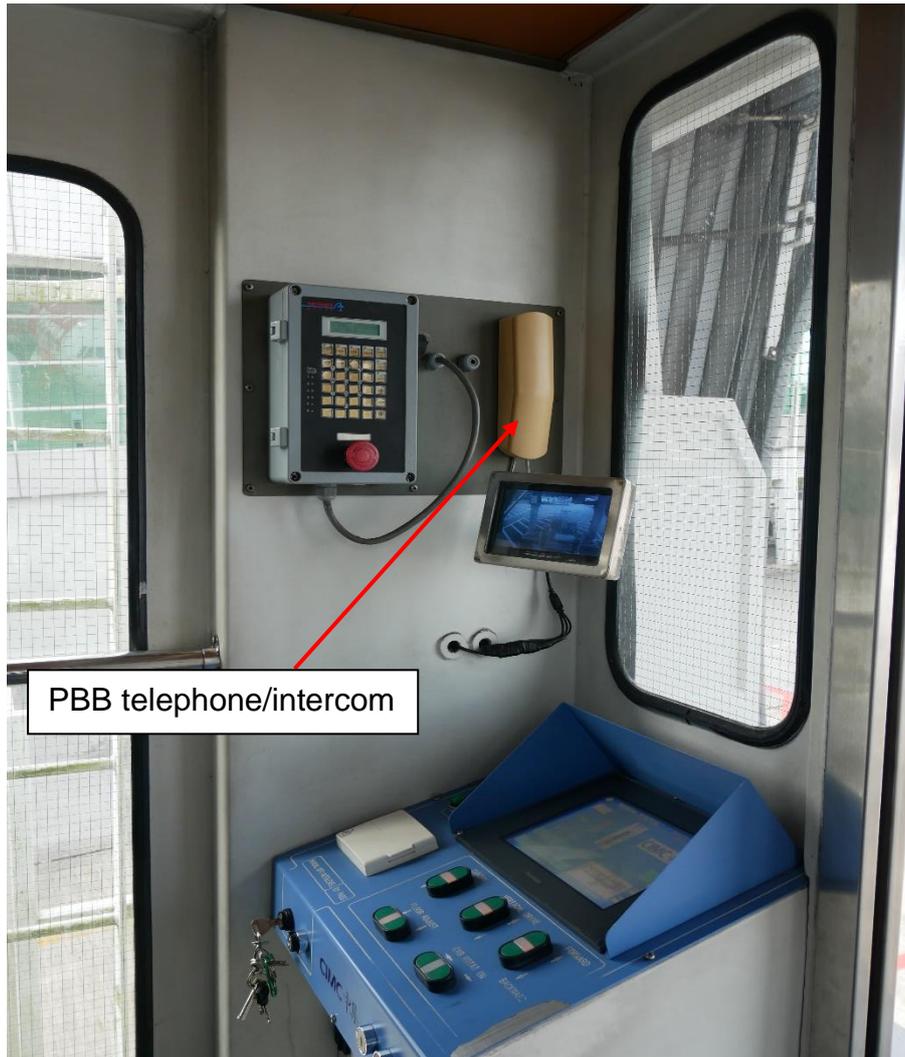
The telephone/intercom located at the PBB Operating Console was inoperative (Figure 22). It was made known to the investigation team that the telephone/intercom was disconnected and not in used for some time. Nevertheless, walkie-talkie was provided to all PBB Operators as the main communication source for the PBB Operators to the Operations Department during their shift hours.

Figure 22: PBB Telephone/Intercom at PBB Operating Console

The aerodrome operator also needs to ensure that the equipment at the PBB are fully functional to support the safe operations of the PBB. Corrective maintenance is needed to repair the unserviceable telephone/intercom, the defective function button and status area page at the LCD touch screen display. Both these factors were present in the precondition for unsafe act defence layer but was not a contributing factor to this incident.

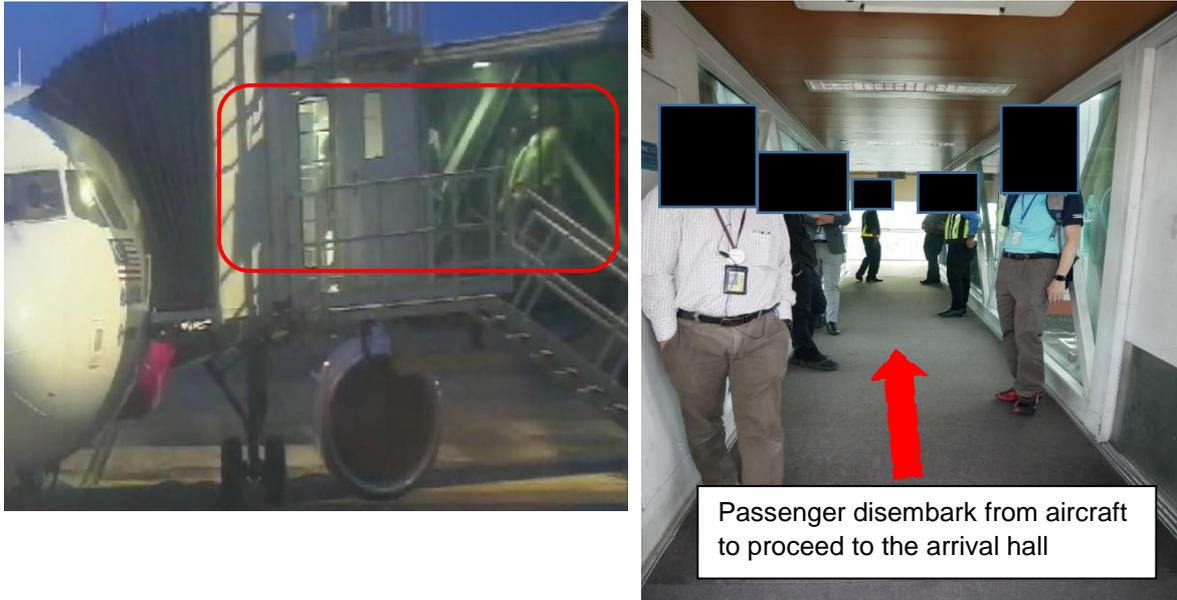
Video surveillance camera recording shows that there were 6 personnel standing near the PBB Operating Console area along the PBB tunnel side wall when the aircraft was taxiing in for parking excluding the PBB Operator. The investigation team observed that the tunnel area of the PBB is reasonably narrow, hence the present of significant numbers of personnel causes unnecessary crowding especially when passengers start to disembark with their hand carry personal belongings.

Figure 23: Video surveillance recording capture crowding at PBB tunnel area just before passengers start to disembark (left). Example of PBB narrow tunnel walk way when crowded with personnel (right)

The aircraft operator needs to review and allow only essential personnel to standby near the PBB Operating Console area especially during aircraft docking and passenger disembarkation process to avoid unnecessary crowding in the PBB (Figure 23). Non-essential personnel example aircraft cleaners and extra ramp or engineering personnel can standby further away from the PBB Operating Console area and to only proceed inside the aircraft after all passengers had fully disembarked or when required only.

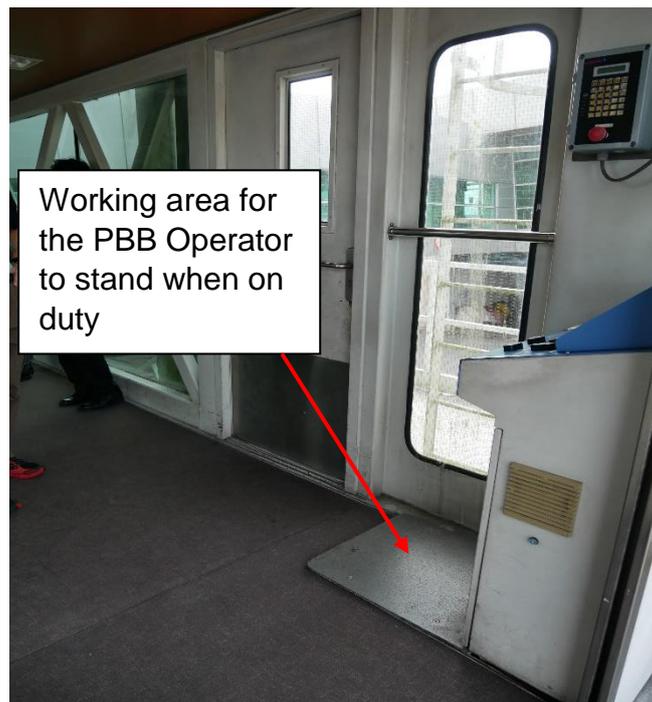
Figure 24: PBB Operating Console

To avoid distraction to the PBB Operator, all aircraft operator's personnel on duty must keep clear of the PBB Operating Console which is the working area for the PBB Operator on duty (Figure 24).

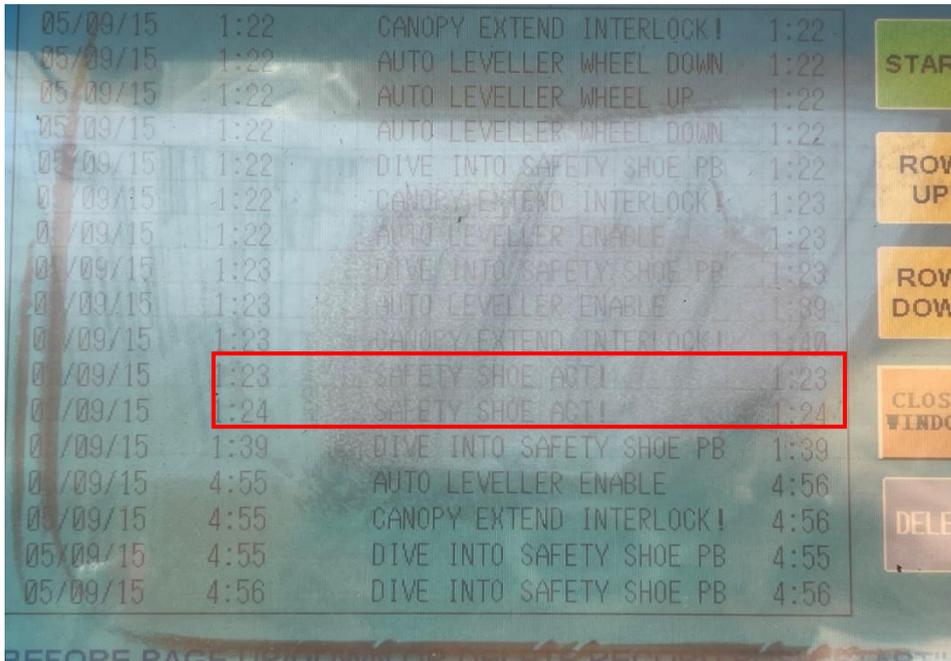
Figure 36: PBB LCD touch screen display showing the safety shoe had been activated two times

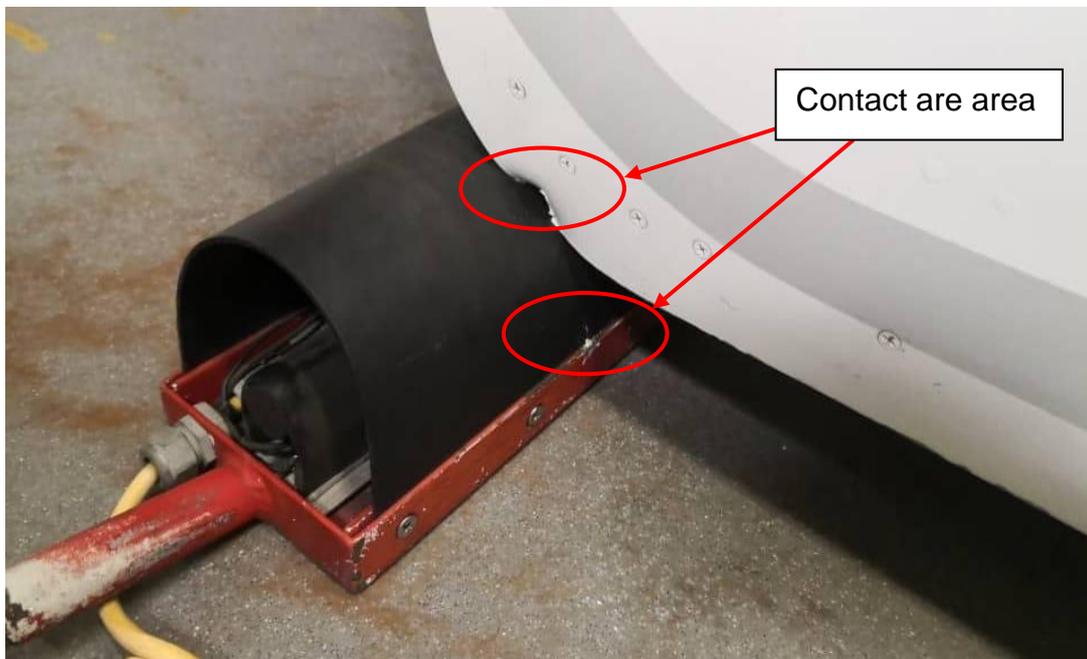
Figure 37: Position of the Safety Shoe at the lower left edge of the aircraft door after the incident showing the contact area

Since the aircraft door edge is stuck with the safety shoe metal structural frame, an automatic downward movement of the PBB when the safety shoe limit switch is activated did not unstuck the door. The continuous pressing of the safety shoe's tactile rod limit switch by the aircraft's bottom door edge causes the canopy and the leveller wheels to retract and the PBB alarm to sound. It resulted in the Forward Passenger Door lower edge skin found torn and slight dent mark on the safety shoe metal structural frame as seen in Figure 37.

The unsafe act that caused this incident were the probable incorrect placement of the safety shoe position which is more towards the bottom left edge of the aircraft passenger door rather than the bottom centre position and the violation of MASB SOP – PBB Operations by leaving the PBB before the last passenger had disembarked from the aircraft.

It was observed that the PBB Operators Training Syllabus – Perform PBB Docking Operation states that the PBB Operator is to apply safety shoe under the aircraft door. It does not specify specifically that the safety shoe should be placed in the middle under the aircraft passenger door. Witness statement from the PBB Operator revealed that it was only mention verbally during the PBB Operator’s training to place the safety shoe at the bottom centre of the aircraft passenger door.
