## AIRCRAFT SERIOUS INCIDENT

### FINAL REPORT

SI 02/21

**Serious Incident Involving Microlight**

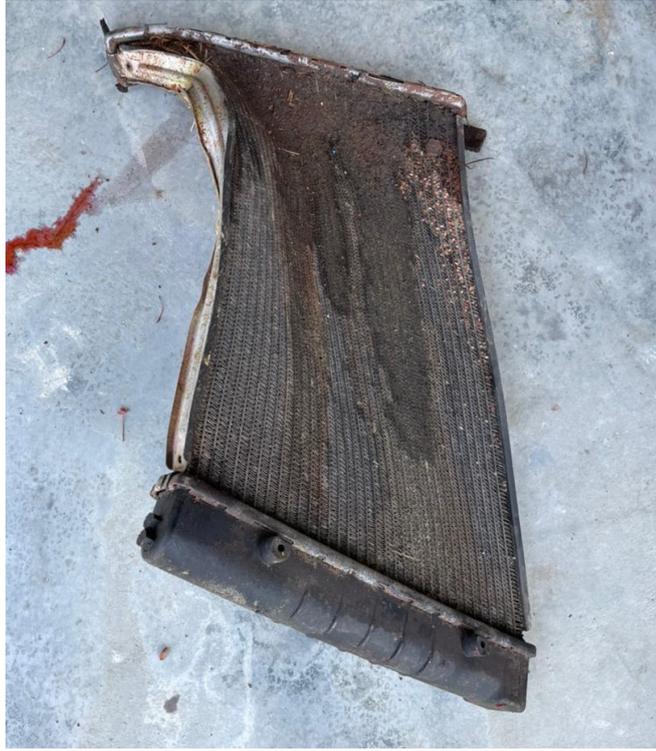
Figure 1: Engine Radiator

- DAMAGE PART : Engine Propeller Blade**  
QUANTITY: Two (2) unit  
STATUS: ~~Serviceable~~/Unserviceable  
ACTION: Replace new part
- DAMAGE PART : Engine Radiator**  
QUANTITY: One (1) unit  
STATUS: ~~Serviceable~~/Unserviceable  
ACTION: Replace new part

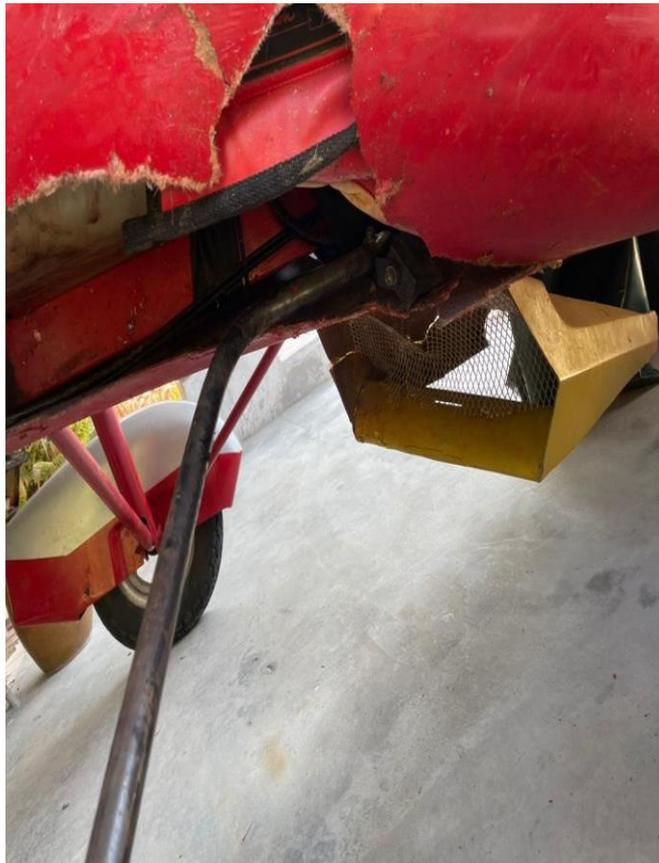
Figure 2: Aircraft Fairing

- DAMAGE PART : Main Landing Gear (Left Side)**  
QUANTITY: One (1) unit  
STATUS: ~~Serviceable~~/Unserviceable  
ACTION: Replace new part
- DAMAGE PART : Aircraft Fairing**  
QUANTITY: One (1) unit  
STATUS: ~~Serviceable~~/Unserviceable  
ACTION: Repair the composite part of the composite damage

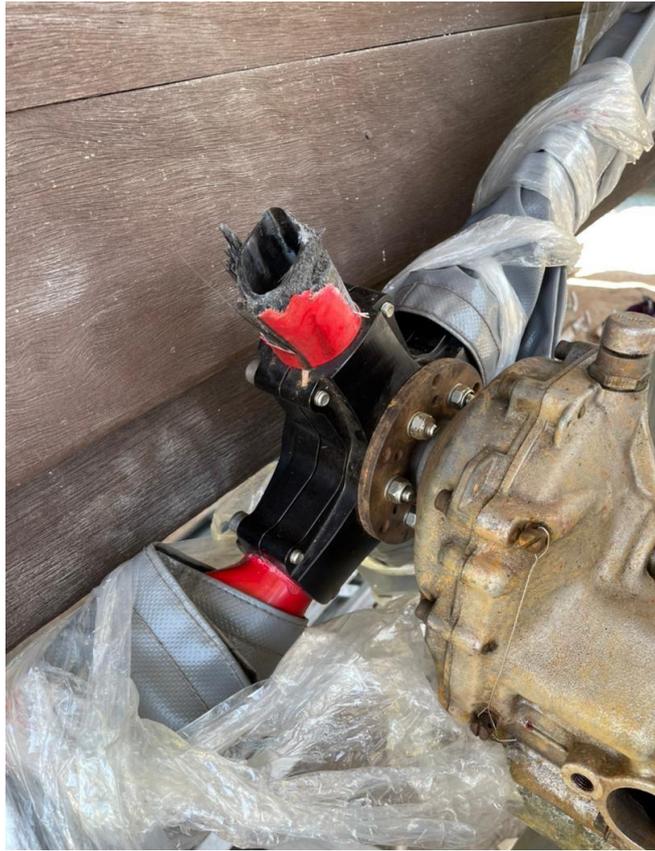
Figure 3: Engine Propeller Blade

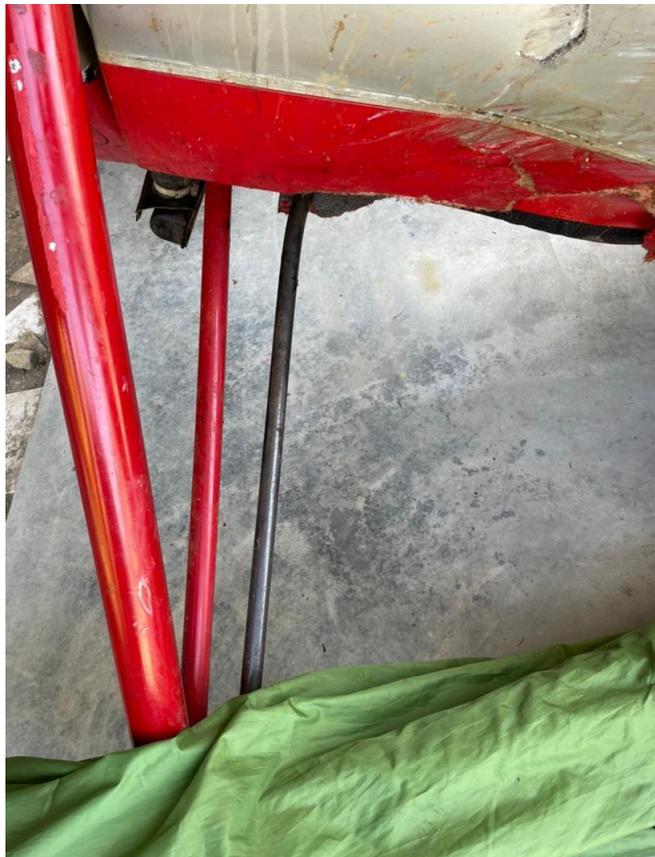
Figure 4: Main landing gear strut (right side)

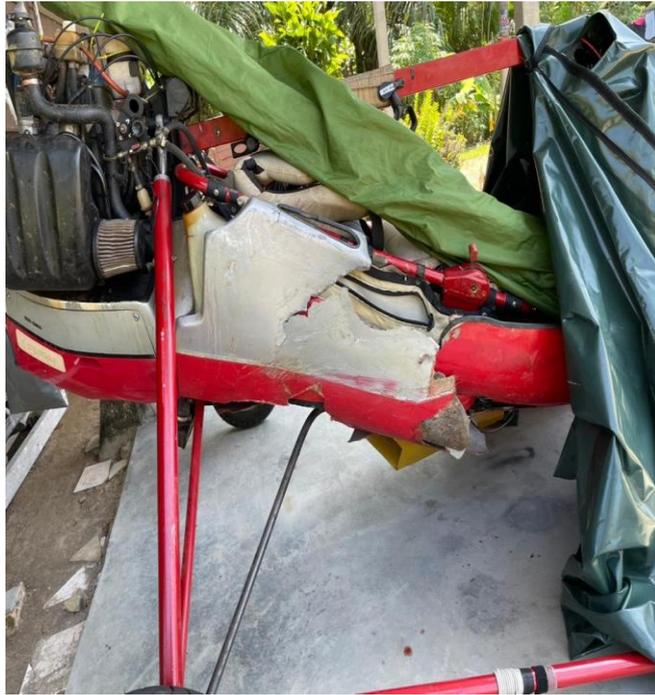
Figure 5: Aircraft Fairing

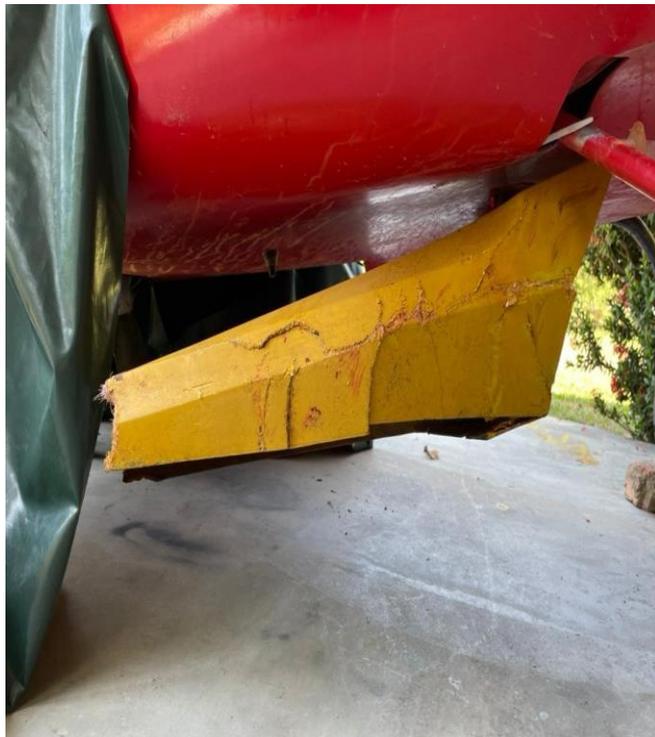
Figure 6: Microlight Fairing

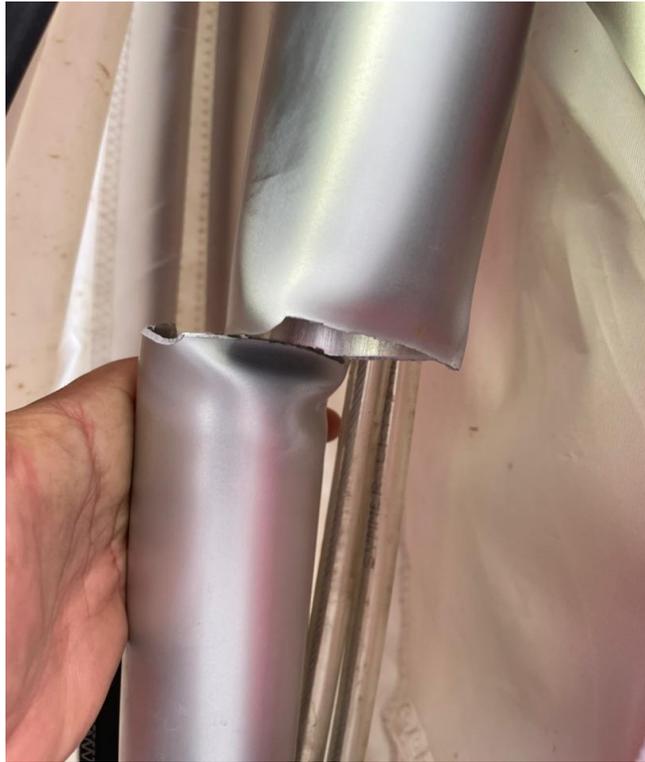
Figure 7: Wing Keel

- DAMAGE PART : Wing Structure (Left leading edge)**  
QUANTITY: One (1) unit  
STATUS: ~~Serviceable~~/Unserviceable  
ACTION: Replace new part
- DAMAGE PART : Wing keel**  
QUANTITY: One (1) unit  
STATUS: ~~Serviceable~~/Unserviceable  
ACTION: Replace new part

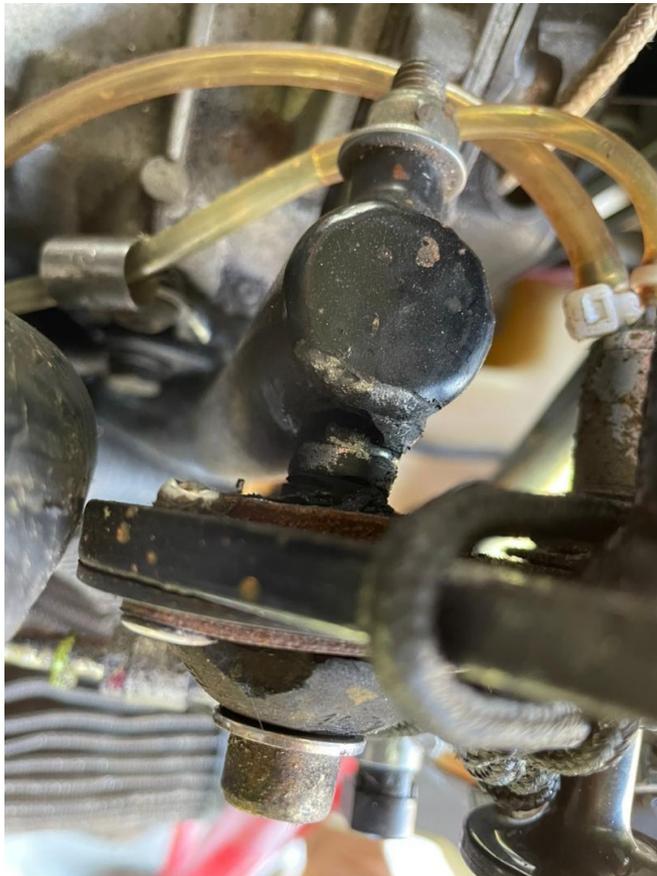
Figure 8: Throttle Cable

The probable cause of the accident was due to Throttle Cable being dented after Microlight came in contact with outreached rope during the landing roll, which led to the failure of the throttle paddle to reduce the speed.

- DAMAGE PART : Throttle Cable**  
QUANTITY: One (1) unit  
STATUS: ~~Serviceable~~/Unserviceable  
ACTION: Replace new part

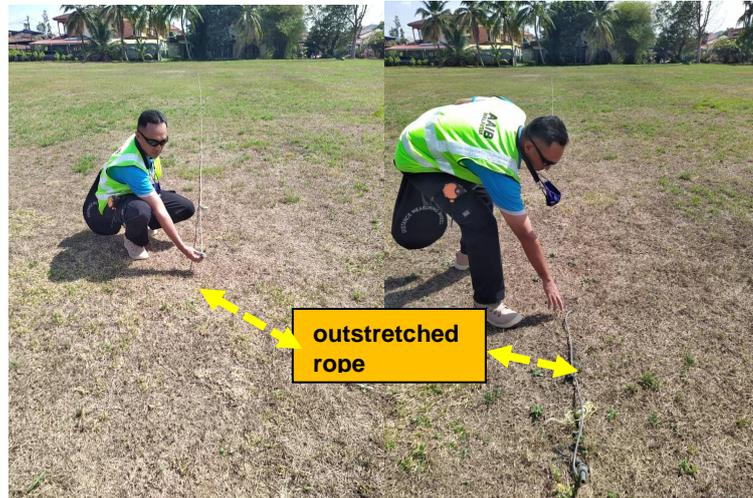
One outstretched rope had broken off during the landing roll before the Microlight hitting three trees that belong to the Custom. No other damages were observed.

Figure 9: Outstretched rope

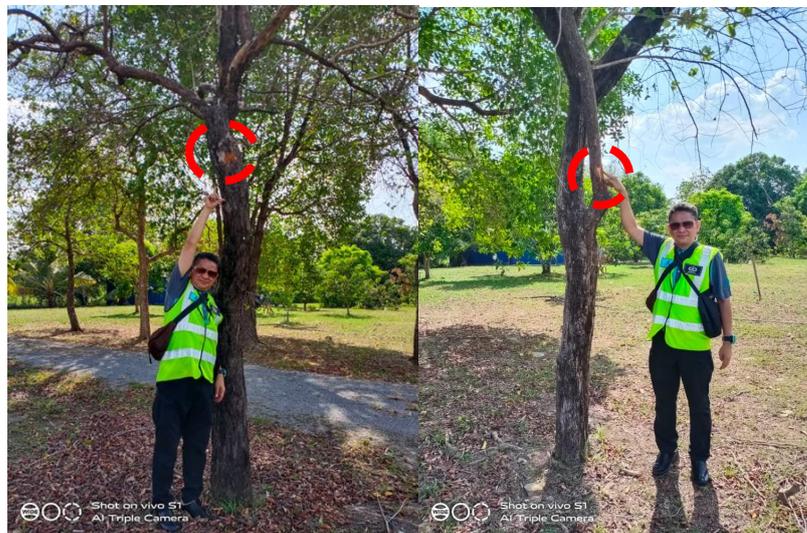
Figure 10: 1<sup>st</sup> & 2<sup>nd</sup> Trees

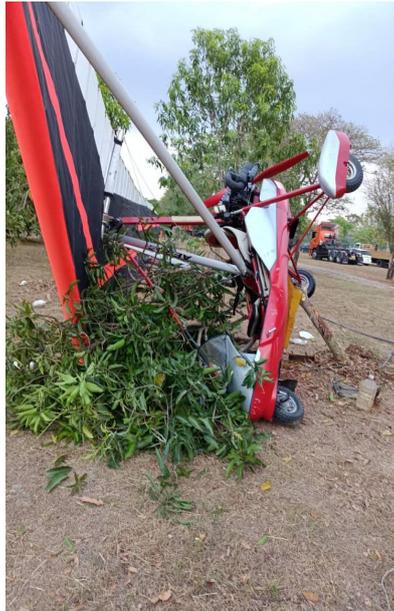
Figure 11: The 3<sup>rd</sup> Tree - Impact and halt

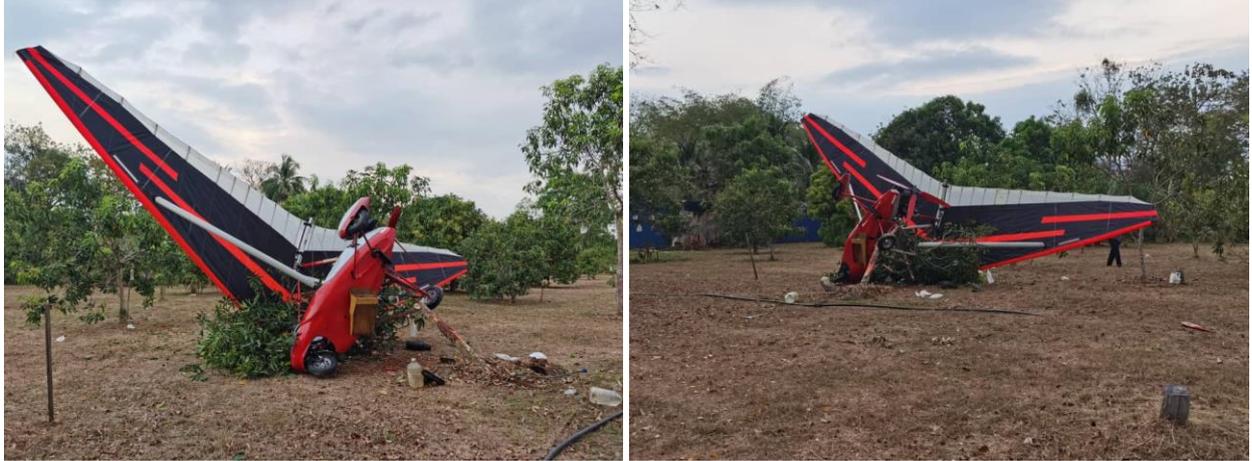
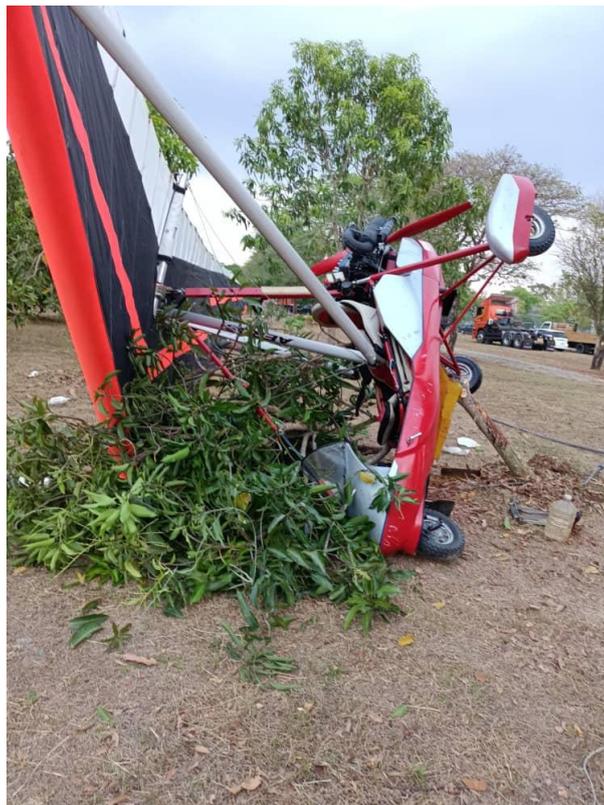
Figure 16: Microlight came to halt after hitting a small tree at the end of the landing area

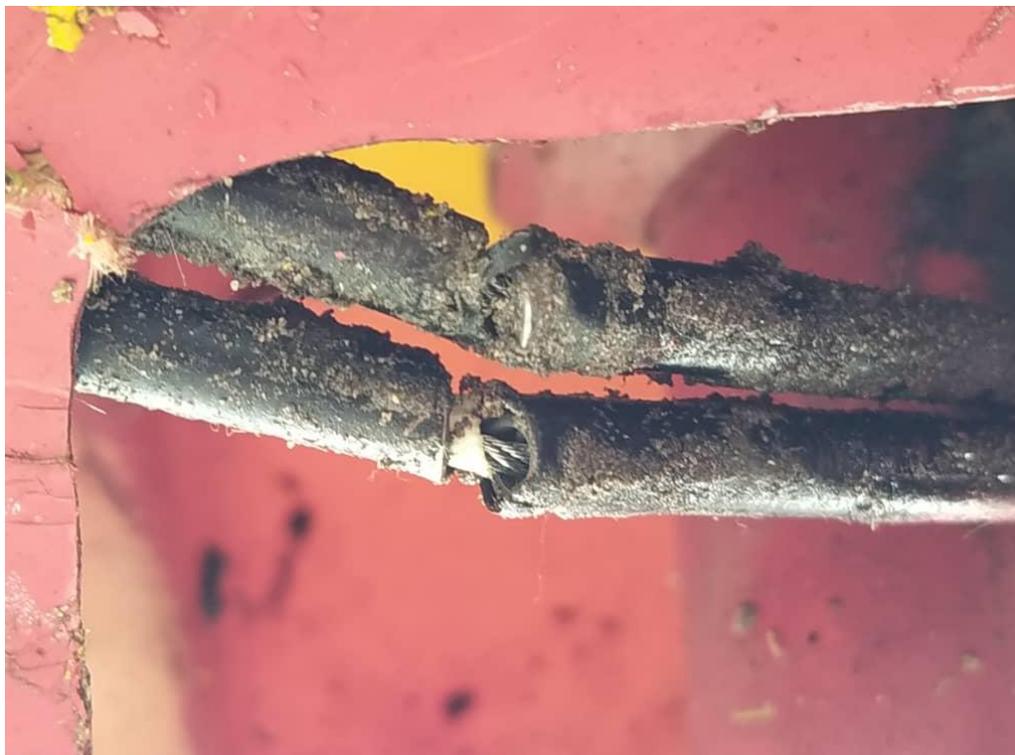
Figure 21: Post incident inspection (Throttle Cable)

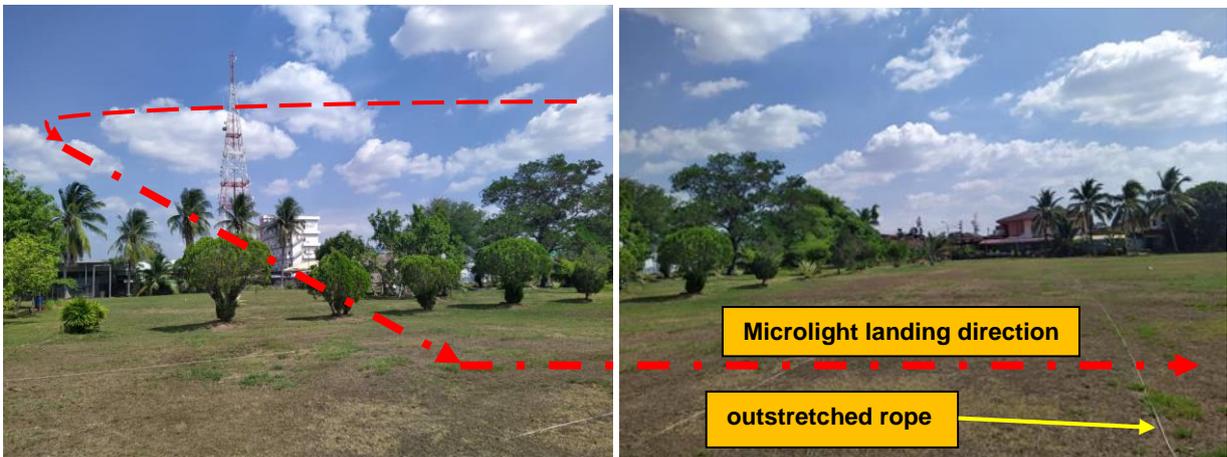
Figure 31: Post-accident investigation found a snapped outstretched rope on the grass area across the open field at Custom Complex

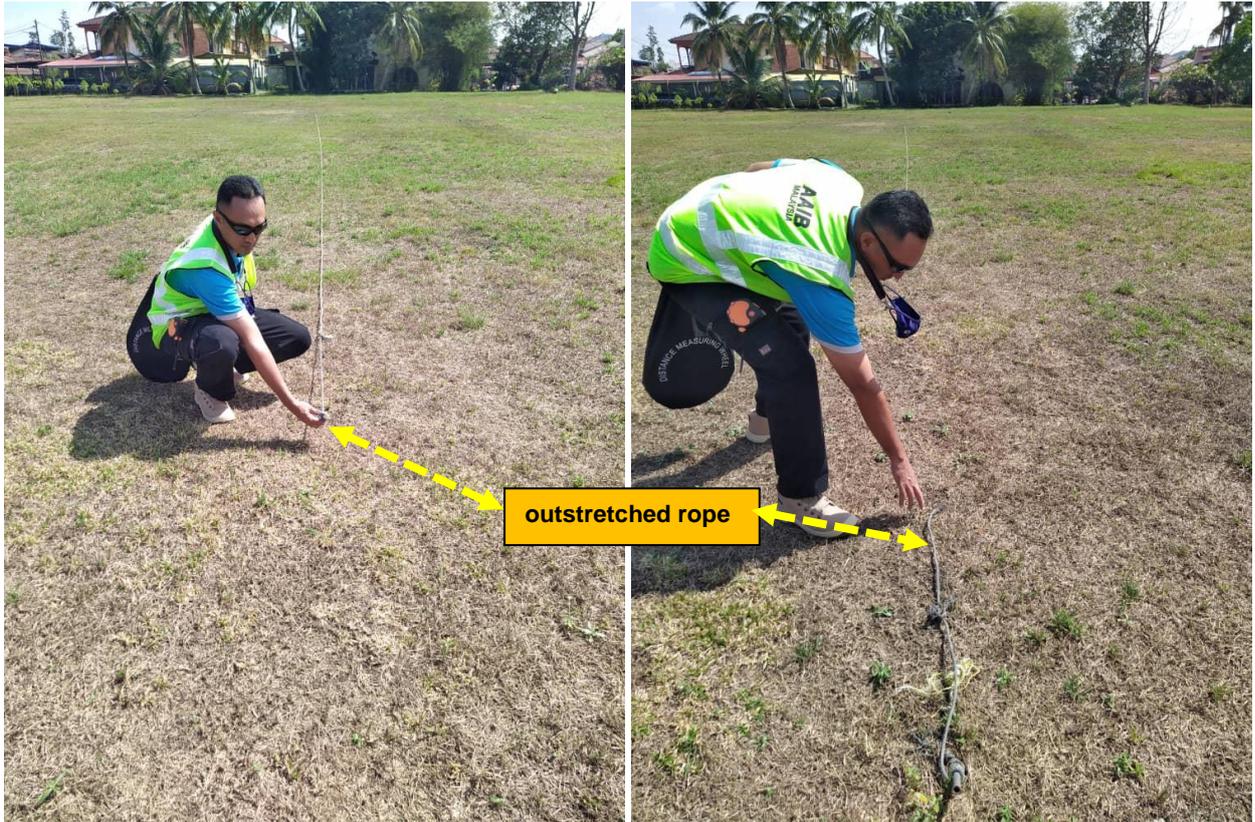
Prior to the landing process the Microlight hit the outstretched rope laying on the grass during landing roll and resulted the throttle cable got stuck and increased the Microlight power.

Figure 32: Outstretched rope was suspected of being stuck by the Microlight during the landing roll

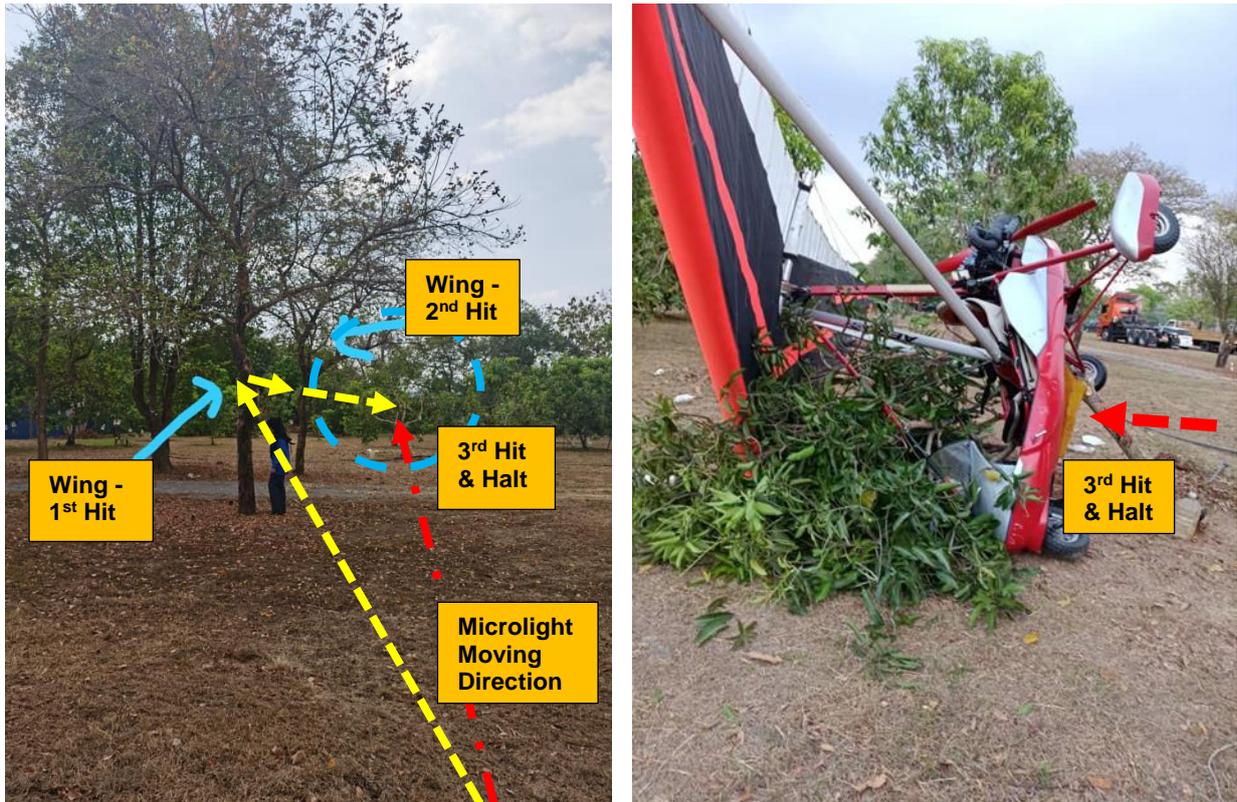
Figure 33: The Microlight Wing hit the two trees before hitting the third tree and halt

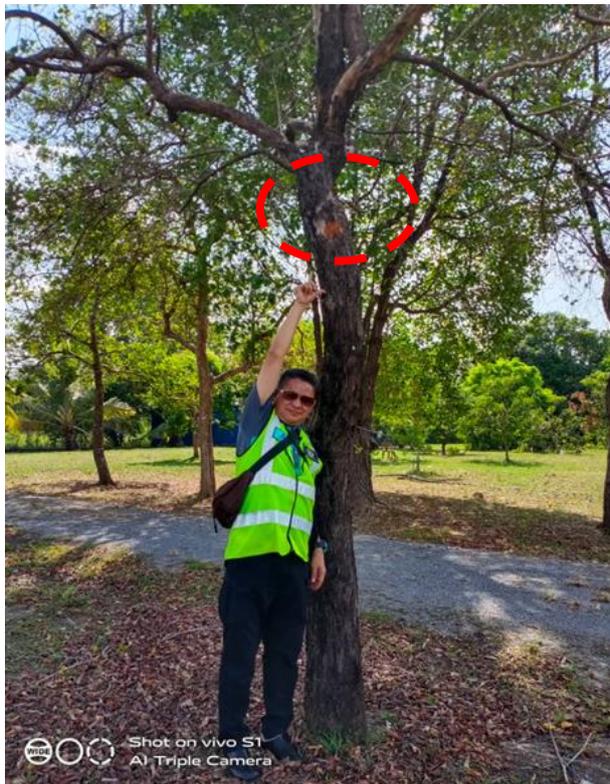
Figure 34: Microlight Wing hit the 1<sup>st</sup> tree

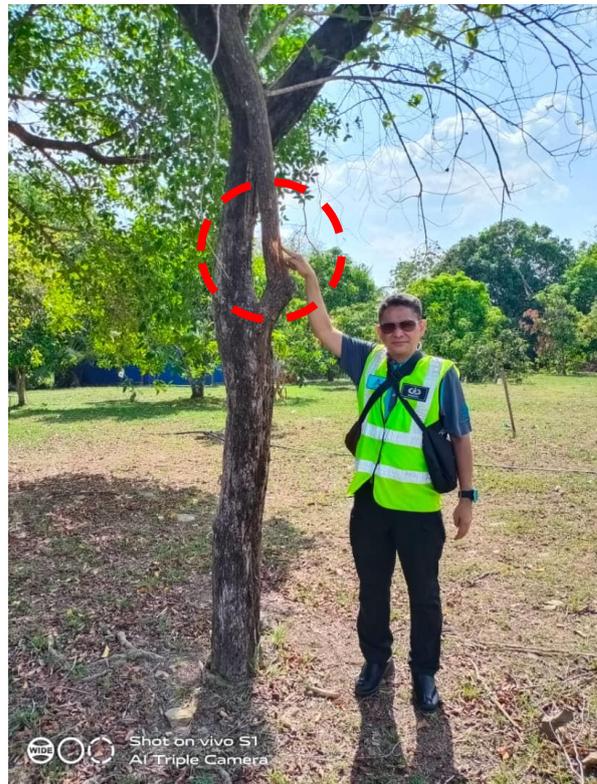
Figure 35: Microlight Wing hit the 2<sup>nd</sup> tree

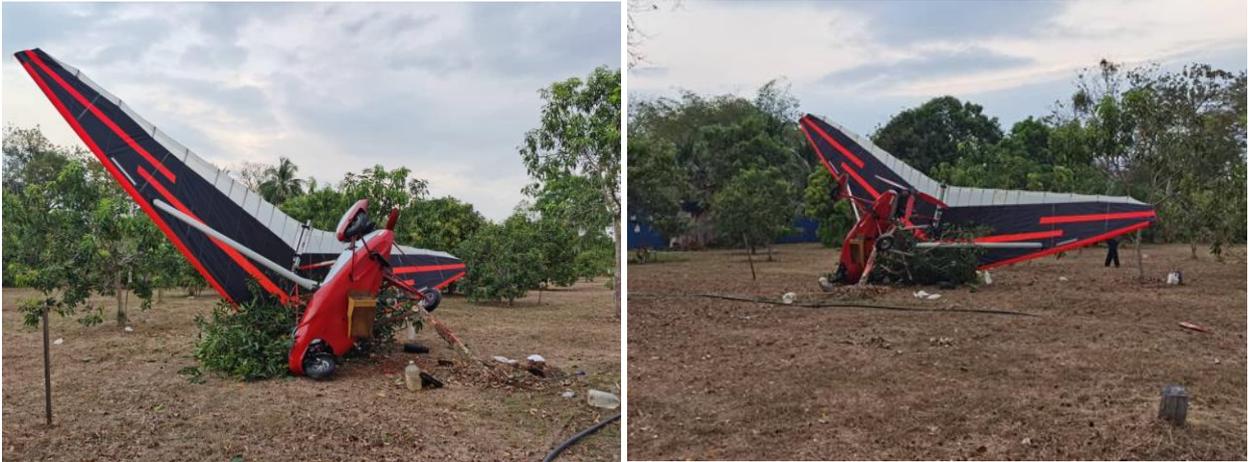
Figure 36: Microlight came to halt after hitting a small tree at the end of the landing area

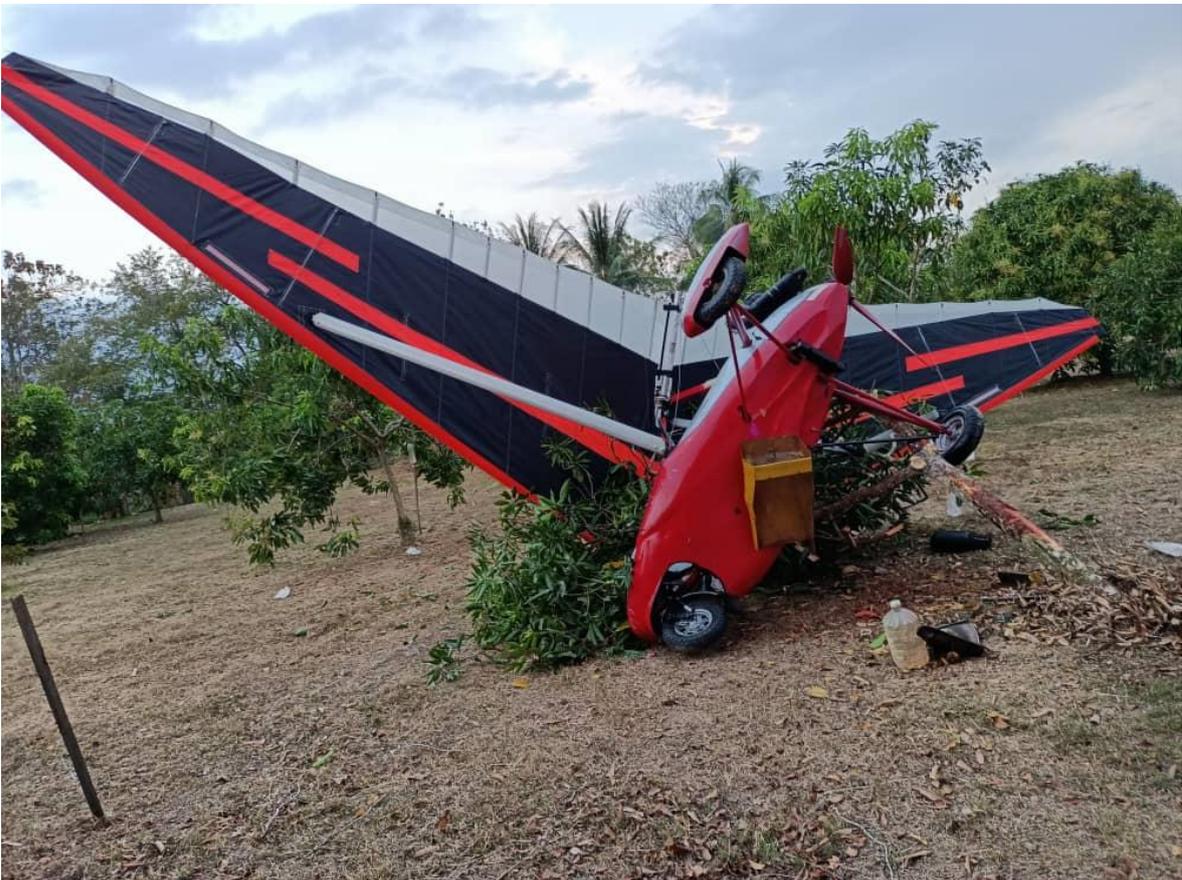
Figure 37: Microlight hit the third tree and halt

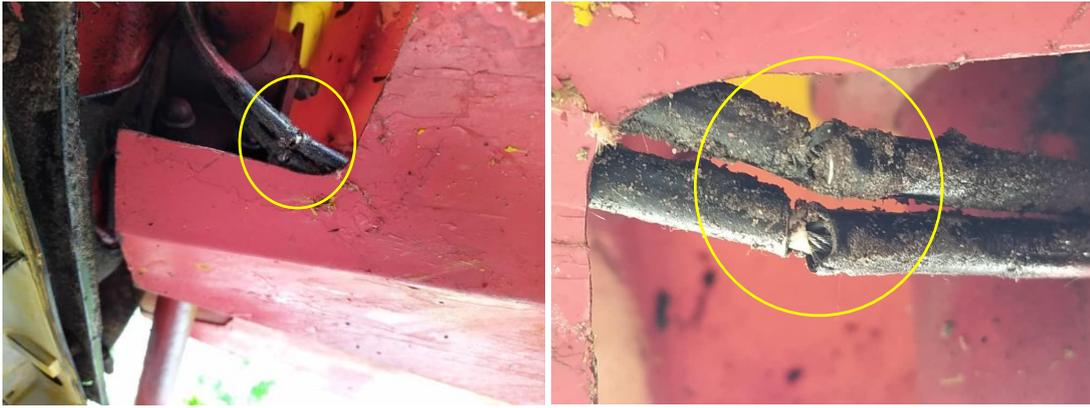
Figure 39: Post-Accident Inspection found the Throttle Cable was dented

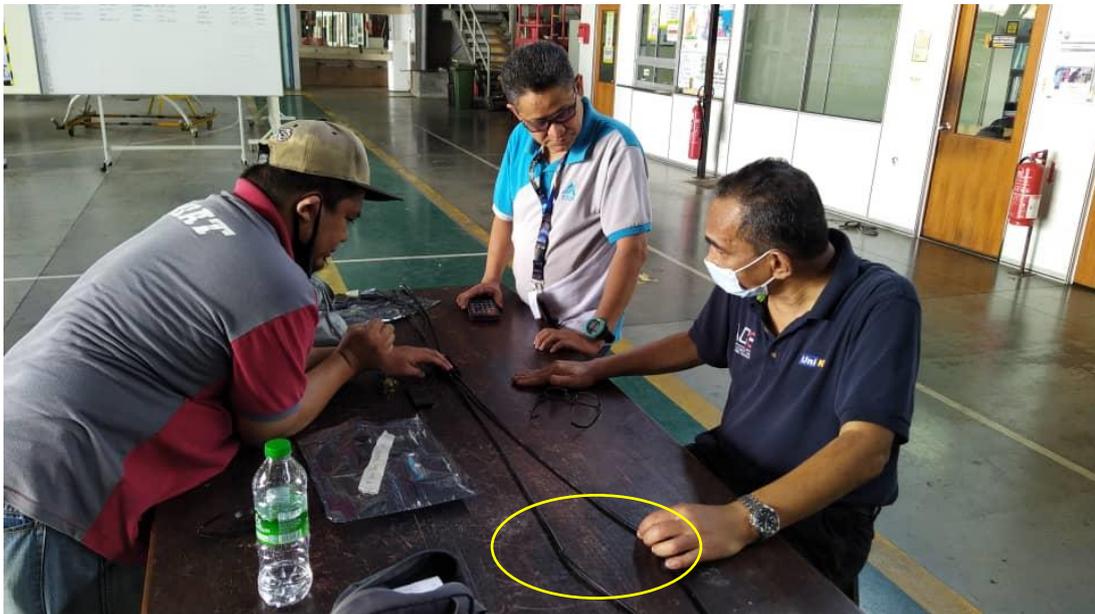
Figure 40: The Throttle Cable was sent for check and confirm that the Throttle Cable was dented

The specialist carried out the Throttle Cable checked, and the result was as per Appendix F. The analysis could not reveal that the dented was due to the occurrence (during the Microlite landing and hitting the outstretched rope on the field). However, it was suspected that prior to the landing process the Microlight hit the outstretched rope laying on the grass during landing roll and resulted the throttle cable got stuck and increased the Microlight power.

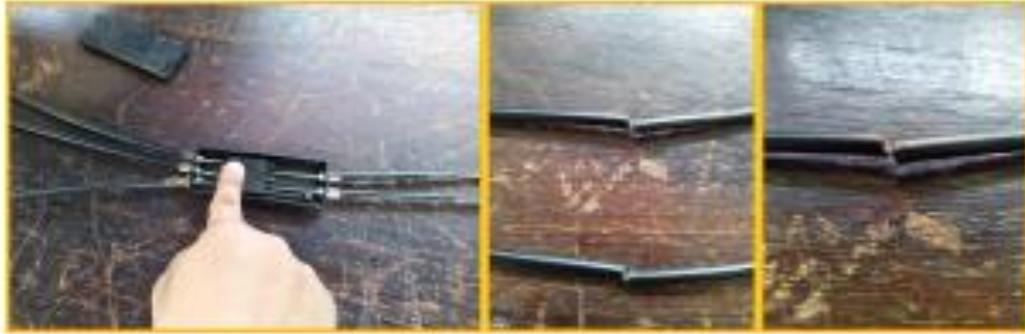
FUEL CONTROL CABLE BOX

For this fuel control cable, we found that these two cables were frayed and broken. This causes restriction of movement to this cable and eventually stuck.

Any cable assembly that has even a single broken wire strand located in a critical fatigue area must be replaced. Per the FAA guidance, a critical fatigue area is defined as the working length of a cable where the cable runs over, under, or around a pulley, sleeve or through a fair-lead; or any section where the cable is flexed, rubbed, or worked in any manner; or any point within one foot of a swaged-on fitting.
