AIRCRAFT ACCIDENT FINAL REPORT
A 01/22P
Air Accident Investigation Bureau (AAIB)
Ministry of Transport Malaysia

Diamond DA 40 D, Registration 9M-HMW
at Langkawi International Airport, Kedah
on the 30 March 2022

FINAL REPORT A 01/22P

OPERATOR : HM AEROSPACE SDN BHD
AIRCRAFT TYPE : DIAMOND DA 40 D
NATIONALITY OF AIRCRAFT : MALAYSIA
REGISTRATION : 9M-HMW
**PLACE OF OCCURRENCE : LANGKAWI INTERNATIONAL AIRPORT,
KEDAH**
DATE AND TIME : 30 MARCH 2022 AT 2004 LT

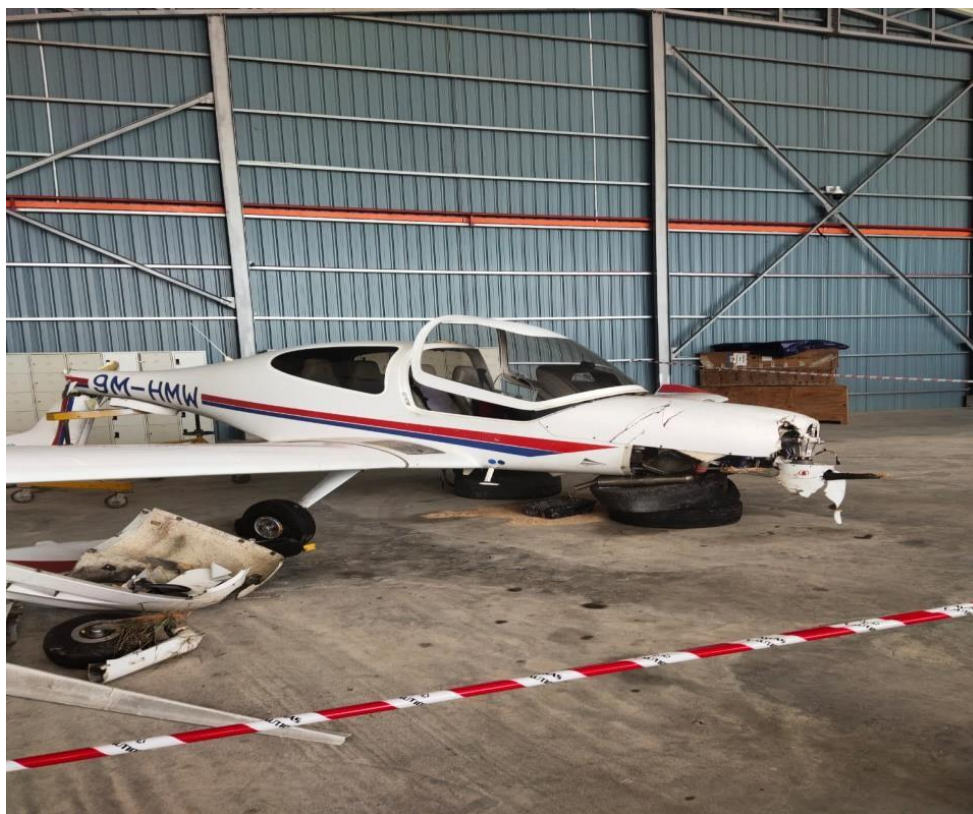
- a. All propeller blades broken.
- b. Nose spinner damaged.
- c. Gear box casing broken.
- d. Lower engine cowling broken and detached.
- e. Upper engine cowling broken at right intercooler duct.
- f. Upper cowling damage right hand side top and forward side of firewall.
- g. Nose landing gear broken.
- h. Left main tyre assembly broken and detached from strut.

- i. Left main landing gear strut bent and twisted.
- j. Tail cone / empennage fully broken 5ft from rudder.

Figure 2: Aircraft parked and impounded at hanger after salvage activities from crash site

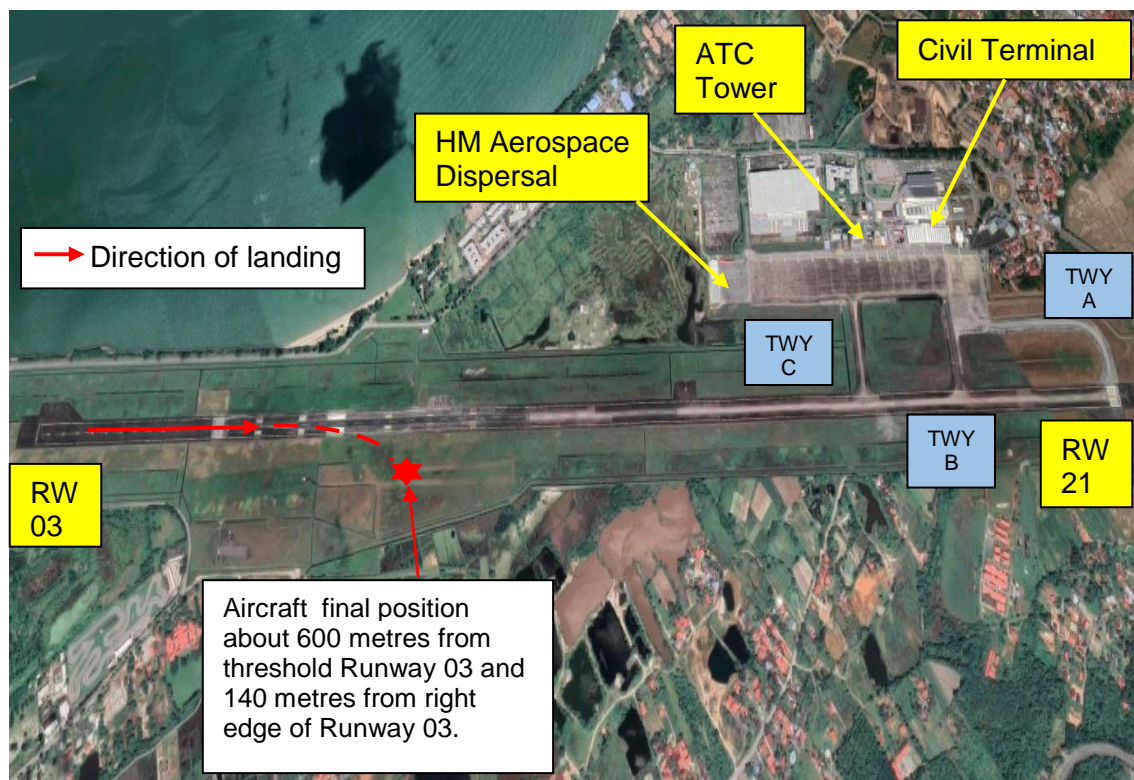
Figure 9: Landing path and final position of aircraft
(Diagram not to scale)

The aircraft suffered major damage in this accident. The aircraft had bounced while attempting to land and veered to the right side of the runway during the attempt go-around. The first impact point was about 120m from the right runway edge and about 600m from Runway 03 threshold. No skid marks were observed on the runway and grass area till the first impact point. The aircraft came to a rest about 140m from the right runway edge with the aircraft nose pointing to the ATC tower.

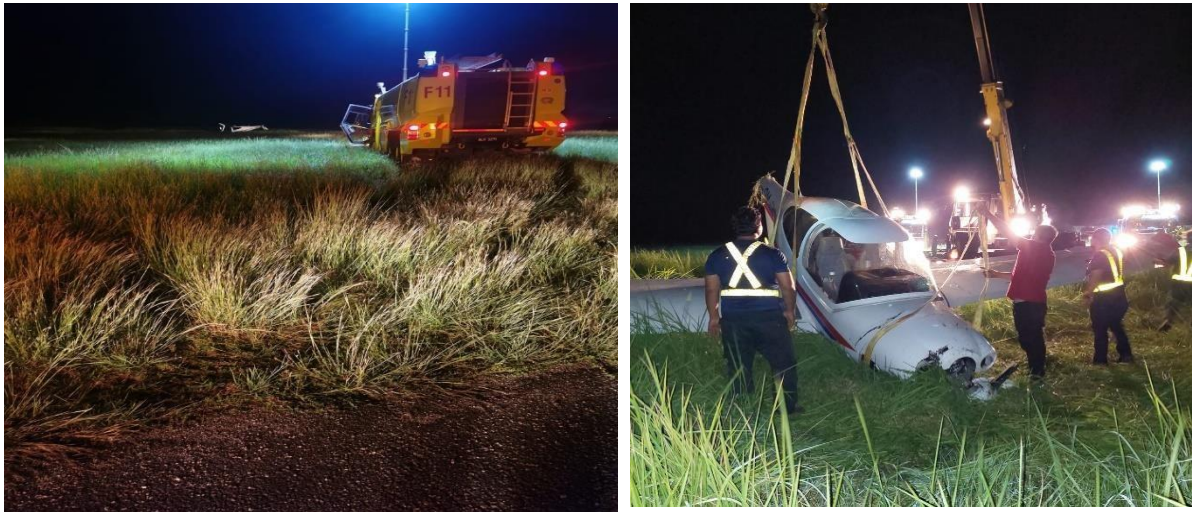
Figure 24: Night – **Evidence Limitation:** Aircraft skid marks and grass foliage evidence around the first impact point to aircraft final stop position were mostly lost due to rescue work by AFRS vehicle and wreckage salvage work by heavy lift crane and personnel movement. Nevertheless, first impact point and final aircraft rest position can be identified clearly.

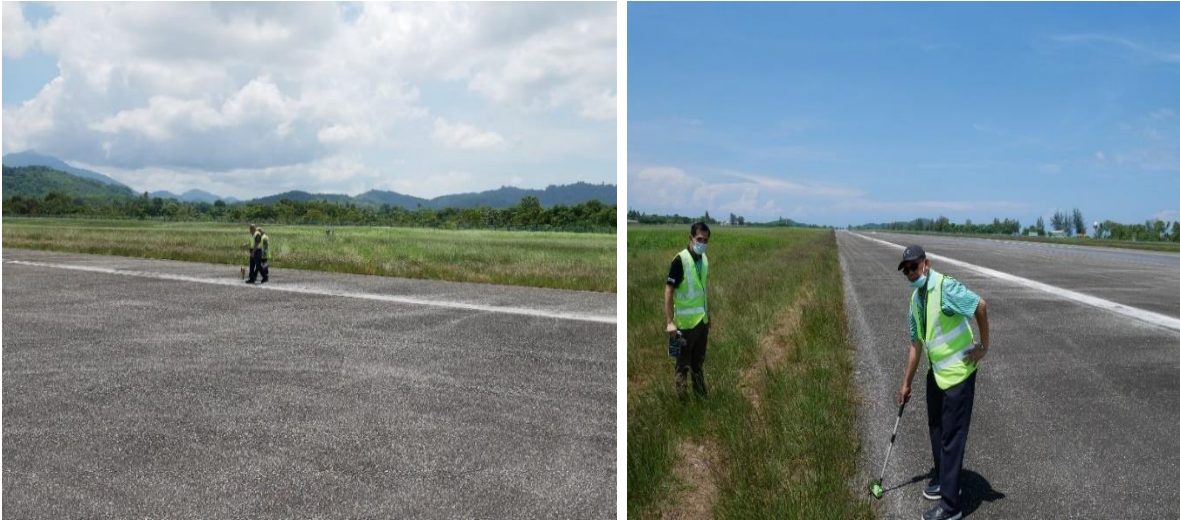
Figure 25: Day - No aircraft tyre track marks were observed on the runway at possible landing area or exiting the runway towards crash site.

Evidence on-site revealed that there were no tyre track marks observed on the possible landing point on the runway or exiting the runway to support a possible aircraft veering out of the runway during the landing roll (Figure 25 & 26).

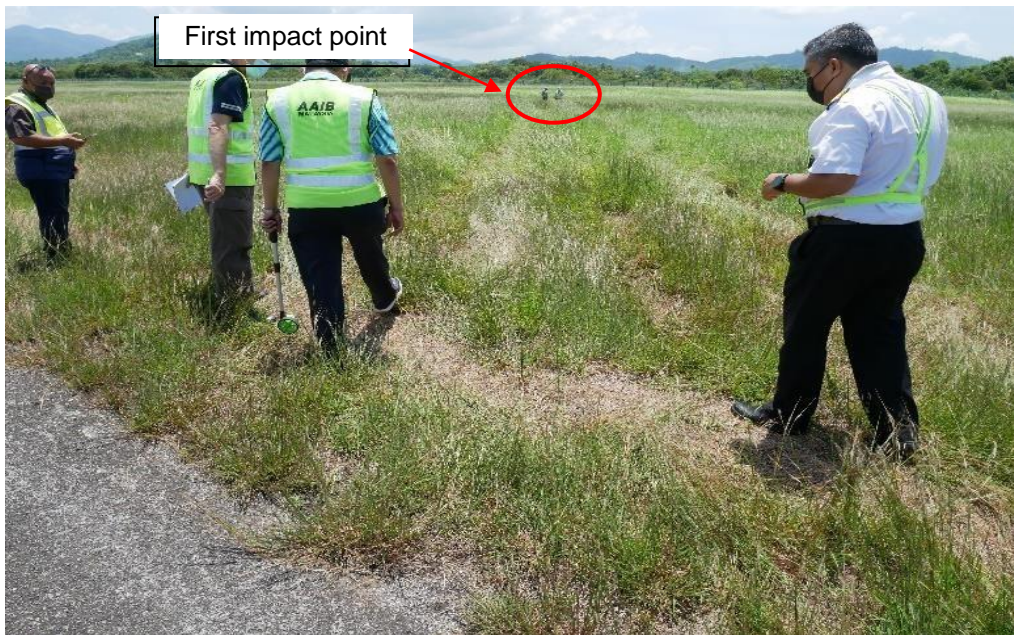
Figure 26: Day - No aircraft tyre track marks were observed exiting the runway towards the crash site. Only AFRS vehicle tyre marks were observed leading towards the crash site.

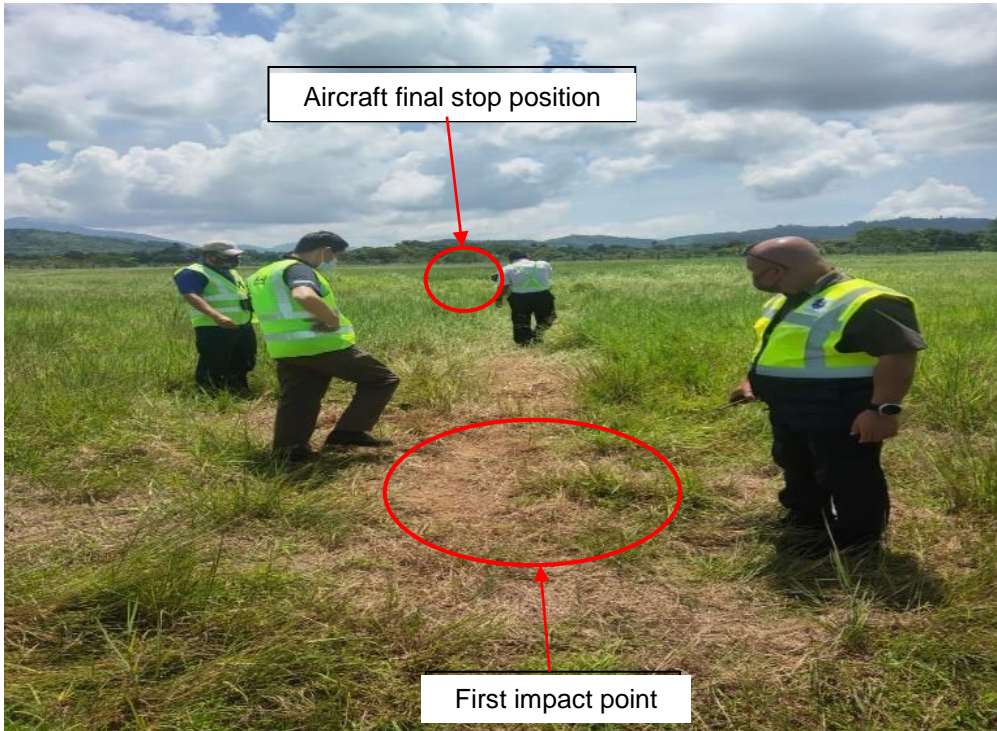
Figure 27: Day - First impact point area and aircraft final stop position view from right side edge of Runway 03.

The first impact point was about 120m from the right runway edge while the aircraft final rest position was about 20m ahead of the first impact point (Figure 27). Clear evidence of leaked aircraft engine oil and propeller debris was found at the first impact point (Figure 28). The lower engine cowling and tail skid which detached on impact was also located very close to this impact point (Figure 29).

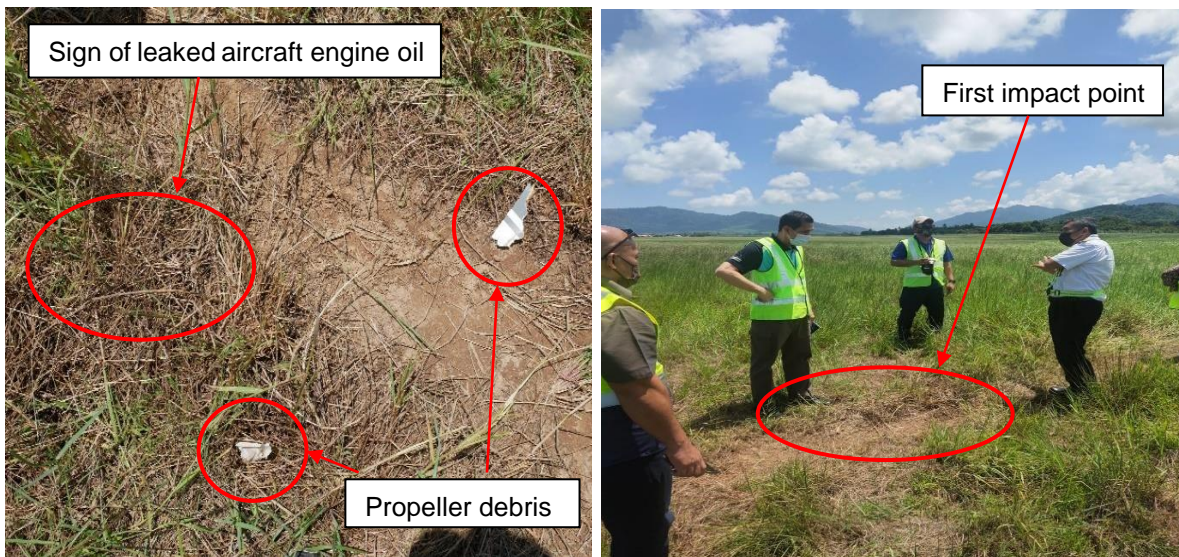
Figure 28: Day - First impact point area. Sign of leaked aircraft engine oil and propeller debris at impact area.

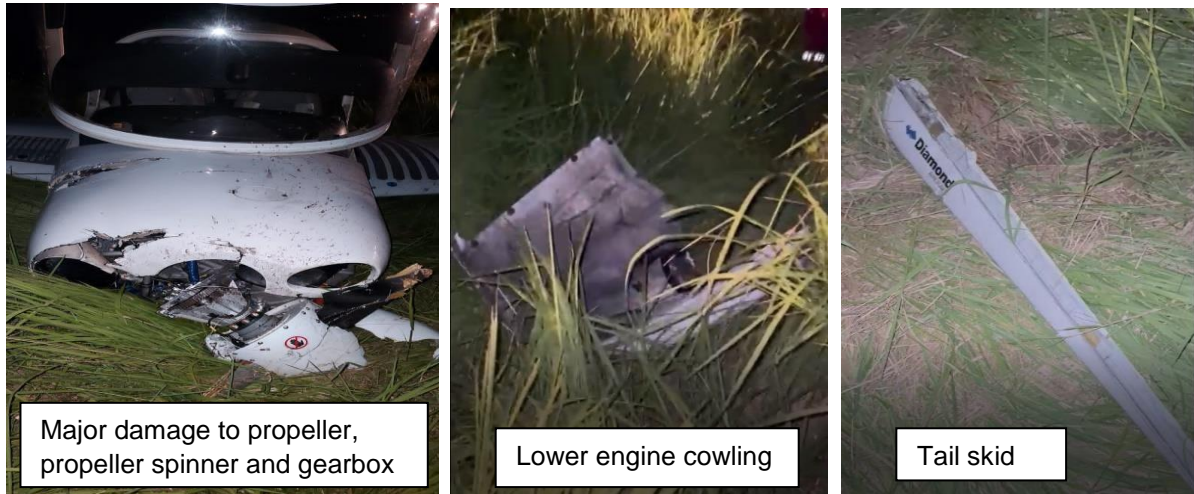
Figure 29: Night – Evidence of heavy impact on the nose section of the aircraft which resulted in major damage to all the propellers, propeller spinner and gearbox at first impact point. The nose landing gear broke and the nosewheel detached from nose landing gear strut on impact to the ground. The lower engine cowling and the tail skid was also found nearby this area.

Post-accident damage assessment revealed that there were major damages to all the propellers, propeller spinner and gearbox. The nose landing gear strut was found broken and the nosewheel had detached from nose landing gear strut. The LH main landing gear strut had twisted and bent with the left main wheel detached from the landing gear strut while the RH main landing gear strut remains intact. The tail skid

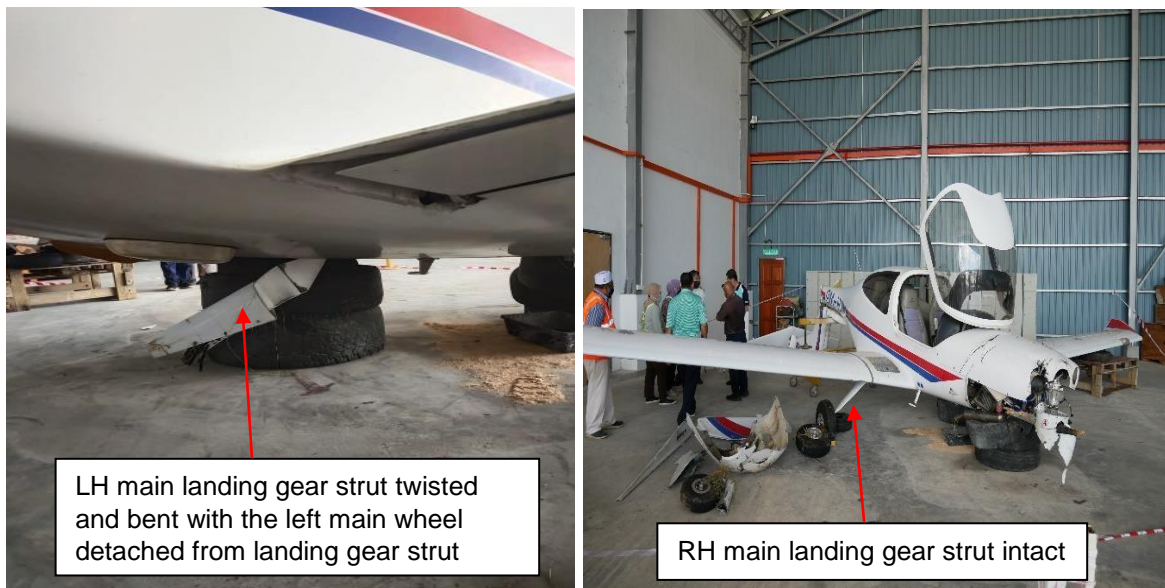
Figure 30: Day - LH main landing gear strut twisted and bent with the left main wheel detached from landing gear strut. RH main landing gear strut remained intact.

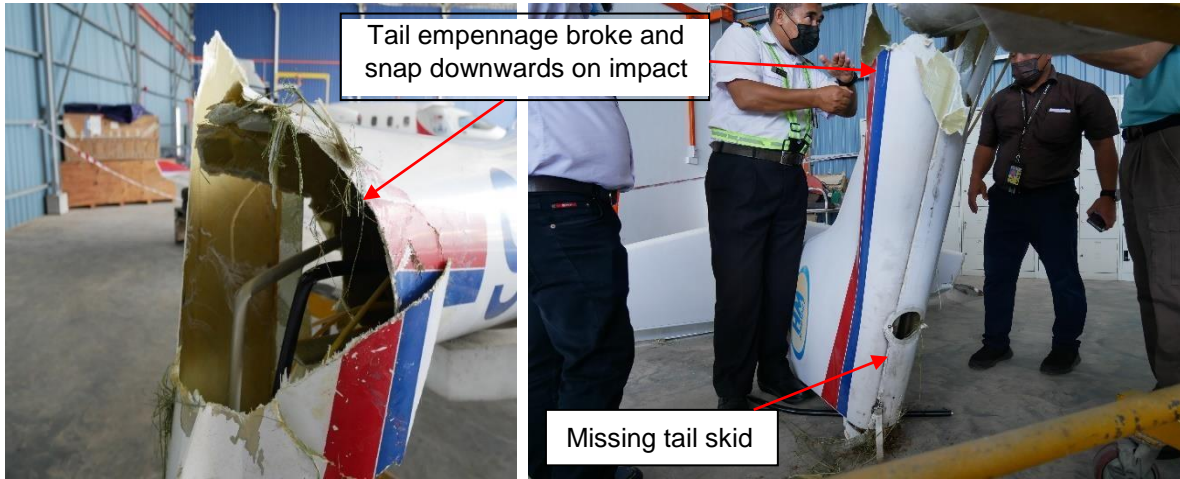
Figure 31: Day - Tail empennage broke and snap downwards on impact. The aircraft tail skid was missing and found near the first impact point area.

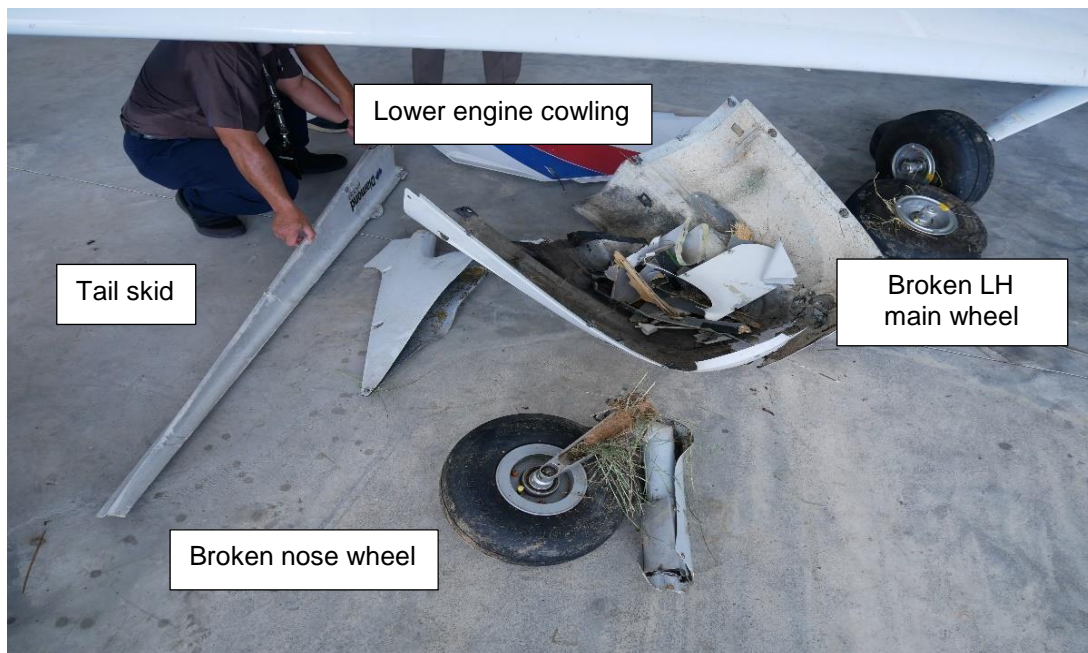
Figure 32: Day – Nose wheel, LH main wheel, Lower engine cowling and Tail Skid

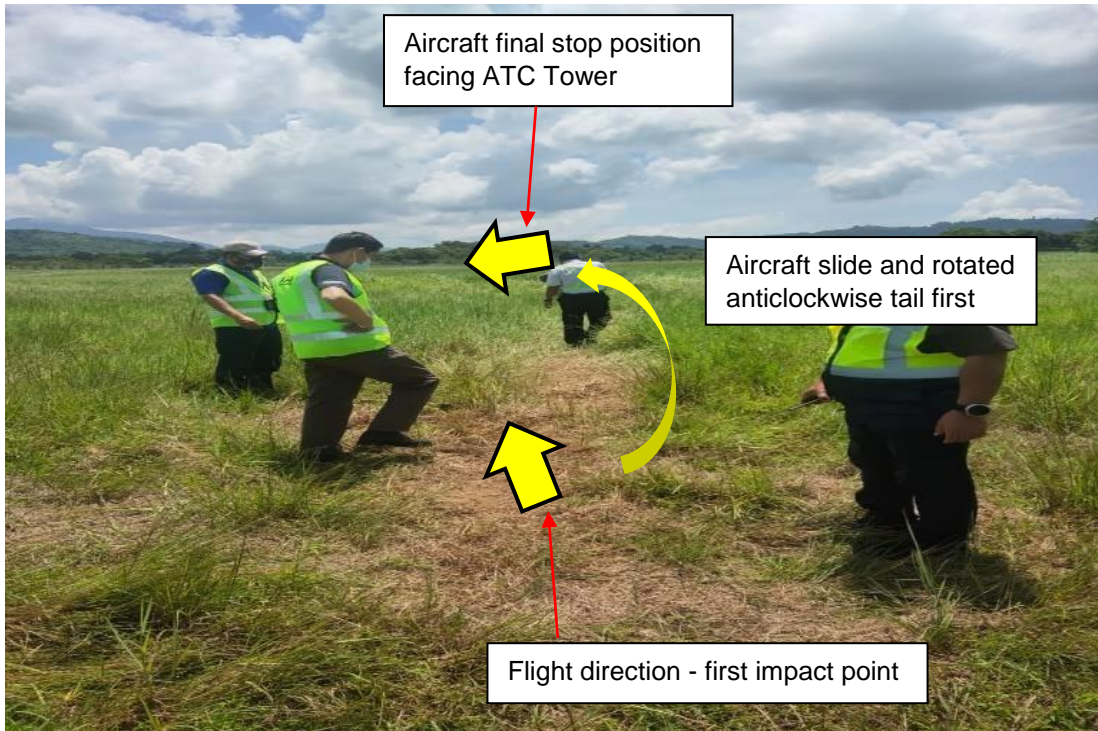
Figure 33: Day - Aircraft slide and rotated anticlockwise tail first before coming to rest with aircraft nose facing the ATC Tower.

The forward momentum of the impact most probably caused the aircraft to slide sideways for about 20m before coming to a full stop. The aircraft had rotated anticlockwise tail first for about 50° (estimated) while sliding sideways pivoting on the LH main landing gear strut which had twisted and broken off (Figure 33). The broken LH main landing gear strut and damage propeller spinner provided movement resistance for the aircraft to stop facing the ATC Tower (Figure 36 & 37). The aerial view location of first impact point, debris location and final aircraft position are shown in Figure 38.

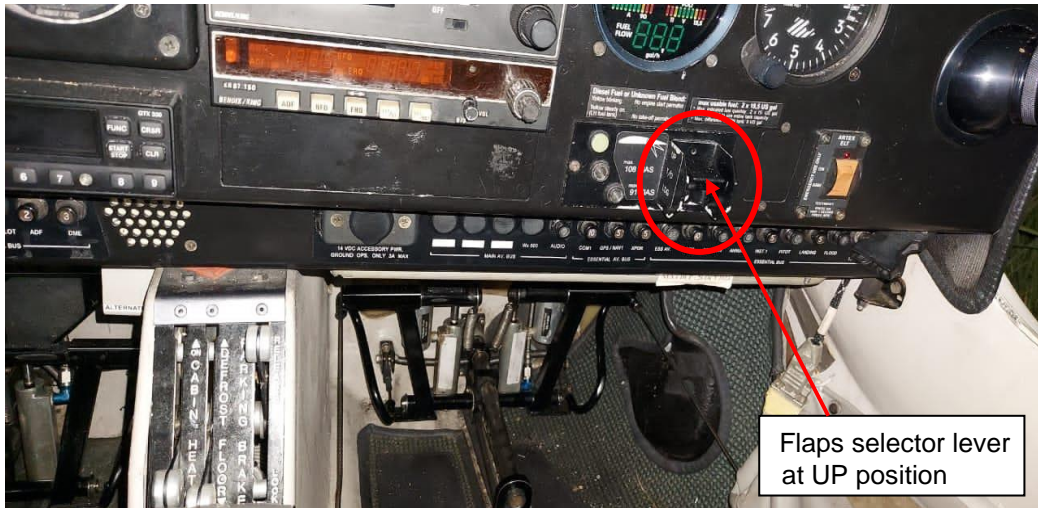
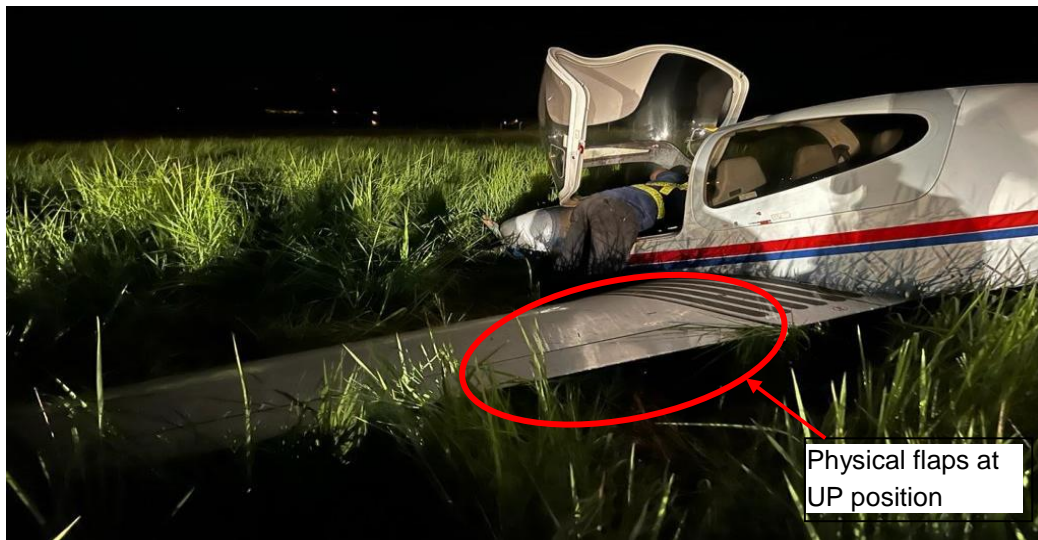
Figure 34: Night - Flaps Selector Lever and physical flaps at UP position

The incorrect selection of the flaps lever to UP had caused a change in the aircraft configuration which the CP was not familiar with. While hesitating to commence a go-around and trying to control the aircraft with minimum power, the aircraft had veered right away from the runway facing darkness which most probably caused the CP to panic. The CP subsequently got disorientated on the actual flight path and loss control of the aircraft.

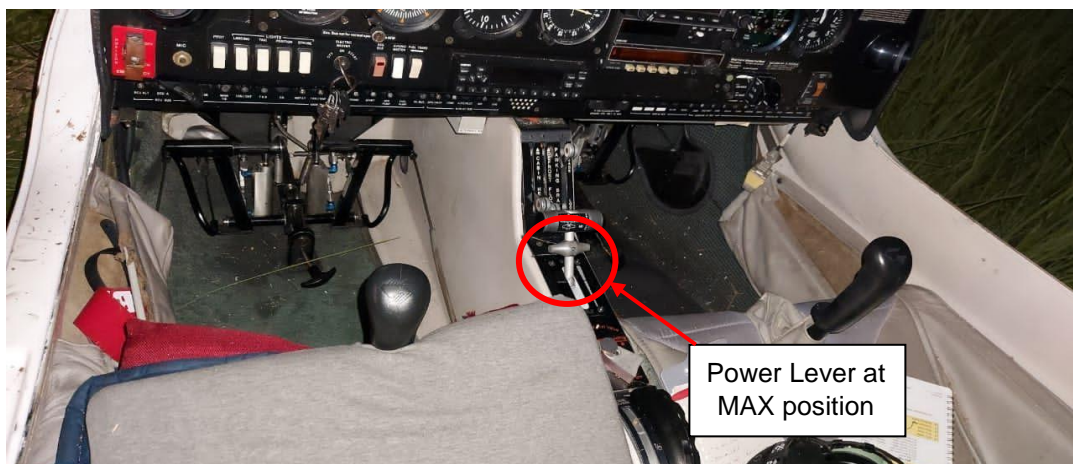
Figure 35: Night - Power Lever at MAX position

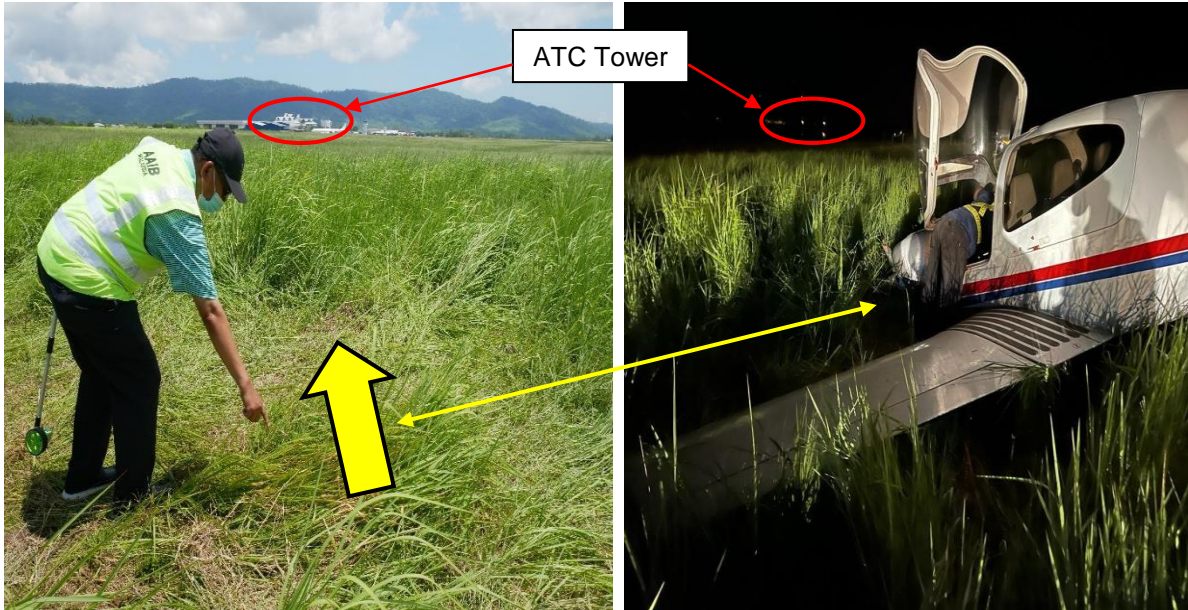
Figure 36: Day & Night - Aircraft final stop position facing ATC Tower.

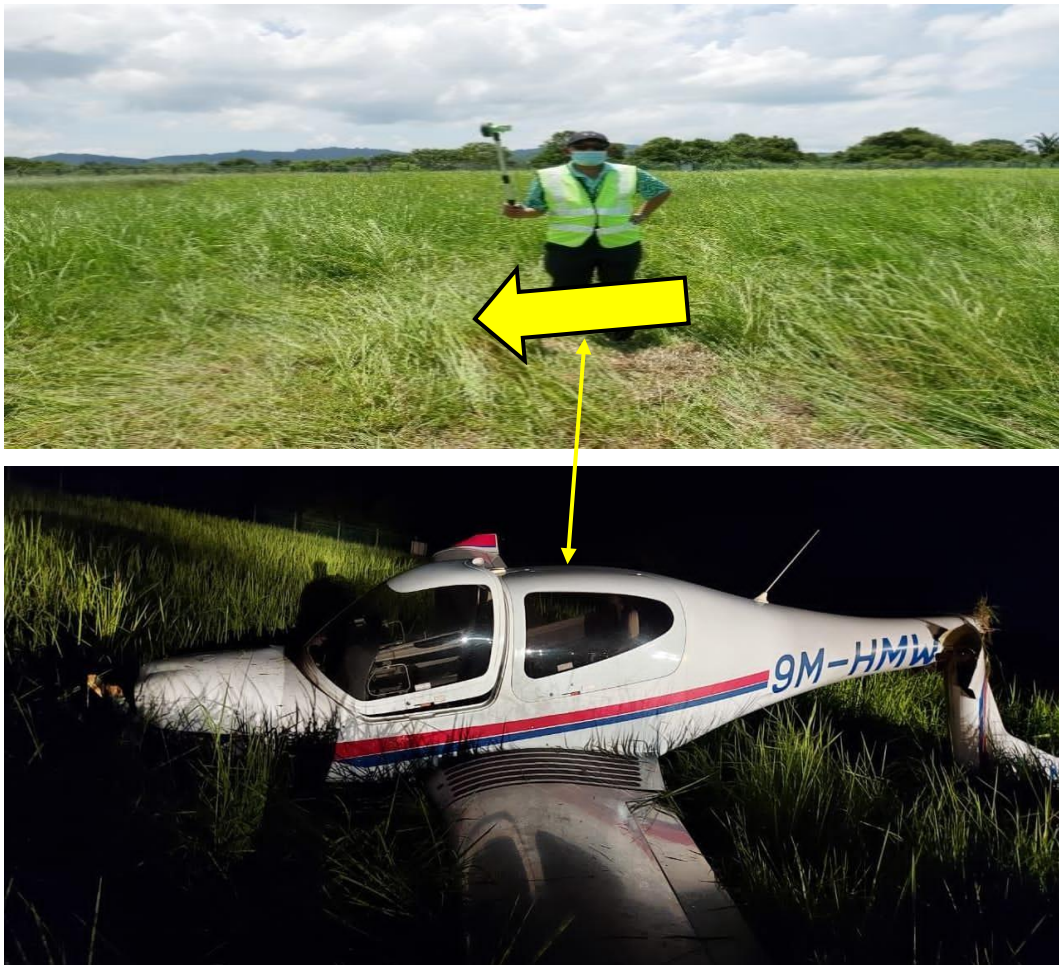
Figure 37: Day & Night - Aircraft final stop position with the broken tail empennage.

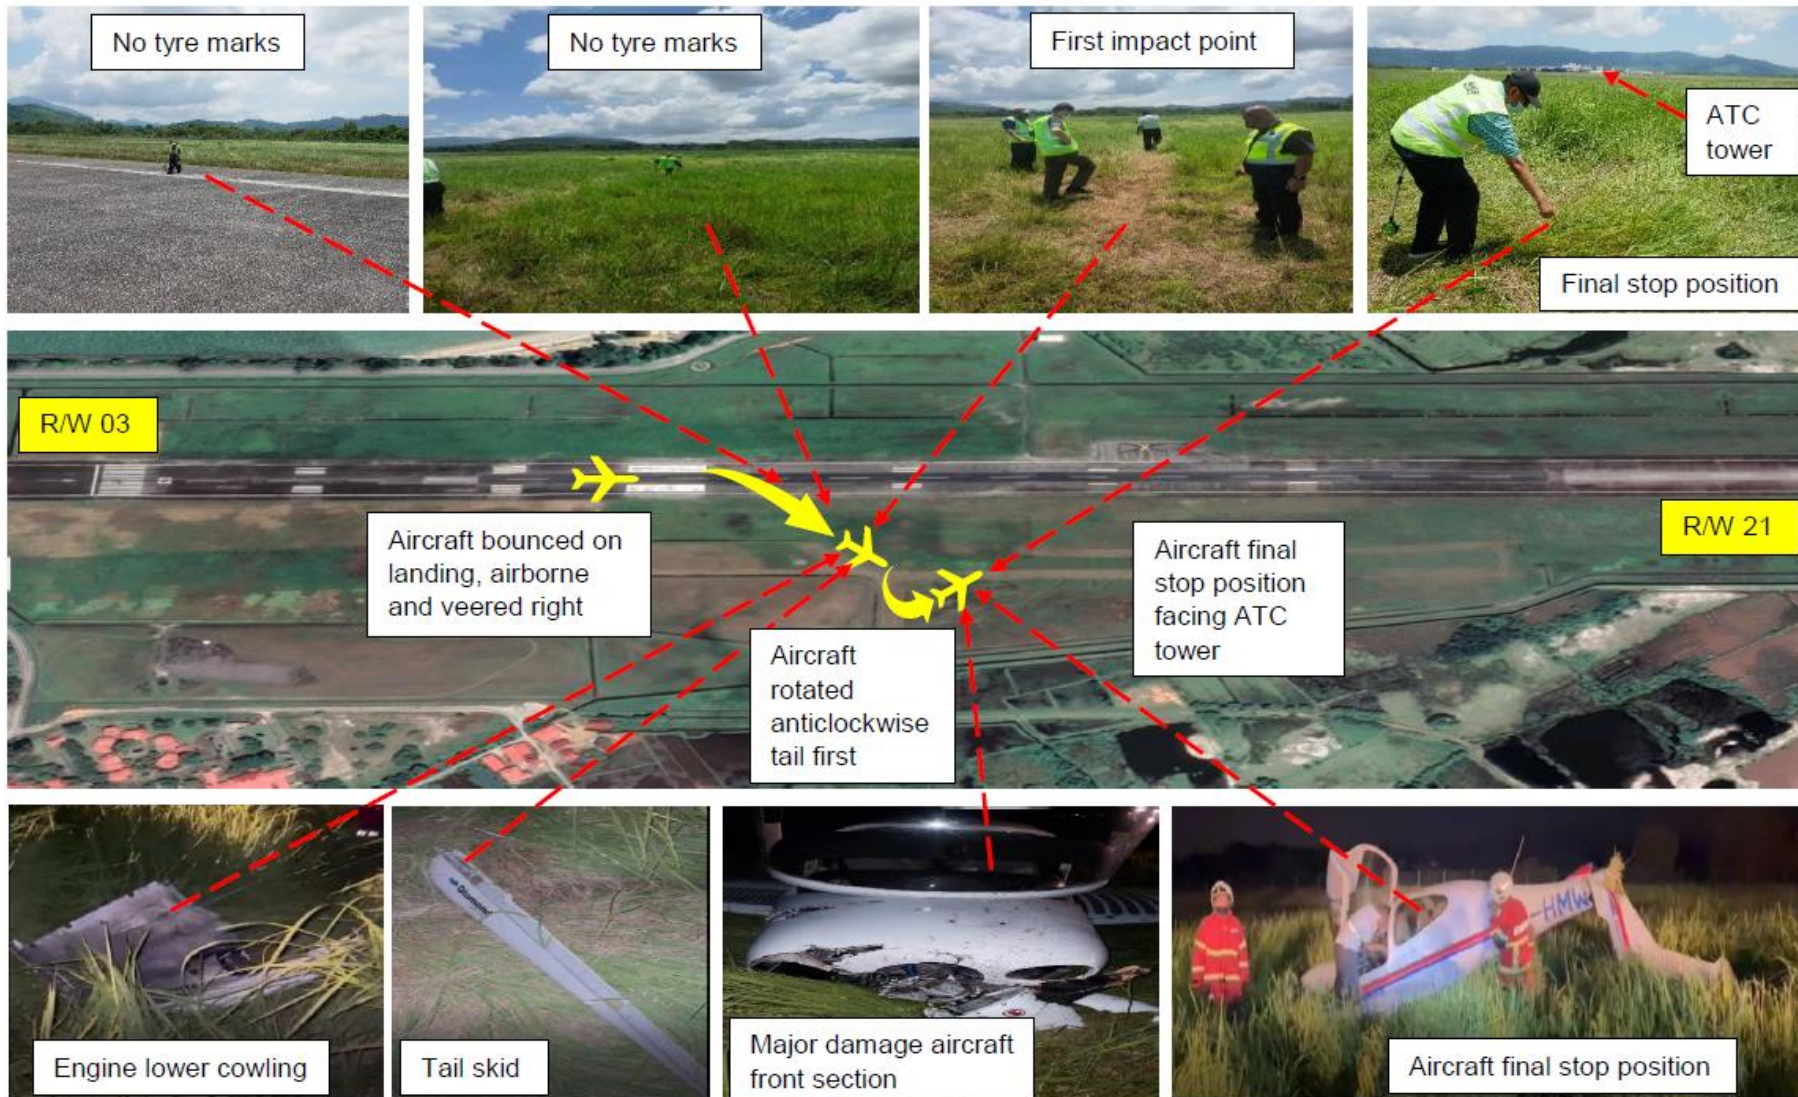
Figure 38: Aerial view location of first impact point, debris location and aircraft final position (Diagram not to scale) 38
