AIRCRAFT SERIOUS INCIDENT FINAL REPORT

SI 04/22P

Serious Incident Involving a Diamond DA42

Registration 9M-HMY

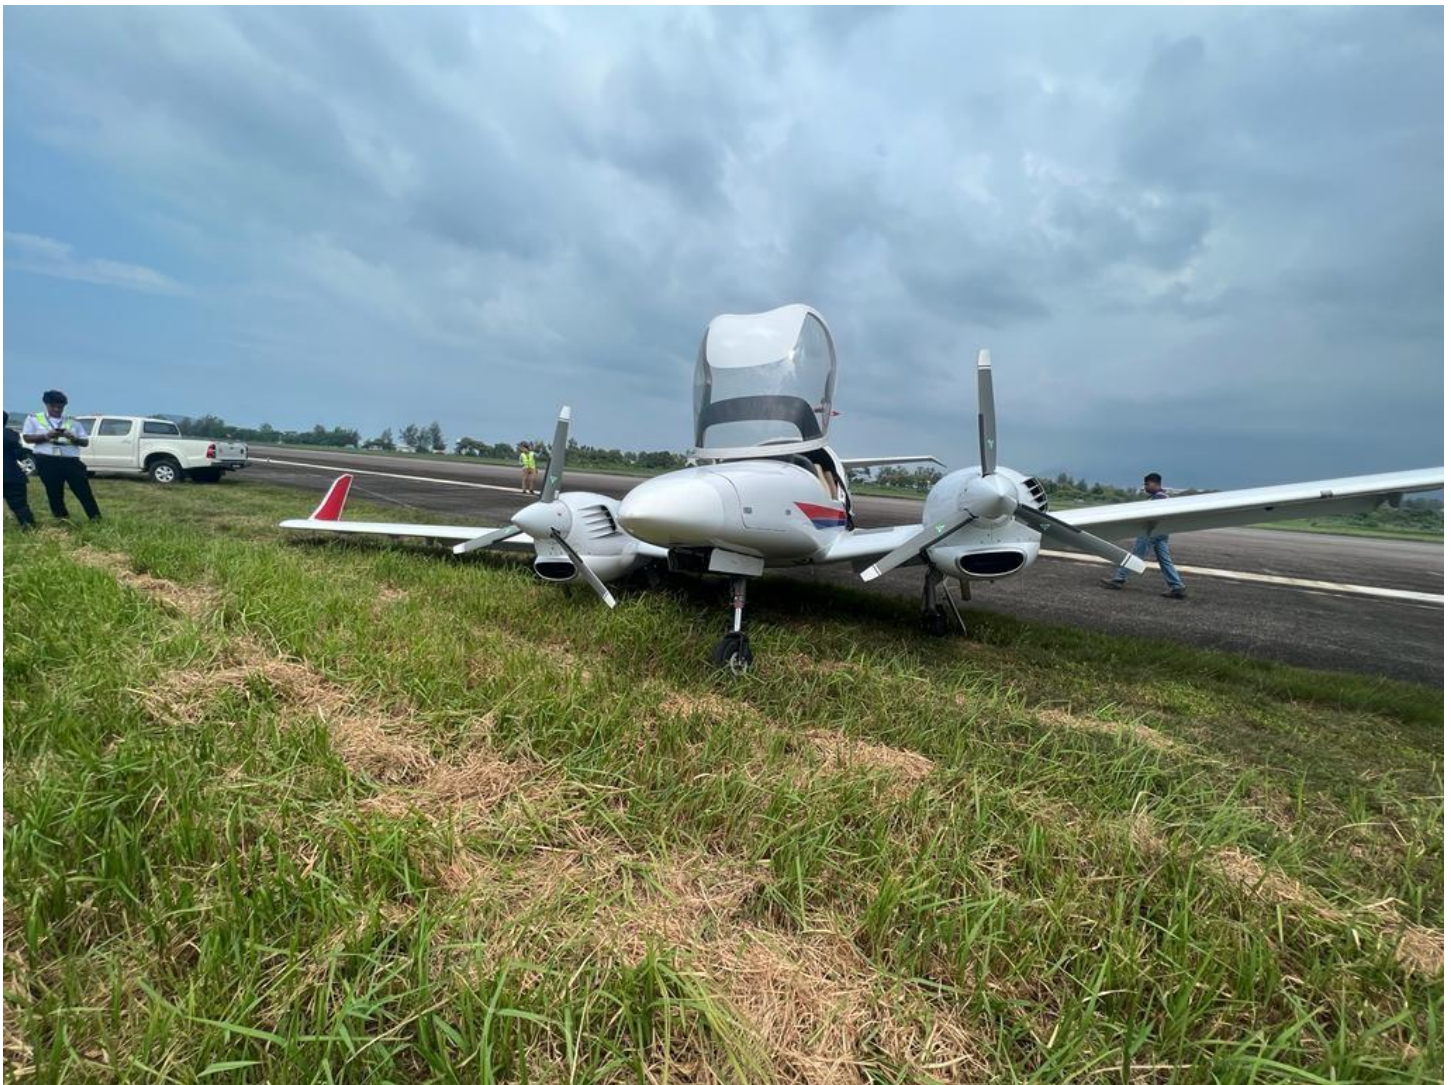
On 8th Aug 2022, at around 1100 hours, a Diamond DA 42 aircraft registration: 9M-HMY was reported as RH MLG collapsed and aircraft veered to the right, after touch down. Aircraft stopped at the side of the runway with all three (03) landing gears on the grassy area. Refer **Picture 01**.

Picture 01. Aircraft stopped at the side of the runway with all three (03) landing gears on the grassy area.

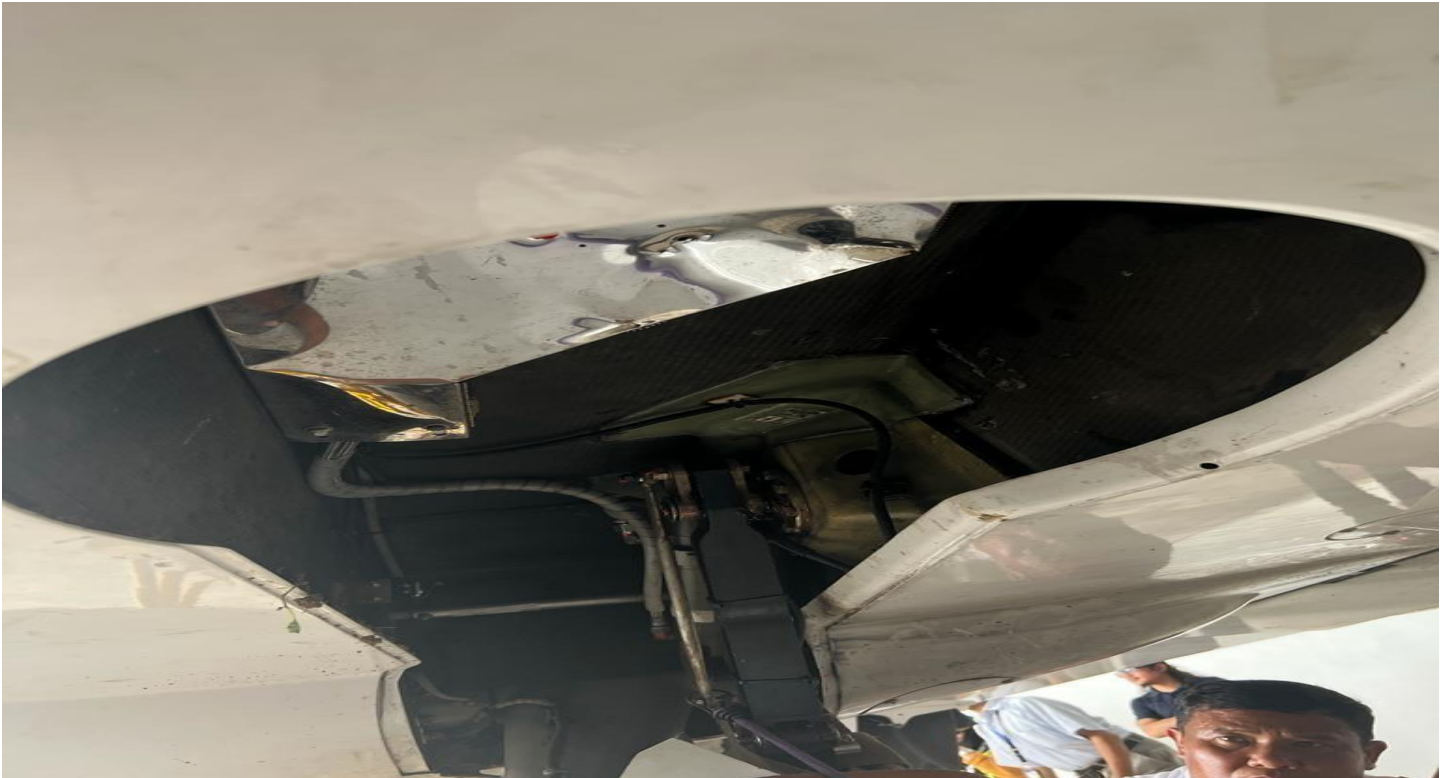
Picture 02.

| No. | Inspection items | Observation |
|---|--|--|
| 1 | Examine the composite structure to which the main landing gear assembly is attached. Look specially for cracks and delamination. | -Initial Visual inspection didn't find any crack. Will proceed details inspection for crack. -Coin tap test for composite delamination and details inspection will perform later. Refer Picture 02 . |

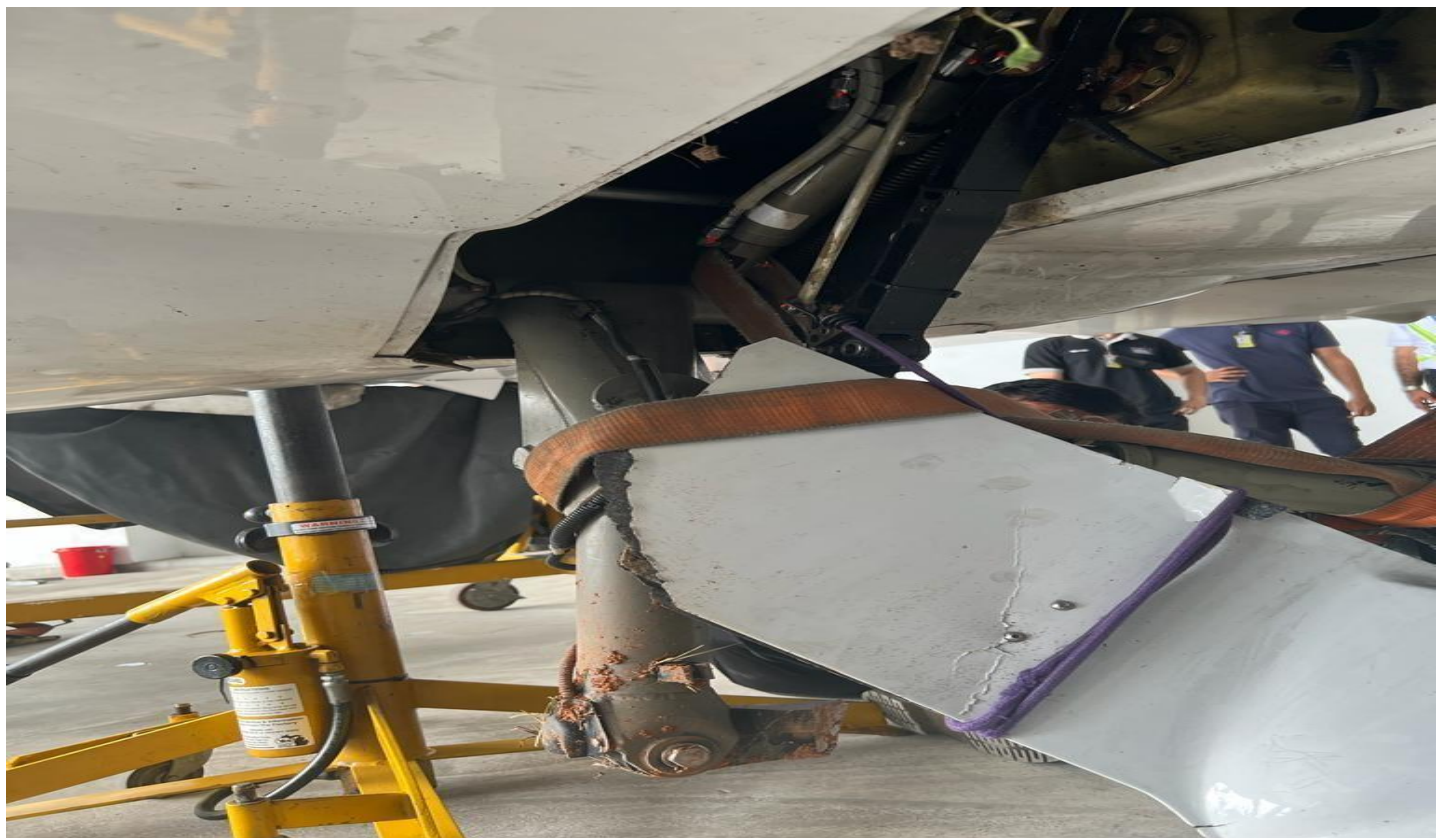
Picture 03.

| No. | Inspection items | Observation |
|---|--|--|
| 2 | Examine the bearings for the main landing gear assemblies in the center wing. Look specially for play. | - Cannot perform due to limited access and obstruction with the door damage. Will proceed upon get clearance from QA and AAIB team. Refer Picture 03 . |

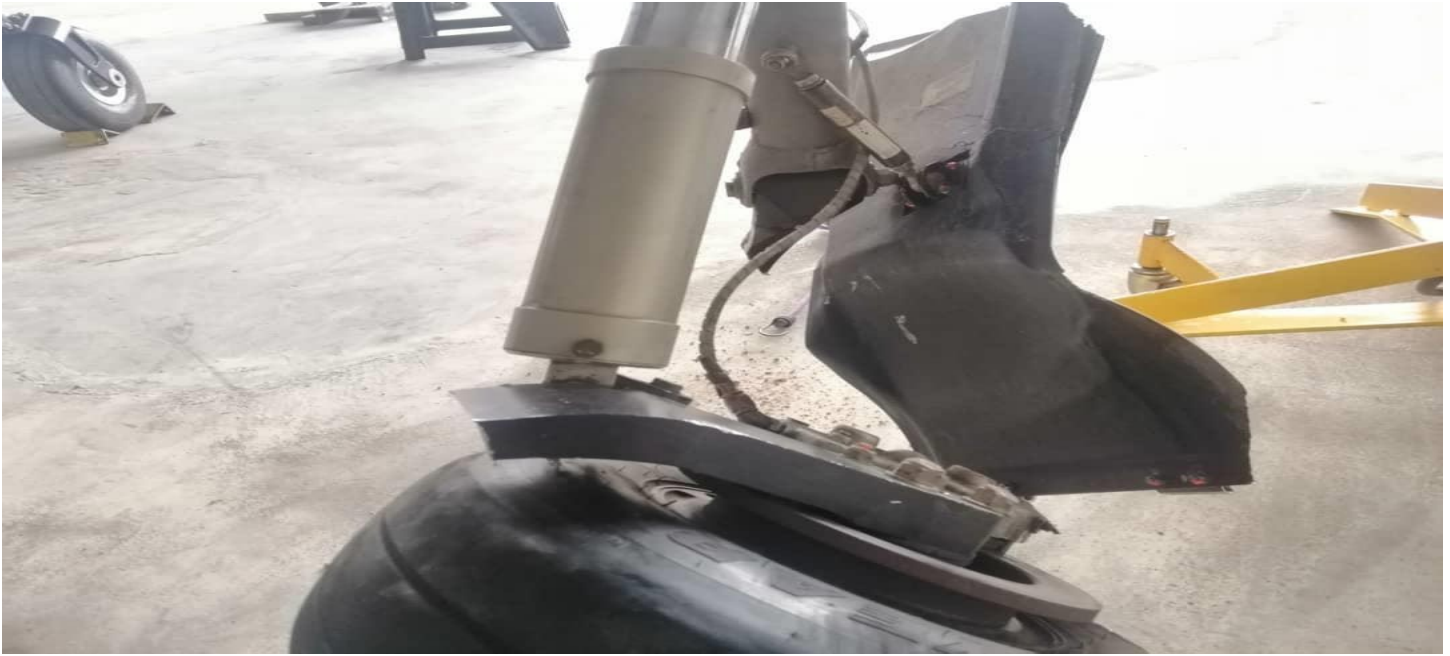
Picture 04.

| No. | Inspection items | Observation |
|---|--|--|
| 3 | Examine the landing gear legs and trailing arms. Look specially for cracks, deformation, corrosion, and damaged surface protection. | - RH Landing gear leg found rubbing. - RH Trailing arm snapped. Refer Picture 04 . |

Based on the operating crew entry in the Aircraft Journey Log, the most probable cause for this incident is the snapped trailing arm of RH main landing gear. Further investigation is required to determine exact root cause of the RH MLG trailing arm failure.

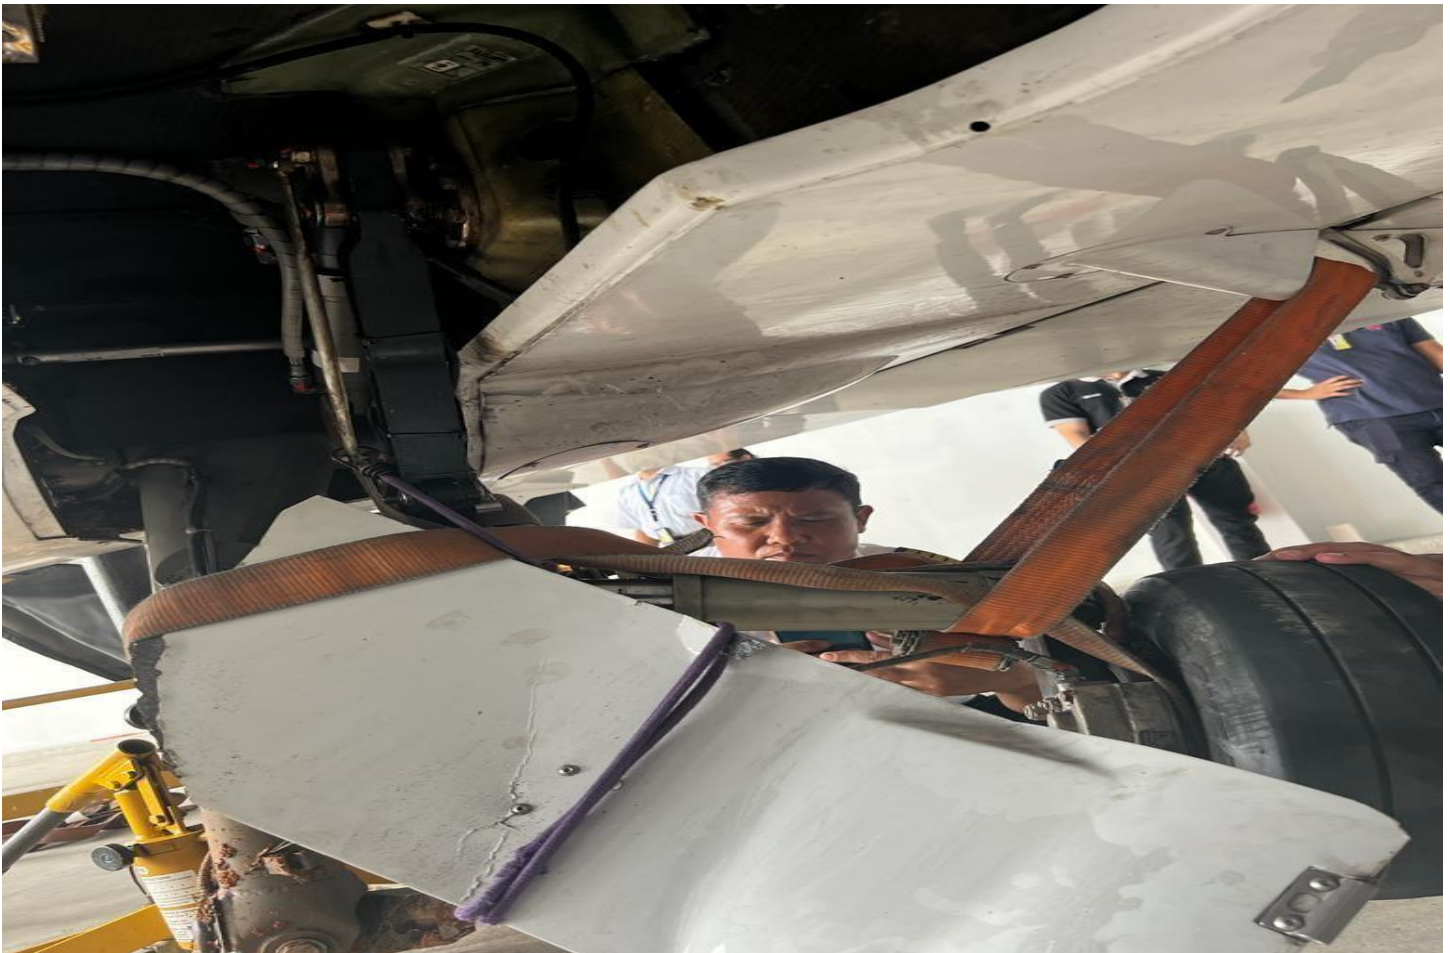
Picture 05.

| No. | Inspection items | Observation |
|---|--|--|
| 4 | Examine the hydraulic lines of the brake system for damage, leakage, and loose or defective connectors. | - NIL sign of leakage. Brake hose still attach to the brake caliper assy. Brake hose show deterioration of outer layer. - Found rubbing on screw bleeder and cylinder. Refer Picture 05 . |

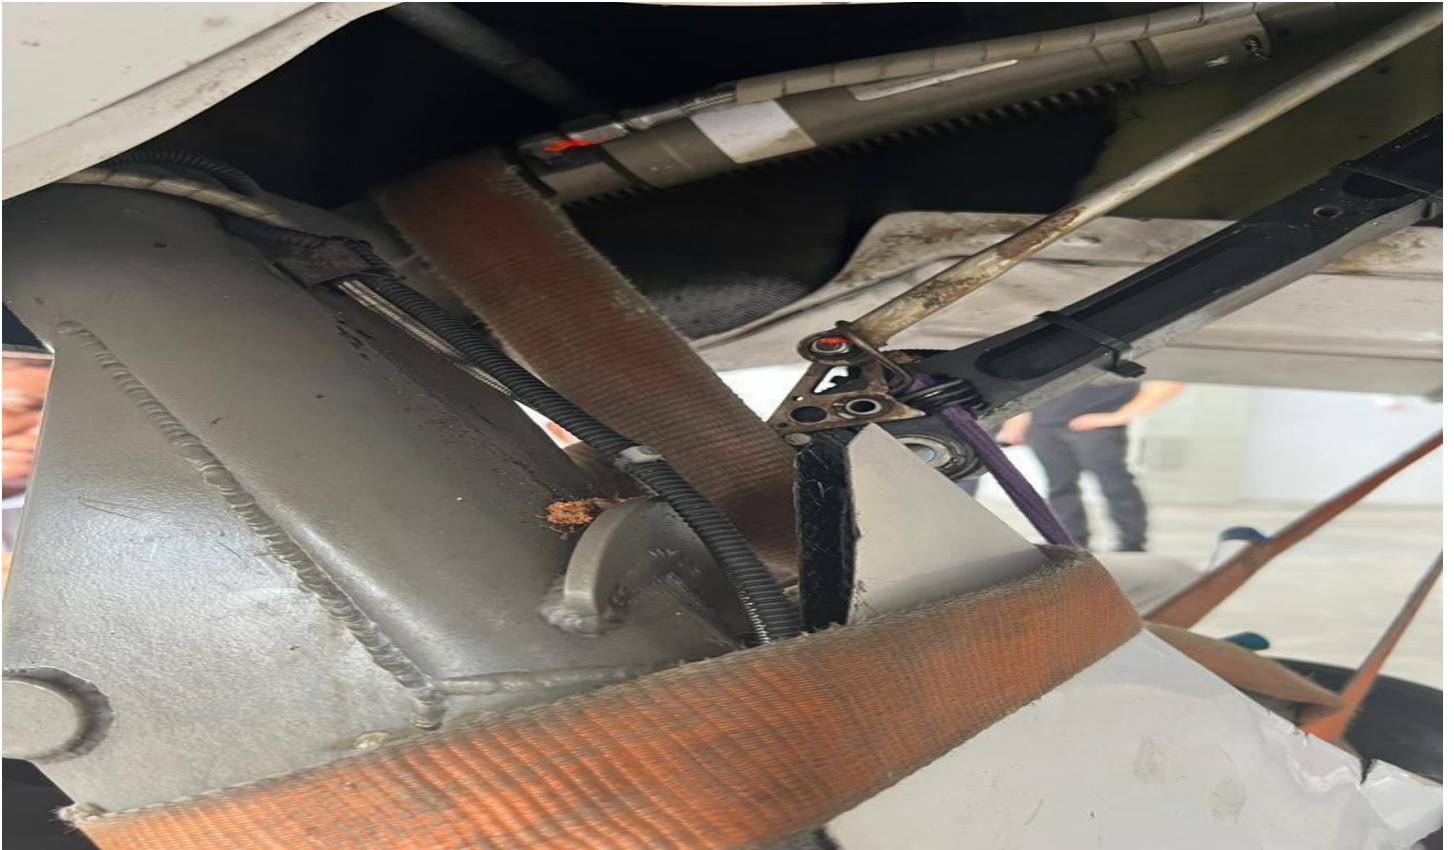
Picture 06.

| No. | Inspection items | Observation |
|---|--|--|
| 5 | Examine the main landing gear actuators and hydraulics. Look specially for leakage. | - NIL sign of leakage. Refer Picture 06 . |

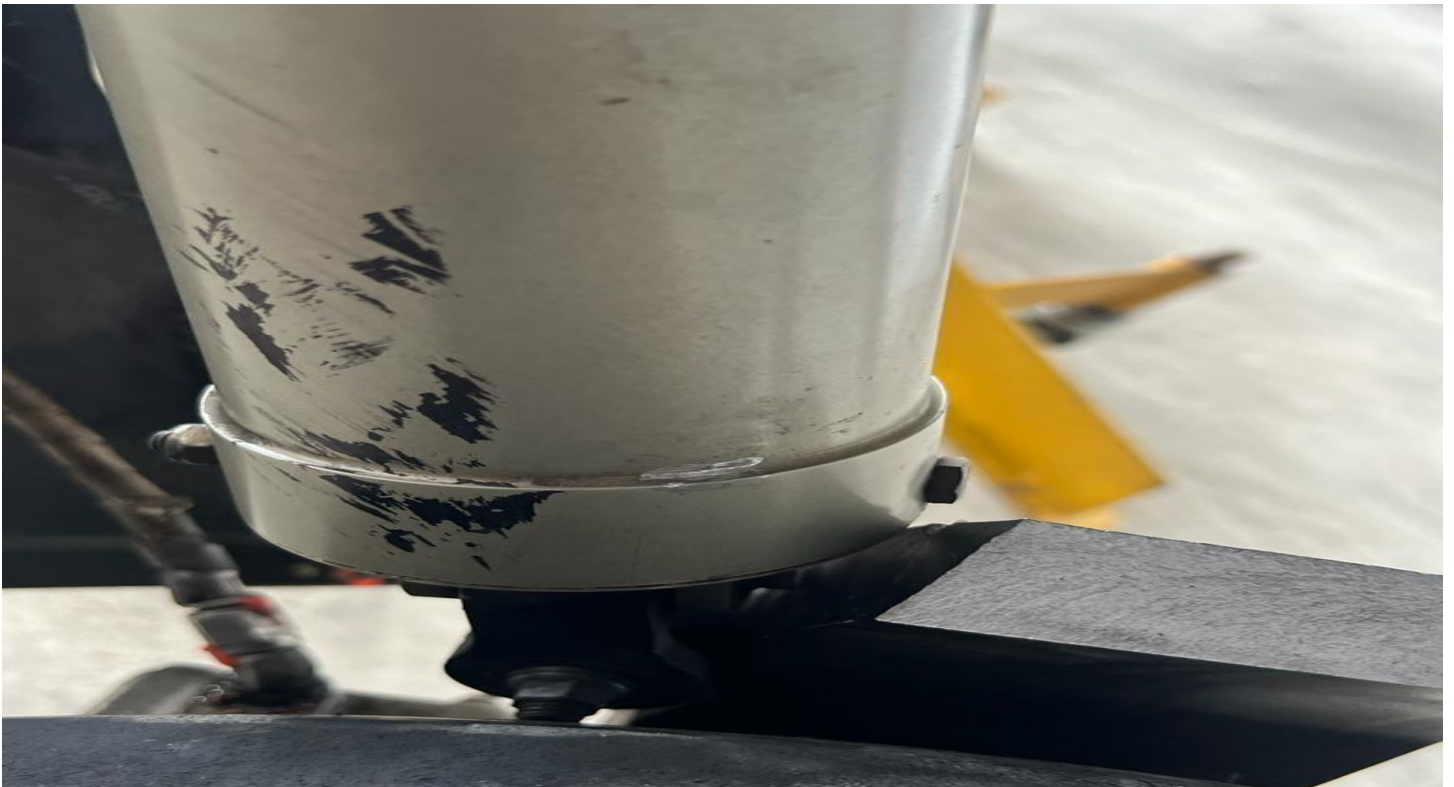
Picture 07.

| No. | Inspection items | Observation |
|---|--|--|
| 6 | Examine the damper. Look specially for leakage. | - NIL sign of leakage. Refer Picture 07 . |

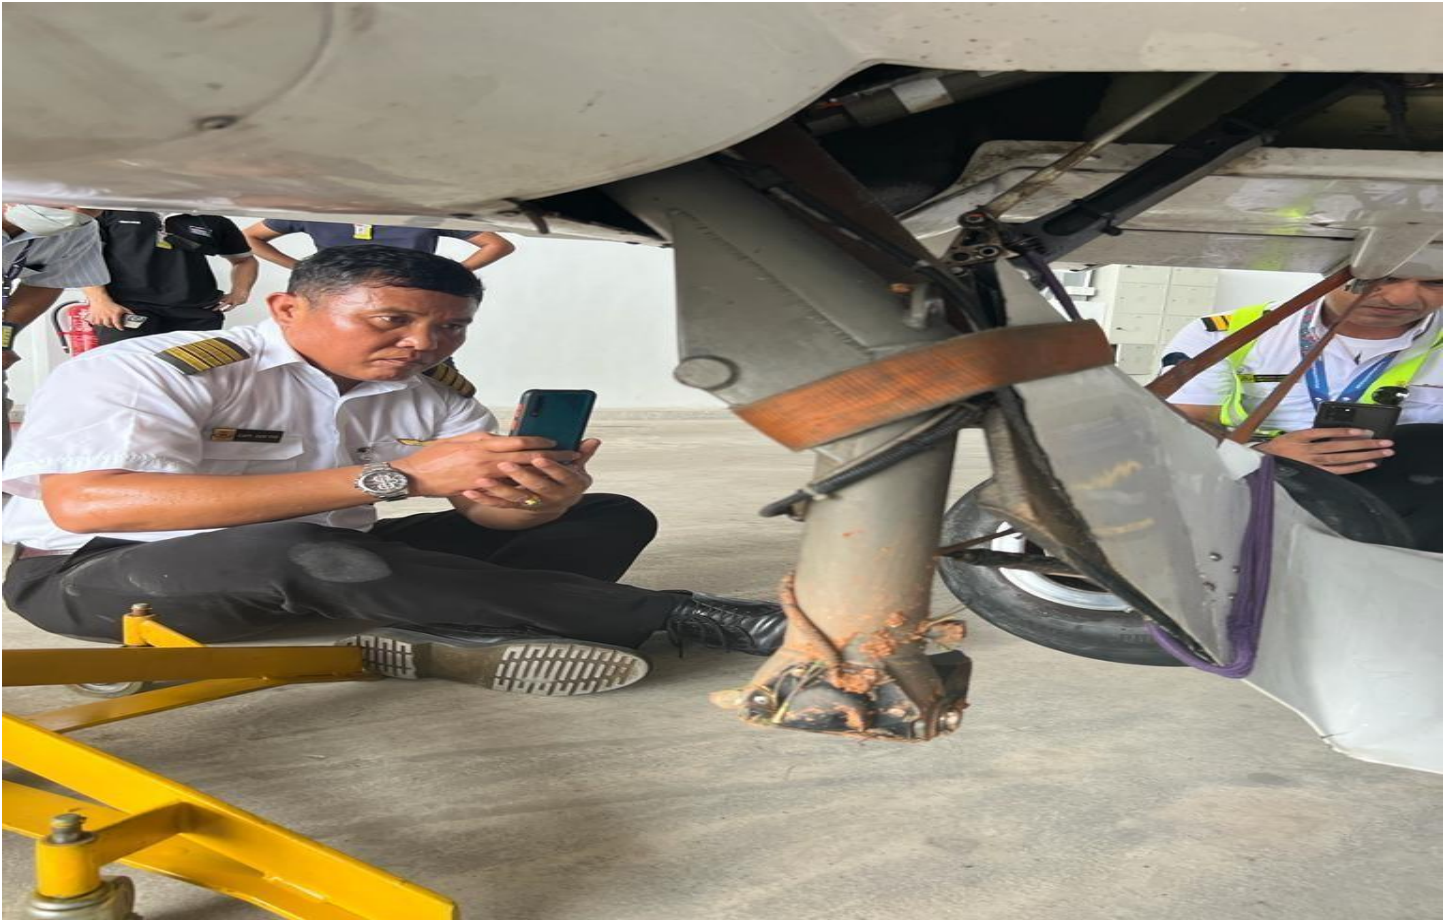
Picture 08.

| No. | Inspection items | Observation |
|---|--|--|
| 7 | Examine the main landing gear doors: <ul style="list-style-type: none"> • Check for damage to the doors. • Check for cracked hinges. • Examine the door operating rods. | - Rubbing, cut and delamination on RH MLG door. - MLG Flap Hinges rear ASSY RH detached and distorted. - DS Bearing 2 LH and RH distorted. - Door opening rod (Coupling Bar MLG Flap) distorted. Refer Picture 08 . |

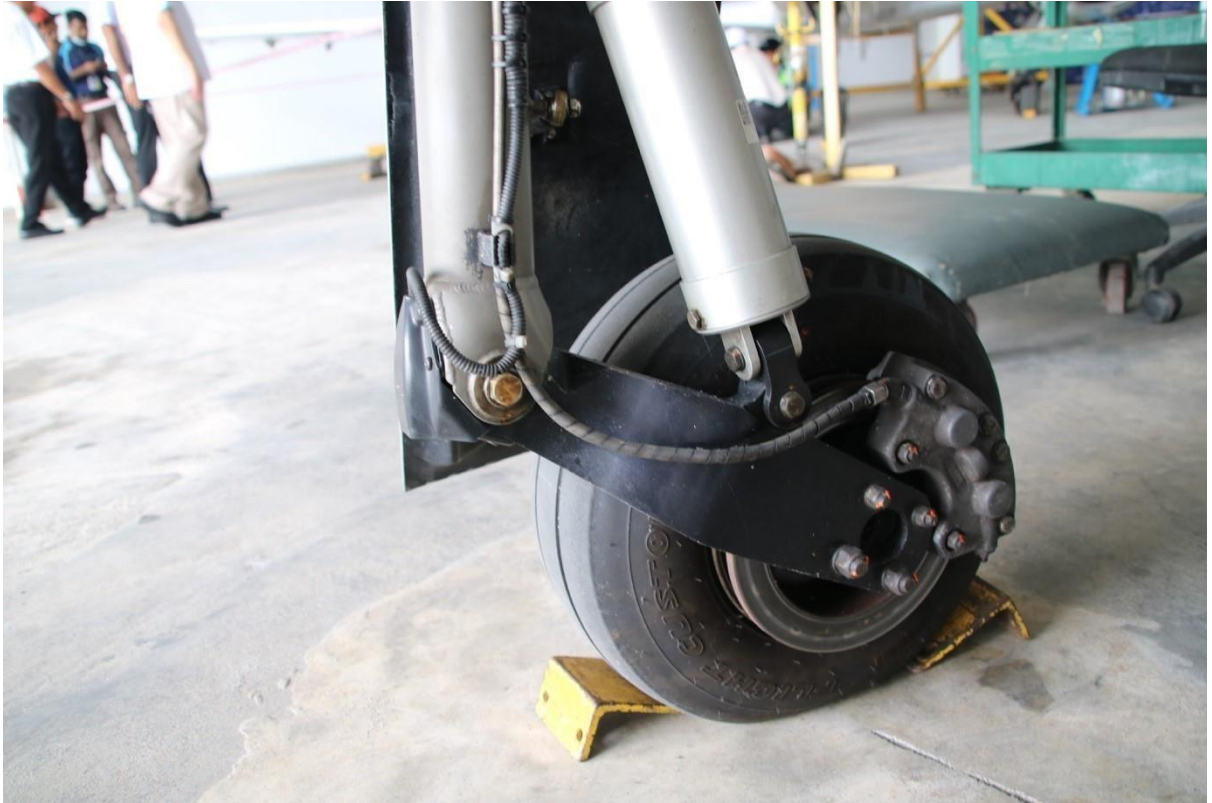
IMAGE 1

Images of the RH MLG Trailing Arm are provided in **Appendix B**. Image 1 shows an undamaged RH MLG Trailing Arm from a similar aircraft. Image 2 shows the damaged RH MLG Trailing Arm when viewed from the front of the aircraft (note the clean break in the Trailing Arm).

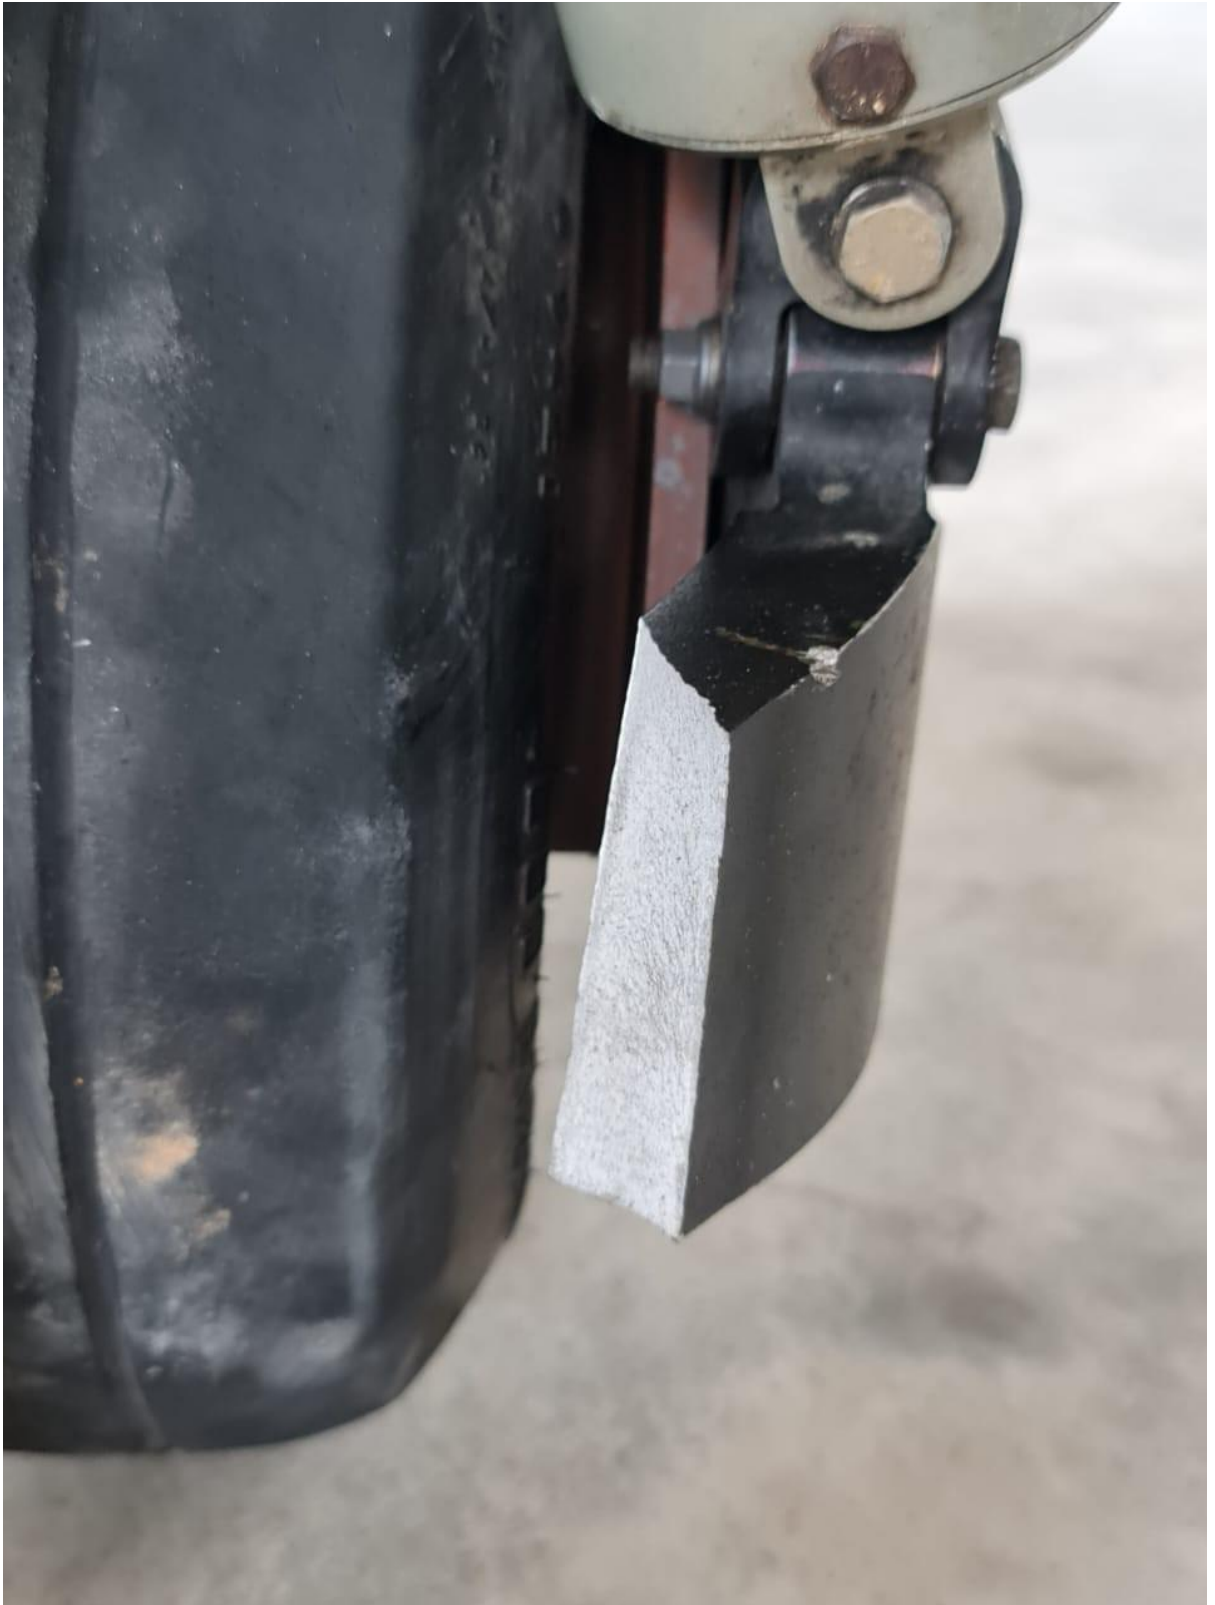
IMAGE 2

The report of damages to the aircraft is provided in the inspection report by the maintenance organisation of the aircraft in **Appendix A**. The preliminary finding of the report states that the most probable cause for this serious incident was the failure of the Right-Hand Main Landing Gear (RH MLG) Trailing Arm.

Nonetheless, the operator has since carried out a one-time inspection on all Trailing Arms of their fleet of aircraft.

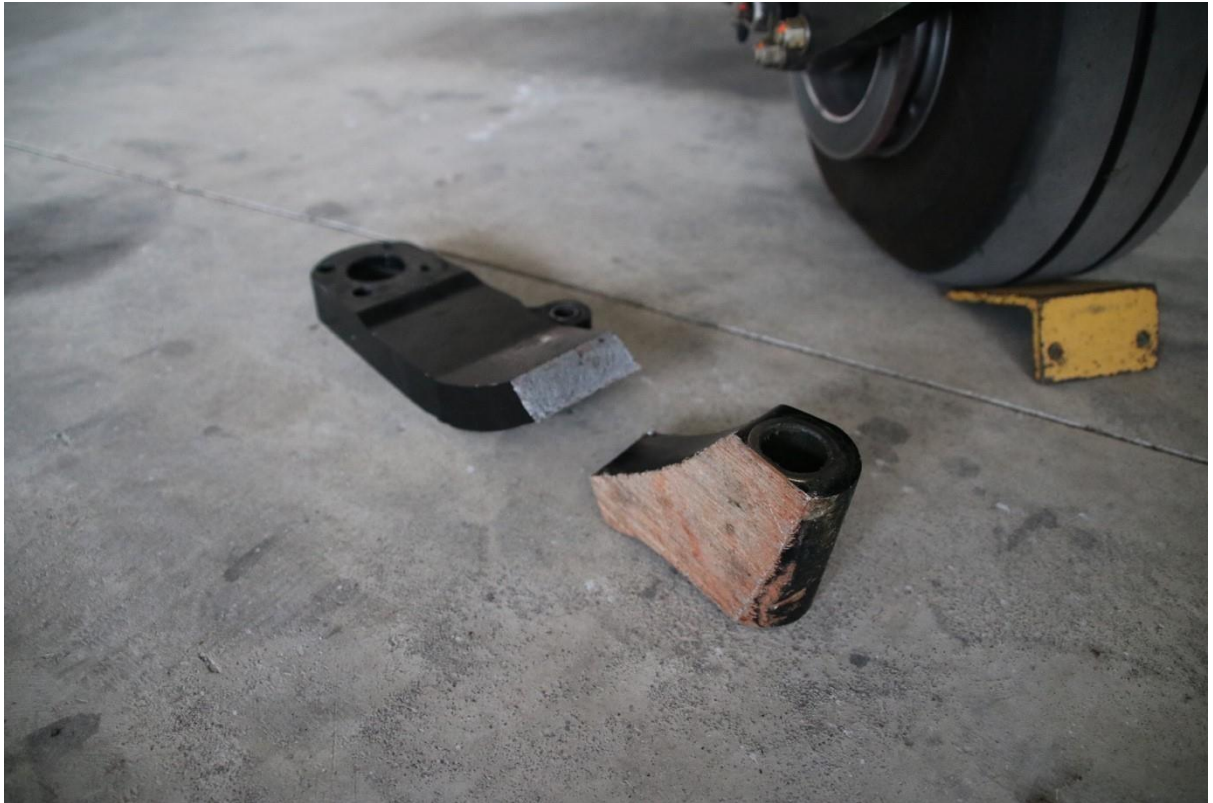
IMAGE 3

Image 3 illustrates the dismantled damaged Trailing Arm with the adjacent piece that had broken off which was once attached to the RH MLG strut assembly.

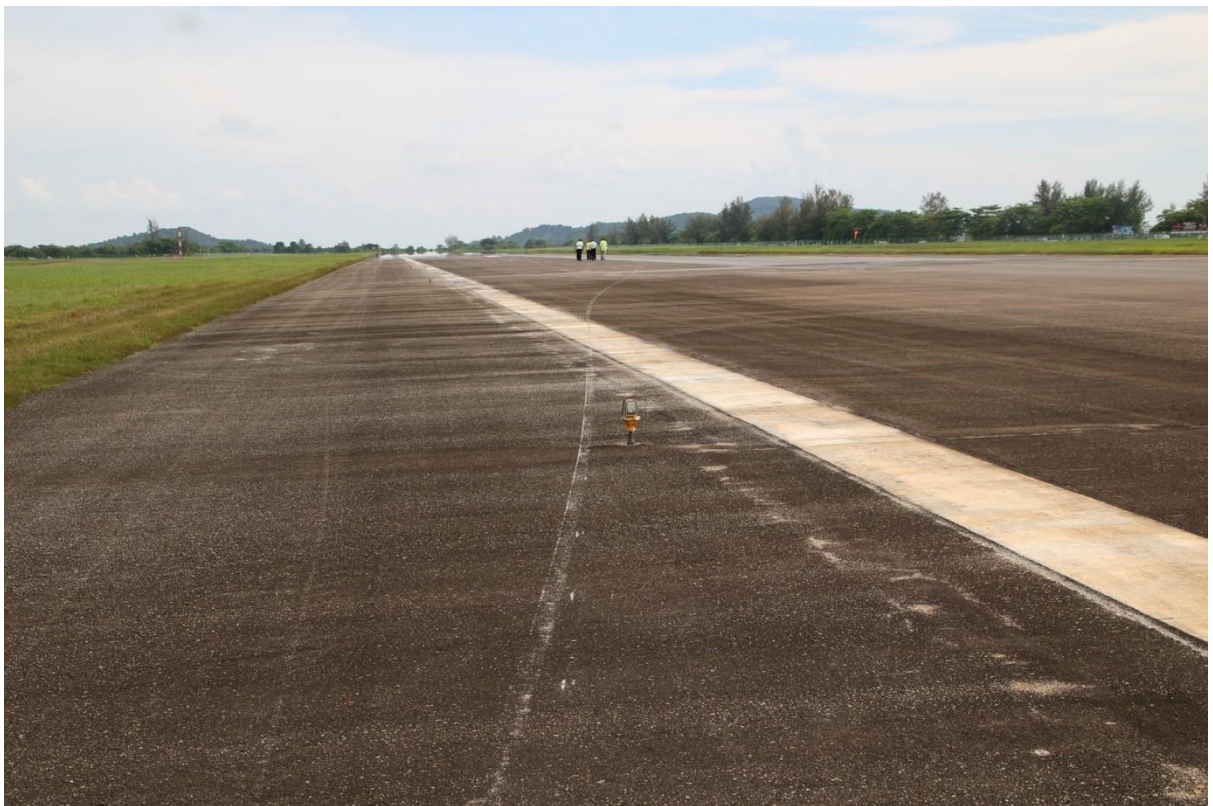
IMAGE 4

There were no other damages to report of other than scratch marks on the runway (**Appendix B**, Image 4).
