AIRCRAFT ACCIDENT FINAL REPORT
A 05/22P
Air Accidents Investigation Bureau (AAIB)
Ministry of Transport Malaysia

Eurocopter EC120B Registration N409HH
in Hutan Simpan Chikus, Bidor, Perak, Malaysia
on the 11 September 2022

ACCIDENT REPORT NO.: A 05/22

OPERATOR : FLYSTAR GLOBAL SDN BHD
AIRCRAFT TYPE : EUROCOPTER EC120B
NATIONALITY OF AIRCRAFT : UNITED STATES OF AMERICA
REGISTRATION : N409HH
**PLACE OF OCCURRENCE : HUTAN SIMPAN CHIKUS, BIDOR,
PERAK, MALAYSIA
(4° 06' 13.8'' N, 101° 12' 45.1'' E)**
DATE AND TIME : 11 SEPTEMBER 2022 AT 1217 LT

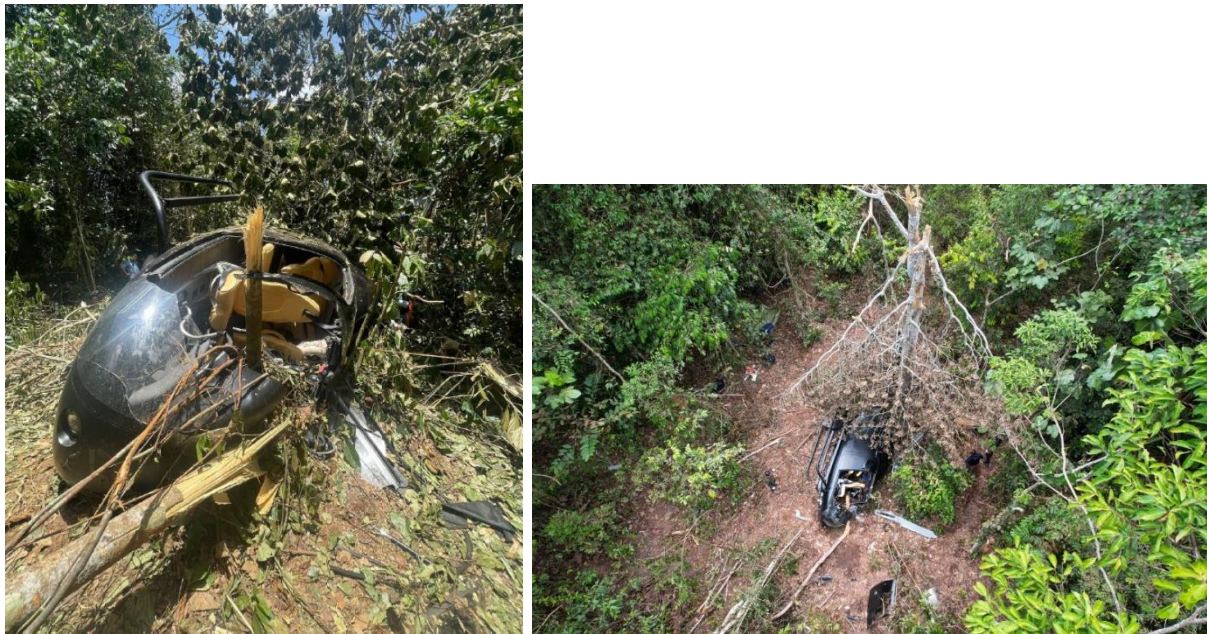
Figure 7: N409HH at the Crash Site

The aircraft ended its trajectory on a tree (stopped by the tree) on which multiple main rotor blade impacts were observed, before falling on the ground lying on its left-hand side. Information of the detailed examination of the wreckage is provided in **Appendices A** and **B**.

As can be seen from the images of damage to the aircraft on-site, N409HH was extensively damaged by its impact on the trees. All the main rotor blades separated from the main rotor hub, the fenestron broke off and the cabin was totally destroyed by a tree trunk which penetrated the passenger cabin.

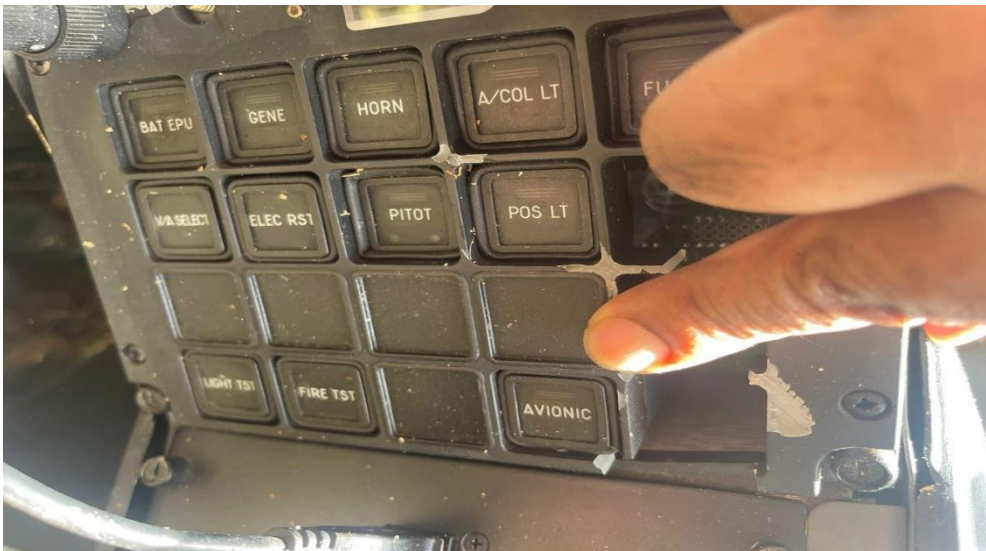
Figure 8:

Unfortunately, this was the case on the ill-fated day. The AVIONIC push button looked like it was depressed (Figure 8) because the faceplate of the console panel had detached slightly away from the console. However, the push button was not depressed, as examination by Airbus Helicopters found that the push button AVIONIC

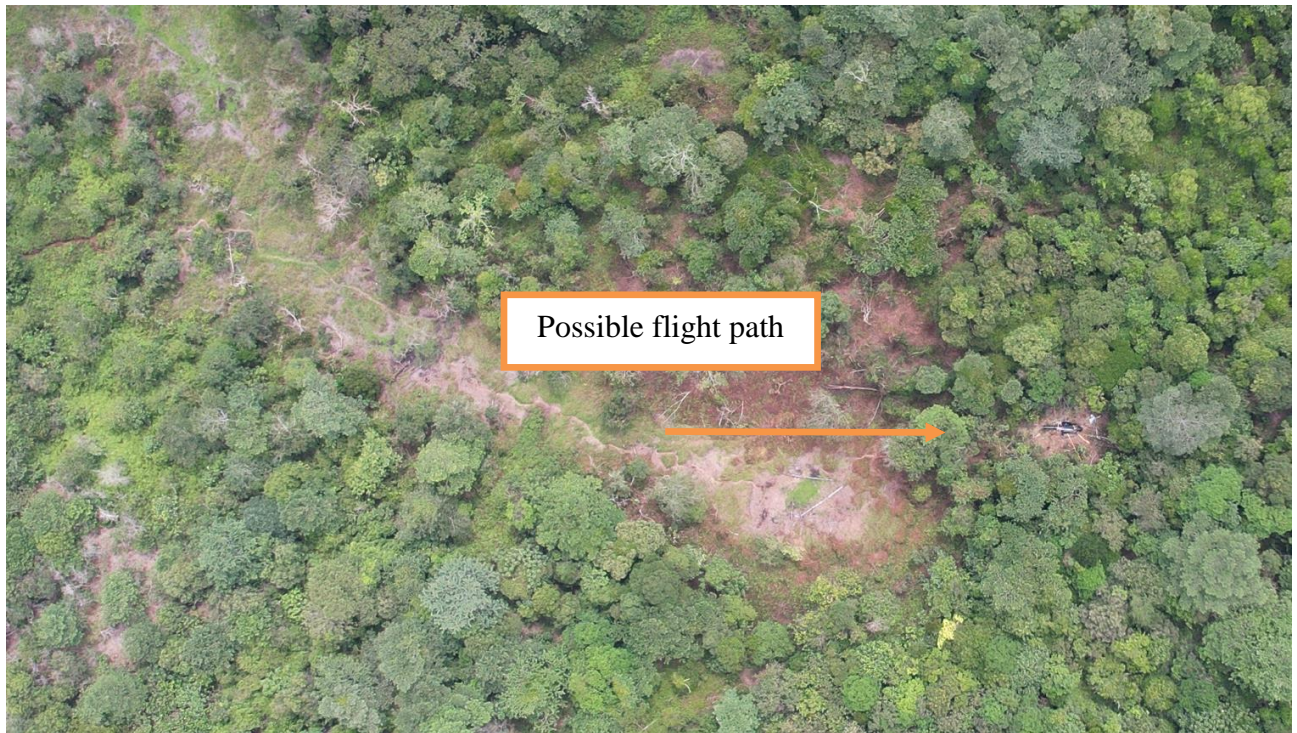
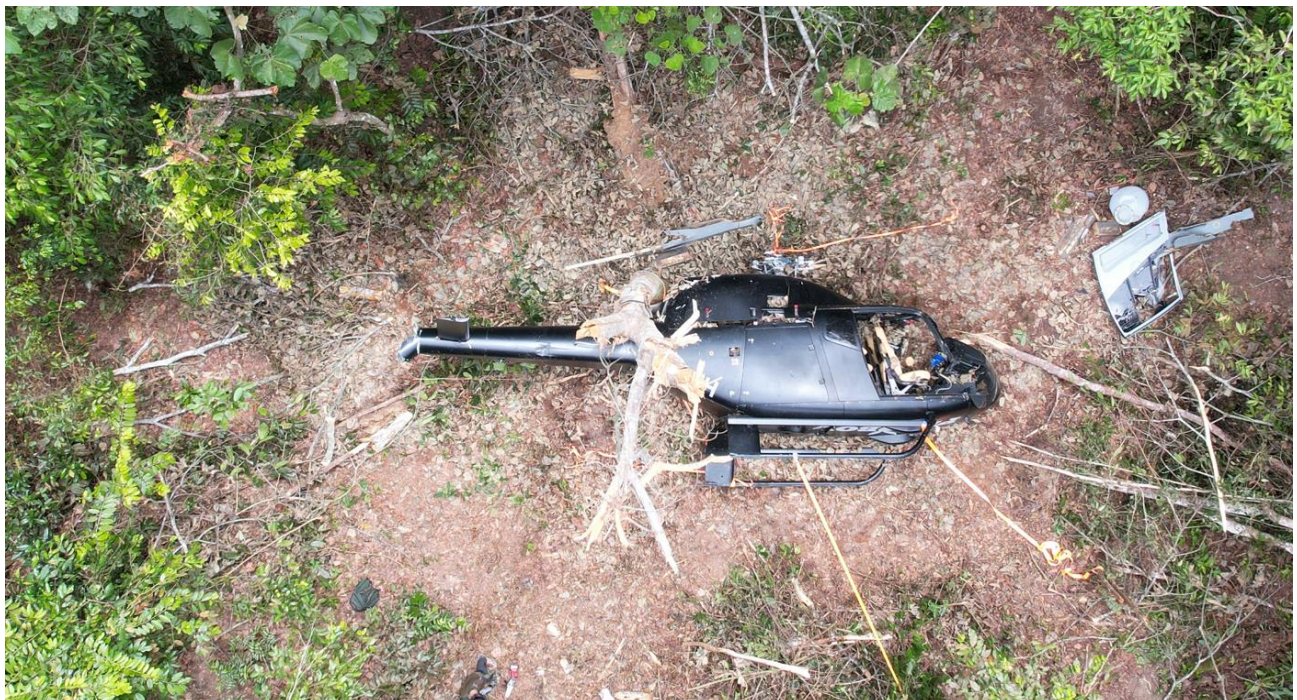
The aircraft was found in the canopy (forest) lying on its left hand side.

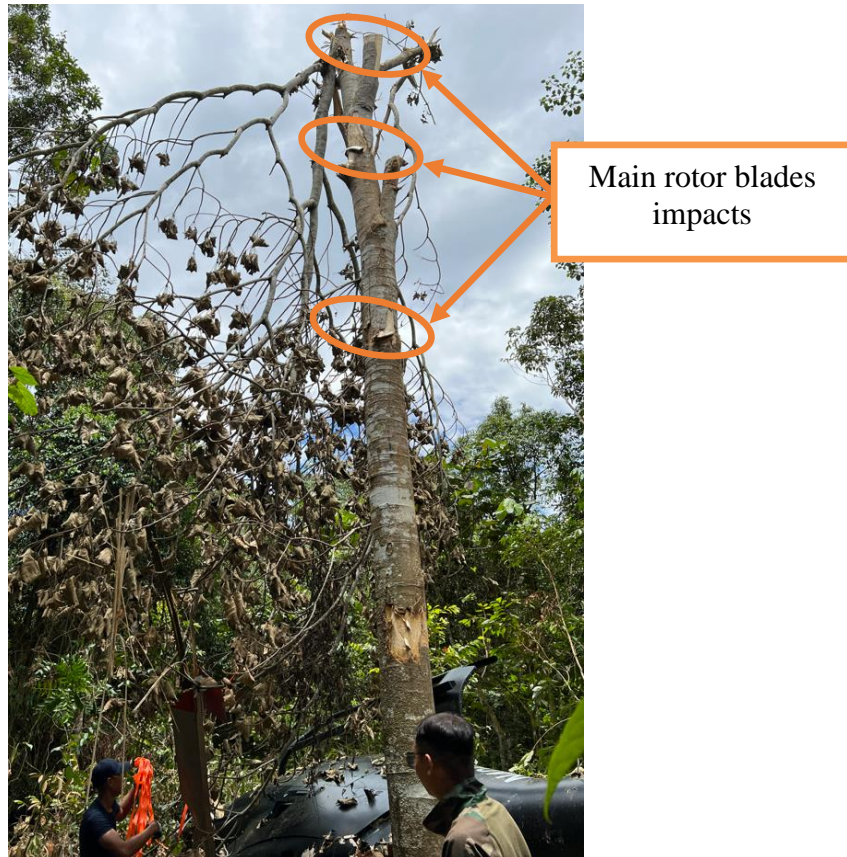
The aircraft ended his trajectory on a tree (stopped by the tree) on which multiple main rotor blade impacts were observed.

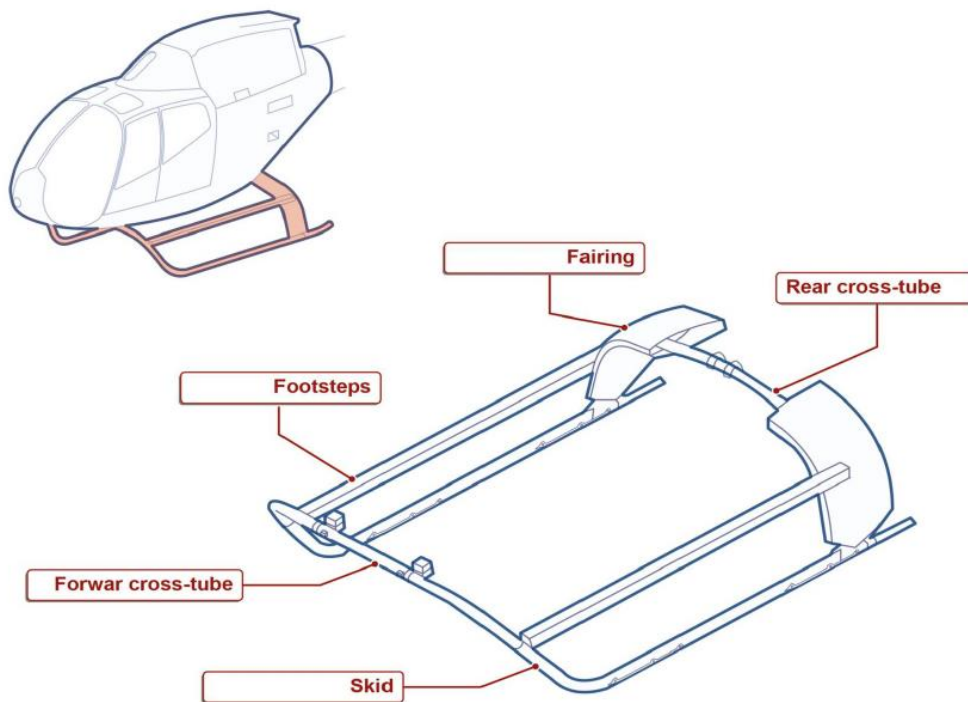
3.2. Landing skids:

The landing skids were in good condition, with no visual deformation observed.

Two contact marks were observed: one on the left hand skid and one on the left hand footstep (see explanation in the next chapter).

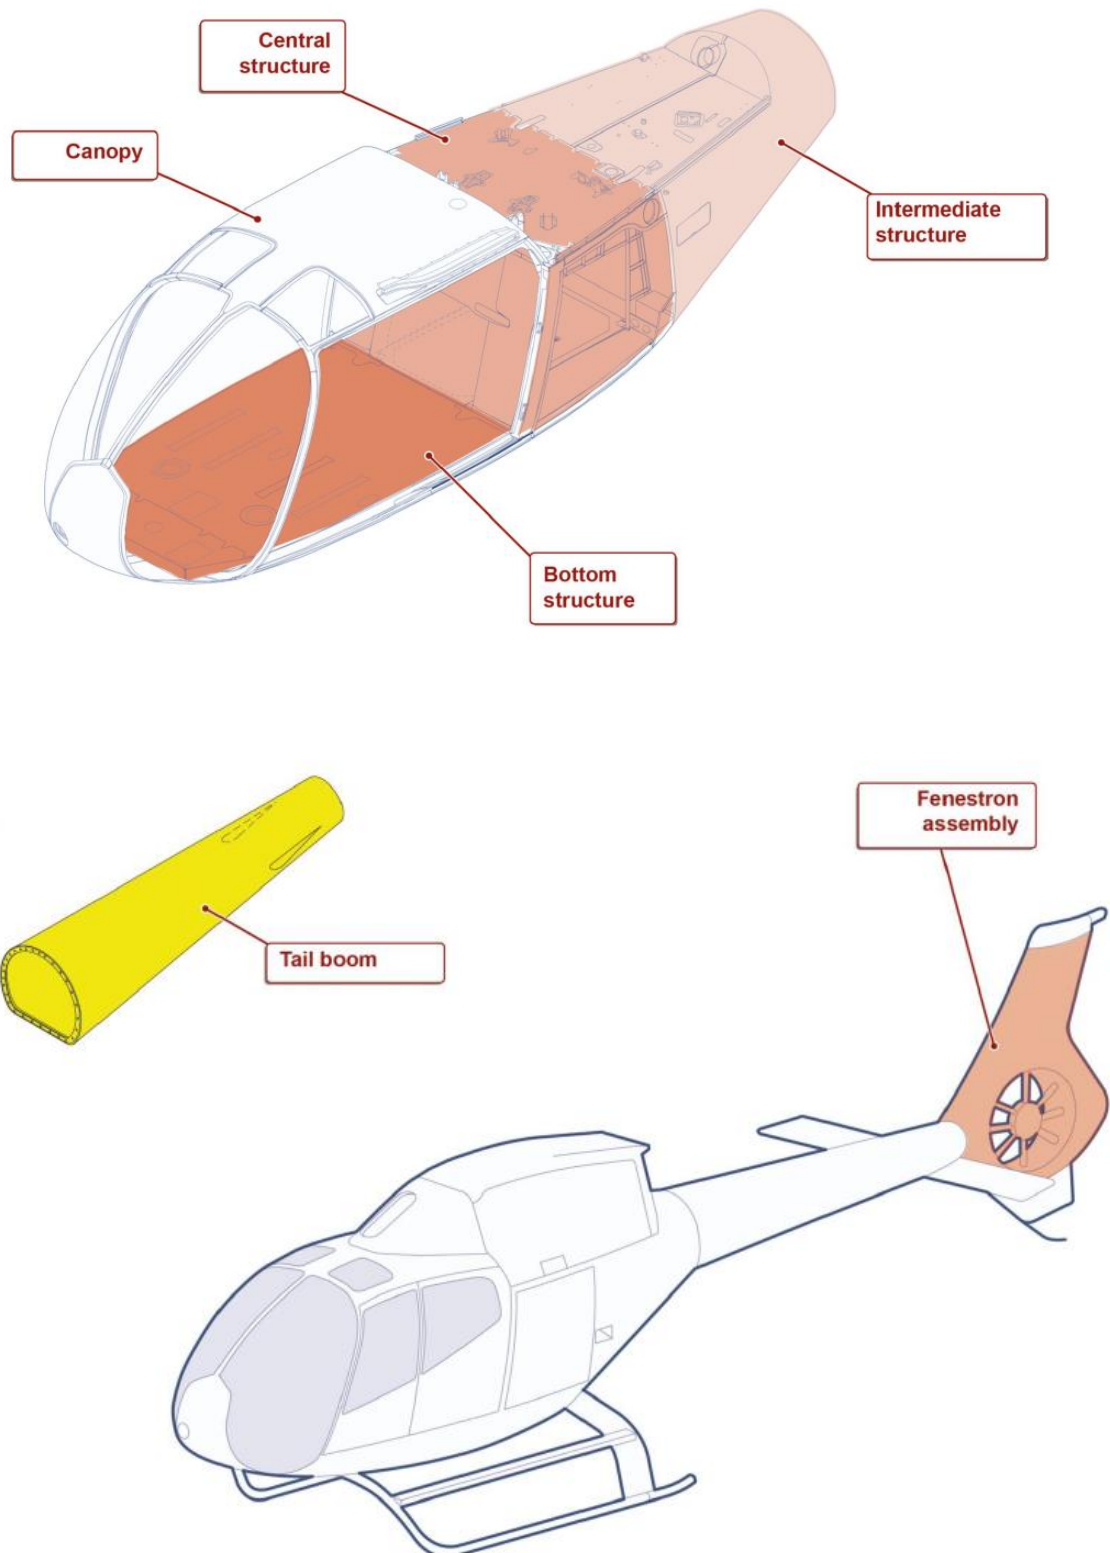
3.3. Fuselage:

The helicopter canopy was completely destroyed: the windshield and its junction frames were broken in pieces, the two front doors were separated from the airframe as a result of the crash sequence. The central structure exhibited deformations on its left hand side, must probably as a result of the tree that stopped the aircraft at the very end of its trajectory.

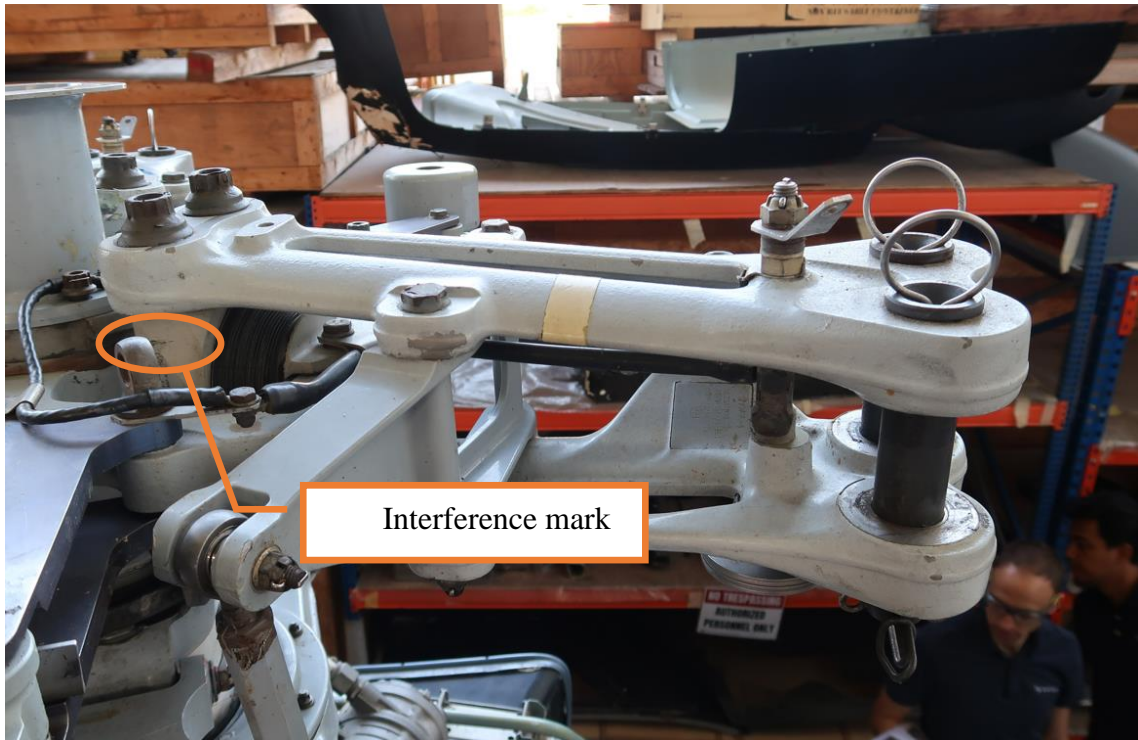
Droop restrainer ring:

The droop restrainer ring and the main rotor blades lower stops exhibited contact marks. The droop restrainer was moved down against the support of the mobile scissor, leading to its displacement.

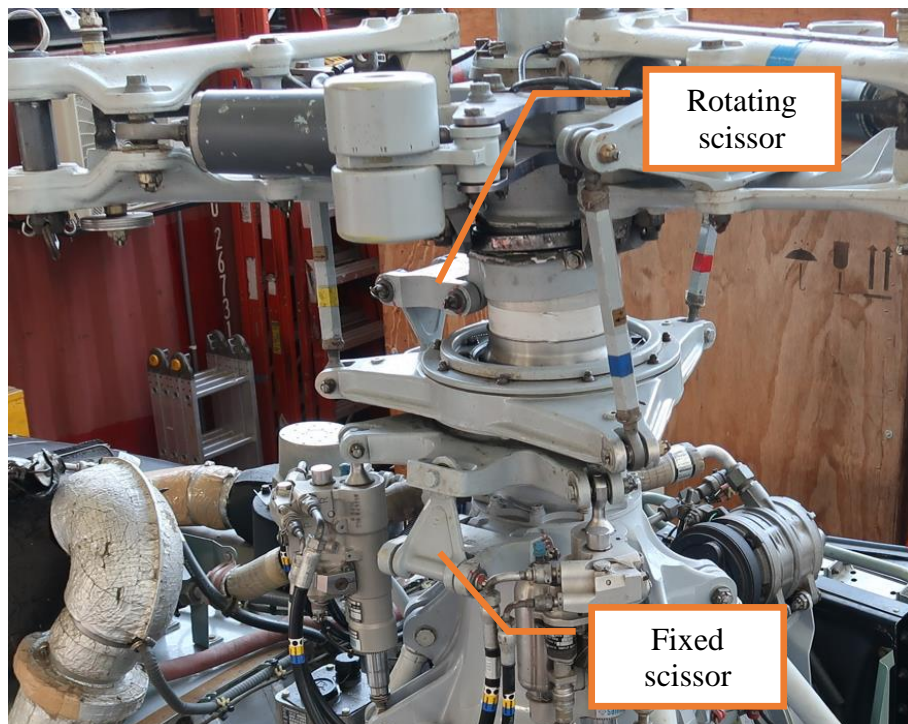
The rotating scissor exhibited slight damage and was displaced down at its junction with the mast. The fixed scissor didn't exhibit visible damage, was still correctly connected to the fixed swashplate and the conical housing.

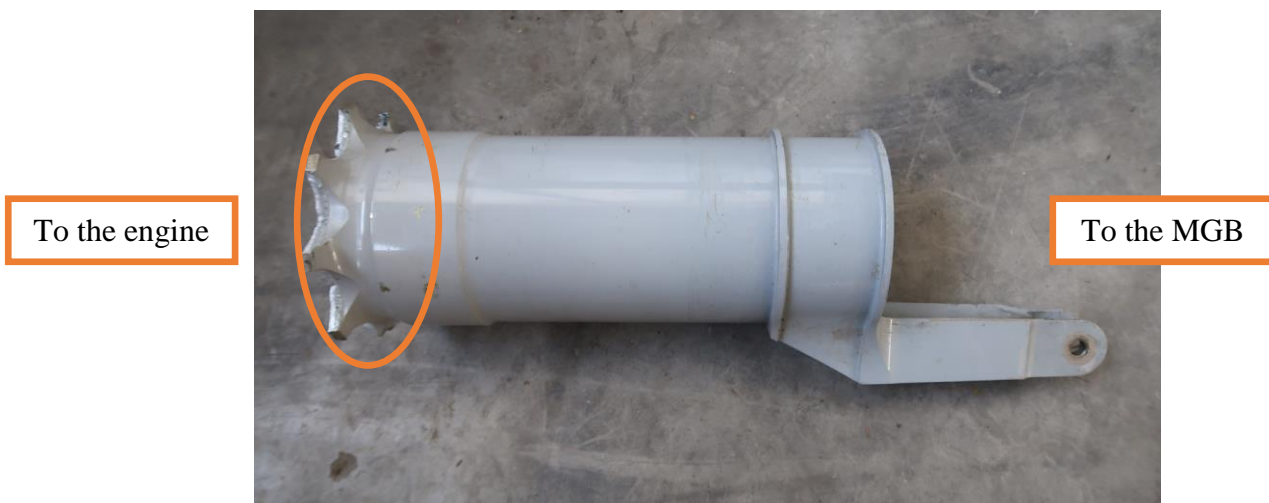
The coupling tube exhibited overload rupture at its junction with the engine, as a result of engine lateral displacement on the right hand side during the crash sequence.

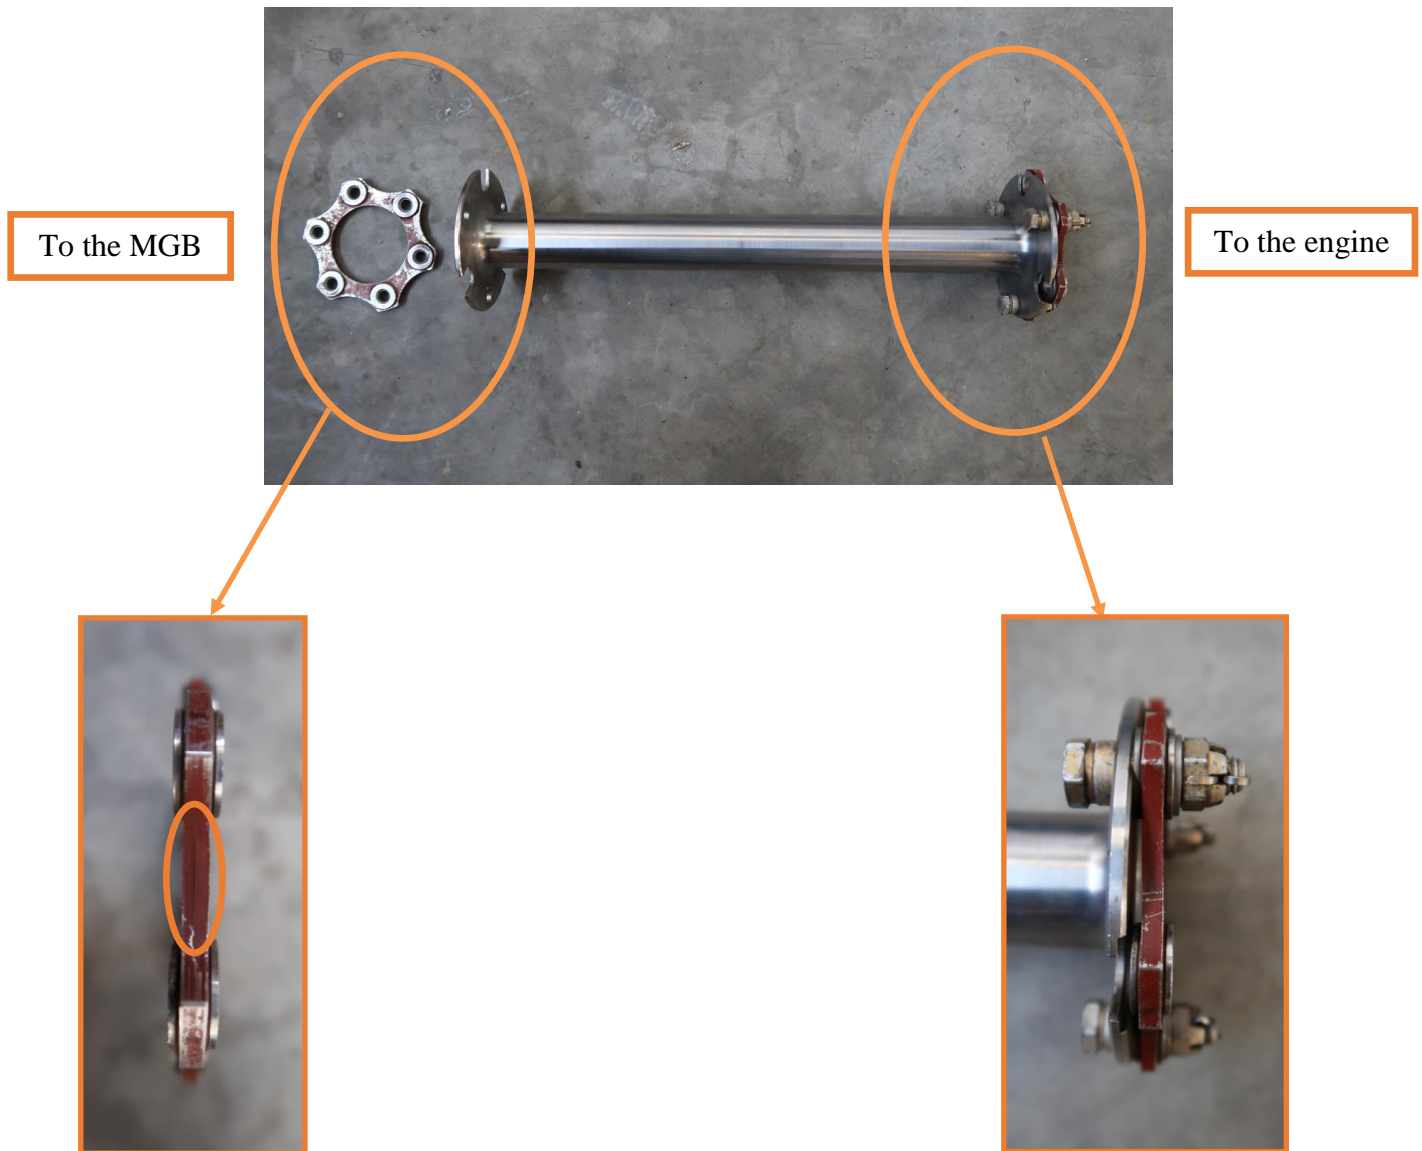
Except a slight buckling on both flexible couplings located at both transmission drive shaft extremities, no visible damage was observed on the engine to MGB drive shaft assembly. This buckling is most probably the result of a torque variation load and displacement applied to the flexible coupling during the crash sequence.

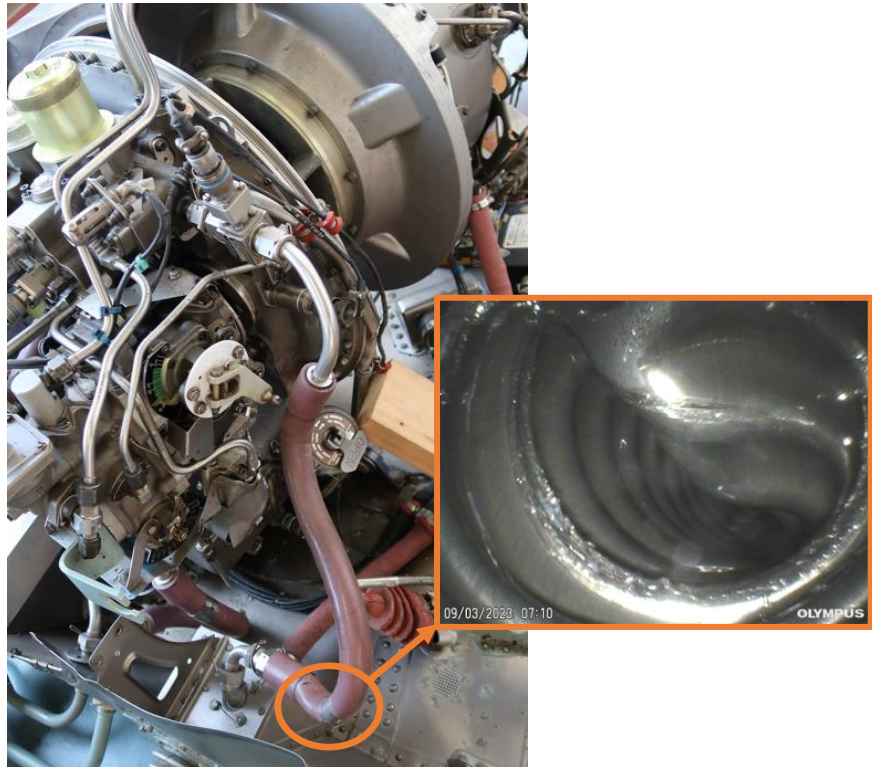
A boroscope inspection was performed, the pinch of the line has consequently reduced its internal section.

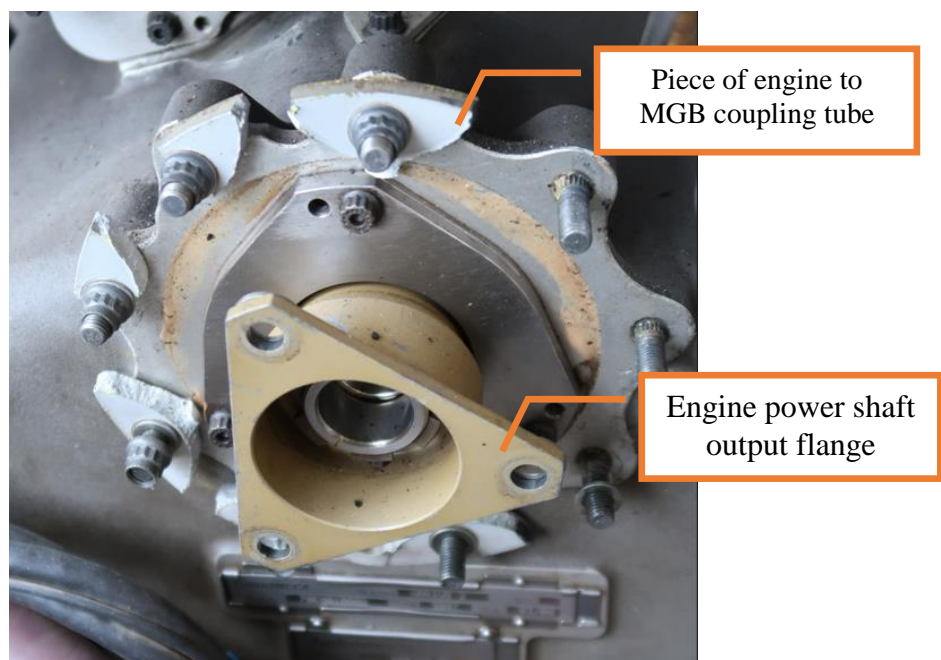
Remains of the engine to MGB coupling tube were still attached to the engine casing.

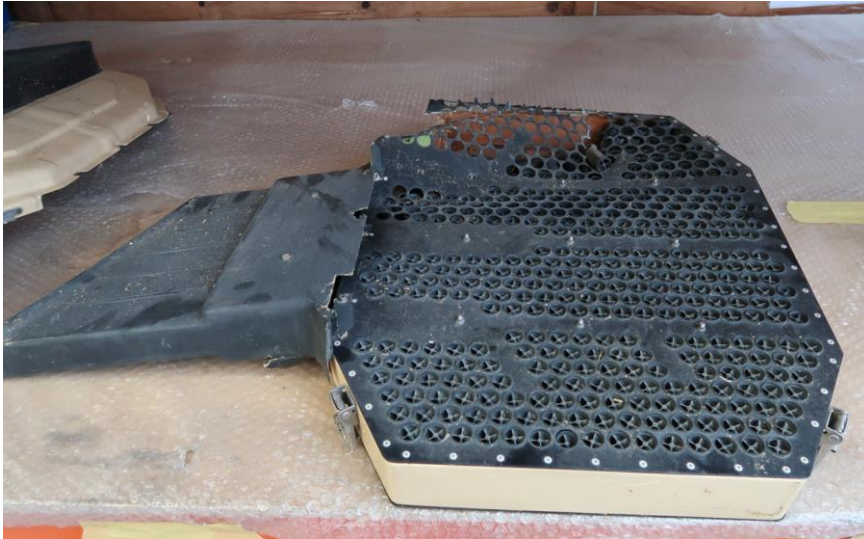
The aircraft was equipped with anti-sand filter installation that was partially damaged during the crash sequence. Some vortex tubes were missing.

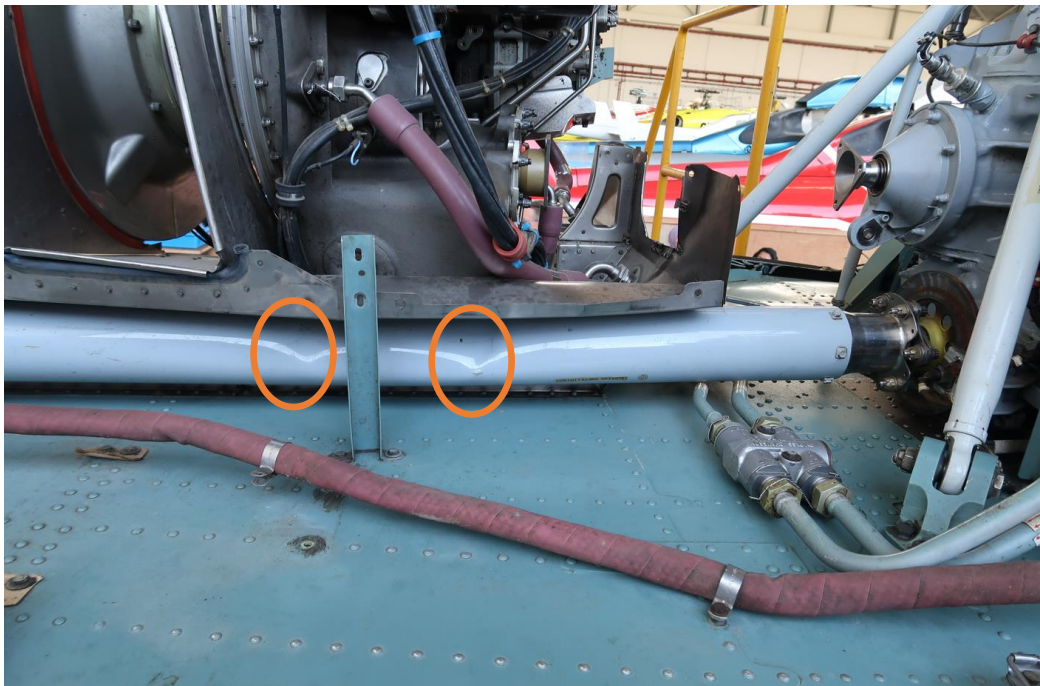
The two indent marks were most probably done at the very end of the crash sequence, when aircraft has hit the ground on its left hand side.

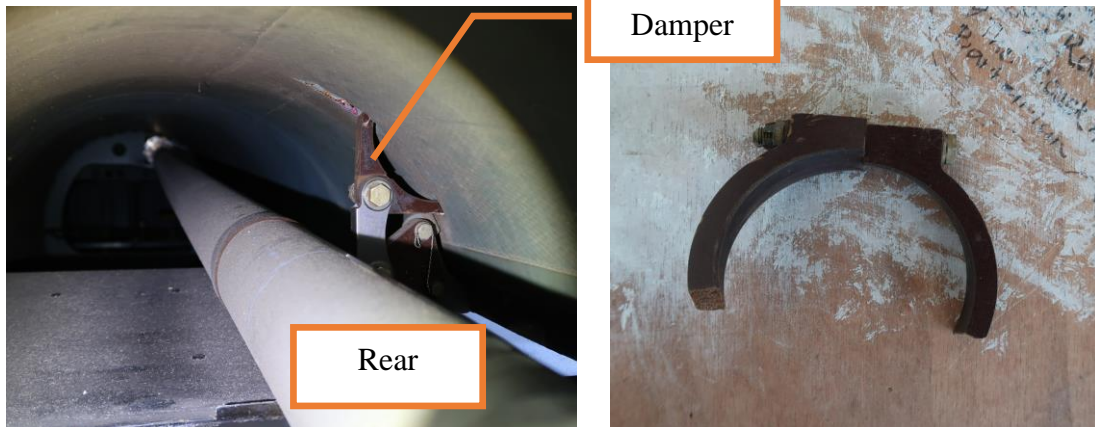
The damper installed on the rear drive shaft was broken in two pieces. One of them was found trapped into the tail boom honeycomb.

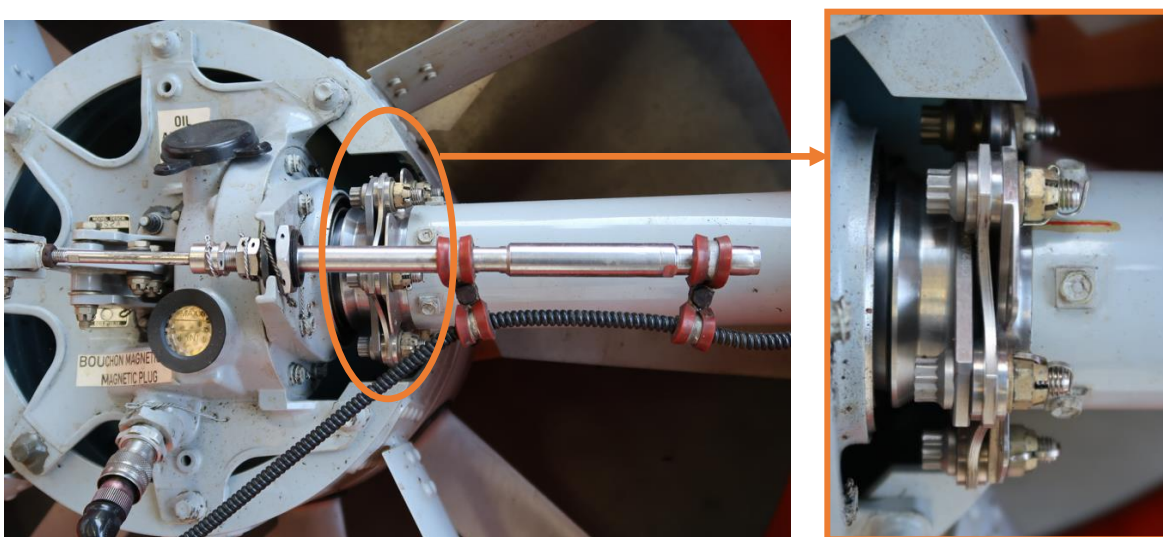
The flexible coupling located at the junction between the rear drive shaft and the TGB input flange exhibited bugling consistent with relative axial displacement or misalignment of the two conjugate flanges.

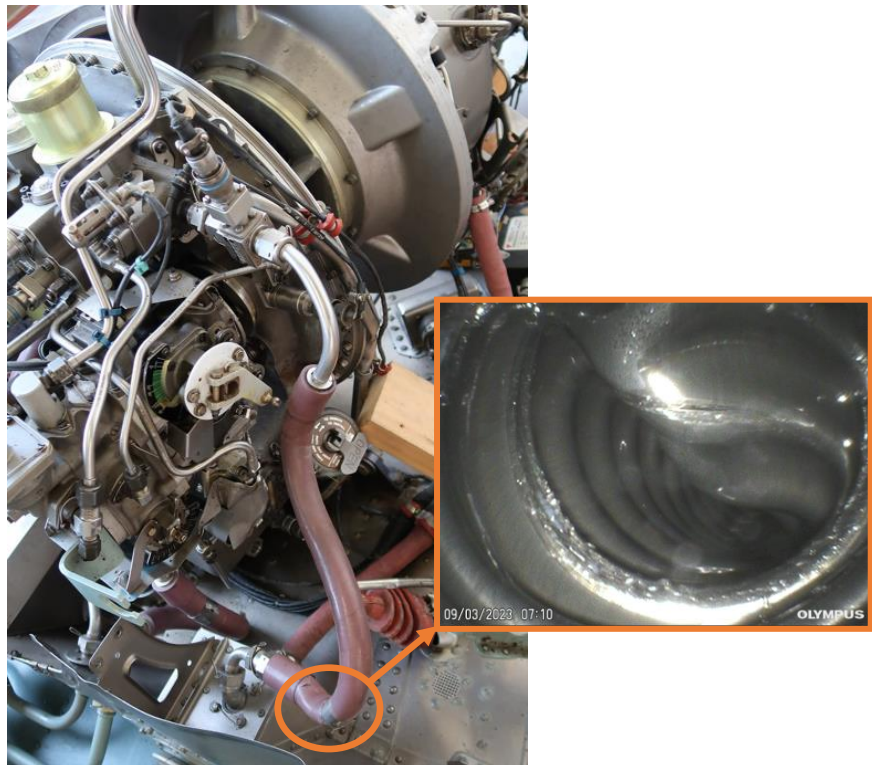
A boroscope inspection of the fuel supply hose was performed, the pinch of the line has significantly reduced its internal section.

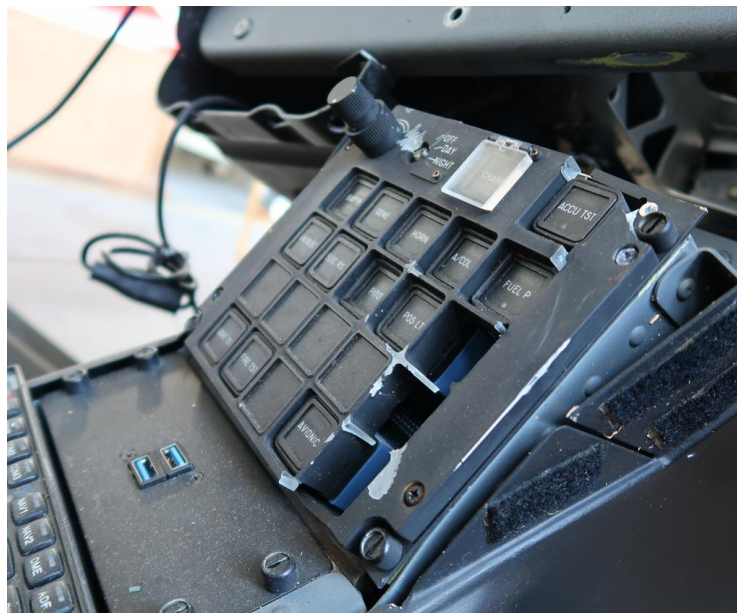
- The Fuel P button for booster pump activation is supposed to be on off position for flight (only used for engine starting purpose).
- The push button Avionic was not activated, leading to the de-energizing of the attitude indicator.

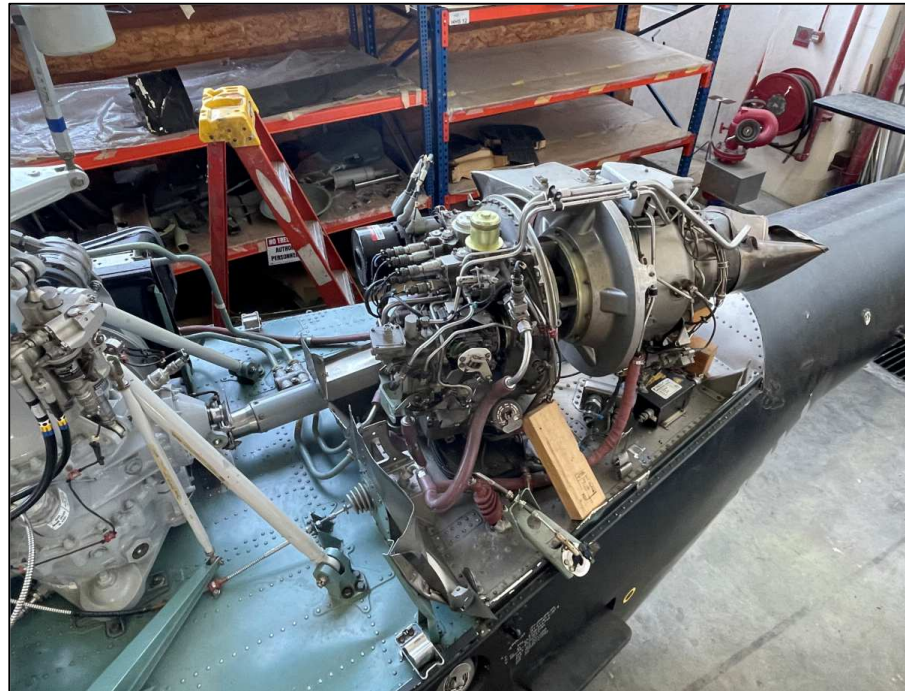
The general inspection mainly revealed significant damage on both engine sides (pipes, exhaust, firewalls, mountings) which was the sign of the strength of the impact.

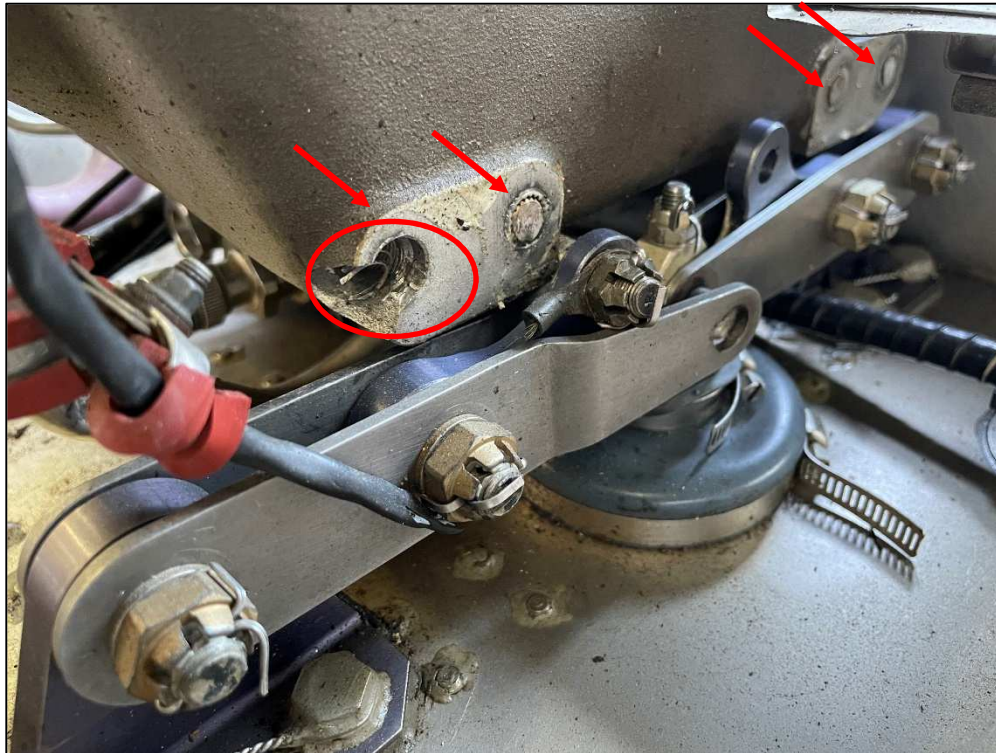
The engine front and rear mountings were totally broken, both flanges were missing.
Casing rear left mounting was damaged (torn off), creating a hole into the casing and into the oil tank, which emptied.
