AIRCRAFT SERIOUS INCIDENT FINAL REPORT

SI 06/22P

Piper PA28-181 Archer III, Registration 9M-SKF

on 14 October 2022

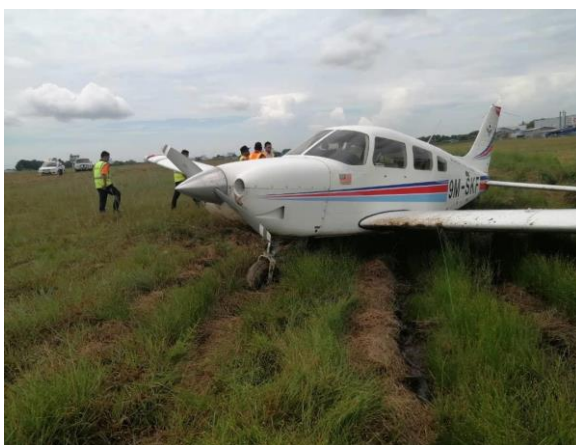
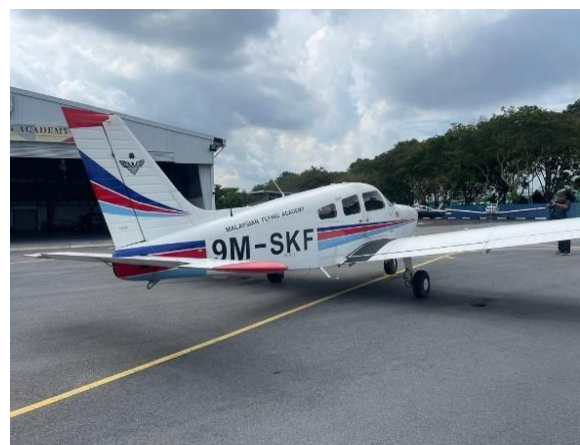
Figure 2: Photos after the incident and after Inspection/Test

Photo after the incident

Photo after Inspection/Test

The Maintenance Organisation completed a physical damage assessment on the aircraft. Detailed inspections were carried out on fuselage, port and starboard wing undercarriage, flight controls, vertical fin, stabilator, cowlings, engine, propeller, and avionics system and found satisfactory. The aircraft had been assessed as having no damage and fit to fly. The Post Accident Damage Assessment Report can be viewed in the Maintenance Organisation's file reference MFA/SKF/18864 dated 24 November 2022.

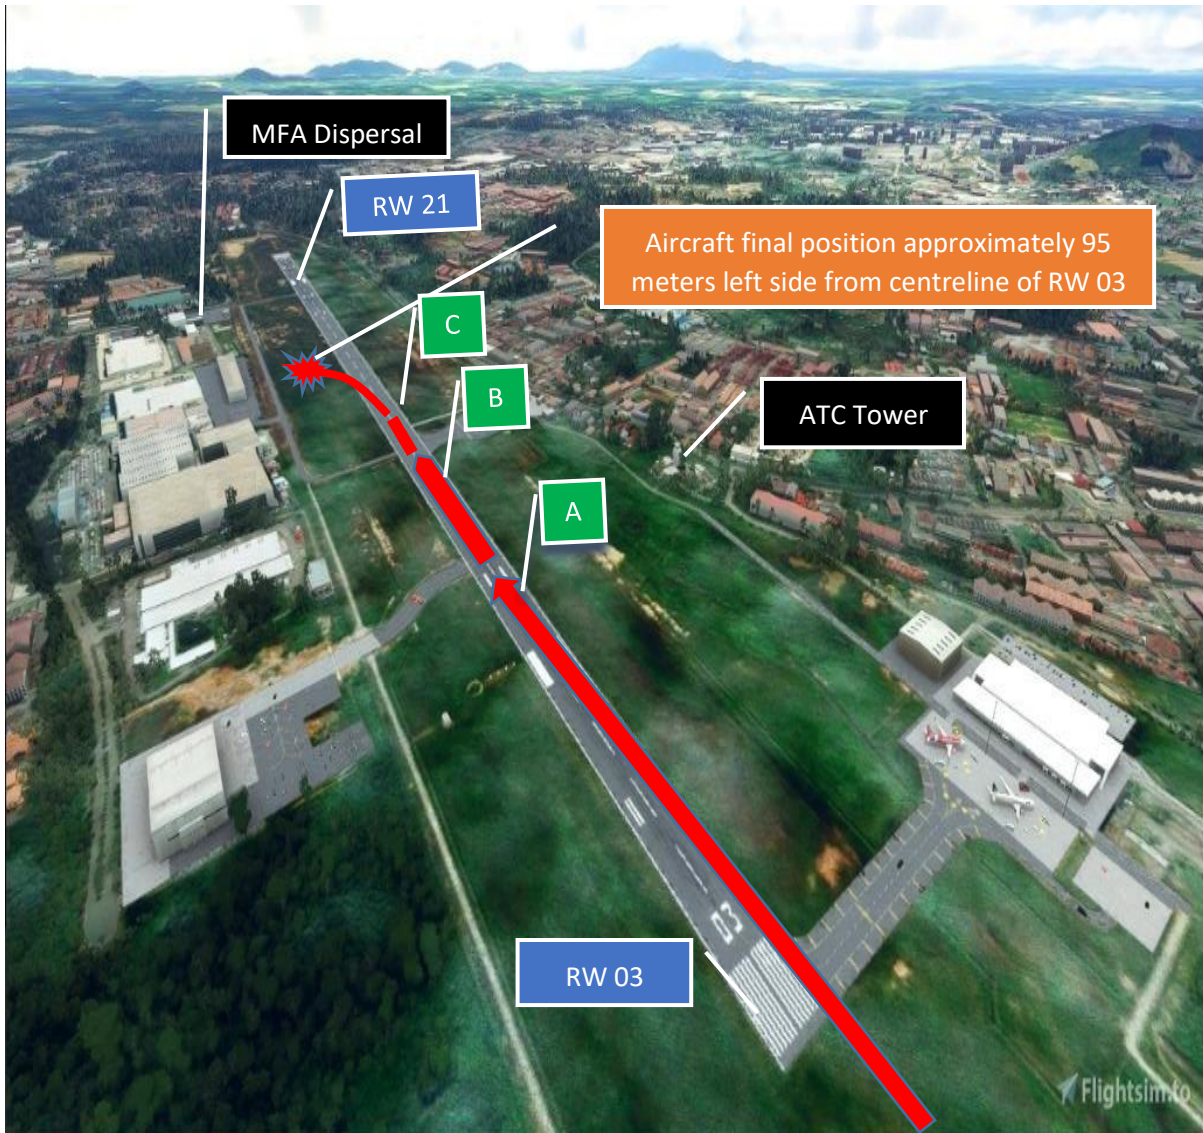
Figure 8: Landing path and roll for take-off and final position of aircraft
(Diagram not to scale)

The aircraft touched down passed the 1000-foot marker Rwy 03 (**Point A**). The aircraft continue to roll on the centreline and the CP then applied take-off power (full power) and began rolling down the runway for take-off. At **point B** the aircraft had veered to the left due to the aircraft’s tendency to yaw to the left.

The CP tried to keep the aircraft on the centreline with the rudder. The CP did not anticipate enough right rudder and panicked. At **point C**, the CP applied the brakes, but due to maximum power, the aircraft veered to the left into the grass area. Skid marks were observed on the runway and grass area till the stopping point. The aircraft came to a rest about 95m from the runway centreline with the aircraft nose pointing to the wind sock Rwy 21.

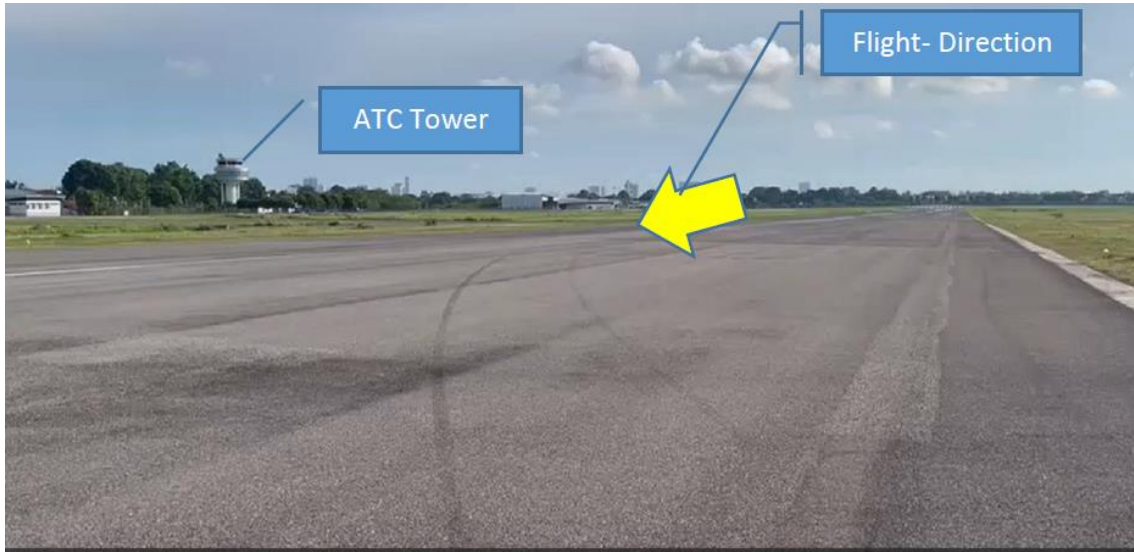
Figure 11: Aircraft tire track marks were observed on the runway at the landing area or exiting the runway towards the crash site.

It is analysed that the CP had initiated a rolling take off but the execution of the rolling take-off did not comply with the **Rolling Take Off Procedure** stated in the SOP. The CP did not carry out actions as per SOP. It started when the CP was shocked and applied the wrong input of control. The result is the aircraft continues to veer to the left from the centre of the runway as shown in **Figure 11**. It shows that the CP did not apply the correct technique as taught by the instructor.

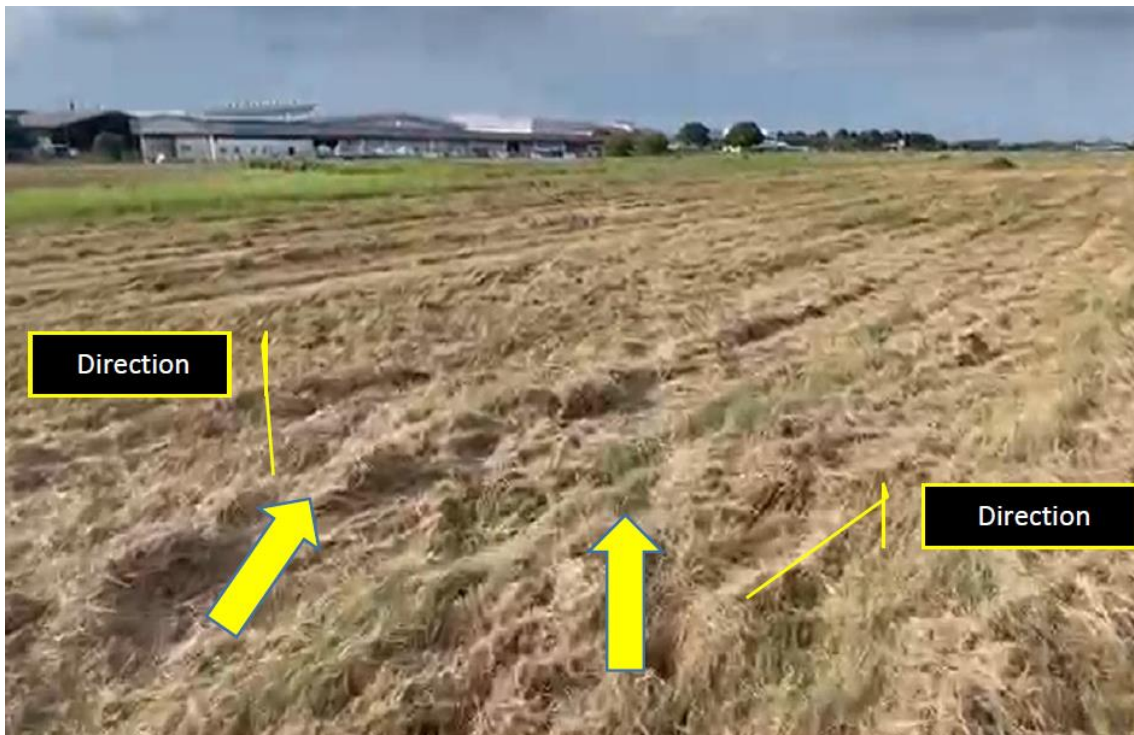
Figure 12: Aircraft tire track marks were observed exiting the runway towards the crash site.

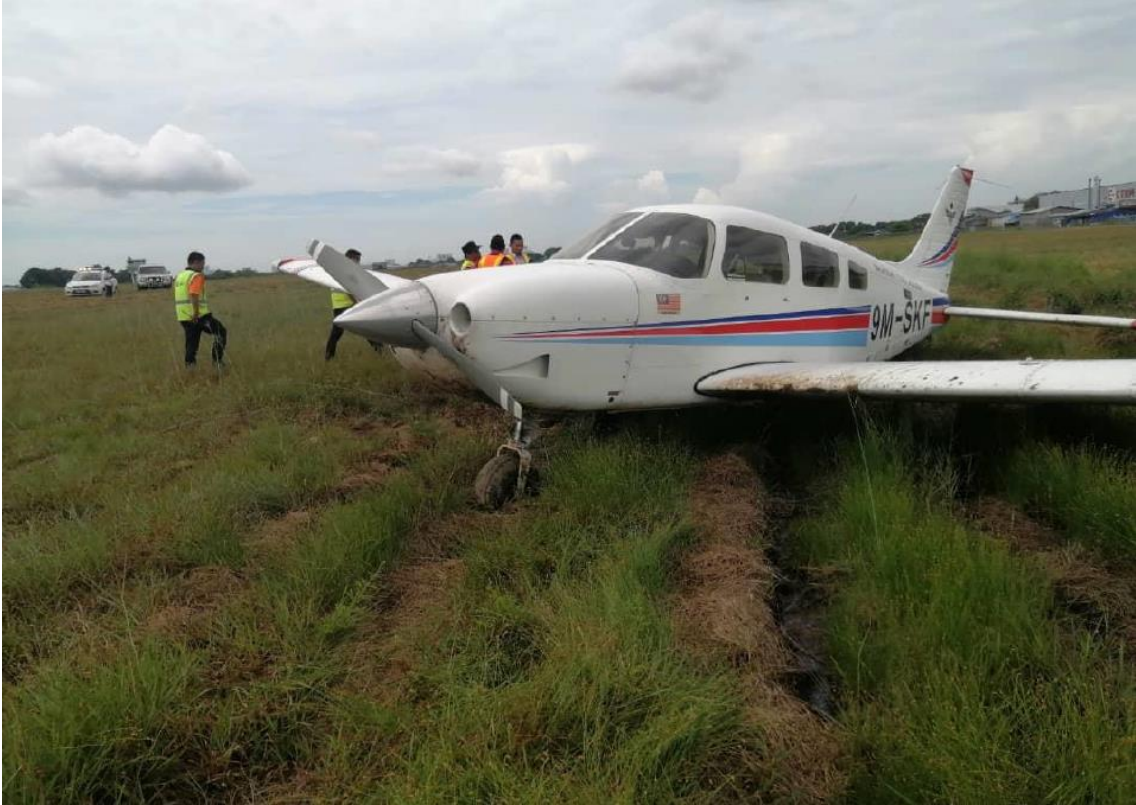
Figure 13: Aircraft final stop position

The aircraft stopped 95m from the runway's centre (Figures 13 and 14). The CP just shut down the aircraft after it comes to a stop. No Aborted/Distress or Emergency call was made by CP.

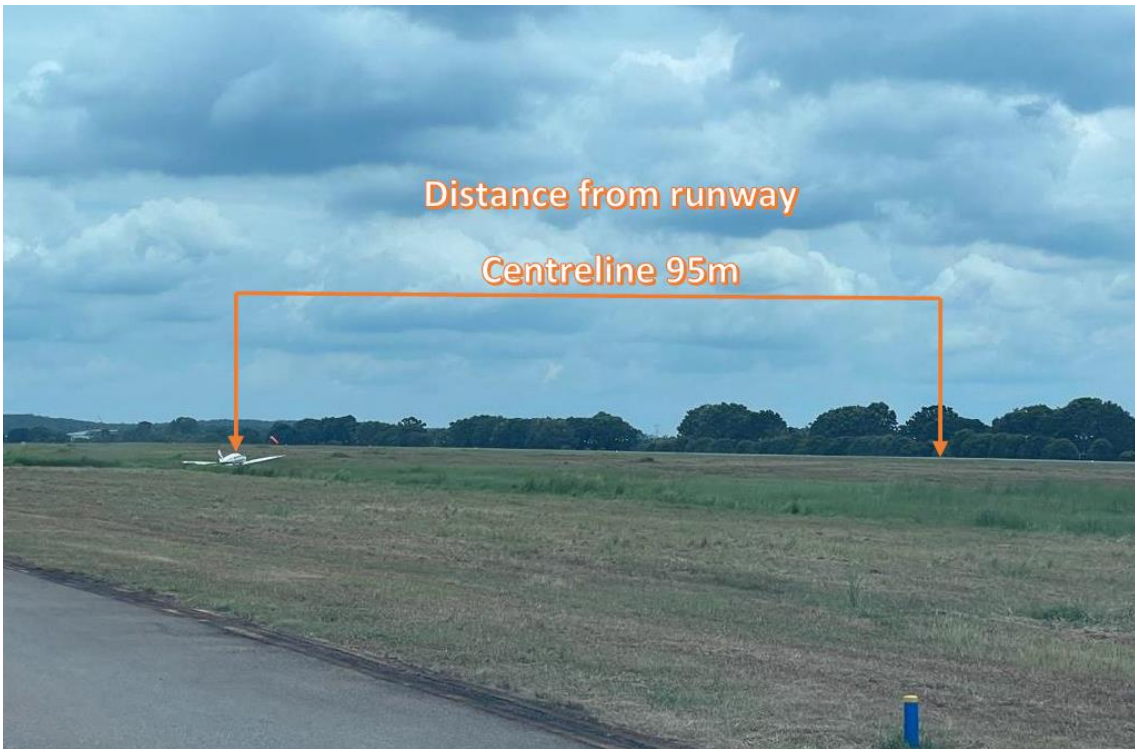
Figure 14: Aircraft final stop position 95m from runway centreline
