AIRCRAFT ACCIDENT FINAL REPORT
SI 07/22P
Air Accident Investigation Bureau (AAIB)
Ministry of Transport Malaysia

Textron Aviation 172S, Registration 9M-HOT
at Sultan Azlan Shah Airport, Ipoh, Perak
on the 25 October 2022

FINAL REPORT SI 07/22P

ACCIDENT REPORT NO.:SI 07/22

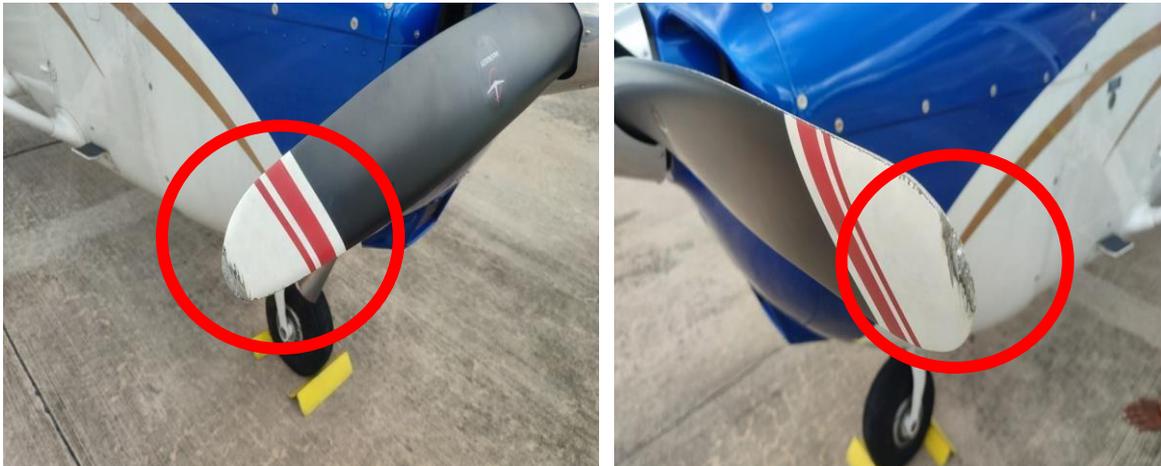
Figure 2: All Propeller blades bent inwards at the blade tips.

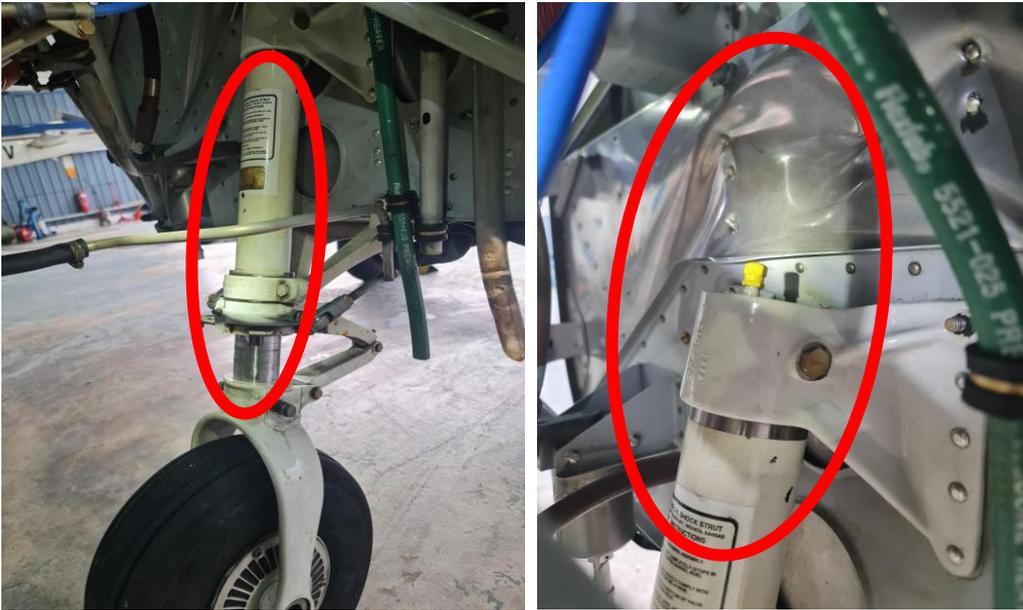
Figure 3: Nose landing gear. Damaged on riveted joints.

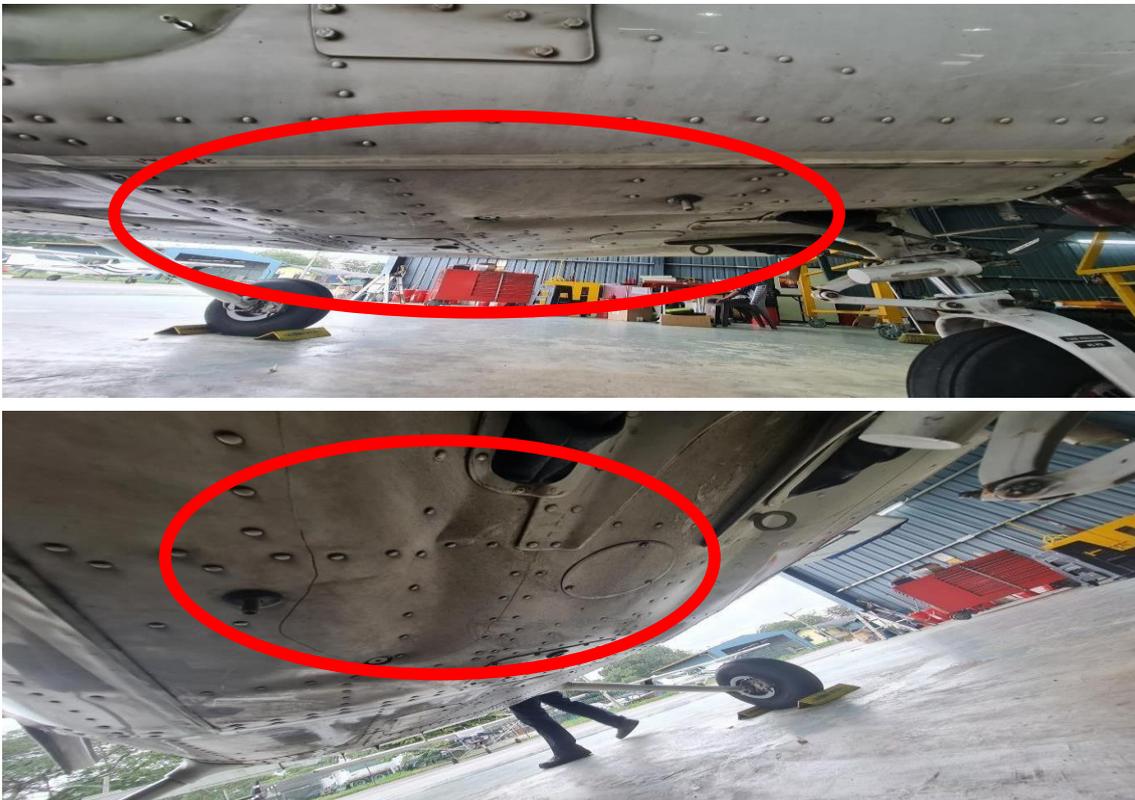
Figure 4: Below fuselage. Found deep scratches.

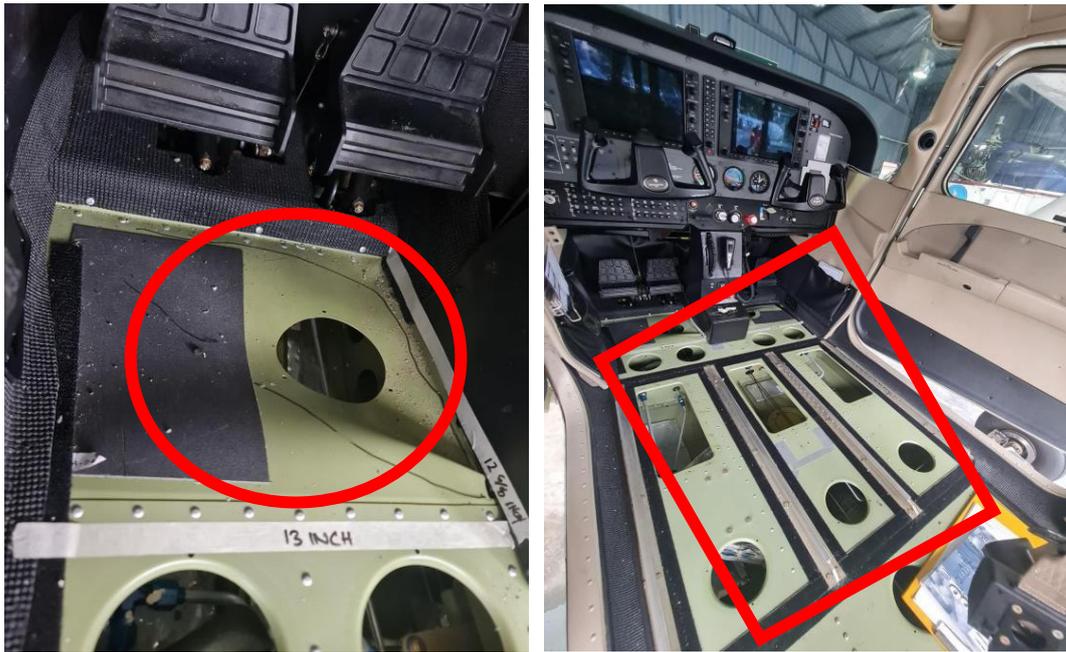
Figure 5: Forward Left and Right Floorboard Assembly found wrinkled and buckled.

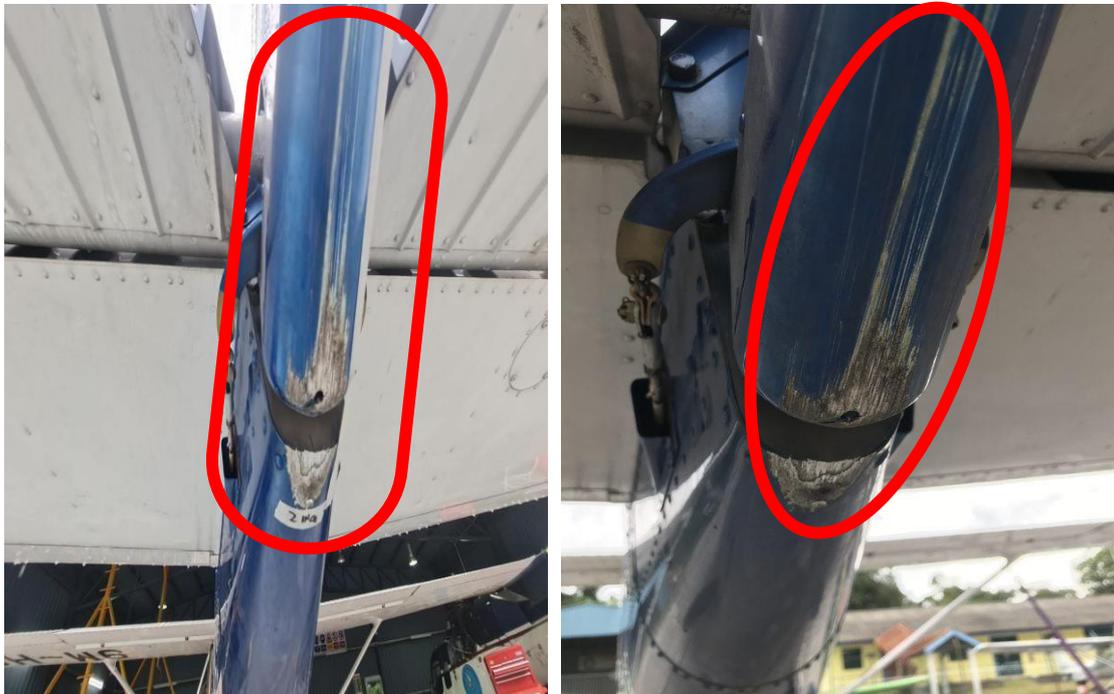
Figure 6: Rudder Lower tip found scratches

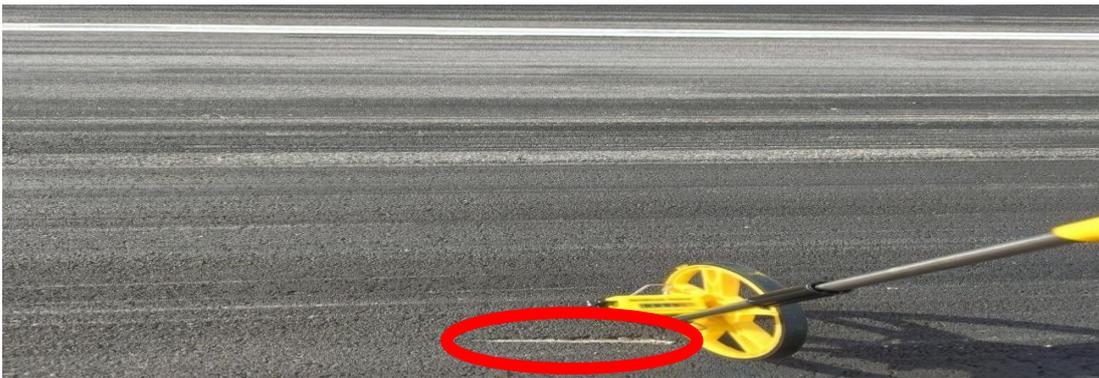
The AAIB Investigation team conducted the investigation on the runway and found 3 scratched markings on the runway. The scratched markings were from the impact of the rudder lower tip (figure 11) and the propeller (figure 12) during the hard landing and was confirmed by the TP during the interview.

Figure 11: Scratched marking from the rudder lower tip on the runway during the hard landing.

The first touchdown which was landing hard resulted the rudder's lower tip striking the runway (figure 11). On the second hard bounce landing, the ac ballooned toward the right of the runway centreline and resulted the propeller hitting the runway (figure 12). On the third bounce, the TP managed to control the ac by bringing it back to the runway centreline and land.

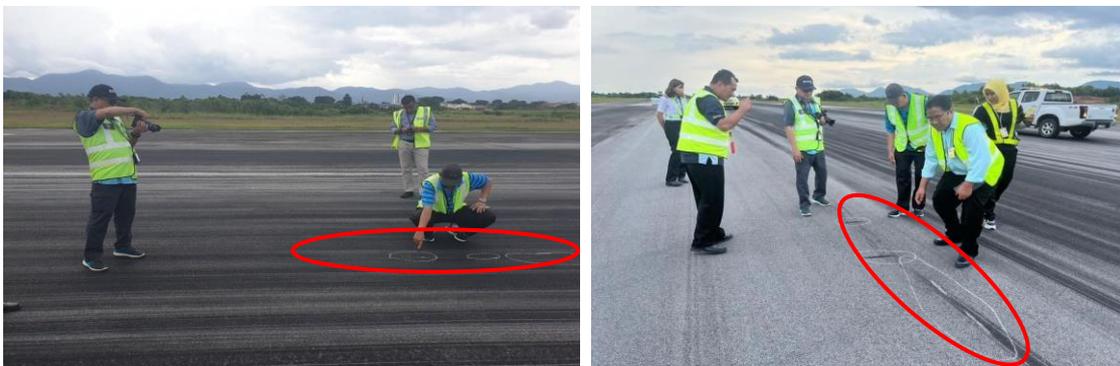
Figure 12: Scratched marking from the propeller on the runway during the hard landing.

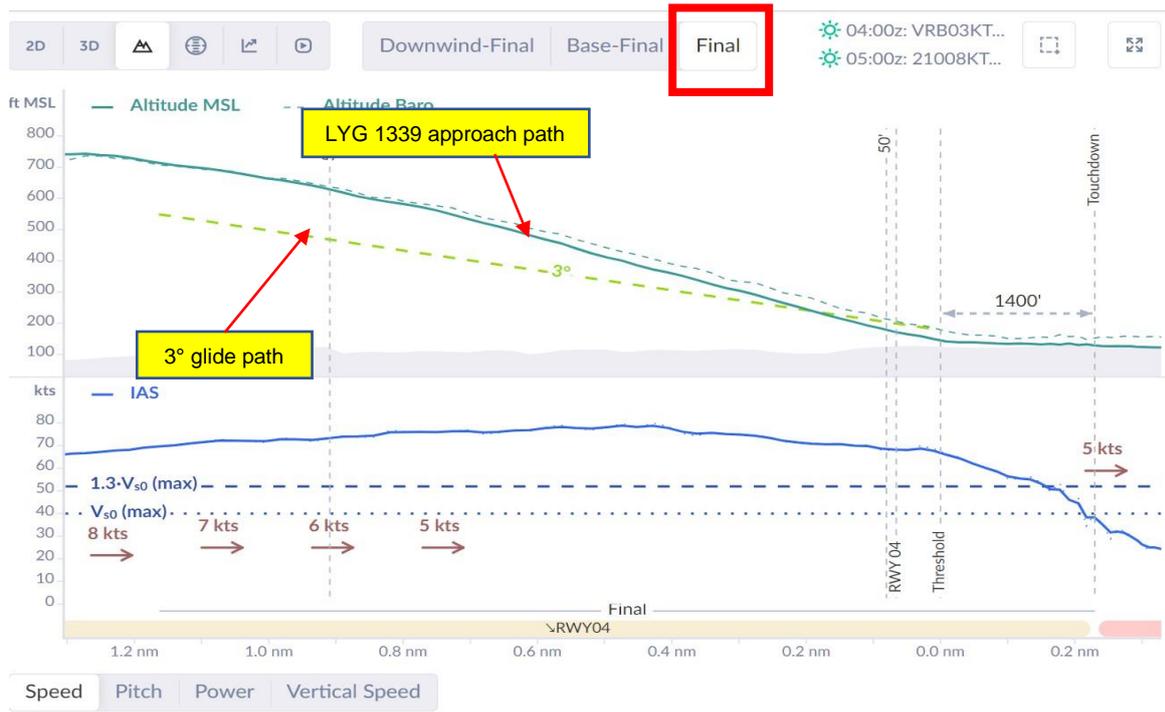
Figure 13 shows the profile of the ac on the final approach to land. The ac approach height was not stable (high) and not as per the 3° glide path. It shows the ac speed of 70-80 KIAS (Figure 14) on the final approach does not follow the C172 SOP Performance Landing Procedure (Figure 15) which states that the final approach technique is achieved not below 65 knots aiming to achieve a touchdown speed of 50 knots. Due to high-speed descent after adjusting the pitch from a high approach, the TP was unable to control the ac to land smoothly. TP's flaring of the ac at 29 ft which the flaring height between 10-15 ft. Due to the high sink rate and the TP applying too much back pressure while flaring the ac, it resulted a hard bounced landing and the ac ballooned on the runway. The TP should initiate a go-around as per LLFA Student Study Guide paragraph 13.3.5 when the approach was seeming to be an unstabilised approach (Figure 16).

Figure 13: Data extracted from Garmin G 1000 shows the flight path of the aircraft during the final approach to land.

4.1.1 To publish instructions or circulars to all Trainee Pilots to execute a go-around procedure on the final if the approach is bad or not stable.

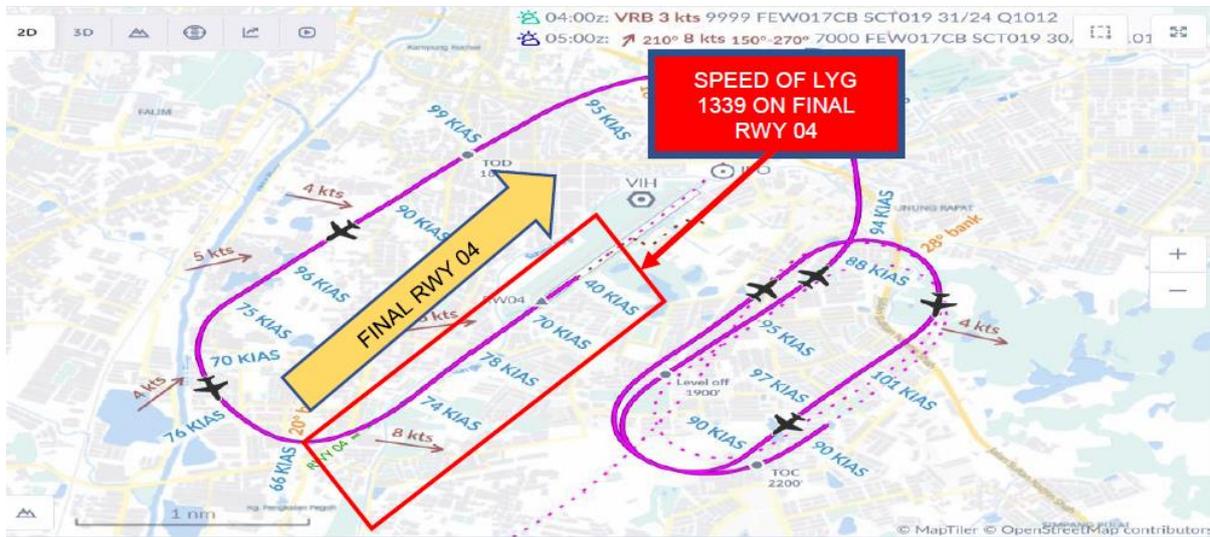
Figure 14: Data from Garmin G1000 shows the speed of the aircraft on the final to land
