AIRCRAFT SERIOUS INCIDENT FINAL REPORT

SI 09/22P

**Textron Aviation Cessna 172P, Registration 9M-GPB
at Kota Kinabalu International Airport, Sabah
on 14 December 2022**

Issued on 8 September 2023
MOT(S).600-5/4/87

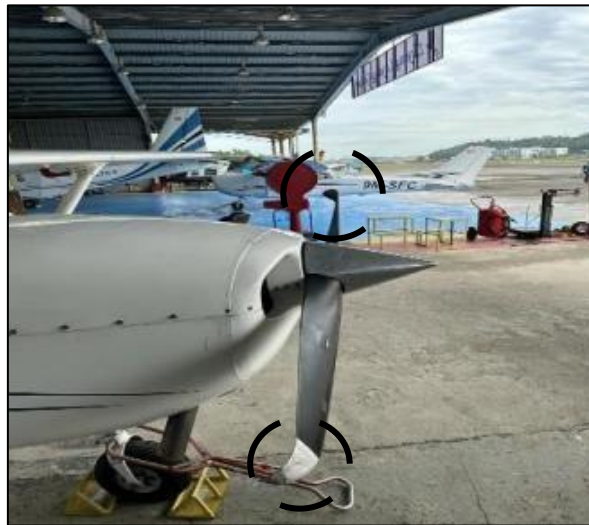
A general visual inspection was carried out to assess and identify the damage to the aircraft after the occurrence. Damage was found on both propeller tips, with scratches and bent on both sides white area of the propeller as can be seen in the pictures below. The initial damage assessment report is as per **Appendix A**.

Figure 1: Bent on both sides white area of the propeller

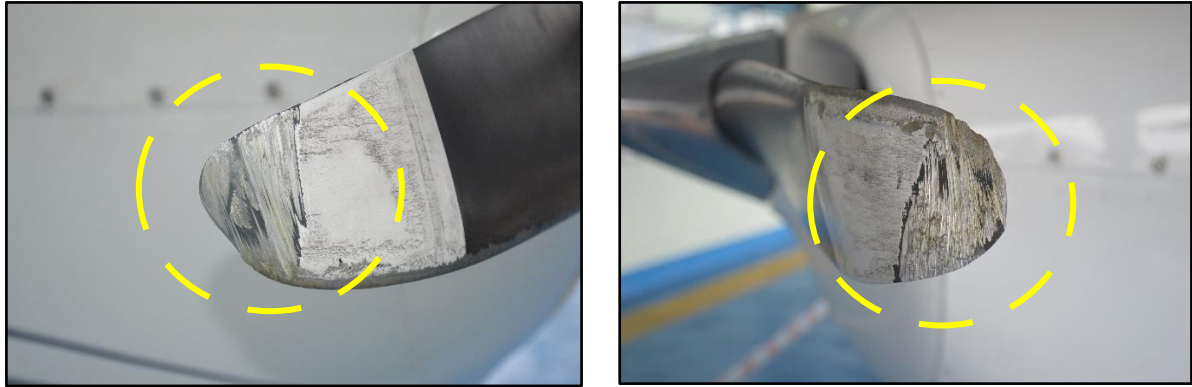
Figures 2 and 3: Scratches on both propeller tips

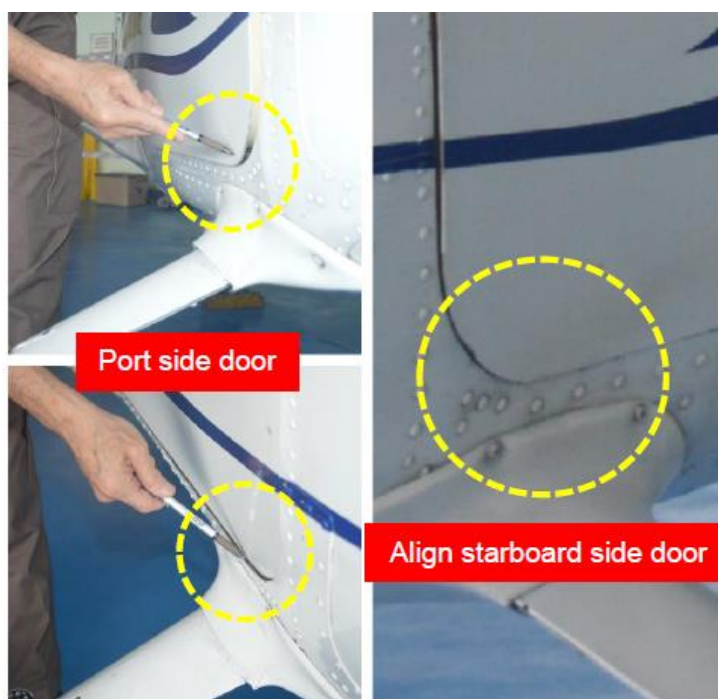
In relation to that, when the investigation team did a general visual inspection of the aircraft, it was found that the port side door of the aircraft (the side where the SP was seated) was not aligned to its door frame where it should be.

Figure 4: Port side door not aligned to its door frame

Figure 4 above shows the port side door is not aligned to its door frame compared to the starboard side door where it is aligned with its door frame. When the SP was asked, all this while when flying the aircraft how this door opened from the inside, the SP stated that the door had to be opened from the outside by putting the hand out of the window and pulling the door latch from the outside. The condition of the door might have contributed to the difficulties for the SP in opening the door to evacuate from the aircraft. From observation, this condition poses a potential safety hazard to the aircraft occupants in the event of smoke or fire to the aircraft or any emergency situations.

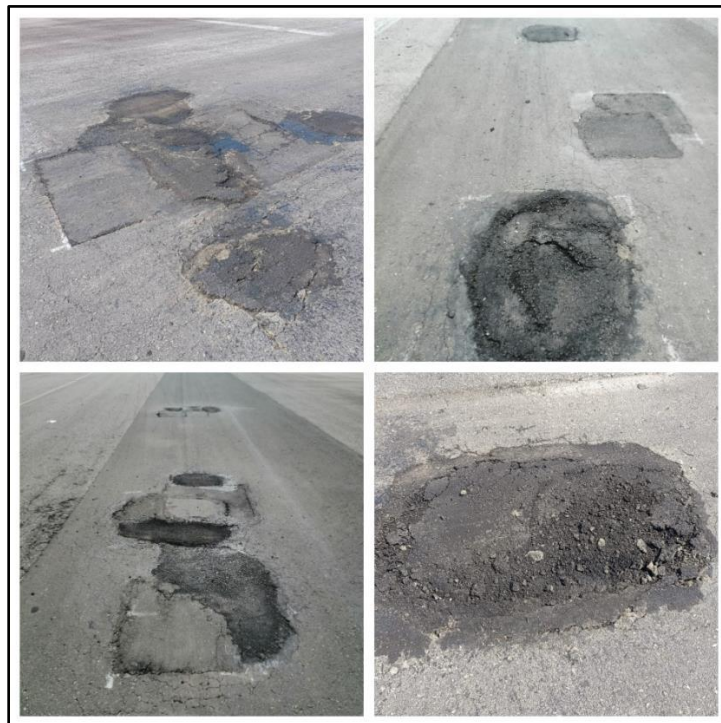
Figure 6: Peeled-off runway surface from temporary patchwork

In summary, there is a serious safety concern about the loose debris on the runway. An international airport cannot be operating with these safety hazards. CAAM as the aerodrome regulator on safety matters should ensure the standard of repair work on the rwy by the aerodrome operator or meets the international requirement to ensure the safety of all aircraft when using the rwy.

The aerodrome operator shall formulate long-term and effective maintenance solutions to improve the poor condition of the runway.

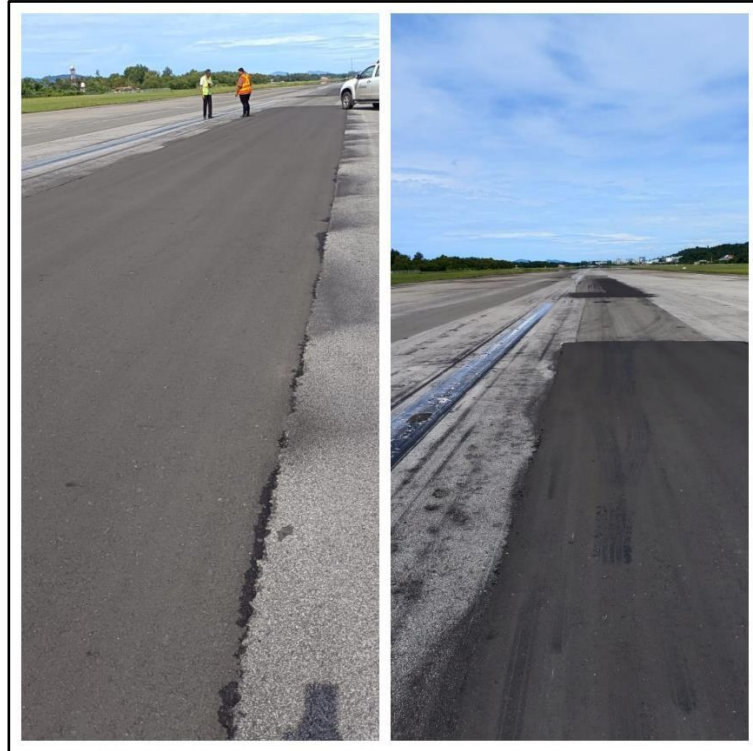
Figure 7: New big patch was applied but the joint at the side between the new and old started to dislodge gradually

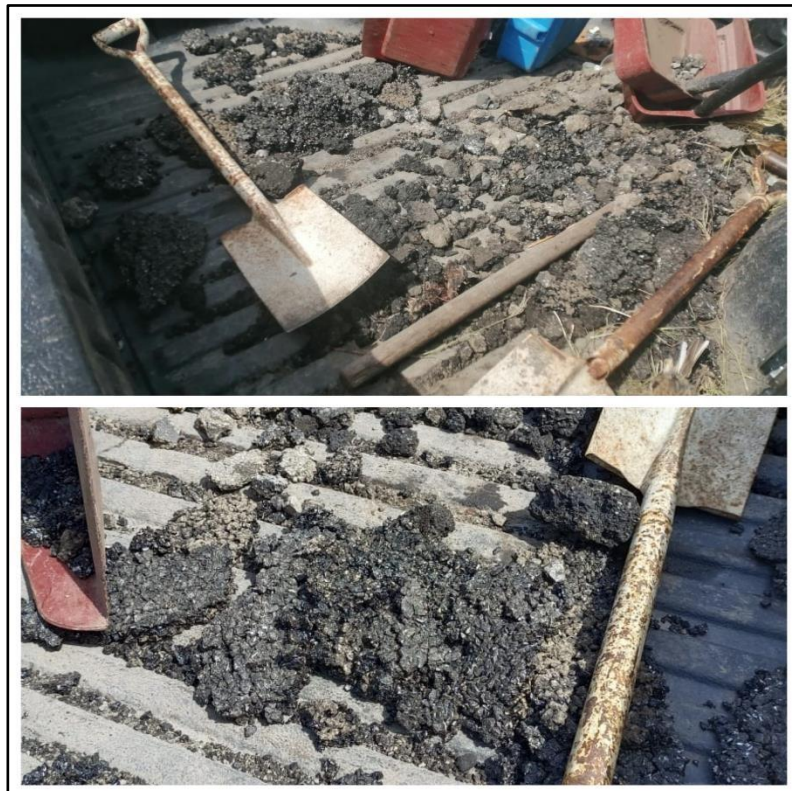
Figure 8: Debris collected after a few days of collection behind the MASB vehicle used for the runway inspection.

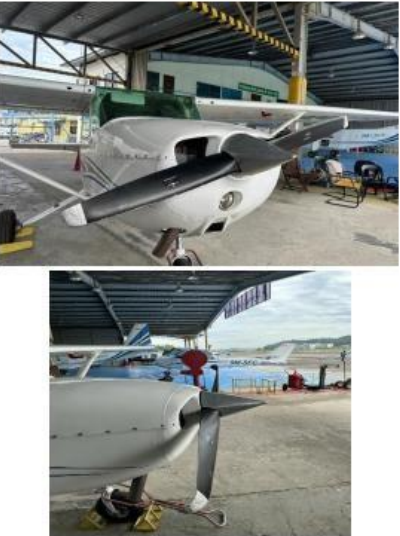
Components	Condition on 9M-GPB	Action
Propeller	Damage on both propeller tip, with scratch and bent on both side white area of the propeller as can be seen until further inspection. Cause: Propeller ground strike
