# **AIRCRAFT SERIOUS INCIDENT**

**SI 09/22**

**Textron Aviation Cessna 172P, Registration 9M-GPB**

**at Kota Kinabalu International Airport, Sabah**

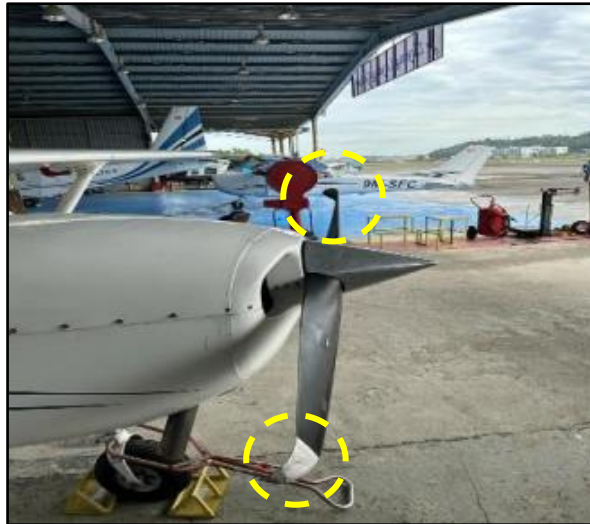
A general visual inspection was carried out to assess and identify the damage to the aircraft after the occurrence. Damage was found on both propeller tips, with scratches and bent on both sides white area of the propeller as can be seen in the pictures below. The initial damage assessment report is as per **Appendix H**.

Figure 1: Bent on both sides white area of the propeller

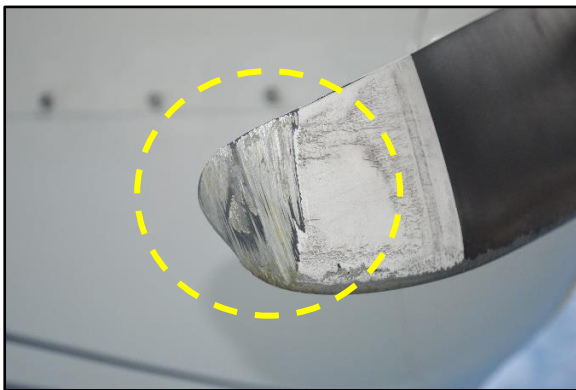
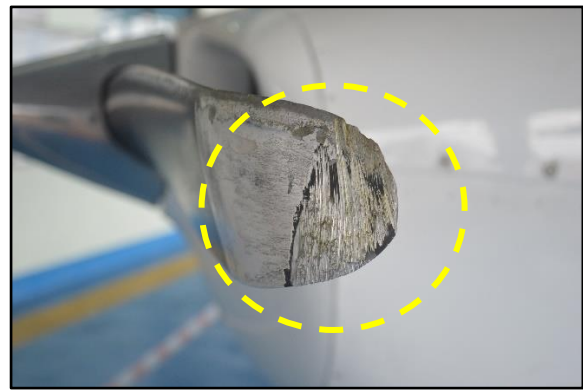
Figures 2 and 3: Scratches on both propeller tips

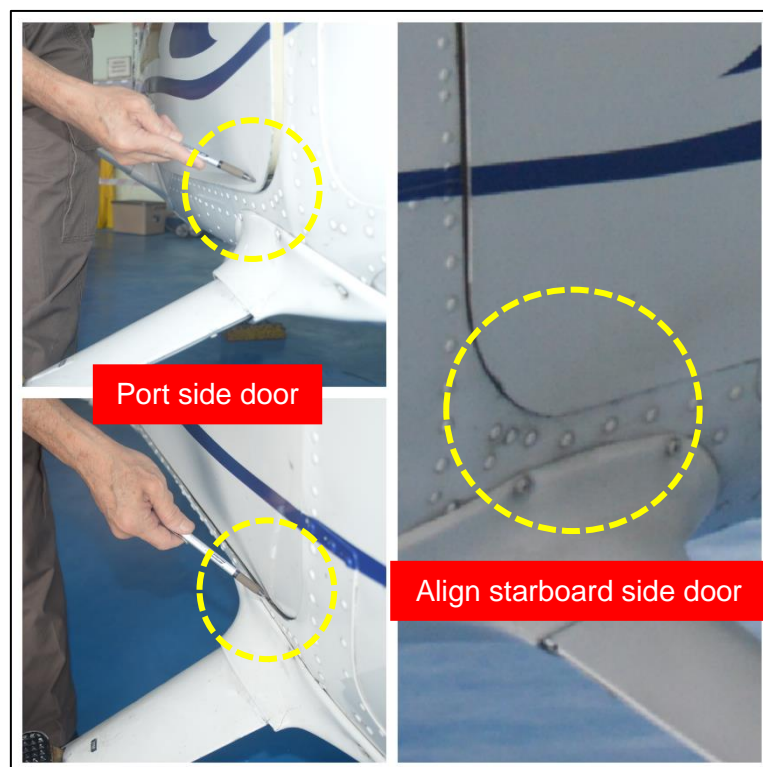
Figure 4: Port side door not aligned to its door frame

Figure 4 above shows the port side door is not aligned to its door frame compared to the starboard side door where it is aligned with its door frame. When the SP was asked, all this while when flying the aircraft how this door

opened from the inside, the SP stated that the door had to be opened from the outside by putting the hand out of the window and pulling the door latch from the outside. The condition of the door might have contributed to the difficulties for the SP in opening the door to evacuate from the aircraft.

From observation, this condition poses a potential safety hazard to the aircraft occupants in the event of smoke or fire to the aircraft or any emergency situations.

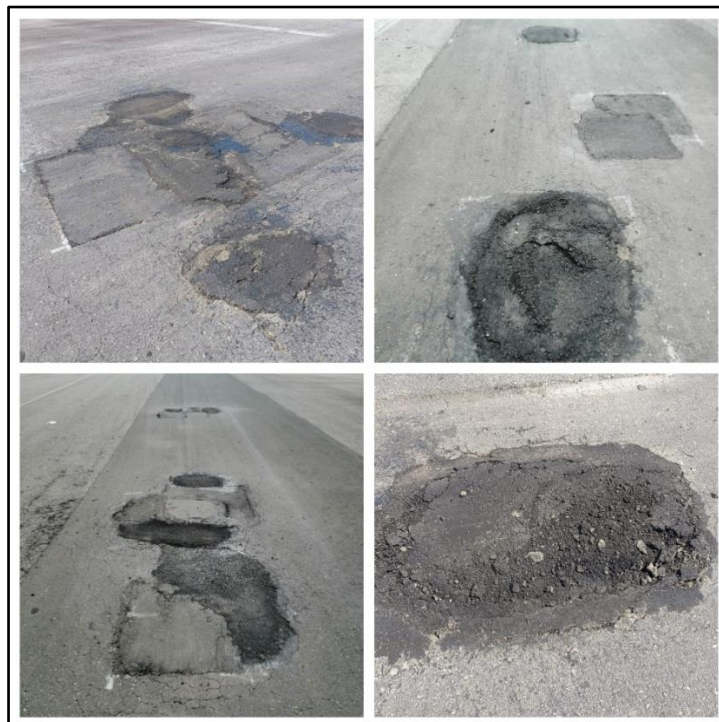
Figure 6: Peeled-off runway surface from temporary patchwork

In summary, there is a serious safety concern about the loose debris on the runway. An international airport cannot be operating with these safety hazards. CAAM as the aerodrome regulator on safety matters should ensure the standard of repair work on the rwy by the aerodrome operator or meets the international requirement to ensure the safety of all aircraft when using the rwy.

- i) The aerodrome operator shall formulate long-term and effective maintenance solutions to improve the poor condition of the runway.

- 4.2.1 To formulate long-term and effective maintenance solutions to improve the poor condition of the runway (proposed in the Preliminary Report).
- 4.2.2 To strictly adhere to the ADARP with regard to the removal of aircraft in the case of an accident or serious incident.

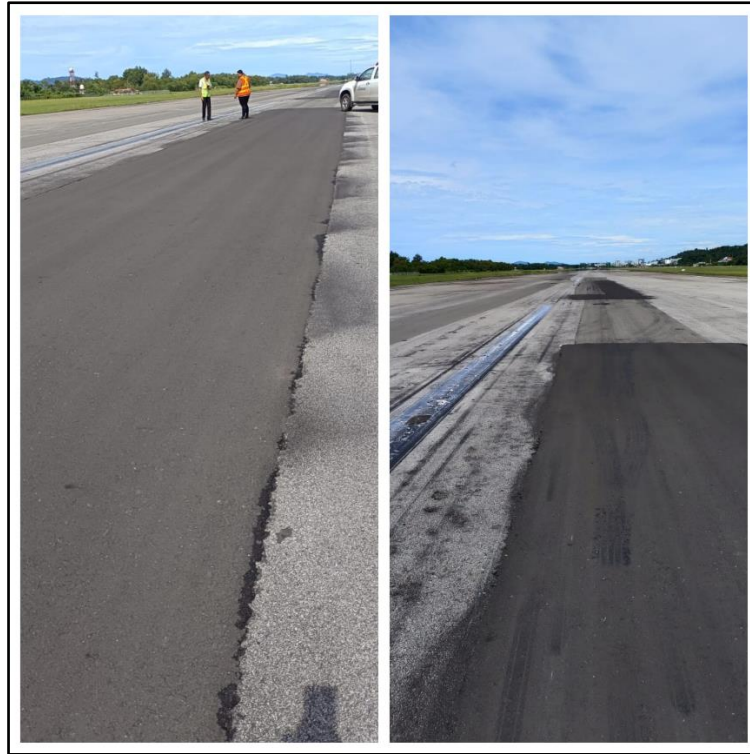
Figure 7: New big patch was applied but the joint at the side between the new and old started to dislodge gradually

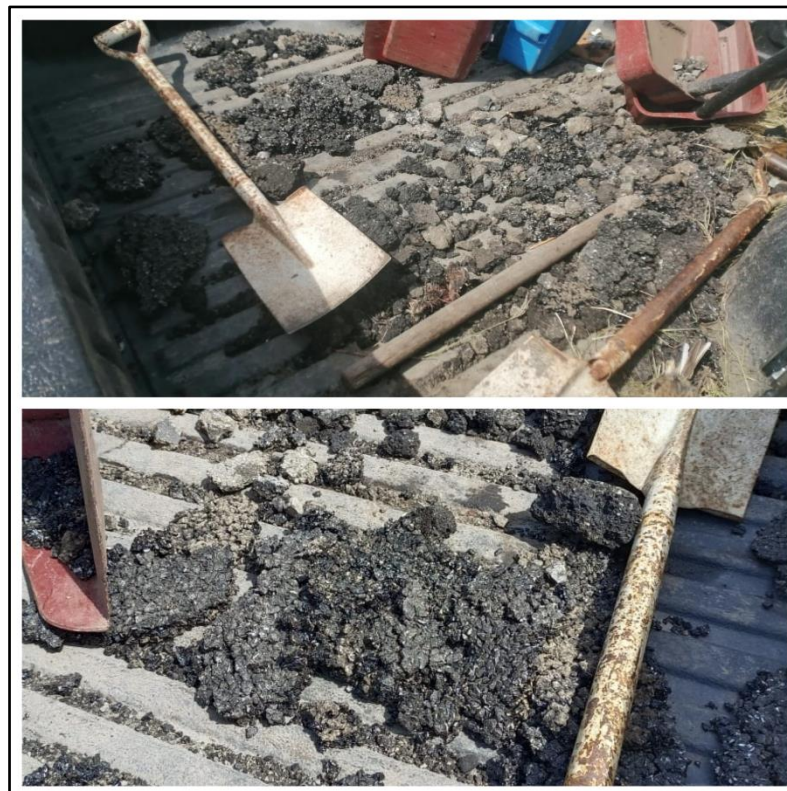
Figure 8: Debris collected after a few days of collection behind the MASB vehicle used for the runway inspection.

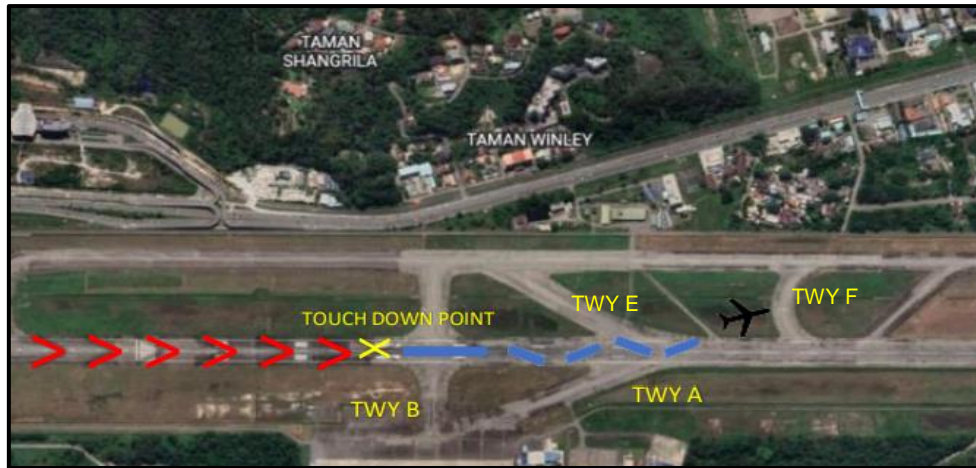
Figure 9 below provides a general description of the site, the final portion of the flight path, the touch-down area, the impact sequence, and the location of impact impressions on the ground. The 'red arrow' indicates the last flight path prior to touch-down, the 'yellow X' is the touch-down point, the 'blue arrow' illustrates the aircraft rolling sequence, and the 'black aircraft' shows the location of the last aircraft position after it stops; between taxiway E and F.

Figure 9: 9M-GPB general description map of the incident  
(Diagram not to scale)

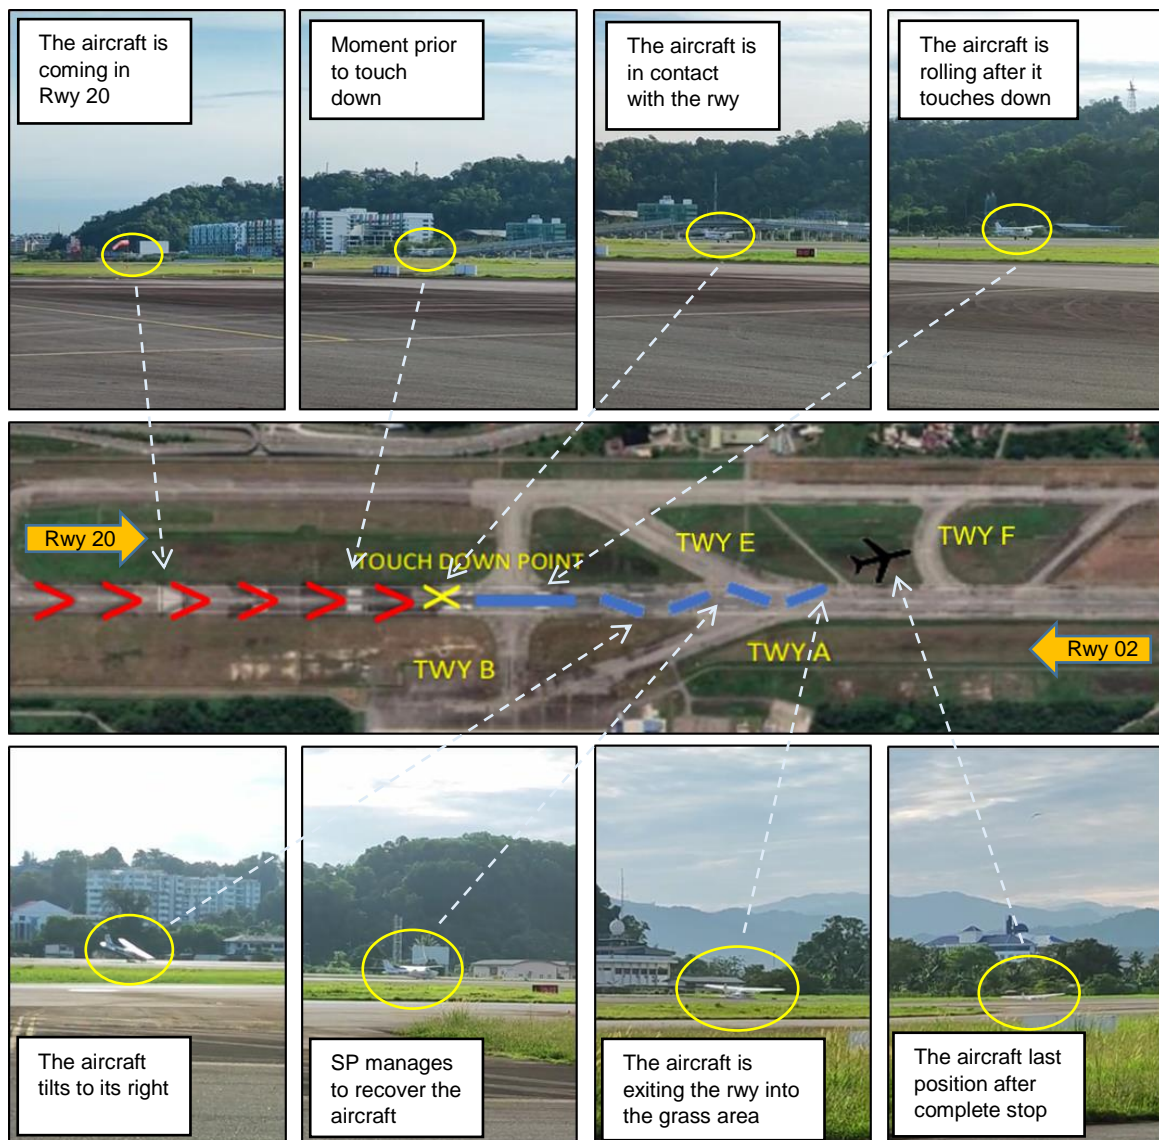
Figure 13: The sequence of the event obtained from a mobile phone video footage (Diagram not to scale)

The misconception that the aircraft had bounced after hitting the runway, with incorrect corrective action made by the SP to remedy the situation during the landing had caused the aircraft to lose its directional control, tilt to its right, veer off the runway centerline, and exit to the left of the runway.

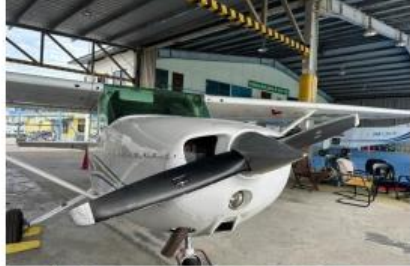
Components	Condition on 9M-GPB	Action
Propeller	Damage on both propeller tip, with scratch and bent on both side white area of the propeller as can be seen until further inspection. Cause: Propeller ground strike
