AIRCRAFT ACCIDENT

SI 07/22

**Serious Incident Involving Fixed Wing Aircraft Textron Aviation
172S, Registration 9M-HOT at Sultan Azlan Shah Airport, Ipoh.
Perak on the 25 October 2022**

OPERATOR : LAYANG LAYANG FLYING ACADEMY
AIRCRAFT TYPE : TEXTRON AVIATION 172S
NATIONALITY : MALAYSIA
REGISTRATION : 9M-HOT
PLACE OF OCCURRENCE : SULTAN AZLAN SHAH AIRPORT, IPOH (WMKI)
DATE AND TIME : 25 OCTOBER 2022 AT 1230 LT

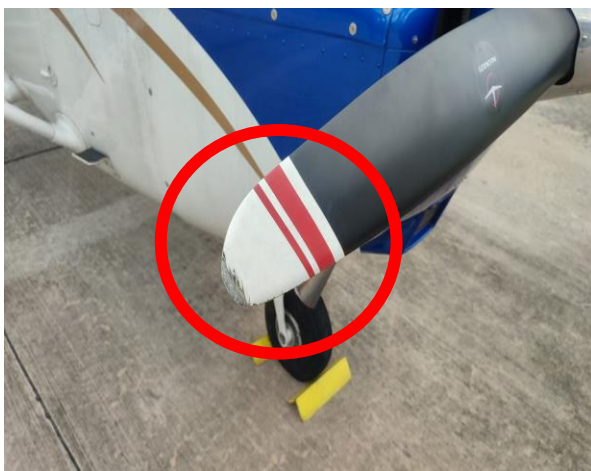
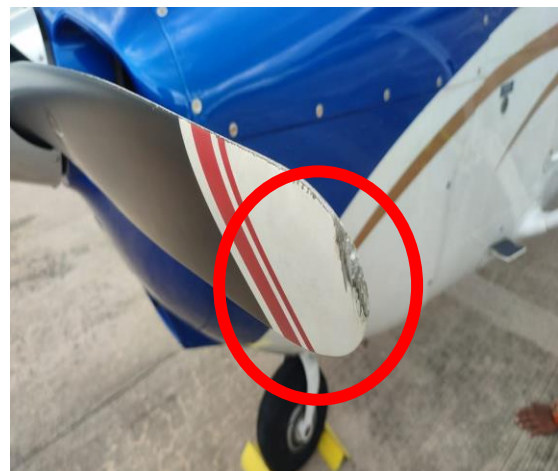
- a. Propeller.

Figure 2: All Propeller blades bent inwards at the blade tips.

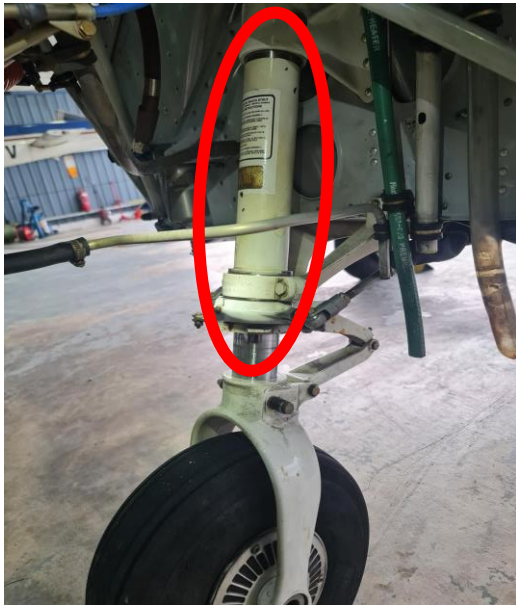
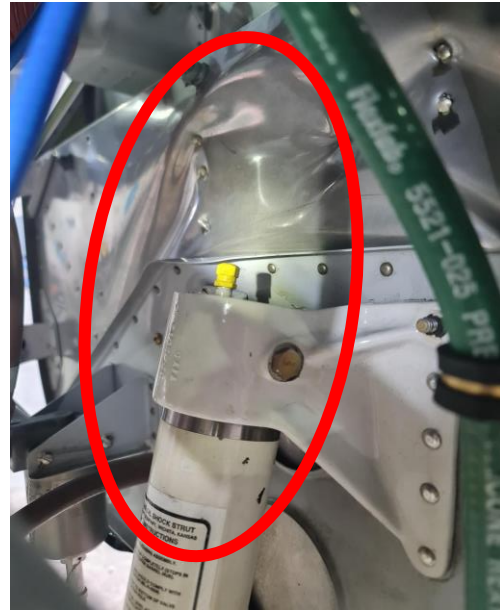
b. Nose landing gear.

Figure 3: Nose landing gear. Damaged on riveted joints.

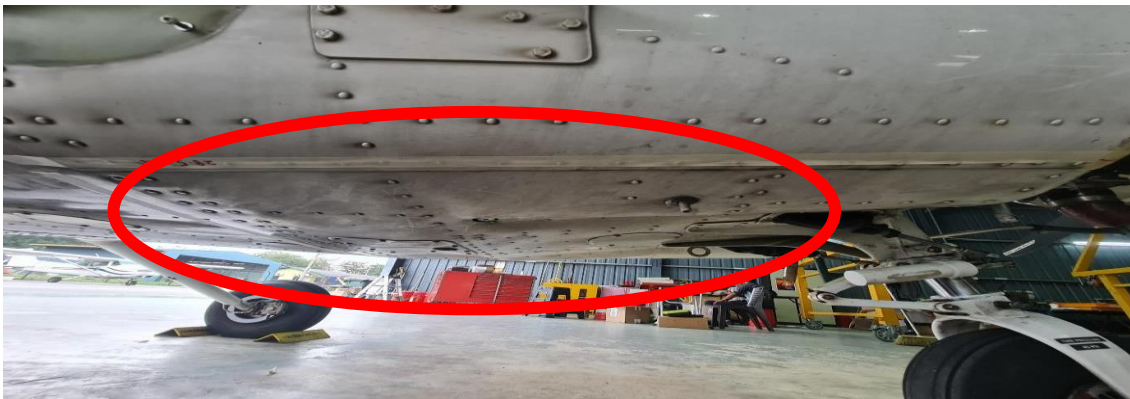
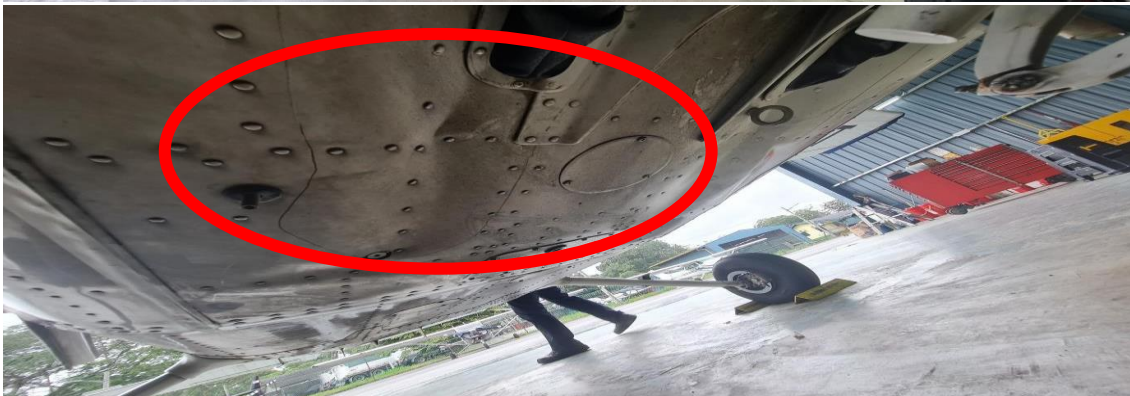
c. Below fuselage.

Figure 4: Below fuselage. Found deep scratches.

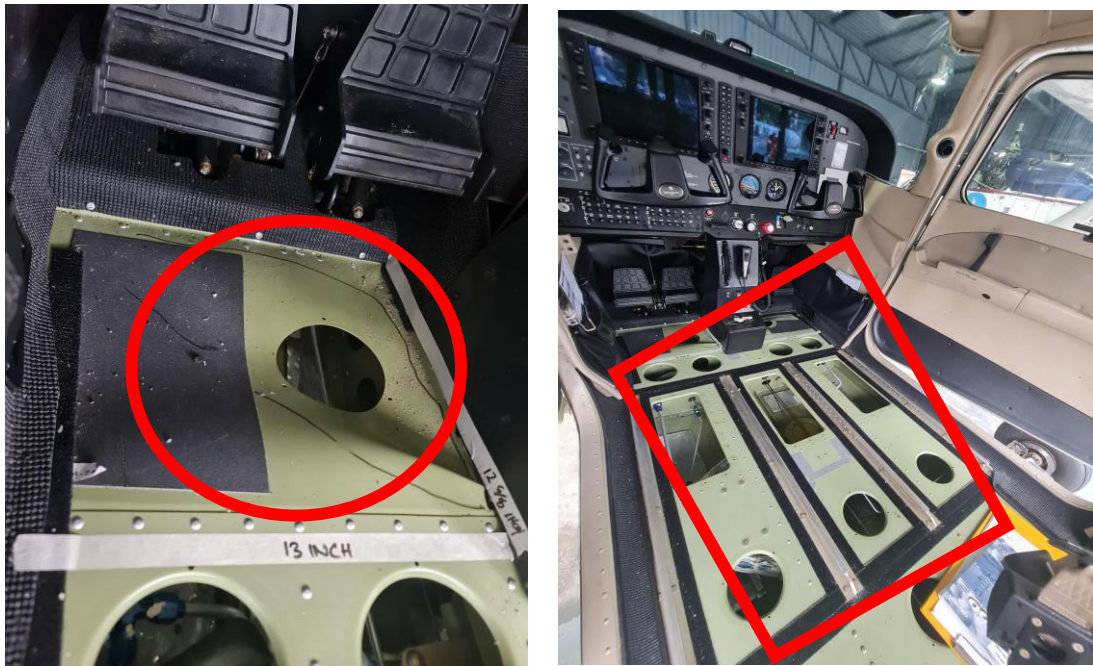
d. Floorboard (Center Pedestal).

Figure 5: Forward Left and Right Floorboard Assembly found wrinkled and buckled.

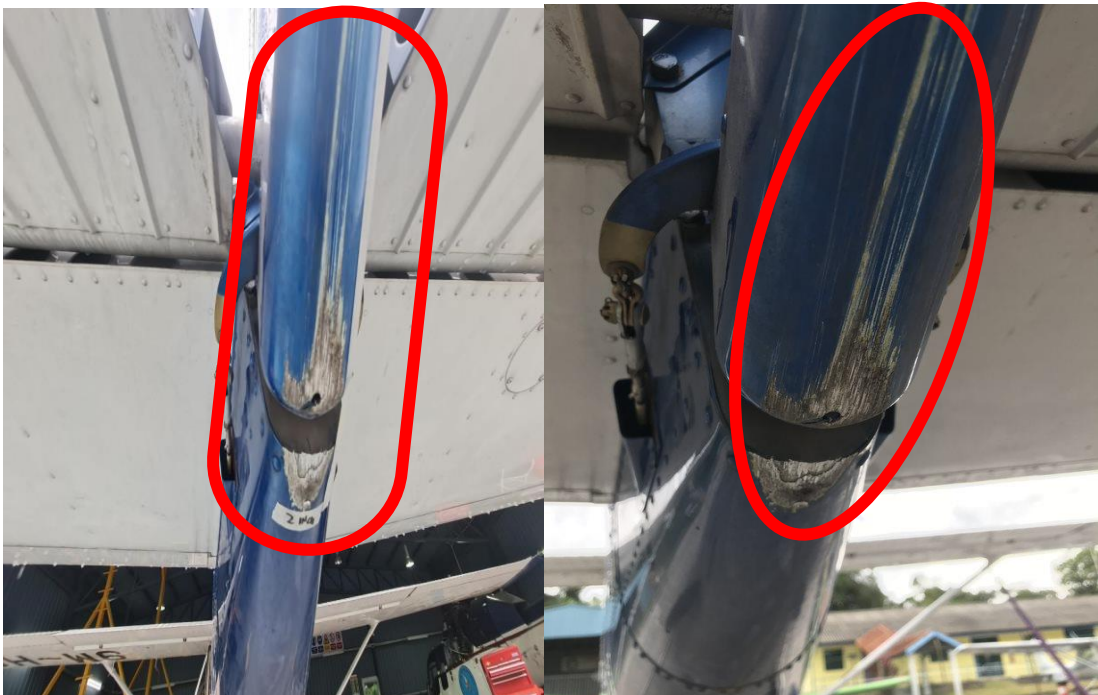
e. Tail section.

Figure 6: Rudder Lower tip found scratches

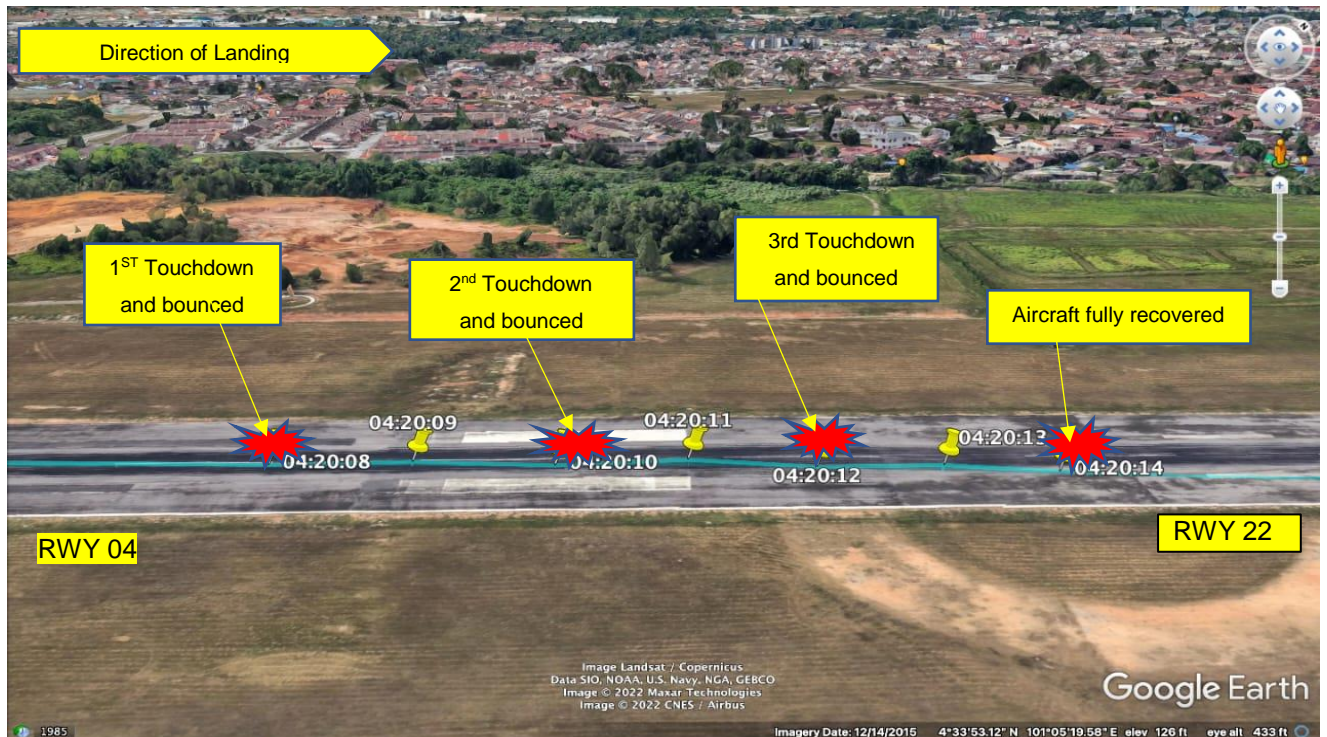
Figure 10: Landing path
(Diagram not to scale)

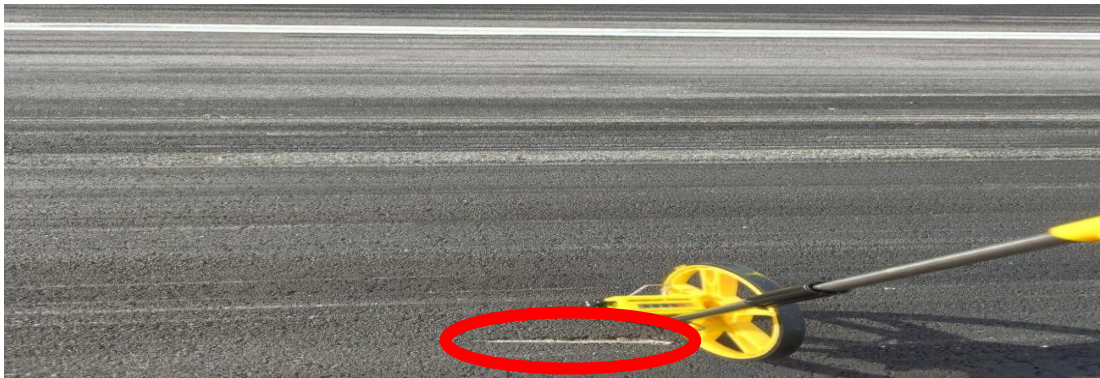
The AAIB Investigation team conducted the investigation on the runway and found 3 scratched markings on the runway. The scratched marking were from the impact of the rudder lower tip (figure 11) and the propeller (figure 12) during the hard landing and was confirmed by the TP during the interview.

Figure 11: Scratched marking from the rudder lower tip on the runway during the hard landing.

The first touchdown which was landing hard resulted the rudder's lower tip striking the runway (figure 11). On the second hard bounce landing, the ac ballooned toward the right of the runway centreline and resulted the propeller hitting the runway (figure 12). On the third bounce, the TP managed to control the ac by bringing it back to the runway centreline and land.

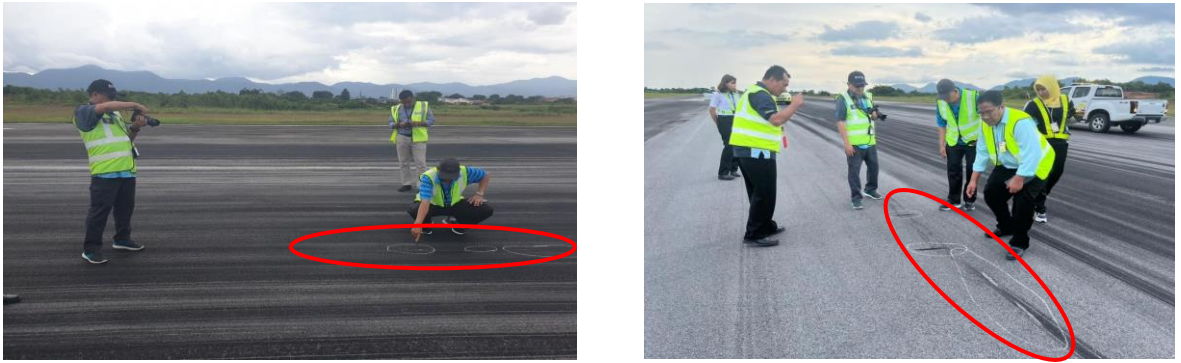
Figure 12: Scratched marking from the propeller on the runway during the hard landing.

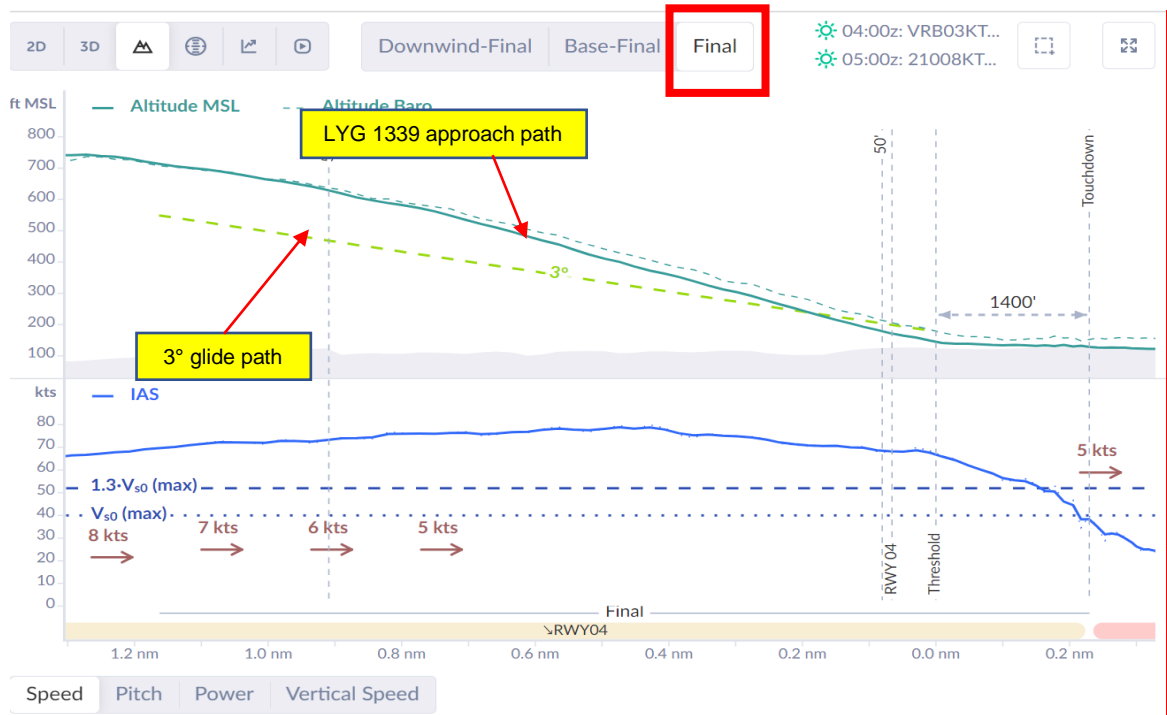
Figure 13 shows the profile of the ac on the final approach to land. The ac approach height was not stable (high) and not as per the 3° glide path. It shows the ac speed of 70-80 KIAS (Figure 14) on the final approach does not follow the C172 SOP Performance Landing Procedure (Figure 15) which states that the final approach technique is achieved not below 65 knots aiming to achieve a touchdown speed of 50 knots. Due to high-speed descent after making adjustments to the pitch from a high approach, the TP was unable to control the ac to land smoothly. TP's flaring of the ac at 29 ft which the flaring height between 10-15 ft. Due to the high sink rate and the TP applying too much back pressure while flaring the ac, it resulted a hard bounced landing and the ac ballooned on the runway. The TP should initiate a go-around as per LLFA Student Study Guide paragraph 13.3.5 when the approach was seem to be an unstabilized approach (Figure 16).

Figure 13: Data extracted from Garmin G 1000 shows the flight path of the aircraft during the final approach to land.

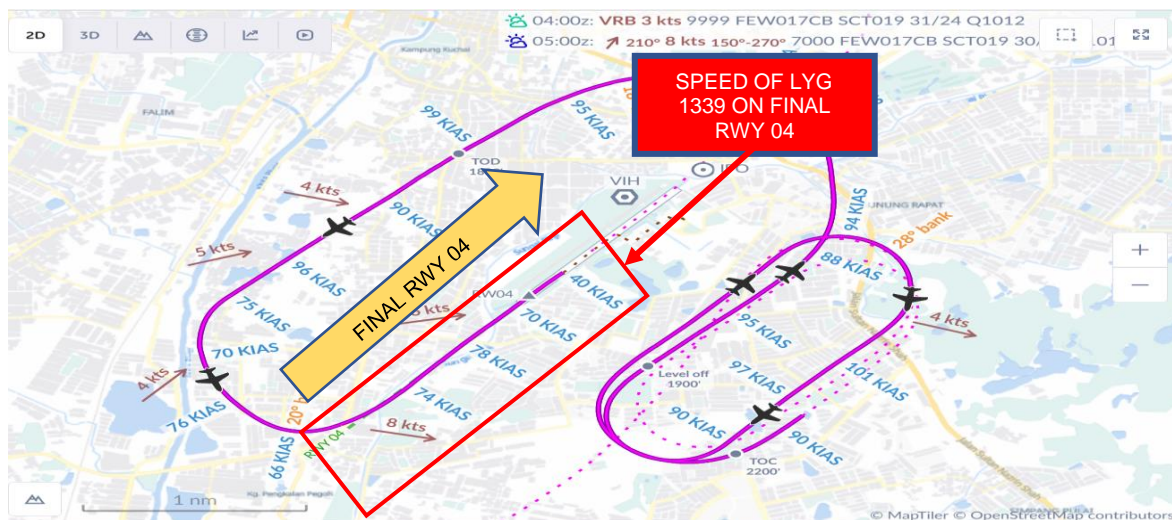
Figure 14: Data from Garmin G1000 shows the speed of the aircraft on the final to land
