AIRCRAFT SERIOUS INCIDENT

SI 06/22

PIPER PA28-181 Archer III, Registration 9M-SKF

at Malacca International Airport, Malacca

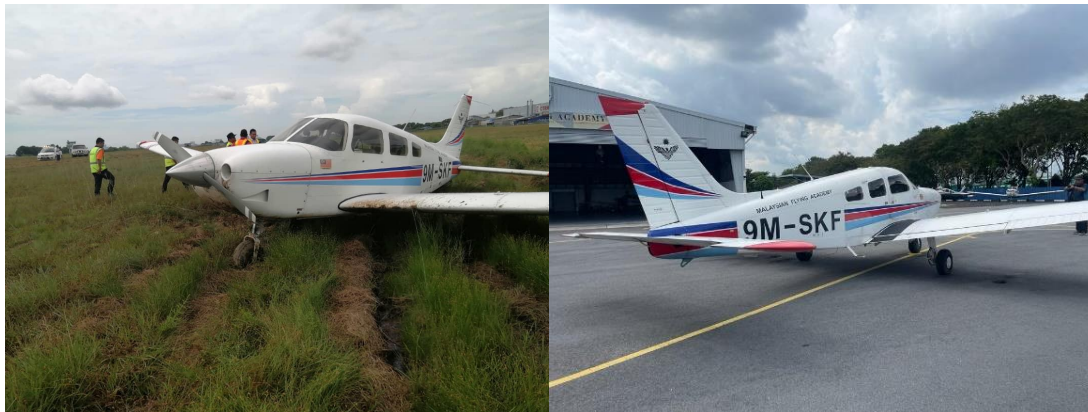
Figure 2: Photos after the incident and after Inspection/Test

Nil

The Maintenance Organisation had completed a physical damage assessment on the aircraft. Detailed inspection carried out on fuselage, port and starboard wing undercarriage, flight controls, vertical fin, stabilator, cowlings, engine, propeller, and avionics system and found satisfactory. The aircraft had been assessed as having no damage and fit to fly. The Post Accident Damage Assessment Report can be viewed in Maintenance Organisation's file reference MFA/SKF/18864 dated 24 November 2022.

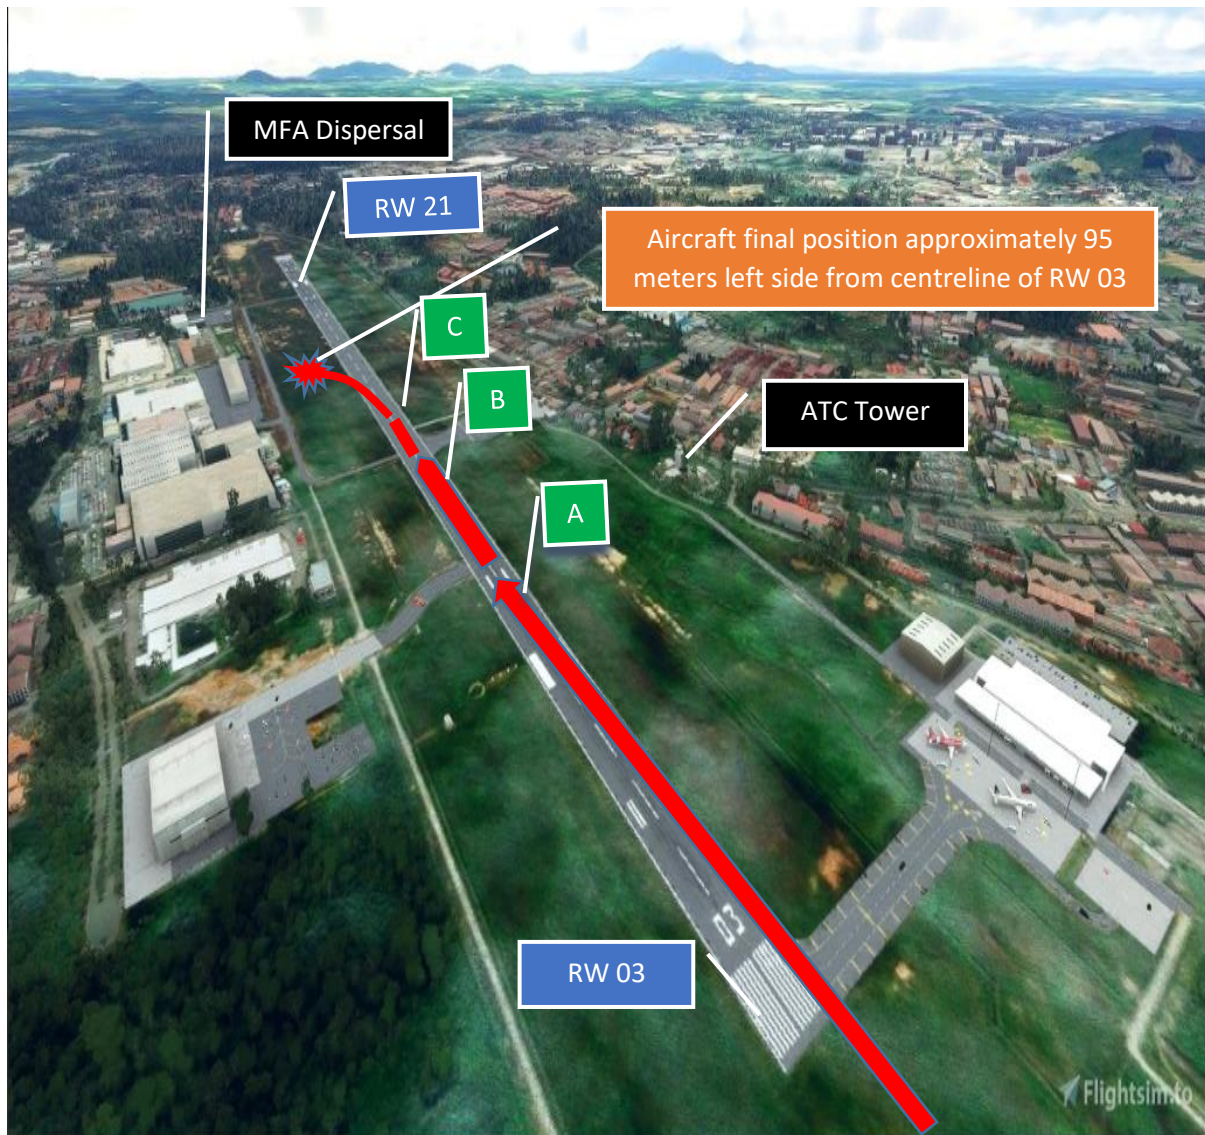
Figure 8: Landing path and roll for take-off and final position of aircraft
(Diagram not to scale)

The aircraft touched down passed the 1000-foot marker Runway 03 (**Point A**). The aircraft continue to roll on the centreline and the CP then applied take-off power (full power) and began rolling down the runway for take-off. At **point B** the aircraft had veered to the left due to the aircraft's tendency to yaw to the left.

The CP tried to keep the aircraft on the centreline with the rudder. The CP did not anticipate enough right rudder and panicked. At **point C**, the CP applied the brakes, but due to maximum power, the aircraft veered to the left into the grass area. Skid marks were observed on the runway and grass area till the stopping point. The aircraft came to a rest about 95m from the runway centreline with the aircraft nose pointing to the wind sock Runway 21.

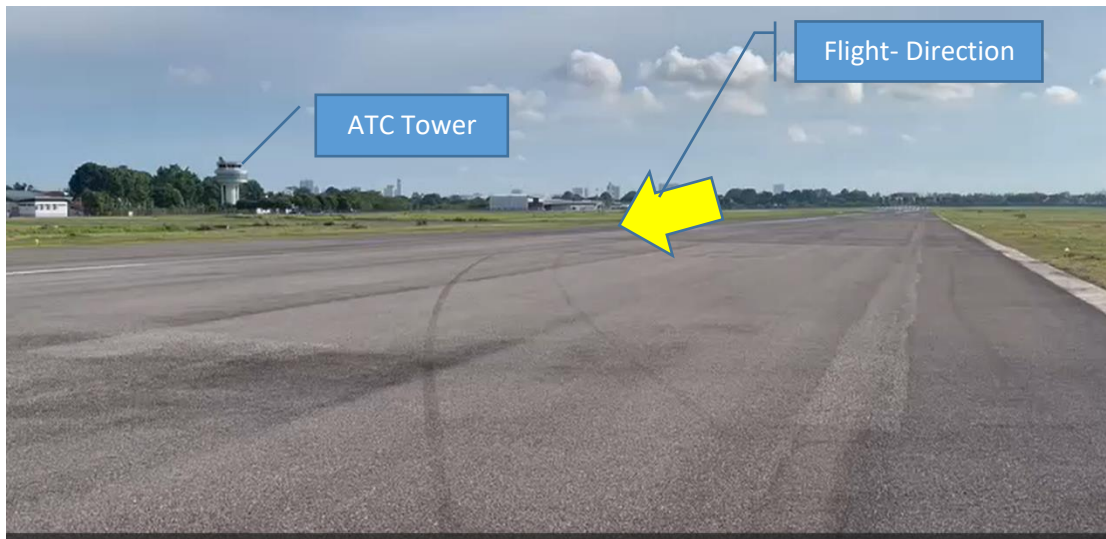
Figure 11: Aircraft tire track marks were observed on the runway at the landing area or exiting the runway towards the crash site.

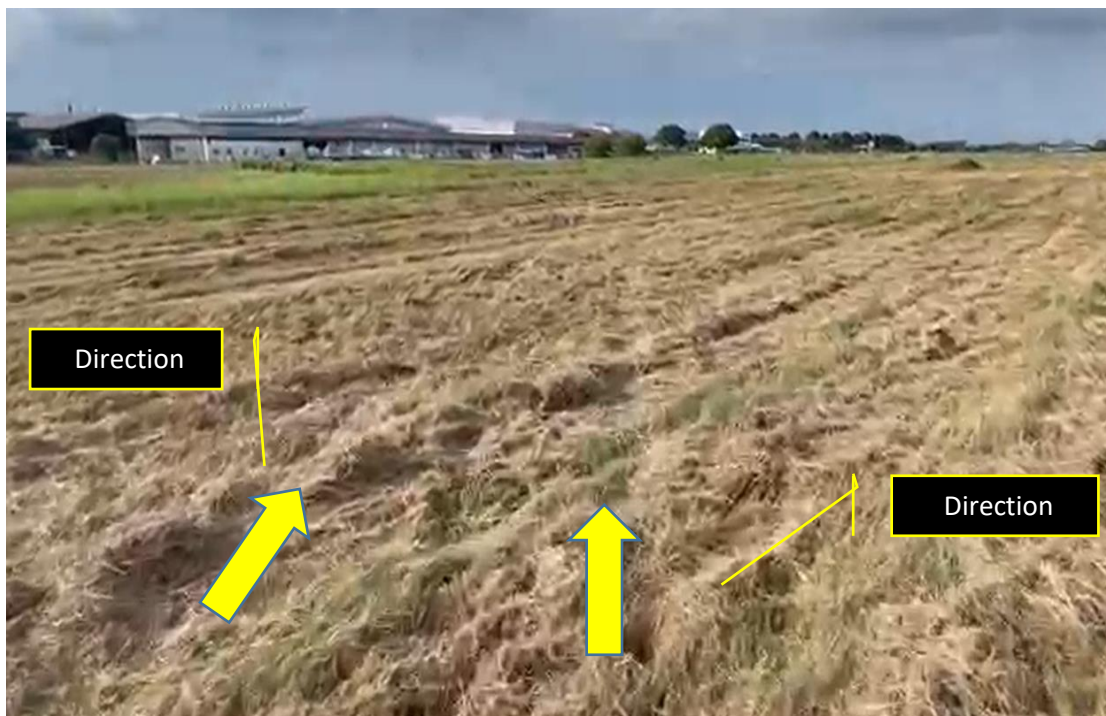
Figure 12: Aircraft tire track marks were observed exiting the runway towards the crash site.

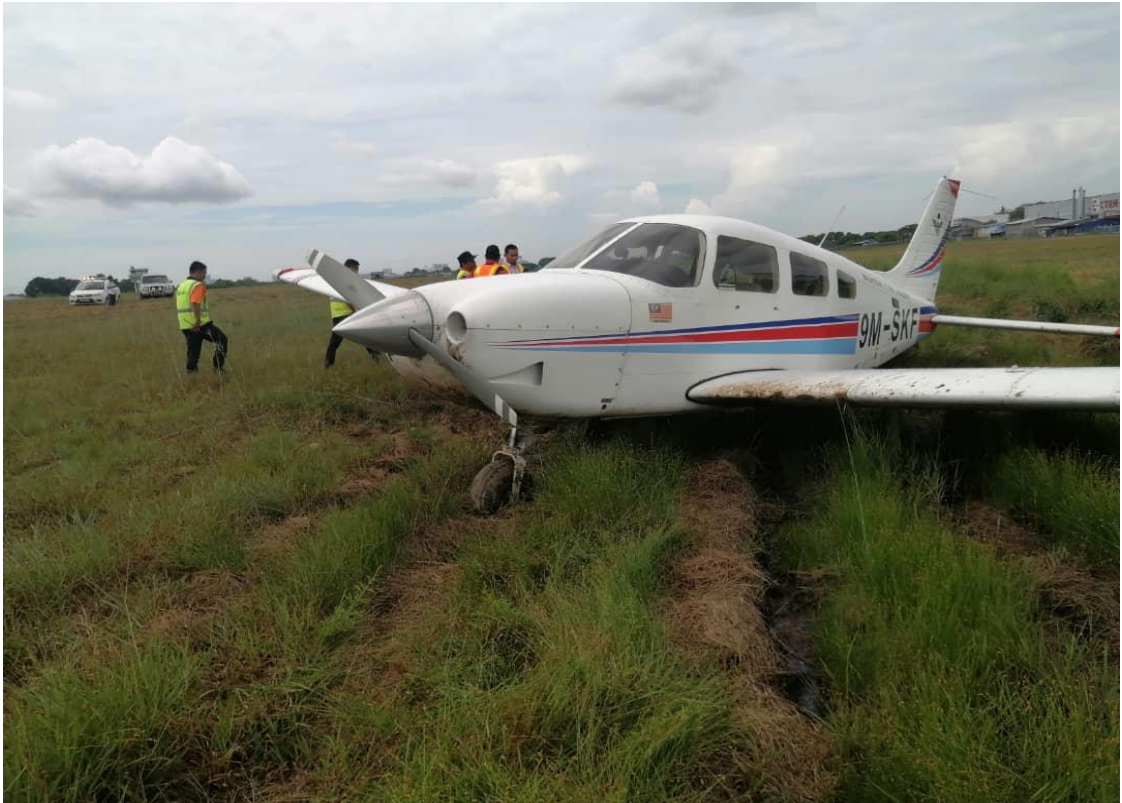
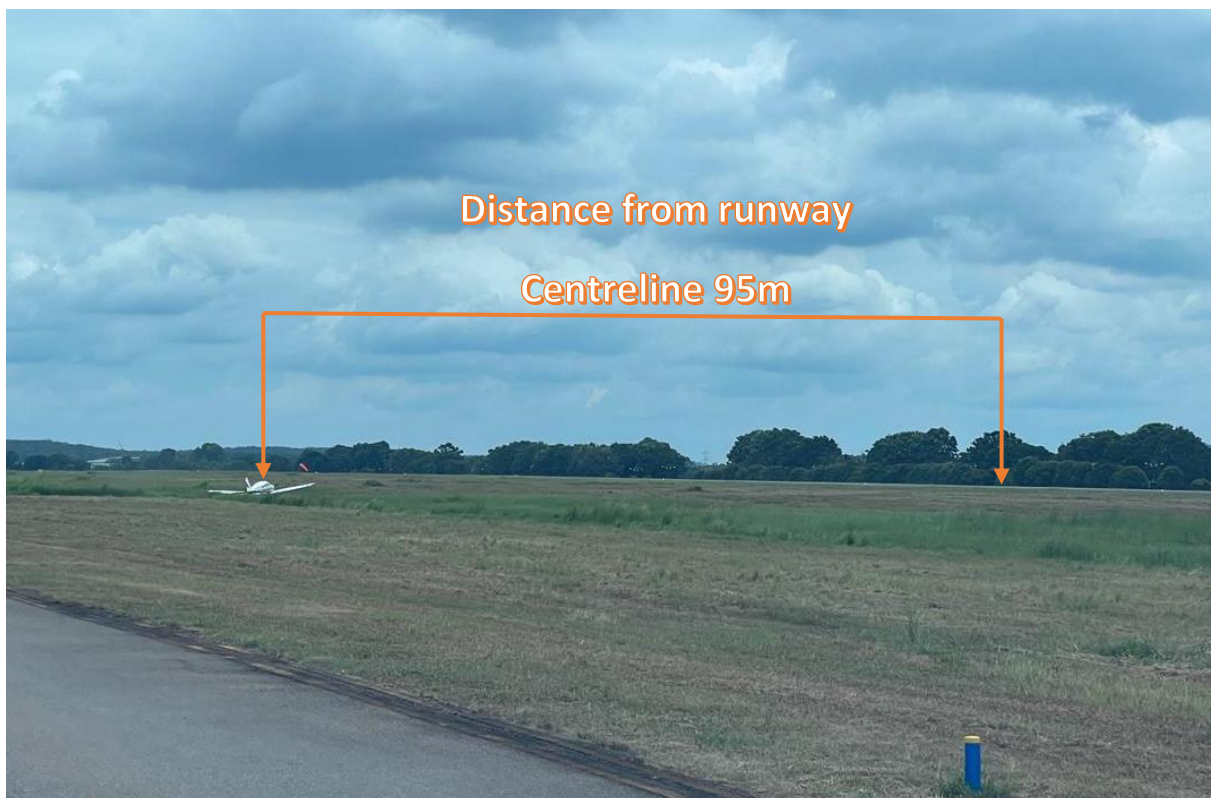
Figure 13: Aircraft final stop position

Figure 14: Aircraft final stop position 95m from runway centreline

The aircraft stopped 95m from the runway's center (Figures 13 and 14). The CP just shut down the aircraft after it comes to a stop. No Aborted/Distress or Emergency call was made by CP.
