AIRCRAFT SERIOUS INCIDENT

SI 02/23P

**Fixed Wing Aircraft Textron Aviation 172Q, Registration 9M-ZAB
at Sultan Azlan Shah Airport, Ipoh. Perak
on the 17 February 2023**

OPERATOR : LAYANG LAYANG FLYING ACADEMY
AIRCRAFT TYPE : TEXTRON AVIATION 172Q
NATIONALITY OF AIRCRAFT : MALAYSIA
REGISTRATION : 9M-ZAB
PLACE OF OCCURRENCE : SULTAN AZLAN SHAH AIRPORT, IPOH.
PERAK (WMKI)
DATE AND TIME : 17 FEBRUARY 2023 AT 0957 LT

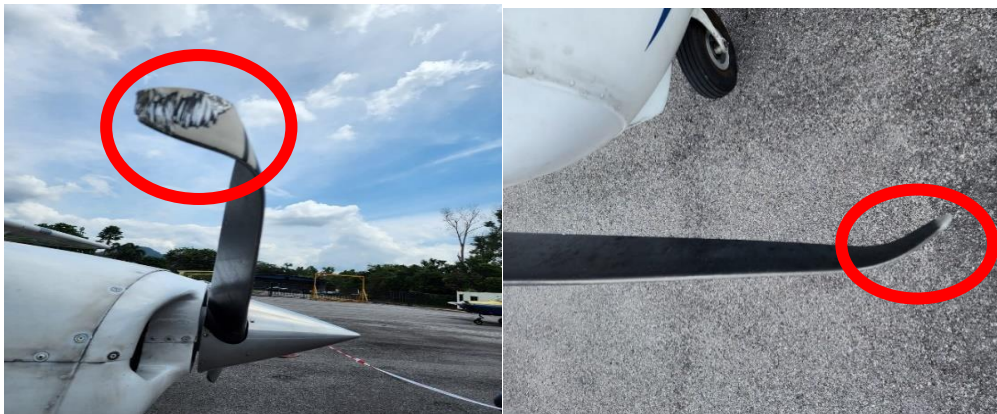
- a. Aircraft Propeller.

Figure 2: Blade tips bend inward

The TP faced difficulties in controlling the aircraft after the go-round because the propeller was damaged from striking the runway during the first attempt to land. A bent blade or nick will severely affect performance and could even damage the engine and transmission. When a propeller has damage to its blades, it creates an imbalance which creates the vibration.

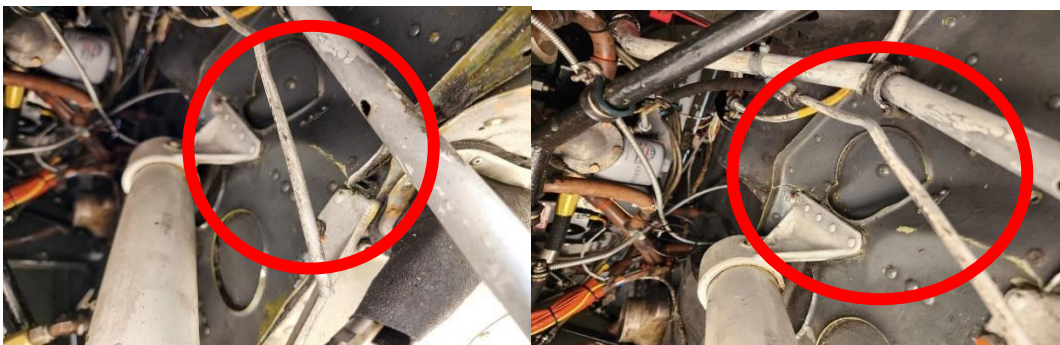
- b. Engine Firewall assembly.

Figure 3: Buckled and damage

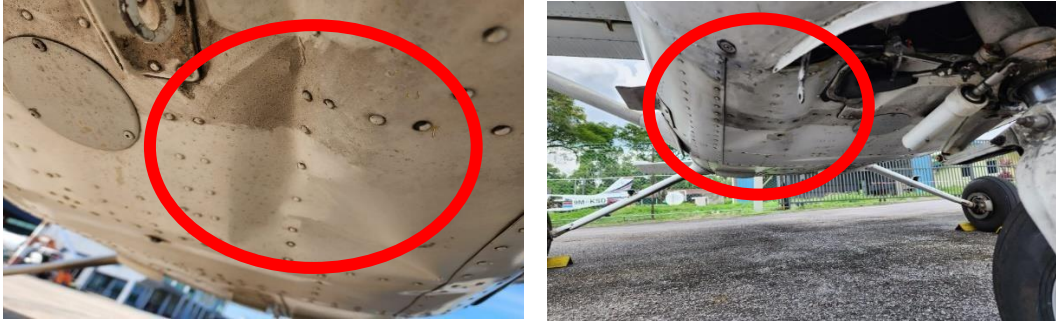
c. Lower skin.

Figure 4: Lower Fuselage Skin dented

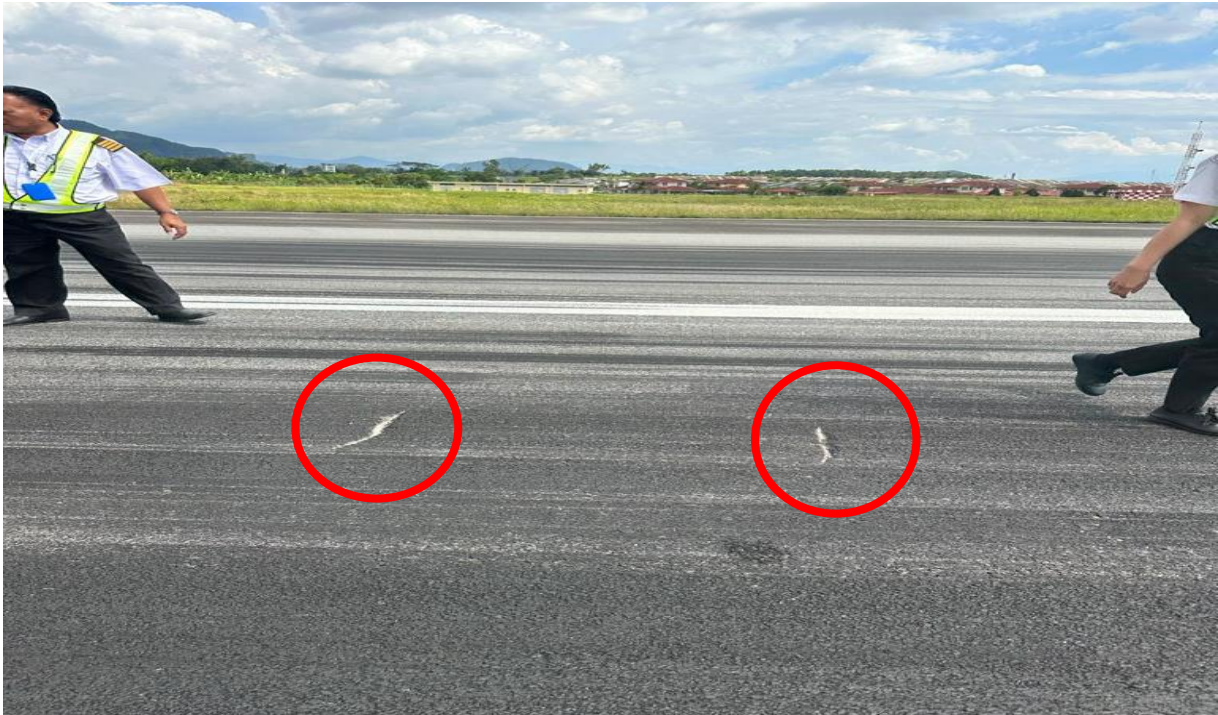
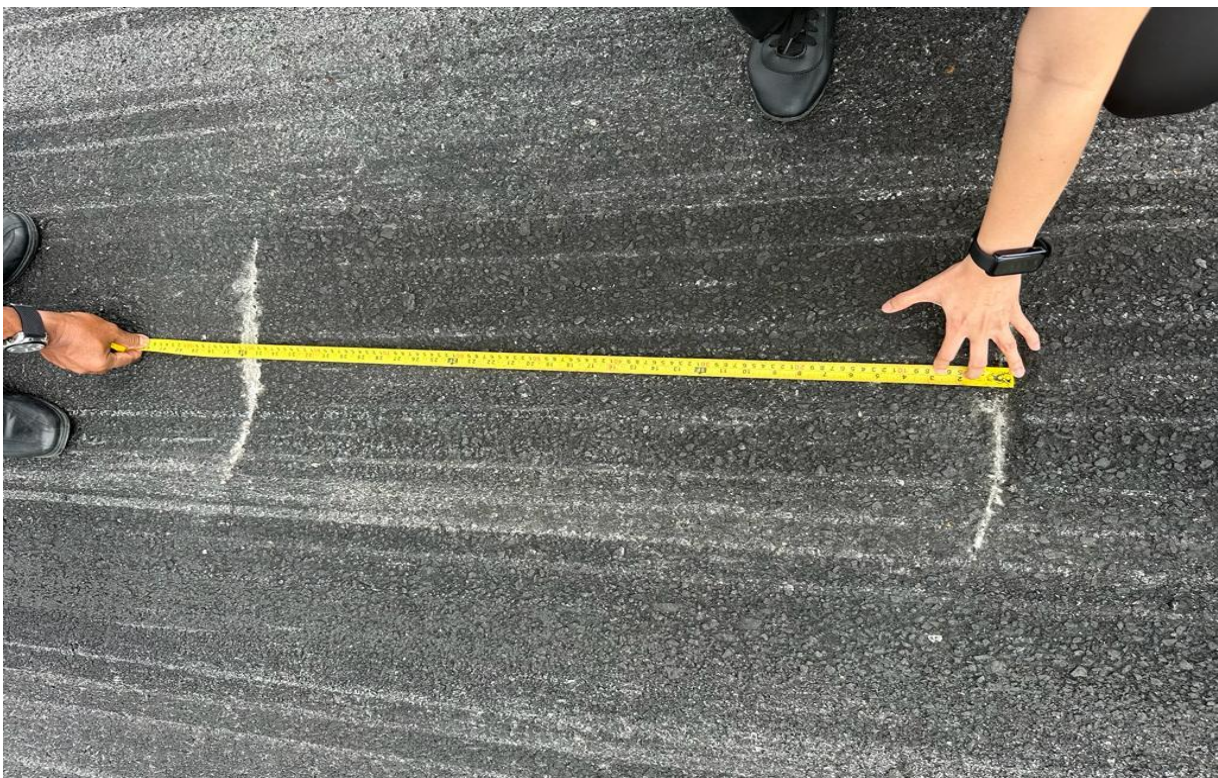
The AAIB Investigation team inspected the runway and found 2 scratched markings on the runway. The scratched marking was from the strike of the propeller (Figure 2) during the hard landing and was confirmed by the TP during the interview.

Figure 11: Scratched marking from the propeller strike during the first attempt to land

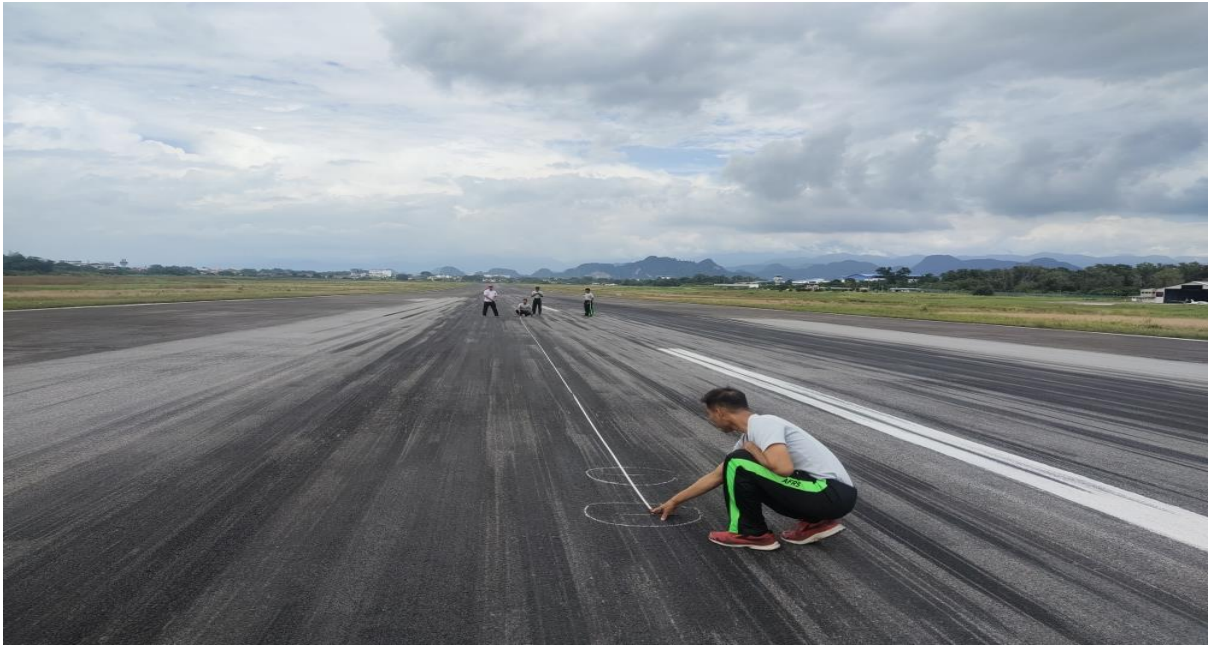
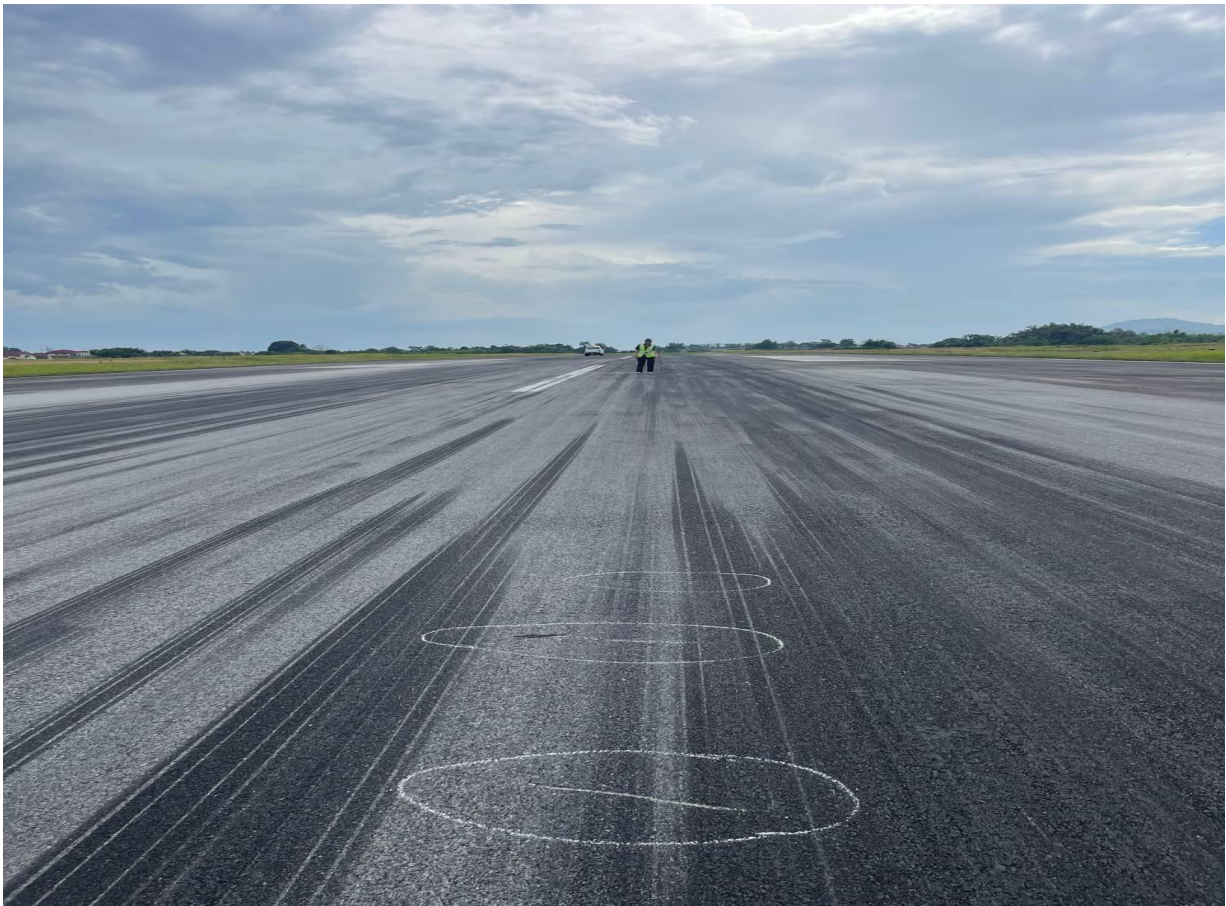
Figure 12: Scratched marking from the propeller strike during the second attempt to land

3.1.8 The TP experienced 3 bounces and the propeller struck the runway during the second attempt to land and managed to land the aircraft safely.
