AIRCRAFT ACCIDENT

FINAL REPORT

A 03/23P

Rotary Wing Helicopter Leonardo AW189

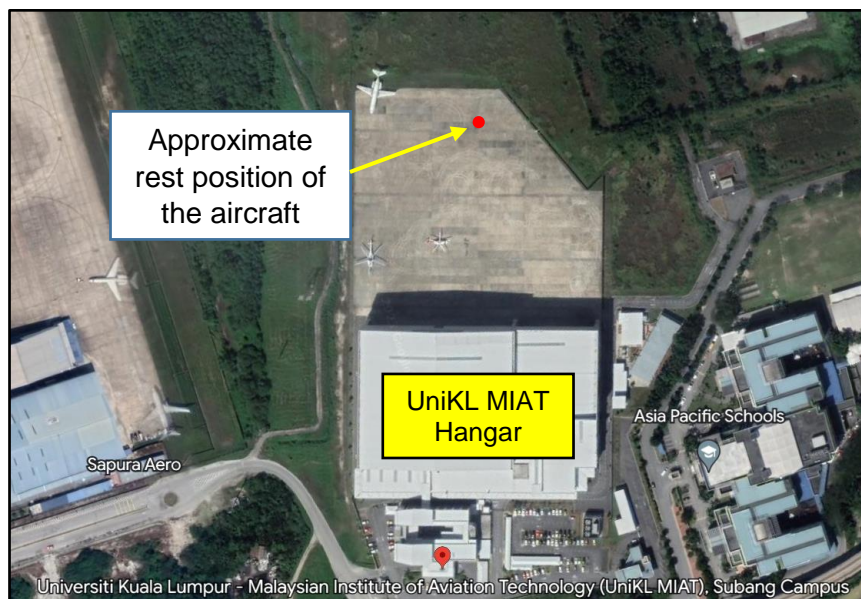
Figure 2: Aircraft's last resting position
(Map Source: Google Earth)

While the correction was being made, the aircraft suddenly spun to the left continuously and toppled. The PIC tried his best to control the spin but to no avail. After rotating for one and a half times, the helicopter rolled to the right, the main rotor blades hit the tarmac surface and stopped by itself, and the aircraft finally rested on its right-hand side (Refer to Figure 2).

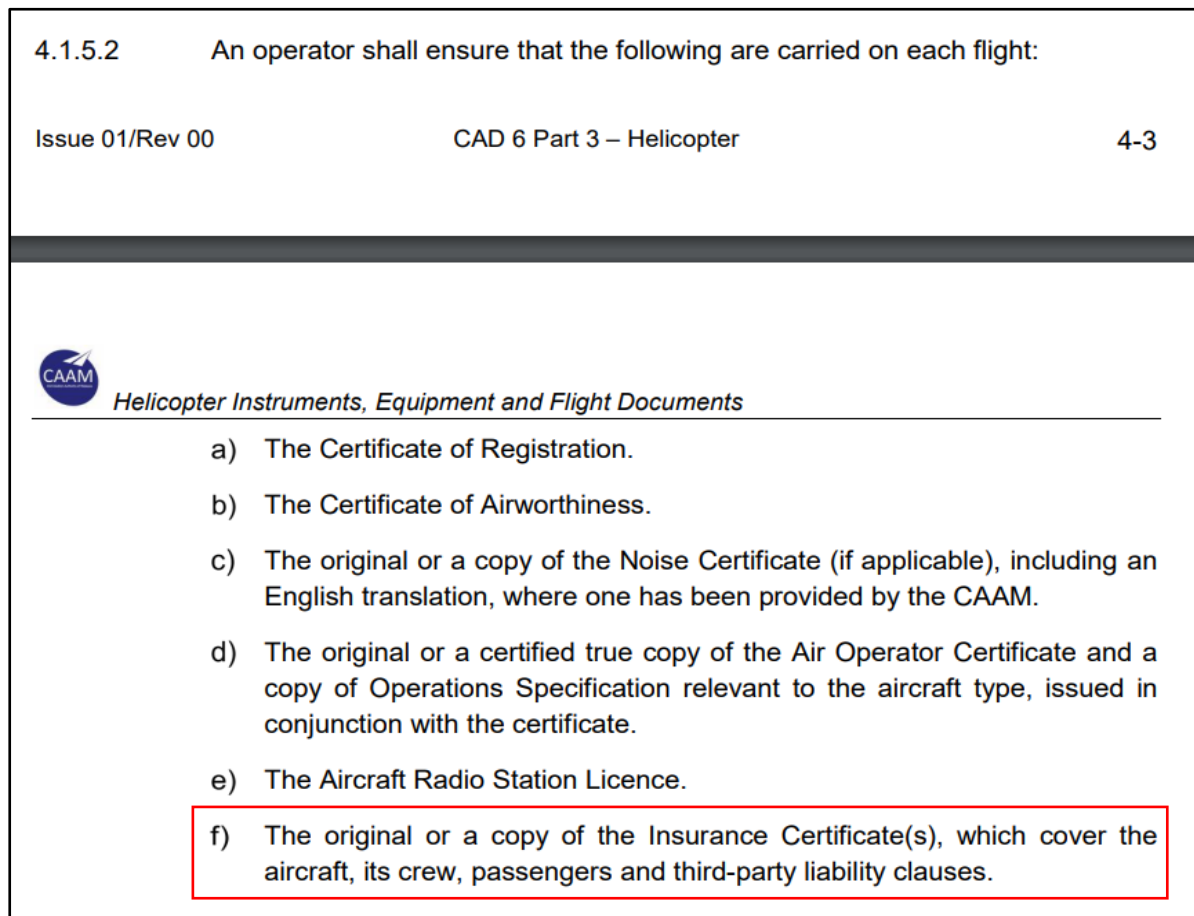
Figure 3: CAD 06 Part 03 – HELICOPTER Section III – General Aviation

The aircraft is a civil registered aircraft; therefore, it is subject to civil aviation rules and regulations, under the category of general aviation operation¹. The Civil Aviation Directives 06 (CAD 06) Part 03 – HELICOPTER Section III – General Aviation, paragraph 4.1.5.2 states that an operator shall ensure that the following are carried on each flight: The original or a copy of the Insurance Certificate(s), which cover the aircraft, its crew, passengers and third-party liability clauses (refer to Figure 3 below).

However, there was no evidence of any insurance certificate being carried on board the aircraft. Upon further investigation, it was found that the aircraft was not insured, as well as an absence of coverage for the third-party liability if the accident were to involve damage, injury, or death to a third party.

- 4.2.3.1 To ensure all government-owned (State) aircraft that are civil registered have valid insurance certificate(s) as required under the provision of the CAD 06 Part 03.
- 4.2.3.2 To review and reconsider the consent for routine aircraft operation at uncertified aerodromes or other flight operation facilities where there is an absence or inadequate risk control and mitigation measures to ensure safe operation. particularly in hazardous environments such as the UniKL MIAT's TFA facility.

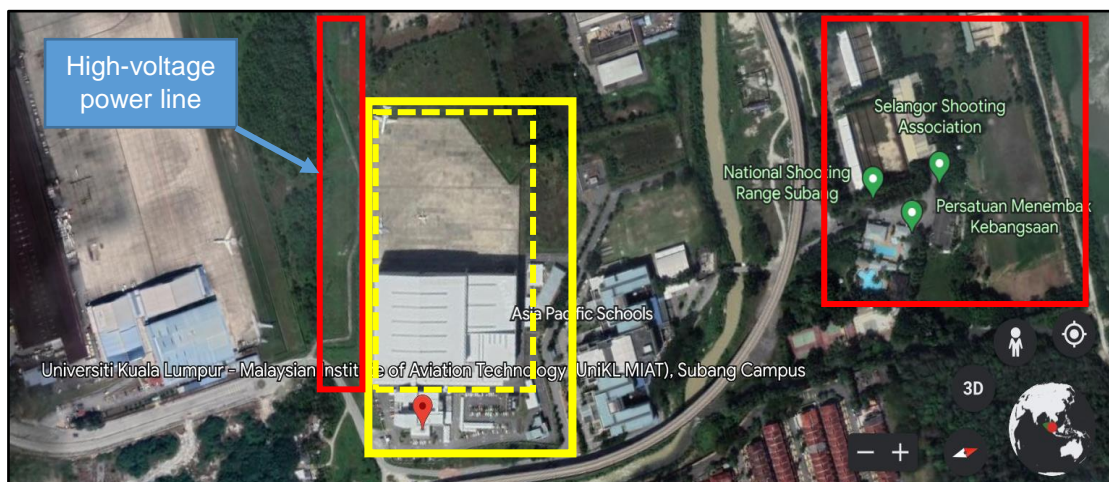
Figure 4: UniKL MIAT Subang Campus
(Map Source: Google Earth)

While on the scene, the investigation team observed that there were several safety hazards around the TFA where the aircraft was operating. Referring to Figure 4, the areas marked by the red squares represent safety hazards to aircraft operation.

The red square on the left indicates high-voltage power lines and pylons that are approximately 28 to 30m in height along the left-hand (southern) side of the TFA. Thus, helicopters operating there have only one way in and one way out from the right-hand (northern) side of the TFA. The other red square on the right contains the National Shooting Range Subang, which is a safety hazard to flying operations due to firearms shooting activities. There were also numerous tall trees averaging from 10 to 30m in height observed around the TFA which could hinder aircraft approaches and landings. There was also a water retention area located near the facility directly below the take-off and landing path of the operating aircraft from the TFA.

3.1.6.2 The TFA is surrounded by safety hazards, such as high-voltage power lines and pylons of substantial height, a shooting range, and tall trees.

- 4.2.2.1 To resolve all the safety hazards at the TFA that have been identified in this report before resuming normal flight operations at the facility.

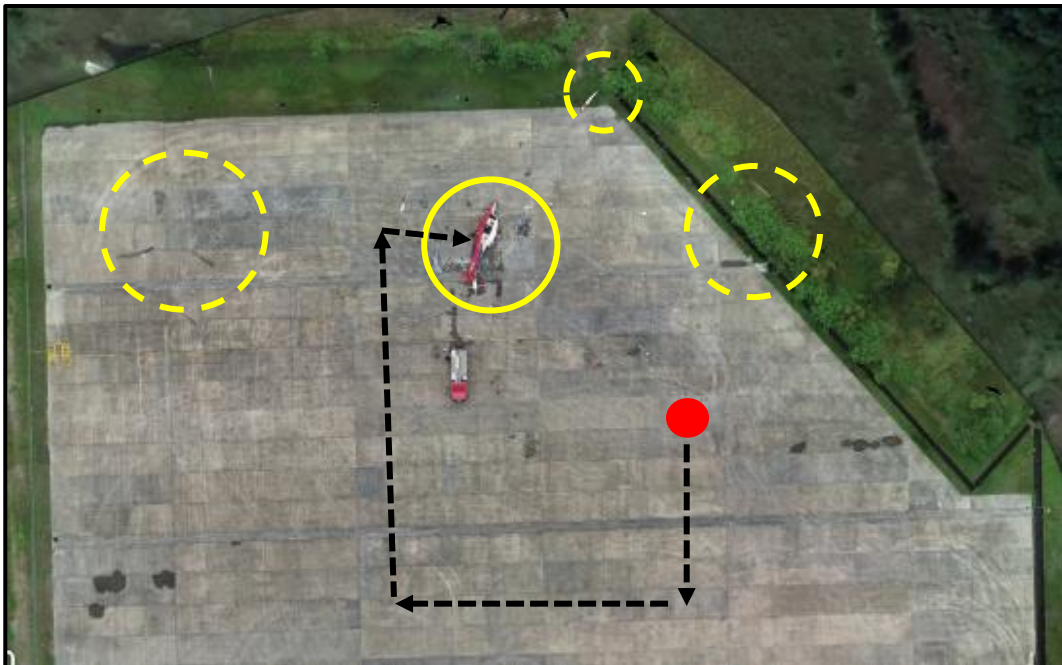
Figure 5: 9M-BOF General Map of The Incident
and Wreckage Distribution

Figure 5 below provides a general description of the accident site, the initial aircraft's EGR location, the taxi path taken by the aircraft, and the location of the aircraft wreckage. The 'big red dot' indicates the EGR location, the 'broken black line' is the taxi route, the 'broken yellow line circle' illustrates the aircraft debris distributions, and the 'yellow line circle' shows the main wreckage.

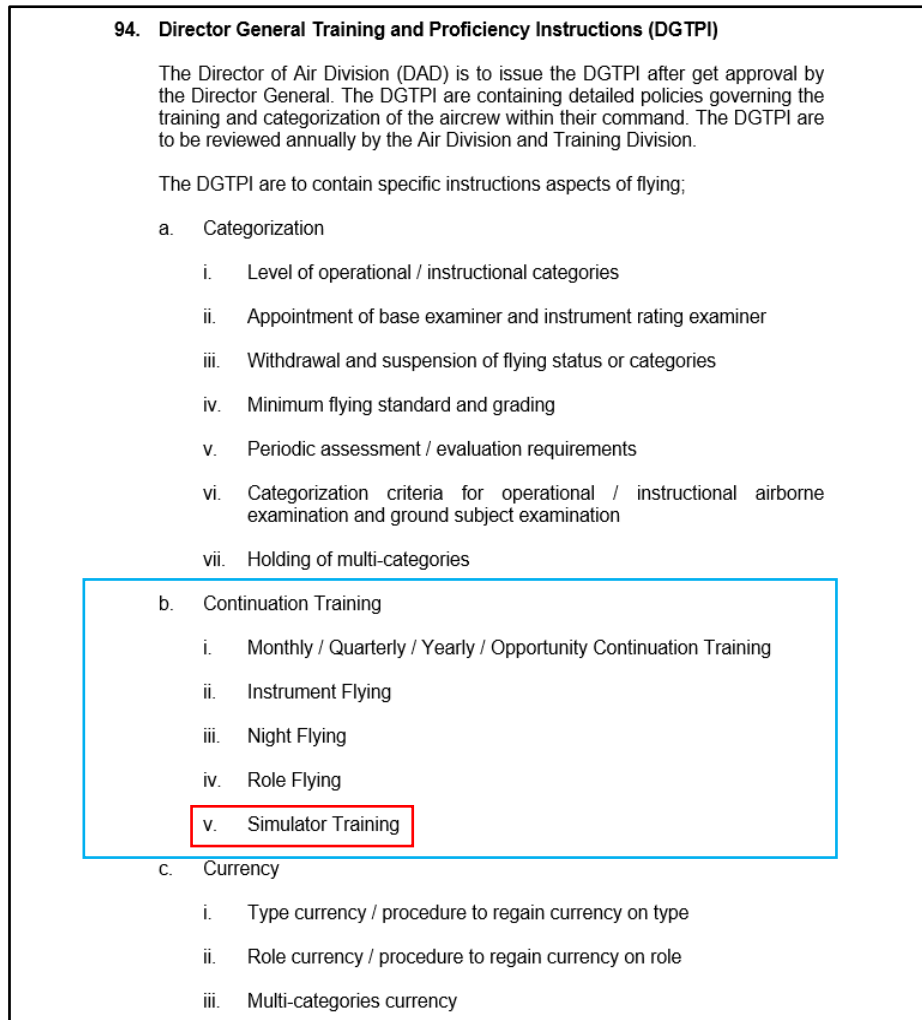
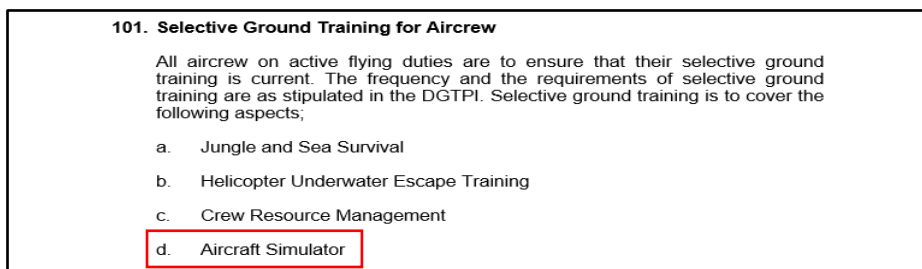
Figure 7: Directive 94(b), DGFD

The investigation found that the FRDM had never sent their AW189 pilots for recurrent flight simulator training. The only time the pilots had attended flight simulator training was during their initial type conversion training. This was not compliant with the stipulation in the Director General Flying Directives (DGFD, Directive 94(b) and Directive 101(d)) as illustrated in Figure 7 and Figure 8.

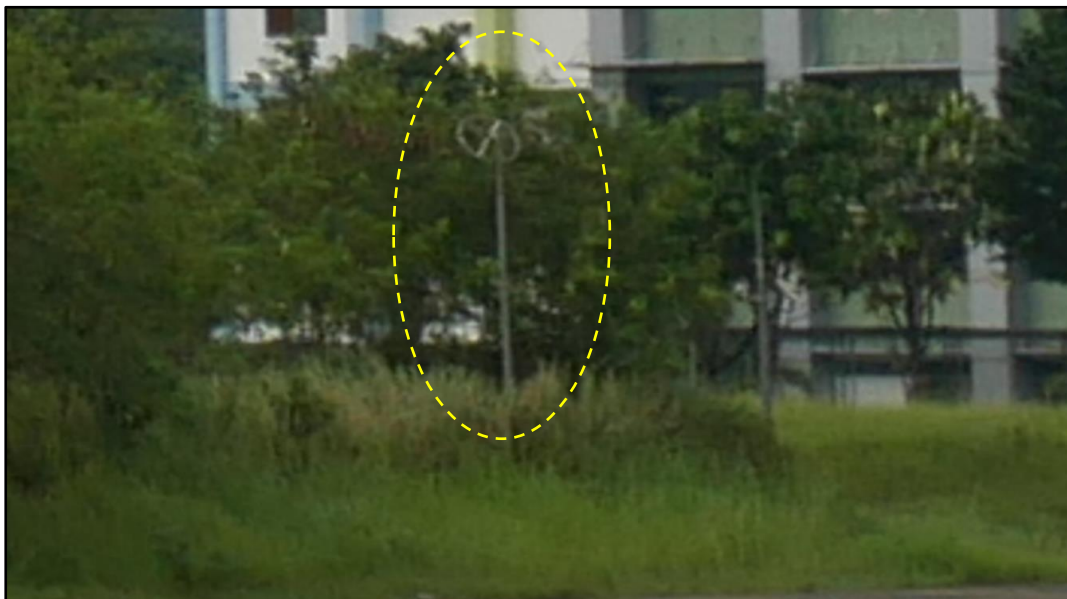
Figure 9: Windsock Pole Without the Windsock

During the investigation, it was observed that the windsock at the TFA was left with the pole only, without any windsock as shown in Figure 9. The absence of a proper windsock in the TFA that is surrounded by vertical obstructions of substantial height, as noted earlier in this report, is hazardous to flight operation due to the unavailability of any actual wind direction and speed indications to aid safe manoeuvring by pilots in such a confined area.

In summary, the CCTVs and the windsock should have been maintained in good working conditions to ensure the safety of operation and security of the facility, its tenants, and the TFA operator itself. This function should be placed under the responsibility of a qualified Safety Officer appointed by the facility provider.

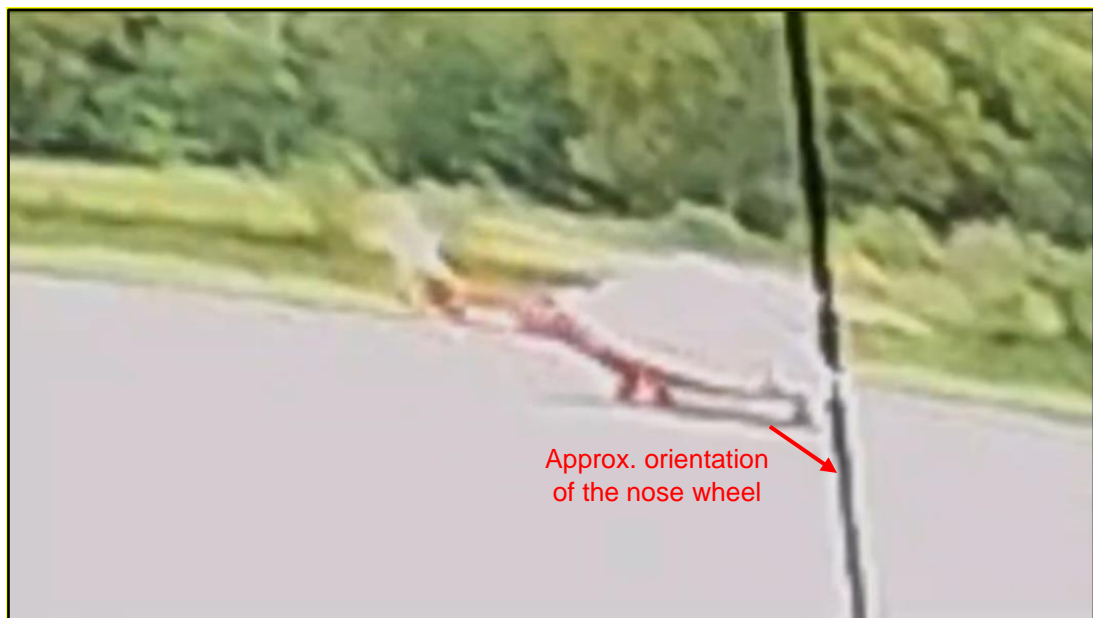
Figure 13: Video footage obtained from a CCTV

The TFA and the hangar were installed with surveillance cameras that were able to record the accident sequence. The video footage obtained includes the recording of all the pre-flight activities and the subsequent helicopter rollover. In the last portion of the video footage, it was possible to observe the final right rotation of the aircraft. Despite the limited quality of the video, it is clear that the nose wheel was not in a centred position when the aircraft completed the right turn and came to a stop (Figure 13).

This evidence explains the reason why the aircraft did not immediately start to rotate on the left when the crew applied the left pedal at time $T = 03:49:10$ (refer to the diagrams below). In the off-centred condition, the nose wheel could have counteracted the left rotation, therefore requiring more tail rotor thrust than necessary for a centred (neutral) nose wheel position.

Unaware of it at the time, the nose wheel's improper centring (as shown in Figure 13) may have prevented the PIC's first left pedal input from producing any discernible left

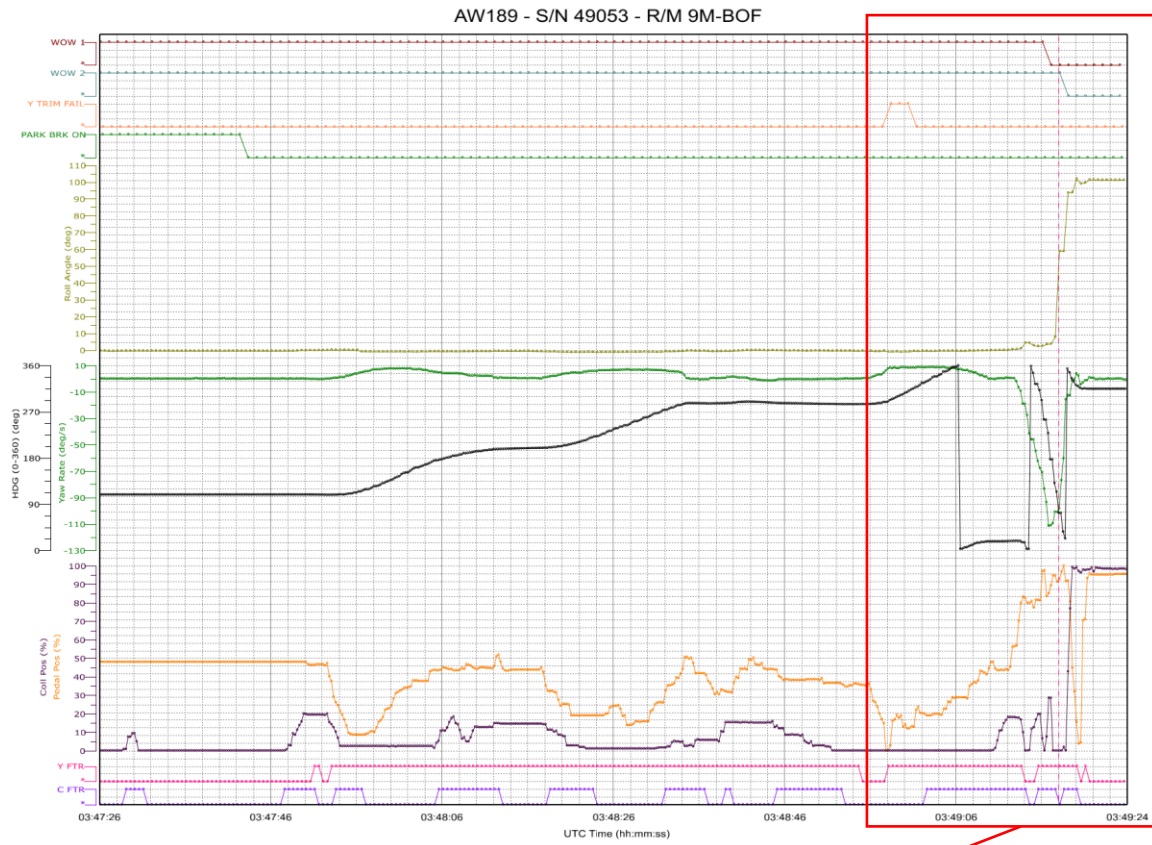
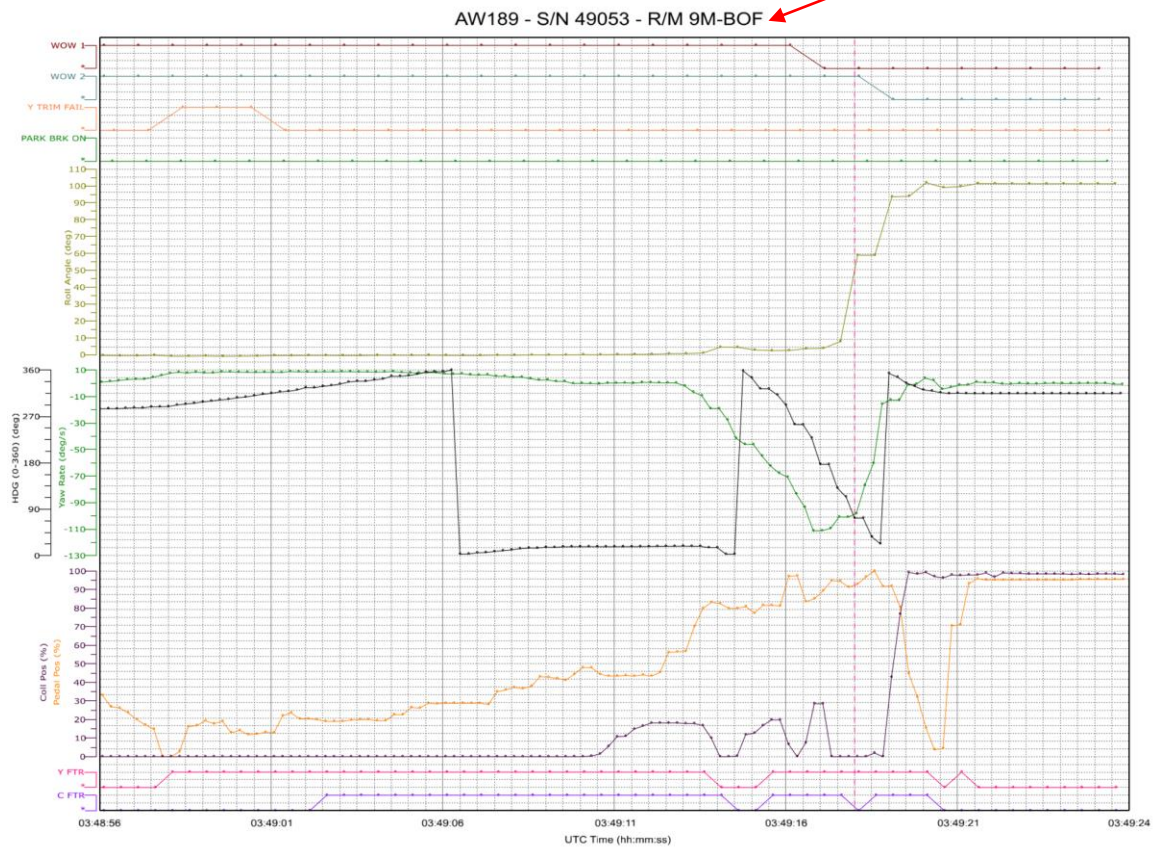
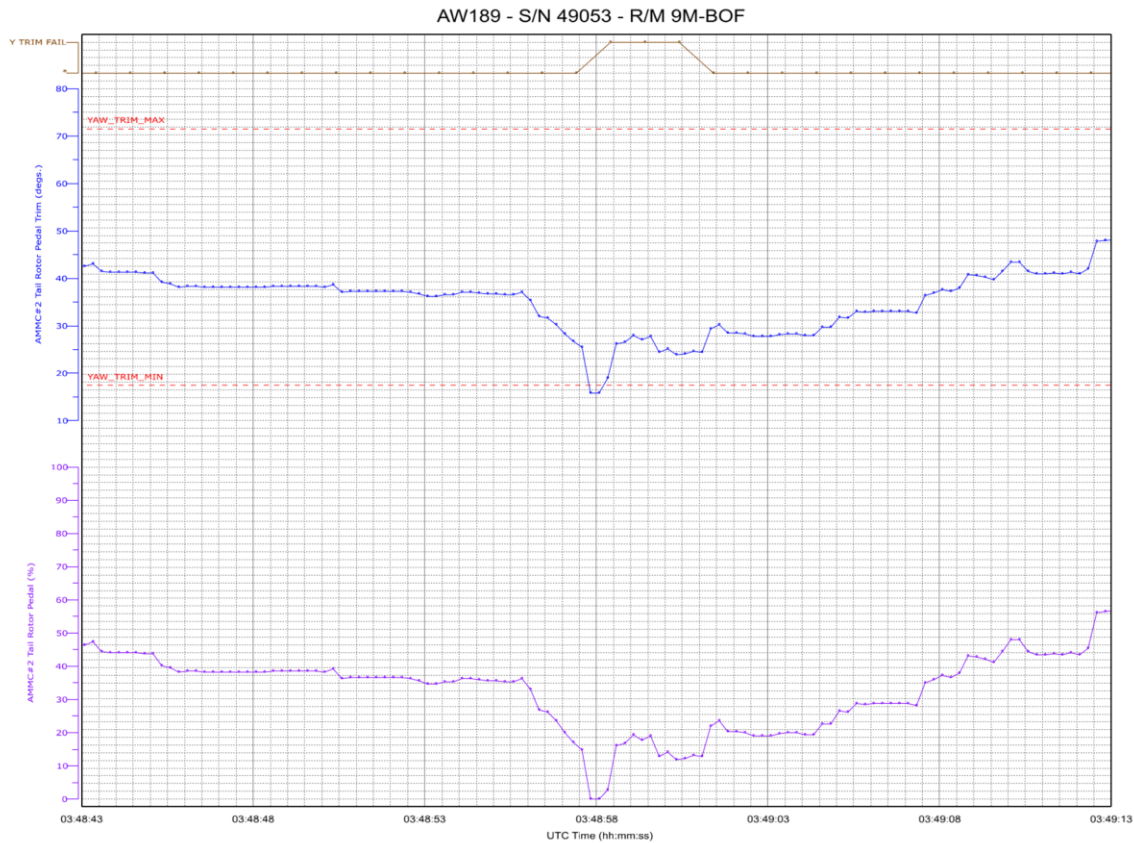
As depicted in the diagrams below, at T = 03:47:40 the crew activated both the Autopilot (AP) channels and immediately deactivated the parking brakes. At T = 03:47:50 the collective Force Trim Release (FTR) switch was activated and the PIC started to gently raise the collective control. The control increased up to 20% in 2 seconds and was kept in position for about 3 seconds when the PIC progressively applied the right pedal while reducing the collective to the Minimum Pitch on Ground (MPOG). The pedal displacement was observed in the range of about 37% in a 3-second timeframe.

After a few more seconds at T = 03:48:55, a new right pedal input was observed – the pedal position went from 36% to 15% in about 3 seconds while maintaining a full down collective position. The pedal movement was not associated with the FTR activation which suggests that the input was commanded by the PIC acting against the pedal feel spring (DET).

Approaching the 15% pedal position, the recorded data shows a step input down to 0% in a quarter of a second. This input took place in conjunction with the activation of the pedal FTR switch and the Y TRIM FAIL caution message, which remained active for about 2 seconds. The aircraft then began to rotate to the right in accordance with the pedal input; the yaw rate increased up to 8° and was kept almost constant with subsequent pedal adjustments. About 13 seconds after the pedal input and having completed a further 90° right rotation, the aircraft came to a stop.

In summary, during the final ground rotation, the PIC was actively acting on the flight controls, and the aircraft response was always in accordance with the recorded inputs. The observed temporary activation of the Y TRIM FAIL caution message, prior to the last 90° rotation to the right, is not considered to be a contributing factor to the subsequent loss of control of the aircraft .
