AIRCRAFT SERIOUS INCIDENT
FINAL REPORT
SI 06/23P
Air Accident Investigation Bureau (AAIB)
Ministry of Transport, Malaysia

Fixed Wing Aircraft Piper PA-28-181 Archer III

Registration 9M-ITQ

REPORT NO.: SI 06/23

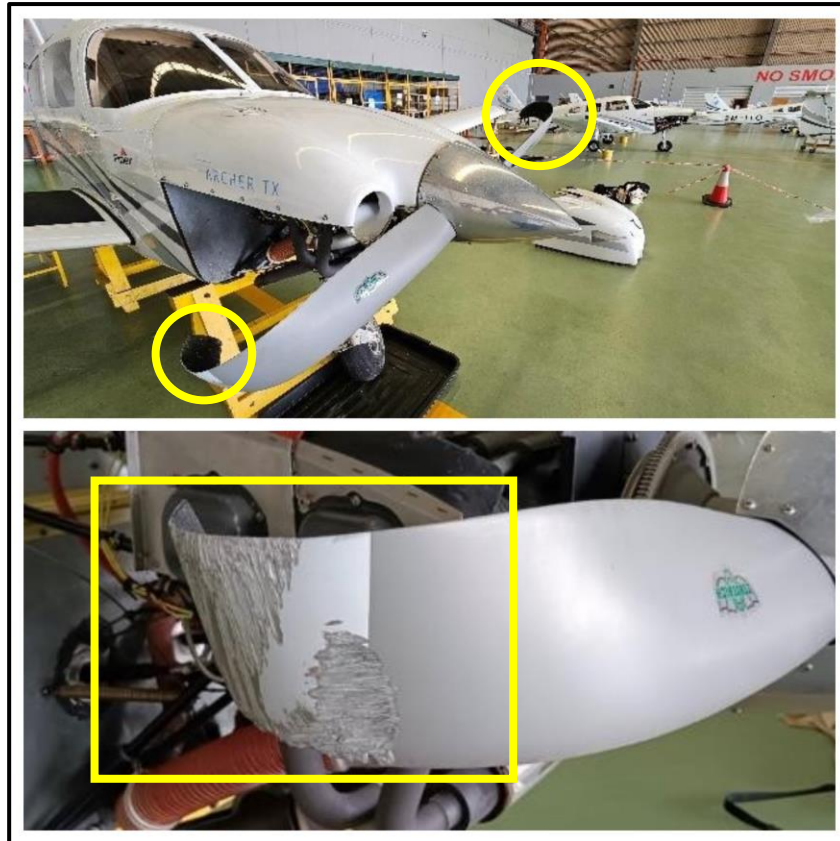
A general visual inspection was carried out to assess and identify the damage to the aircraft after the occurrence. Damage was found on both propeller tips, with scratches and bent on both sides of the propeller, the NLG broken, and some damage on the aircraft belly skin as can be seen in the pictures below.

Figure 1: Bent and scratches on both sides of the propeller

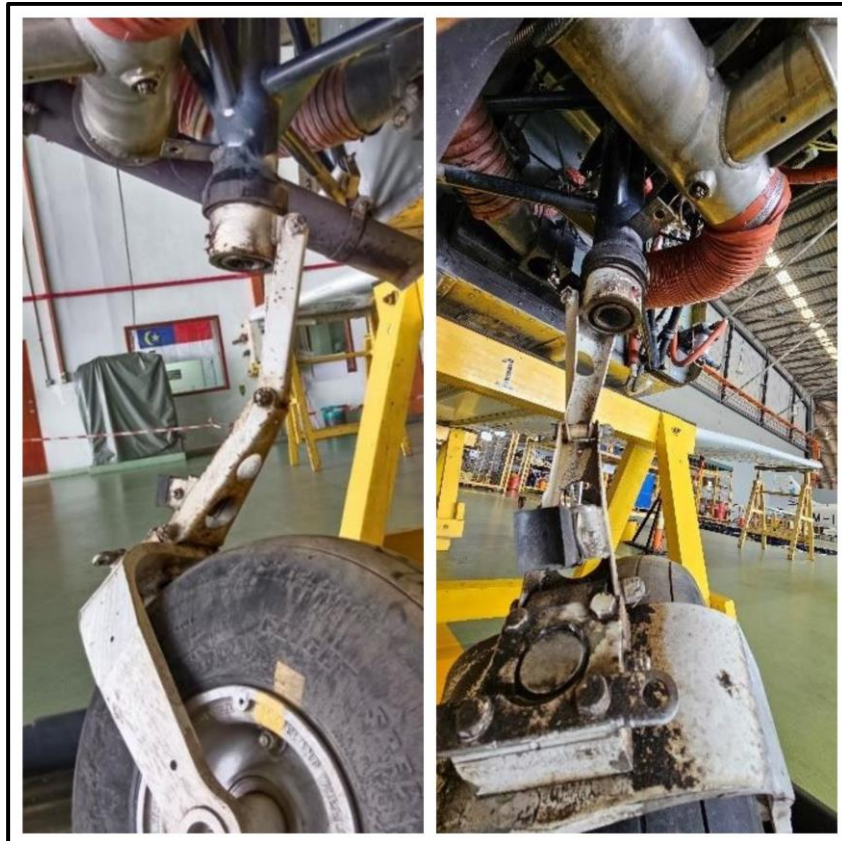
As the aircraft was coming for landing at Malacca International Airport, Melaka (WMKM), as soon as the wheels touched the surface of the runway, the aircraft bounced several times and caused the nose landing gear (NLG) to collapse and eventually came to rest slightly to the right from the center of the runway.

Figure 2: Broken nose landing gear (NLG)

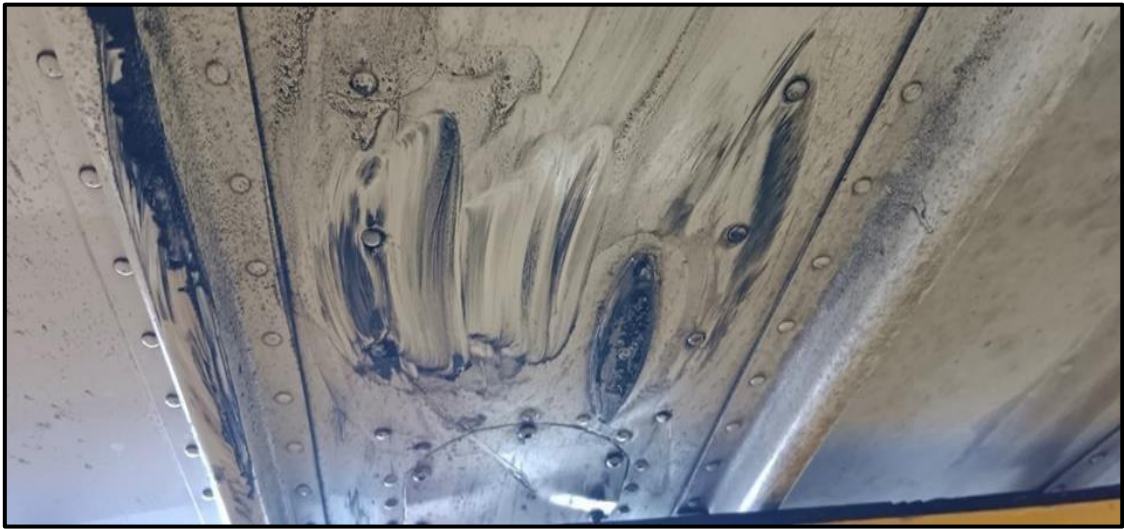
Figure 3: Damaged belly skin

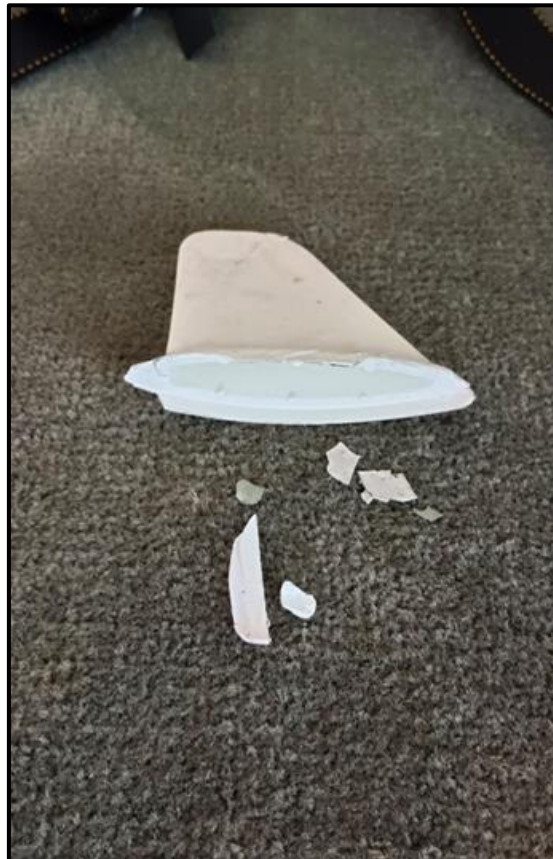
Figure 4: DME Antenna broken

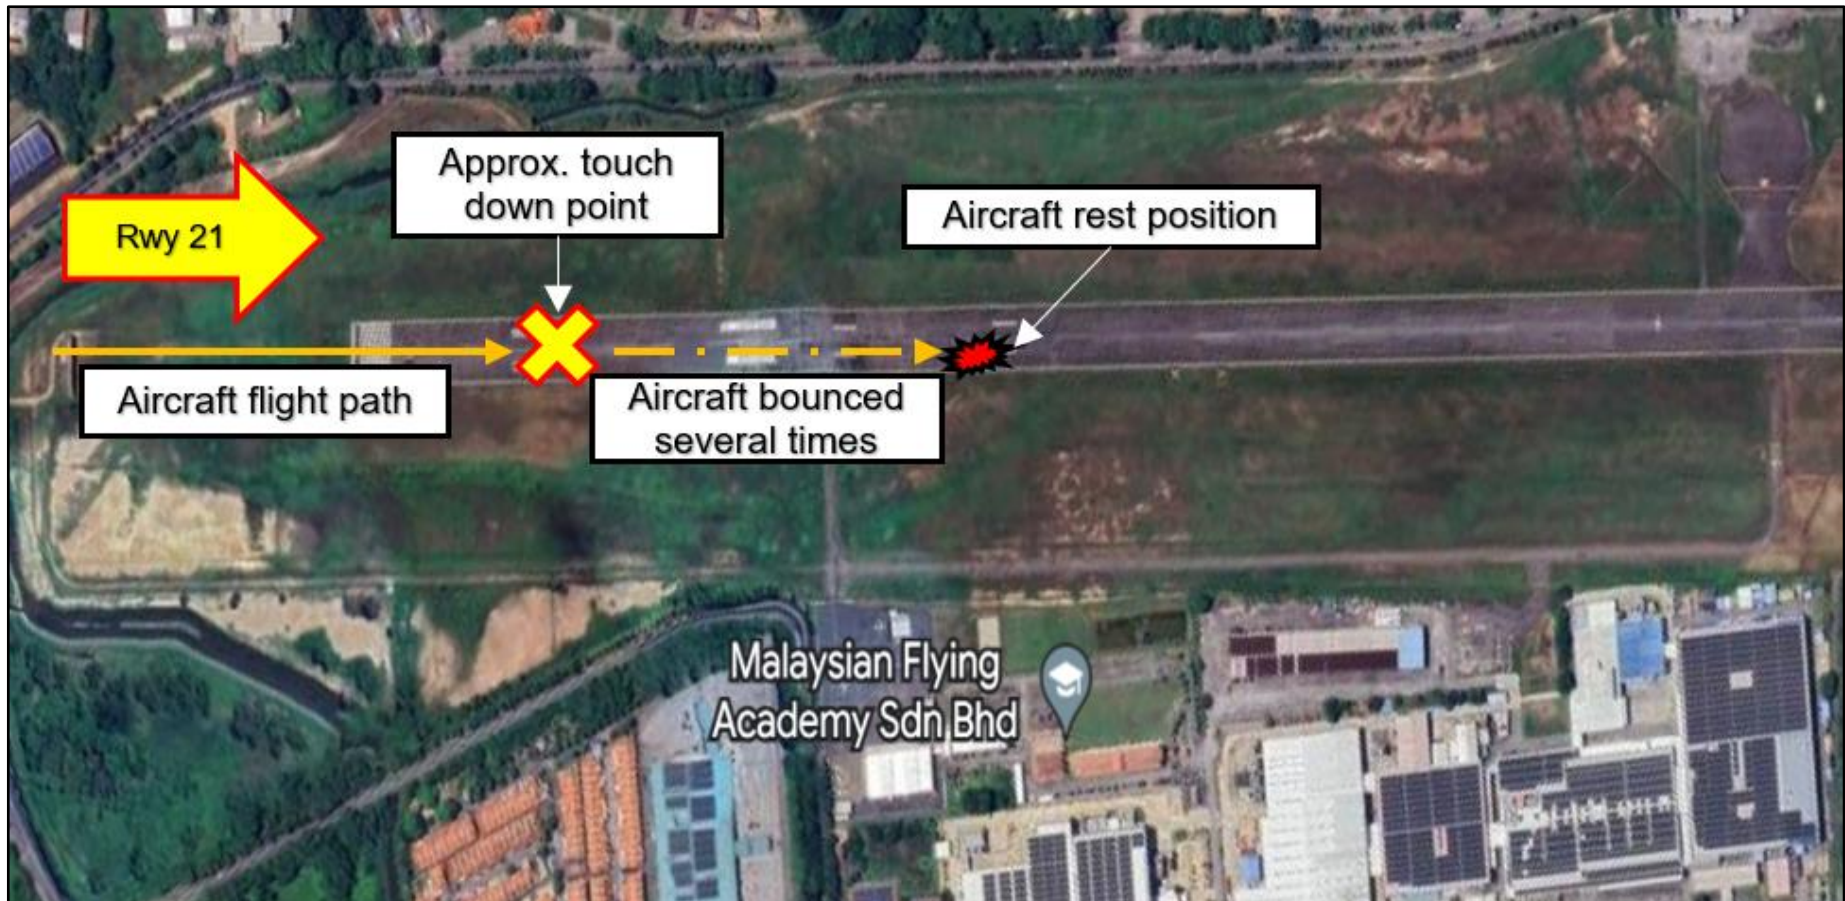
Figure 6: 9M-ITQ general description map of the incident (Source: Google Earth)

Figure 6 below provides a general description of the site, the final portion of the flight path, the touch-down area, the impact sequence, and the location of impact impressions on the ground. The 'orange arrow' indicates the last flight path prior to touch-down, the 'yellow X' is the touch-down point, the 'broken orange arrow'

illustrates the aircraft bounce sequence, and the 'red area' shows the location of the last aircraft position after it stops

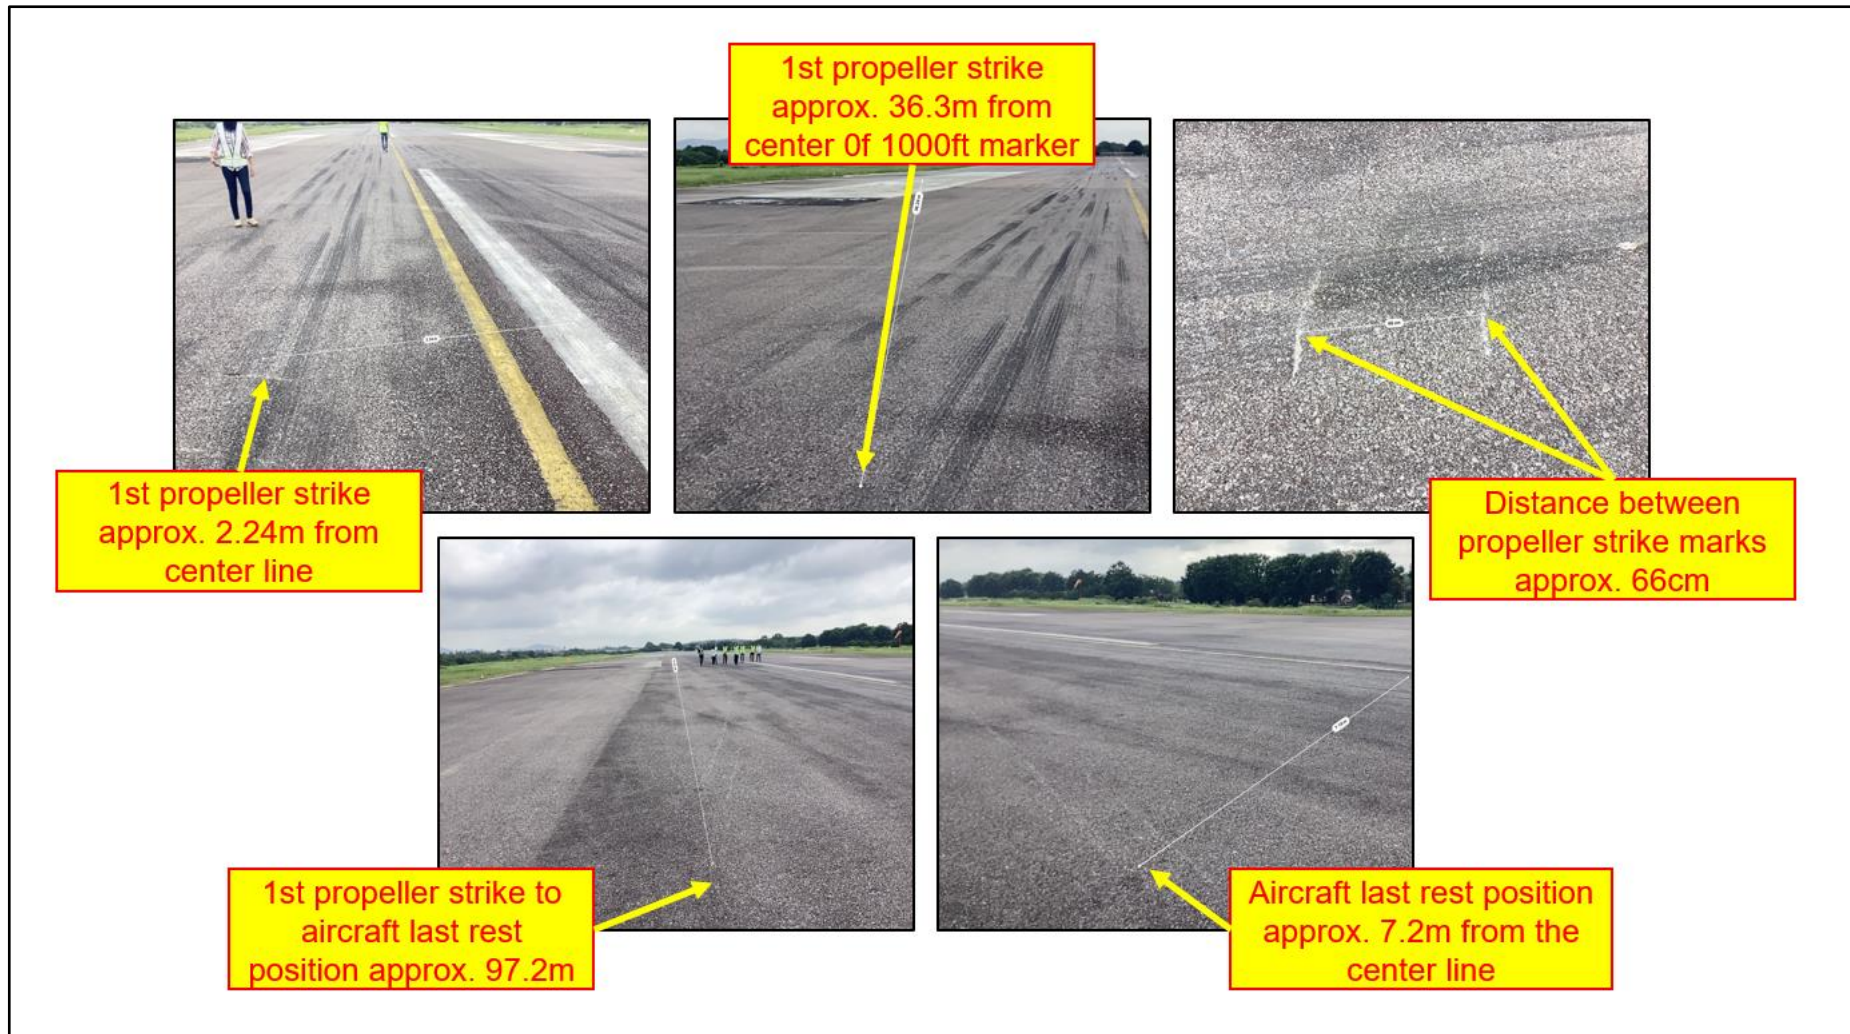
Figure 7: General description of the impact information

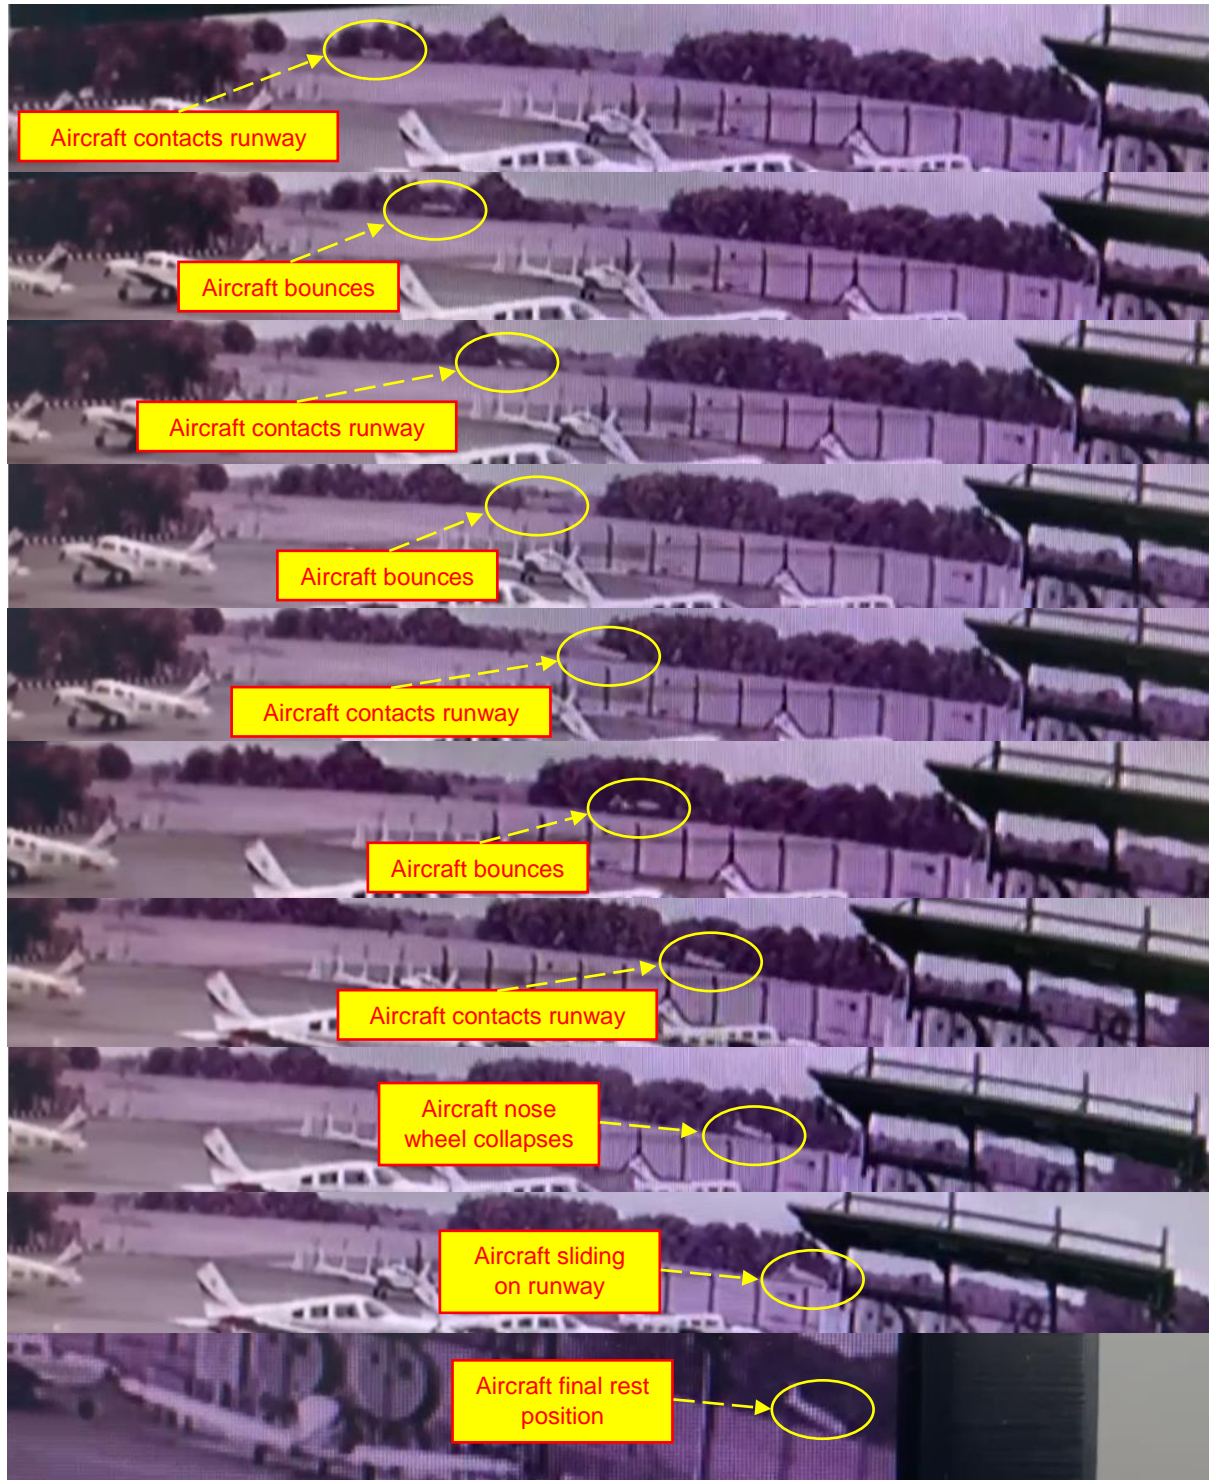
installed onboard the aircraft and the video footage obtained from one of the CCTV from the Malaysia Flying Academy (MFA). The sequence of events during the landing retrieved from the CCTV is depicted in Figure 12.

Figure 12: 9M-ITQ sequence of events during landing
