AIRCRAFT SERIOUS INCIDENT

SI 01/23

Piper Archer III PA28-181, Registration 9M-SKJ

at an Open Construction Area in Jasin, Malacca

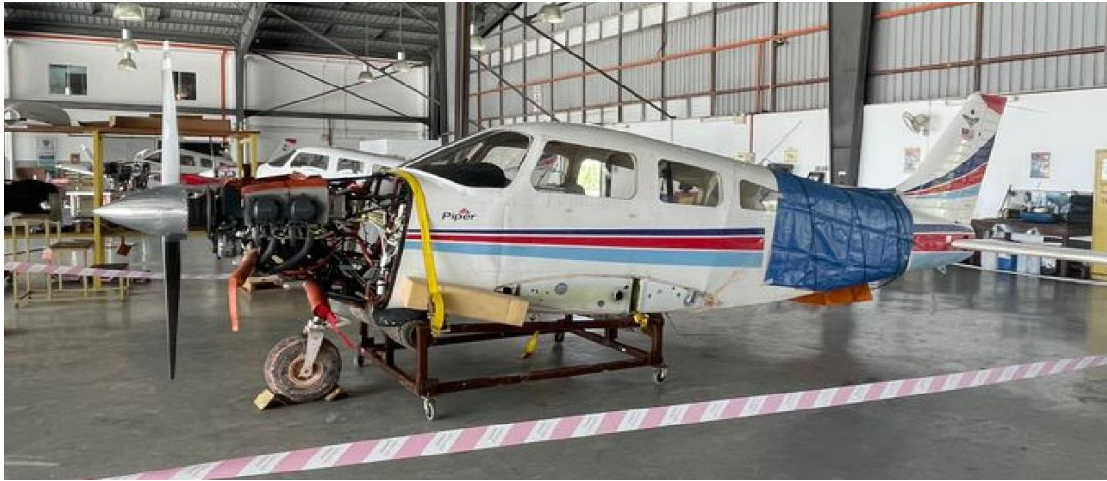
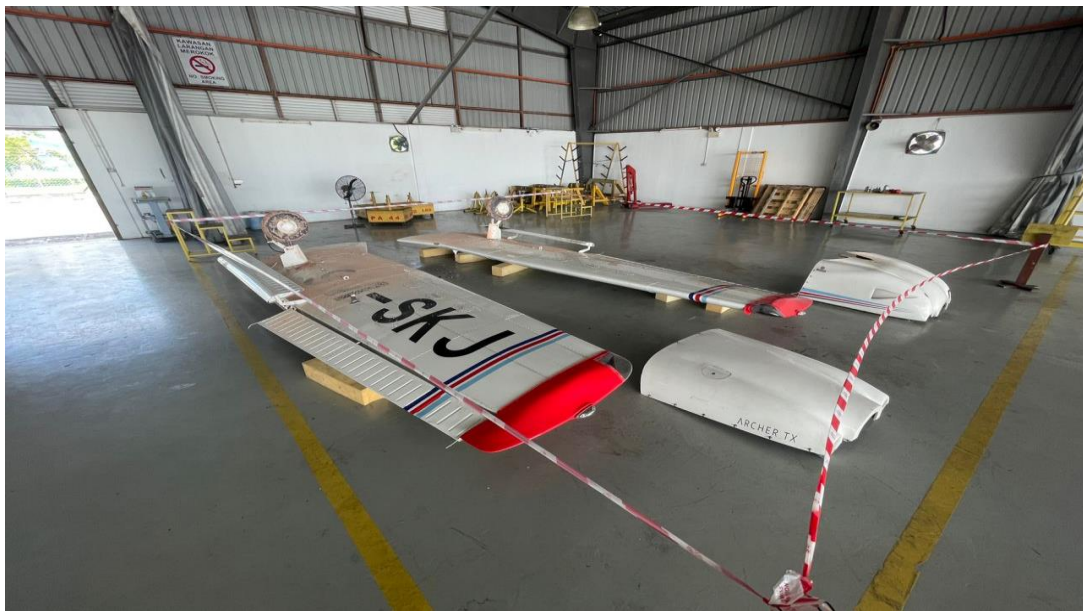
Post-incident inspection revealed no damages to the aircraft. Both the aircraft wings were disassembled at the incident site and the aircraft was transported back by road to the aircraft operator's hangar at Batu Berendam, Malacca.

Figure 2: Aircraft condition at the hangar after salvage activities from the crash site

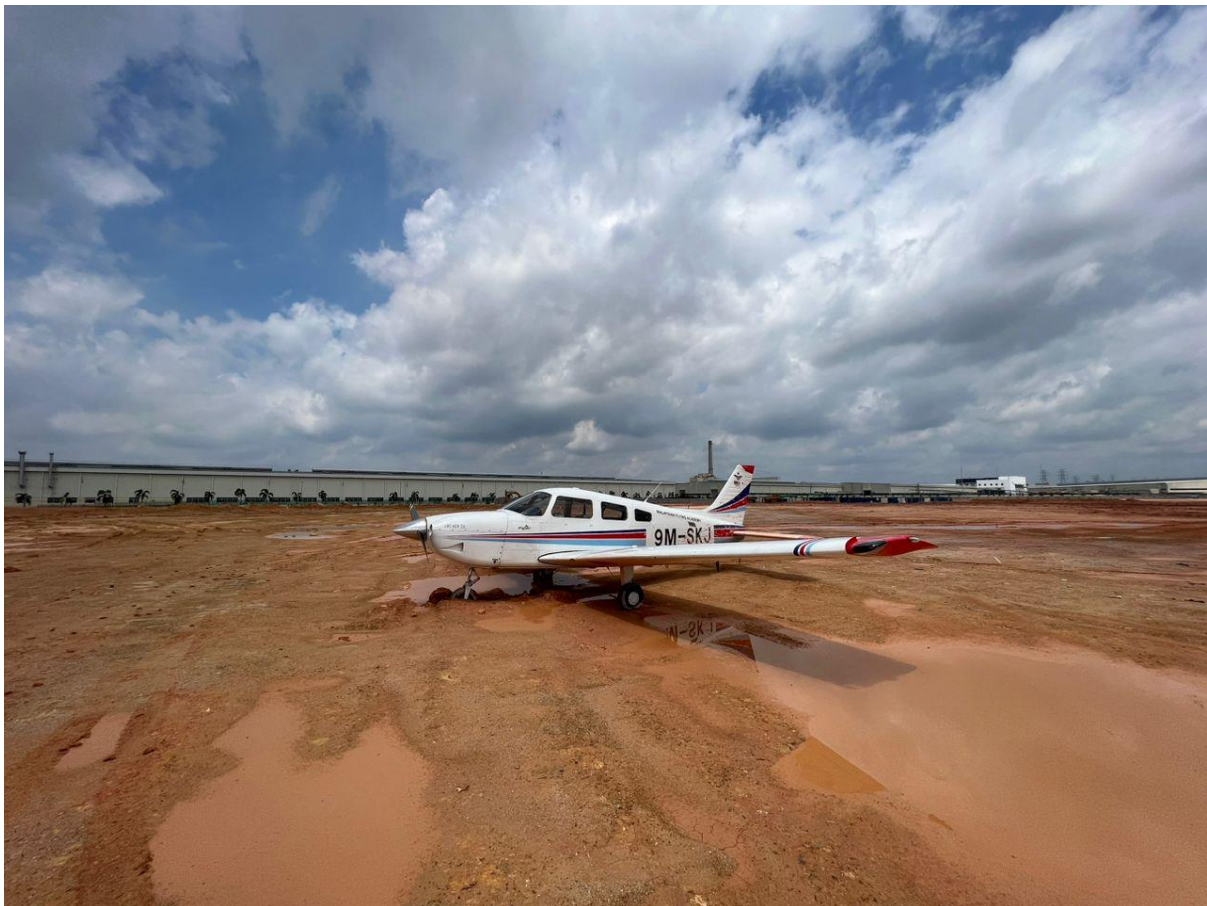
Figure 12: Final position of aircraft at the open construction area in Jasin.

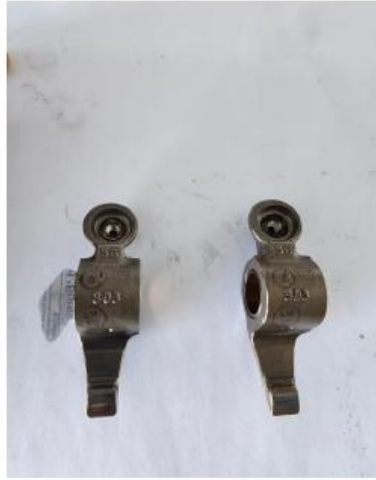
1. ROCKER ARMS

No abnormalities were discovered during our inspection of cylinder #3.
