# Runway excursions on take-off involving Airbus A330-323, 9M-MTL, and Boeing 787-9, VN-A819

Melbourne Airport, Victoria, on 7 and 18 September 2023

Aviation Occurrence Investigation (Systemic)

AO-2023-043

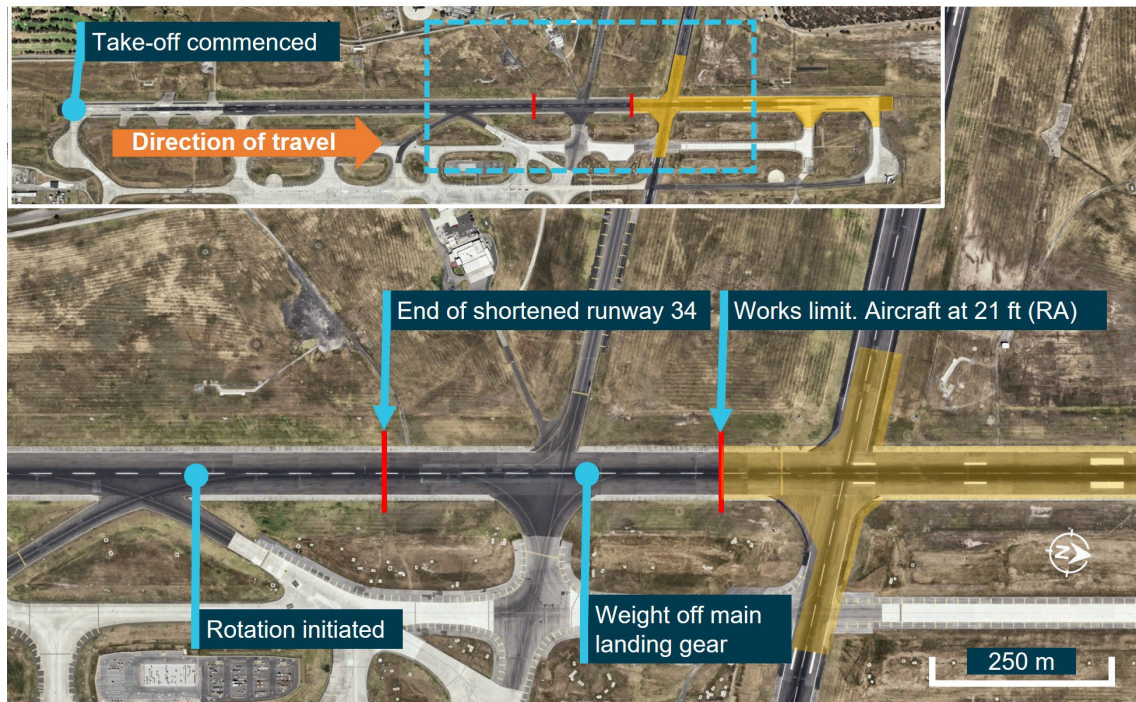
**Figure 3: 9M-MTL take-off relative to runway works**

<sup>20</sup> Radio altitude is calibrated to record zero height above ground as the main landing gear touches the runway in typical landing attitude. The values in this report are corrected for the additional aircraft pitch angle on take-off which would introduce a small error due to the position of the radio antennae. Additionally, the A330 position data was recorded at 2 second intervals, which would also introduce a small uncertainty in the aircraft position and height, however, the relevant data point was adjacent to the works limit.

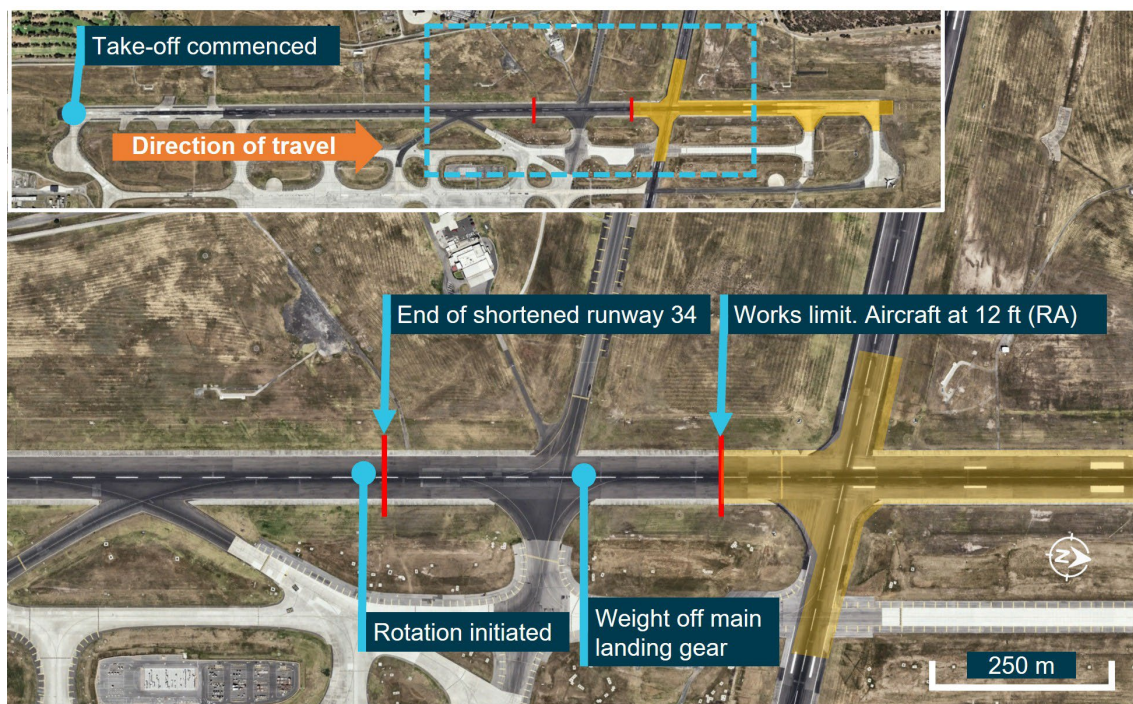
**Figure 6: VN-A819 take-off relative to runway works**

During the take-off run, the PM and PIC observed that the runway end lights appeared closer than normal at lift-off. ATSB flight data analysis identified the lift-off point<sup>31</sup> as just past the runway intersection with taxiway E (Figure 6). As the aircraft crossed the works limit line, the recorded radio altitude was approximately 15 ft (4.5 m).<sup>32</sup> A visual impression of the proximity of the aircraft to the works limit is shown in Figure 7.

Jet blast on the works limit displaced and damaged unserviceability lights and marking cones. There were no reported physical injuries, however, one worker reported a stress-related injury as a result of the close proximity of the aircraft to their vehicle.

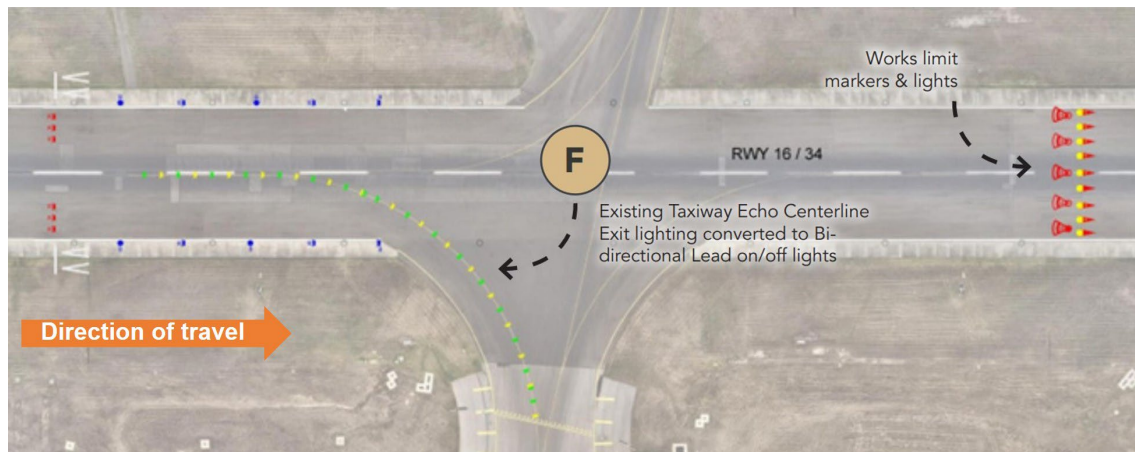
**Figure 12: Temporary runway 34 end and works limit arrangement**

- The runway centreline lighting was not available (switched off) and the runway edge lights were not colour-coded for the displaced threshold.<sup>57</sup>
- Temporary runway 34 end lights were installed, consisting of 6 lights, in 2 groups of 3 with a central gap. This was due to the presence of the declared stopway/starter-extension, to allow aircraft to pass through for departure from the runway 16 displaced threshold.
- A row of evenly-spaced, low-intensity,<sup>58</sup> unserviceability lights were placed across the works limit line.
